## Post Installation Report

Creative Play (UK) Ltd.

The Steyning Centre Play Area

Fletchers Croft, Steyning, BN44 3XZ

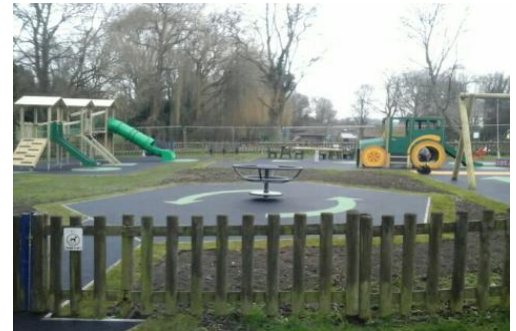
**Item:** Site General  
**Manufacturer:** Owner/Operator  
**Surface Type:** N/A  
**Equipment Compliance:** N/A  
**Surface Area Compliance:** N/A

It is recommended that information signs with emergency contact details are installed at each entrance/exit point to the playground - Provide in accordance with the recommendations set out in BS EN 1176

The landscaping is incomplete - Complete landscaping

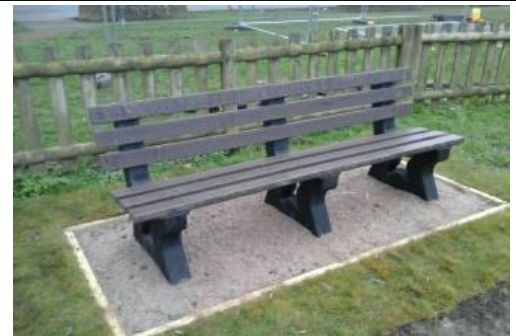
**Item:** Bench  
**Manufacturer:** Not Identified  
**Surface Type:** Gravel  
**Equipment Compliance:** N/A  
**Surface Area Compliance:** N/A

This item is satisfactory - no work required -

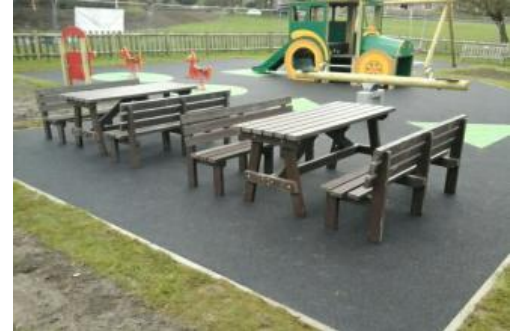
**Item:** Picnic Table  
**Manufacturer:** Not Identified  
**Surface Type:** Wet Pour  
**Equipment Compliance:** N/A  
**Surface Area Compliance:** N/A

This item is satisfactory - no work required -

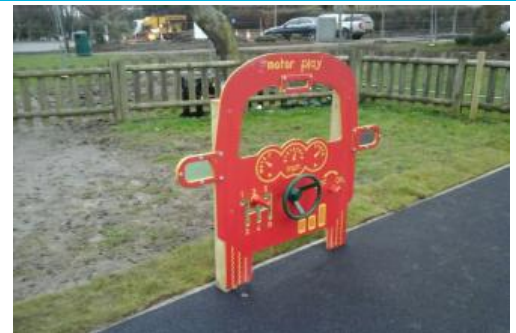
**Item:** Play Panel  
**Manufacturer:** Creative Play  
**Surface Type:** Wet Pour  
**Equipment Compliance:** Yes  
**Surface Area Compliance:** N/A

This item is satisfactory - no work required -

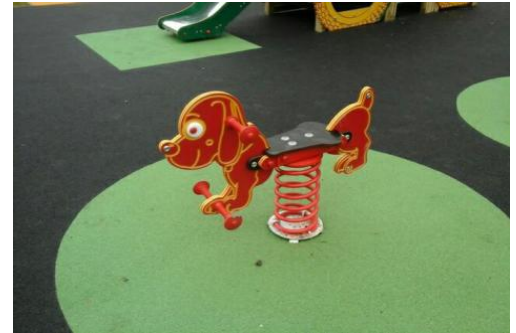
**Item:** Spring Dog  
**Manufacturer:** Creative Play  
**Surface Type:** Wet Pour  
**Equipment Compliance:** Yes  
**Surface Area Compliance:** Yes

There is no identification label affixed to the equipment - Provide an identification label

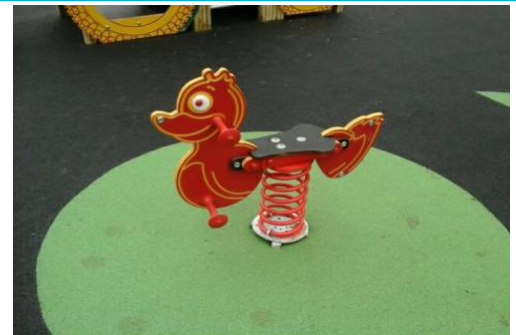
**Item:** Spring Duck  
**Manufacturer:** Creative Play  
**Surface Type:** Wet Pour  
**Equipment Compliance:** Yes  
**Surface Area Compliance:** Yes

There is no identification label affixed to the equipment - Provide an identification label

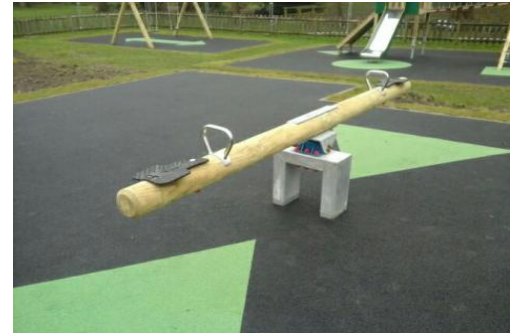
**Item:** See Saw  
**Manufacturer:** Creative Play  
**Surface Type:** Wet Pour  
**Equipment Compliance:** Yes  
**Surface Area Compliance:** Yes

There is no identification label affixed to the equipment - Provide an identification label

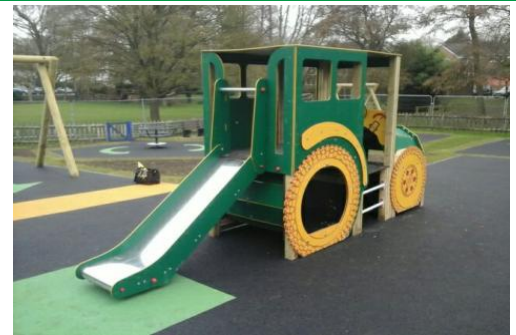
**Item:** Tractor  
**Manufacturer:** Creative Play  
**Surface Type:** Wet Pour  
**Equipment Compliance:** No  
**Surface Area Compliance:** Yes

There is significant flexibility within the panel above the 'front' window, gaps in excess of 12mm can be opened up - Secure panel

There is no identification label affixed to the equipment - Provide an identification label

There are a number of missing fixings in and around the tunnel - Provide all missing fixings

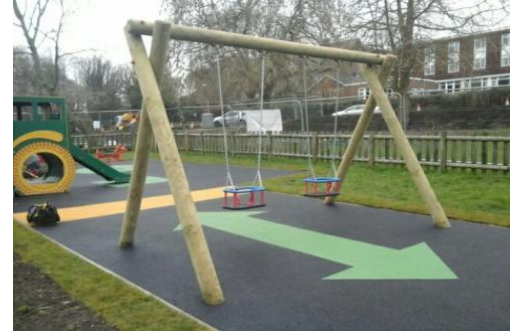
**Item:** 1 Bay 2 Seat (Cradle)  
**Manufacturer:** Creative Play  
**Surface Type:** Wet Pour  
**Equipment Compliance:** Yes  
**Surface Area Compliance:** Yes

There is no identification label affixed to the equipment - Provide an identification label

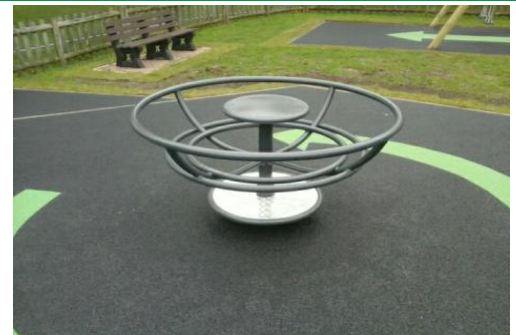
**Item:** Roundabout  
**Manufacturer:** Not Identified  
**Surface Type:** Wet Pour  
**Equipment Compliance:** Yes  
**Surface Area Compliance:** Yes

The distance between the underside of the roundabout platform and the playing surface is in excess of 110mm and contravenes the requirements of BS EN 1176 Part 5 which requires that the distance be maintained between 60mm-110mm - for the entire circumference of the roundabout (upto 125mm around approximately 50% of the circumference) - Refer to the contractor

There is no identification label affixed to the equipment - Provide an identification label

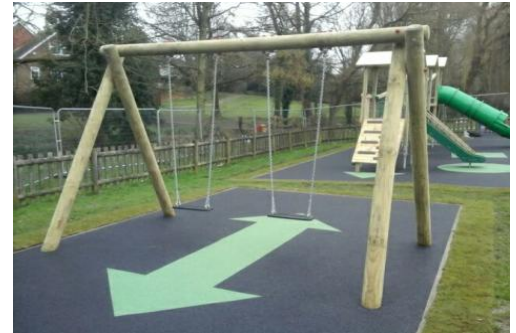
**Item:** 1 Bay 2 Seat (Flat)  
**Manufacturer:** Creative Play  
**Surface Type:** Wet Pour  
**Equipment Compliance:** Yes  
**Surface Area Compliance:** Yes

There is no identification label affixed to the equipment - Provide an identification label

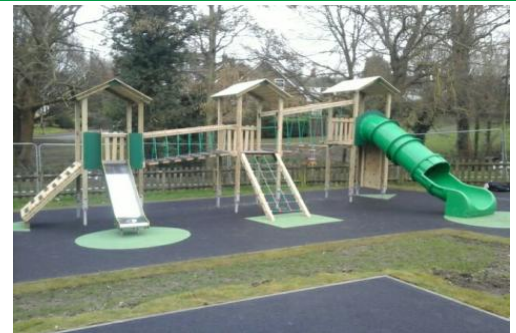
**Item:** Multi Play (Junior)  
**Manufacturer:** Creative Play  
**Surface Type:** Wet Pour  
**Equipment Compliance:** No  
**Surface Area Compliance:** Yes

The slide side height is 40mm less than the 150mm recommended by BS EN 1176 for this slide (free height of fall exceeds 1.2m) - Refer to the manufacturer

There are unused fixing points under the top of the tunnel slide - Refer to the manufacturer and provide if required

There are finger entrapments in some platform corners and the item fails to meet the requirements of BS EN 1176 Part 1 4.2.7.6 Entrapment of fingers - Refer to the manufacturer

The connecting links are in excess of 8.6mm and less than 12mm and fail the requirements of BS EN 1176 Part 1; clause 4.2.13, Chains - Refer to manufacturer

There are bolt cap covers missing on the tunnel slide - Provide missing bolt cap covers

There are gaps between the sliding sections inside the tunnel slide - Remove gaps

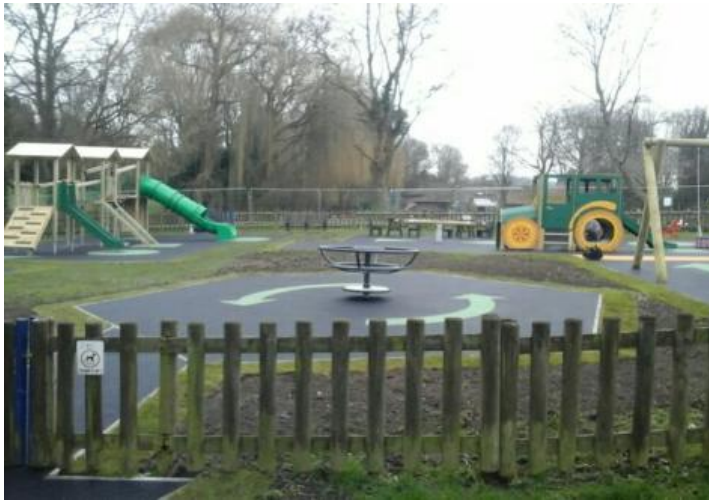
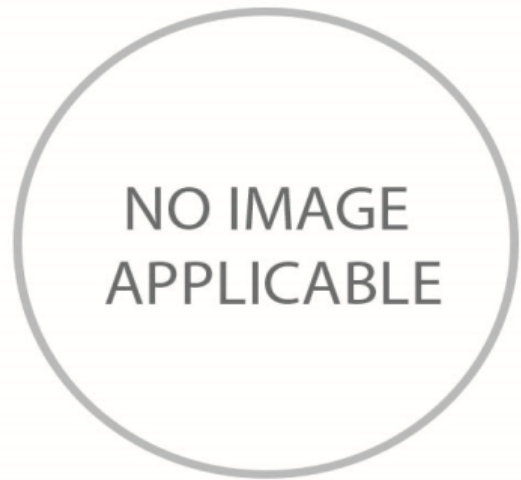
**Item:** Ancillary Items - Site General  
**Manufacturer:** Owner/Operator

**Finding:** It is recommended that information signs with emergency contact details are installed at each entrance/exit point to the playground  
**Action:** Provide in accordance with the recommendations set out in BS EN 1176

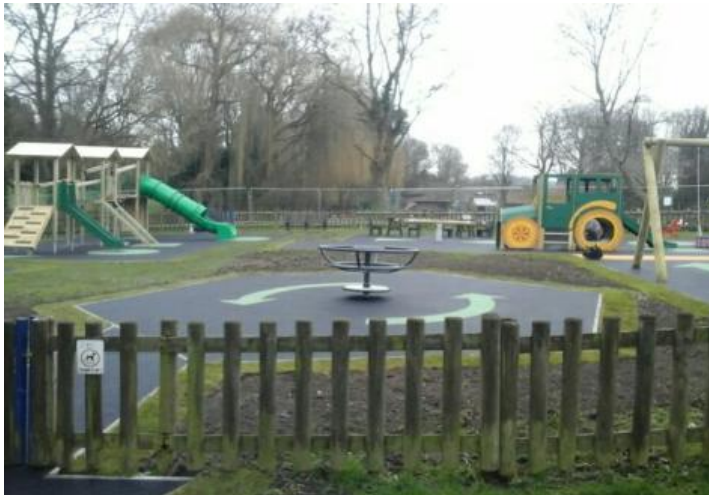
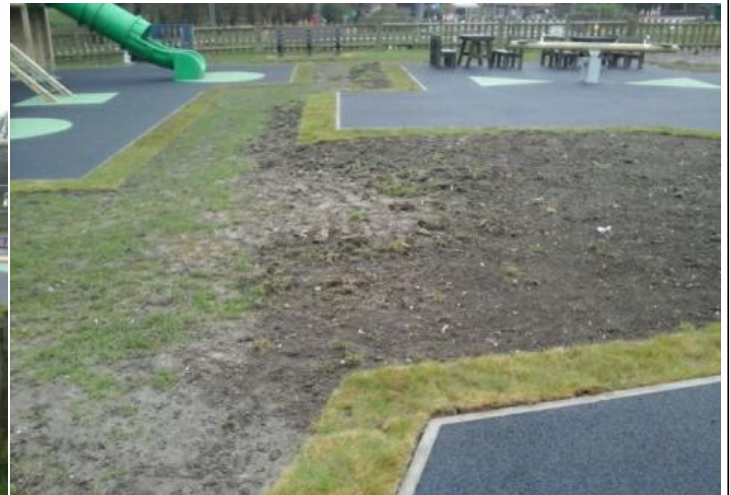
**Item:** Ancillary Items - Site General  
**Manufacturer:** Owner/Operator

**Finding:** The landscaping is incomplete

**Action:** Complete landscaping

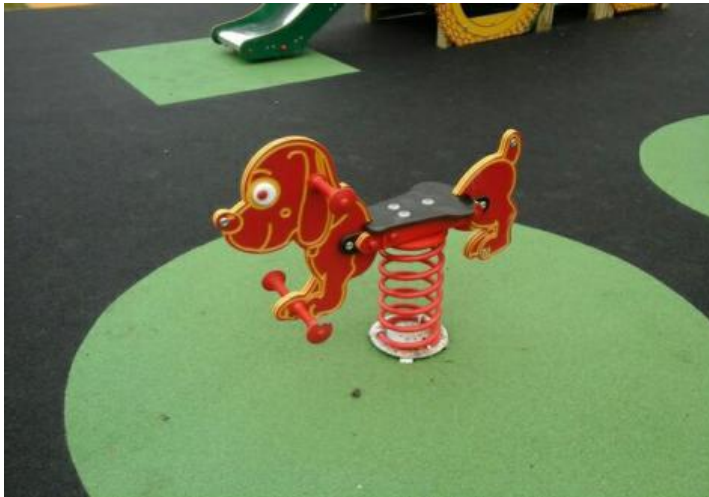
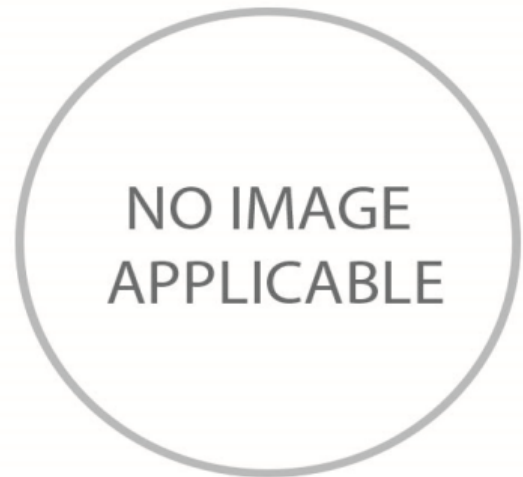
**Item:** Rocking Equipment - Spring Dog  
**Manufacturer:** Creative Play

**Finding:** There is no identification label affixed to the equipment

**Action:** Provide an identification label

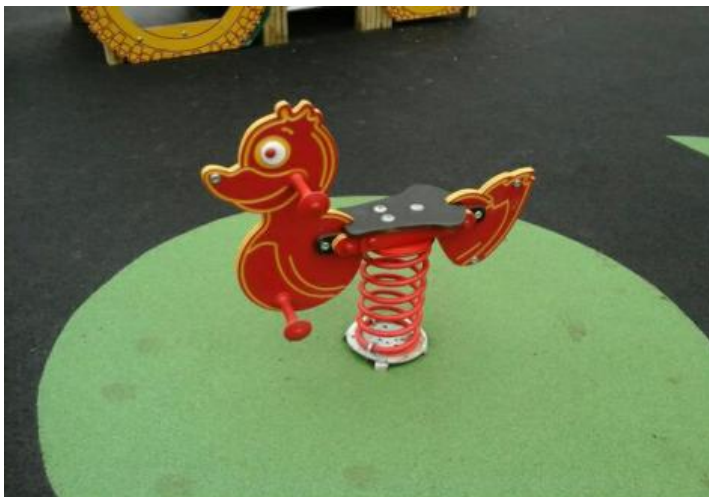
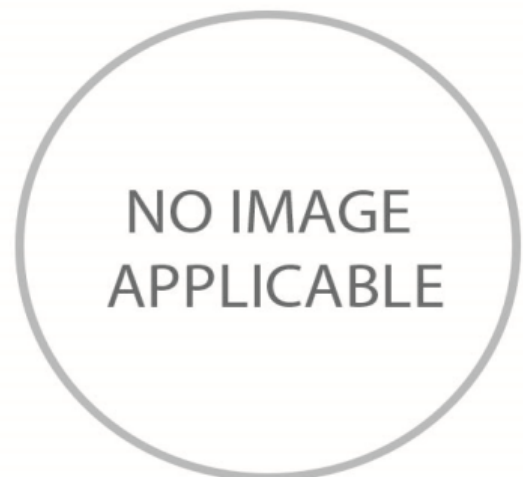
**Item:** Rocking Equipment - Spring Duck  
**Manufacturer:** Creative Play

**Finding:** There is no identification label affixed to the equipment

**Action:** Provide an identification label

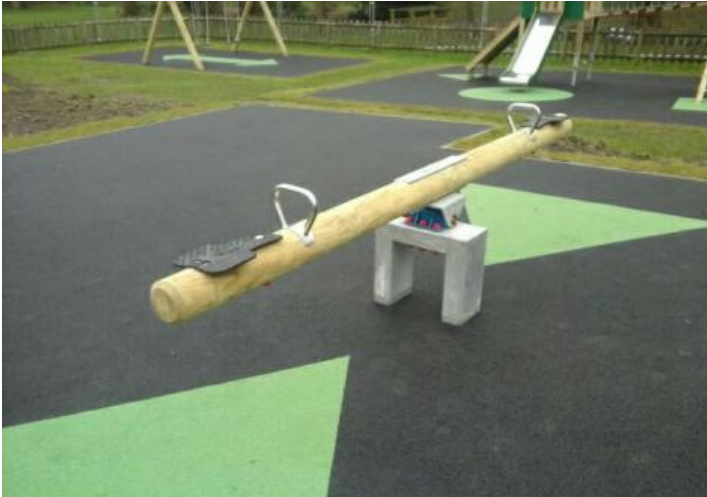
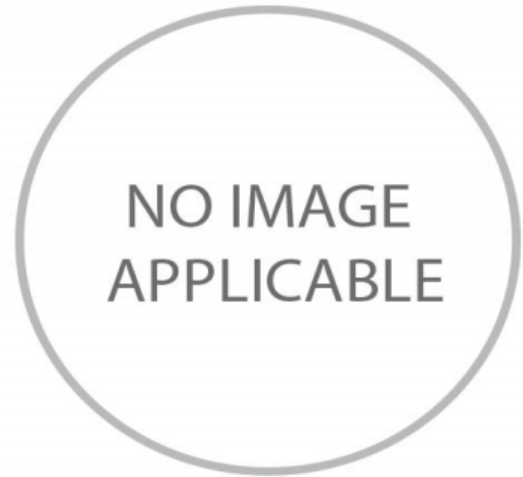
**Item:** Rocking Equipment - See Saw  
**Manufacturer:** Creative Play

**Finding:** There is no identification label affixed to the equipment

**Action:** Provide an identification label

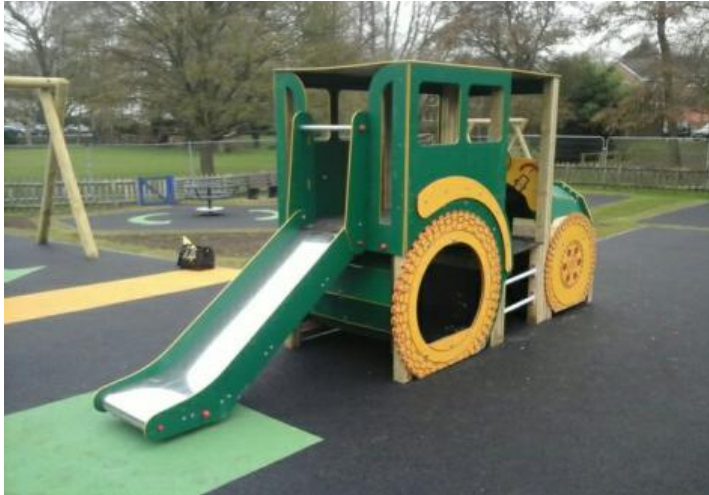
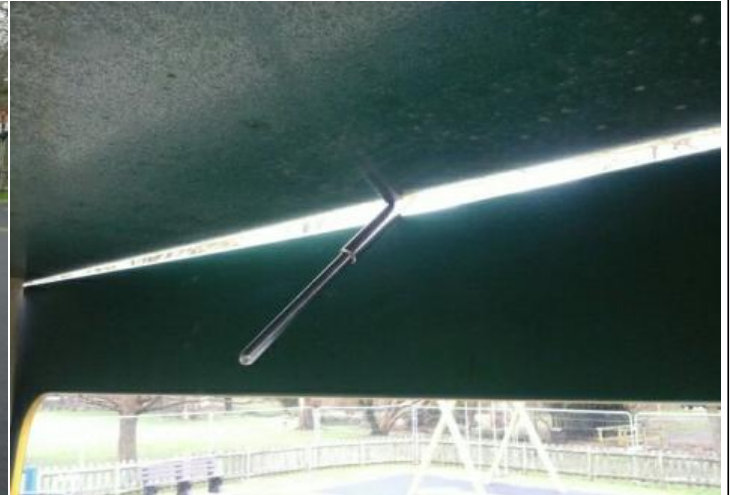
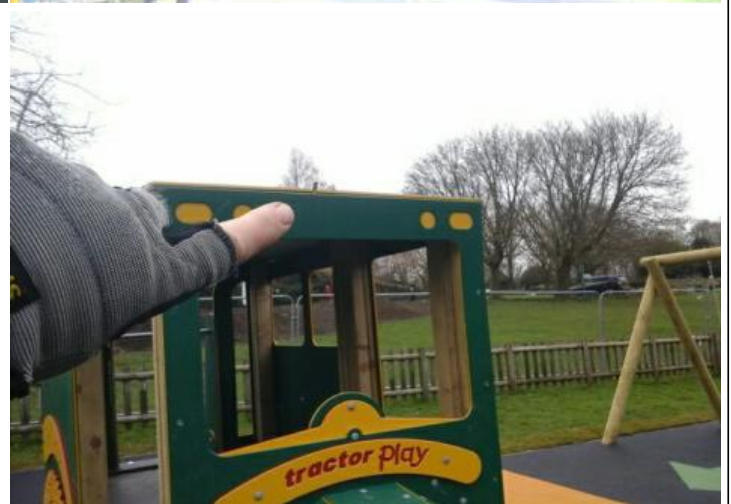
**Item:** Activity Equipment - Tractor  
**Manufacturer:** Creative Play

**Finding:** There is significant flexibility within the panel above the 'front' window, gaps in excess of 12mm can be opened up  
**Action:** Secure panel

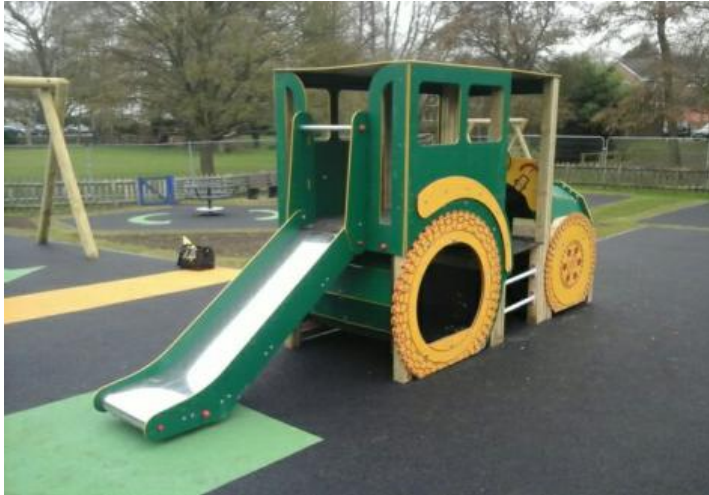
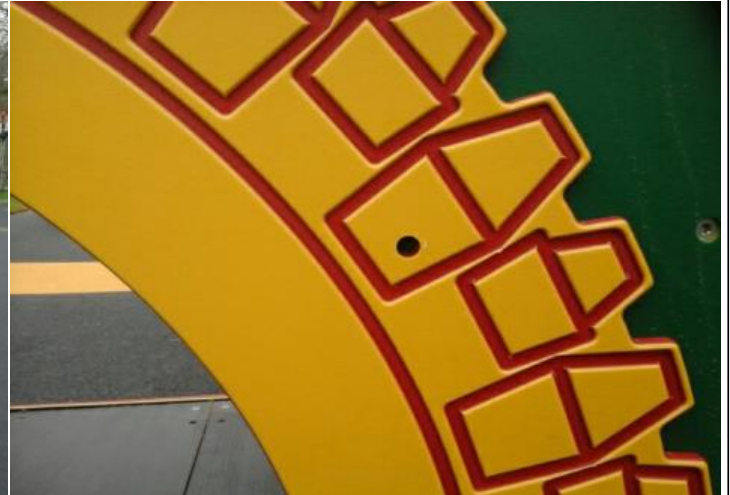
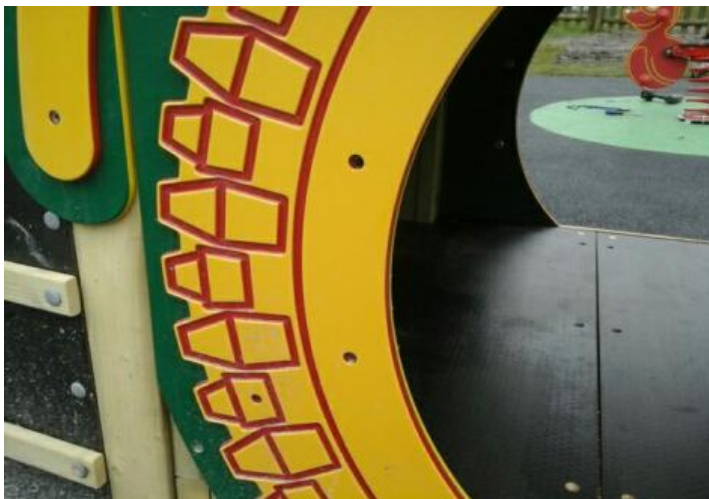
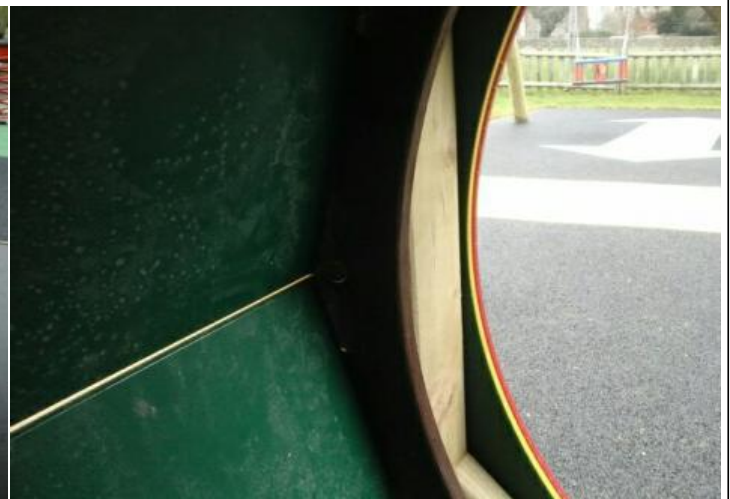
**Item:** Activity Equipment - Tractor  
**Manufacturer:** Creative Play

**Finding:** There are a number of missing fixings in and around the tunnel

**Action:** Provide all missing fixings

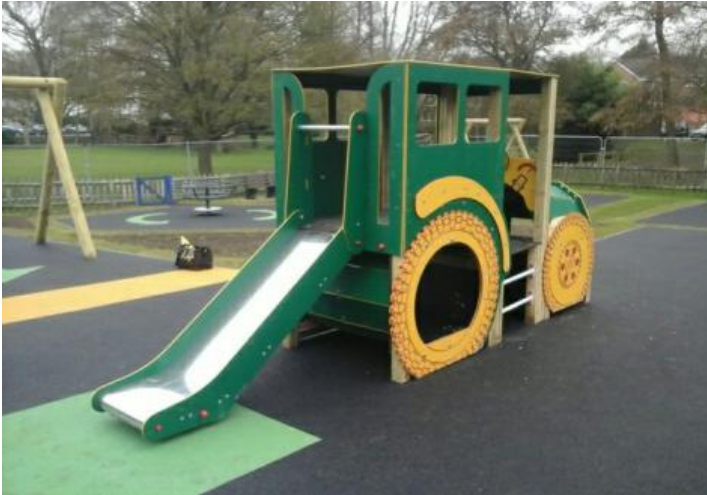
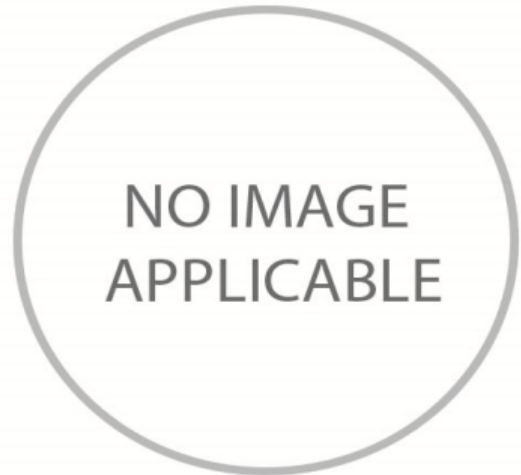
**Item:** Activity Equipment - Tractor  
**Manufacturer:** Creative Play

**Finding:** There is no identification label affixed to the equipment

**Action:** Provide an identification label

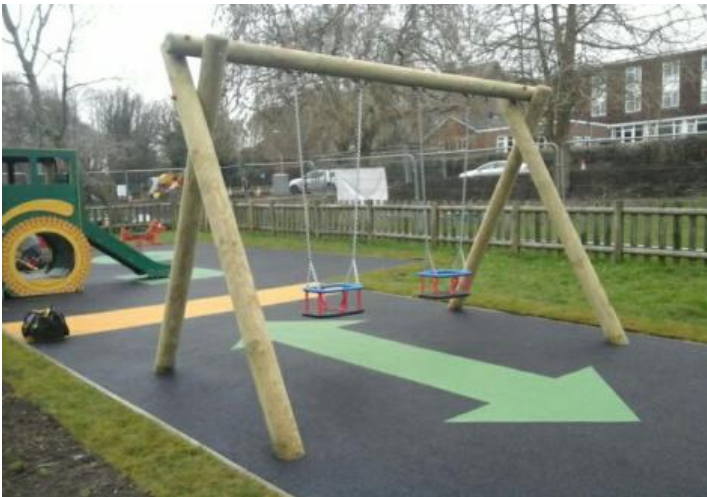
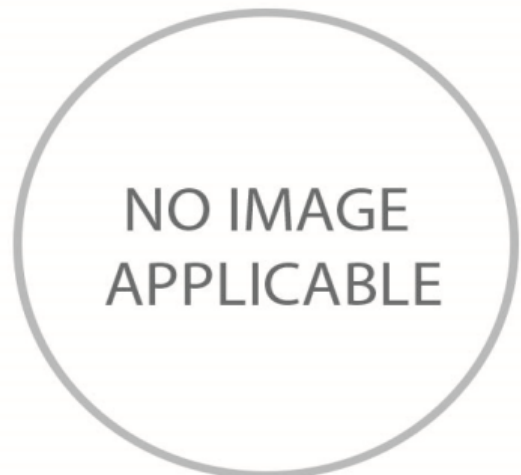
**Item:** Swings - 1 Bay 2 Seat (Cradle)  
**Manufacturer:** Creative Play

**Finding:** There is no identification label affixed to the equipment

**Action:** Provide an identification label

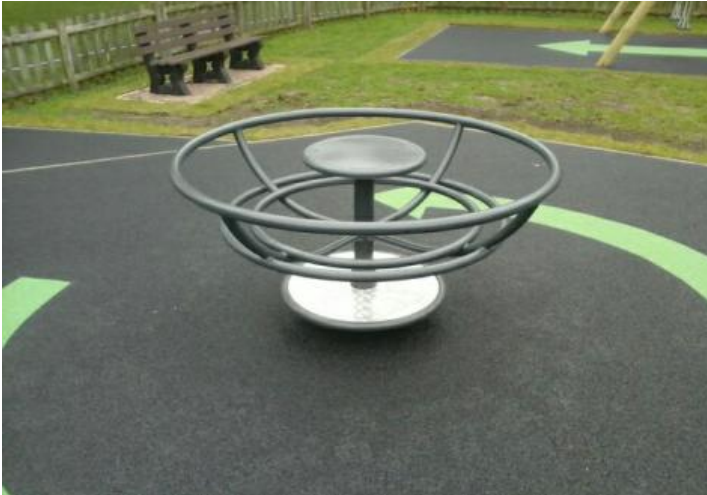
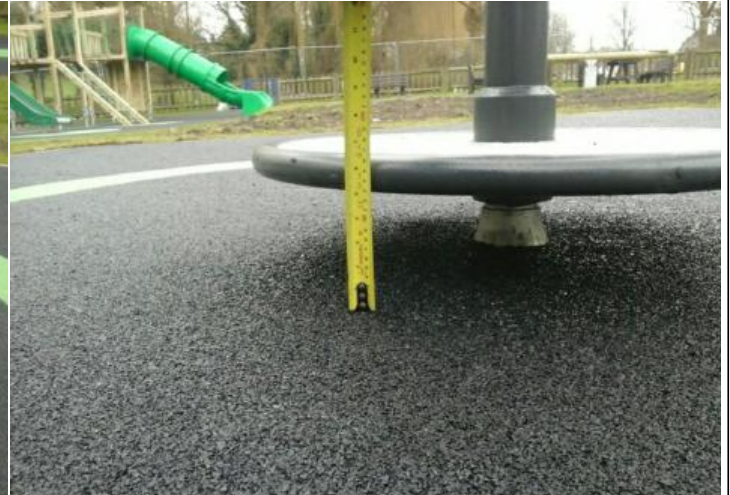
**Item:** Rotor Play - Roundabout  
**Manufacturer:** Not Identified

**Finding:** The distance between the underside of the roundabout platform and the playing surface is in excess of 110mm and contravenes the requirements of BS EN 1176 Part 5 which requires that the distance be maintained between 60mm-110mm - for the entire circumference of the roundabout (upto 125mm around approximately 50% of the circumference)

**Action:** Refer to the contractor

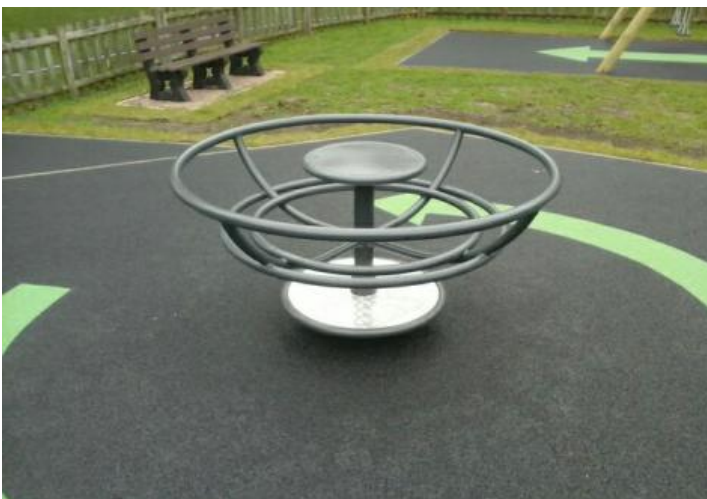
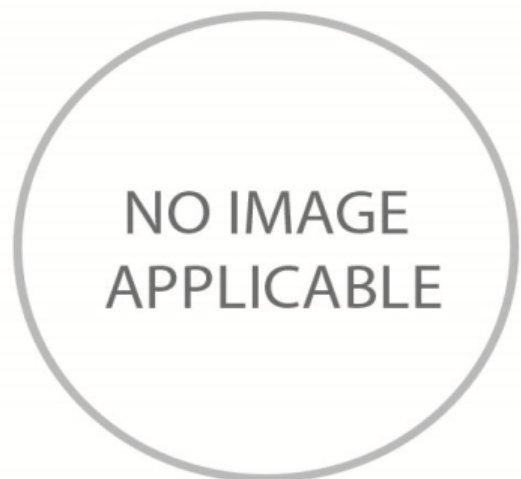
**Item:** Rotor Play - Roundabout  
**Manufacturer:** Not Identified

**Finding:** There is no identification label affixed to the equipment

**Action:** Provide an identification label

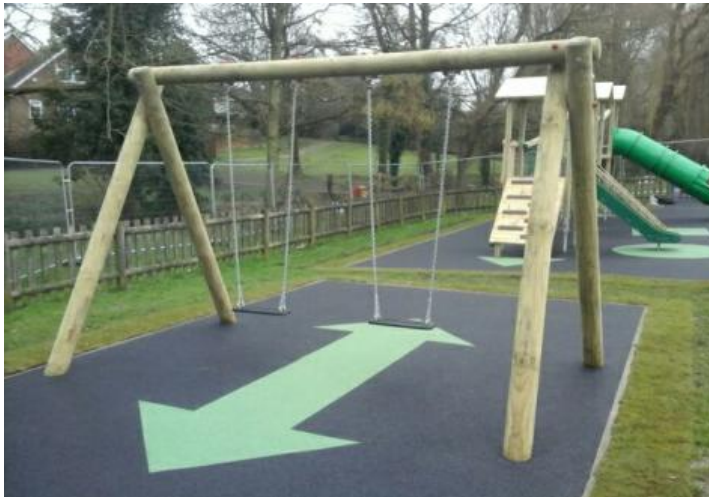
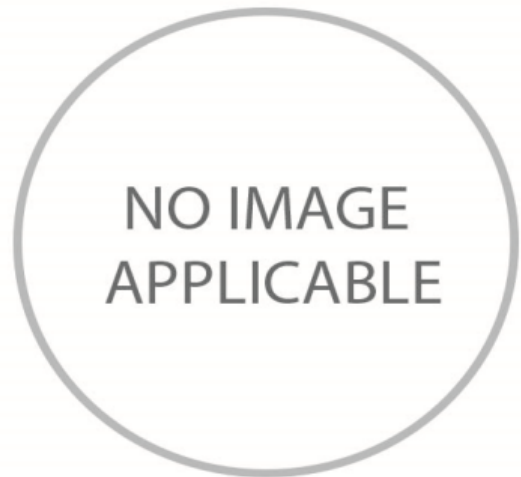
**Item:** Swings - 1 Bay 2 Seat (Flat)  
**Manufacturer:** Creative Play

**Finding:** There is no identification label affixed to the equipment

**Action:** Provide an identification label

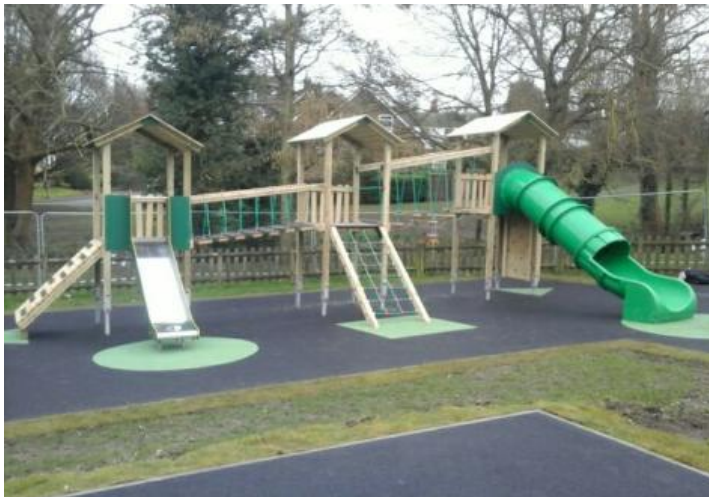
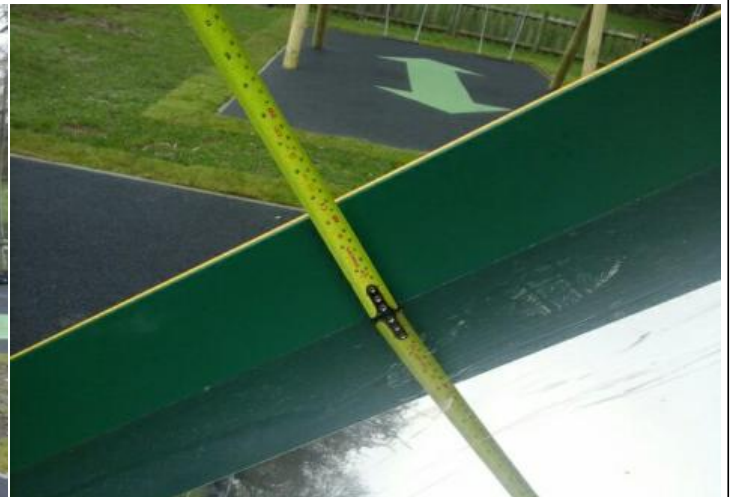
**Item:** Activity Equipment - Multi Play (Junior)  
**Manufacturer:** Creative Play

**Finding:** The slide side height is 40mm less than the 150mm recommended by BS EN 1176 for this slide (free height of fall exceeds 1.2m)

**Action:** Refer to the manufacturer

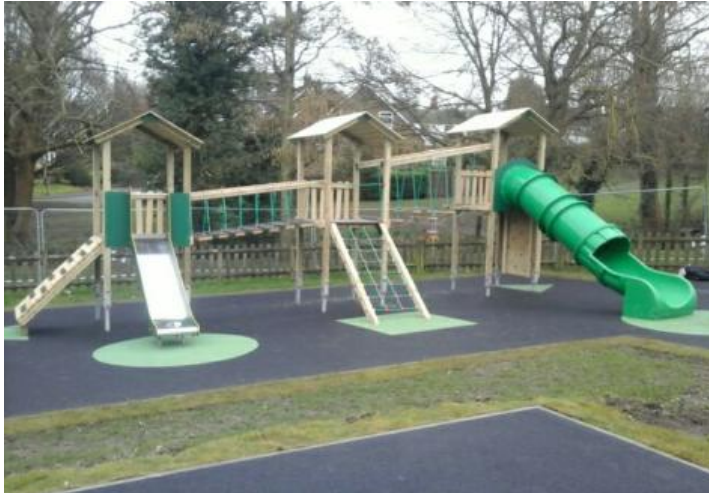
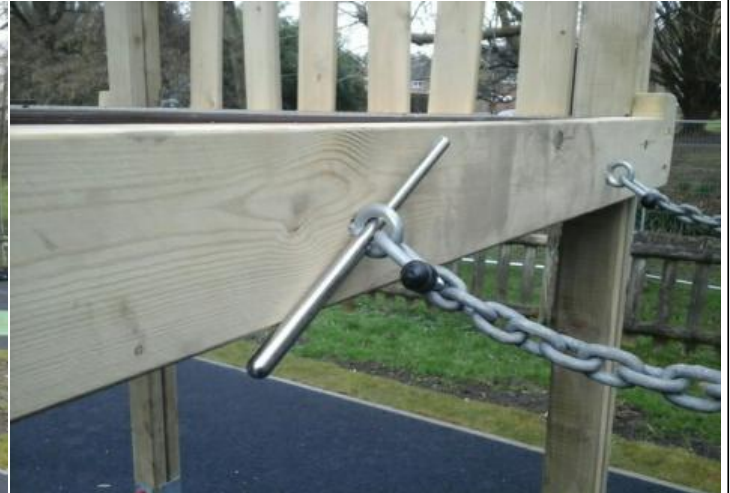
**Item:** Activity Equipment - Multi Play (Junior)  
**Manufacturer:** Creative Play

**Finding:** The connecting links are in excess of 8.6mm and less than 12mm and fail the requirements of BS EN 1176 Part 1; clause 4.2.13, Chains

**Action:** Refer to manufacturer

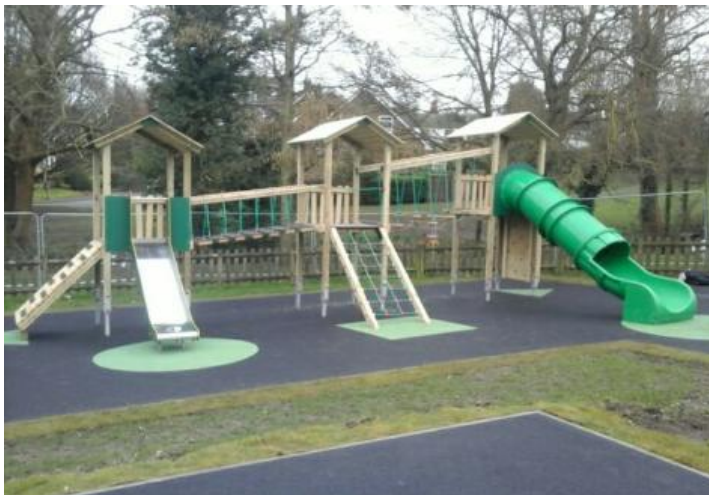
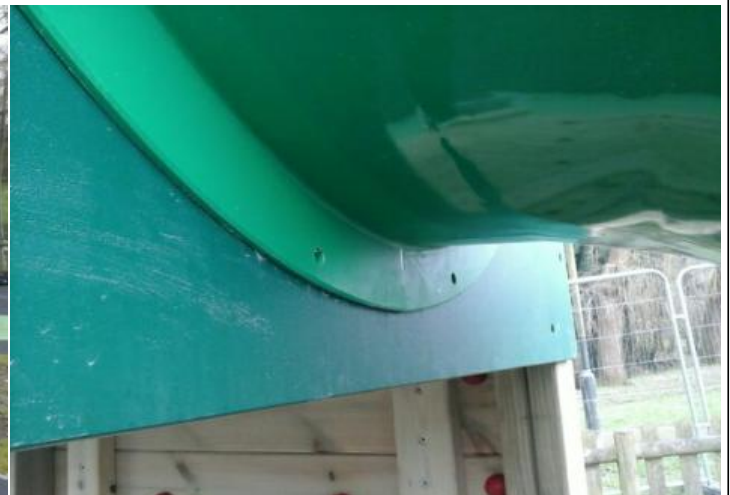
**Item:** Activity Equipment - Multi Play (Junior)  
**Manufacturer:** Creative Play

**Finding:** There are unused fixing points under the top of the tunnel slide

**Action:** Refer to the manufacturer and provide if required

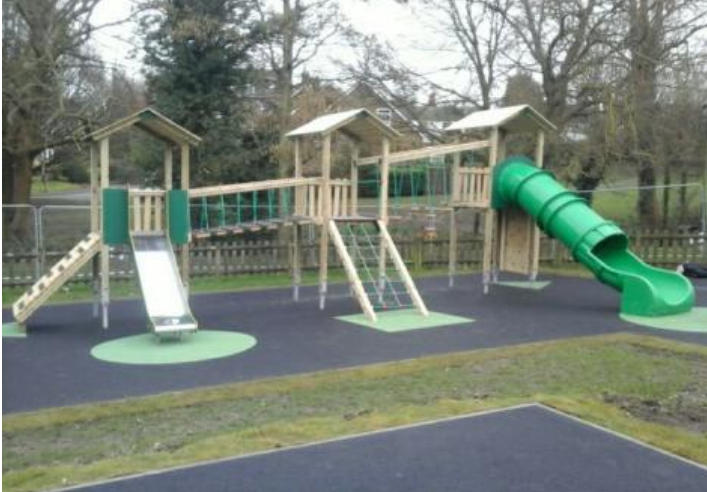
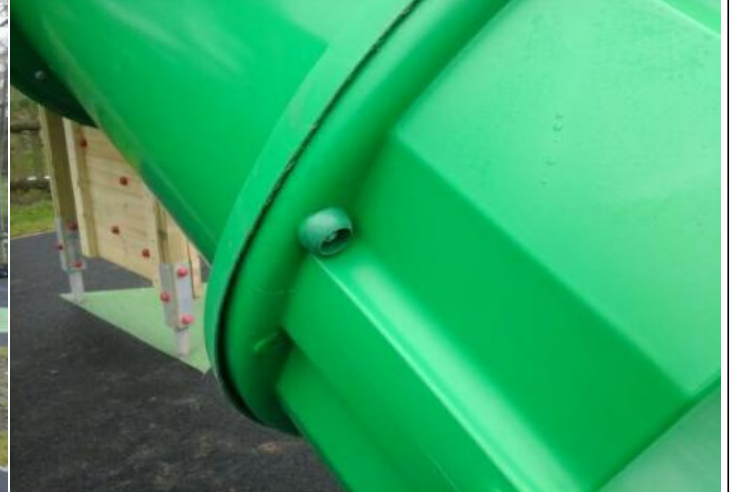
**Item:** Activity Equipment - Multi Play (Junior)  
**Manufacturer:** Creative Play

**Finding:** There are bolt cap covers missing on the tunnel slide

**Action:** Provide missing bolt cap covers

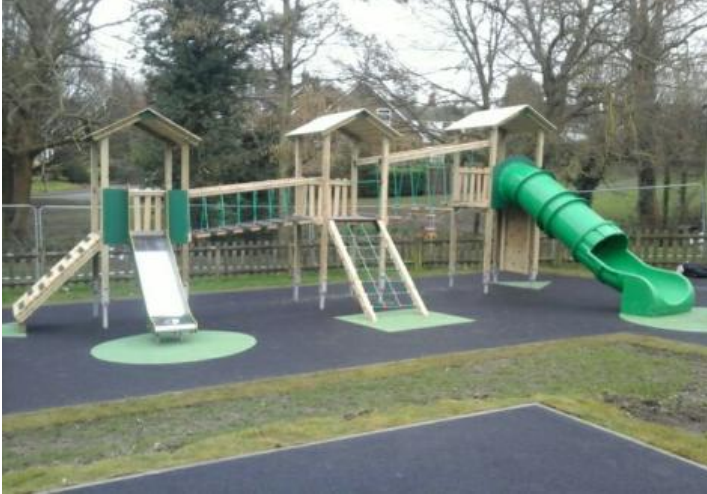
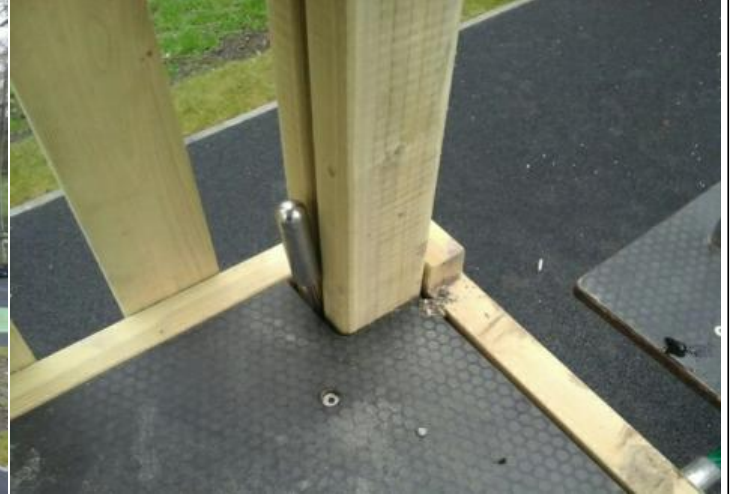
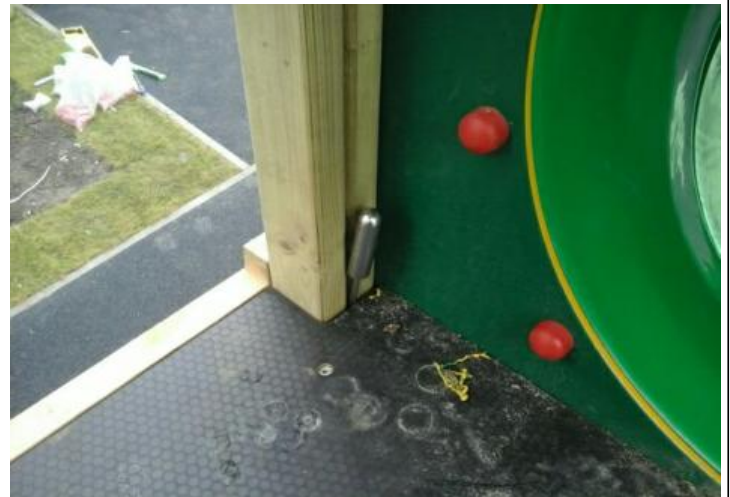
**Item:** Activity Equipment - Multi Play (Junior)  
**Manufacturer:** Creative Play

**Finding:** There are finger entrapments in some platform corners and the item fails to meet the requirements of BS EN 1176 Part 1 4.2.7.6 Entrapment of fingers

**Action:** Refer to the manufacturer

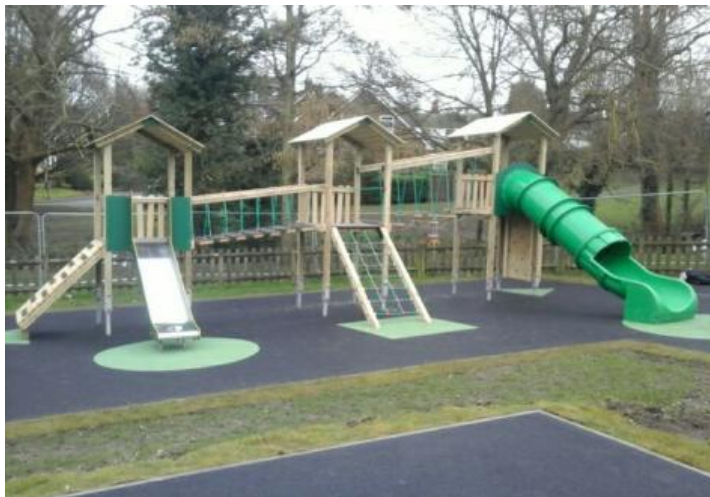
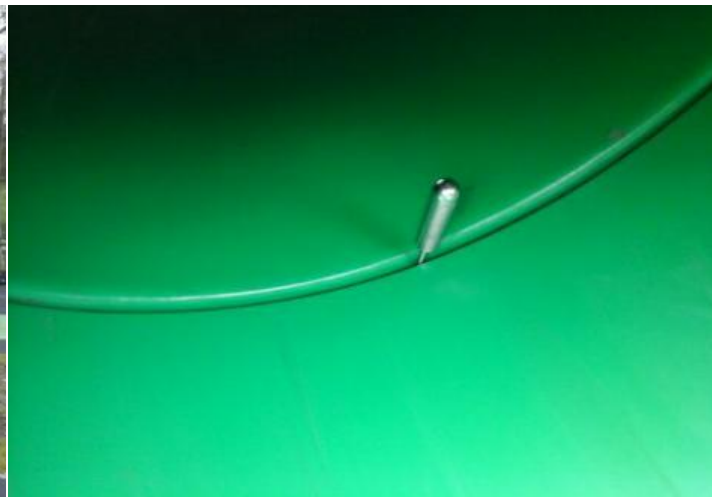
**Item:** Activity Equipment - Multi Play (Junior)  
**Manufacturer:** Creative Play

**Finding:** There are gaps between the sliding sections inside the tunnel slide  
**Action:** Remove gaps
