## Annual Inspection

Steyping Parish Council

Abbey Road Play Area

Inspection Ref: 1389657  
Property Ref: 1254964-413932

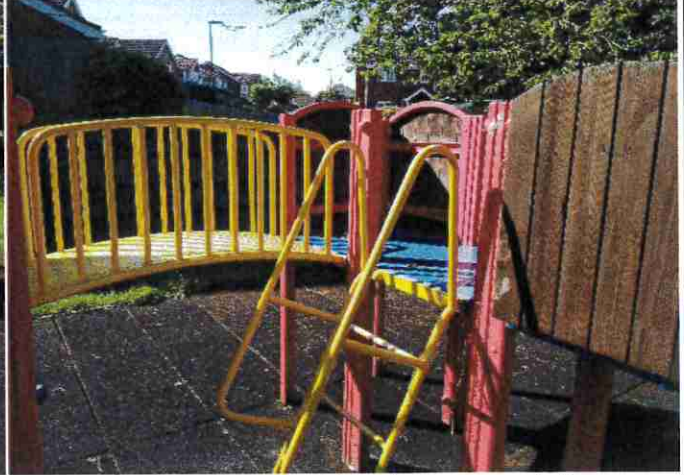
**Finding:** There is an opening in the barriers exceeding the width allowed (500mm) in BS EN 1176, and no guardrail has been provided; this is a low risk failure and no remedial action is required

**Action:** Monitor - No remedial work recommended

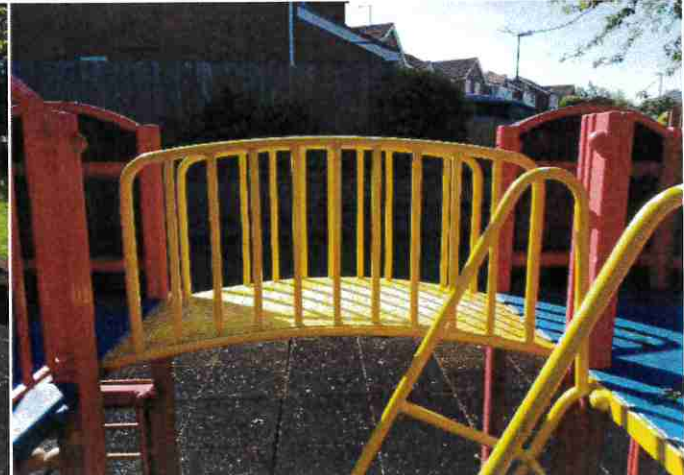
**Finding:** The height of the bridge barrier(s) is insufficient and fails to meet the requirements of BS EN 1176 Part 1

**Action:** Monitor - No remedial work recommended

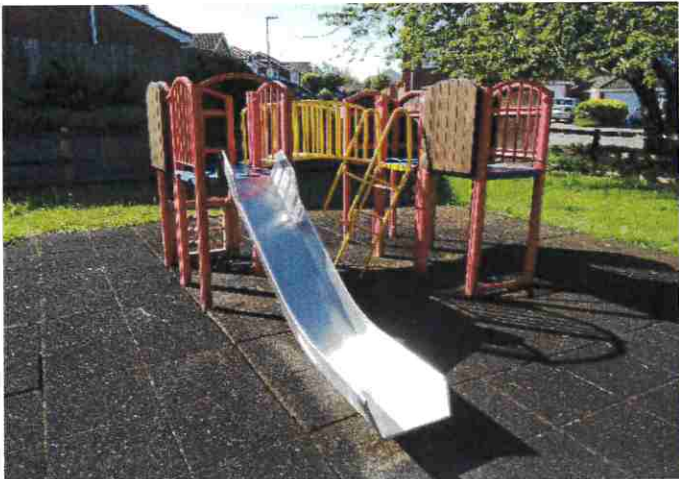
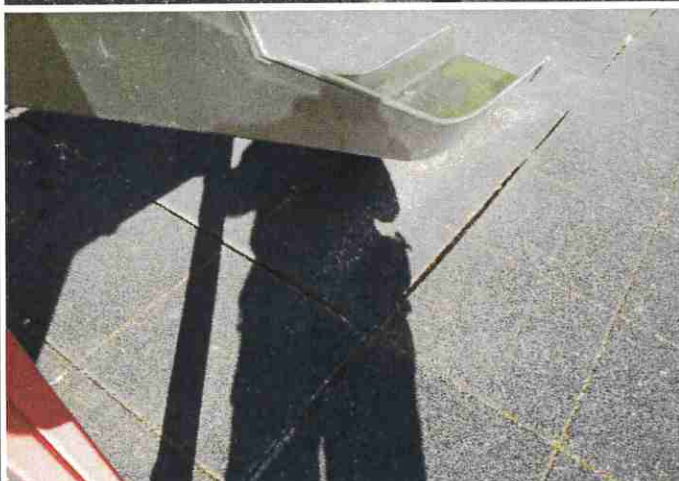
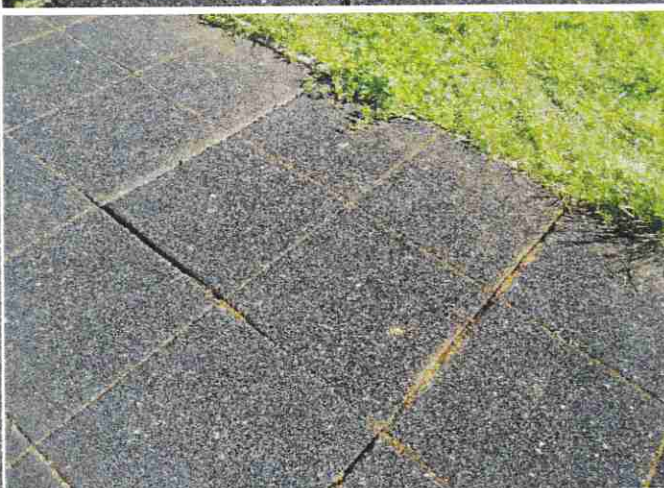
| 6 - Low Risk (Finding 3) | | | |
|---|---|---|---|
| <b>Finding:</b> There are gaps opening in between the tiles | | <b>Action:</b> Monitor for any further deterioration and repair as required or upgrade | |

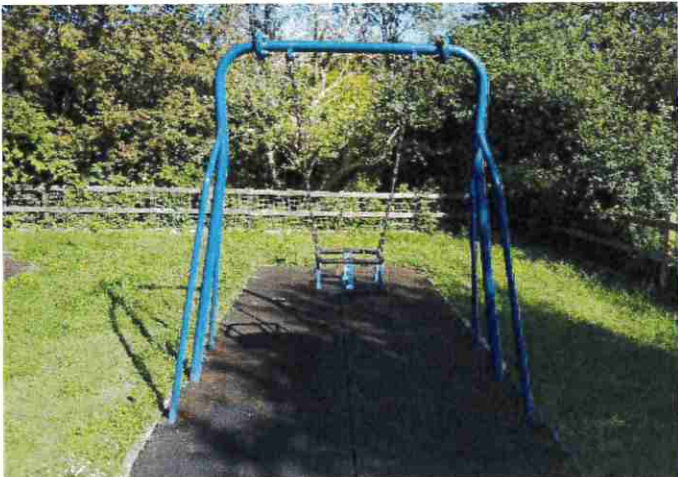
**Finding:** There is some notable evidence of chain wear

**Action:** Monitor for any further deterioration and replace when 40% worn

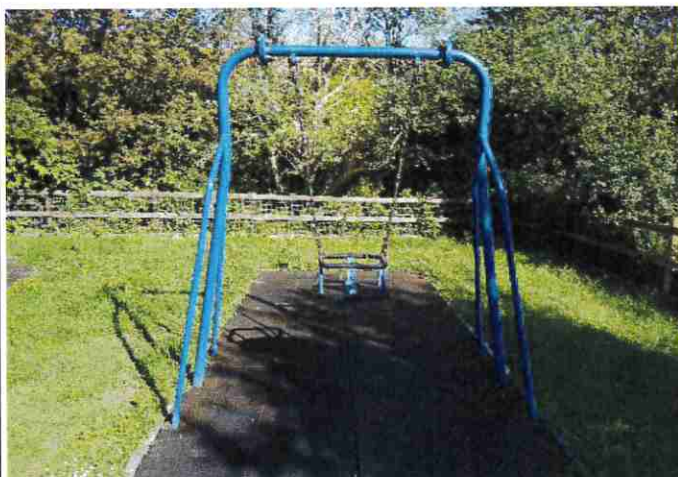
**Finding:** The item has exposed threads max 8mm with a radius of less than 3mm and fails the requirements of BS EN 1176

**Action:** Cut off and Provide a 3mm radius

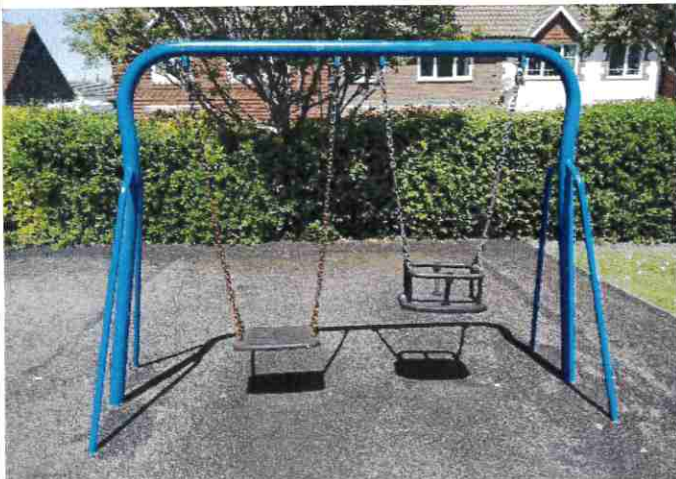
| 12 - Moderate Risk (Finding 1) | | | |
|---|---|---|---|
| <b>Finding:</b> The bushes are worn or missing | | <b>Action:</b> Replace worn or missing bushes | |

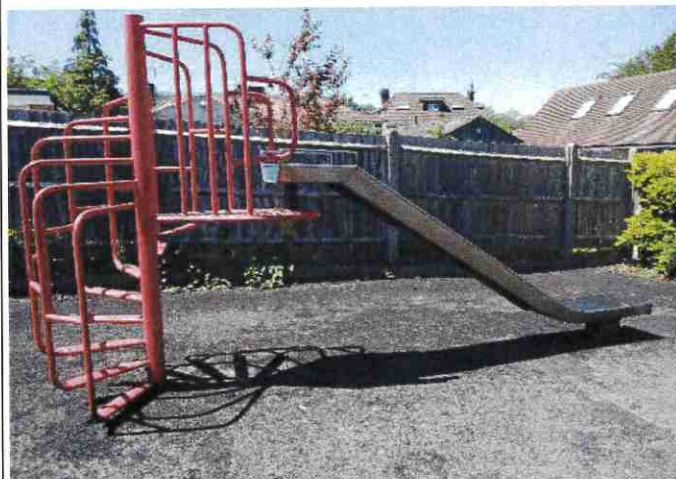
| 15 - Moderate Risk (Finding 1) | | | |
|---|---|---|---|
| <b>Finding:</b> The item is loose in its foundations | | <b>Action:</b> Reinstall item to secure or dur to age/condition upgrade unit | |

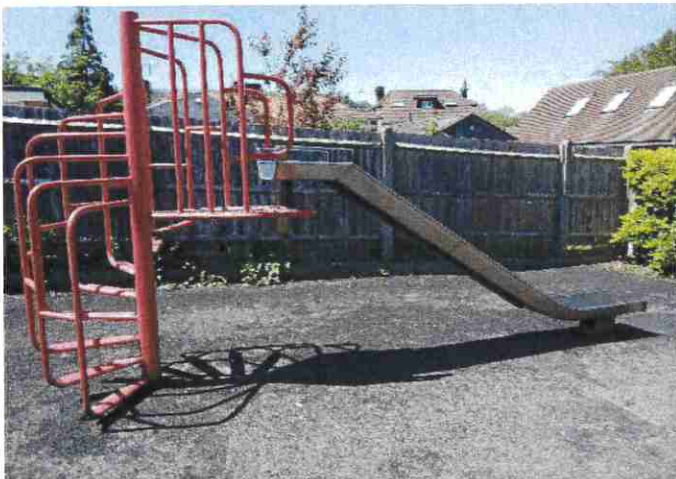
**Finding:** There is an opening in the barriers exceeding the width allowed (500mm) in BS EN 1176, this is a low risk failure and no remedial action is required

**Action:** Monitor - No remedial work recommended

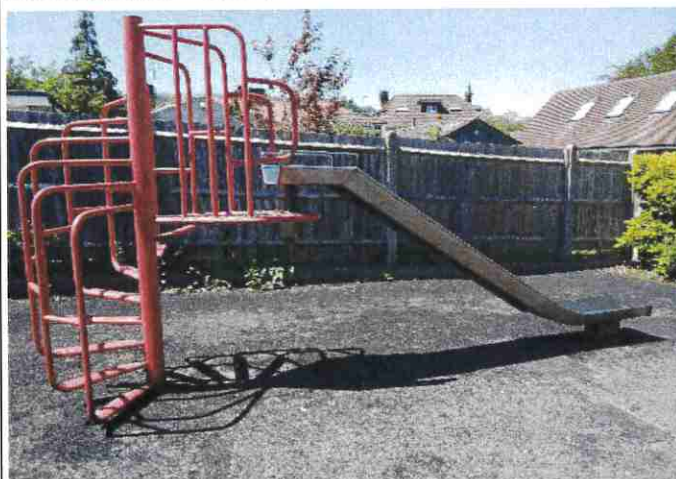
**Finding:** The depth of the step tread is less than 110mm and fails the requirements of BS EN 1176 Part 1

**Action:** Monitor - No remedial work recommended

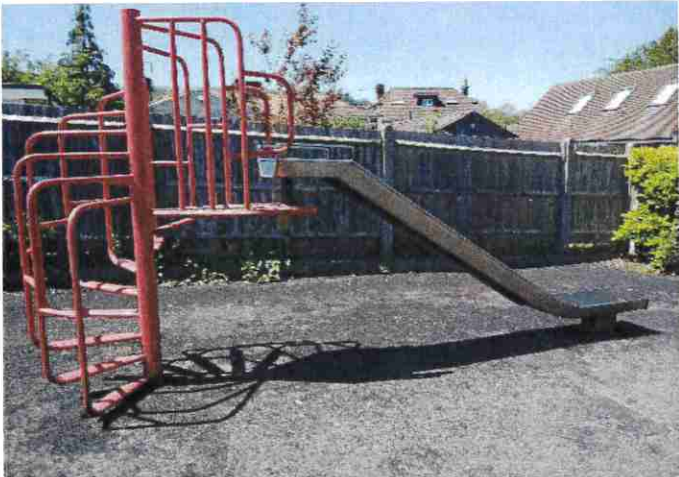
| 10 - Low Risk (Finding 4) | | | |
|---|---|---|---|
| <b>Finding:</b> The stair design forms a hard object within the falling space of the equipment in contravention of the requirements of BS EN 1176 Part 1 | | <b>Action:</b> Monitor - No remedial work recommended | |

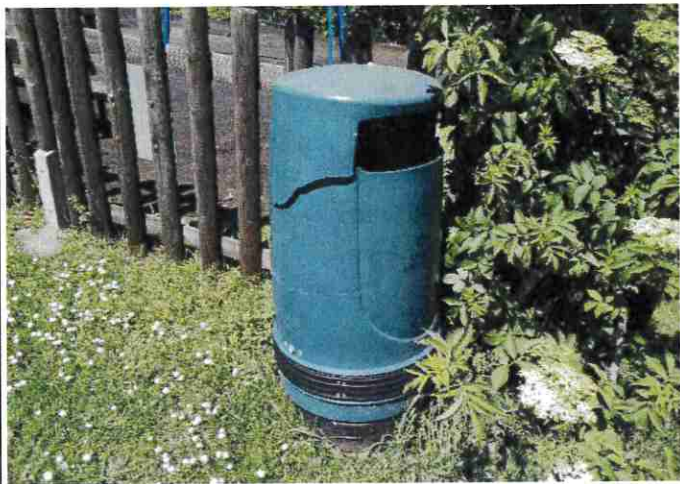
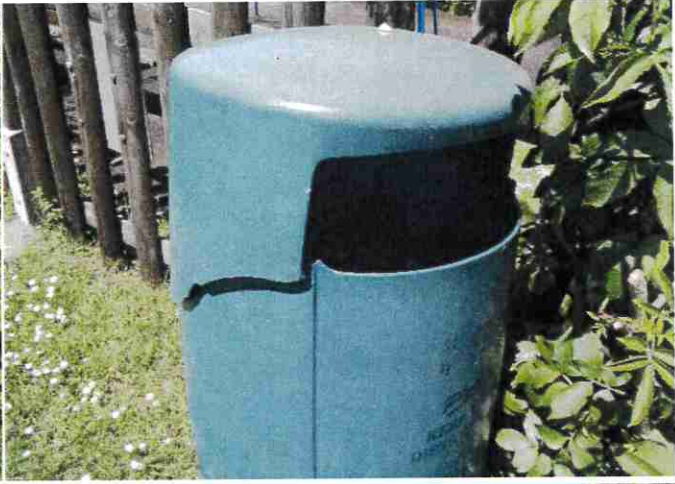
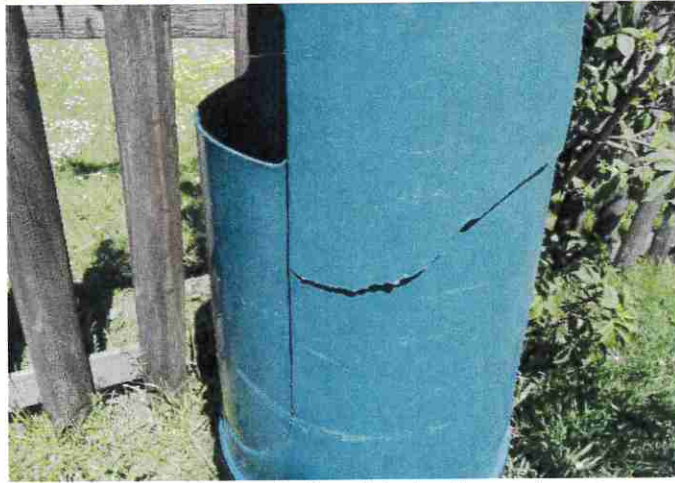
| 10 - Low Risk (Finding 1) | | | |
|---|---|---|---|
| | | <p><b>Finding:</b> There is some damage to the item</p> <p><b>Action:</b> Monitor for any further deterioration and repair as required</p> | |

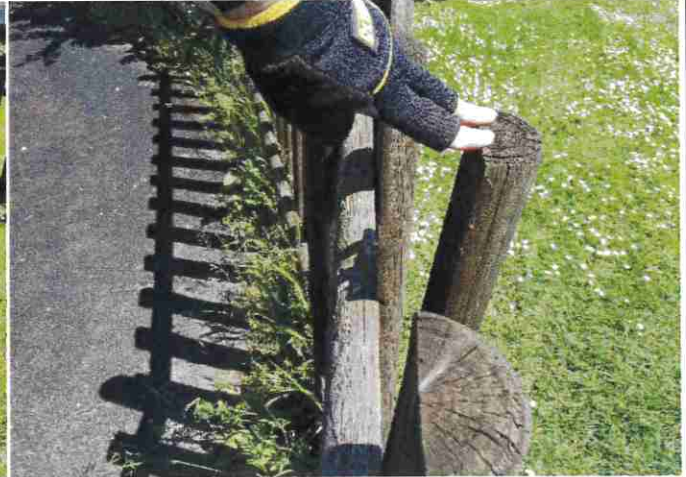
**Finding:** There are a number of loose slats around the fence

**Action:** Repair as required

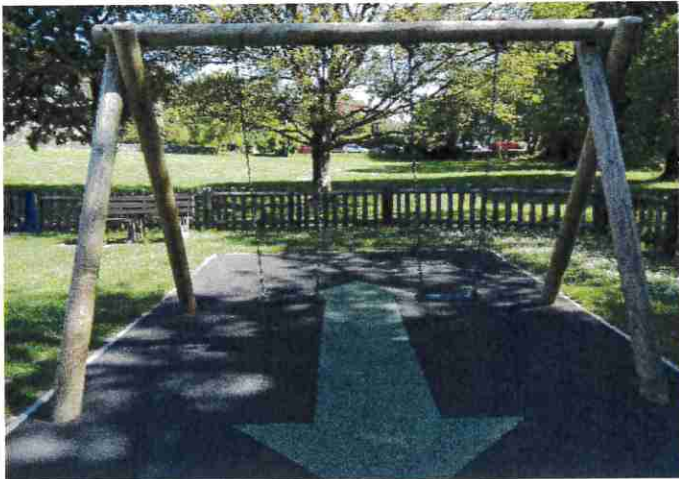
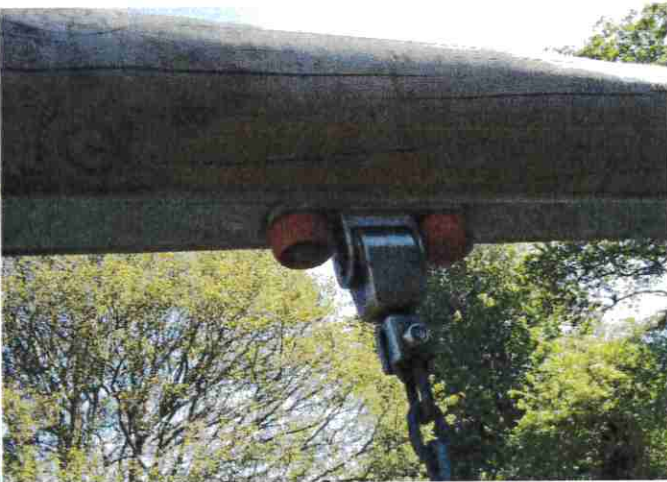
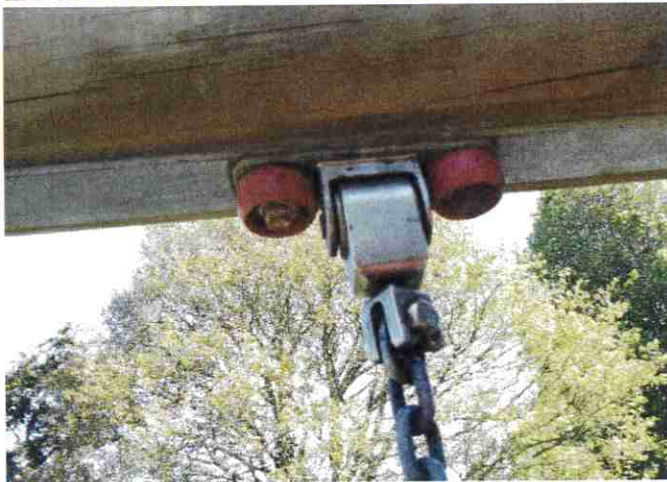
| 4 - Very Low Risk (Finding 1) | | | |
|---|---|---|---|
| <b>Finding:</b> There are bolt cap covers missing or damaged on the item | | <b>Action:</b> Replace missing bolt cap covers | |

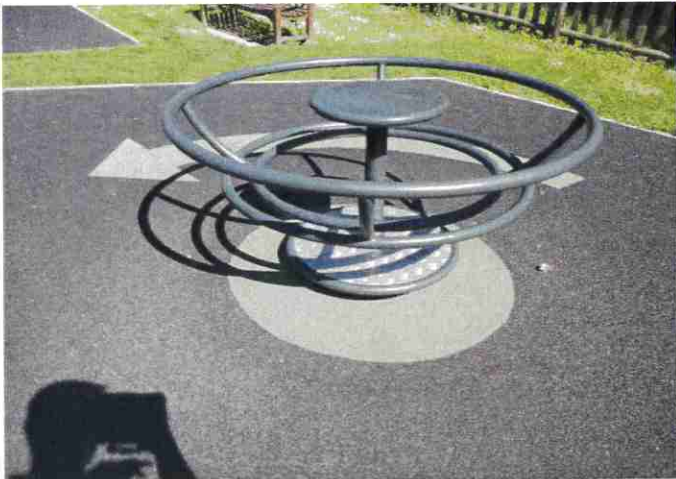
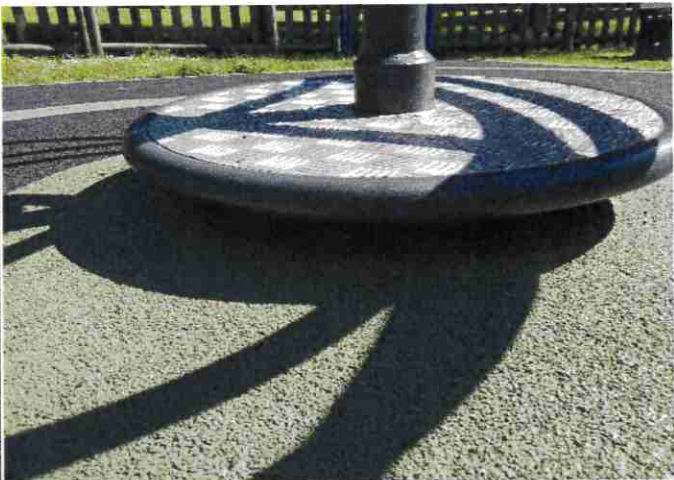
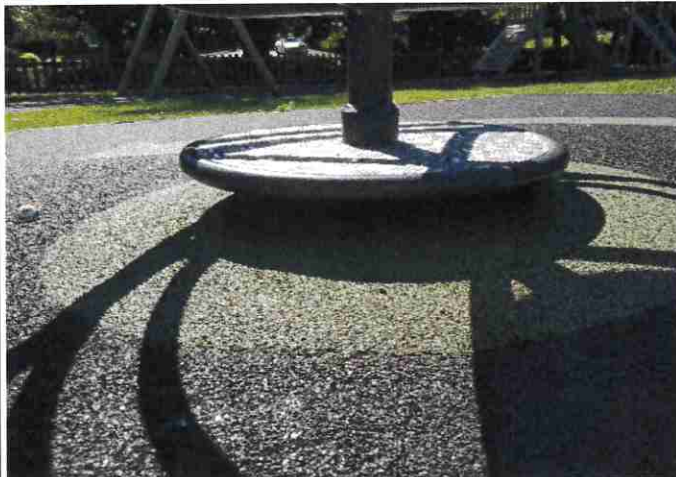
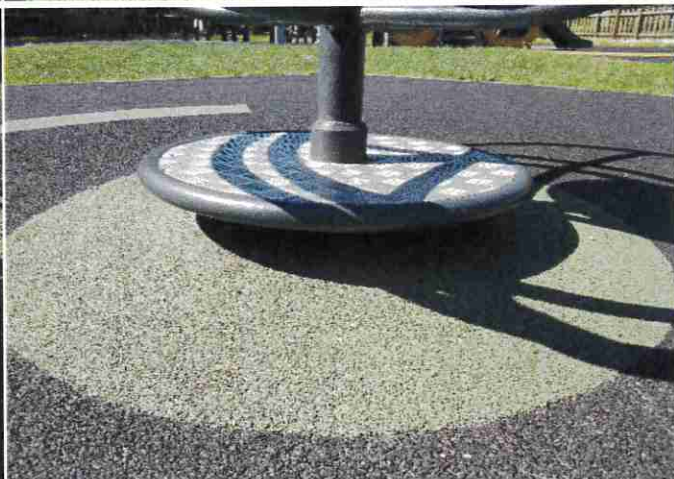
| 15 - Moderate Risk (Finding 1) | | | |
|---|---|---|---|
| <b>Finding:</b> The item is loose in its foundations | | <b>Action:</b> Reinstall item to secure | |

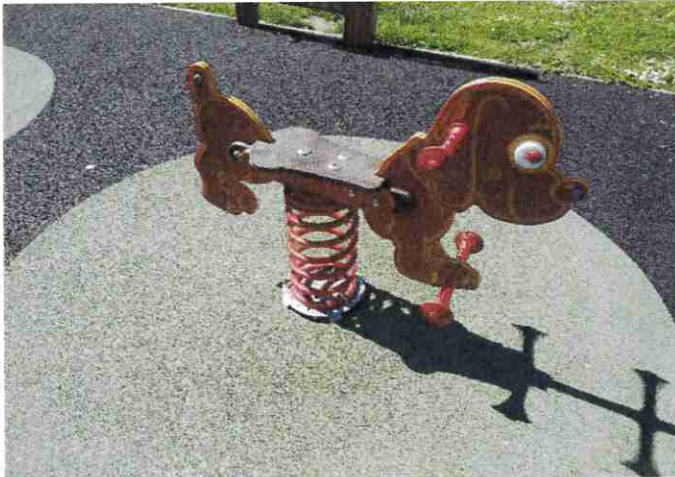
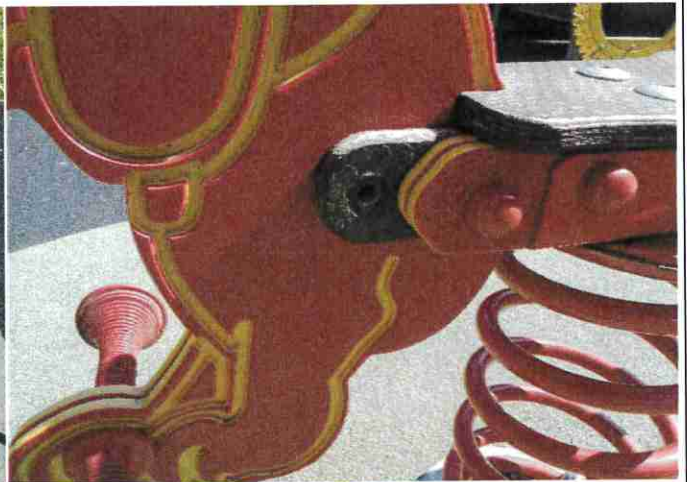
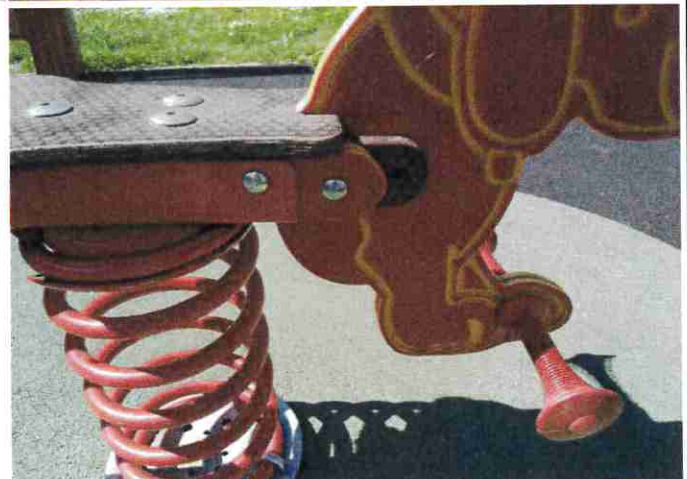
**Finding:** There are fixings missing on the item

**Action:** Replace all missing fixings

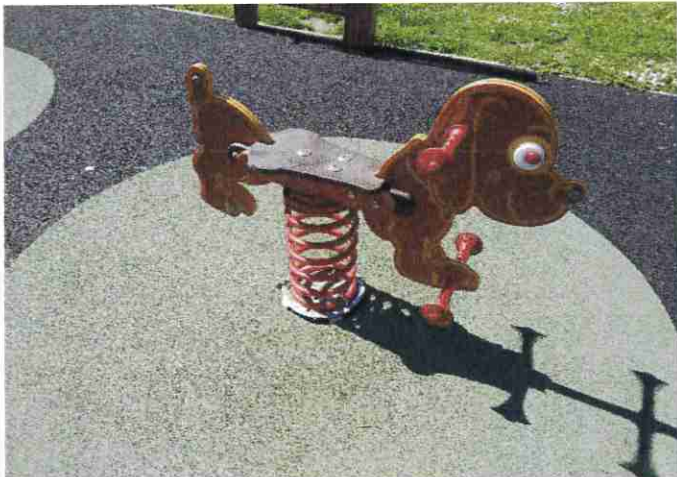
| 10 - Low Risk (Finding 2) | | | |
|---|---|---|---|
| <b>Finding:</b> The Handgrips/Footrests rotate and may cause an unexpected movement for the user | | <b>Action:</b> Secure Handgrips/Footrests to prevent rotation. | |

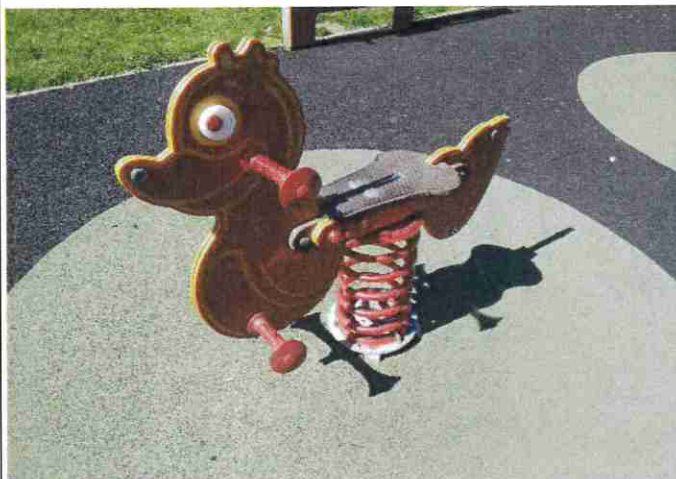
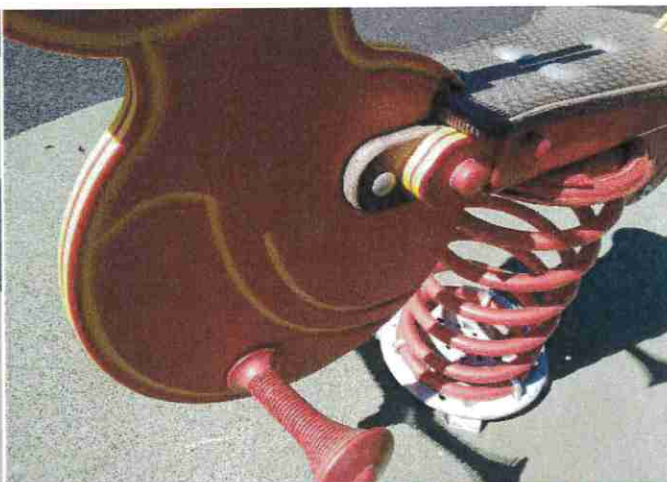
**Finding:** A number of fixing(s) have worked loose

**Action:** Secure all loose fixings

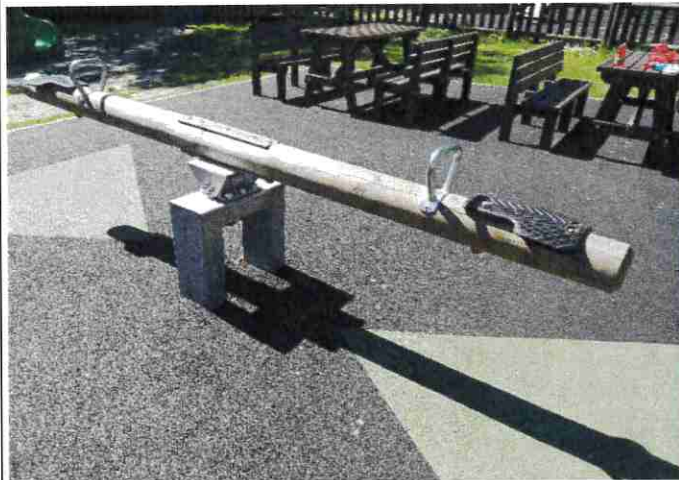
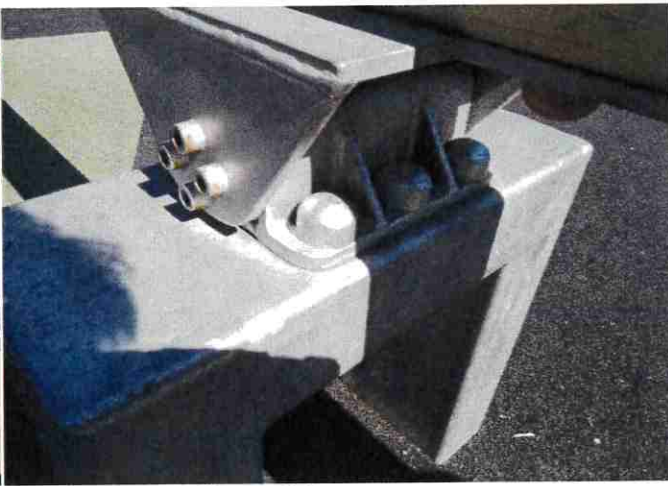
**Finding:** A number of fixing(s) have worked loose

**Action:** Secure all loose fixings

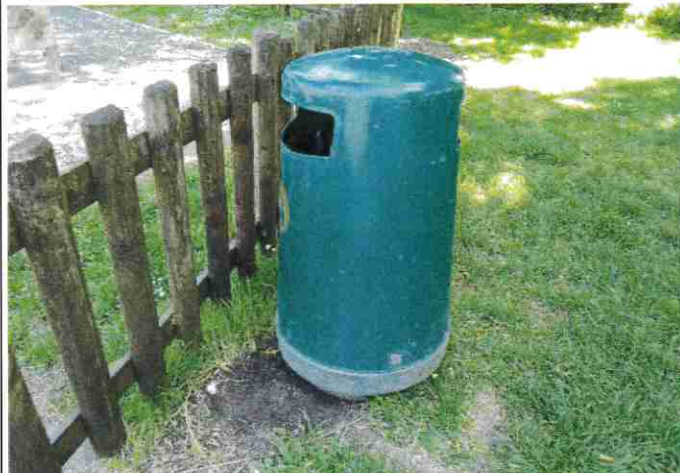
**Finding:** The liner of the litter bin is not secured

**Action:** Recommend ground fixing

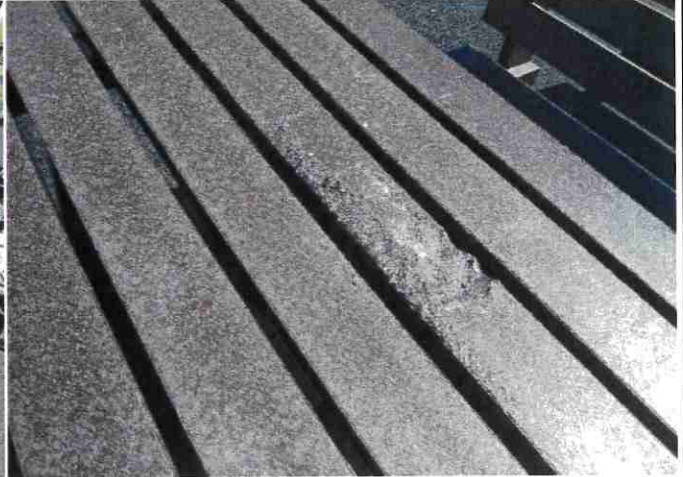
**Finding:** There is some evidence of fire damage to the item  
**Action:** Monitor for any further deterioration and repair as required

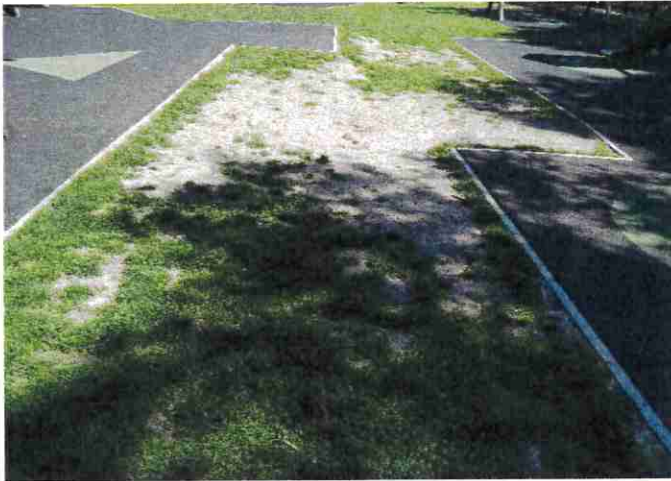
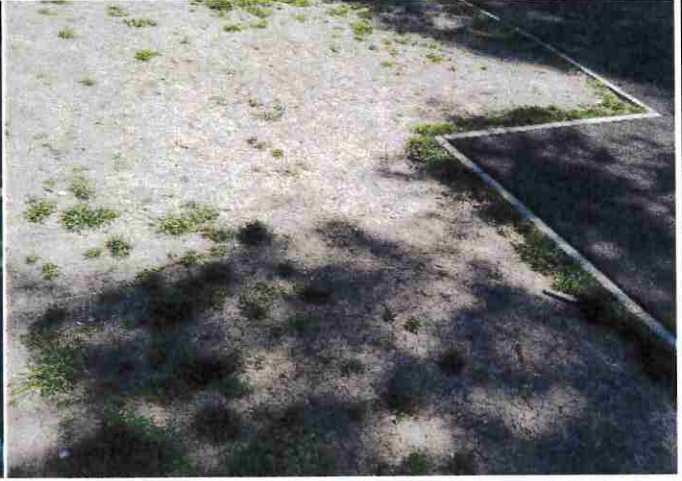
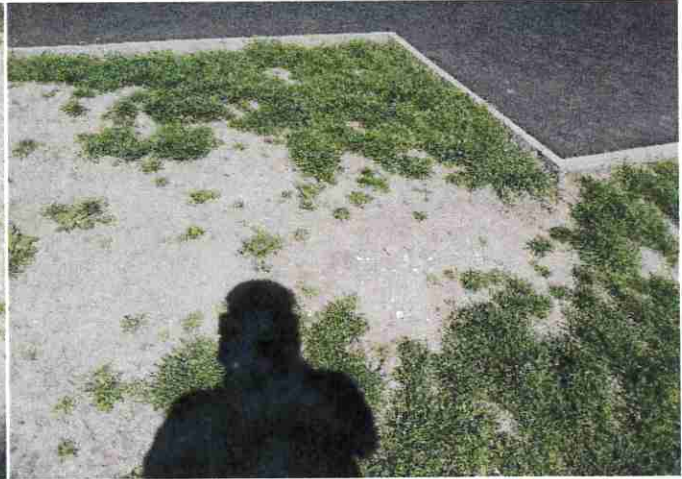
**Finding:** There are trip hazards at the edges of the surface

**Action:** Reinstate surrounding surface levels to remove the trip points

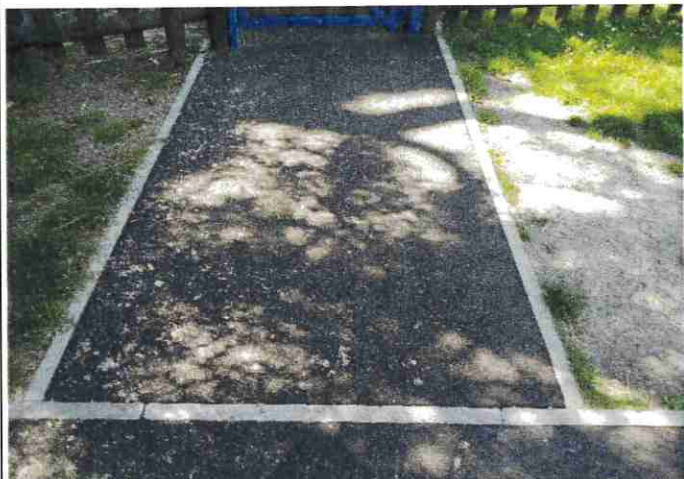
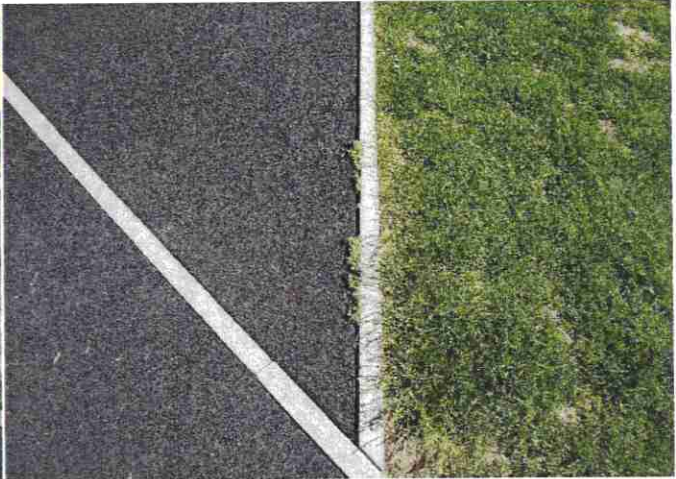
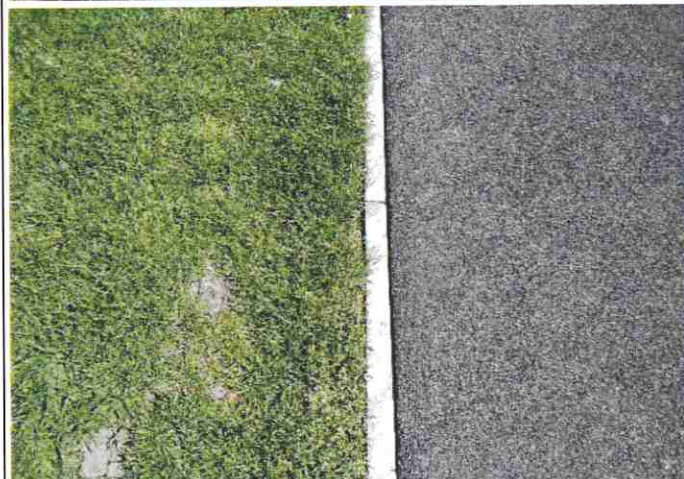
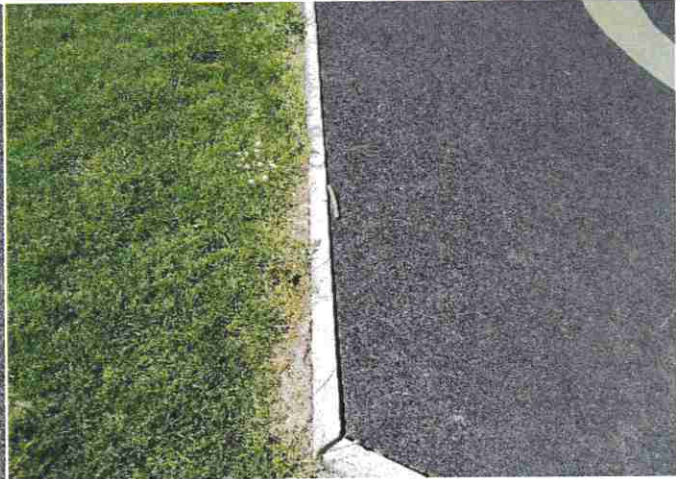
| 6 - Low Risk (Finding 1) | | | |
|---|---|---|---|
| <p><b>Finding:</b> There are gaps opening between the surfacing and the edging surround or between the joints in the surfacing</p> <p><b>Action:</b> Monitor for any further deterioration and repair as required</p> | | | |

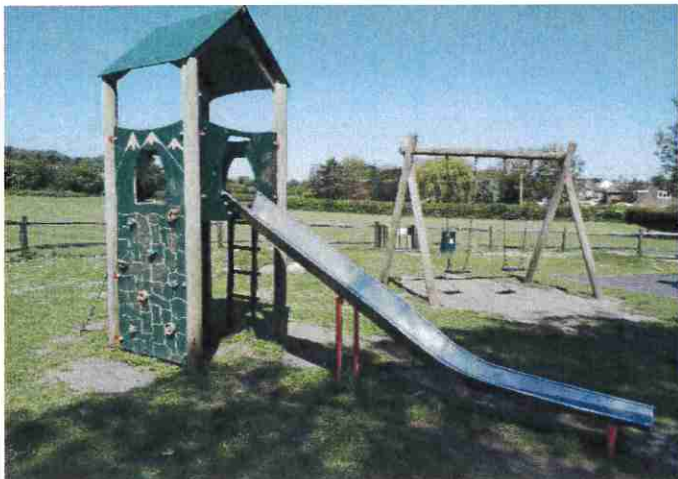
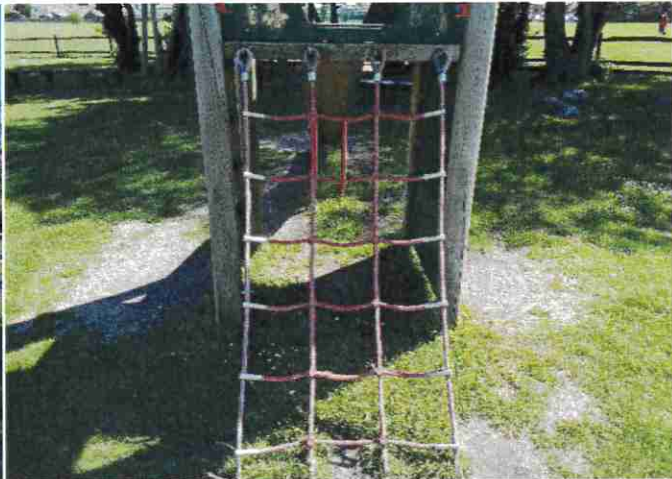
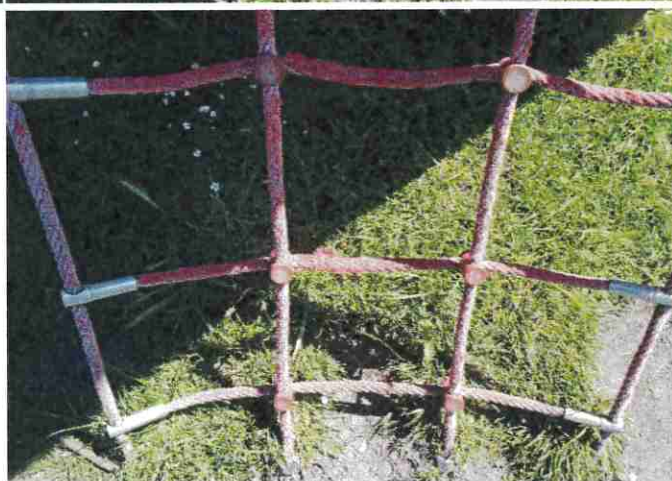
| 6 - Low Risk (Finding 1) | | | |
|---|---|---|---|
| | | <p><b>Finding:</b> The ropes/nets are worn/damaged in places</p> <p><b>Action:</b> Monitor for any further deterioration and repair or replace as required</p> | |

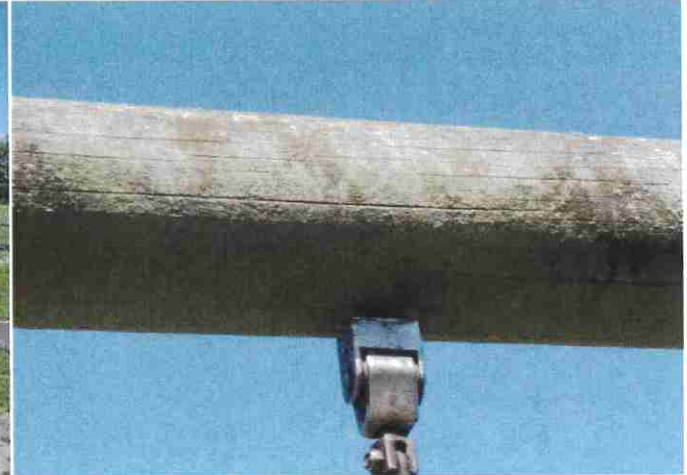
**Finding:** A number of chain support top bar fixing(s) have worked loose

**Action:** Secure all loose fixings

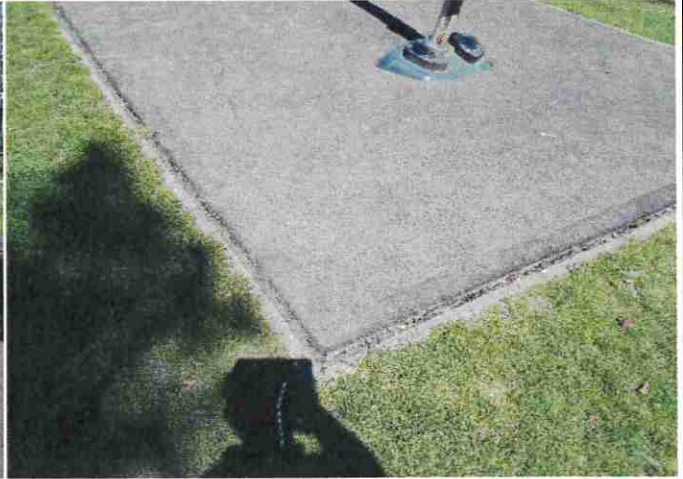
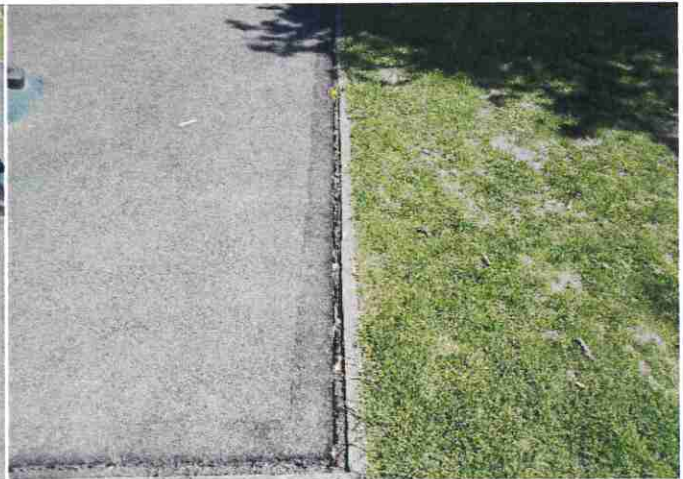
**Finding:** There are significant gaps (over 30mm) between the surface and the edging or between the joints in the surface; these are large enough for a small foot to enter

**Action:** Repair surfacing or upgrade

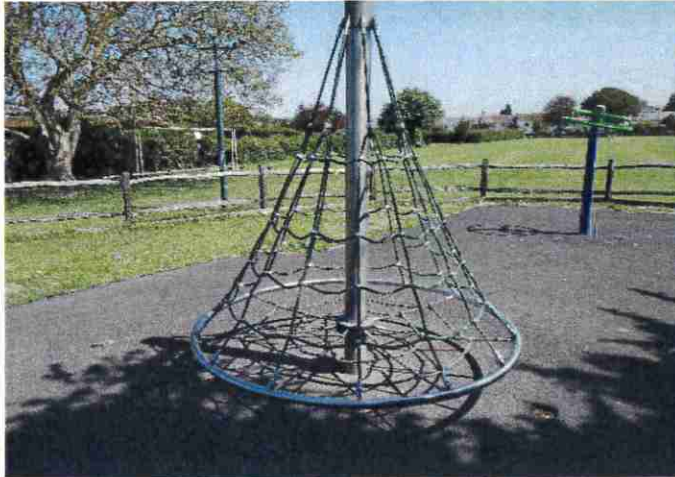
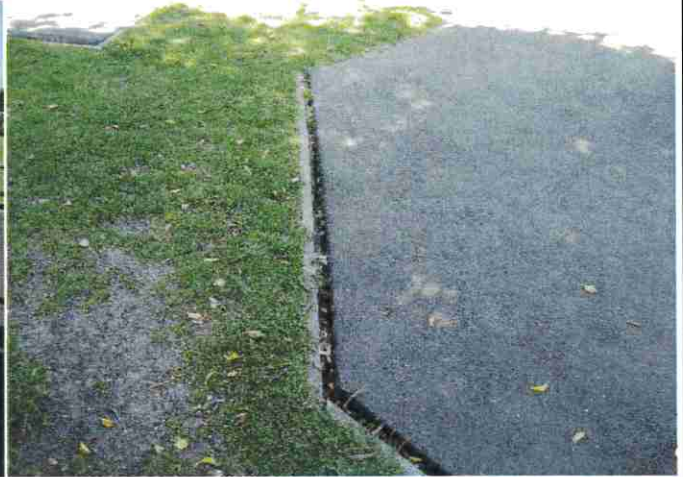
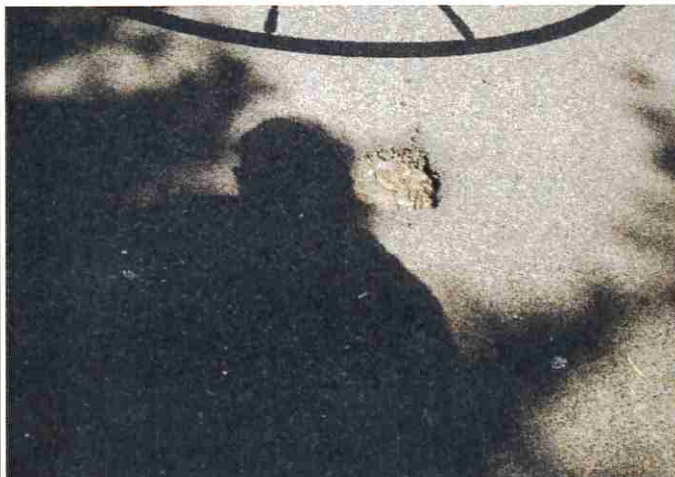
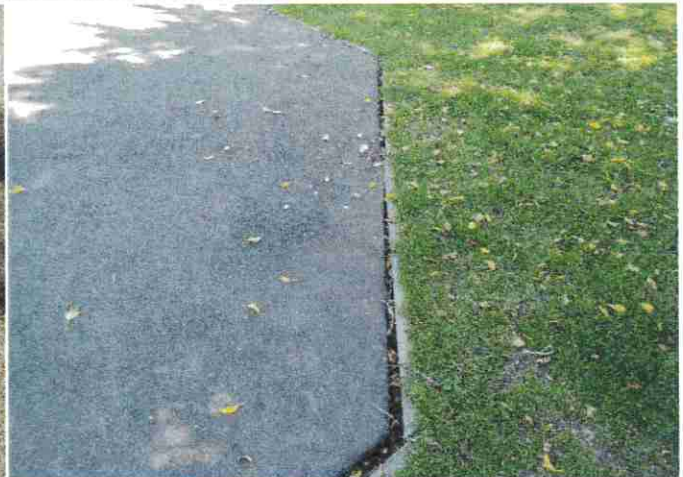
**Finding:** The surfacing is severely damaged

**Action:** Repair damaged areas of surfacing or upgrade

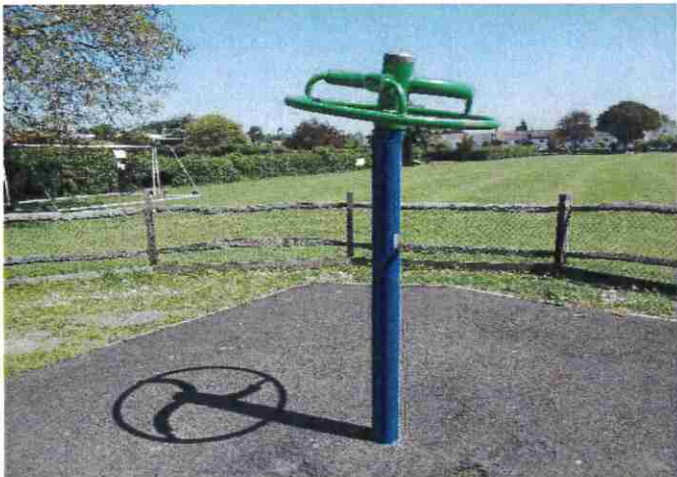
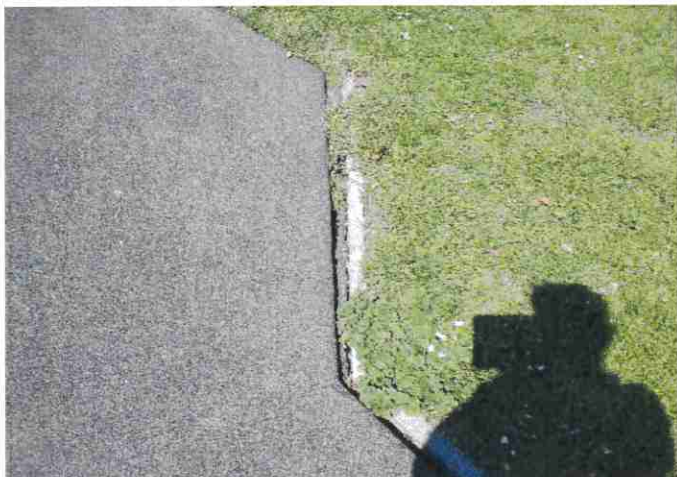
| 12 - Moderate Risk (Finding 1) | | | |
|---|---|---|---|
| <b>Finding:</b> The surfacing is severely damaged | | <b>Action:</b> Repair damaged areas of surfacing or upgrade | |

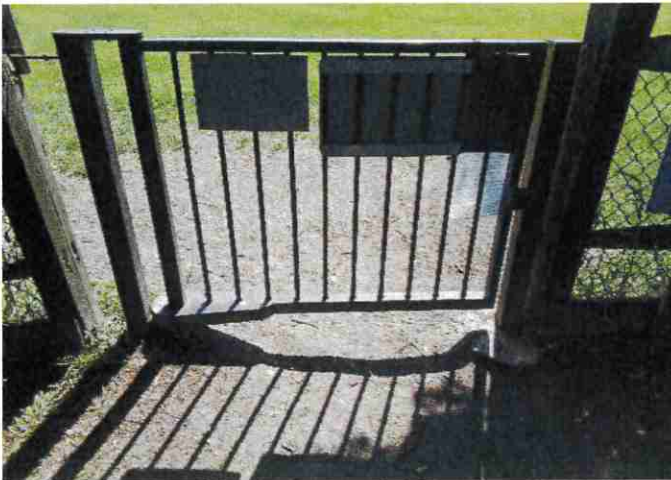
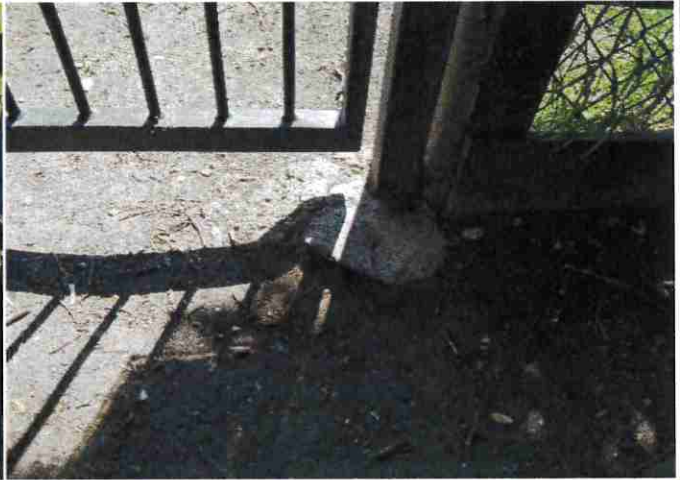
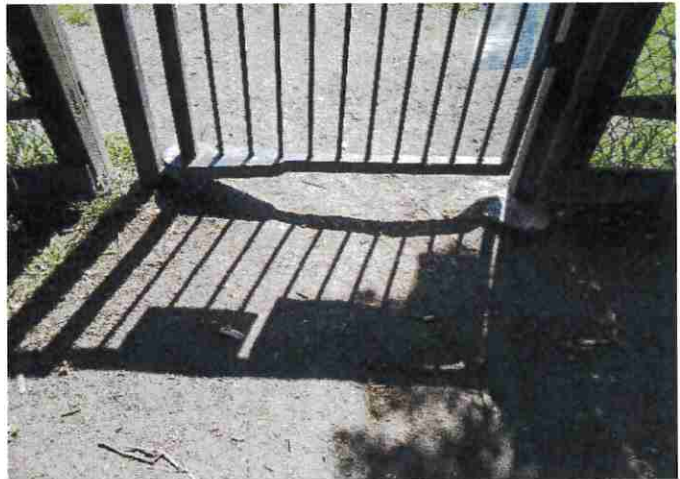
**Finding:** The surface has subsided at both gates in some areas

**Action:** Repair as required

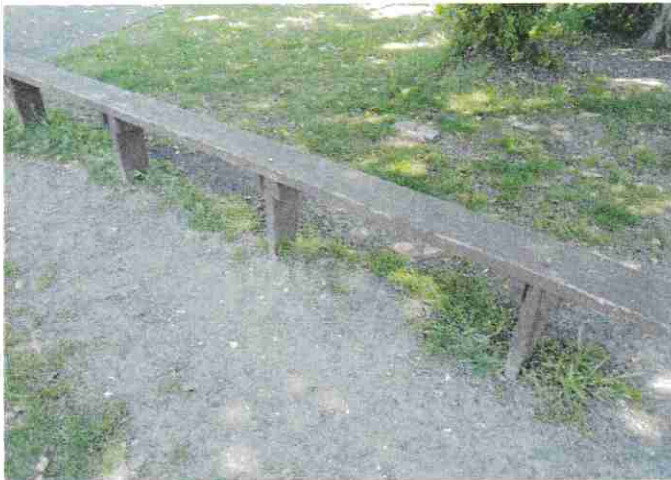
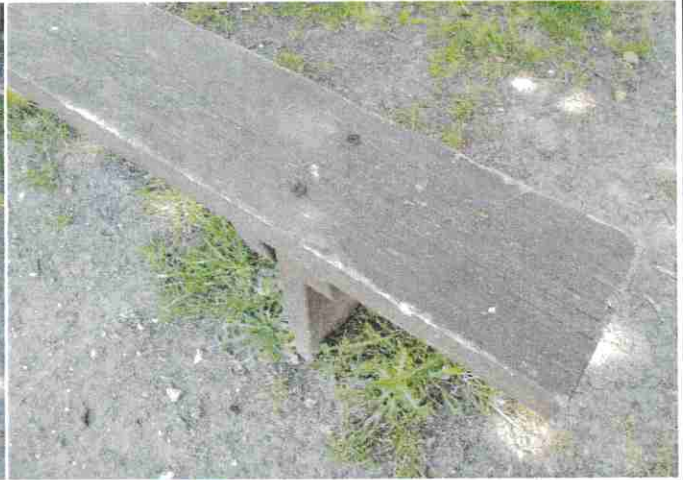
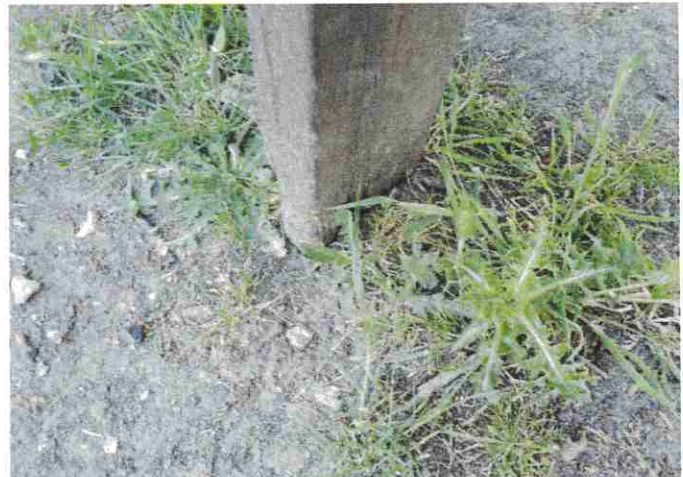
**Finding:** There are areas or parts of the timber on the structure that have rotted

**Action:** Replace all affected timbers

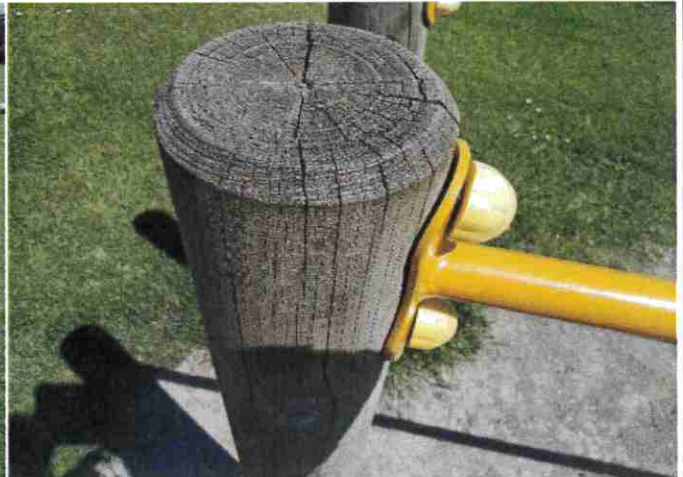
**Finding:** A number of fixing(s) have worked loose

**Action:** Secure all loose fixings

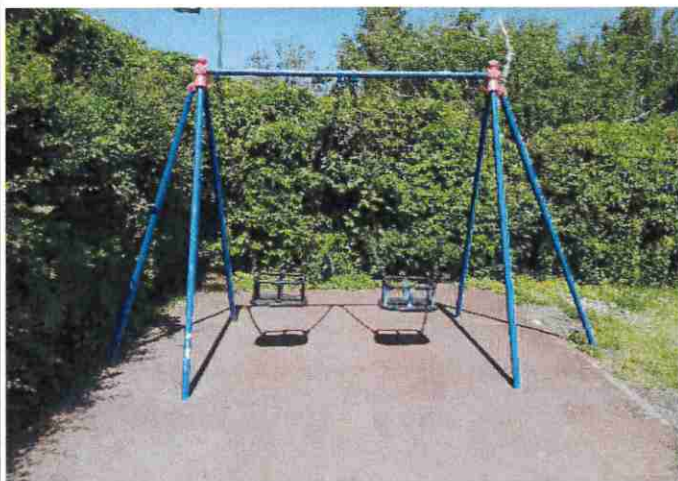
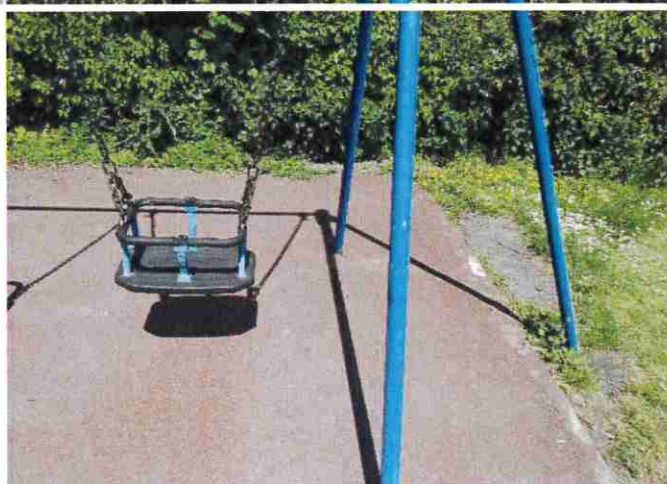
**Finding:** The seats are too close to the frame as defined in BS EN 1176 Part 2; this is a low risk failure and no remedial action is required

**Action:** Monitor - No remedial work recommended

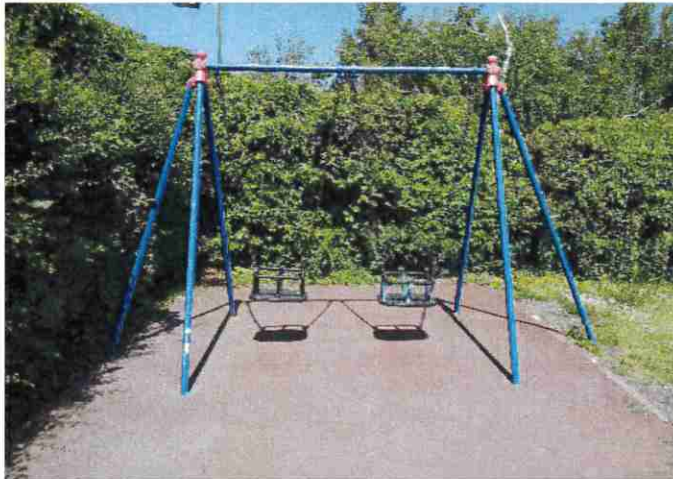
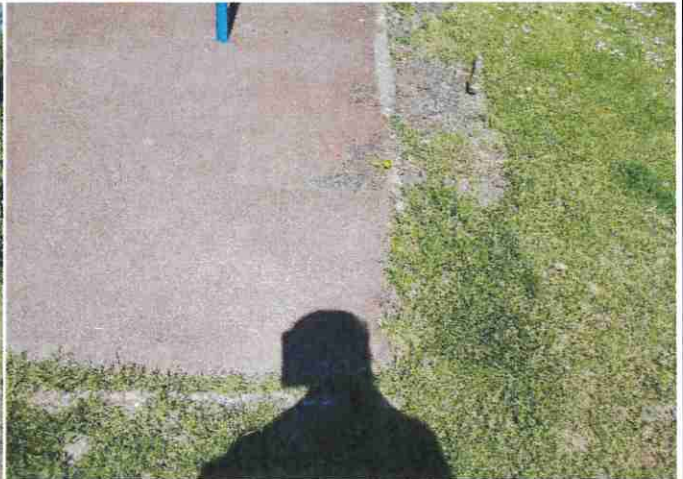
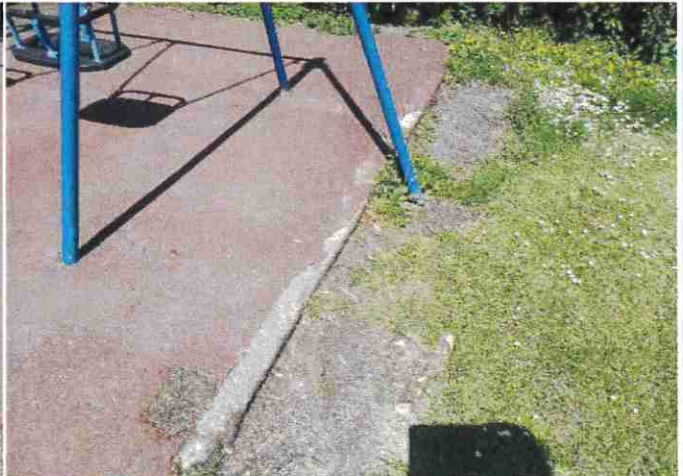
**Finding:** The surfacing around the item is damaged

**Action:** Repair the damaged areas of surfacing or upgrade

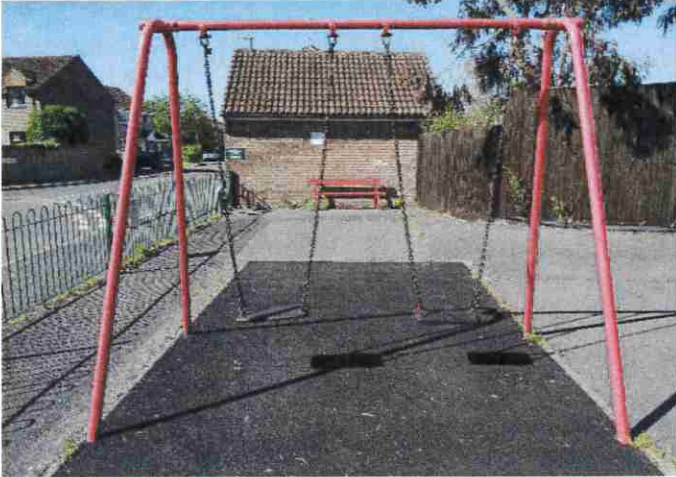
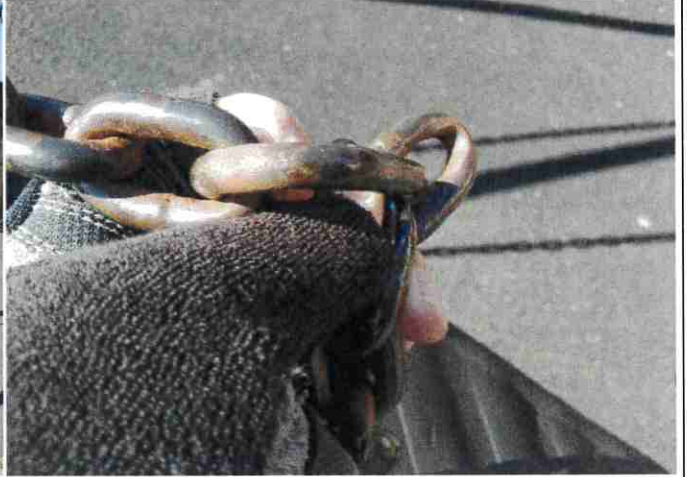
| 6 - Low Risk (Finding 1) | | | |
|---|---|---|---|
| <b>Finding:</b> There is some notable evidence of chain wear | | <b>Action:</b> Monitor for any further deterioration and replace when 40% worn | |
