## Annual Inspection

Steyping Parish Council

Abbey Road Play Area

Inspection Ref: 1389657  
Property Ref: 1254964-413932

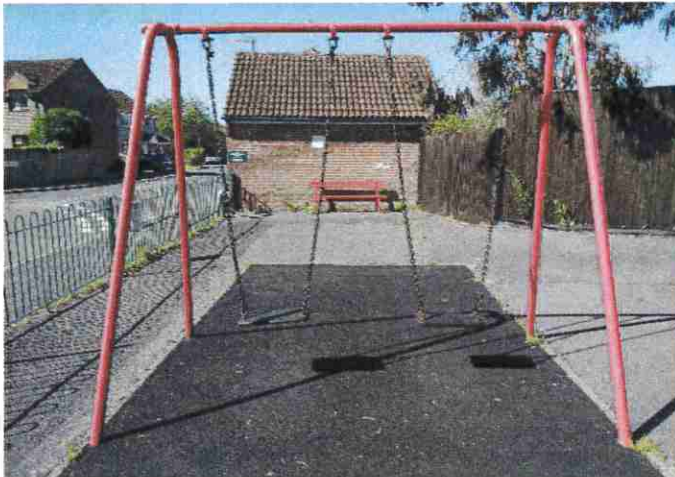
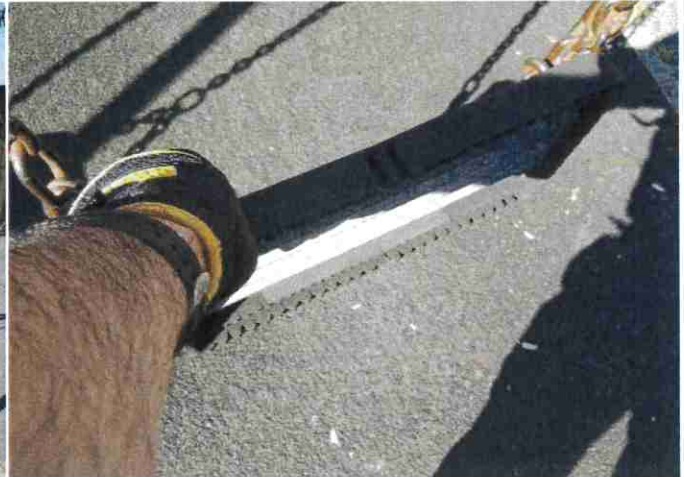
**Finding:** The seat has minor damage or wear

**Action:** Monitor for any further deterioration and replace as required

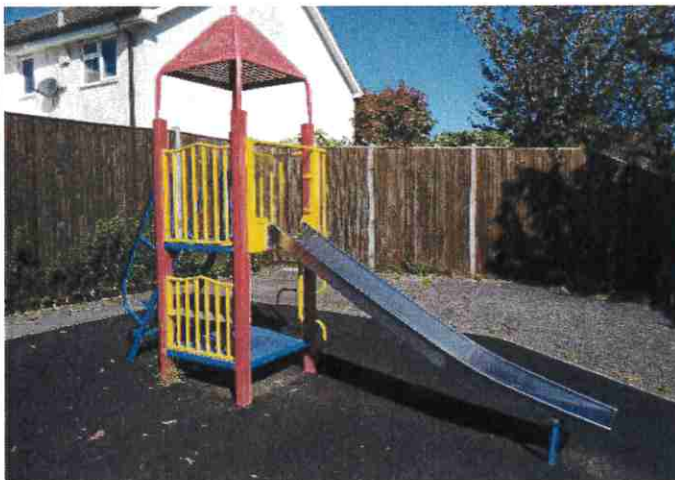
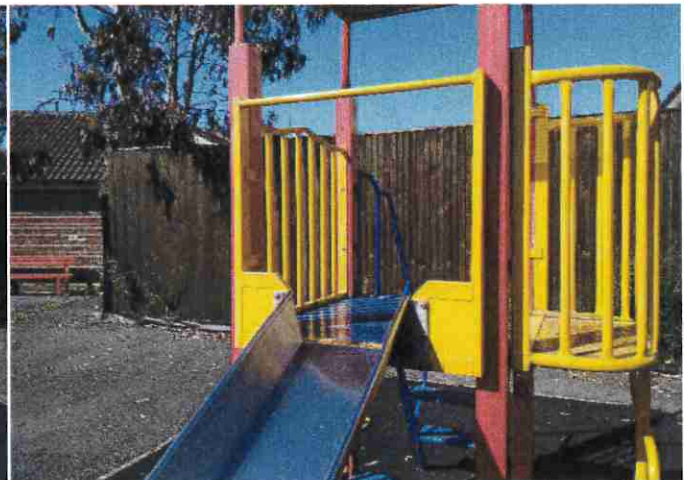
**Finding:** The unit is easily accessible and has an opening in the barrier to steep play elements in excess of 500mm in contravention of BS EN 1176 Part 1

**Action:** Monitor - No remedial work recommended
