## Annual Inspection

Steyping Parish Council

Memorial Playing Field Play Area

Charlton Street, Steyping, Sussex, BN44 3LE

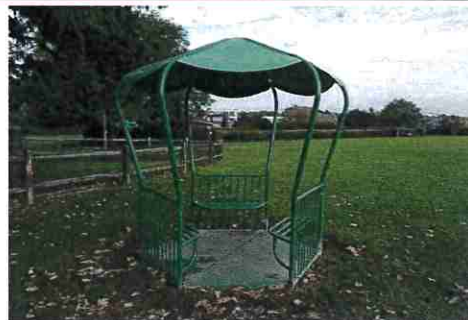
A number of fixing(s) have worked loose - Secure all loose fixings

There is some graffiti present - Remove the graffiti

The surface has eroded in some areas - Reinstate the surface

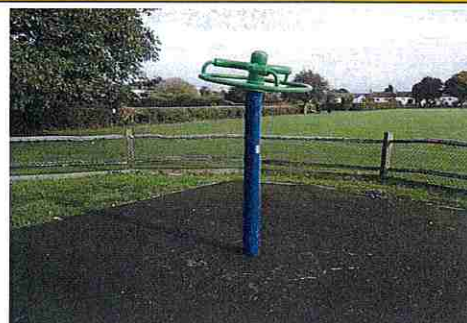
The bearing is showing signs of wear - Monitor for any further deterioration and replace as required

The surfacing edging is severely damaged - Repair damaged areas of surfacing 3m concrete curb

The surfacing around the item is damaged - Repair the damaged areas of surfacing 2m x 2m Black

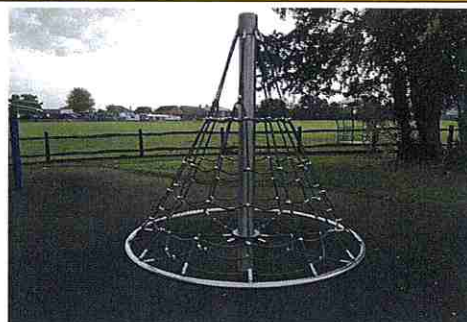
There are significant gaps (over 30mm) between the surface and the edging or between the joints in the surface; these are large enough for a small foot to enter - Repair surfacing 17m black

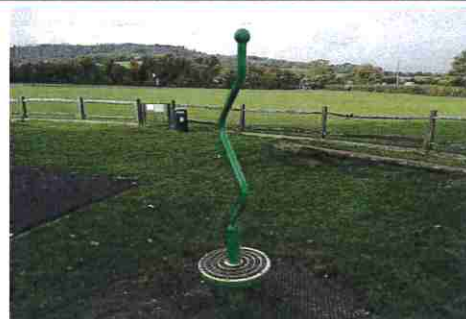
The bearing is showing signs of wear - Monitor for any further deterioration and replace as required

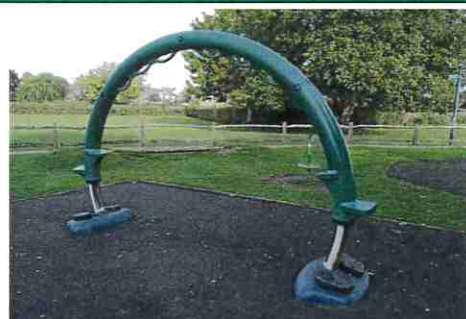
There are significant gaps (over 30mm) between the surface and the edging or between the joints in the surface; these are large enough for a small foot to enter - Repair surfacing around item ground covers 2m black

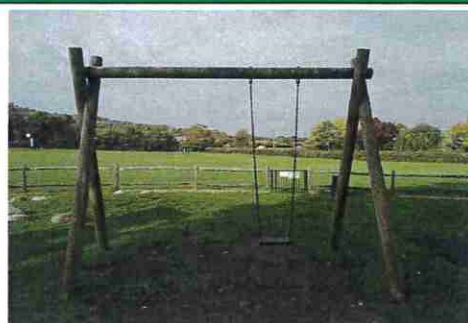
One seat and suspension were missing at the time of inspection and the inspector was unable to make a full compliance assessment - Replace missing seat and suspension

There are gaps opening between the grass mat tiles - Reinstate surface

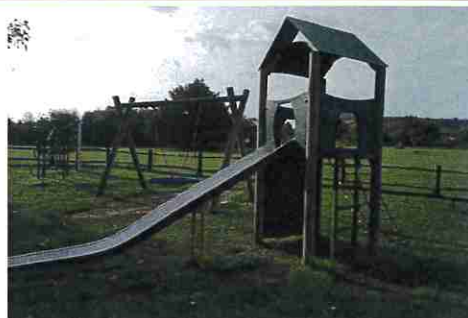
The climbing rope covering is damaged - Recommend monitor and replace as required

There is some graffiti present - Remove the graffiti

Parts of the steel uprights on this item have corroded excessively in places - Ensure all affected areas are treated/repainted or replaced

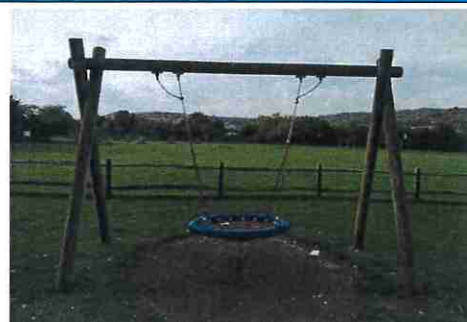
There are bolt cap covers missing or damaged on the item - Replace missing or damaged bolt cap covers

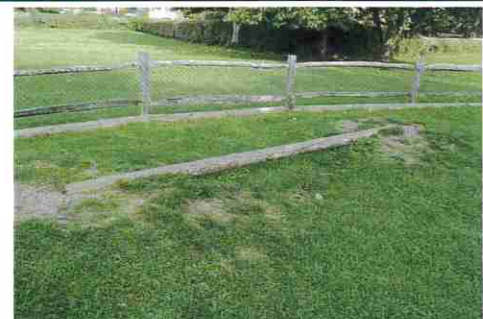
The surface has eroded in some areas - Reinstate the surface

The timber has a number of splits/shakes or air cracks and this may affect the stability or allow water ingress which will accelerate the rotting process - Monitor to ensure the splits do not cross through fixing points of the structure and/or cause any instability

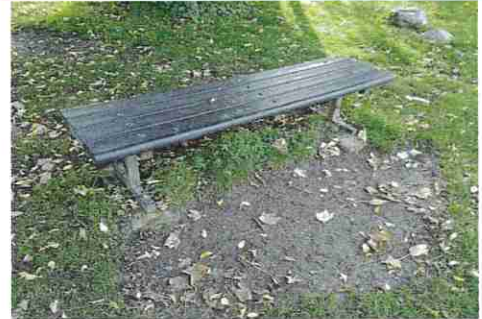
The surface has eroded in some areas - Reinststate the surface

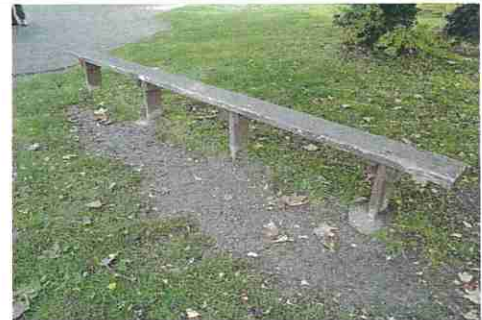
A number of fixing(s) have worked loose - Secure all loose fixings

There is some strimmer / machinery damage apparent on the posts, this can penetrate the preservative applied to the timber and accelerate the rotting process - Monitor for any deterioration (rot) and replace as required

The surface has eroded in some areas - Reinststate the surface

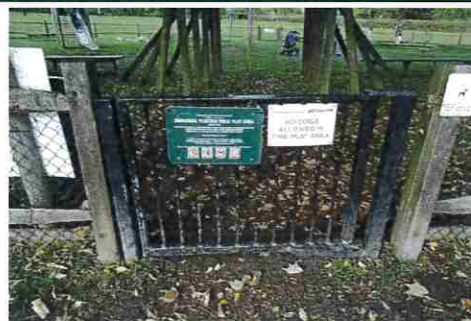
The gate is closing too quickly (less than 4 seconds) - Take corrective action to ensure that the gate closes in 4-8 seconds

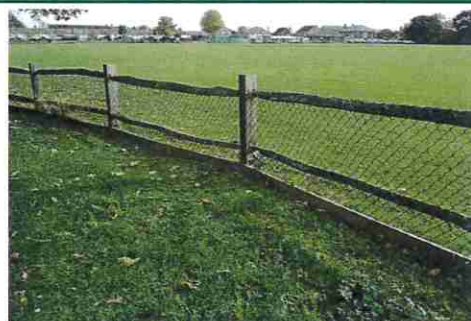
There is some damage to the fence sections - Monitor for any further deterioration and repair as required

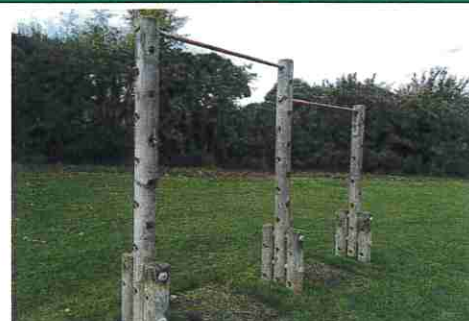
Parts of the timber are rough or splintered - Remove all rough or sharp edges Spare parts no longer available

The paintwork on this item has been damaged or worn exposing the metal underneath which is rusting - Treat any rusting components and repaint

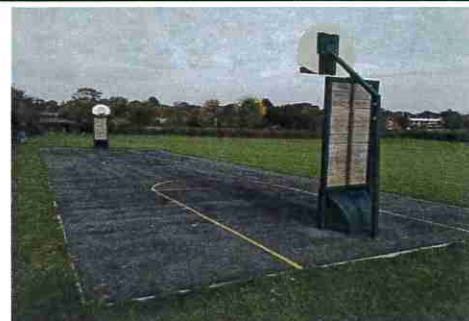
A clearly visible facility sign should be provided in a prominent position with the wording as detailed BS EN 15312- the equipment is not intended for children less than 3 years old- the warning - Do not climb on the framework or nets- the warning - Do not hang on the ring (if provided)- the warning - Do not wear rings or other jewellery- name and telephone number of the administrator- number to call in case of accident - Provide signage to BS EN 15312

There is some evidence of fire damage to the surfacing - Monitor for any further deterioration and repair as required

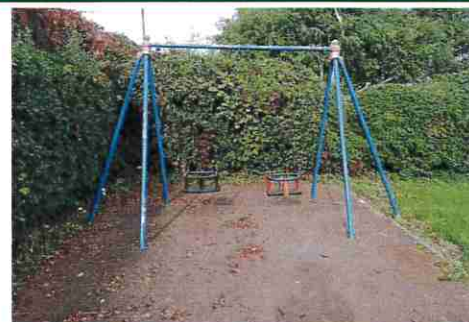
The seats are too close to the frame as defined in BS EN 1176 Part 2; this is a low risk failure and no remedial action is required - Monitor - No remedial work recommended

The surfacing around the item is damaged - Repair the damaged areas of surfacing or upgrade

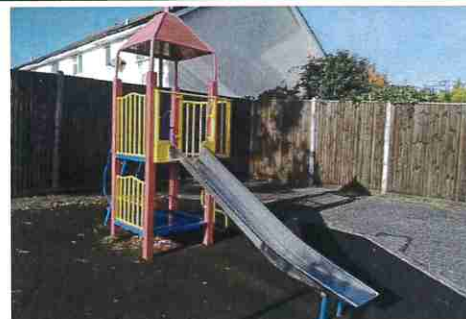
The unit is easily accessible and has an opening in the barrier to steep play elements in excess of 500mm in contravention of BS EN 1176 Part 1 - Monitor - No remedial work recommended

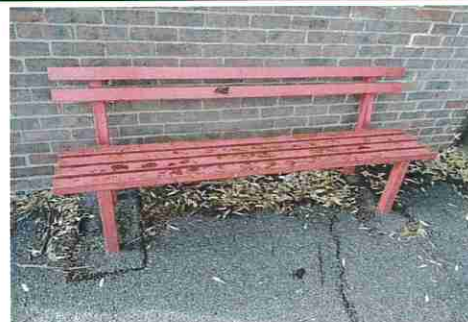
The paintwork on this item has been damaged or worn exposing the metal underneath which is rusting - Treat any rusting components and repaint

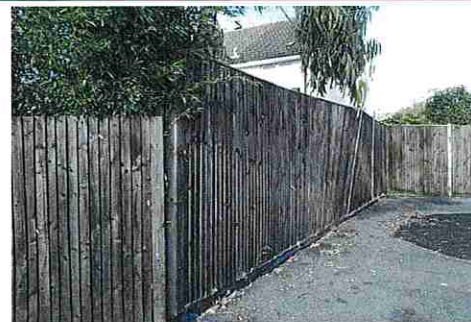
There is a tall leaning post around the fence - Monitor for any further deterioration and reset as required

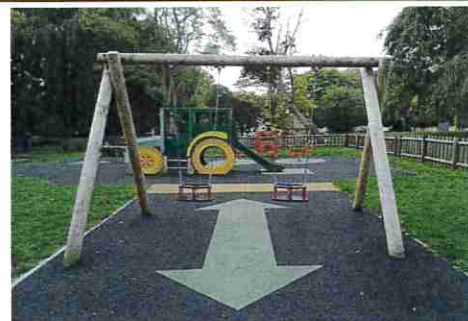
There are significant gaps (over 30mm) between the surface and the edging or between the joints in the surface; these are large enough for a small foot to enter - Repair surfacing edge 22m black 1m yellow

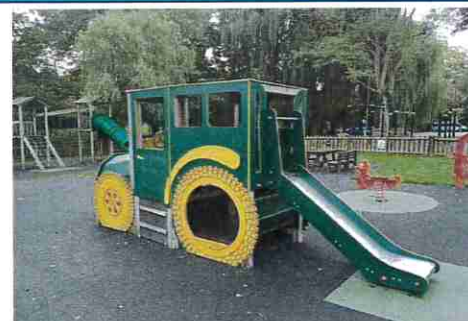
There is a finger entrapment appearing at the climbing ramp/deck and the item fails to meet the requirements of BS EN 1176 Part 1 4.2.7.6 Entrapment of fingers - Monitor - No remedial work recommended

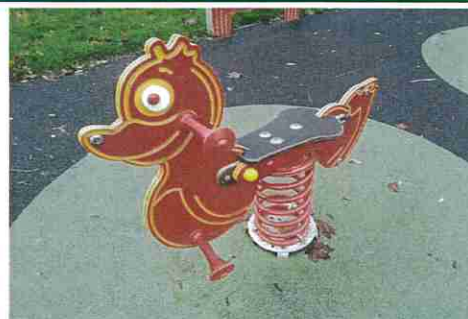
The Footrests rotate and may cause an unexpected movement for the user - Secure Handgrips/Footrests to prevent rotation.

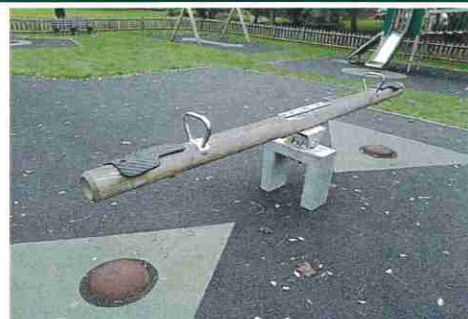
There are significant gaps (over 30mm) between the surface and the edging or between the joints in the surface; these are large enough for a small foot to enter - Repair surfacing edge 40m black

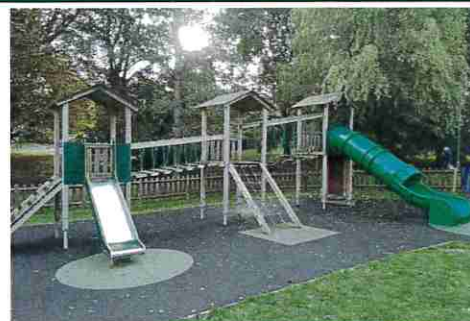
There are gaps opening between the surfacing and the edging surround or between the joints in the surfacing - Monitor for any further deterioration and repair as required

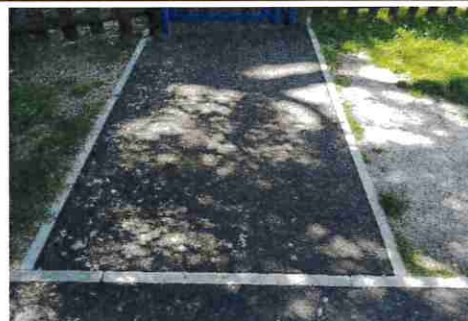
There are significant gaps (over 30mm) between the surface and the edging or between the joints in the surface; these are large enough for a small foot to enter - Repair surfacing edge 6m black

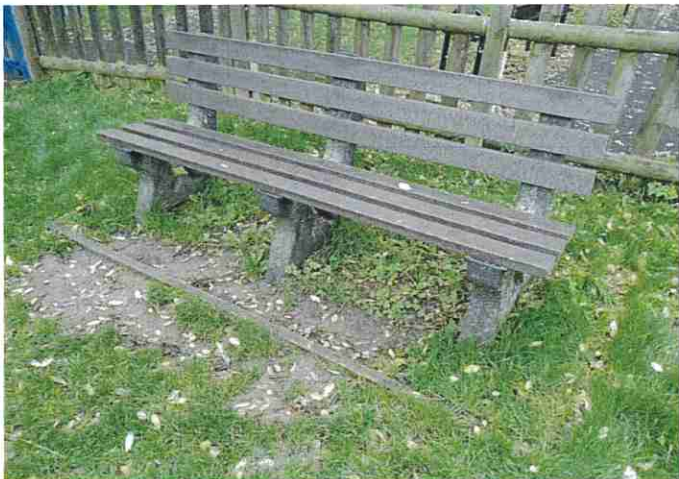
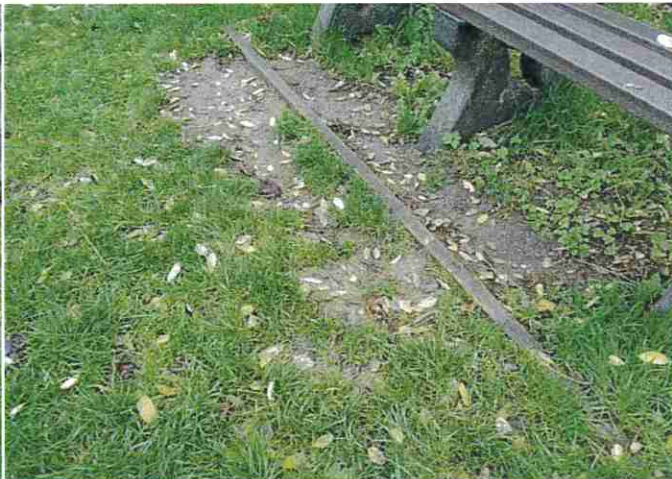
**Finding:** The surface has eroded in some areas

**Action:** Reinstate the surface

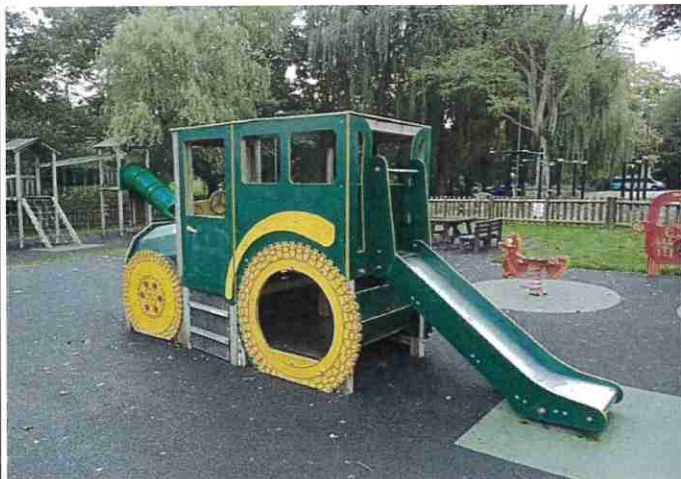
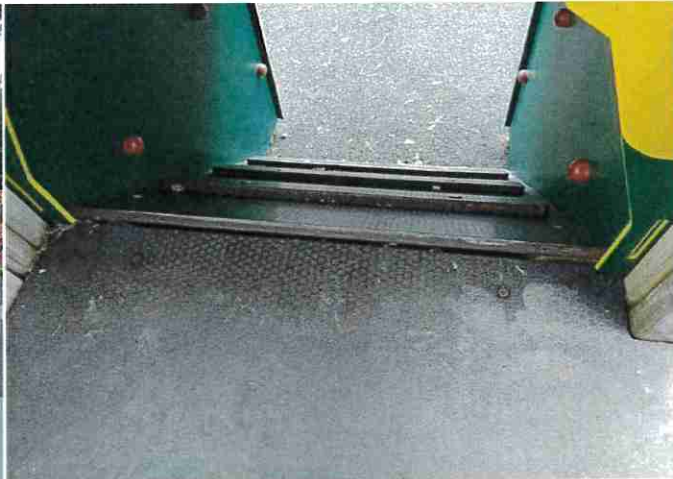
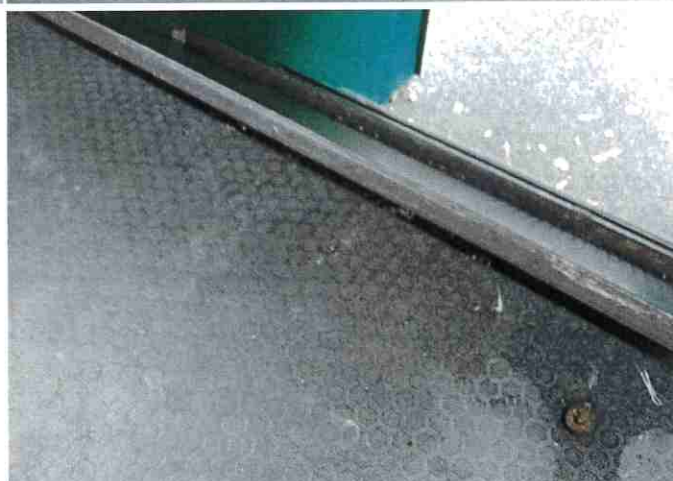
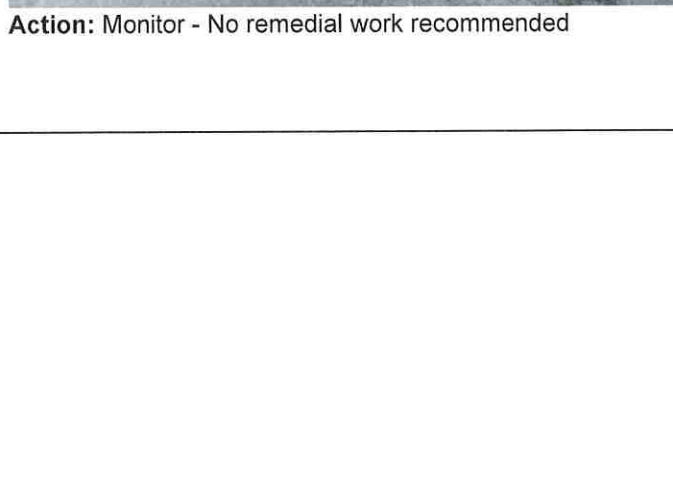
| 5 - Very Low Risk (Finding 1) | | | |
|---|---|---|---|
| <b>Finding:</b> There is a finger entrapment appearing at the climbing ramp/deck and the item fails to meet the requirements of BS EN 1176 Part 1 4.2.7.6 Entrapment of fingers | | <b>Action:</b> Monitor - No remedial work recommended | |

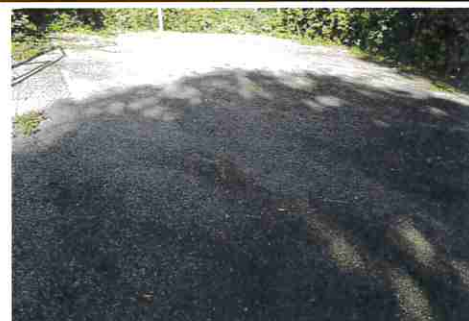
There is algae or moss growth on the surface resulting in slippery conditions - Clean and treat appropriately

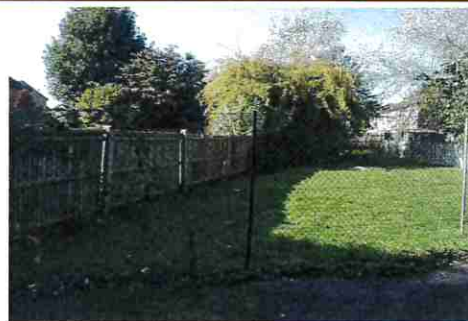
There is some damage/leaning uprights to the fence sections - Repair as required

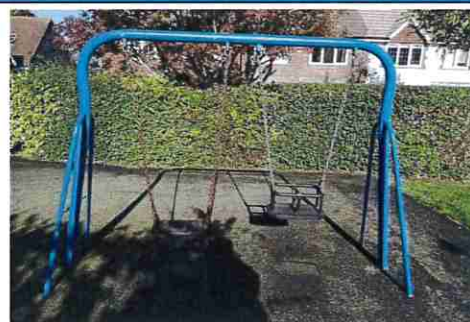
The bush housing's are showing signs of wear - Monitor for any further deterioration and replace as required

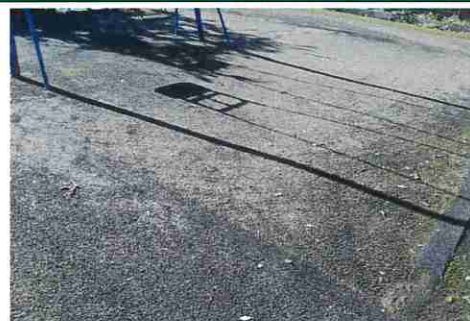
There is algae or moss growth on the surface resulting in slippery conditions - Clean and treat appropriately

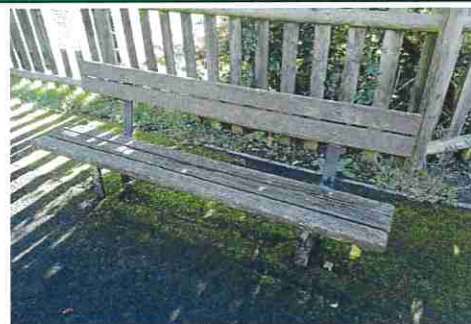
Parts of the timber are rough or splintered - Remove all rough or sharp edges

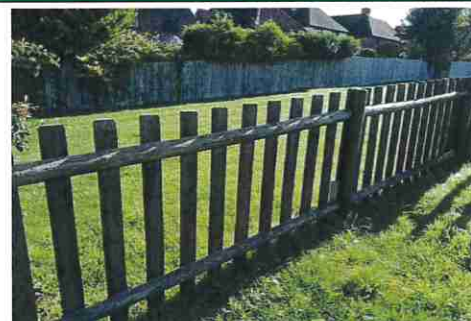
There is a loose slat around the fence - Repair as required

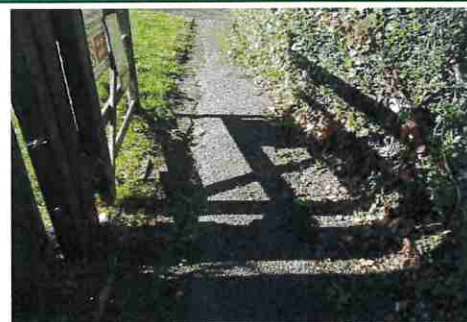
The path surfacing is cracking/damaged - Repair the damaged areas of surfacing

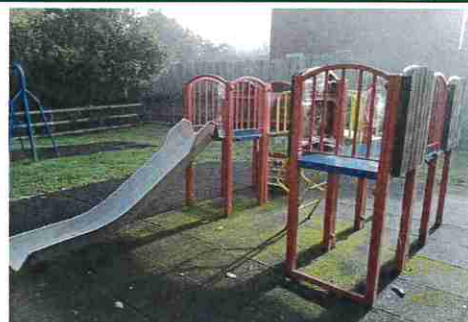
The item fails to meet the requirements of BS EN 1176 Part 1 for head and neck entrapment in the barriers and grabrails - Monitor - No remedial work recommended

The height of the bridge barrier(s) is insufficient and fails to meet the requirements of BS EN 1176 Part 1 - Monitor - No remedial work recommended

There is algae or moss growth on the surface resulting in slippery conditions - Clean and treat appropriately

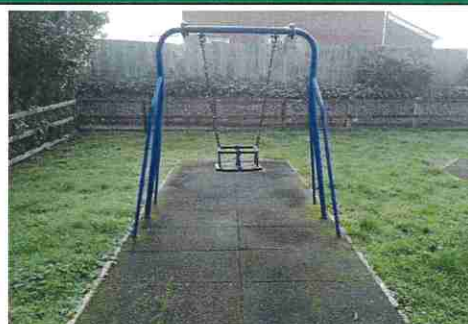
There is some notable evidence of chain wear - Monitor for any further deterioration and replace when 40% worn

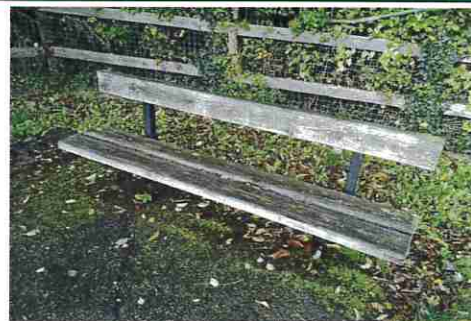
There is algae or moss on the surface of the equipment - Clean and treat appropriately

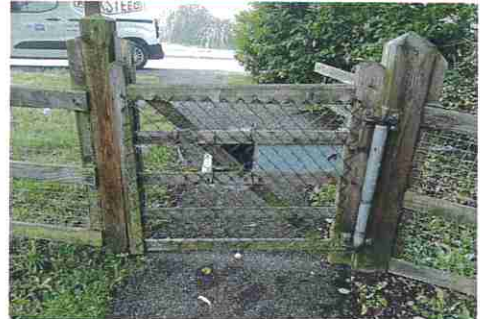
The gate is closing too quickly (less than 4 seconds) - Take corrective action to ensure that the gate closes in 4-8 seconds
