## COMMUNITY COMMITTEE MEETING HELD ON TUESDAY 4<sup>th</sup> FEBRUARY 2025 AT 7.30 PM AT THE STEYPING CENTRE

# DRAFT MINUTES

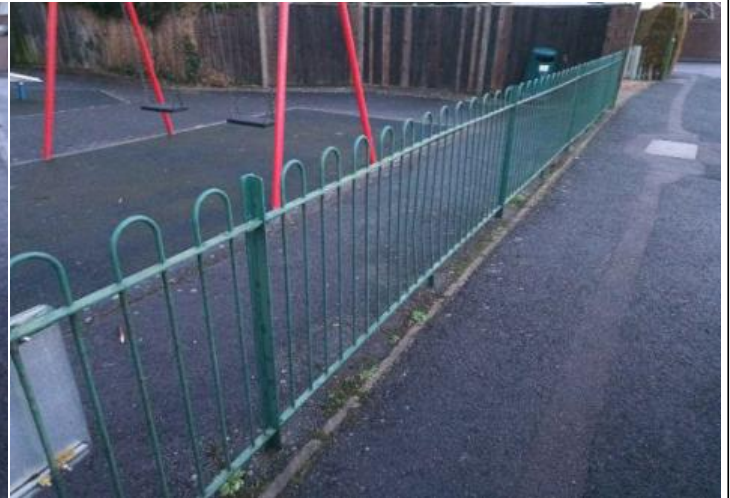
**Finding:** There is some damage to the fence sections

**Action:** Monitor for any further deterioration and repair as required

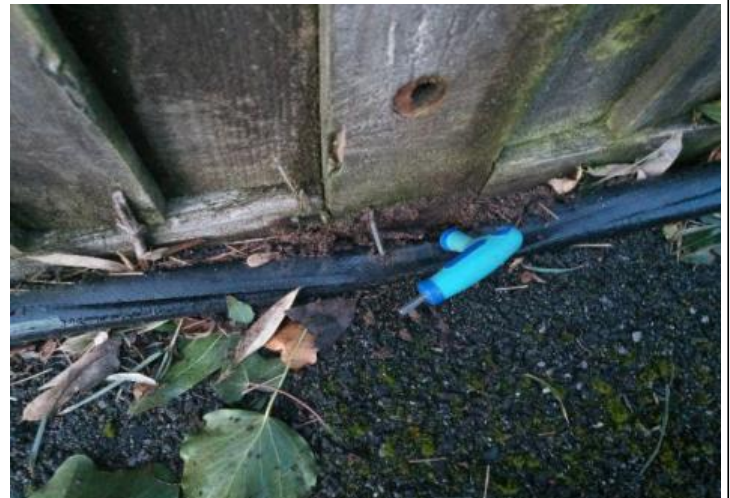
**Finding:** One of the tall posts is leaning and there is evidence of rot at the base

**Action:** Replace affected post

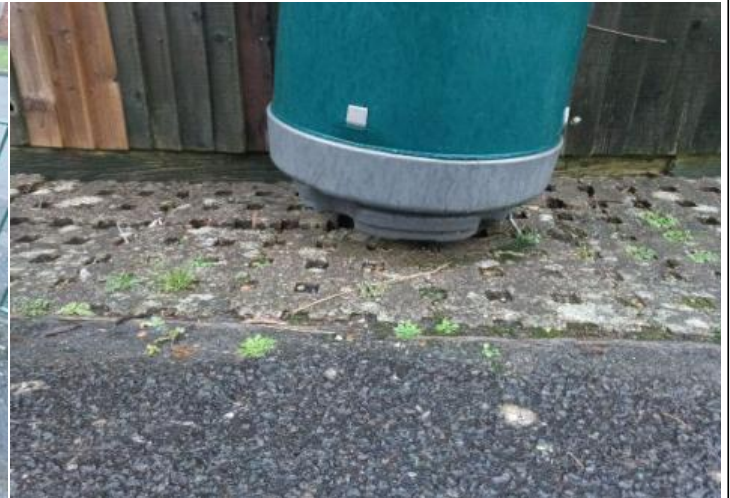
**Finding:** The item is slightly loose in its foundations

**Action:** Monitor for any further deterioration and repair as required

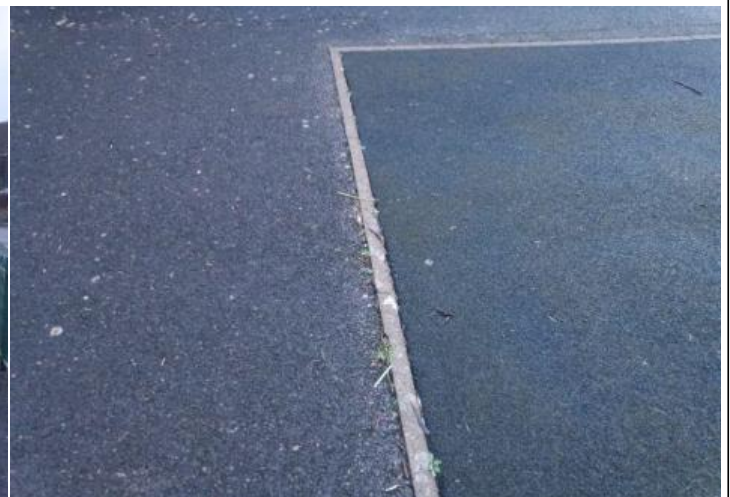
**Finding:** There are gaps opening between the surfacing and the edging surround or between the joints in the surfacing

**Action:** Monitor for any further deterioration and repair as required

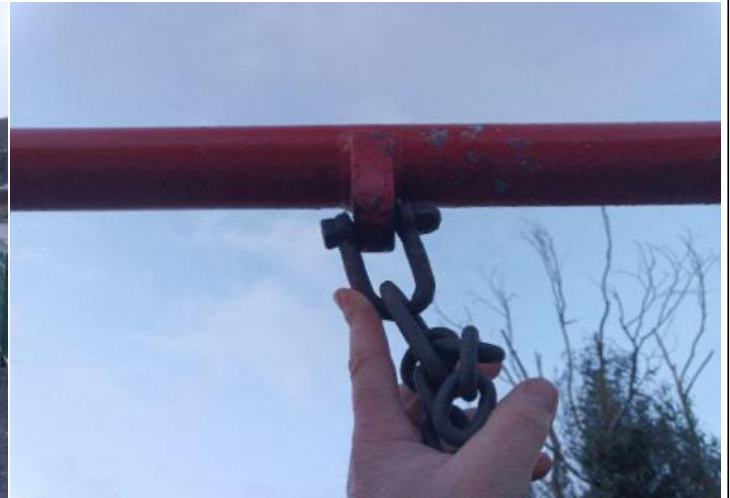
**Finding:** The bush / bushes is / are worn or missing and the fixing lugs are wearing  
**Action:** Replace worn or missing bushes

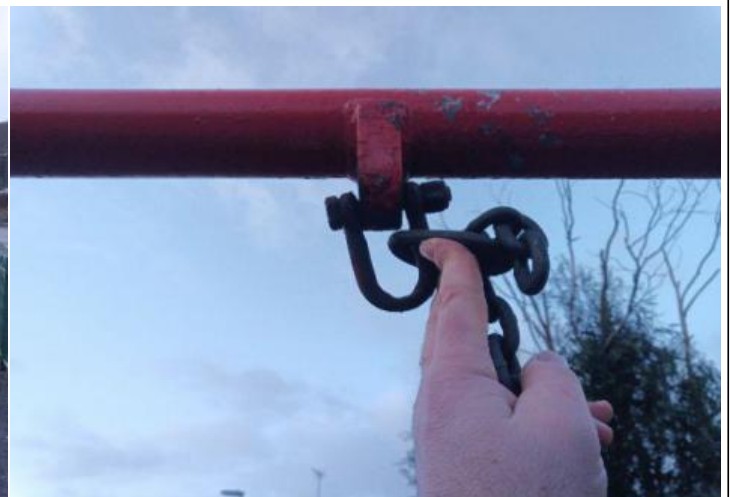
**Finding:** There is some wear to the shackles.

**Action:** Monitor for any further deterioration and replace when 40% worn

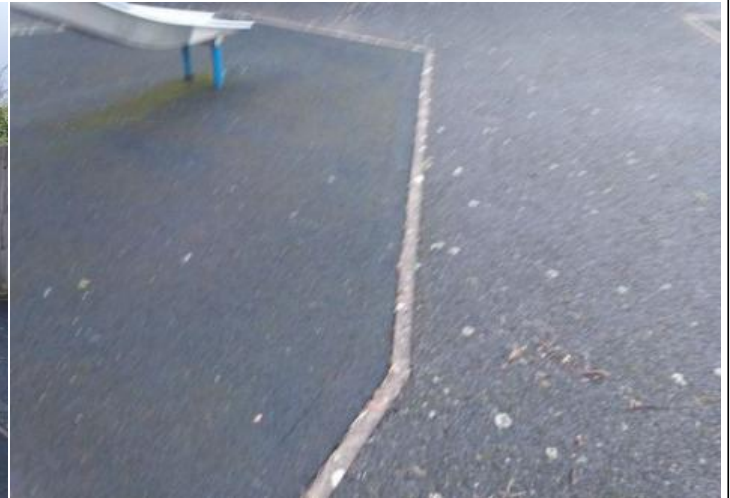
**Finding:** There are gaps opening between the surfacing and the edging surround or between the joints in the surfacing  
**Action:** Monitor for any further deterioration and repair as required

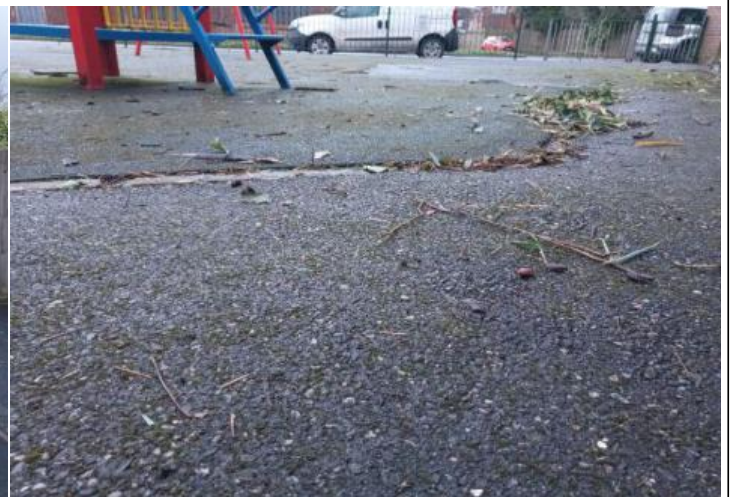
**Finding:** The surface is lifting at the edges and creating trip points  
**Action:** Repair perimeter of surfacing to remove trip points

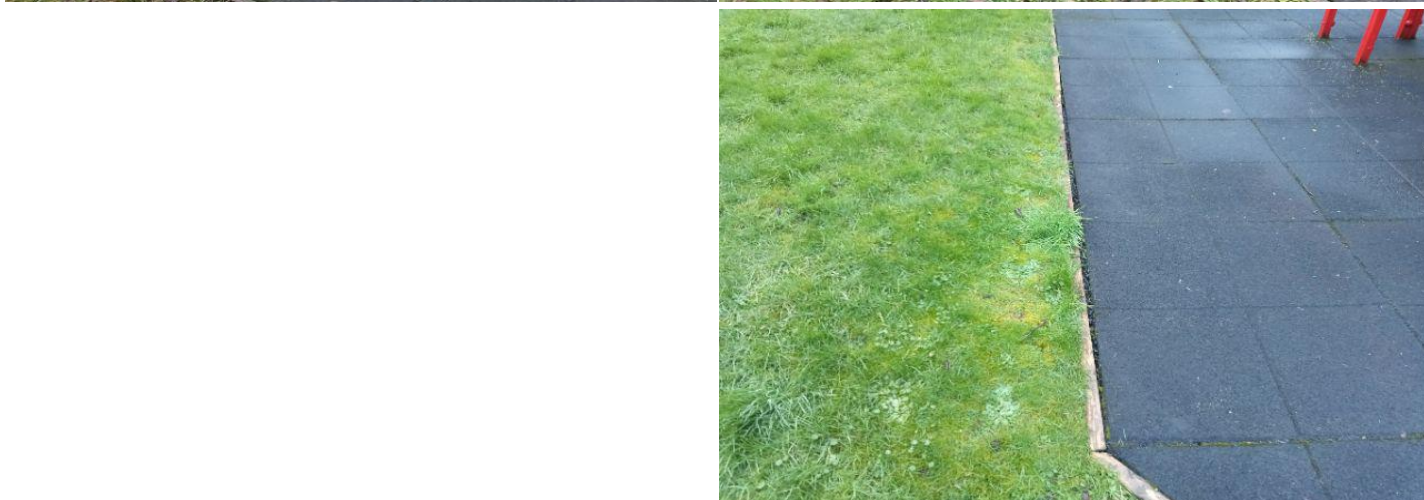
**Finding:** There are gaps opening between the surfacing and the edging surround or between the joints in the surfacing  
**Action:** Monitor for any further deterioration and repair as required

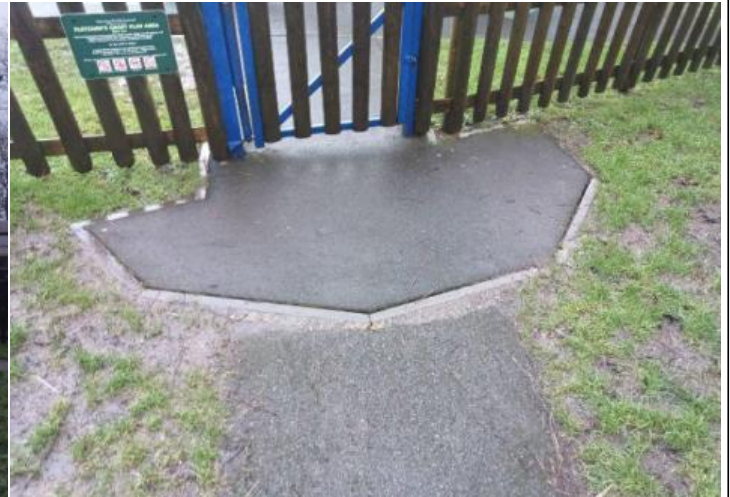
**Finding:** There are gaps opening between the surfacing and the edging surround or between the joints in the surfacing **Action:** Monitor for any further deterioration and repair as required

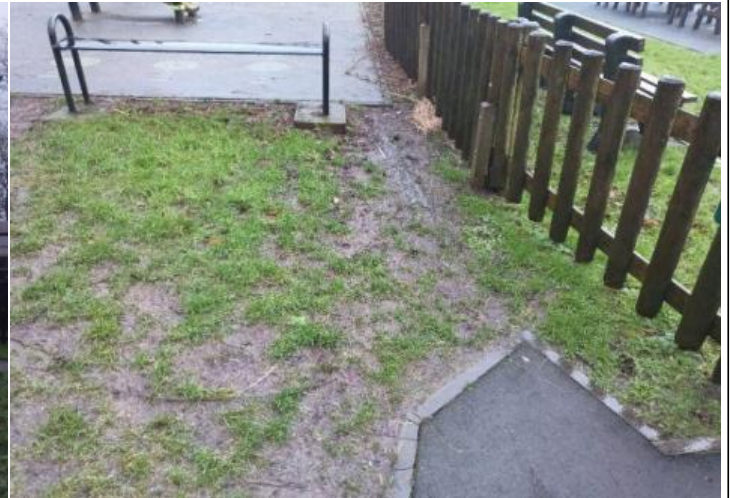
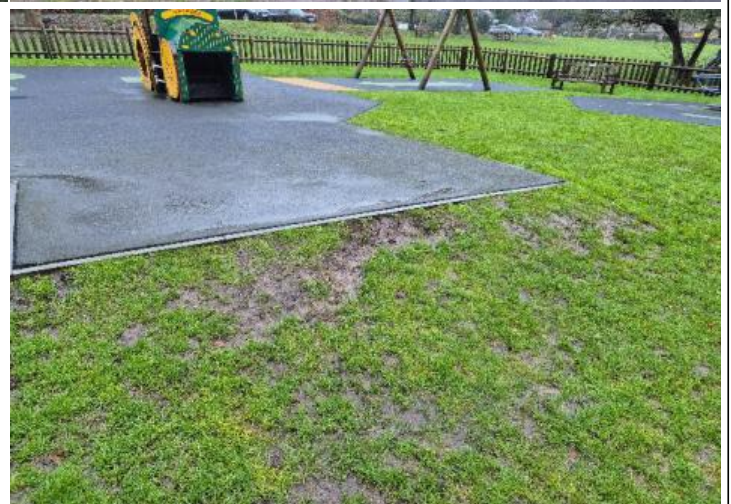
**Finding:** The surface has eroded in some areas and may be slippery in wet conditions  
**Action:** Reinstate the surface

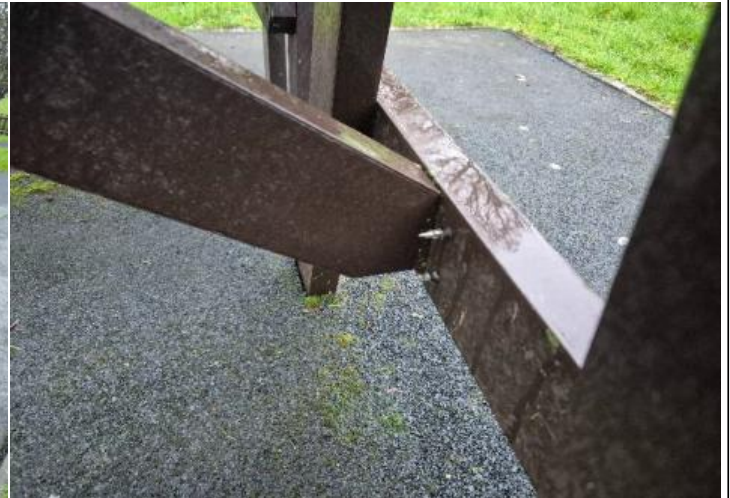
**Finding:** There are projecting screws present due to missing rail

**Action:** Remove screws or replace missing rail

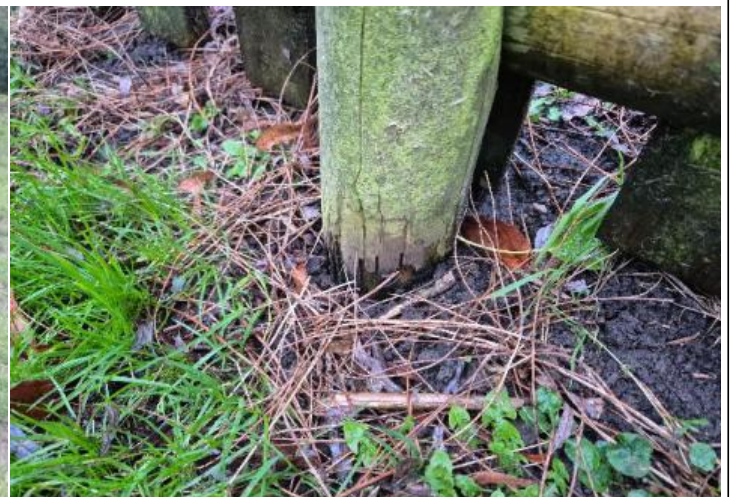
**Finding:** There is some strimmer / machinery damage apparent on the posts, this can penetrate the preservative applied to the timber and accelerate the rotting process

**Action:** Monitor for any deterioration (rot) and replace as required

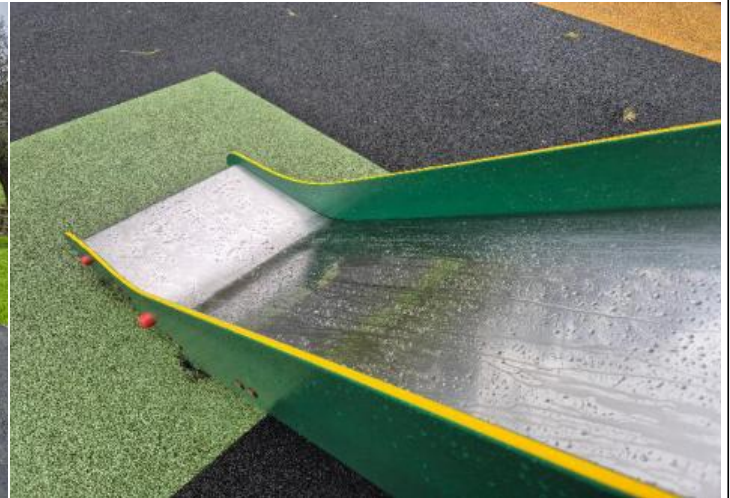
**Finding:** There are a number of dents in the slide surface

**Action:** Monitor for any further deterioration and repair as required

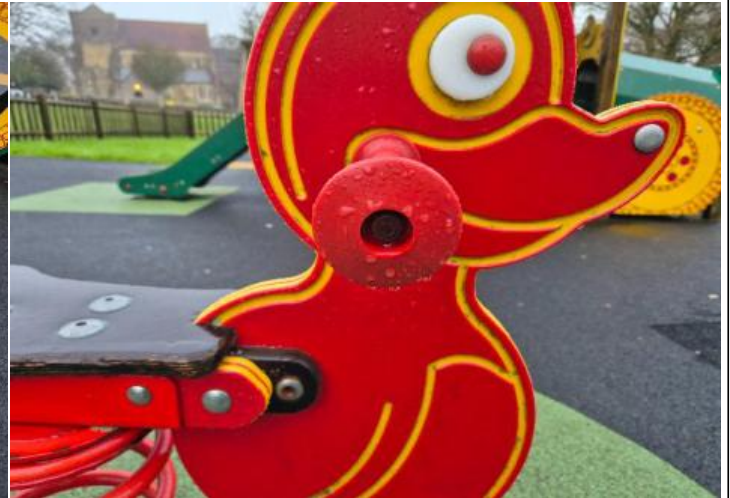
**Finding:** There is/are inserts missing

**Action:** Replace missing inserts

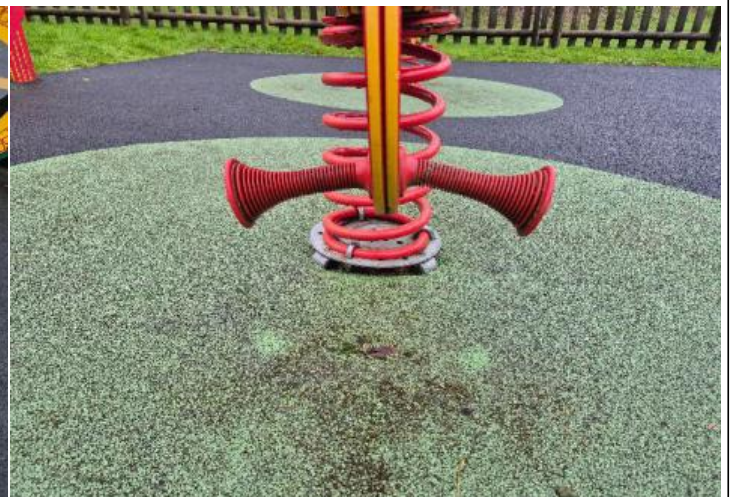
**Finding:** The item has been damaged

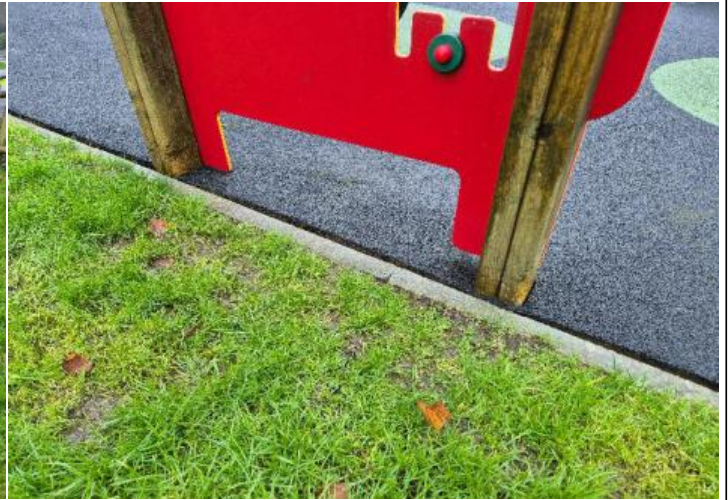
**Finding:** There is some strimmer / machinery damage apparent on the posts, this can penetrate the preservative applied to the timber and accelerate the rotting process

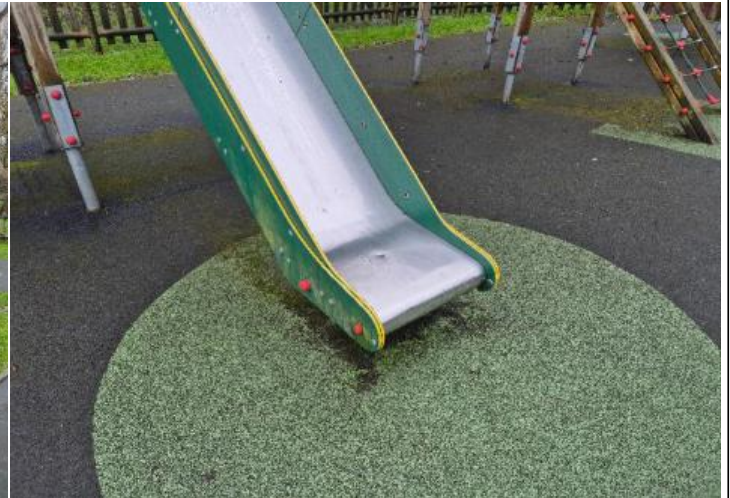
**Finding:** There are a number of dents in the slide surface

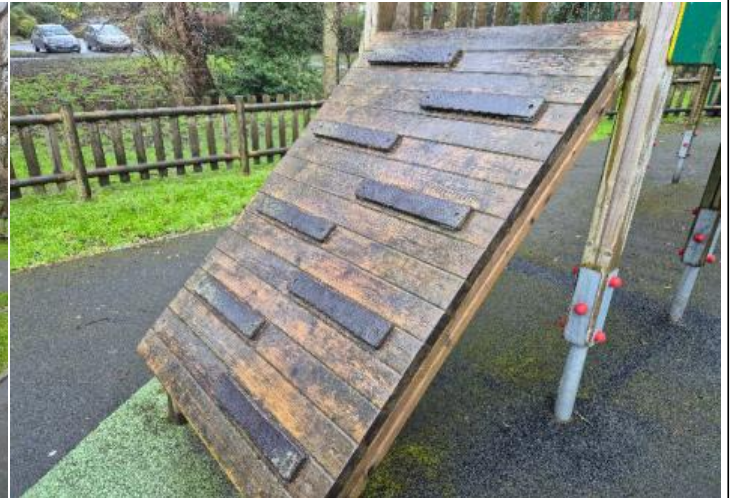
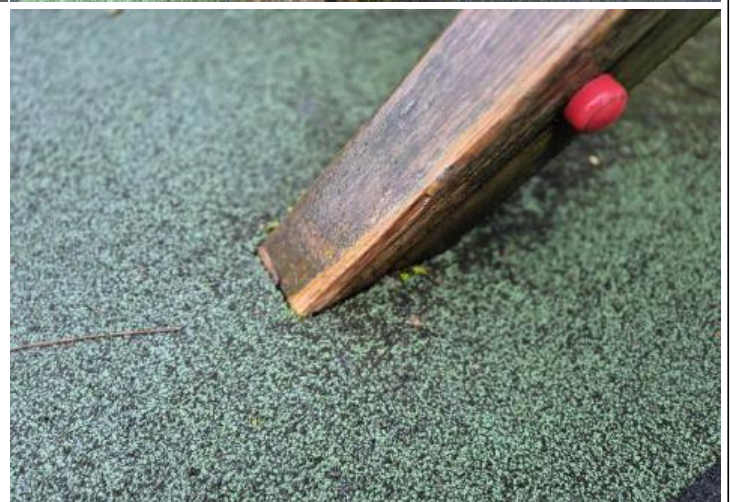
**Finding:** There is algae growth on the surface of the equipment resulting in slippery conditions

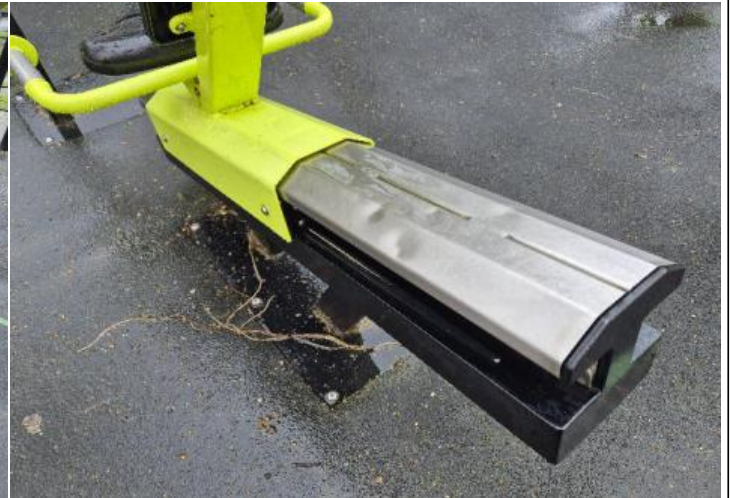
**Finding:** The item has been damaged

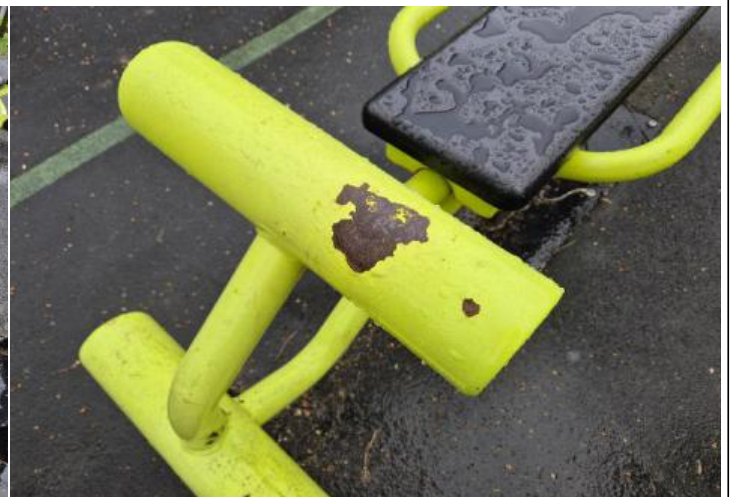
**Finding:** The paintwork on this item has been damaged or worn exposing the metal underneath which is rusting / corroding

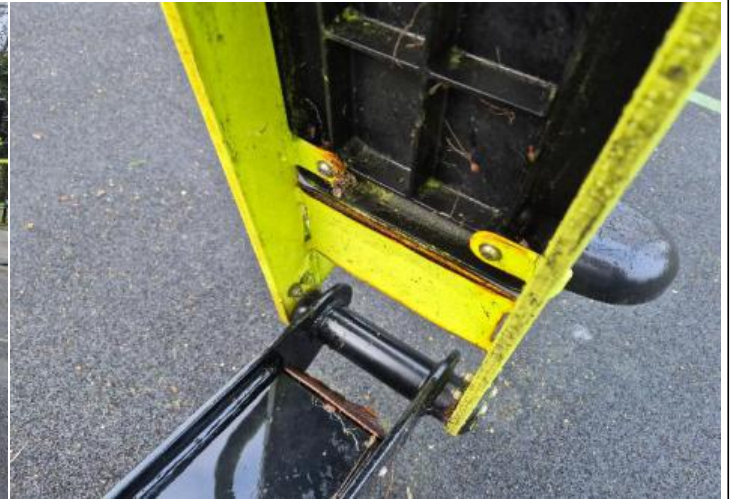
**Finding:** The paintwork on this item has been damaged or worn exposing the metal underneath which is rusting / corroding

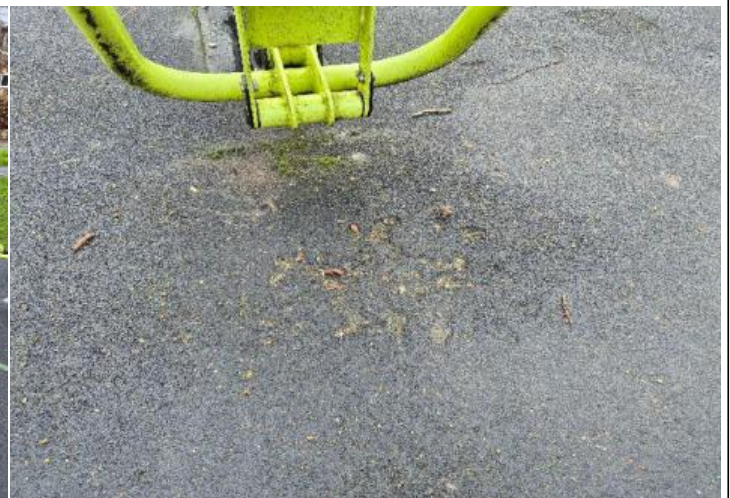
**Finding:** There is some minor damage to the surface  
**Action:** Monitor for any further deterioration and repair as required

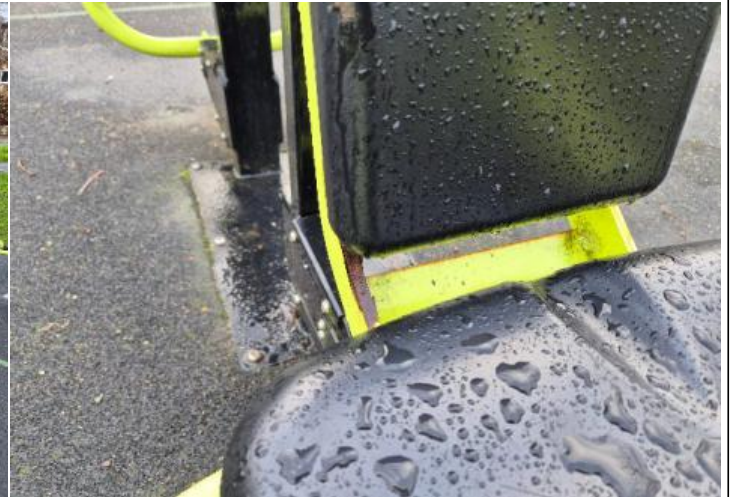
**Finding:** The paintwork on this item has been damaged or worn exposing the metal underneath which is rusting / corroding

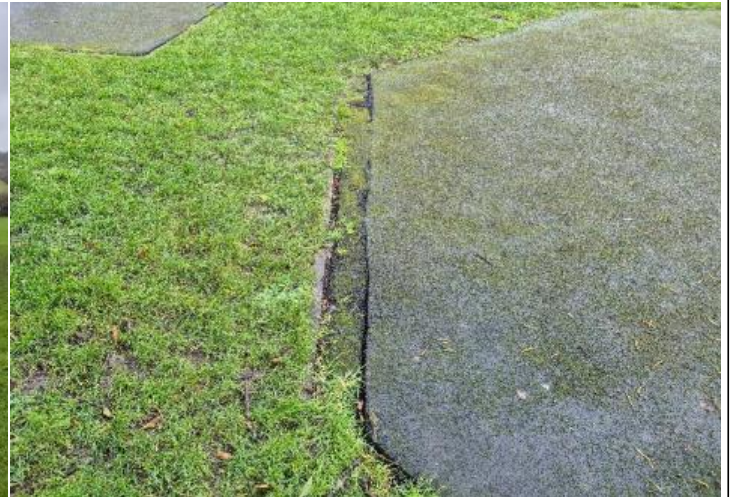
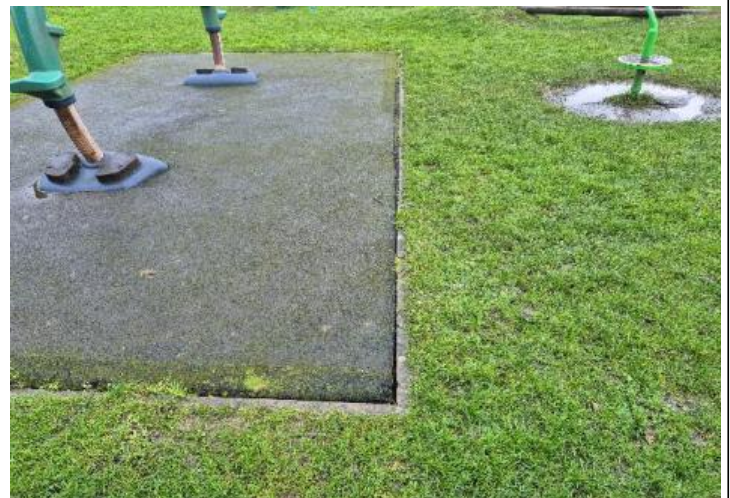
**Finding:** There are gaps opening between the surfacing and the edging surround or between the joints in the surfacing **Action:** Monitor for any further deterioration and repair as required

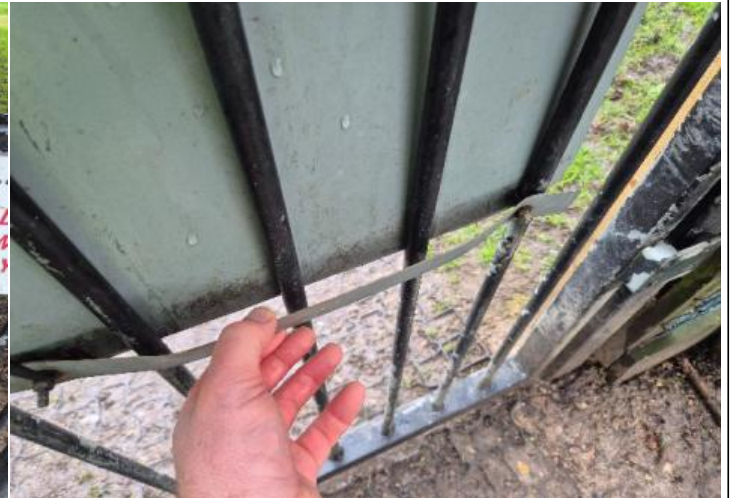
**Finding:** A number of fixing(s) have worked loose

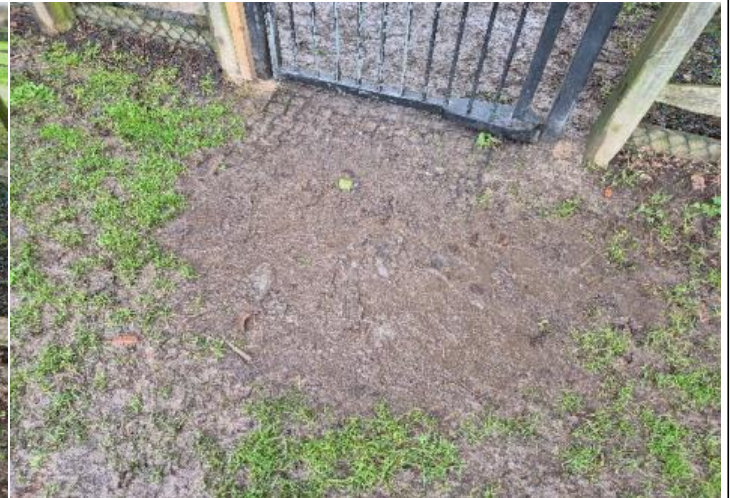
**Finding:** The area under the gate has eroded leaving uneven areas, or the concrete foundations exposed, resulting in trip hazards at the entrance/exit to the playground

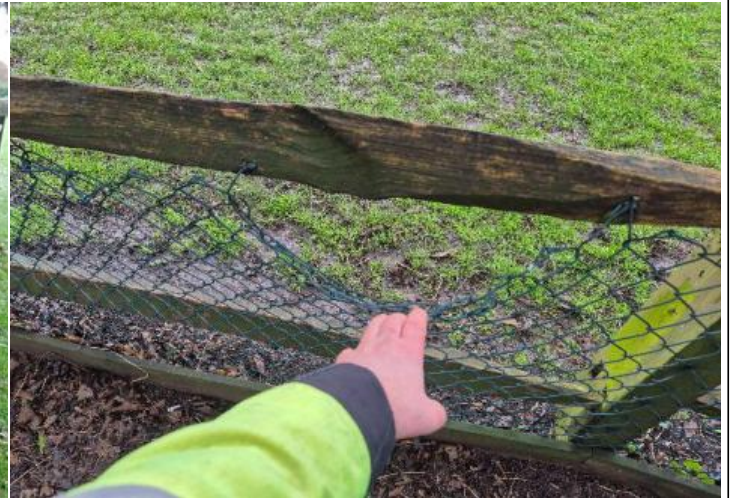
**Finding:** There are a number of fixings missing from the fence

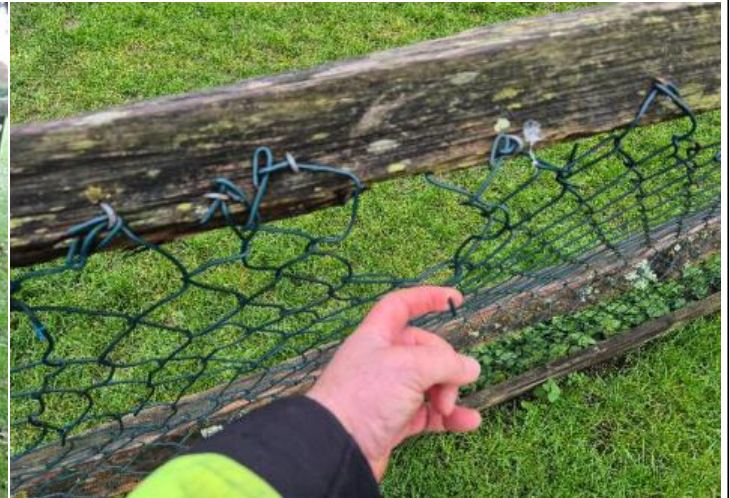
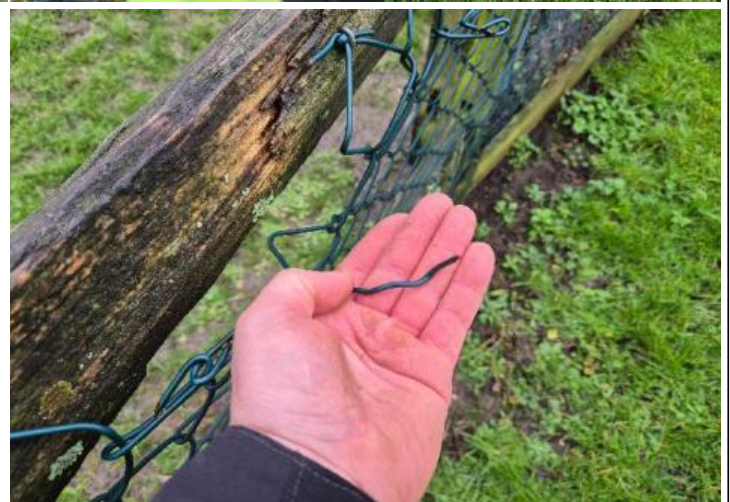
**Finding:** The fence is damaged in places leaving sharp protruding wires

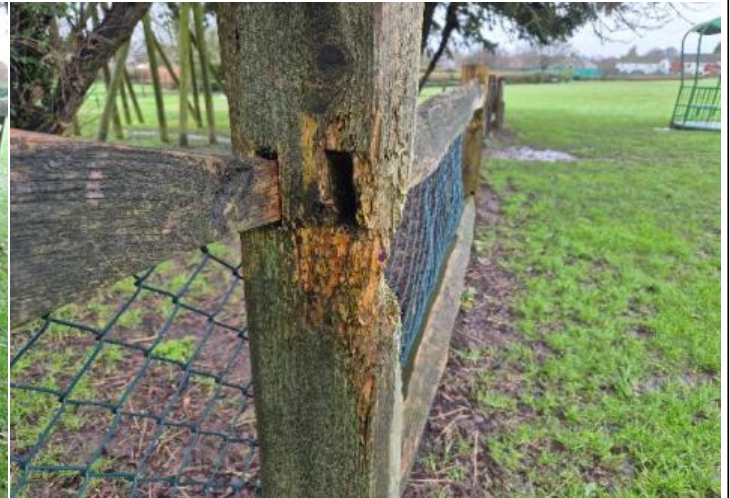
**Finding:** There is some damage to the fence sections

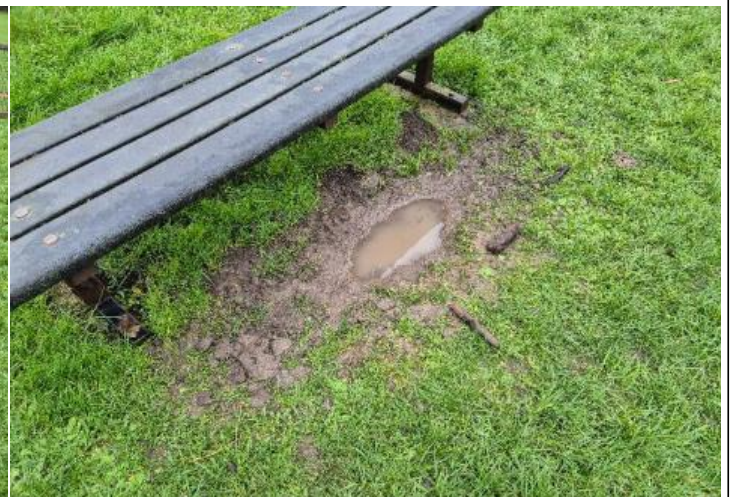
**Finding:** The surface has eroded in some areas and may be slippery in wet conditions

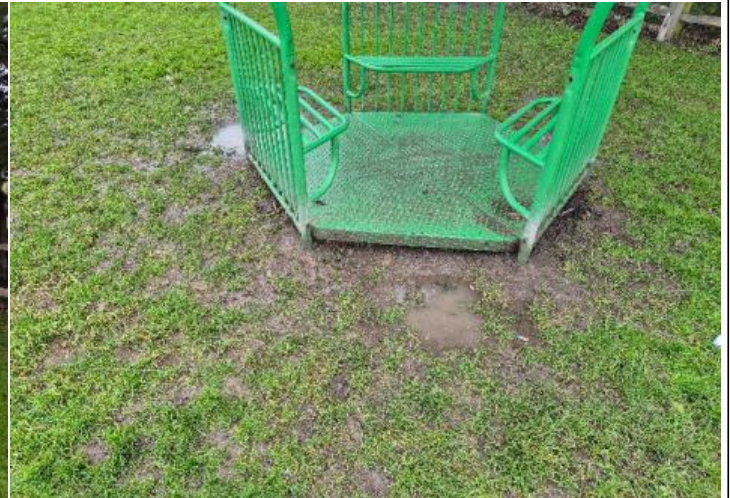
**Finding:** The surface has eroded in some areas and may be slippery in wet conditions  
**Action:** Reinstate the surface

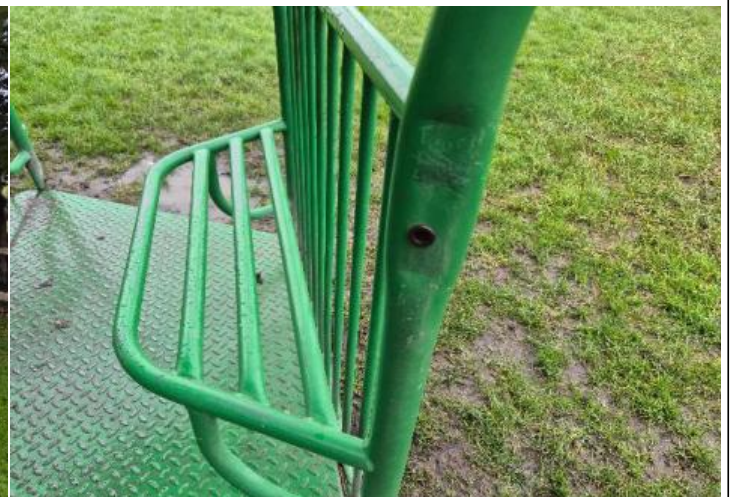
**Finding:** There is/are inserts missing  
**Action:** Replace missing inserts

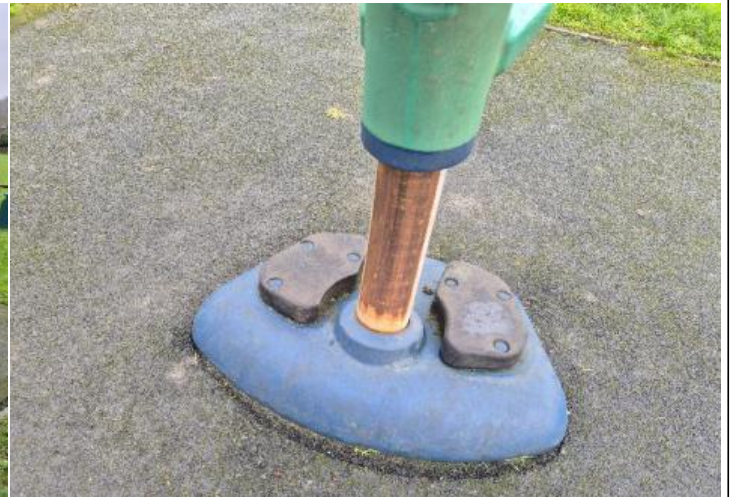
**Finding:** The paintwork on this item has been damaged or worn exposing the metal underneath which is rusting / corroding

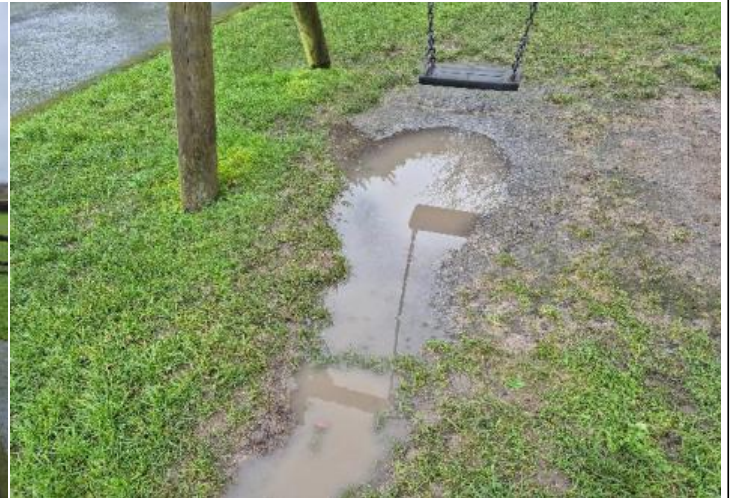
**Finding:** The surface has subsided in some areas

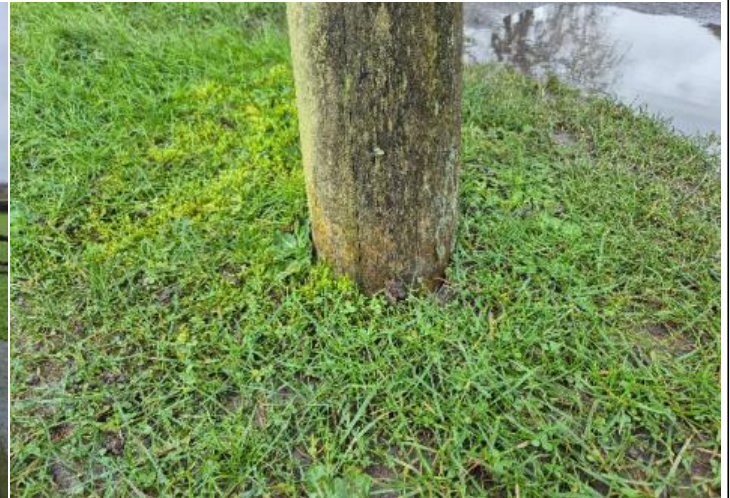
**Finding:** There is some strimmer / machinery damage apparent on the posts, this can penetrate the preservative applied to the timber and accelerate the rotting process

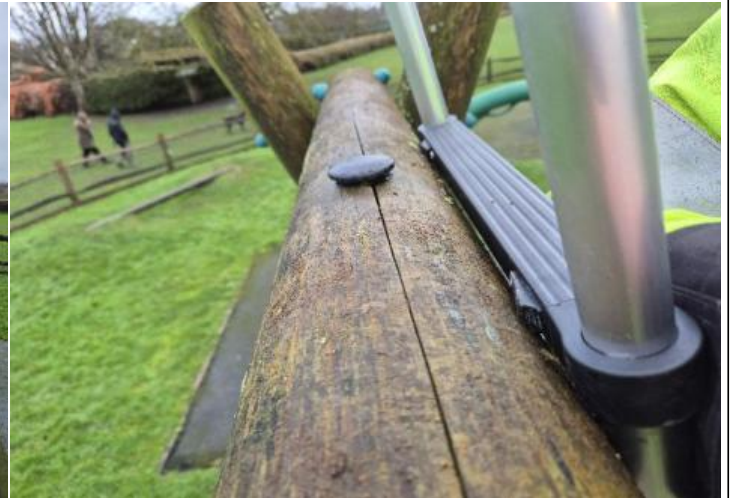
**Finding:** The timber has a number of splits/shakes or air cracks and this may affect the stability or allow water ingress which will accelerate the rotting process

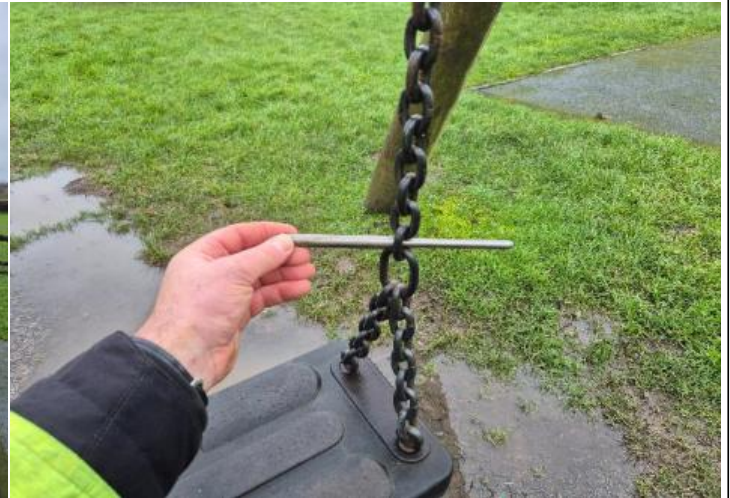
**Finding:** The chain openings are in excess of the 8.6mm as recommended by BS EN 1176 **Action:** Monitor - No action given the risk assessment

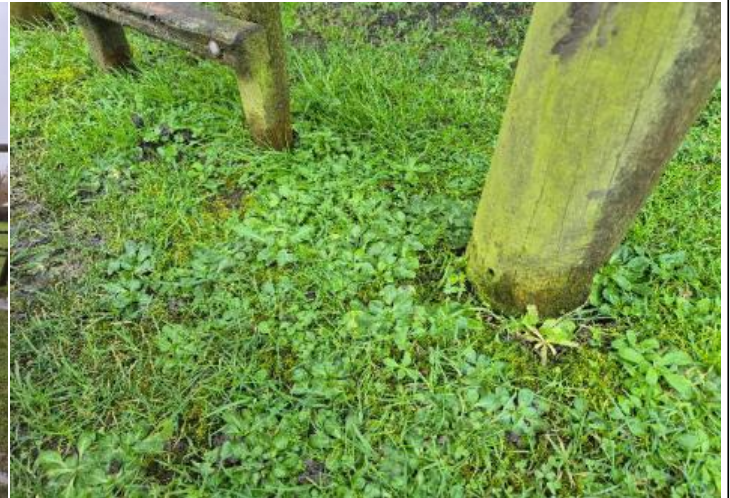
**Finding:** There is some strimmer / machinery damage apparent on the posts, this can penetrate the preservative applied to the timber and accelerate the rotting process

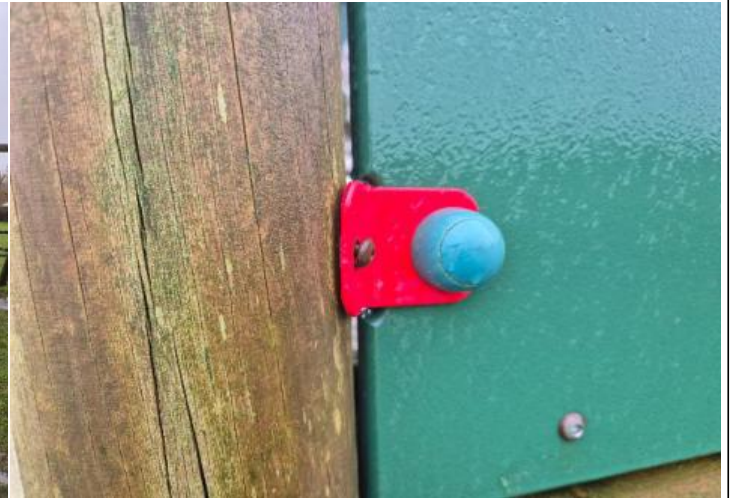
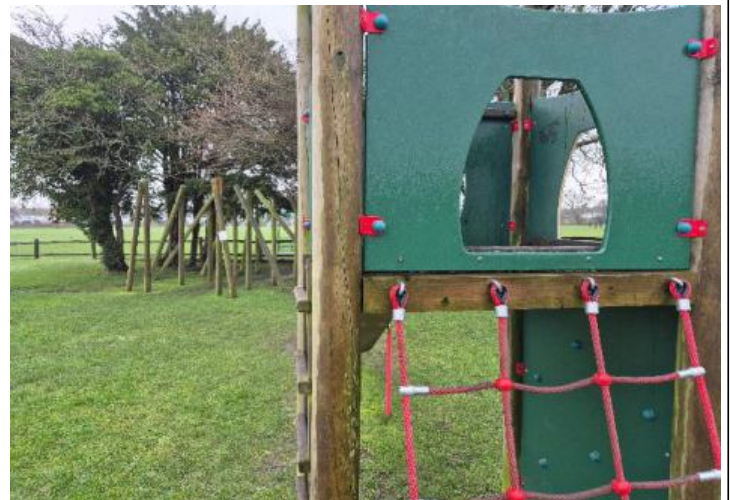
**Finding:** A number of fixing(s) have worked loose

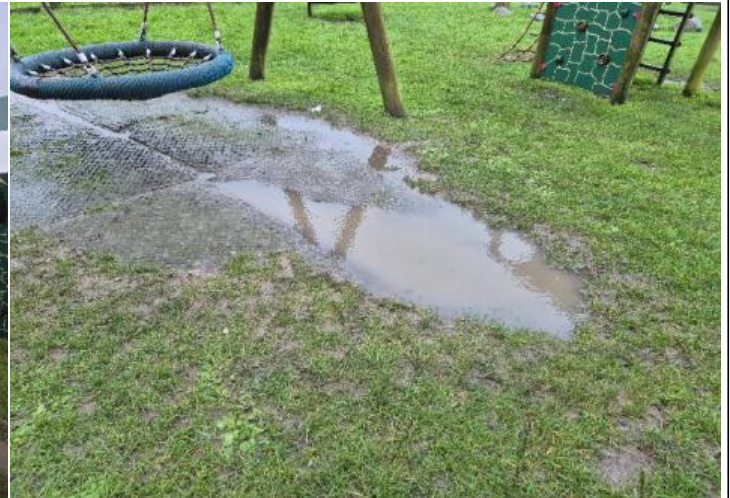
**Finding:** The surface has subsided in some areas

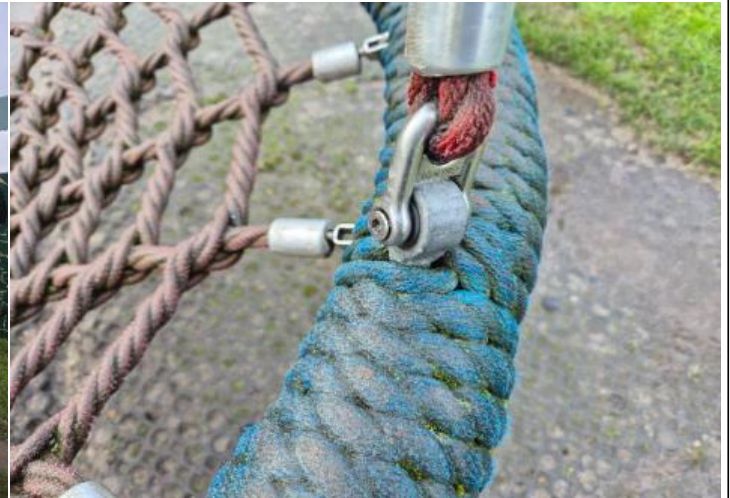
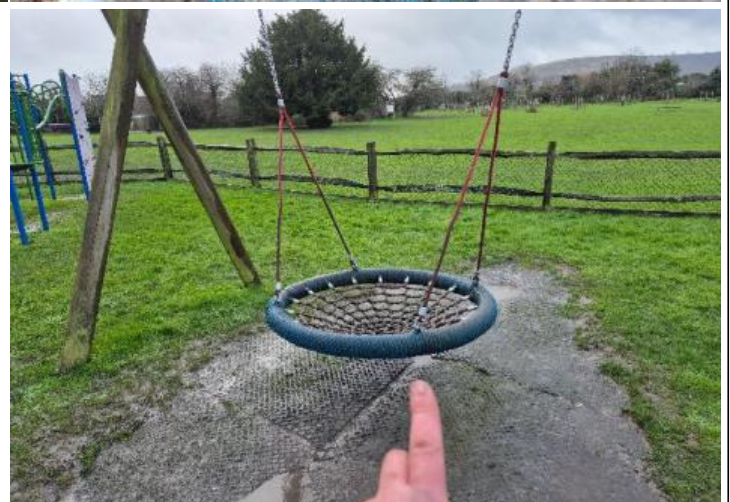
**Finding:** A number of fixing(s) have worked loose

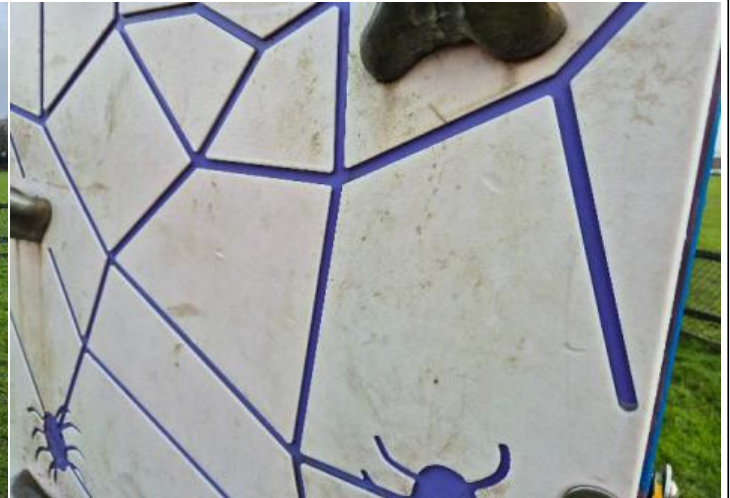
**Finding:** The item has been damaged

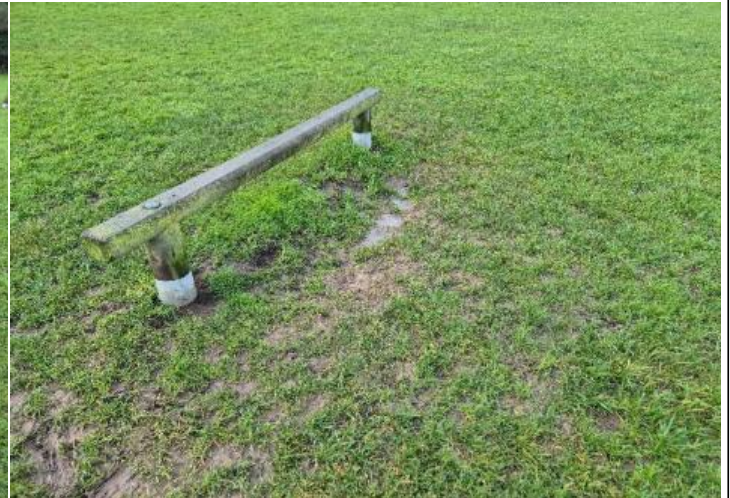
**Finding:** The surface has eroded in some areas and may be slippery in wet conditions  
**Action:** Reinstate the surface

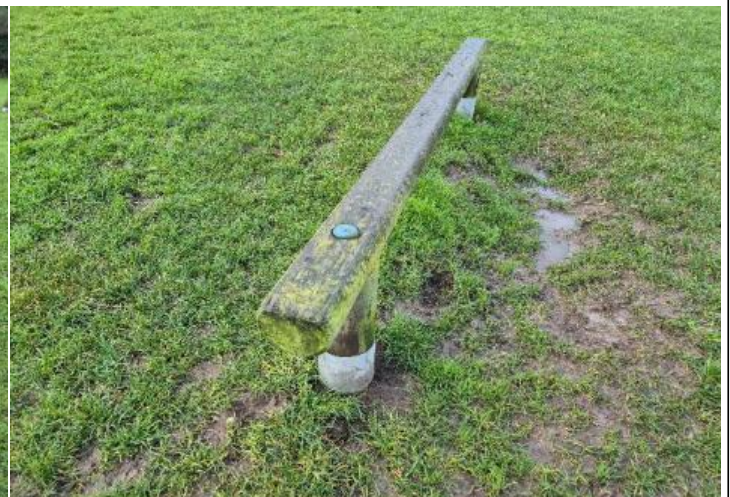
**Finding:** There is algae growth on the surface of the equipment resulting in slippery conditions

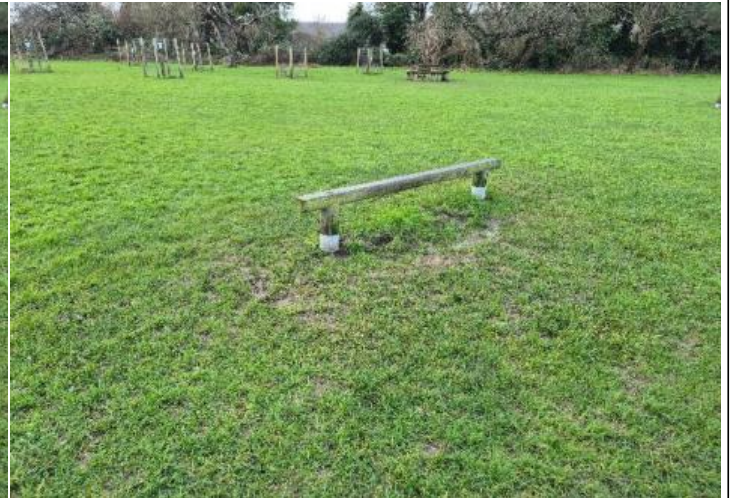
**Finding:** There are steel strimmer guards fitted and the inspector could not fully inspect for rot

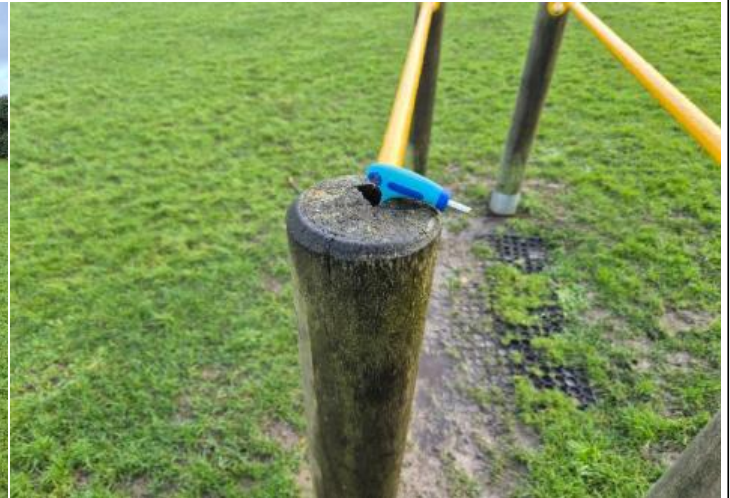
**Finding:** There are areas or parts of the timber on the structure that have rotted

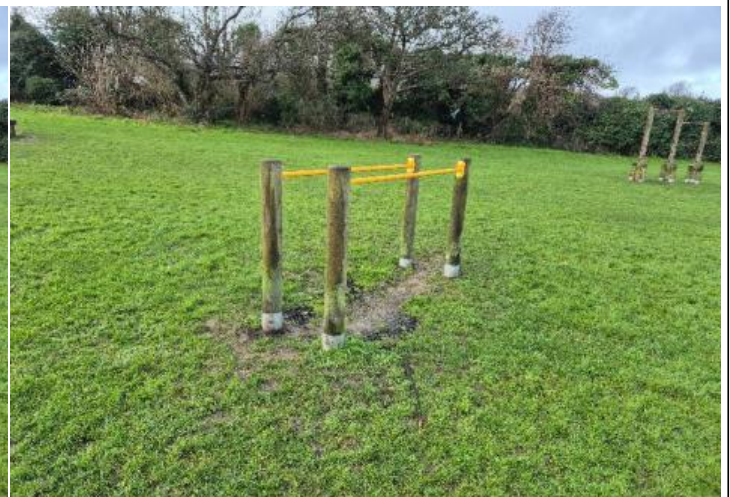
**Finding:** There are strimmer guards fitted and the inspector could not fully inspect for rot

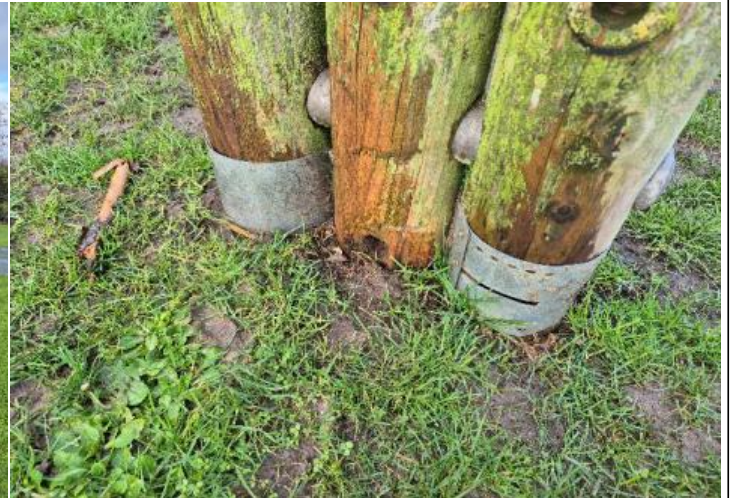
**Finding:** There is some strimmer / machinery damage apparent on the posts, this can penetrate the preservative applied to the timber and accelerate the rotting process

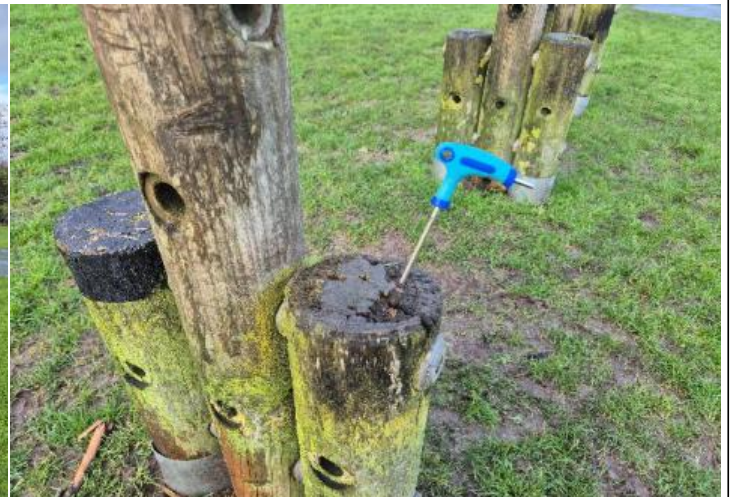
**Finding:** There is some evidence of rot in the timber

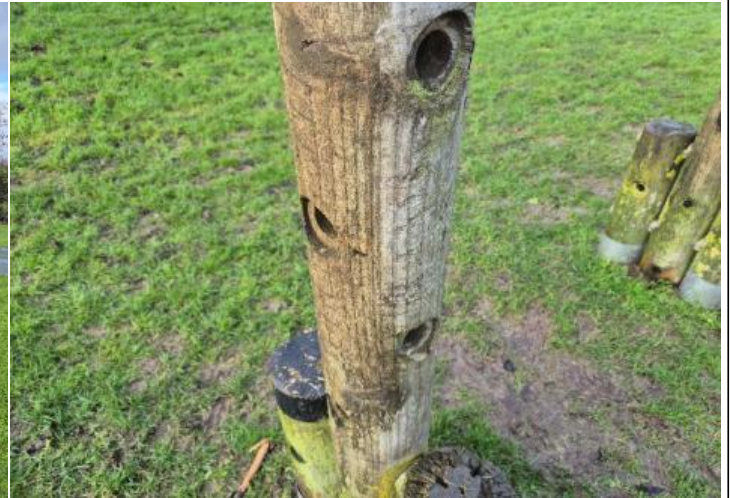
**Finding:** The item has been damaged

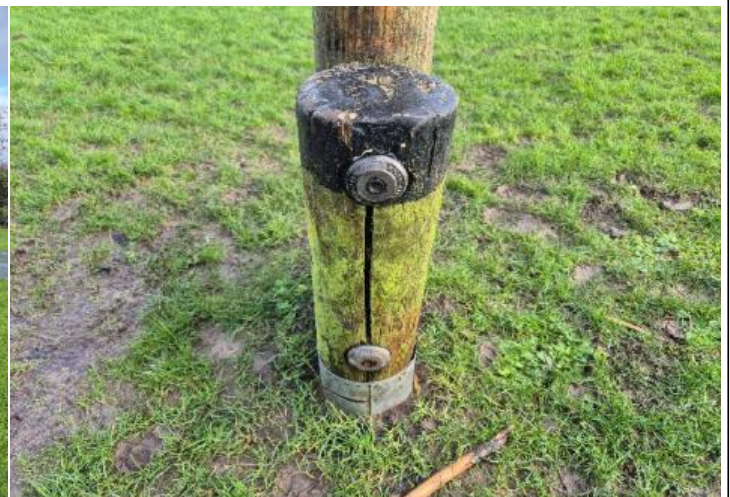
**Finding:** The timber has a number of splits/shakes or air cracks and this may affect the stability or allow water ingress which will accelerate the rotting process
