## COMMUNITY COMMITTEE MEETING HELD ON TUESDAY 4<sup>th</sup> FEBRUARY 2025 AT 7.30 PM AT THE STEYPING CENTRE

# DRAFT MINUTES

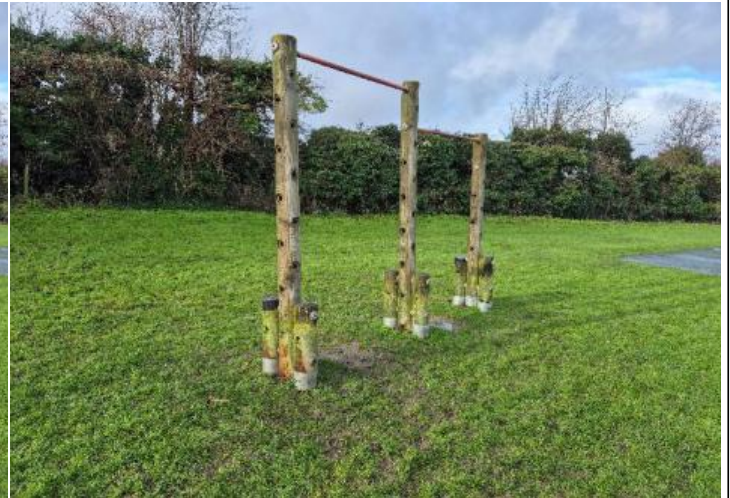
**Finding:** There are steel strimmer guards fitted and the inspector could not fully inspect for rot

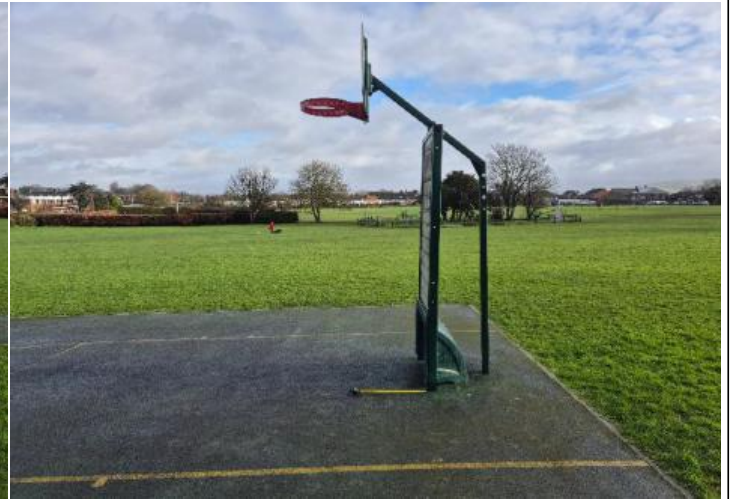
**Finding:** The free space between the backboard and the framework is less than 600mm and fails the requirements of BS EN15312:2007 +A1 2010

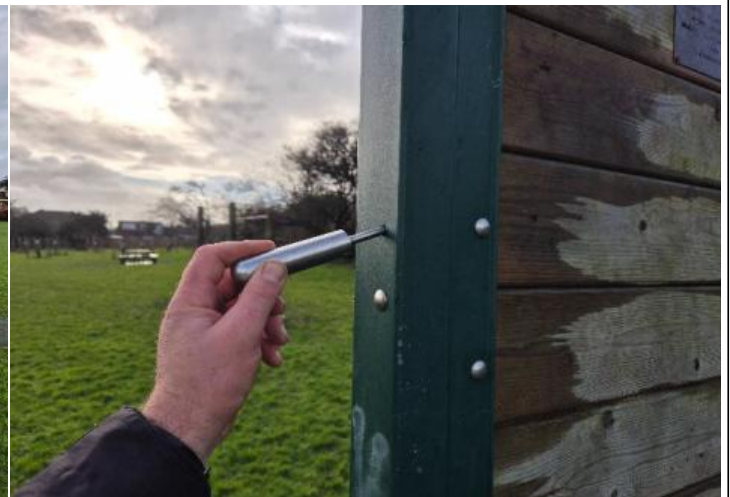
**Finding:** There is/are finger entrapments due to missing inserts/fixings and the item fails to meet the requirements of BS EN 15312 Clause 4.4.2.2 Entrapment of fingers

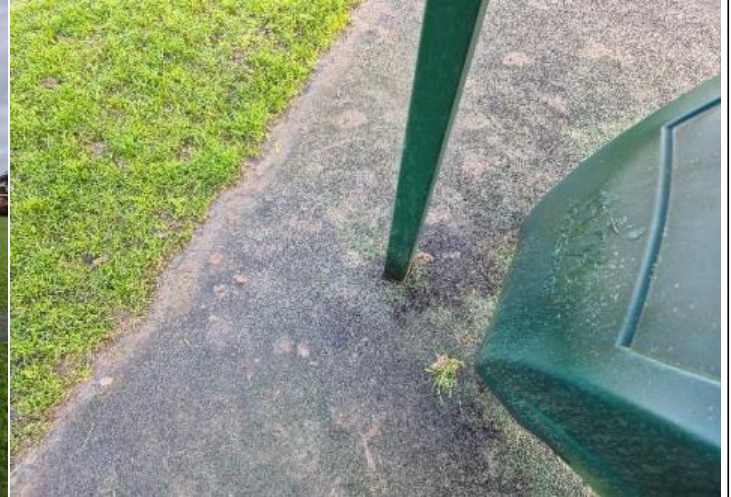
**Finding:** The item is slightly loose in its foundations

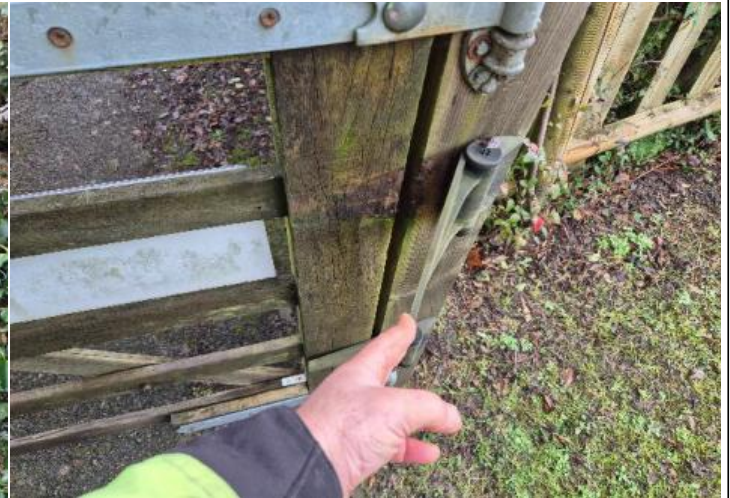
**Finding:** There is or are fixings missing on the item

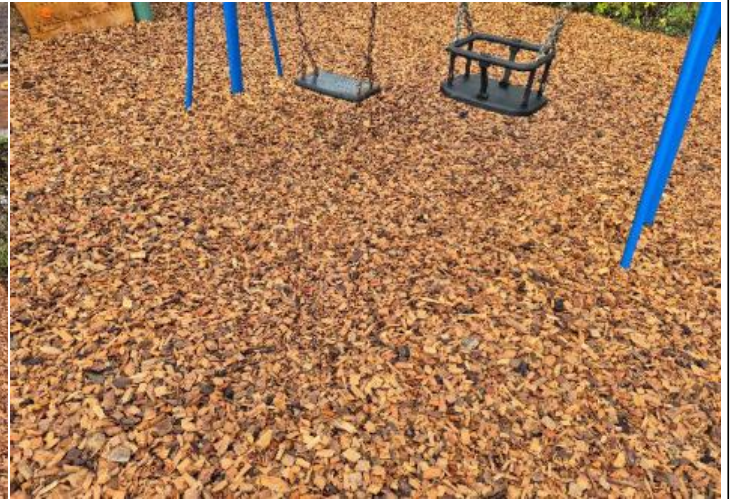
**Finding:** The loosefill surfacing has displaced from under or around the equipment

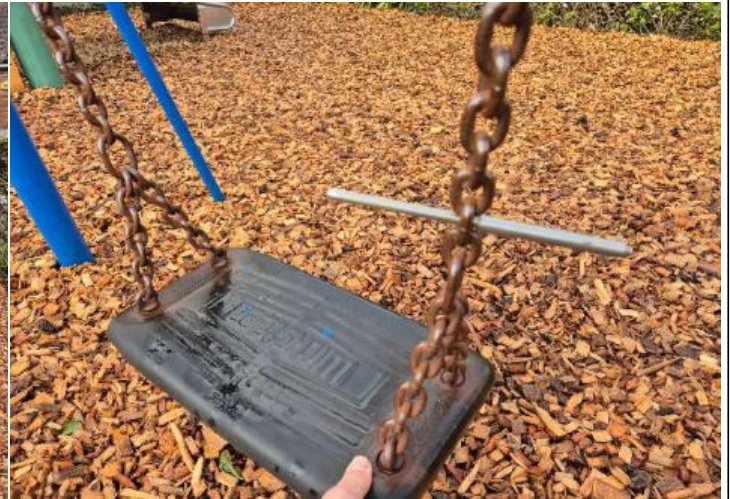
**Finding:** The chain openings are in excess of the 8.6mm as recommended by BS EN 1176  
**Action:** Monitor - No action given the risk assessment

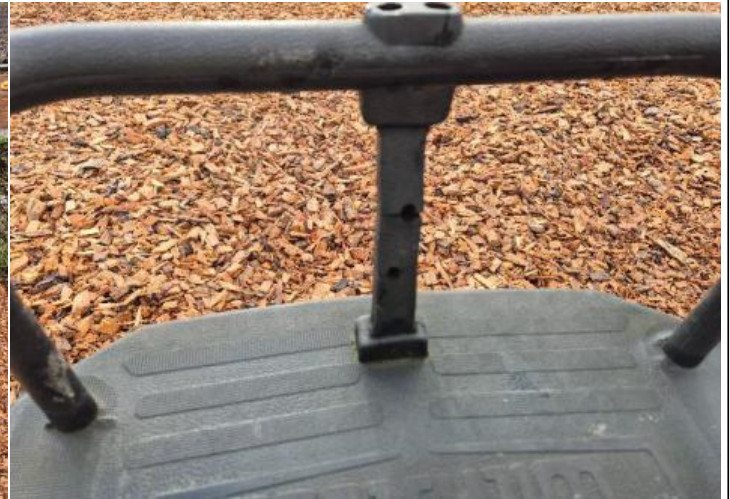
**Finding:** The seat has minor damage or wear

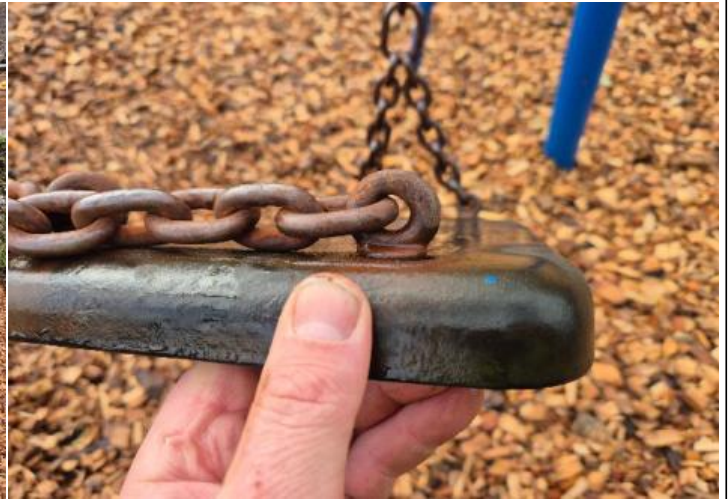
**Finding:** The swing seat connectors have some wear present

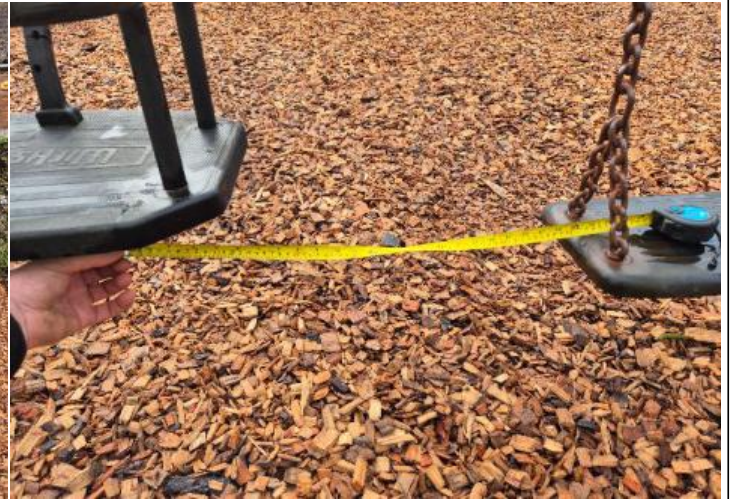
**Finding:** The seats are too close to each other as defined in BS EN 1176 Part 2; this is a low risk failure and no remedial action is required
