## COMMUNITY COMMITTEE MEETING HELD ON TUESDAY 3<sup>rd</sup> MARCH 2026 AT 7.30 PM AT THE STEYPING CENTRE

# DRAFT MINUTES

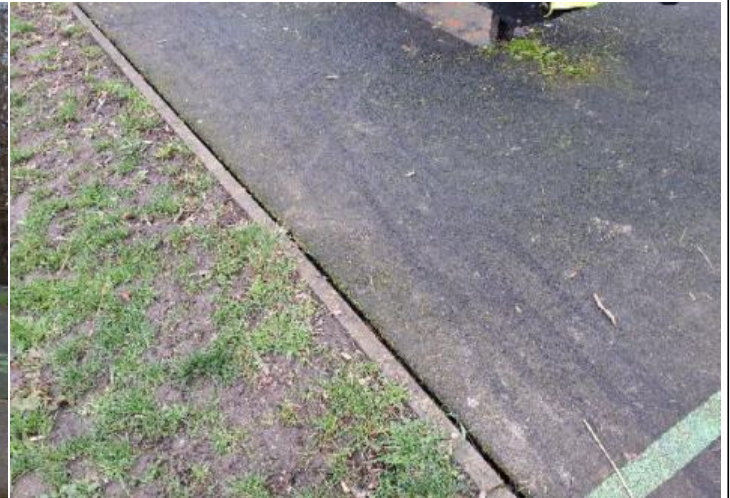
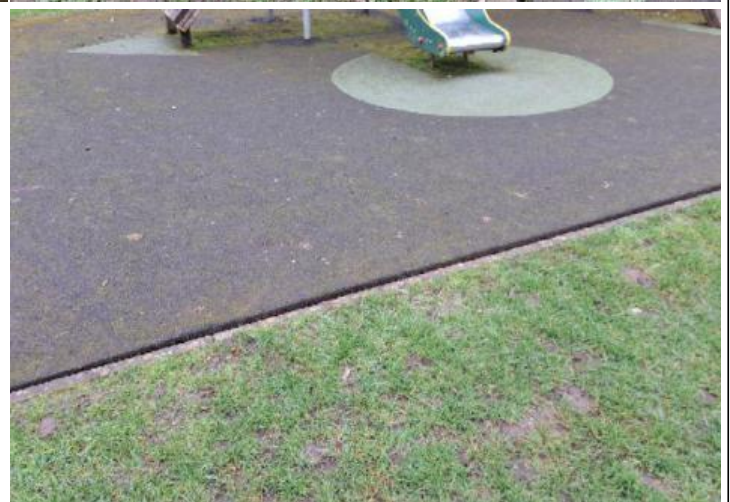
**Finding:** The surface is lifting at the edges and creating trip points **Action:** Repair perimeter of surfacing to remove trip points

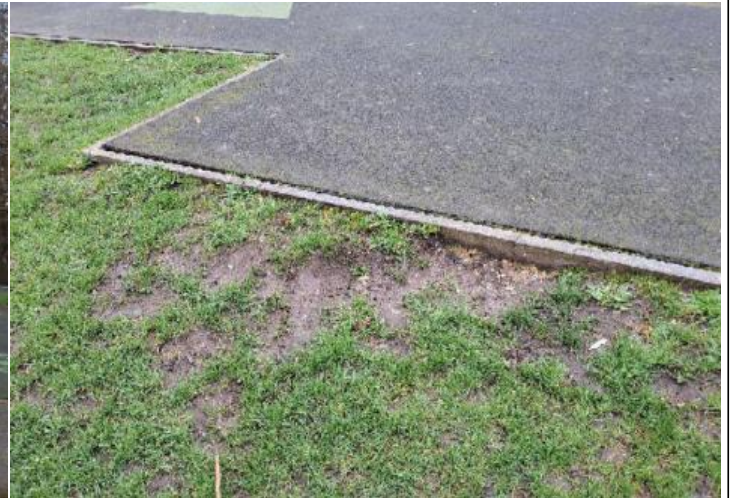
**Finding:** There are trip hazards at the edges of the surface **Action:** Remove trip hazard

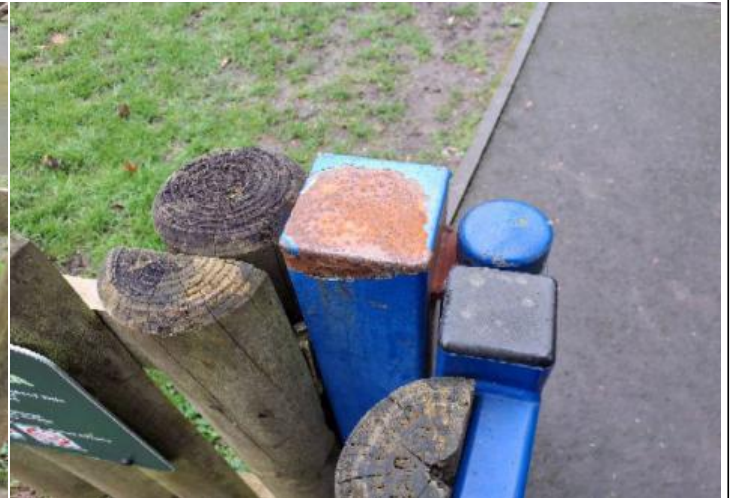
**Finding:** The paintwork on this item has been damaged or worn exposing the metal underneath which is rusting / corroding

**Action:** Treat affected areas and repaint

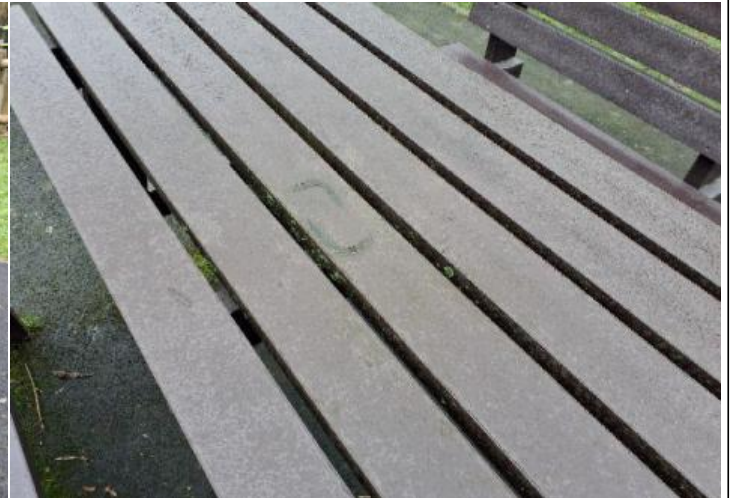
**Finding:** There is some evidence of fire damage to the item **Action:** Monitor for any further deterioration and repair as required

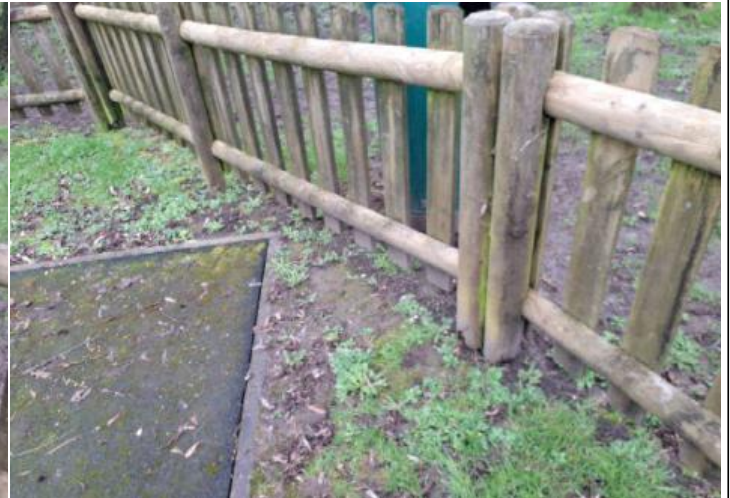
**Finding:** A number of posts have rotted

**Action:** Replace all affected timber

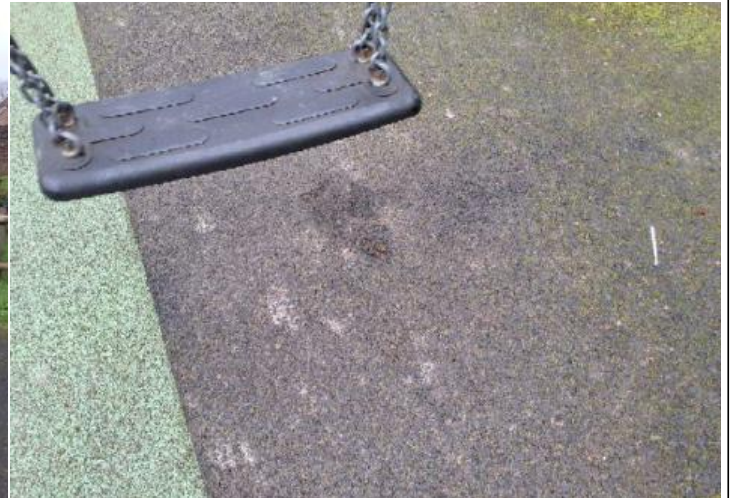
**Finding:** There is some minor damage to the surface

**Action:** Monitor for any further deterioration and repair as required

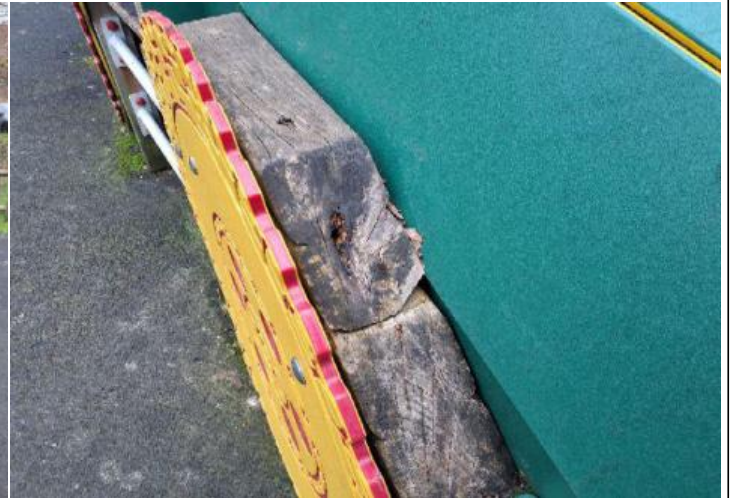
**Finding:** There is some evidence of rot in the timber

**Action:** Monitor for any further deterioration and replace as required

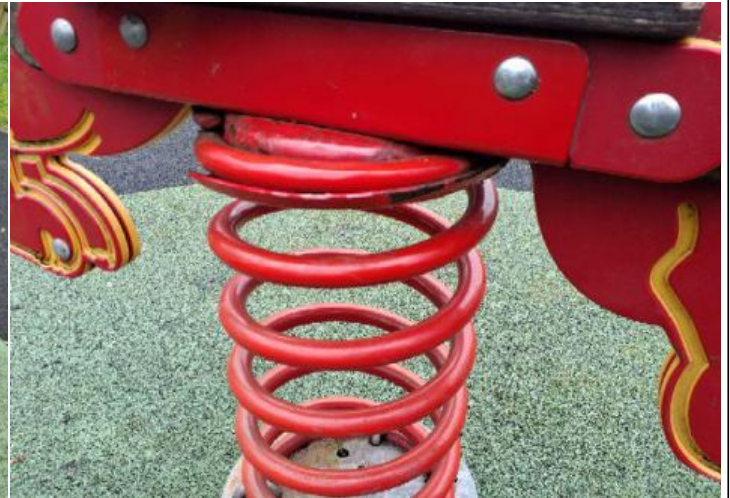
**Finding:** The paintwork on the spring has been damaged or worn exposing the metal underneath which is rusting  
**Action:** Treat any rusting components and repaint

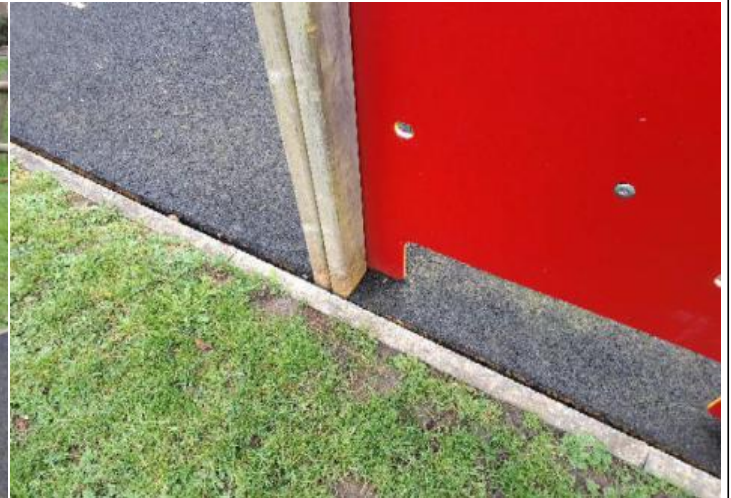
**Finding:** There is some strimmer / machinery damage apparent on the posts, this can penetrate the preservative applied to the timber and accelerate the rotting process

**Action:** Monitor for any deterioration (rot) and replace as required

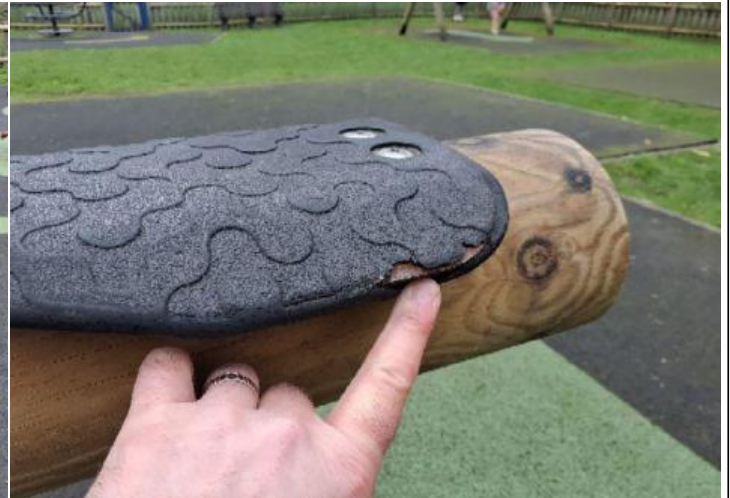
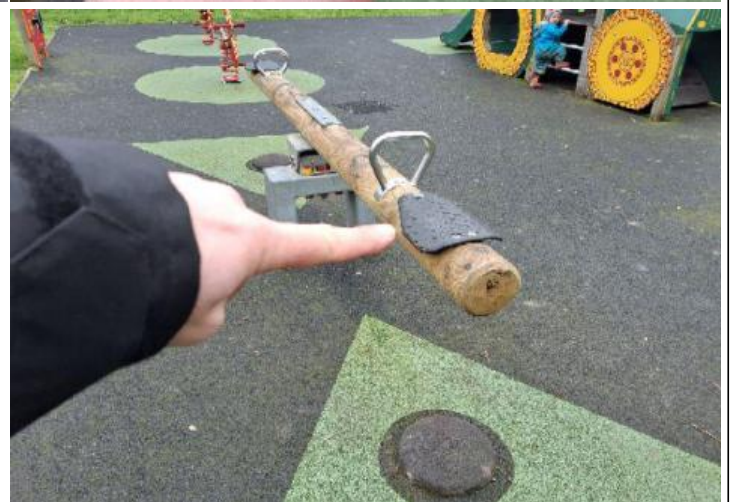
**Finding:** The seat has been severely damaged

**Action:** Repair / replace the seat as required

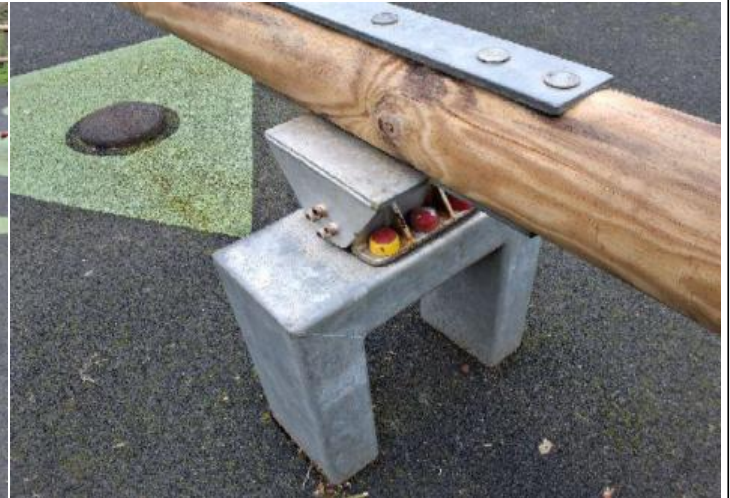
**Finding:** A number of fixing(s) have worked loose

**Action:** Secure all loose fixings

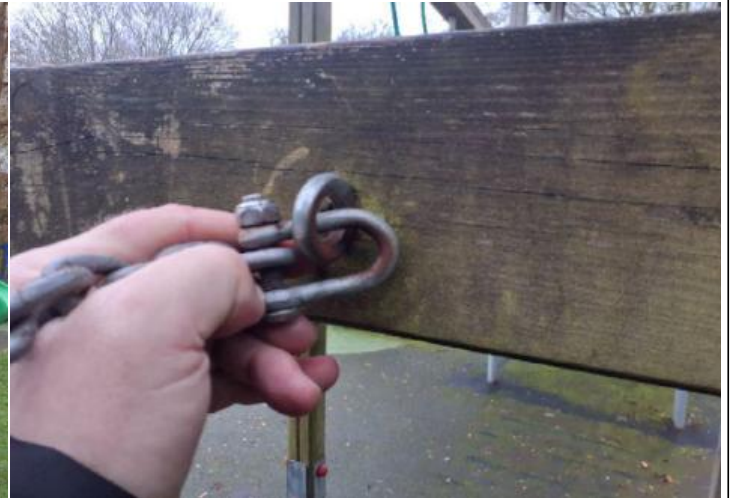
**Finding:** There is some wear to the shackles.

**Action:** Monitor for any further deterioration and replace when 40% worn

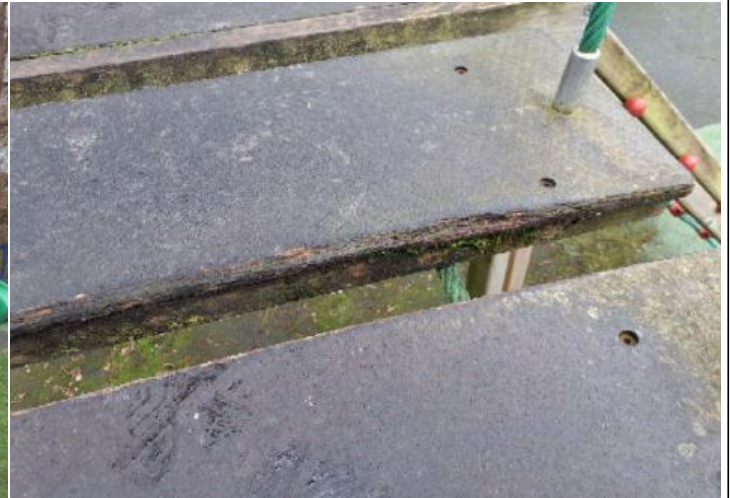
**Finding:** There is some evidence of rot in the timber

**Action:** Monitor for any further deterioration and replace as required

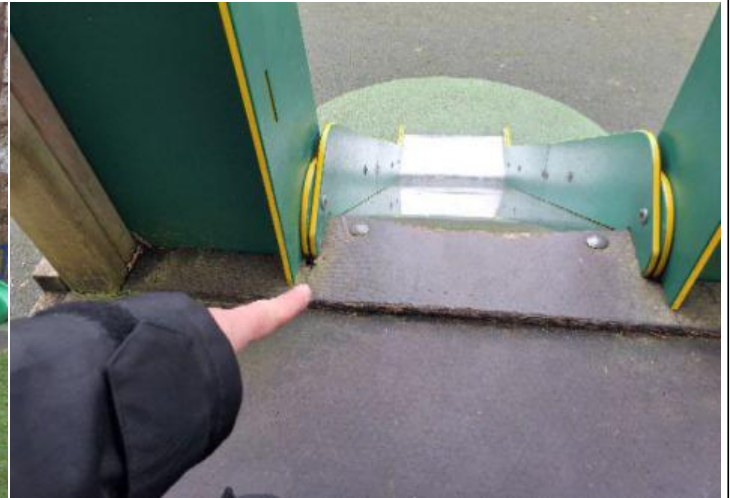
**Finding:** There are areas or parts of the timber at the top of the slide that have rotted  
**Action:** Replace all affected timbers

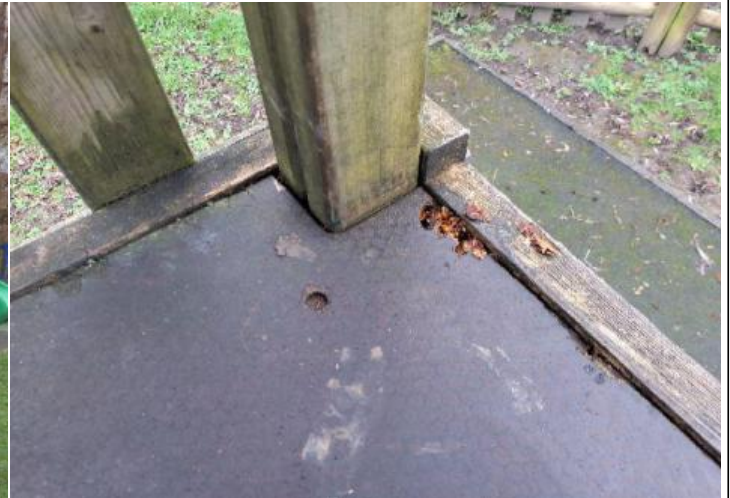
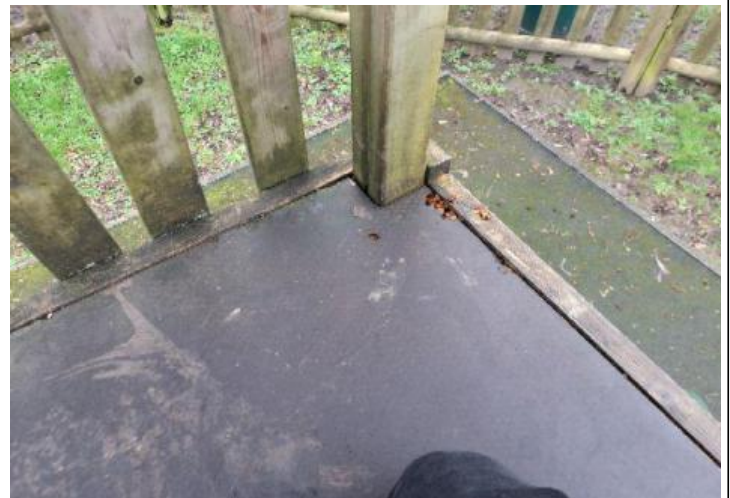
**Finding:** There are areas or parts of the timber on the platforms that have rotted

**Action:** Replace all affected timbers

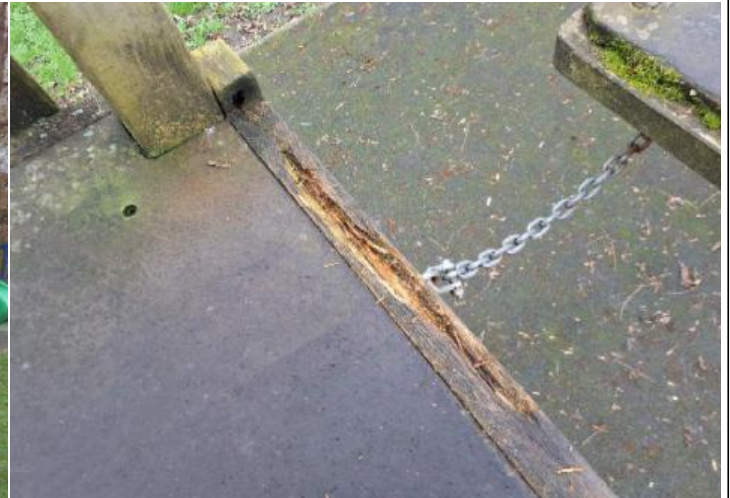
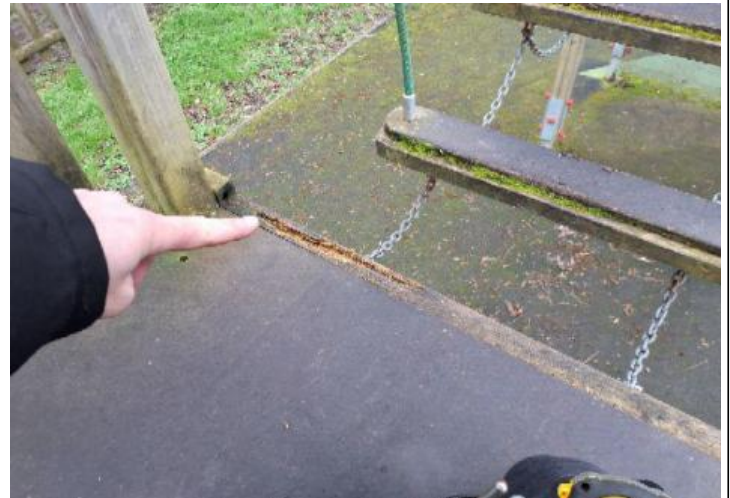
**Finding:** There are areas or parts of the timber on the structure that have rotted

**Action:** Replace all affected timbers

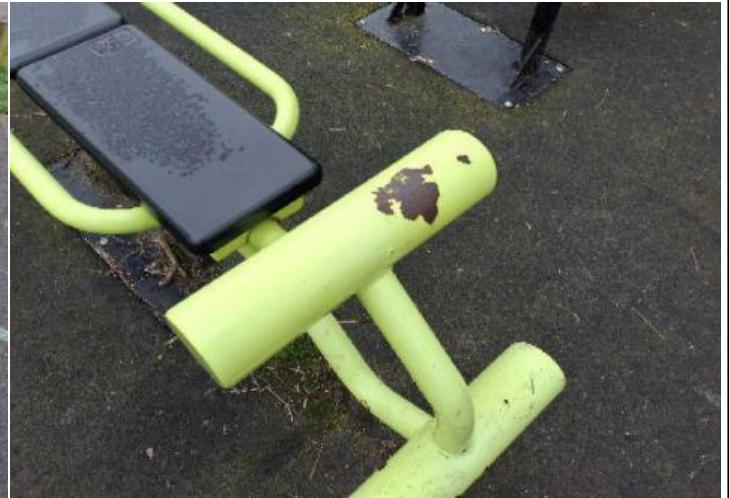
**Finding:** The paintwork on this item has been damaged or worn exposing the metal underneath which is rusting / corroding  
**Action:** Treat affected areas and repaint

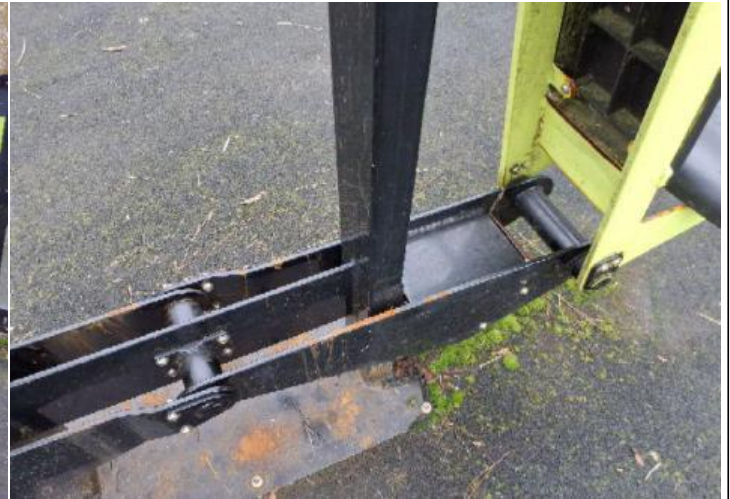
**Finding:** The paintwork on this item has been damaged or worn exposing the metal underneath which is rusting / corroding

**Action:** Treat affected areas and repaint

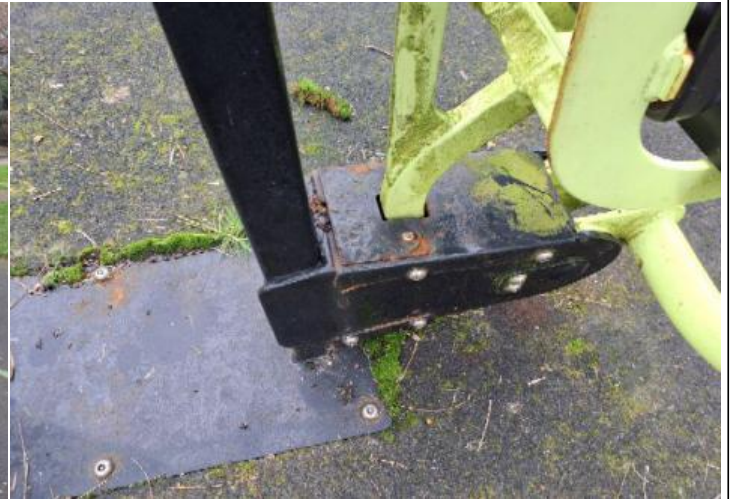
**Finding:** The paintwork on this item has been damaged or worn exposing the metal underneath which is rusting / corroding

**Action:** Treat affected areas and repaint

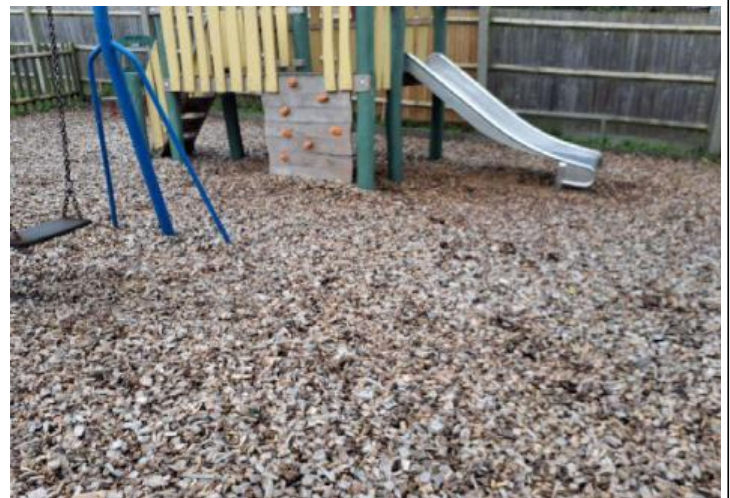
**Finding:** The depth of the loose fill surfacing is lower than the recommended depth specified in BS EN 1176; the free height of fall of the equipment is less than 2.0m and a minimum of 300mm depth should be provided (including an extra 100mm to allow for compaction and displacement as per BS EN 1176 Part 1 - Table 4)

**Action:** Top up loose fill surfacing to recommended levels

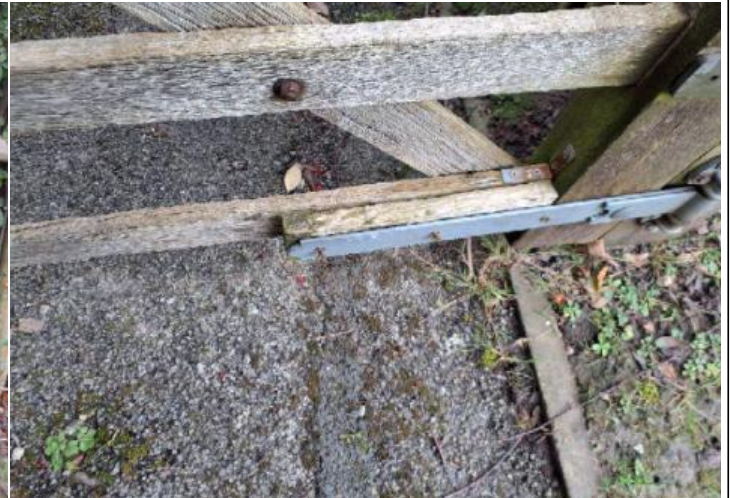
**Finding:** A number of fixing(s) have worked loose

**Action:** Secure all loose fixings

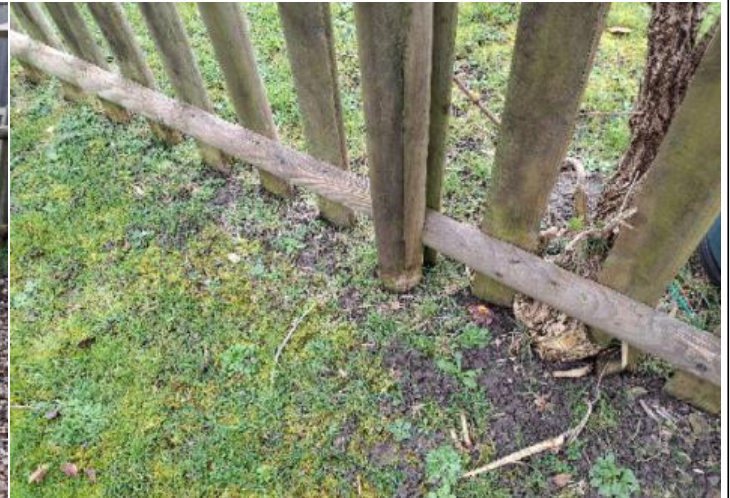
**Finding:** There is some strimmer / machinery damage apparent on the posts, this can penetrate the preservative applied to the timber and accelerate the rotting process

**Action:** Monitor for any deterioration (rot) and replace as required

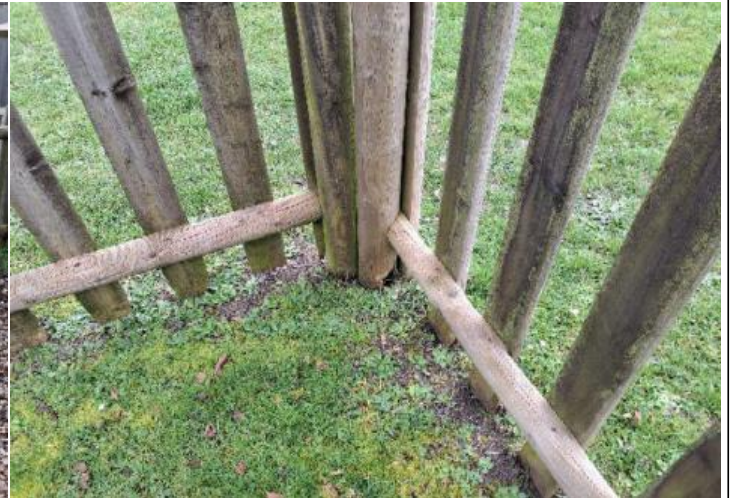
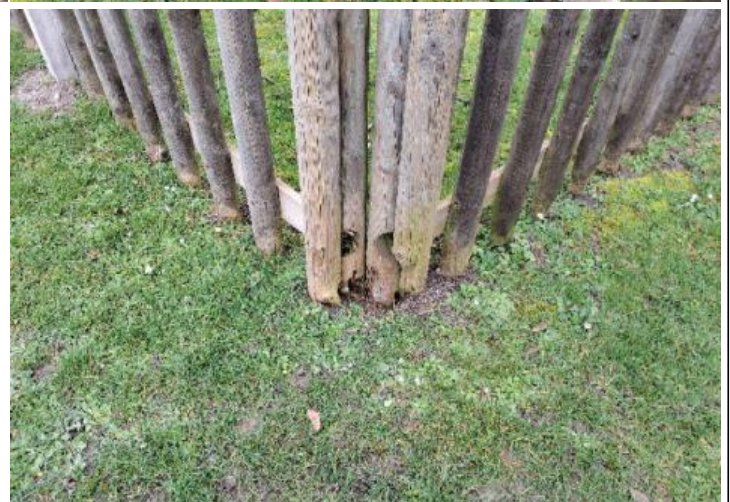
**Finding:** A number of posts have rotted at ground level

**Action:** Replace all affected timber

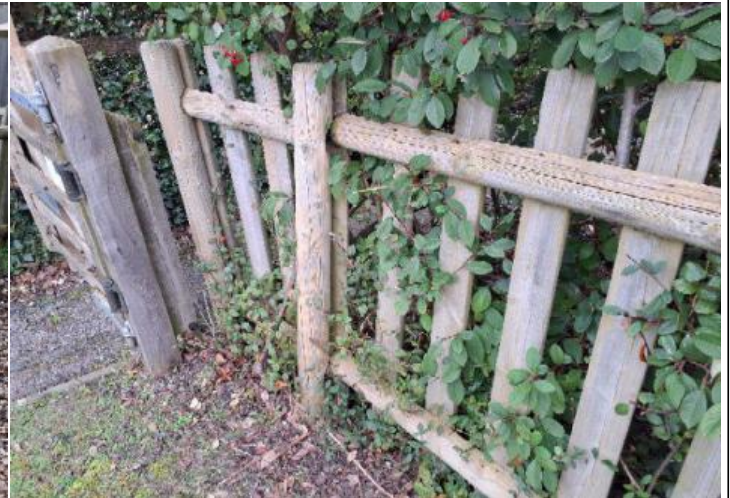
**Finding:** The fence is severely damaged in places

**Action:** Repair or replace all affected sections

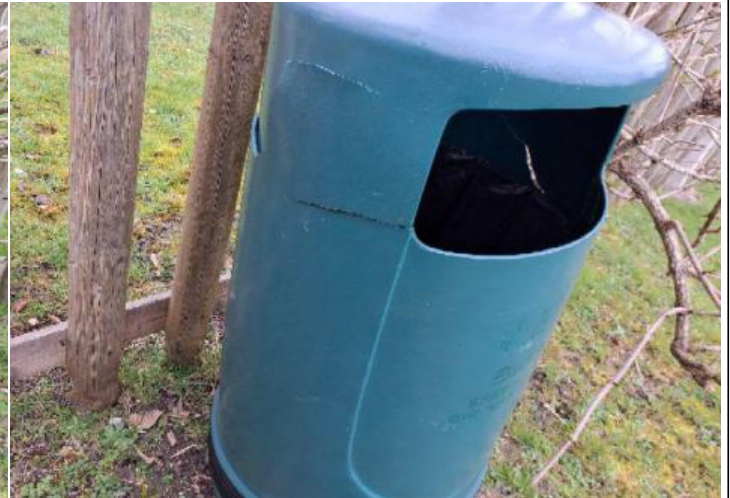
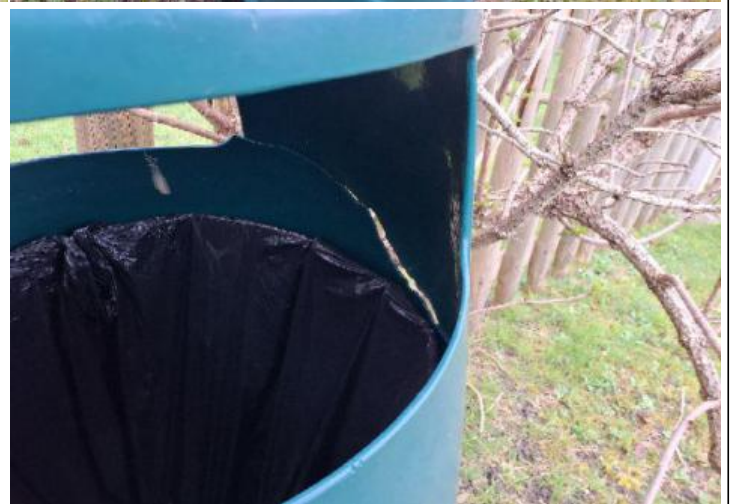
**Finding:** The item has been severely damaged

**Action:** Repair or replace the item / affected part

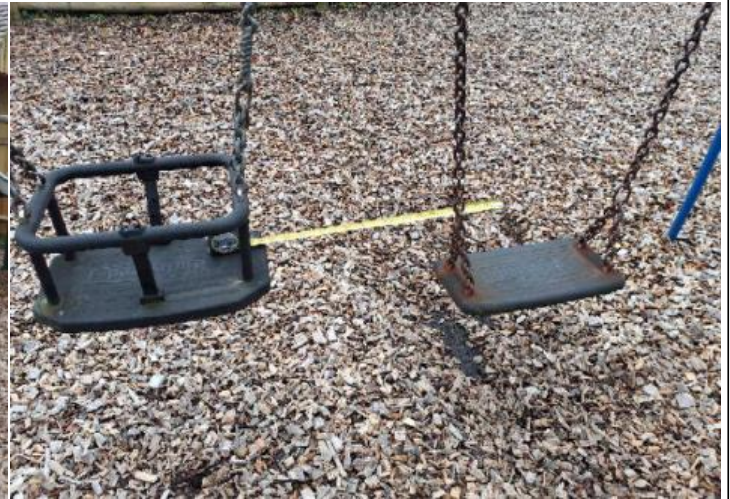
**Finding:** The seats are too close to each other as defined in BS EN 1176 Part 2; this is a low risk failure and no remedial action is required  
**Action:** Monitor - No action given the risk assessment

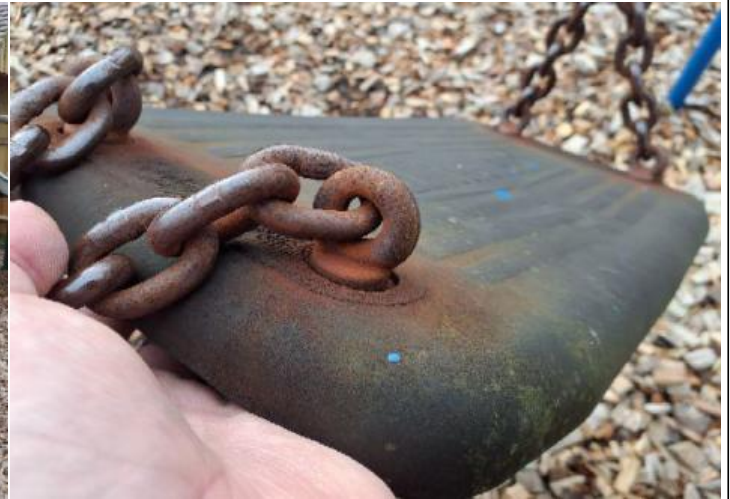
**Finding:** The swing seat connectors have some wear present

**Action:** Monitor for further deterioration and replace when 40% worn

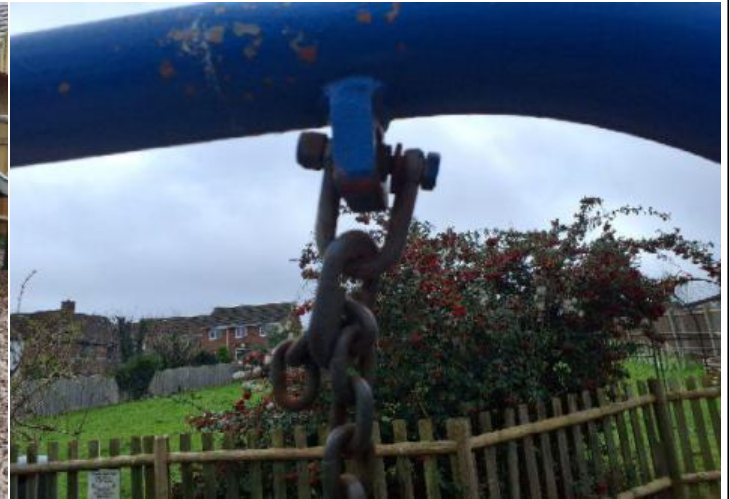
**Finding:** There is some wear to the shackles.

**Action:** Monitor for any further deterioration and replace when 40% worn

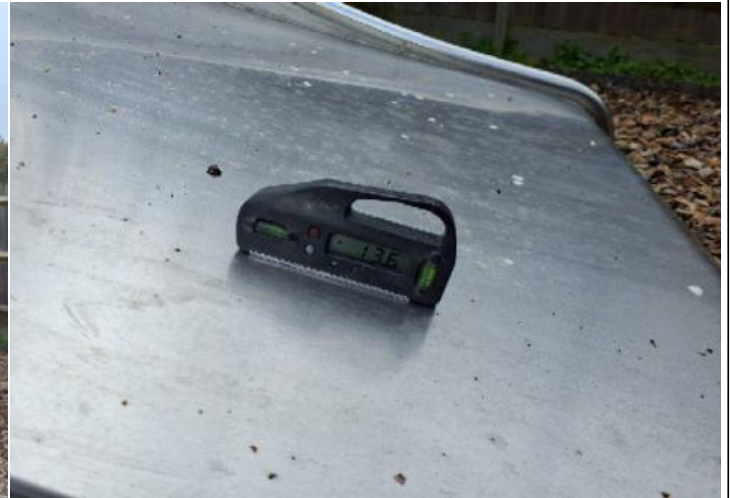
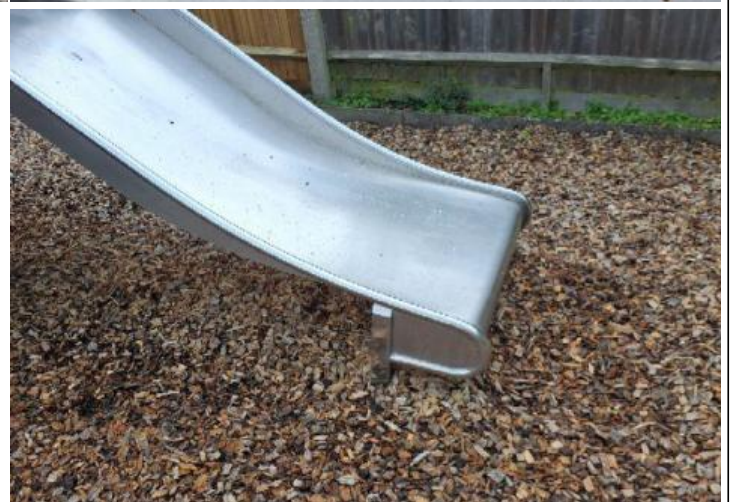
**Finding:** The slide runout is inclined at more than the 10 degrees recommended by BS EN 1176 Part 3 for a Type 1 slide

**Action:** Monitor - No action given the risk assessment

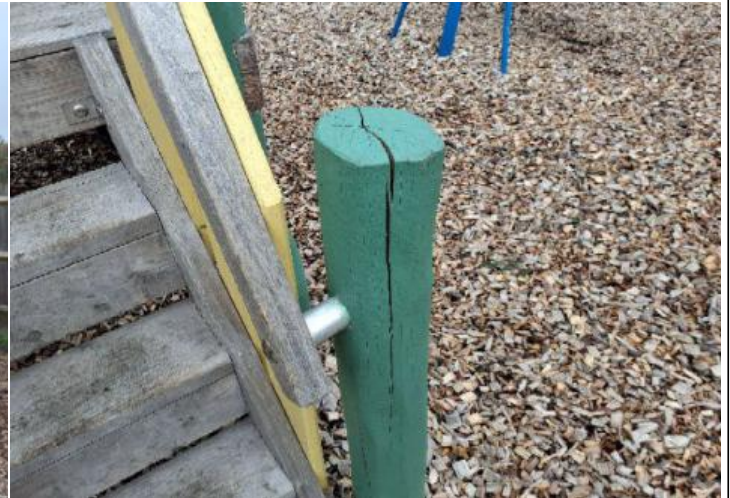
**Finding:** The timber has a number of splits/shakes or air cracks and this may affect the stability or allow water ingress which will accelerate the rotting process. Timber splits may also create rough / splintering edges.

**Action:** Monitor, sand down any rough edges and ensure the splits do not cross through fixing points of the structure and/or cause any instability

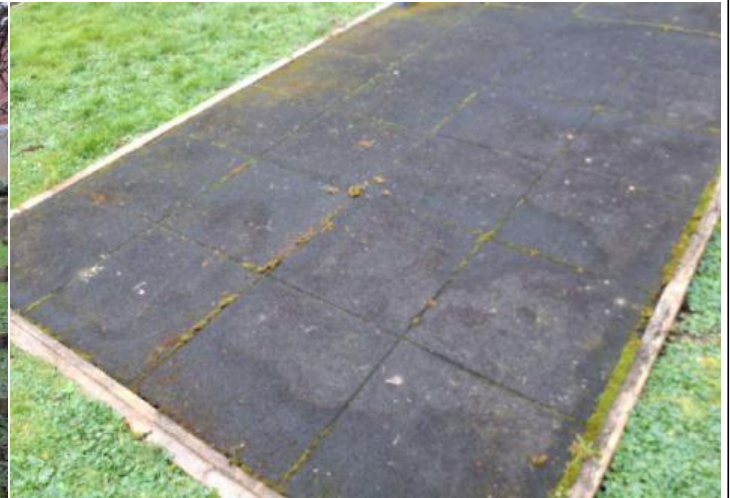
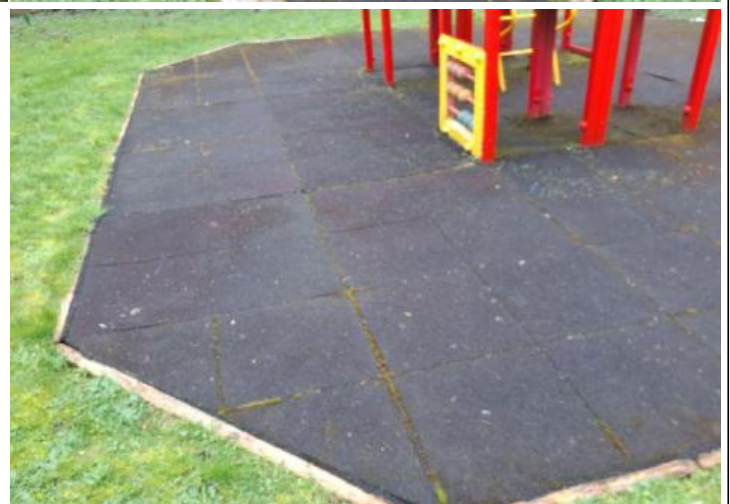
**Finding:** There is algae, silt or moss growth on the surface resulting in slippery conditions

**Action:** Clean and treat appropriately

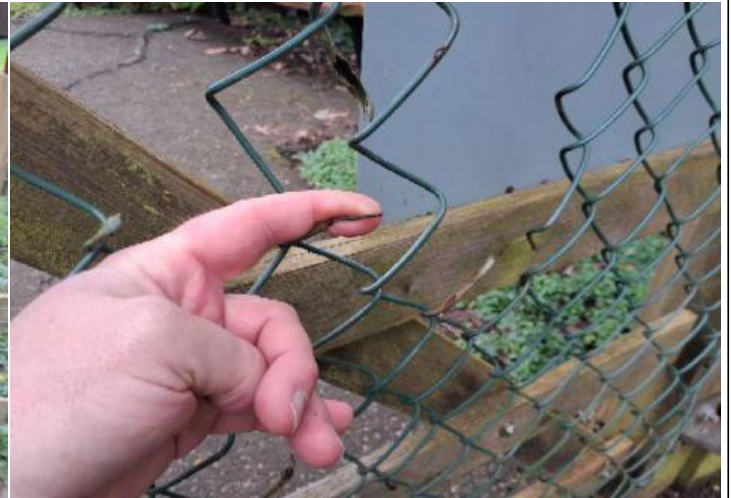
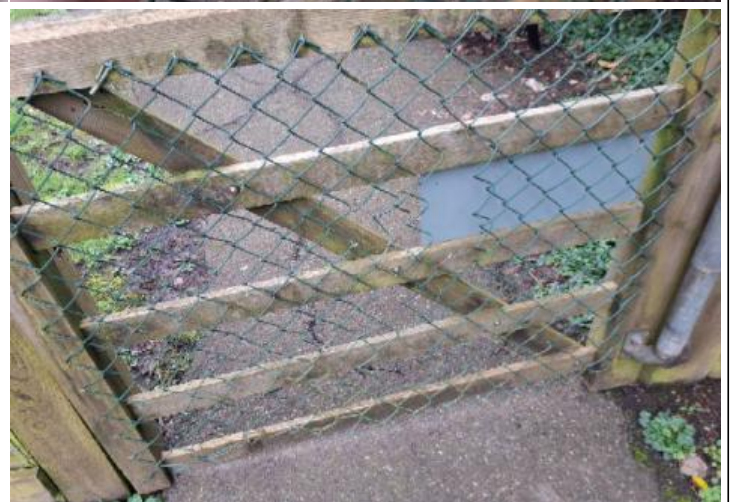
**Finding:** The mesh is damaged and there are sharp wire strands protruding

**Action:** Repair or replace

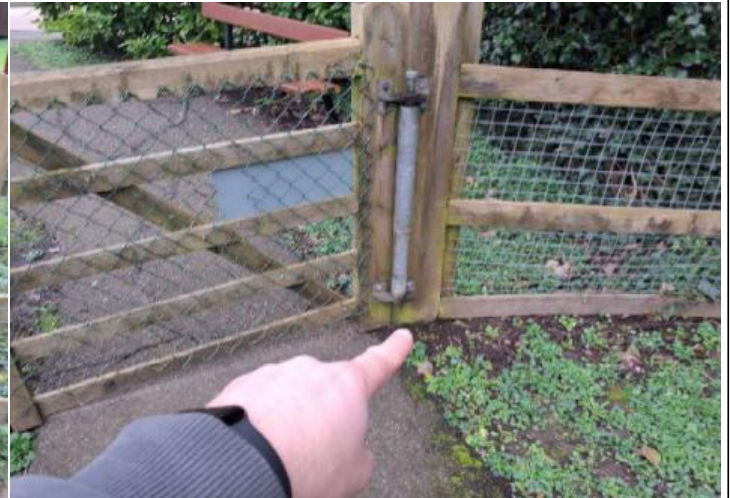
**Finding:** There are areas or parts of the timber on the structure that have rotted

**Action:** Replace all affected timbers

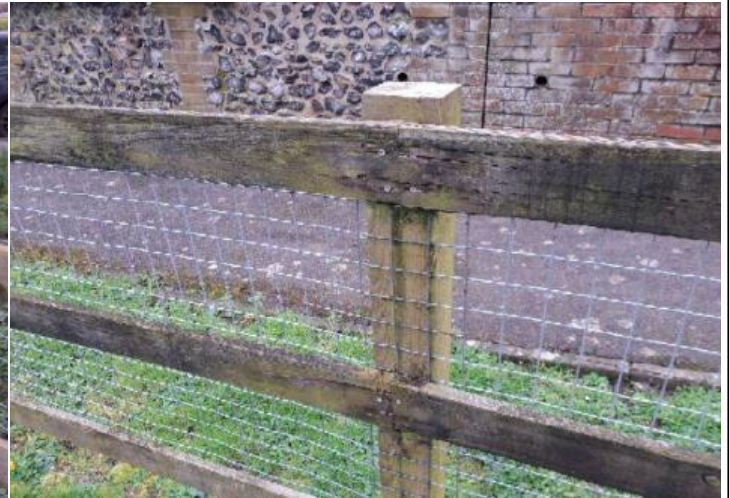
**Finding:** There is some evidence of rot in the timber

**Action:** Monitor for any further deterioration and replace as required

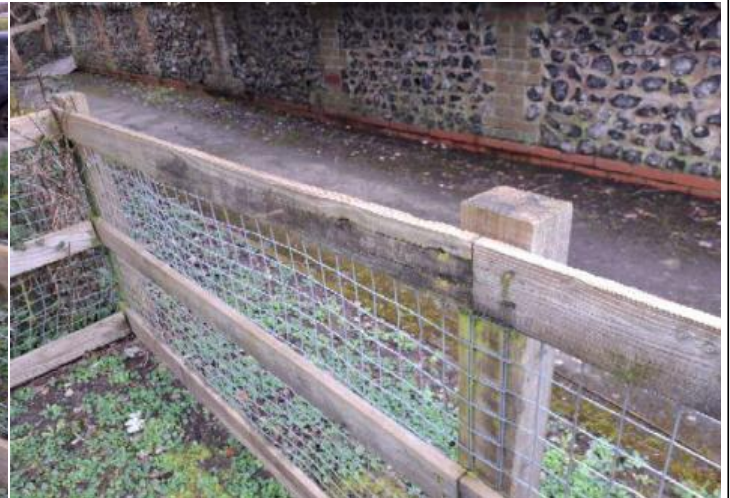
**Finding:** The item has been damaged

**Action:** Monitor for any further deterioration and replace as required

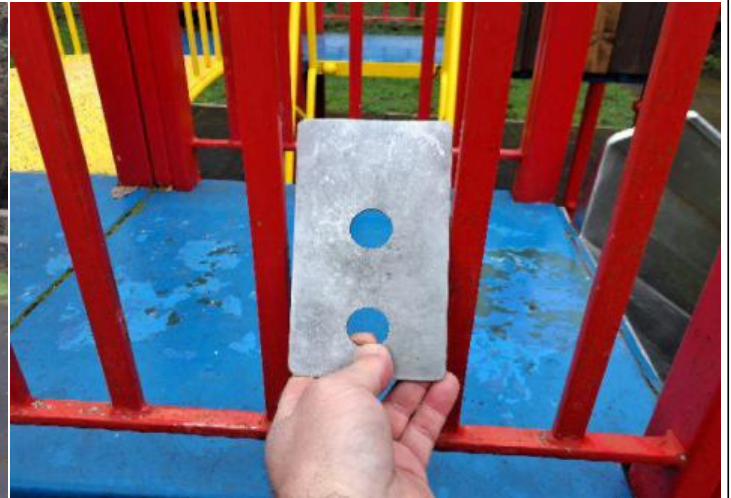
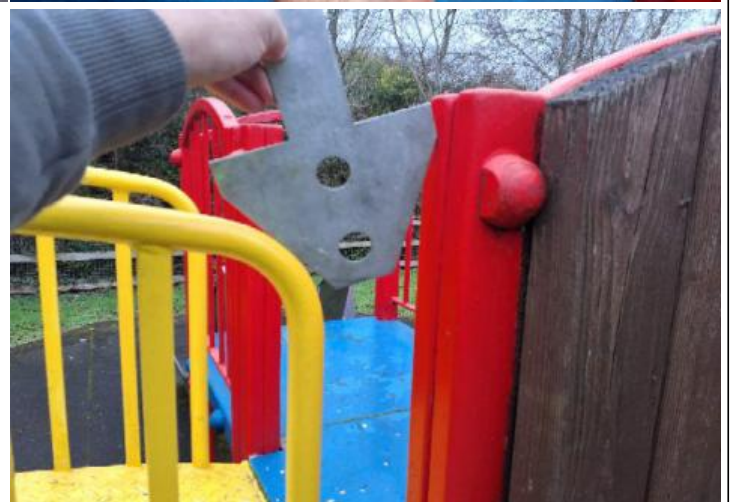
**Finding:** The item fails to meet the requirements of BS EN 1176 Part 1 4.2.7.2 head and neck entrapment in the barriers and/or steps

**Action:** Monitor - No action given the risk assessment

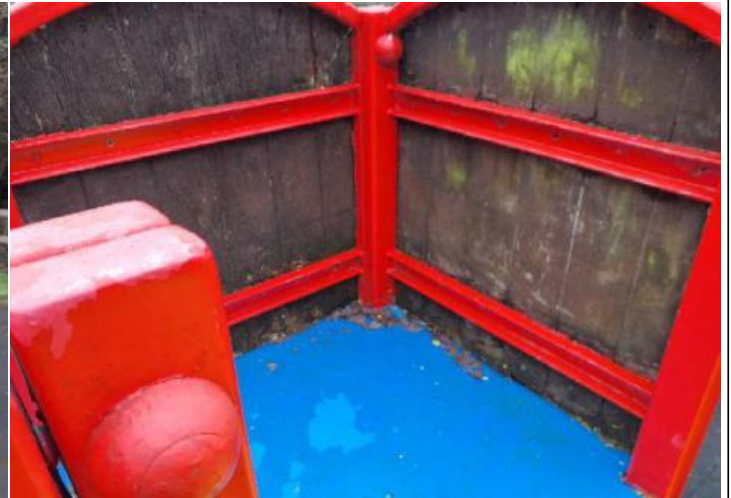
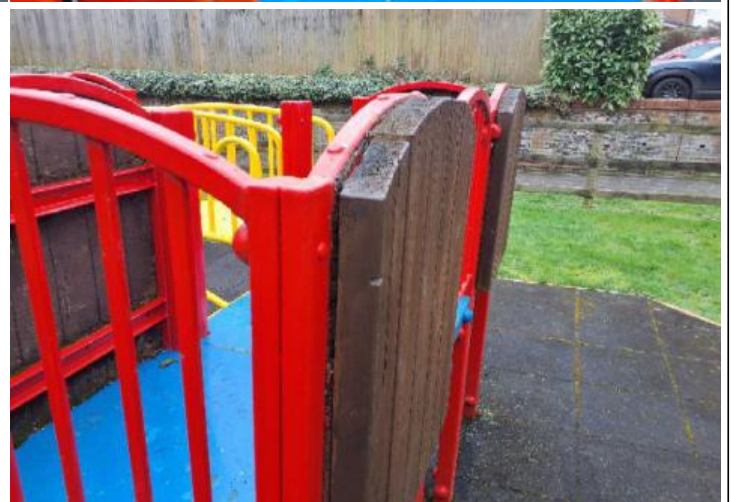
**Finding:** There are areas or parts of the timber on the barriers that have rotted

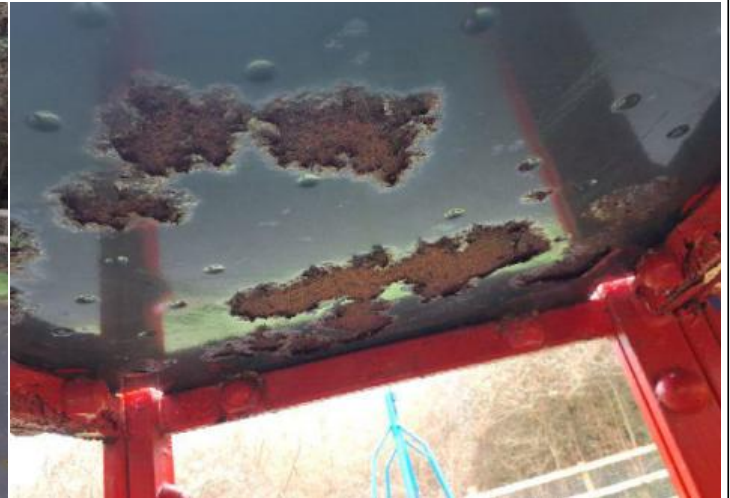
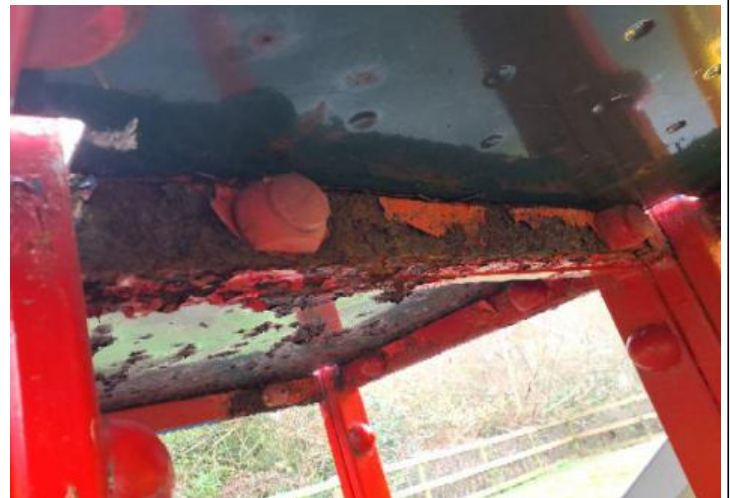
**Finding:** The paintwork on this item has been damaged or worn exposing the metal underneath which is rusting / corroding

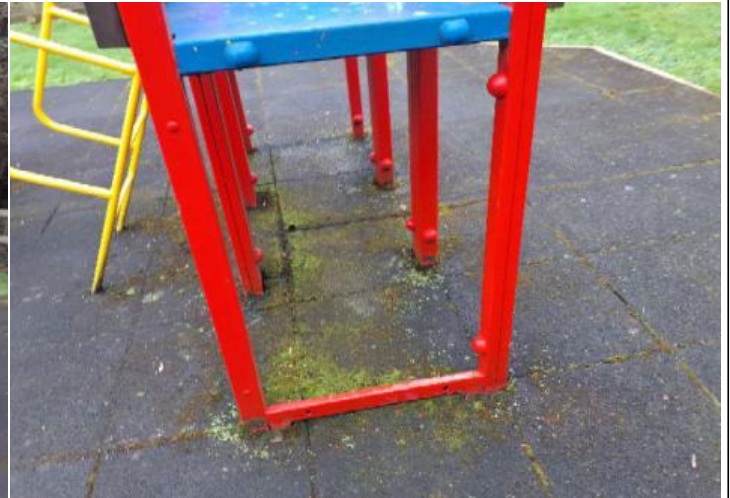
**Finding:** The item has missing component(s)

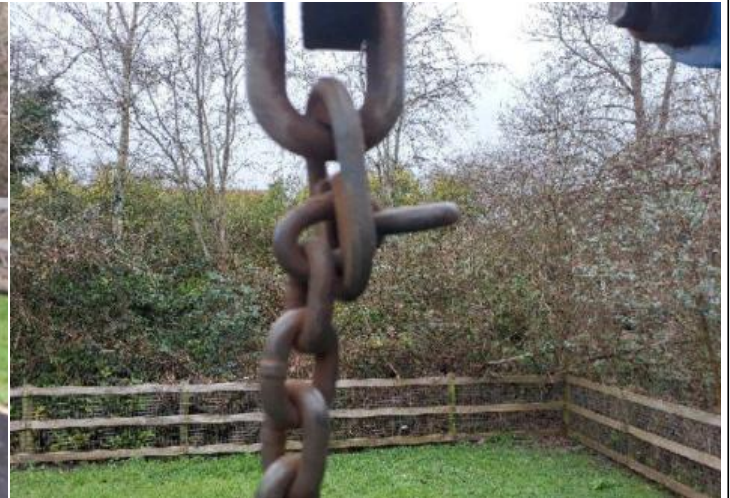
**Finding:** Crucifix or T connectors should have at least two complete chain links through the connector to meet with the manufacturers recommendations

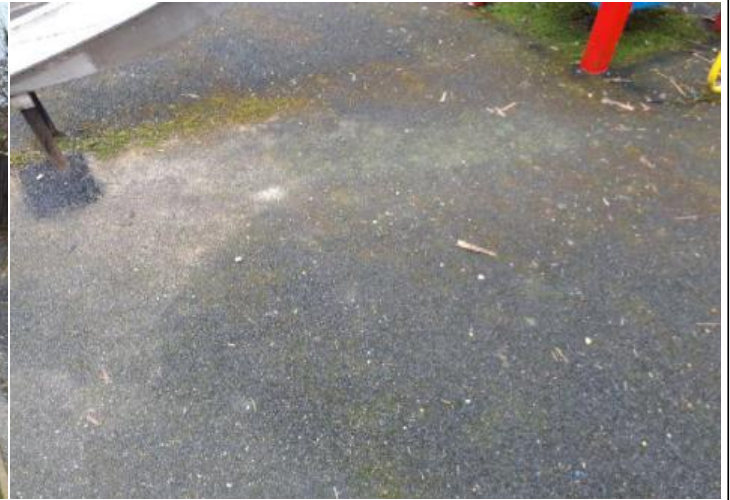
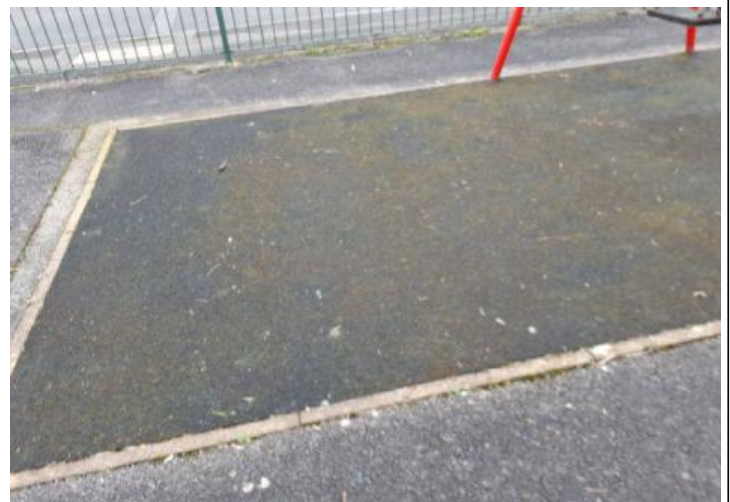
**Finding:** The safety surface around the area is beginning to wear

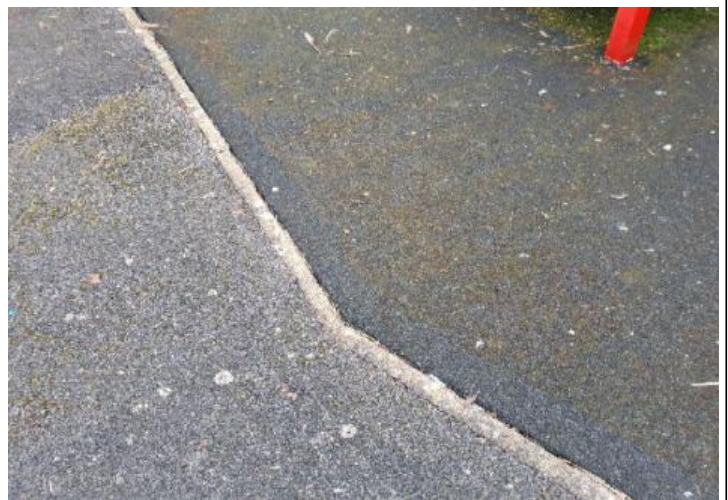
**Finding:** There are gaps opening between the surfacing and the edging surround or between the joints in the surfacing  
**Action:** Monitor for any further deterioration and repair as required

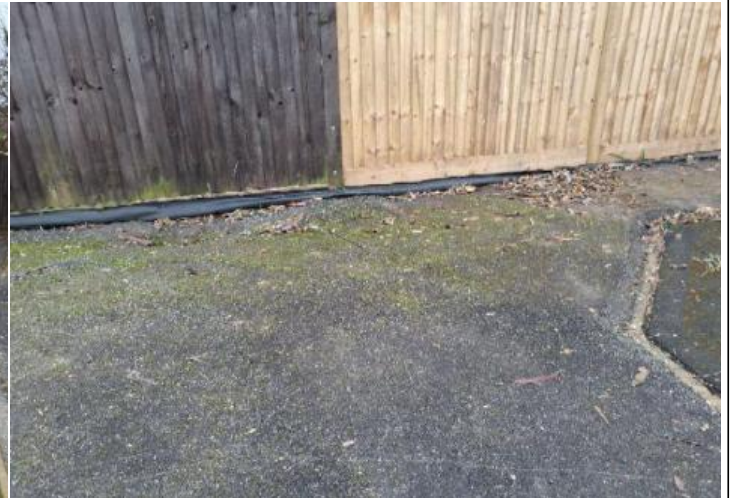
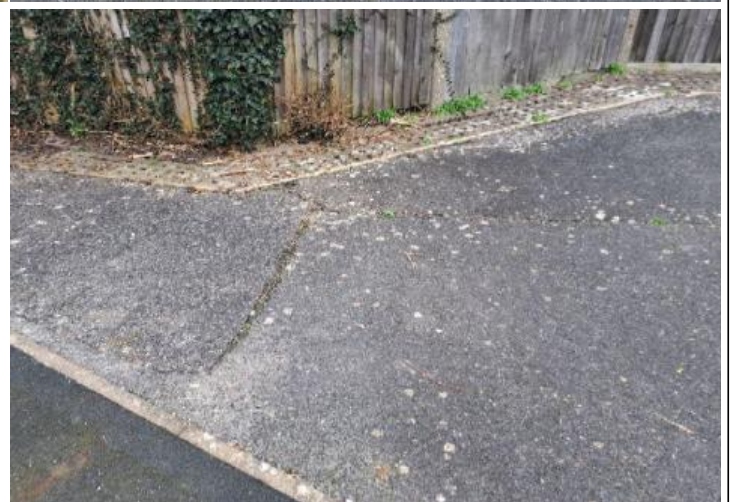
**Finding:** The bitumen surface is worn or damaged

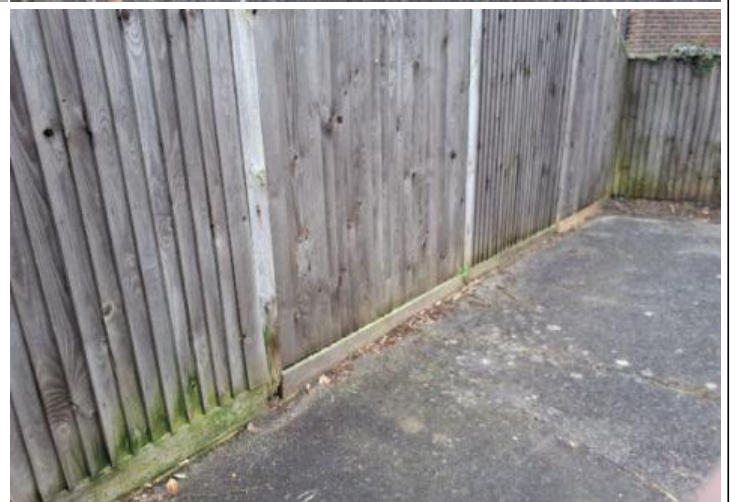
**Finding:** A number of posts have rotted at ground level
