## COMMUNITY COMMITTEE MEETING HELD ON TUESDAY 3<sup>rd</sup> MARCH 2026 AT 7.30 PM AT THE STEYPING CENTRE

# DRAFT MINUTES

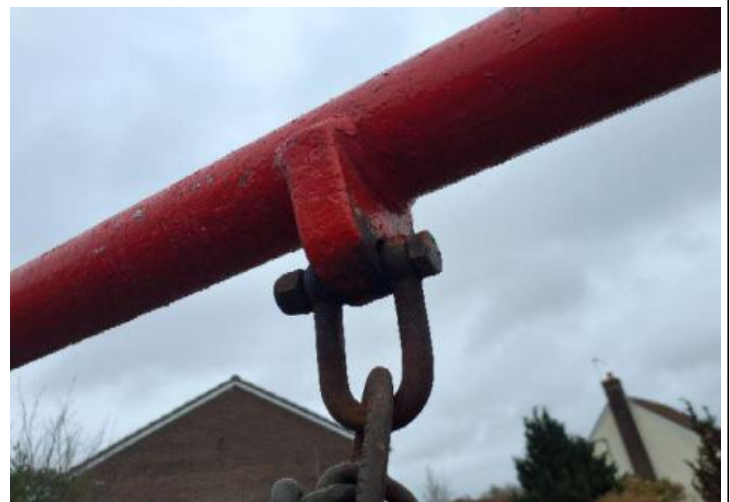
**Finding:** The bushes are worn or missing and the shackles and crossbar lugs are severely worn

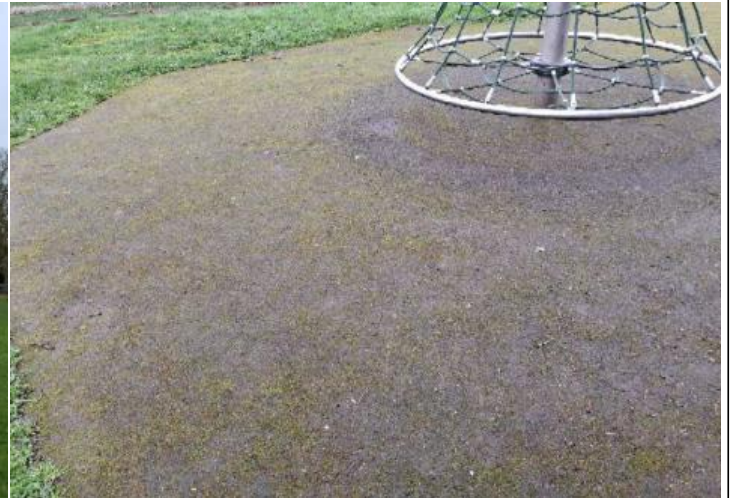
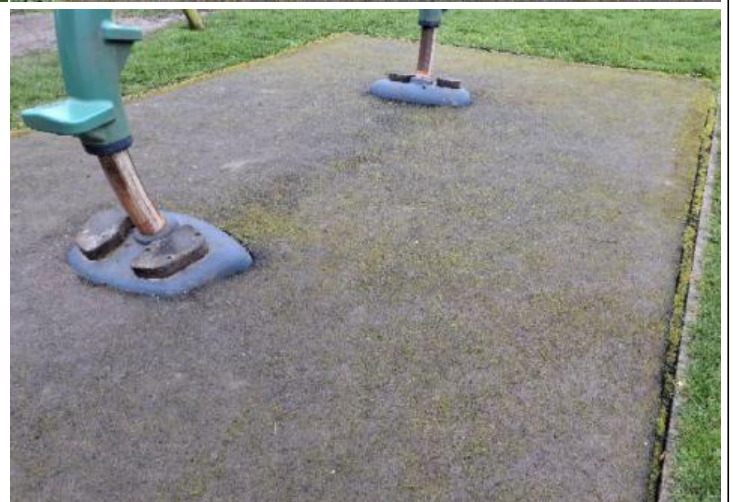
**Finding:** The safety surface around the area is beginning to wear  
**Action:** Monitor for any further deterioration and repair as required

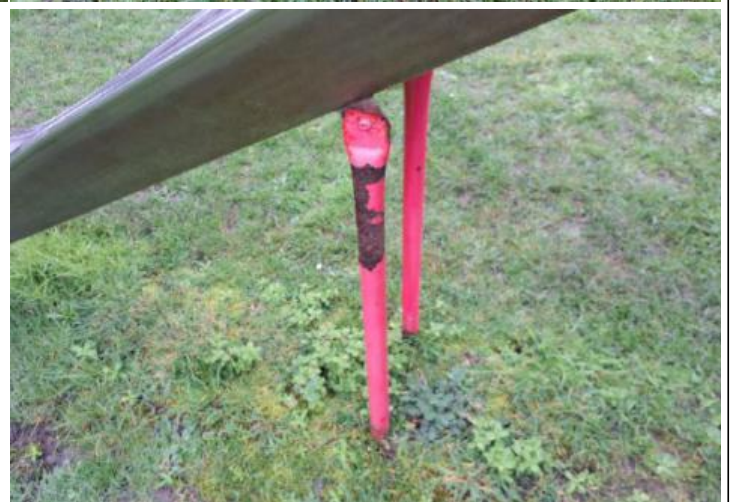
**Finding:** The paintwork on this item has been damaged or worn exposing the metal underneath which is rusting / corroding

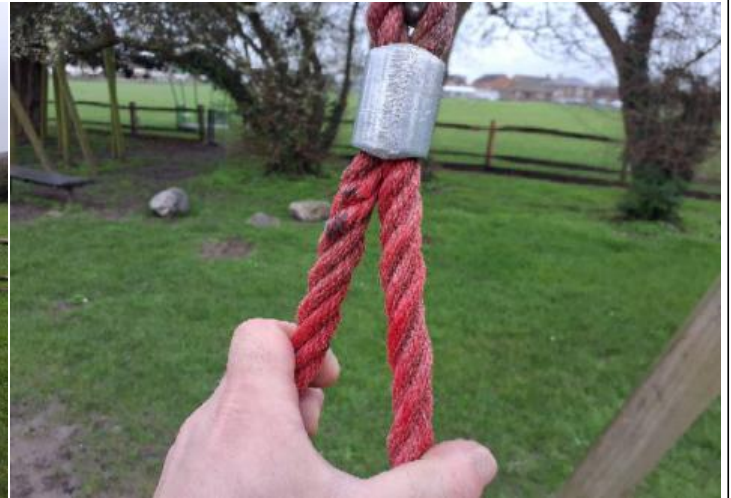
**Finding:** The ropes/nets are worn/damaged in places

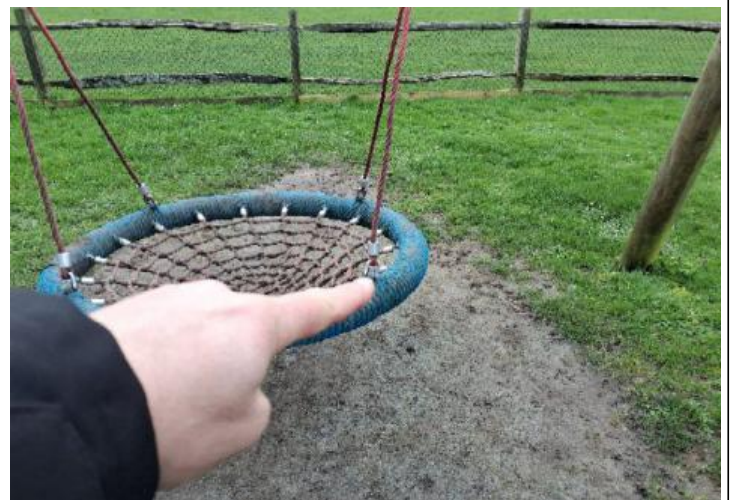
**Finding:** A number of fixing(s) have worked loose

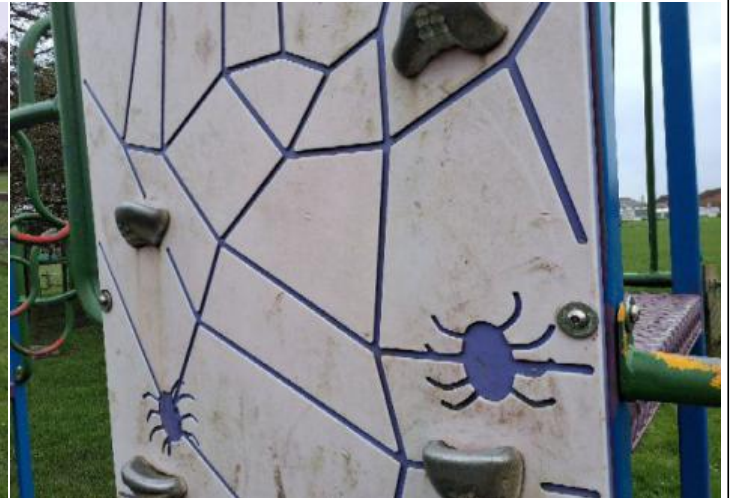
**Finding:** The item has been damaged

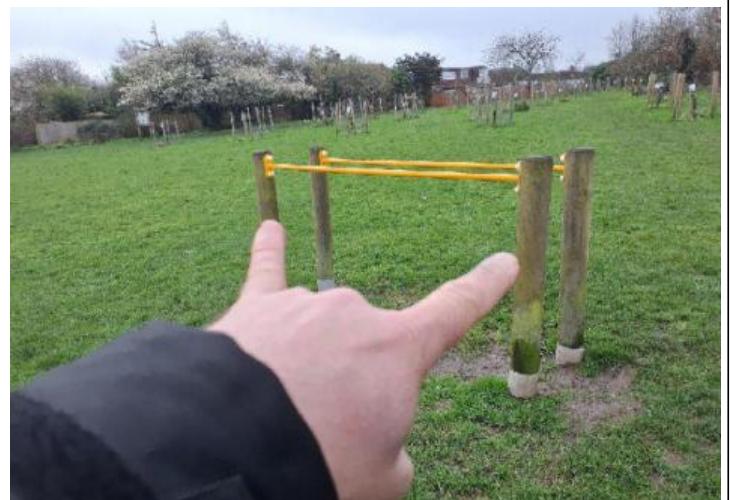
**Finding:** There are areas or parts of the timber on the structure that have rotted

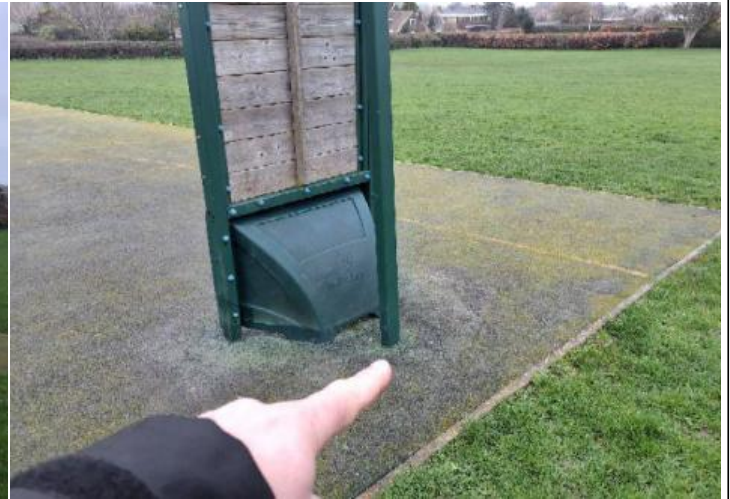
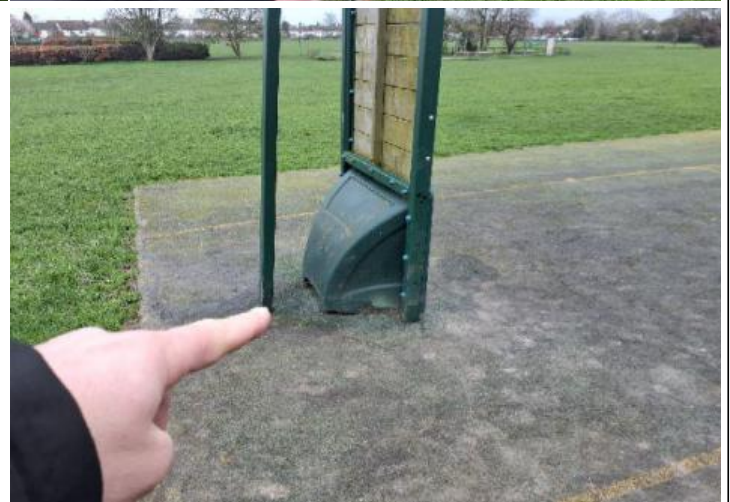
**Finding:** The item is loose in its foundations

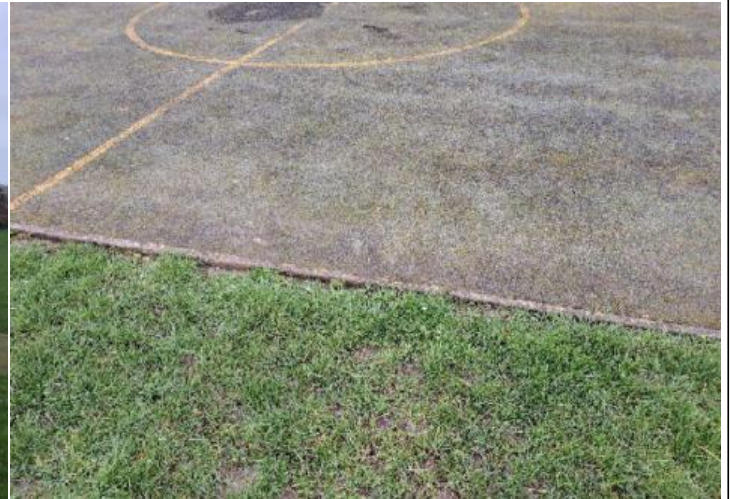
**Finding:** There are trip hazards at the edges of the surface **Action:** Remove trip hazard
