## COMMUNITY COMMITTEE MEETING HELD ON TUESDAY 2<sup>nd</sup> SEPTEMBER 2025 AT 7.30 PM AT THE STEYPING CENTRE

# DRAFT MINUTES

# Gale Tree Consultancy

## Tree Condition Report

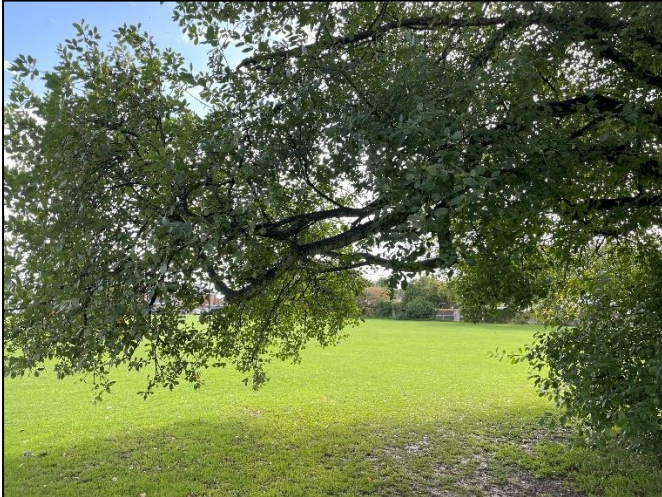
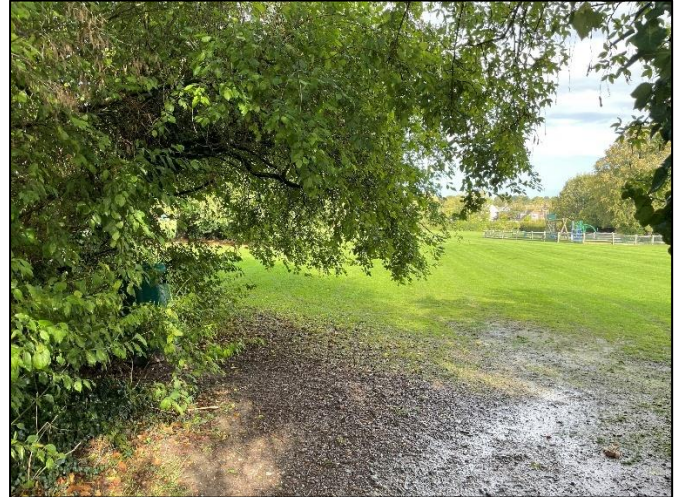
T11/002 Goat willow and G16/685 Plum spp. overhanging the footpaths around the site

| Tree No | Tag No. | Species | Stem Dia. | Height | Cr. Spr. | Age Class | Phy. Cond. | Comments | Recommendations | Priority |
|---|---|---|---|---|---|---|---|---|---|---|
| G16 | 685 | Plum spp. | 150-350 | 0-5 | 5-10 | M | FAIR | Tag replaced - formerly T287<br>Low crown over access path and bin | Crown lift to achieve a clearance of 2.2m over the access path | HS2 |

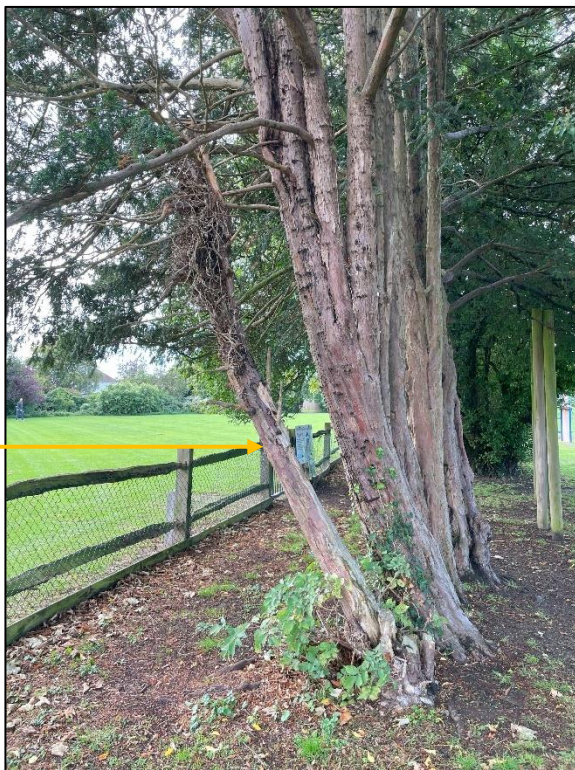
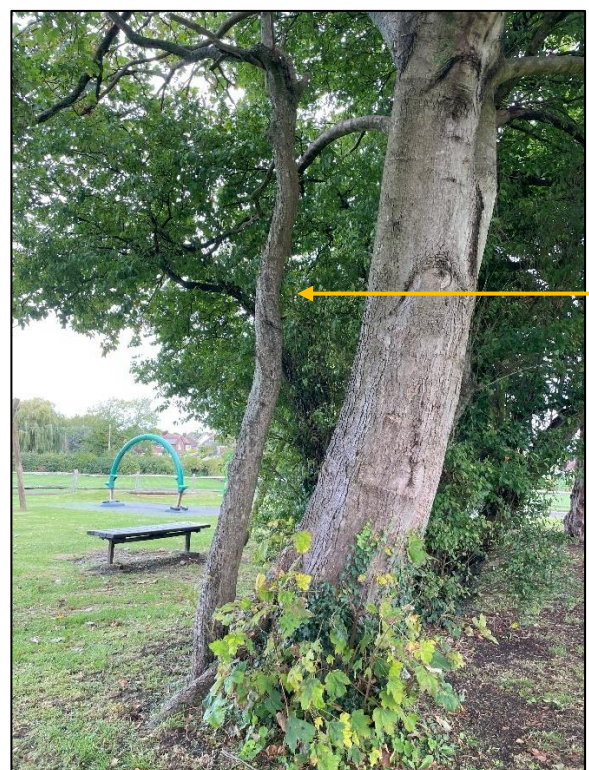
T34/688 Yew with dead subordinate stem section

T37/005 Sycamore with dead Hawthorn growing within its rooting system

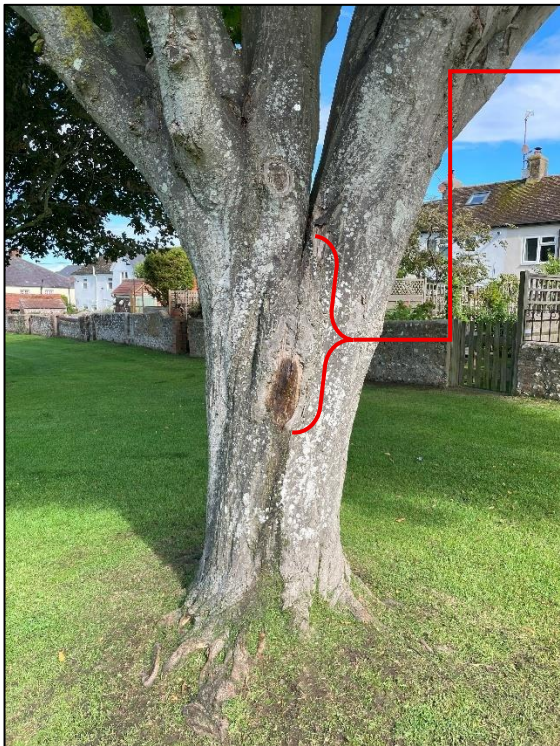
T41/689 Hornbeam with deeply included union starting at c.1m with the union separating at c.1.7m. Note the water exiting the bottom of the union

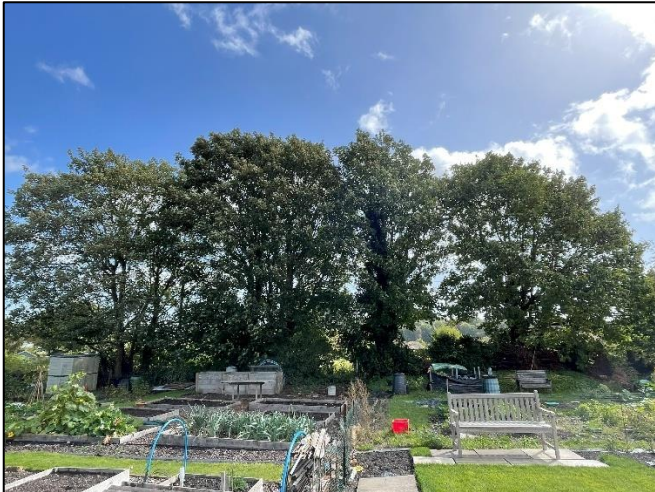
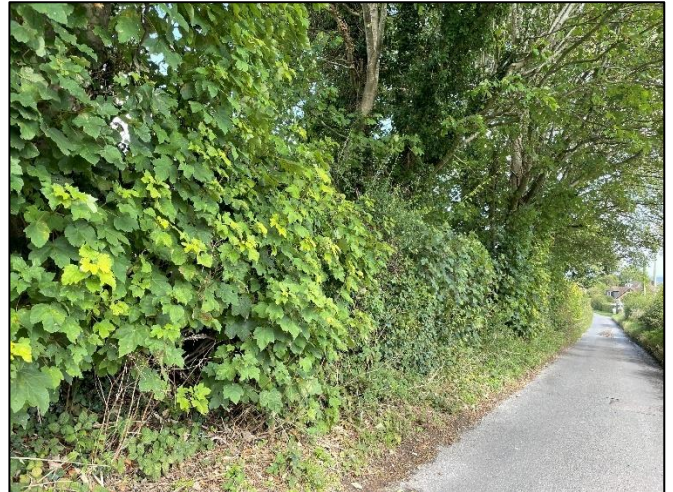
- The main issue experienced on site was dense ivy restricting an assessment of the trees and their unions and dense undergrowth limiting the assessment of the lower stem and buttress root areas
- Where recommended, the ivy should be severed as described and access routes cleared ahead of the next assessment

Ivy and dense vegetation restricting thorough assessments of the buttress roots, lower stem and major branch unions

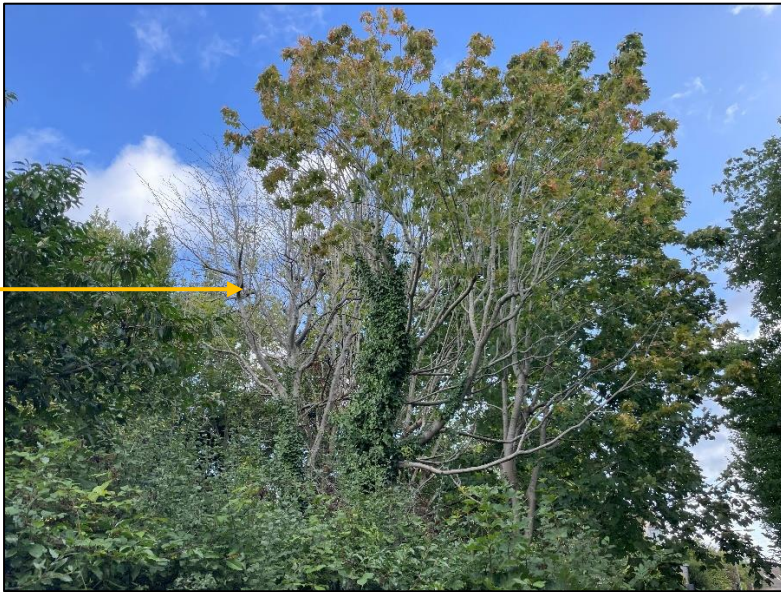
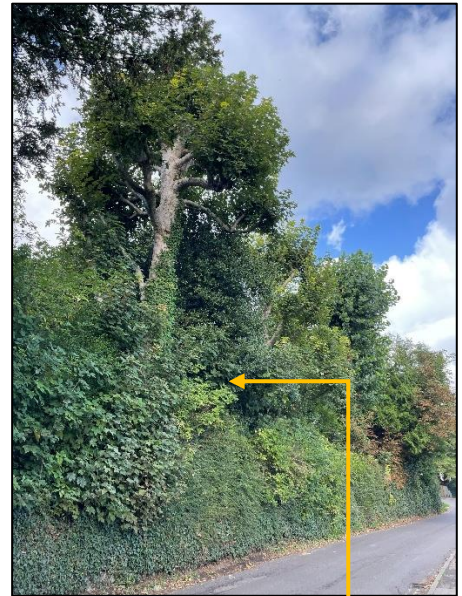
- G2/319 consists of a group of Norway maple trees with mature Portuguese laurel bushes growing within the group
- Within the group is a dead and declining Norway maple tree. Ivy is also establishing itself within the group
- Due to the dense undergrowth it was not possible to inspect the lower stems of the affected trees
- A recommendation to fell the dead tree has been made, plus the periodic review of the group throughout the growing seasons until the next assessment
- T6/323 Sycamore and T8/325 Sycamore have both recently been reduced in height
- Due to dense undergrowth it was not possible to access the basal area of the trees, so only their physiological condition was assessed. Ahead of the next assessment, an access route should be made so the lower stem and buttress root area can be assessed

Dead and declining trees within G2/319 and the dense vegetation alongside Cripps Lane  
Note the recently reduced tops of the two trees

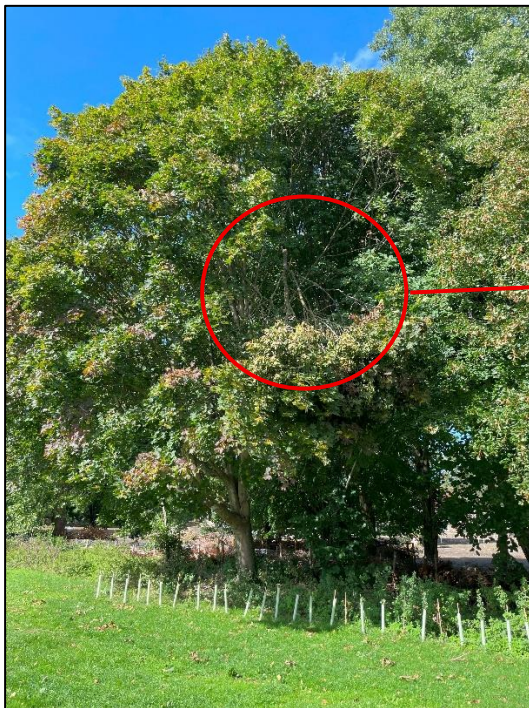
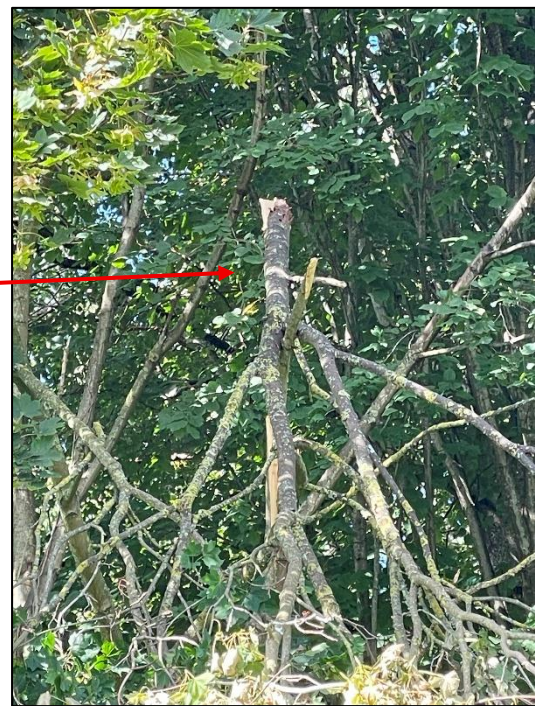
- T10/335 Norway maple has a suspended section of storm damage hanging over the grassed area, hence the Urgent priority rating. The Clerk to the Parish Council was made aware of this as soon as it was noticed

T10/335 Norway maple with suspended section of storm damage in crown

| Tree No | Tag No. | Species | Stem Dia. | Height | Cr. Spr. | Age Class | Phy. Cond. | Comments | Recommendations | Priority |
|---|---|---|---|---|---|---|---|---|---|---|
| T10 | 335 | Norway maple | 351-550 | 15-20 | 5-10 | EM | FAIR | Suspended section of storm damage easy side of crown over grass area | Remove suspended section of storm damage | Urgent |

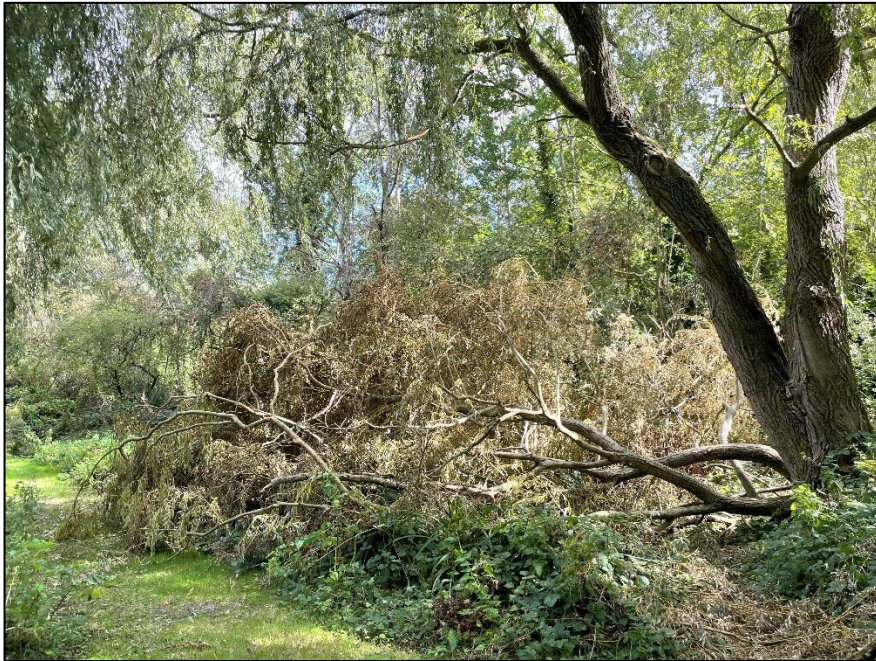
- A tertiary stem section was damaged when the large stem section failed and now has a split running down, terminating at the junction with a larger stem section. In the event the tertiary stem section were to fail, it could reach the path so consideration should be made to removing it back to the union although this is by no means essential

T22/347 Weeping willow with fallen section of storm damage partially across the path

| Tree No | Tag No. | Species | Stem Dia. | Height | Cr. Spr. | Age Class | Phy. Cond. | Comments | Recommendations | Priority |
|---|---|---|---|---|---|---|---|---|---|---|
| T22 | 347 | Weeping willow | 751-1000 | 15-20 | 10-15 | M | FAIR | Large stem failure, fallen section encroaching onto path<br>Subordinate/remaining tertiary stem section has a split | Clear off path<br>Consider removing tertiary stem section back to union with larger stem section | HS2 |

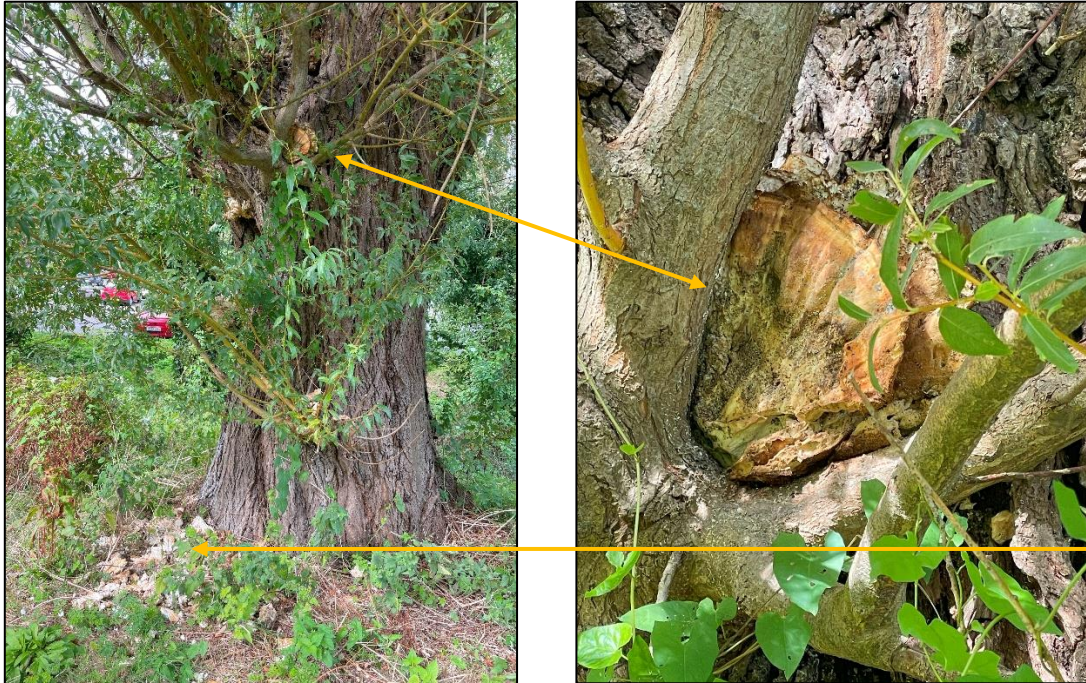
T15/715 White willow - Desiccated fungal fruiting bodies of *Laetiporus sulphureus* south stem side of stem from c.2m up to c.3m; note the desiccated remains on the floor

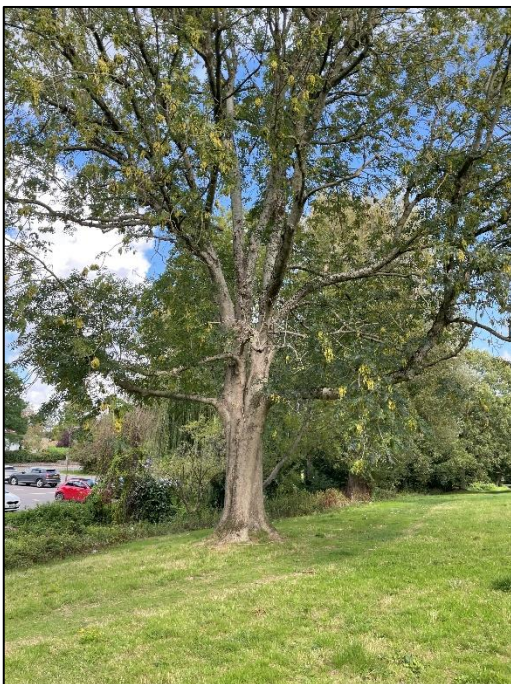
T19/719 Common ash - early symptoms of ADB  
Suspended sections of deadwood and dead branches

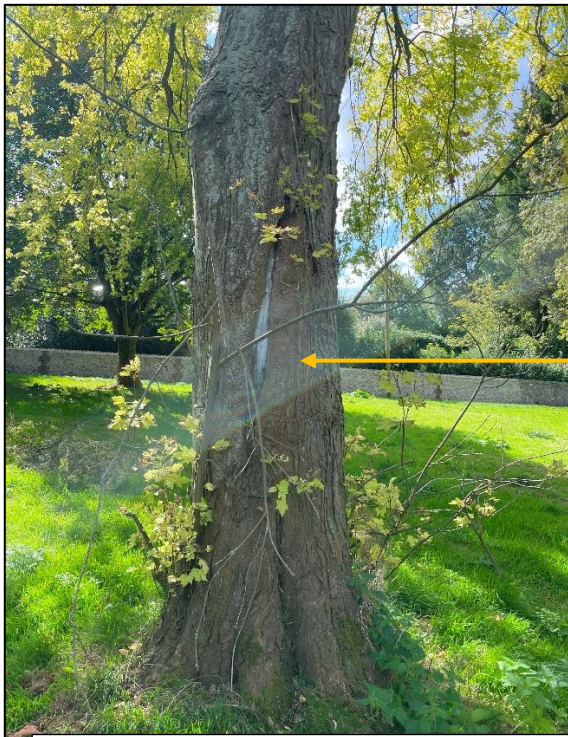
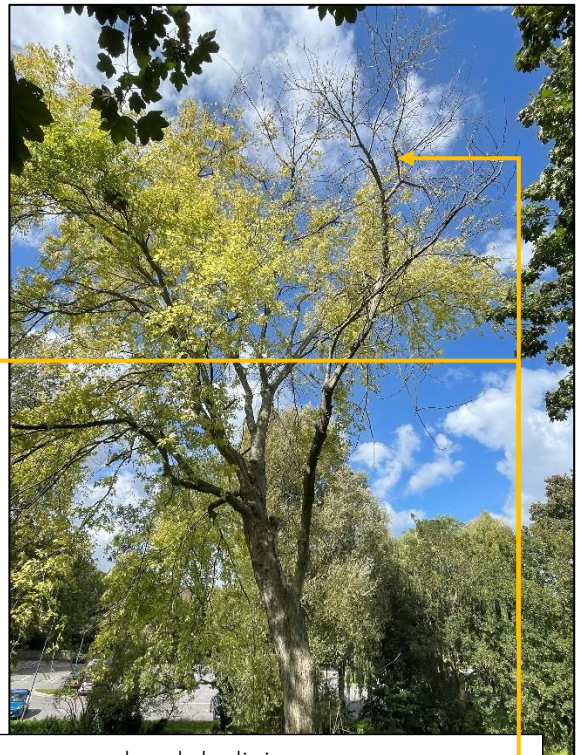
T21/721 Silver maple - note the stem wound and declining crown

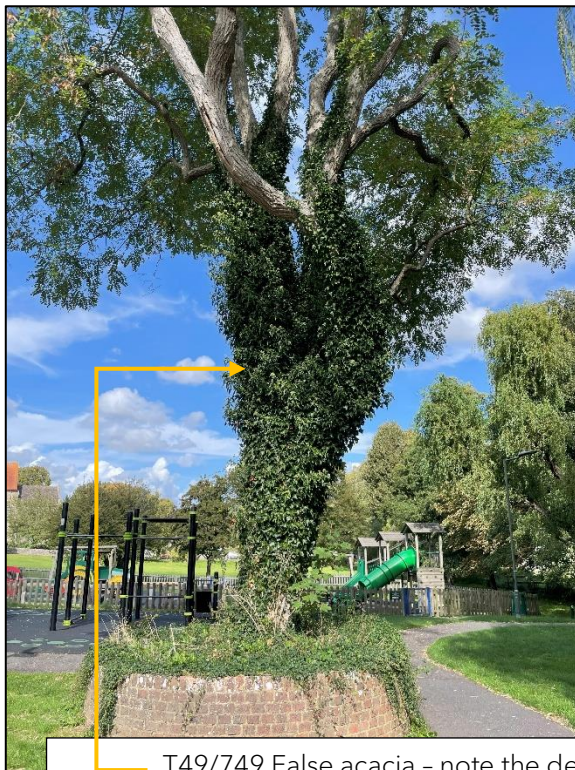
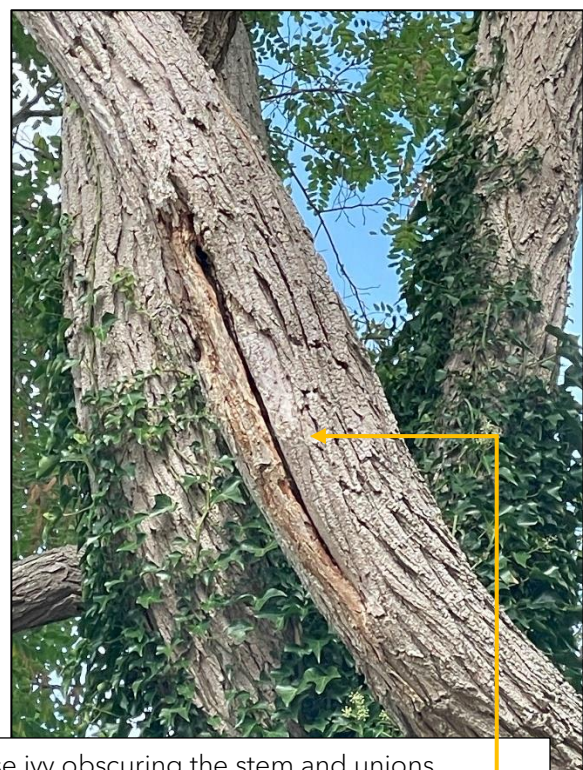
T49/749 False acacia - note the dense ivy obscuring the stem and unions  
Longitudinal bark anomaly requiring further investigation
