## Steyning Parish Council

## Committee Report

## STEYNING PARISH COUNCIL WINTER MAINTENANCE PLAN AUTUMN 2018- SPRING 2019

## Tree Condition Report

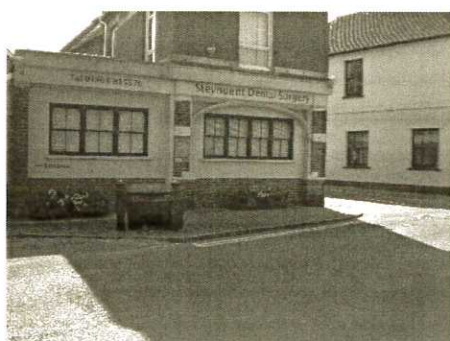
No. 1 Bramber Road, near junction with Jarvis Lane

| Position of Permanent Grit/Salt bins | In place | Checked September 2018 |
|---|---|---|
| Bramber Road near junction with Jarvis Lane, outside Dental Surgery (photo 1) | Y | Full / Good quality |

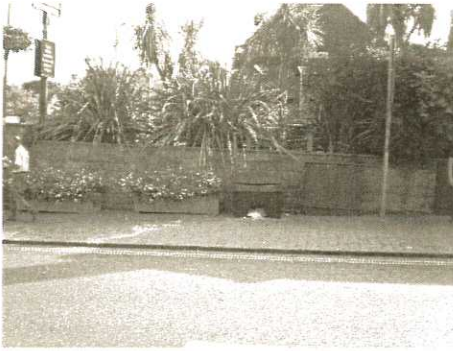
No. 2 High Street, outside White Horse

| Position of Permanent Grit/Salt bins | In place | Checked September 2018 |
|---|---|---|
| High Street, outside White Horse between 2 BT units (photo 2) | Y | 25% /good |

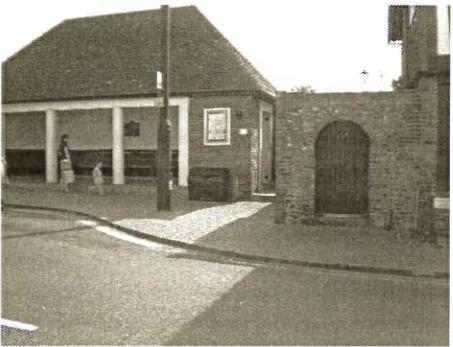
No.3 High Street, Bus Shelter

| Position of Permanent Grit/Salt bins | In place | Checked September 2018 |
|---|---|---|
| High Street, outside Bus Shelter, on right facing (photo 3) | Y | Half full Good |

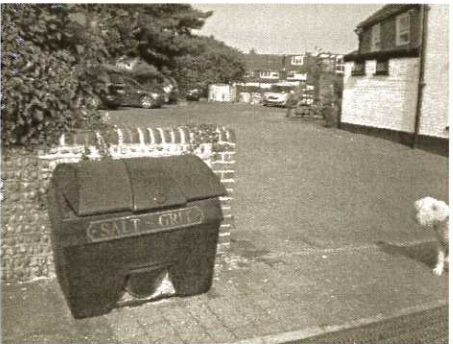
No.4 High Street, by The Star

| Position of Permanent Grit/Salt bins | In place | Checked September 2018 |
|---|---|---|
| High Street, by the wall to Star Pub, next to refuse bin (photo 4) | Y | Half Full/good |

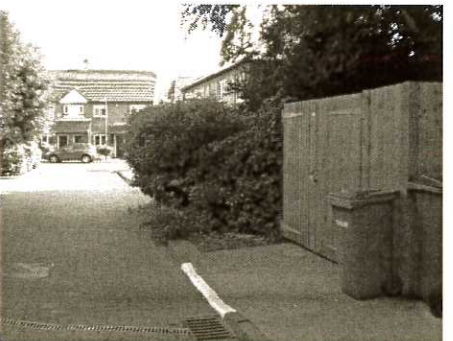
No. 5 Penns Court (in green dustbin marked Sulo)

| Position of Permanent Grit/Salt bins | In place | Checked September 2018 |
|---|---|---|
| Penns Court bin store, in green dustbin marked SULO (needs remarking) (photo 5) | Y | 75% /good |

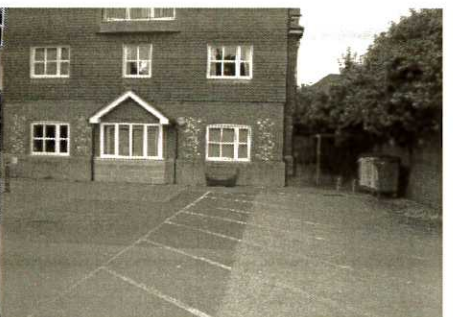
No. 6 Steyning Health Centre

| Position of Permanent Grit/Salt bins | In place | Checked September 2018 |
|---|---|---|
| Steyning Health Centre, Tanyard Lane, green grit/salt bin (photo 6) | Y | Full /good |

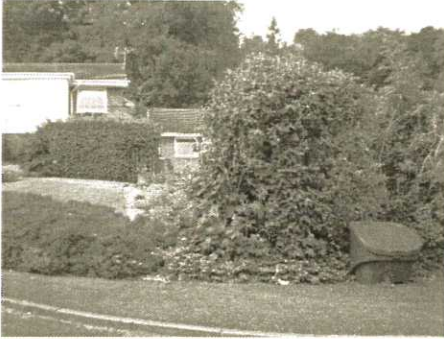
No. 7 55-57 Penlands Vale

| Position of Permanent Grit/Salt bins | In place | Checked September 2018 |
|---|---|---|
| At crest of Penlands Vale, outside Nos 55-57 (photo 7) | Y | Half Full/good |

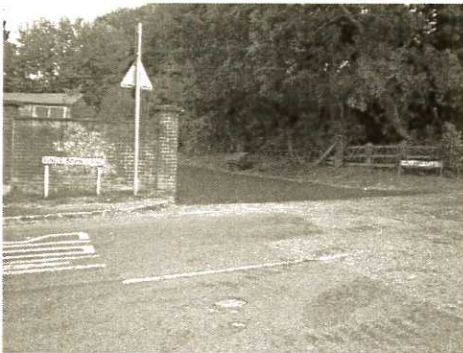
No. 8 Kings Barn Villas

| Position of Permanent Grit/Salt bins | In place | Checked September 2018 |
|---|---|---|
| Kings Barn Villas, on grass verge by Kings Barn Lane road sign (photo 8) | Y | Half Full/good |

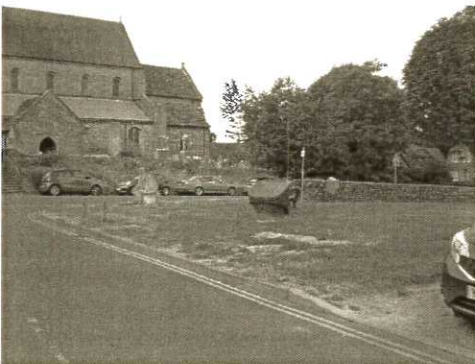
No. 9 – Entrance to Fletcher's Croft car park

| Position of Permanent Grit/Salt bins | In place | Checked September 2018 |
|---|---|---|
| Entrance to Fletcher's Croft Car Park on hard standing on grass (photo 9) | Y | Half Full/good |

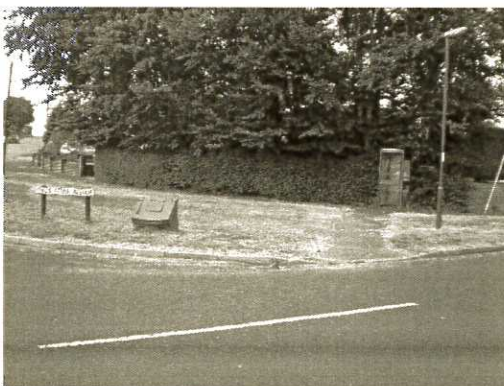
No. 10 Roman Road at junction with King's Stone Avenue

| Position of Permanent Grit/Salt bins | In place | Checked September 2018 |
|---|---|---|
| Roman Road, at junction of King's Stone Ave by telephone box (photo 10) | Y | 75% Average |

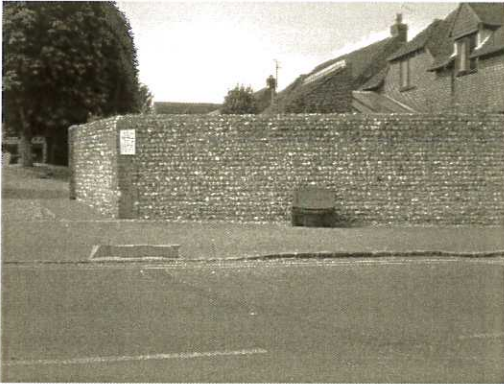
No. 11 White Horse Square

| Position of Permanent Grit/Salt bins | In place | Checked September 2018 |
|---|---|---|
| White Horse Square, In front of flint wall to left of entrance to Tester/Pilgrim Cottage/Myatts ( photo 11) | Y | Full Average |

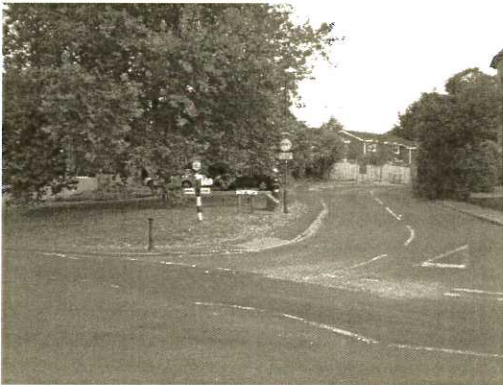
No. 12 Corner of Bostal Road, opposite Goring Road

| Position of Permanent Grit/Salt bins | In place | Checked September 2018 |
|---|---|---|
| Corner of Bostal Road/Goring Road in front of grass bank (photo 12) | Y | Full Good |

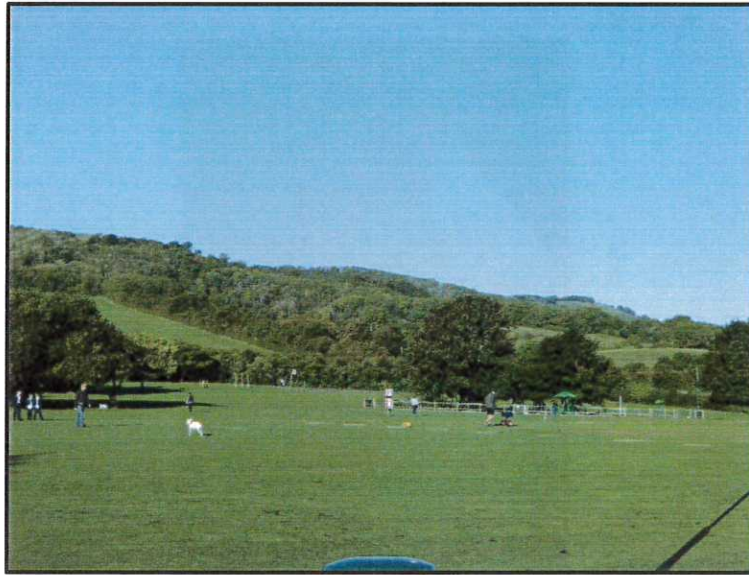
## Memorial Playing Field and Rublees Allotments

An open expanse of playing field with an enclosed play area within its centre, a cricket and football pitch towards the north and a community orchard to its south; the area is extremely well used by dog walkers, fitness enthusiasts.

Rublees Allotments are to the south of the Memorial Playing Field with access gained via gates to the east and west; mature hedgerows are present to the north and south of the allotment site.

| No | Tag No | Species | SD | Height | Crown Spread | Age Class | Comments | Action Required | Priority |
|---|---|---|---|---|---|---|---|---|---|
| 3 | 798 | Goat willow | Twin | 10 – 15 | 5 – 10 | M | Deadwood greater than 25mm in diameter over playing field<br>Bark damage conducive to that caused by a sharp implement such as an axe or machete | Remove deadwood greater than 25mm over the playing field | HS3 |
| 4 | 799 | Apple | 400 | 5 – 10 | 5 – 10 | M | Stem cavity 1.8m on north side.<br>Fructification in wound – most probably <i>Cerioporos squamosus</i> (formerly <i>Polyporus squamosus</i> ) | Employ a microdrill to assess the condition of the stem | HS2 |
| 5 | 800 | Apple | Twin | 5 – 10 | 5 – 10 | M | Cavity south side of stem c. ground level<br>The cavity extends into the stem in excess of 250mm<br>The tree is in a sheltered position<br>2 x small fructifications of the decay fungus <i>Inonotus hispidus</i> in upper canopy | Assess after extreme weather events due to the risk of failure | N/A |

T4/799 Apple has an open cavity and a fruiting body of what is most likely *Cerioporus squamosus* emanating from it. The mode of this decay is to form a white rot where the lignin is removed; in extreme cases the decay can result in failure. The recommendations are to assess the tree with a microdrill which will determine the condition of the wood and as such help with the management of the tree.

T5/800 is another apple that is in a relatively sheltered location. At the base is a cavity that extends into the stem in excess of 250mm; within the upper branch structure two small fructifications of the decay fungus *Inonotus hispidus* were observed.

The mode of this fungus is a simultaneous white-rot where both the lignin and cellulose are removed at equal rates; this can result in brittle fractures occurring in extreme cases.

- Perform the works within the time frame specified

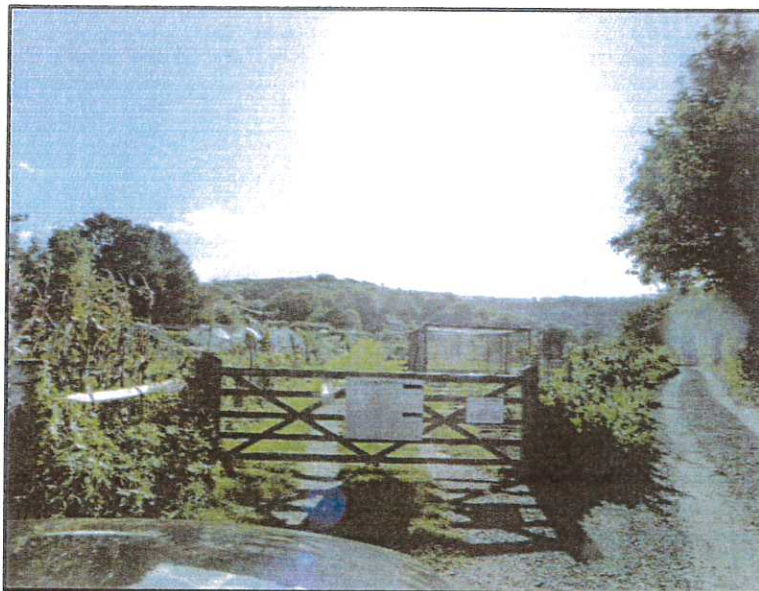
### Canada Garden Allotments

A small site with trees located along its eastern and western boundary fence line; access is via a gate along the northern boundary line.

| No | Tag No | Species | SD | Height | Crown Spread | Age Class | Comments | Action Required | Priority |
|---|---|---|---|---|---|---|---|---|---|
| 1 | 802 | Sycamore | 1000 | 10 – 15 | 5 – 10 | EM | Cavity on west side c. 1.5m with a dull tone around the immediate area<br>Fructification of the decay fungus <i>Cerioporus squamosus</i> (formerly <i>Polyporus squamosus</i> ) evident<br>Thick ivy (dead) restricts a full inspection of the remaining stem area | Perform a decay evaluation employing either sonic tomography or resistance drilling | HS1 |

The fruiting body emanating from the cavity is that of *Cerioporus squamosus* emanating from it. The mode of the decay is to form a white rot where the lignin is removed; in extreme cases the decay can result in failure.

- Perform the decay evaluation within the time frame specified

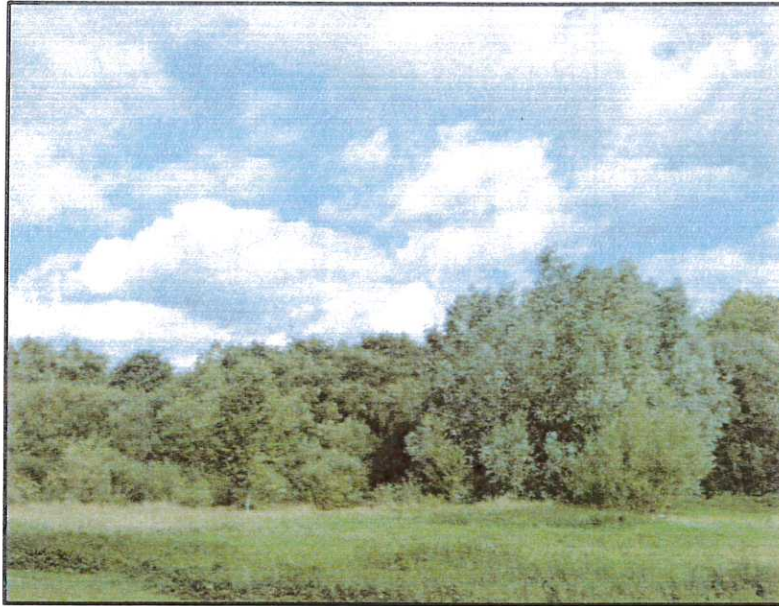
### Abbey Road

The Abbey Road site is located to the north of the village and is surrounded by housing to its east, south and west and the A283 to its north; it also includes a small play area to the south east of the site.

- Perform a visual inspection of the White willow to the east of the removed tree T1/804 after extreme weather events
- Consider the removal of T2/805

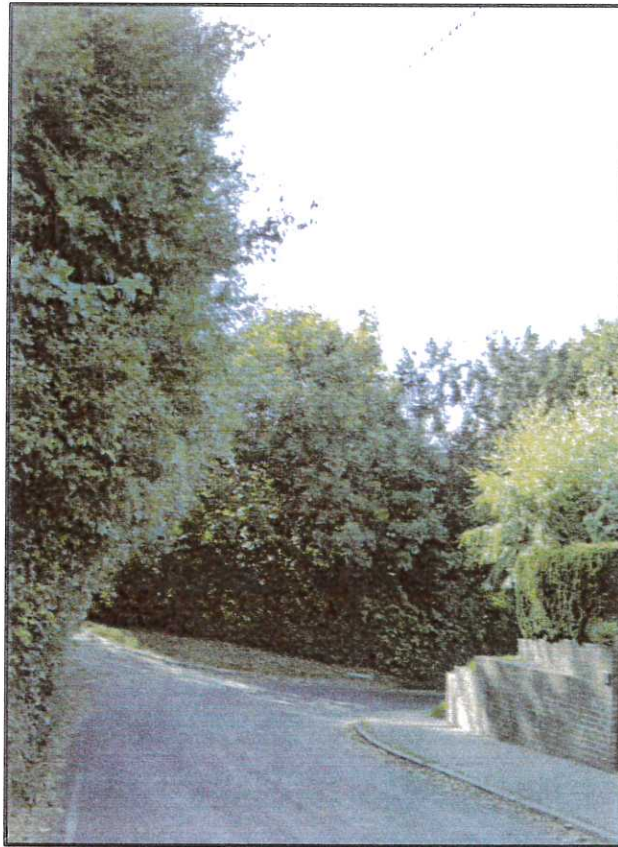
Cripps Lane is a narrow section of road with a bank on its south west side; either side of the lane are houses and a junction to Jarvis Lane at the south west end.

- Perform the pruning work within the time frame specified

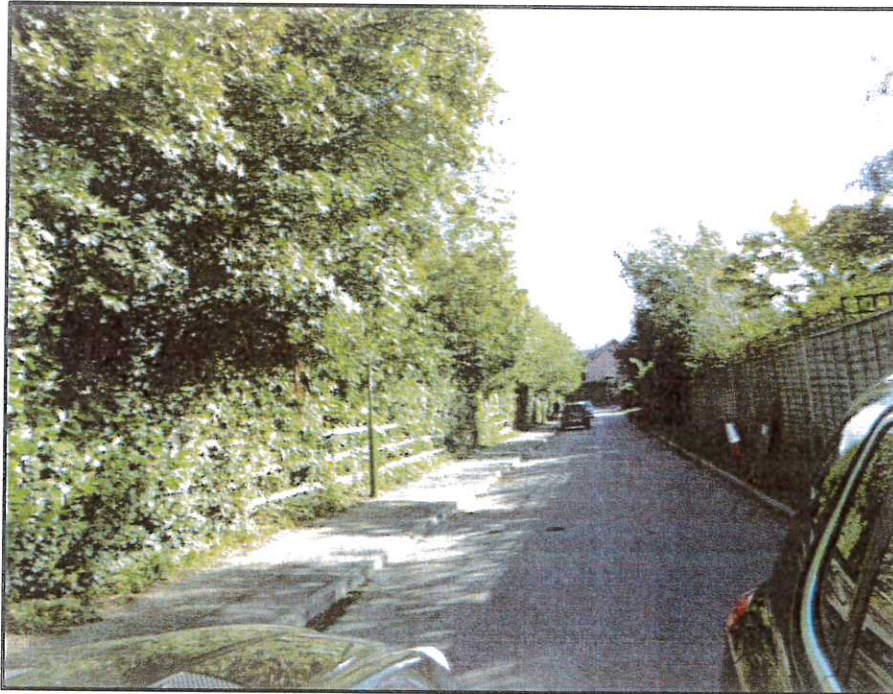
Godstalls Lane is an access road that serves a number of properties; the row of trees along its eastern side are located on a bank that falls towards the neighbouring properties in Newham Close.

- o Perform the pruning work within the time frame specified

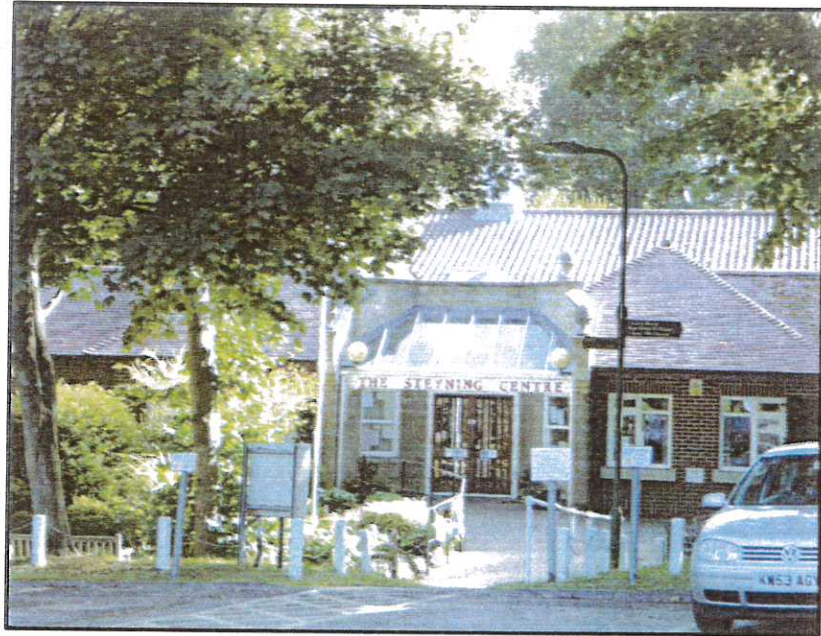
### The Steyning Centre

The Steyning Centre is located off Vicarage Lane and has car parking to its immediate north; pedestrian access to Steyning Grammar School runs along the north side of the centre.

St Andrew's Pre-School operates within the Steyning Centre and has a play area to the south and east of the Centre.

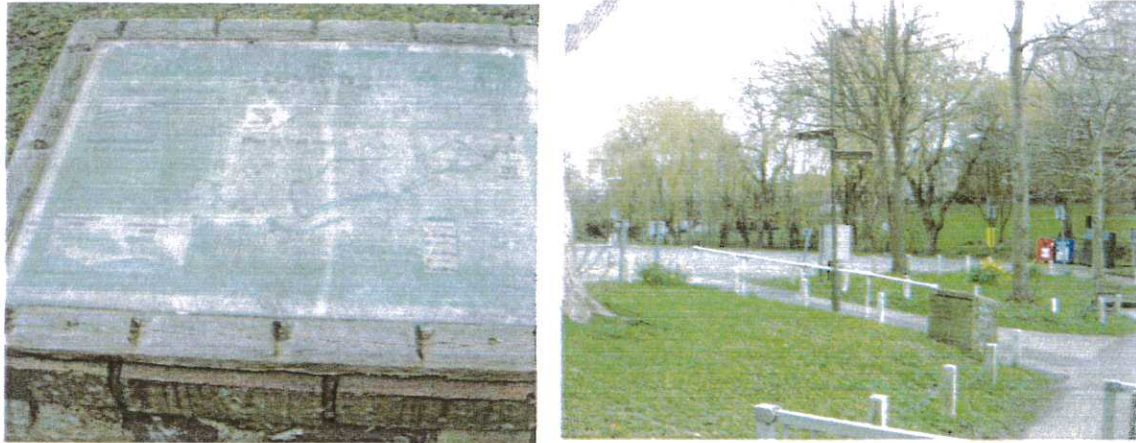
## Interpretation Panel – Plinth outside the Steyning Centre

Councillors will be aware this has a very dilapidated timber surround containing a faded, damaged and stained map of the horseshoe walks to the north of the playing fields. Apart from being illegible it gives visitors a very poor impression of civil pride.

Steyning Partnership have applied to LEADER for funds to replace the panel with an oak framed panel showing the route up to the South Downs Way via the High Street and footpath off Mill Road alongside the playing fields, indicating the alternatives of the upper/lower horseshoe walks and location of the Steyning Downland Scheme.
