## **Assessment of Fletcher's Croft Children's Play Area following complaint that it is not disabled friendly**

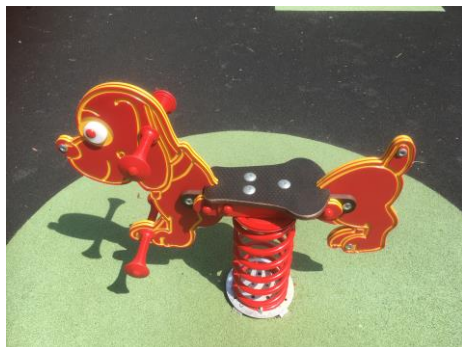
**4. The sit on duck and dog (below) are** both on a spiral spring and younger children can be placed and held on the seat if necessary. They don't appear to move very much.

**Not an exciting piece of equipment**
