# **Preliminary Assessment of the Car Park Public Toilets**

## **Part 2**

Discussion Paper (30th June 2019)

SPC Premises Committee Working Party

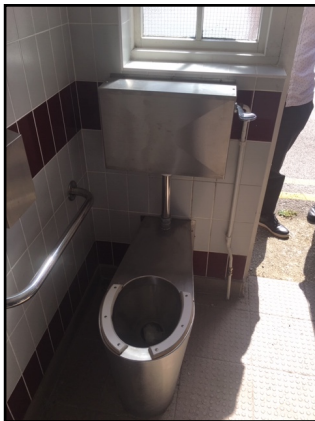
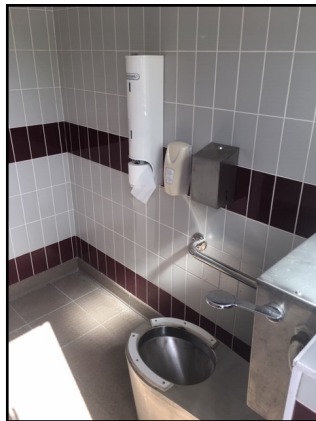
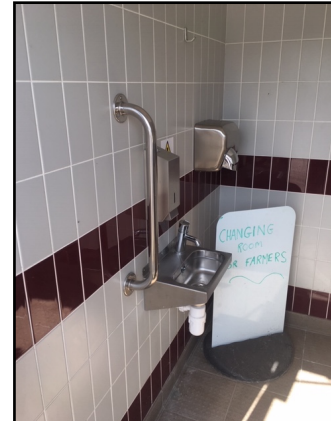
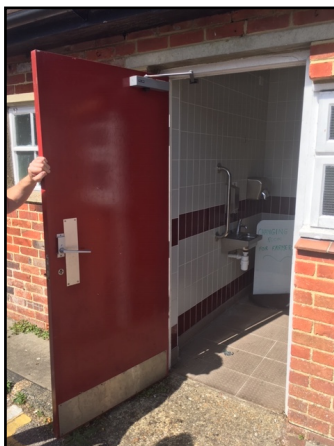
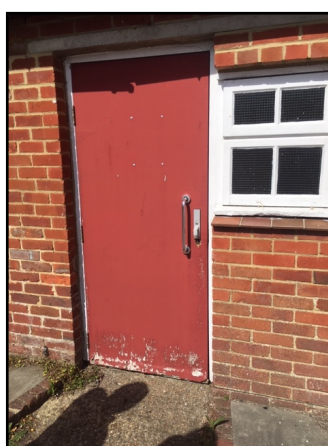
The Rear Toilet is only utilised at the time of the monthly Farmers Market. The reason for this situation is that during the Farmers Market car parking is forbidden and so there is no danger to pedestrians accessing the rear toilet. At other times it is considered that the flow of traffic is a health and safety risk. This is a significant waste of a valuable asset because if it could be brought into full time use it would increase the capacity of the current facilities.

The toilet seat requires upgrading but the toilet facility as a whole is of acceptable appearance and has a compact feel. Two possible access options are under review for this medium to longer term project:

(iii) Replacement of existing door to the rear toilet. A quotation of £462.43 has been received from T C Maintenance for this work including repairs to the door frame. However the quotation was for a fire door and a quotation is now being sought for a lower specification door. In addition consideration might also be given to fitting a standard Engaged/Vacant lock to allow occupancy of this toilet to be more easily recognised. At present this toilet is under-utilised and serious thought has been given to a means of providing public access to this toilet 365 days per year.

(i) Expand utilisation of the Rear Toilet by its integration into main toilet block via an internal access via the Mens urinal or an external access via a protected pathway.

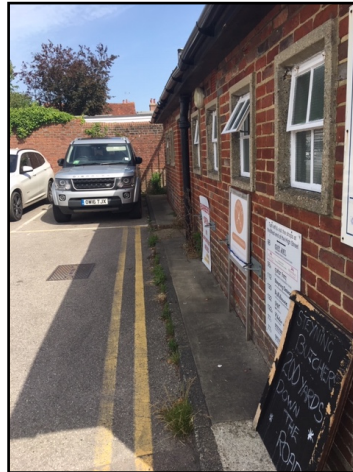
(i) Access via a protected pathway: Installing a rear pathway has been one of the considerations in relation to the installation of an ATM in part of the large unisex toilet. Installing such a pathway would result in the loss of at least one parking space where the 4 x 4 vehicle can be seen in the photograph. The loss of a single parking space is to be regretted but it would mobilise a redundant resource that must have cost thousands of pounds to install. The pathway with protective railing would probably have to extend out to the edge of the manhole cover along the full length of the building.

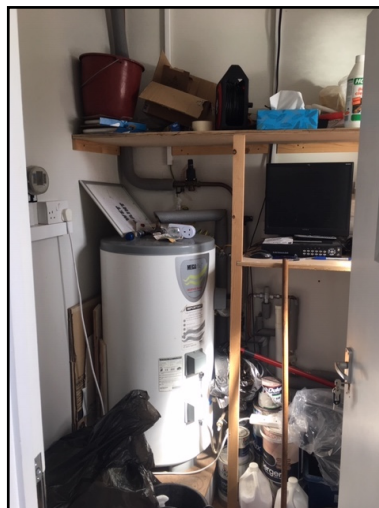
(ii) Access to Rear Toilet via the Mens urinal: The advantage of this option is that it would upgrade the urinal to a full Mens toilet. It would also avoid the loss of a car parking space and the need to construct a protected pathway at the rear of the building.

The current disadvantage of this option is that the caretaker store contains the water heating system and other equipment that makes access to the Rear toilet problematic without significant works. Creating door access between the store and the rear toilet would require building works to undertaken but it does seem to be feasible. The caretaker cleaning equipment could be relocated to a cupboard in the large Unisex toilet.

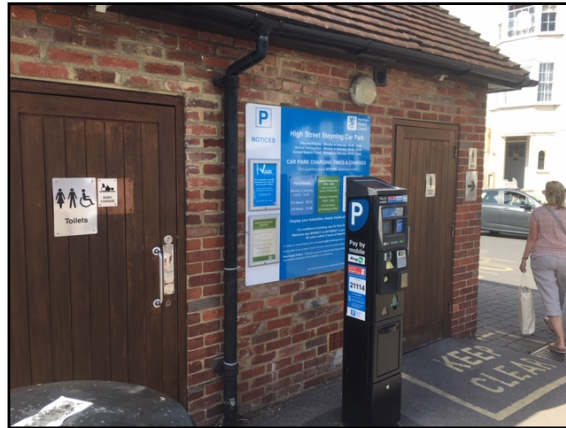
The Ladies toilet is located at the eastern end of the bus shelter/toilet block and it is therefore highly visible and accessible to residents, visitors and tourists.

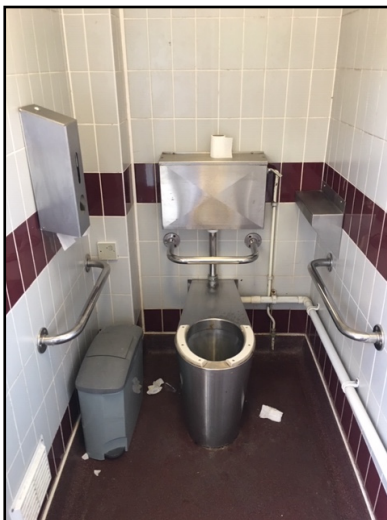
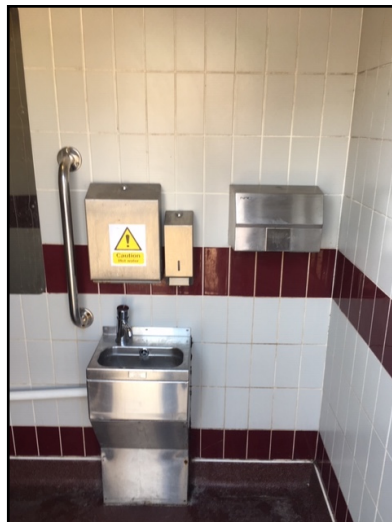
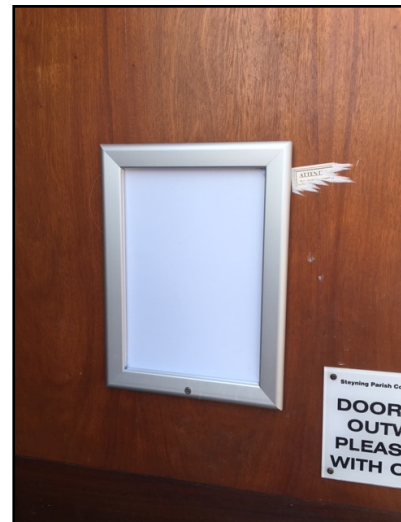
In common with the other two toilets (Unisex and Rear) the current seat design is unacceptable and will need to be replaced with a heavy duty folding seat without delay. Being clearly identified as a Ladies toilet it is less likely to be impacted by male soiling although no doubt that does occur from time to time. The layout of the stainless steel fitments is acceptable because the scale seems to fit the size of the room. A caretaker inspection pad on the inside of the door shows no record of visits but that may not necessarily indicate that visits are not made. A simple wedge would allow a male cleaner to keep the door open during inspection and cleaning.

(i) Fitment of hinged heavy duty toilet seats to three existing stainless steel toilets. The seats should be, as far as possible, vandal proof and be fitted to the existing stainless steel toilets. If that proves to be impracticable then the three stainless steel toilets may have to be replaced with suitable alternatives similar to the one observed at the Crematorium.

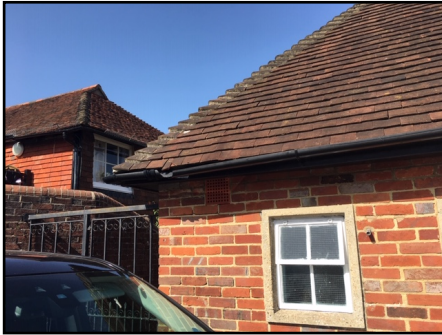
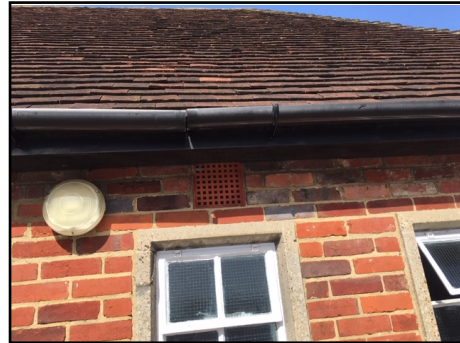
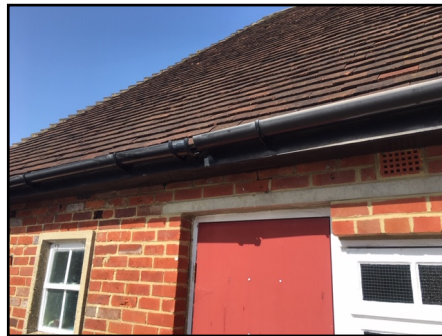
The gutter to the rear of the bus shelter is broken in a number of places and needs replacement and repair without delay. It is not clear what exactly caused the multiple breakages but it would seem that the quality of the original material might not have been adequate. A quotation for replacing the gutter has been received from T C Maintenance and the cost is £113.00.

(ii) Repair of guttering to the rear of the toilet block. A quotation for this work has been received from T C Maintenance at a cost of £113.00. The gutter is currently broken in numerous locations and is in urgent need of repair.

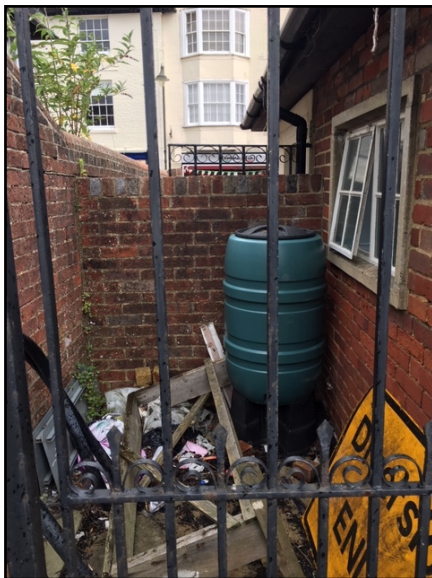
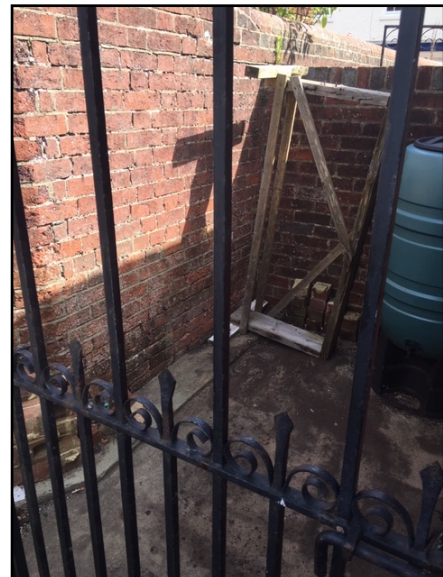
The open storage area to the rear of the bus shelter has now been cleared of the majority of litter and debris. A small amount of clearance is still required to remove some bricks and a wooden frame. The two photos show the before and after situation.

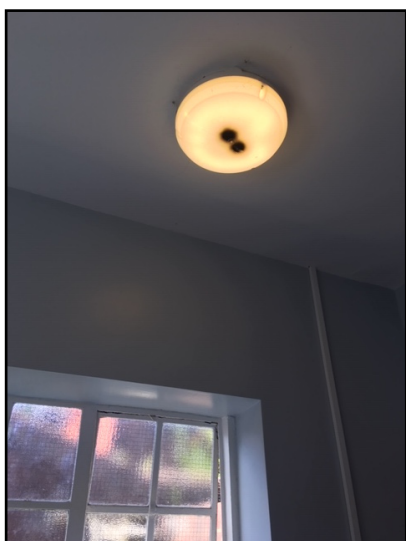
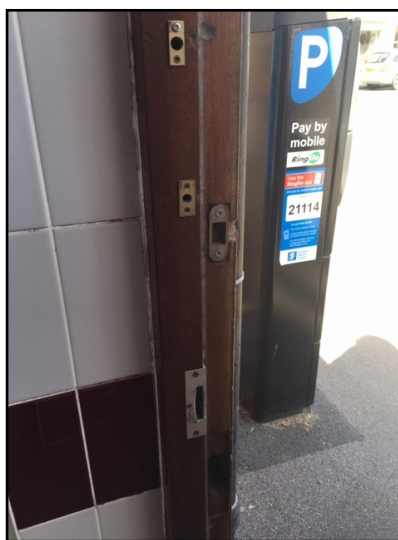
The light fitment in the Mens Urinal needs replacing whilst the frame and the door locking system on the main Unisex toilet needs to be repaired in due course

(iv) Replacement of light fitting in the Mens Urinal

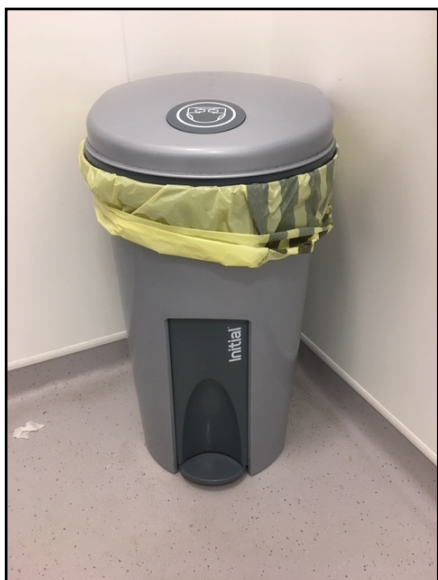
Councillor Bissett-Powell considered that the waste bins used in the toilets were inadequate and that consideration might be given in the future to a more industrial type unit. The pedal operated waste bin below was located in the Crematorium toilet and had significant capacity.
