## Annual Inspection

Steyping Parish Council

Abbey Road Play Area

Inspection Ref: 1389657  
Property Ref: 1254964-413932

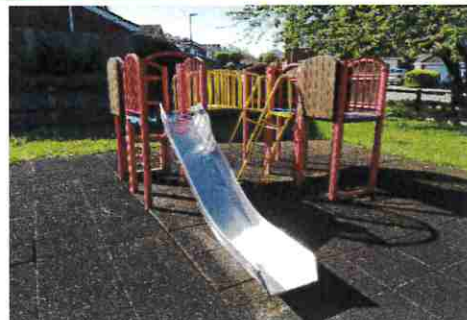
There is an opening in the barriers exceeding the width allowed (500mm) in BS EN 1176, and no guardrail has been provided; this is a low risk failure and no remedial action is required - Monitor - No remedial work recommended

The height of the bridge barrier(s) is insufficient and fails to meet the requirements of BS EN 1176 Part 1 - Monitor - No remedial work recommended

There are gaps opening in between the tiles - Monitor for any further deterioration and repair as required or upgrade

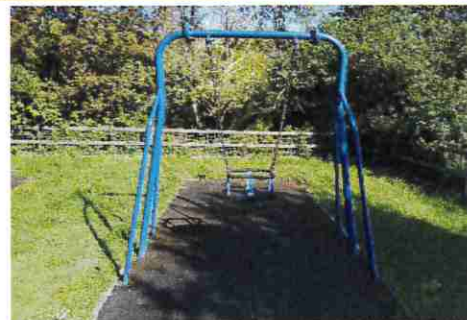
There is some notable evidence of chain wear - Monitor for any further deterioration and replace when 40% worn

The item has exposed threads max 8mm with a radius of less than 3mm and fails the requirements of BS EN 1176 - Cut off and Provide a 3mm radius

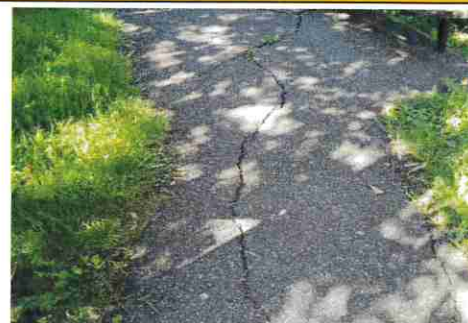
The pathway surfacing is damaged - Repair the damaged areas of surfacing

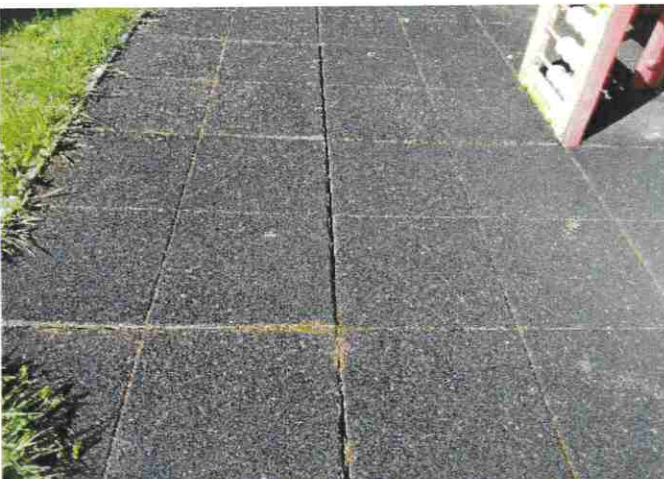
| 6 - Low Risk (Finding 3) | | | |
|---|---|---|---|
| <b>Finding:</b> There are gaps opening in between the tiles | | <b>Action:</b> Monitor for any further deterioration and repair as required or upgrade | |

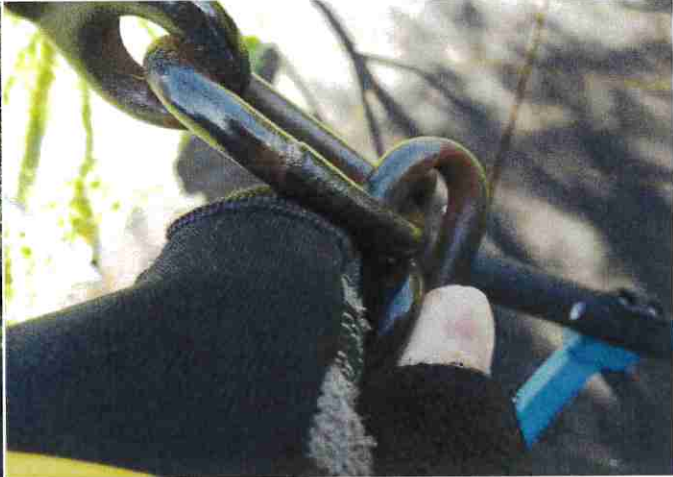
**Finding:** There is some notable evidence of chain wear

**Action:** Monitor for any further deterioration and replace when 40% worn

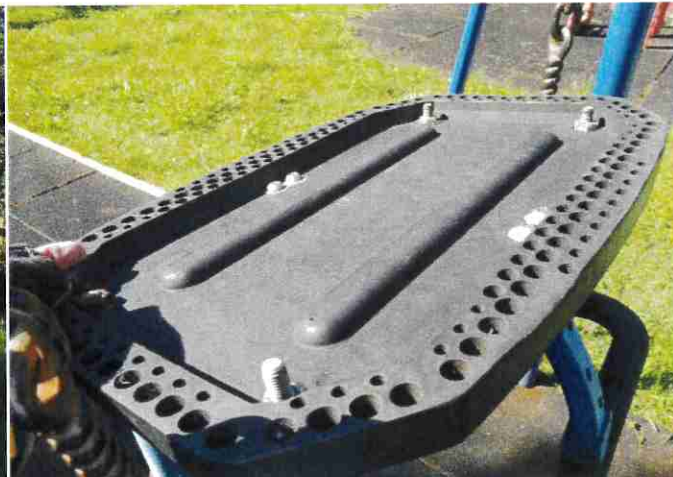
**Finding:** The item has exposed threads max 8mm with a radius of less than 3mm and fails the requirements of BS EN 1176

**Action:** Cut off and Provide a 3mm radius

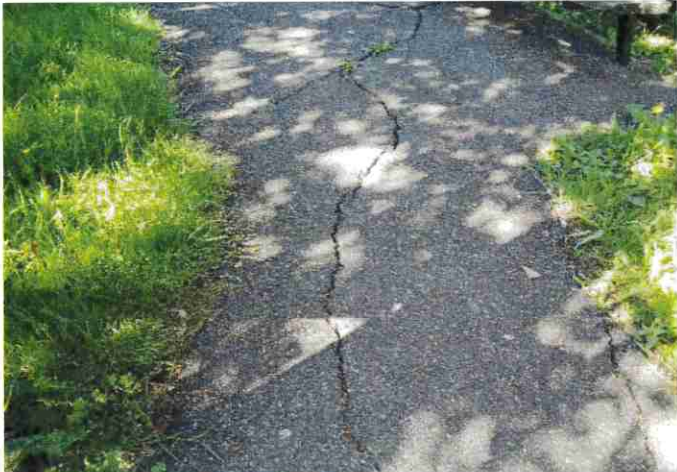
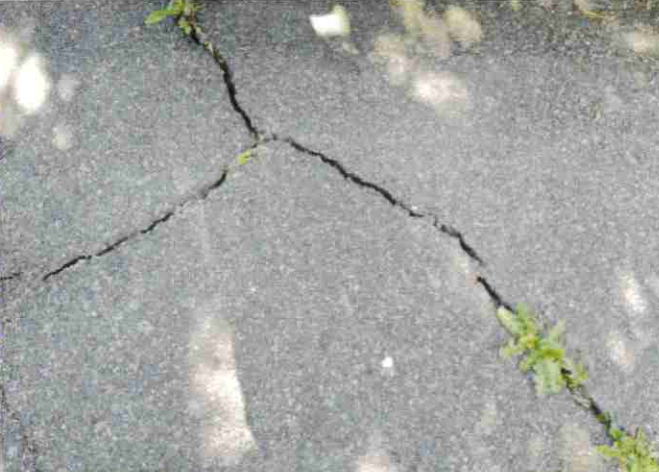
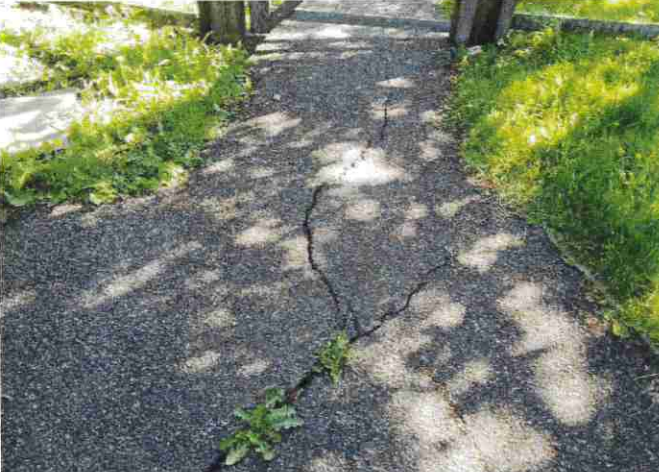
| 12 - Moderate Risk (Finding 1) | | | |
|---|---|---|---|
| <b>Finding:</b> The pathway surfacing is damaged | | <b>Action:</b> Repair the damaged areas of surfacing | |

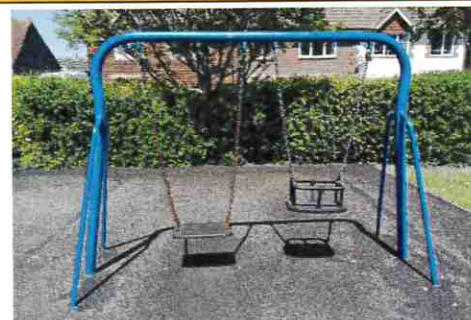
The bushes are worn or missing - Replace worn or missing bushes

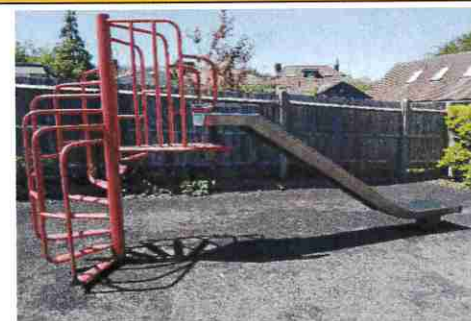
The item is loose in its foundations - Reinstall item to secure or due to age/condition upgrade unit

There is an opening in the barriers exceeding the width allowed (500mm) in BS EN 1176, this is a low risk failure and no remedial action is required - Monitor - No remedial work recommended

The depth of the step tread is less than 110mm and fails the requirements of BS EN 1176 Part 1 - Monitor - No remedial work recommended

The stair design forms a hard object within the falling space of the equipment in contravention of the requirements of BS EN 1176 Part 1 - Monitor - No remedial work recommended

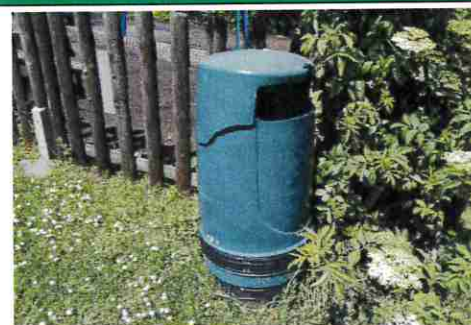
There is some damage to the item - Monitor for any further deterioration and repair as required

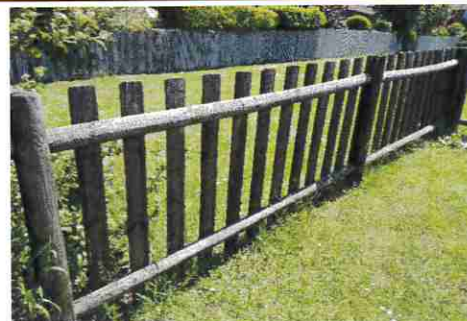
There are a number of loose slats around the fence - Repair as required

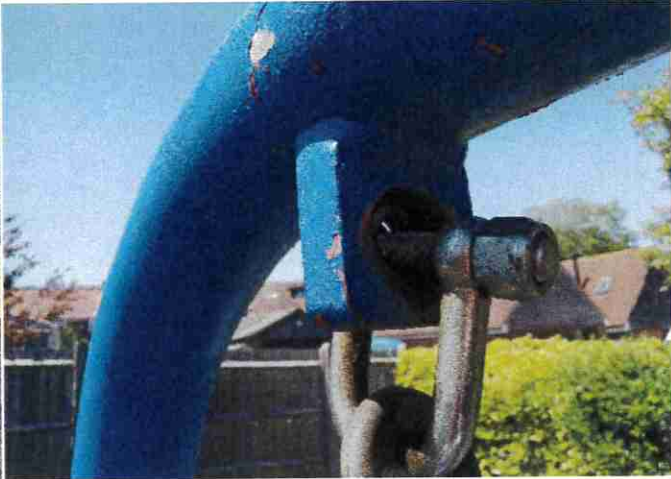
| 12 - Moderate Risk (Finding 1) | | | |
|---|---|---|---|
| <b>Finding:</b> The bushes are worn or missing | | <b>Action:</b> Replace worn or missing bushes | |

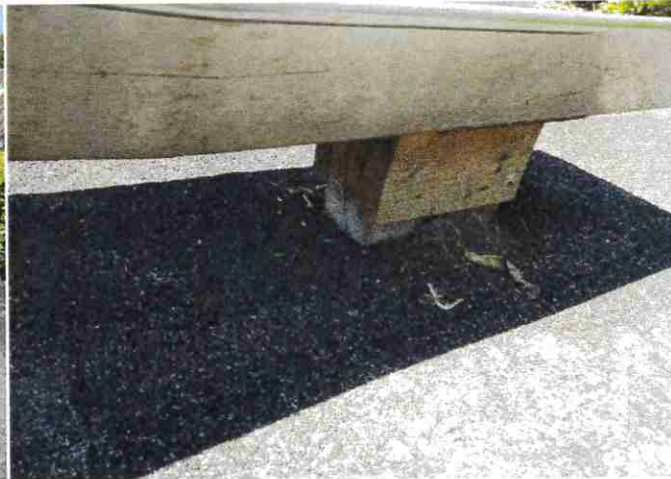
| 15 - Moderate Risk (Finding 1) | | | |
|---|---|---|---|
| <b>Finding:</b> The item is loose in its foundations | | <b>Action:</b> Reinstall item to secure or dur to age/condition upgrade unit | |

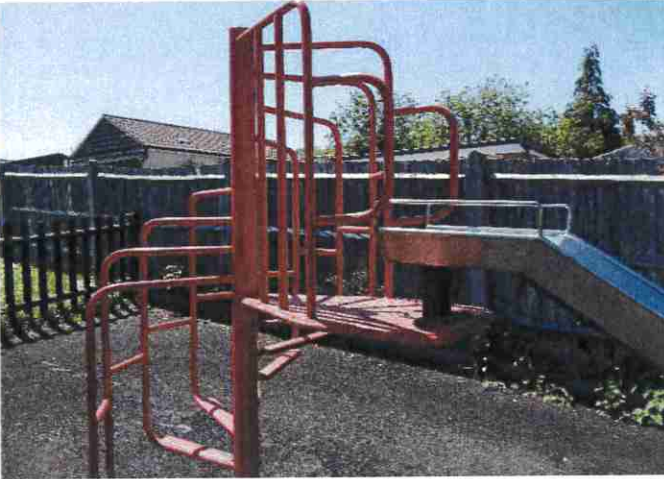
**Finding:** There is an opening in the barriers exceeding the width allowed (500mm) in BS EN 1176, this is a low risk failure and no remedial action is required

**Action:** Monitor - No remedial work recommended

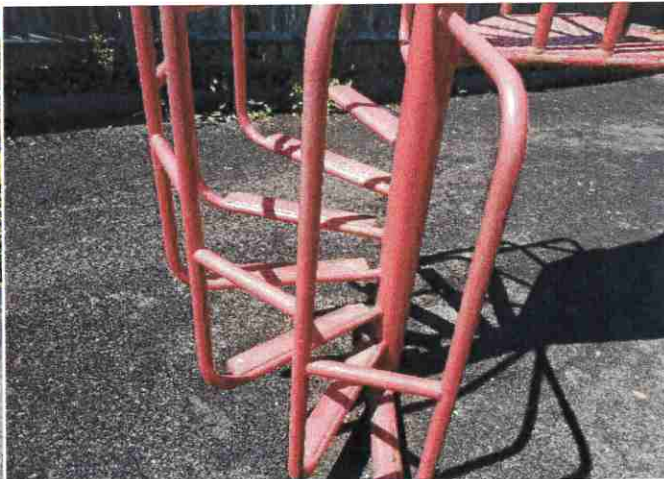
**Finding:** The depth of the step tread is less than 110mm and fails the requirements of BS EN 1176 Part 1

**Action:** Monitor - No remedial work recommended

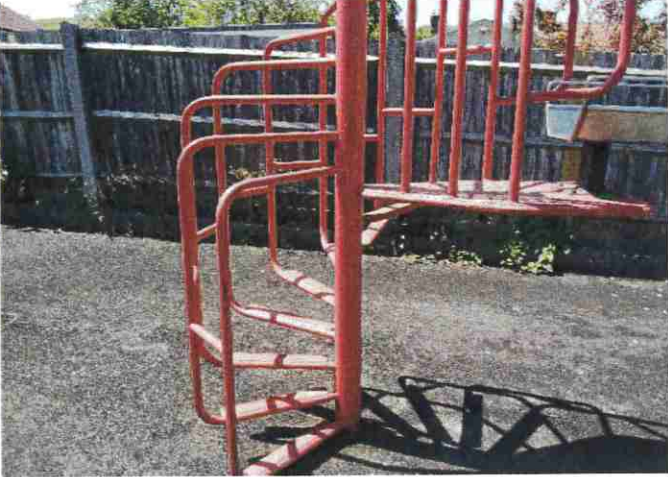
| 10 - Low Risk (Finding 4) | | | |
|---|---|---|---|
| <b>Finding:</b> The stair design forms a hard object within the falling space of the equipment in contravention of the requirements of BS EN 1176 Part 1 | | <b>Action:</b> Monitor - No remedial work recommended | |

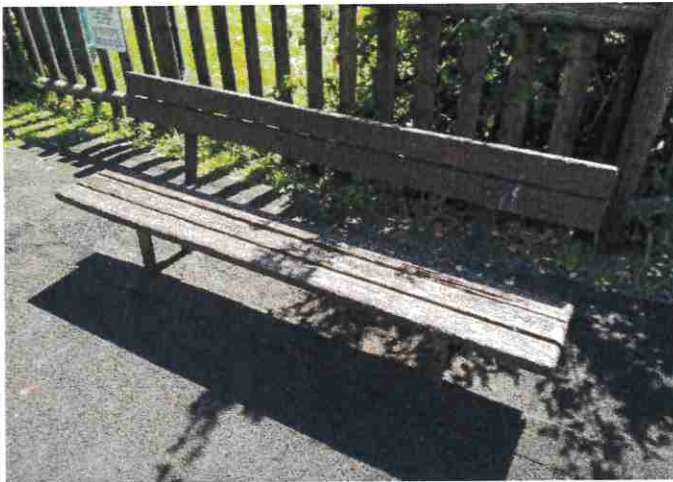
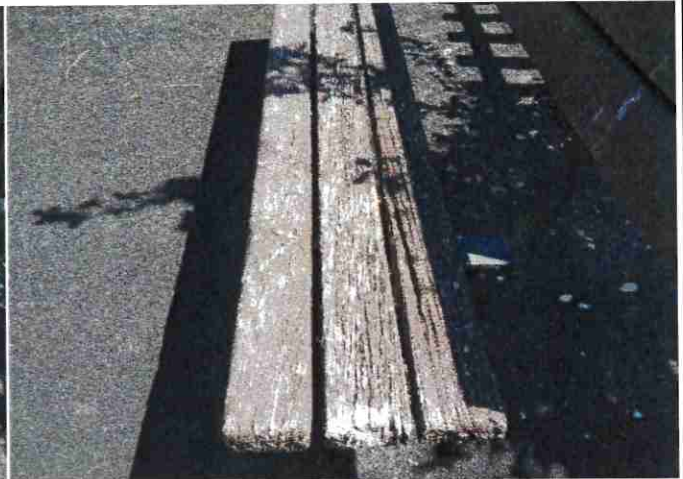
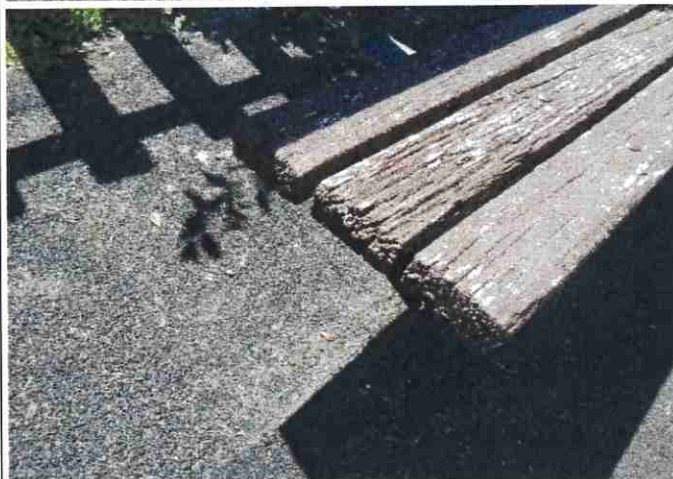
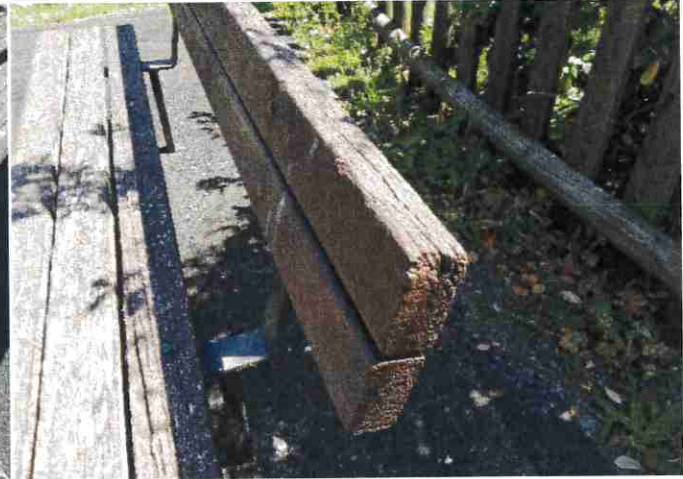
**Finding:** Parts of the timber are rough or splintered

**Action:** Remove all rough or sharp edges

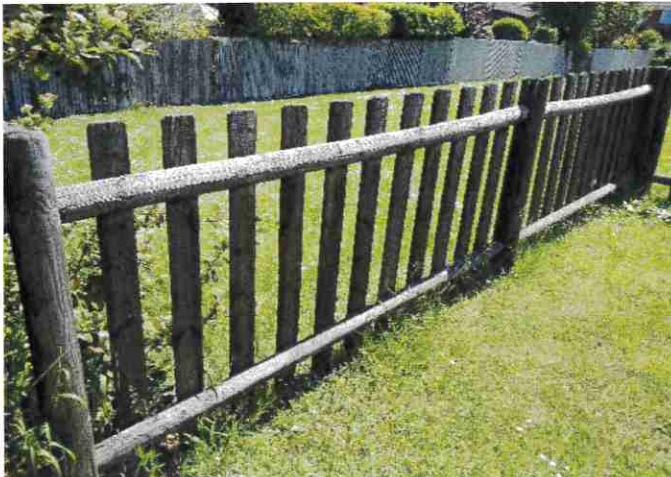
**Finding:** There are a number of loose slats around the fence

**Action:** Repair as required

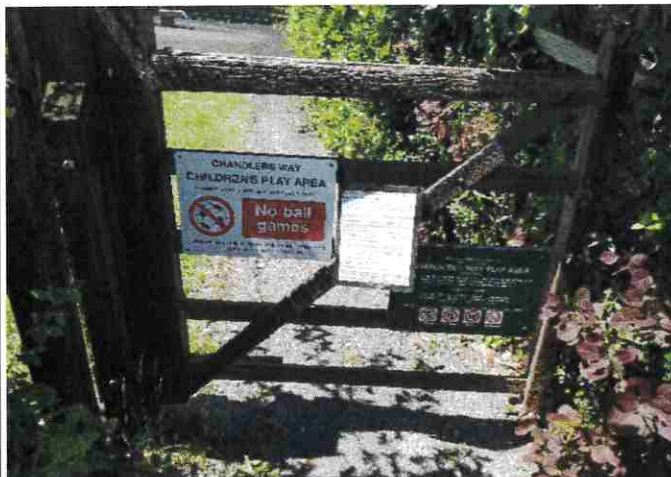
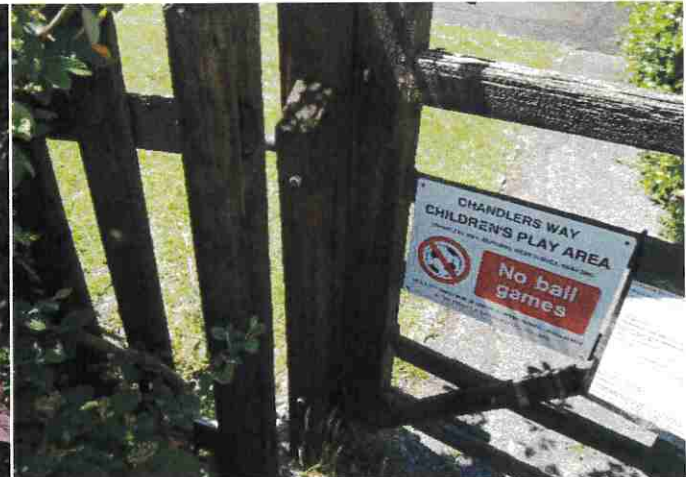
**Item:** Gates - Gate - Pedestrian  
**Manufacturer:** Unknown

**Finding:** There are openings that are less than 12mm that could trap or crush fingers

**Action:** Where possible a 12mm gap should be maintained on both sides or between the gate leaves

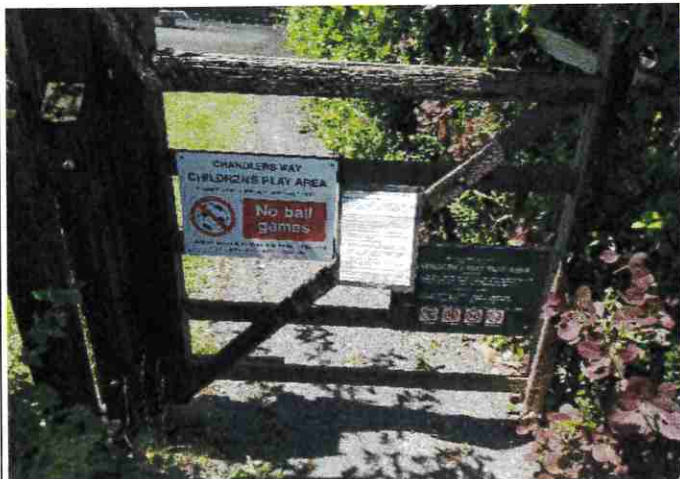
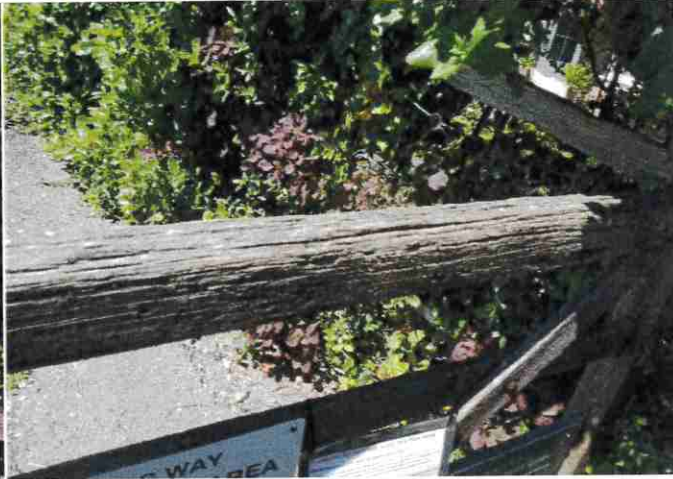
| 6 - Low Risk (Finding 2) | | | |
|---|---|---|---|
| <b>Item:</b> | Gates - Gate - Pedestrian | <b>Risk Level:</b> | L - Low Risk |
| <b>Finding:</b> Parts of the timber are rough or splintered | | <b>Action:</b> Remove all rough or sharp edges | |

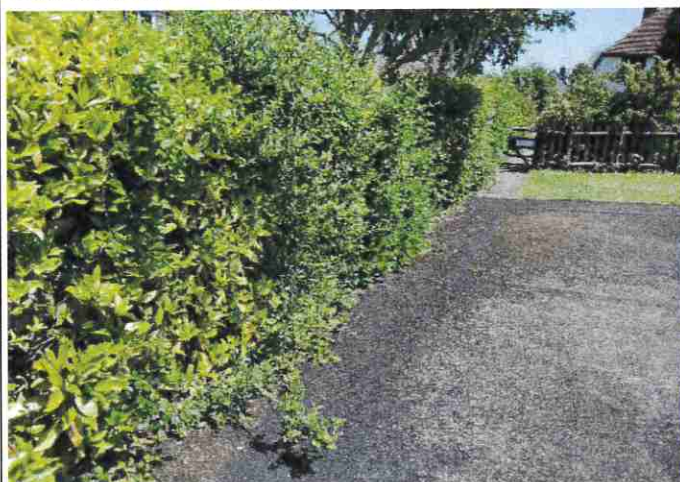
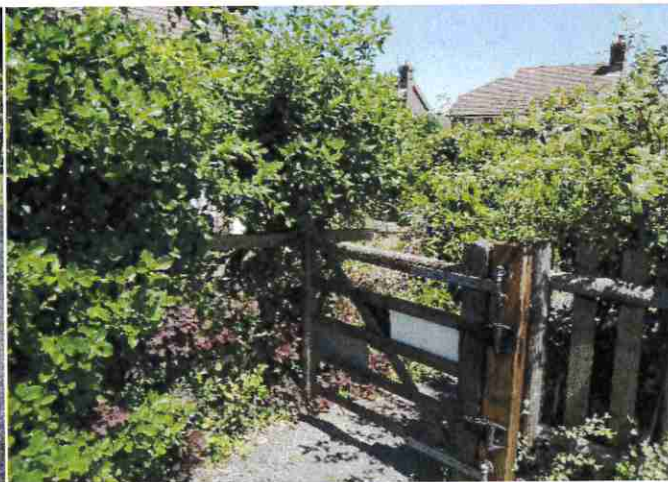
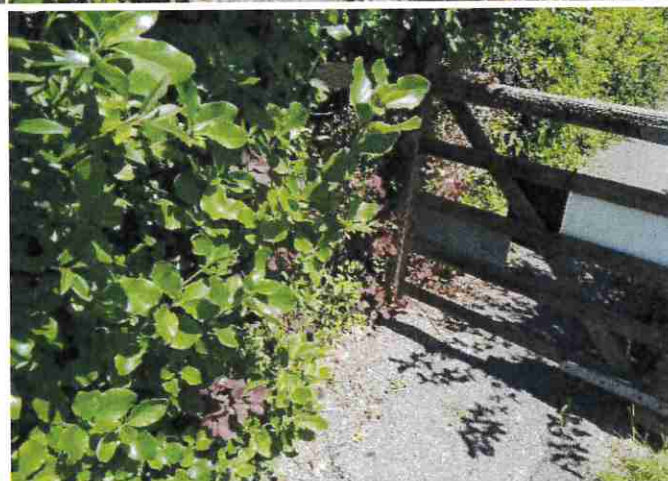
**Item:** Ancillary Items - Hedge  
**Manufacturer:** Unknown

**Finding:** Tree/shrub canopies overhang the access route to the equipment

**Action:** Lift tree/shrub canopy to ensure a minimum clearance of 2.0m from ground level

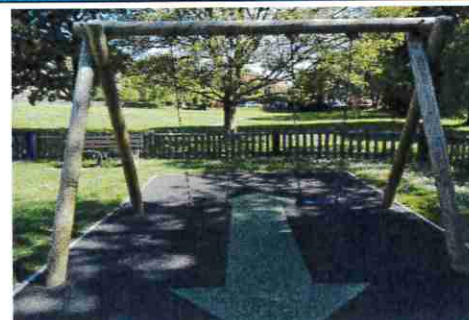
**Item:** 1 Bay 2 Seat (Flat)  
**Manufacturer:** Creative Play  
**Surface Type:** Wet Pour  
**Item Quantity:** 1  
**Equipment Compliance:** N/A  
**Surface Area Compliance:** N/A

There are bolt cap covers missing or damaged on the item - Replace missing bolt cap covers

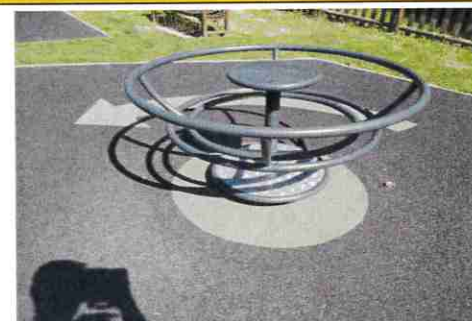
**Item:** Chair Spinner  
**Manufacturer:** Creative Play  
**Surface Type:** Wet Pour  
**Item Quantity:** 1  
**Equipment Compliance:** N/A  
**Surface Area Compliance:** N/A

The item is loose in its foundations - Reinstall item to secure

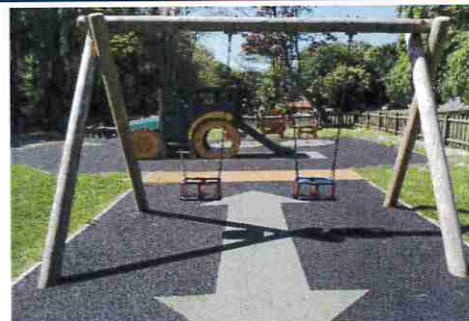
**Item:** 1 Bay 2 Seat (Cradle)  
**Manufacturer:** Creative Play  
**Surface Type:** Wet Pour  
**Item Quantity:** 1  
**Equipment Compliance:** N/A  
**Surface Area Compliance:** N/A

There are bolt cap covers missing or damaged on the item - Replace missing bolt cap covers

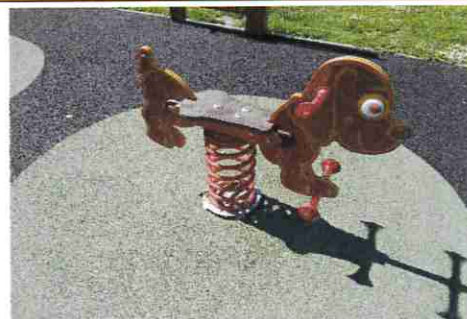
**Item:** Spring Dog  
**Manufacturer:** Creative Play  
**Surface Type:** Wet Pour  
**Item Quantity:** 1  
**Equipment Compliance:** N/A  
**Surface Area Compliance:** N/A

There are fixings missing on the item - Replace all missing fixings

The Handgrips/Footrests rotate and may cause an unexpected movement for the user - Secure Handgrips/Footrests to prevent rotation.

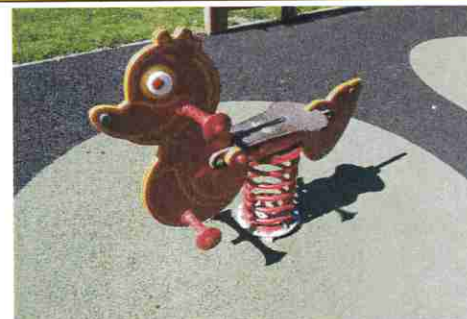
**Item:** Spring Duck  
**Manufacturer:** Creative Play  
**Surface Type:** Wet Pour  
**Item Quantity:** 1  
**Equipment Compliance:** N/A  
**Surface Area Compliance:** N/A

A number of fixing(s) have worked loose - Secure all loose fixings

The Handgrips/Footrests rotate and may cause an unexpected movement for the user - Secure Handgrips/Footrests to prevent rotation.

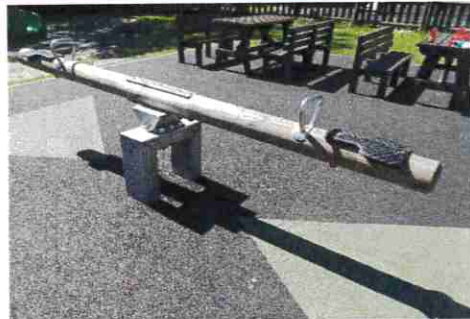
**Finding 1**  
A number of fixing(s) have worked loose - Secure all loose fixings

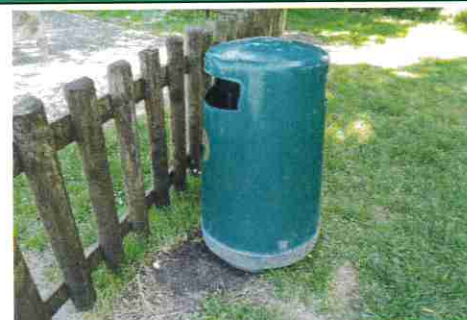
**Item:** Litter Bin  
**Manufacturer:** Unknown  
**Surface Type:** Grass  
**Item Quantity:** 1  
**Equipment Compliance:** N/A  
**Surface Area Compliance:** N/A

The liner of the litter bin is not secured - Recommend ground fixing

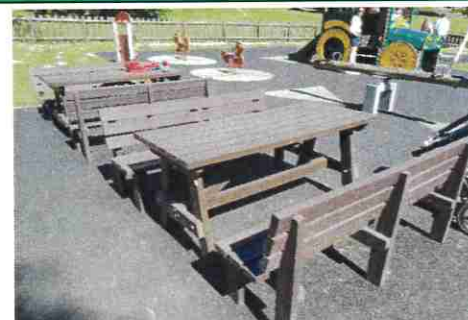
**Item:** Seating Area  
**Manufacturer:** Unknown  
**Surface Type:** Wet Pour  
**Item Quantity:** 1  
**Equipment Compliance:** N/A  
**Surface Area Compliance:** N/A

There is some evidence of fire damage to the item - Monitor for any further deterioration and repair as required

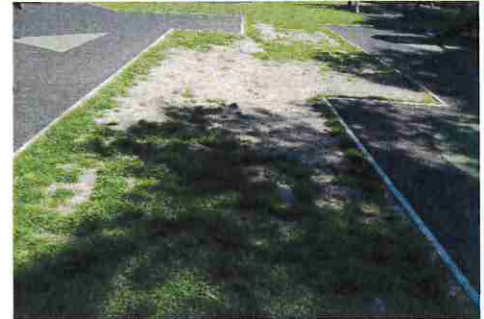
Item: Grass  
Manufacturer: Unknown  
Surface Type: Grass  
Item Quantity: 1  
Equipment Compliance: N/A  
Surface Area Compliance: N/A

There are trip hazards at the edges of the surface - Reinstate surrounding surface levels to remove the trip points

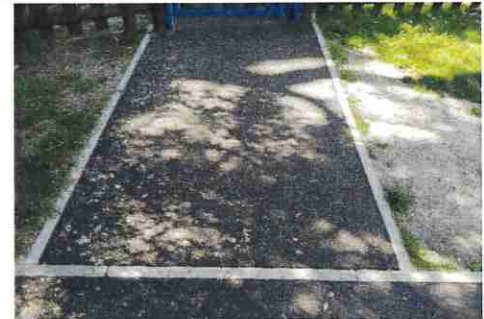
Item: Wet Pour  
Manufacturer: Creative Play  
Surface Type: Wet Pour  
Item Quantity: 1  
Equipment Compliance: N/A  
Surface Area Compliance: N/A

There are gaps opening between the surfacing and the edging surround or between the joints in the surfacing - Monitor for any further deterioration and repair as required

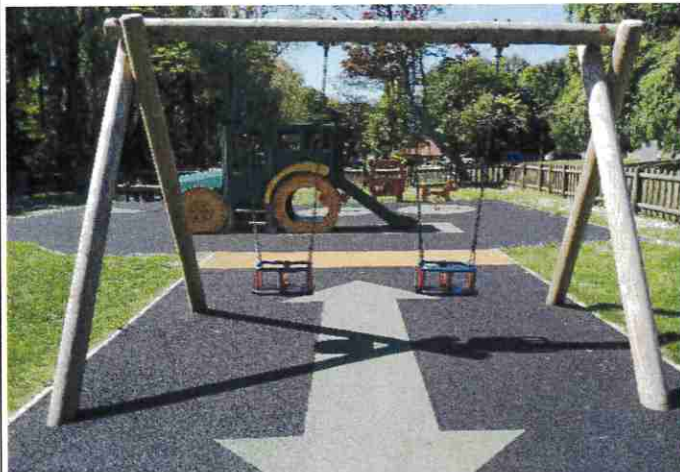
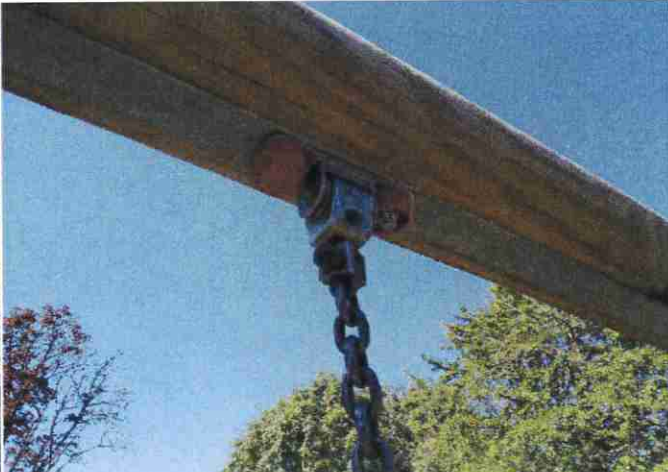
| 4 - Very Low Risk (Finding 1) | | | |
|---|---|---|---|
| <b>Item:</b> | Swings - 1 Bay 2 Seat (Cradle) | <b>Risk Level:</b> | V - Very Low Risk |
| <b>Finding:</b> There are bolt cap covers missing or damaged on the item | | <b>Action:</b> Replace missing bolt cap covers | |

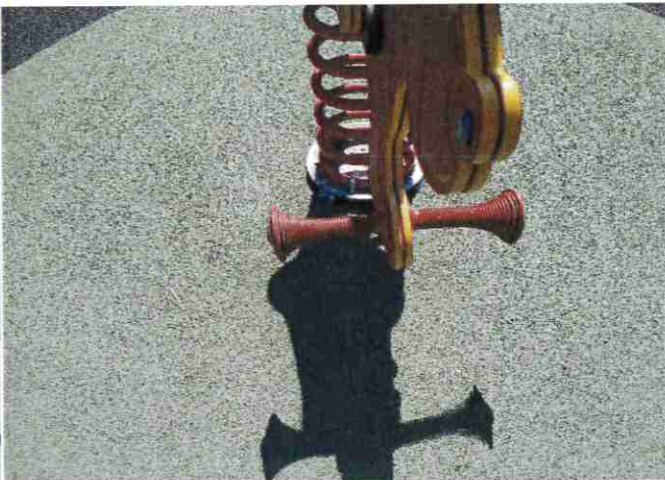
| 10 - Low Risk (Finding 2) | | | |
|---|---|---|---|
| Item: | Rocking Equipment - Spring Dog | Risk Level: | L - Low Risk |
| <b>Finding:</b> The Handgrips/Footrests rotate and may cause an unexpected movement for the user | | <b>Action:</b> Secure Handgrips/Footrests to prevent rotation. | |

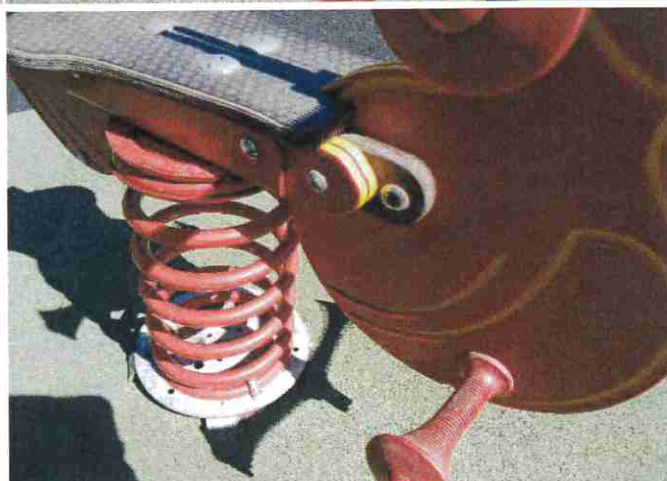
**Item:** Rocking Equipment - Spring Duck  
**Manufacturer:** Creative Play

**Finding:** A number of fixing(s) have worked loose

**Action:** Secure all loose fixings

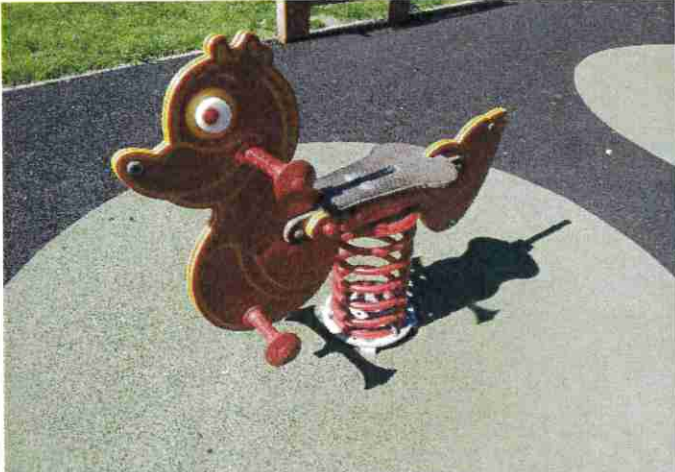
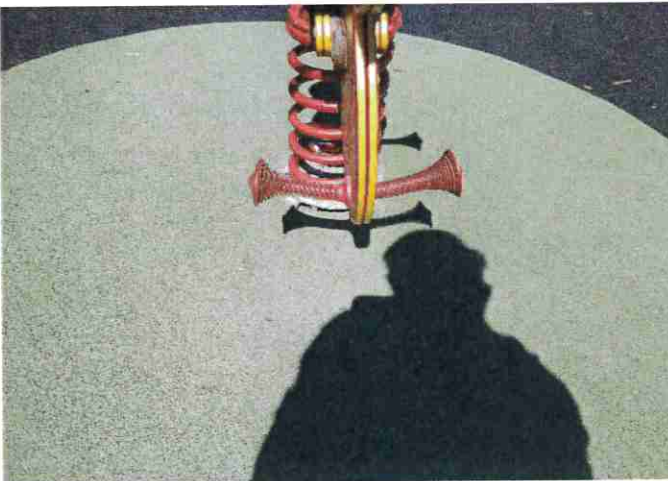
| <b>Item:</b> | Rocking Equipment - Spring Duck | <b>Risk Level:</b> | L - Low Risk |

**Finding:** The Handgrips/Footrests rotate and may cause an unexpected movement for the user

**Action:** Secure Handgrips/Footrests to prevent rotation.

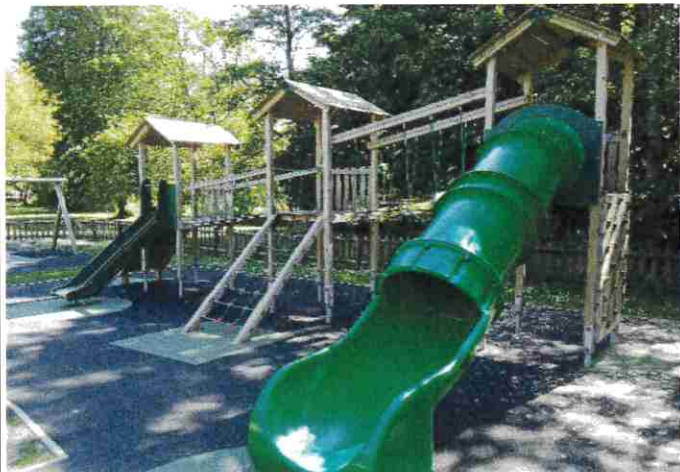
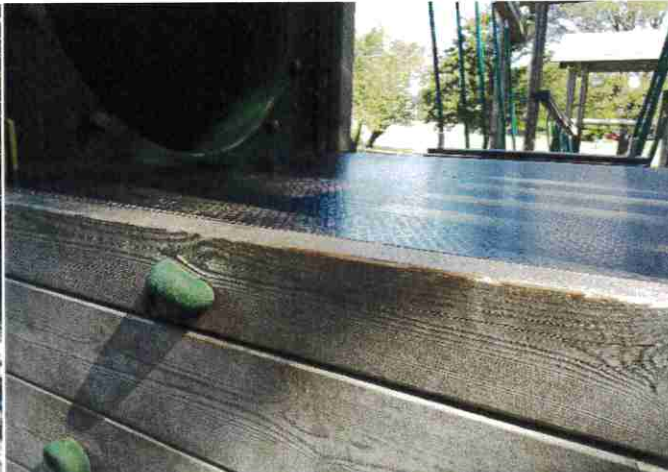
| <b>Item:</b> | Activity Equipment - Multi Play (Senior) | <b>Risk Level:</b> | L - Low Risk |

**Finding:** Parts of the timber are rough or splintered

**Action:** Remove all rough or sharp edges

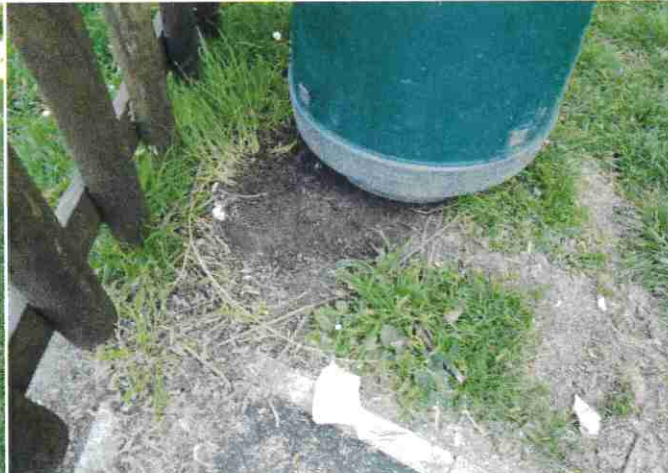
| <b>Item:</b> | Ancillary Items - Litter Bin | <b>Risk Level:</b> | L - Low Risk |

**Finding:** The liner of the litter bin is not secured

**Action:** Recommend ground fixing

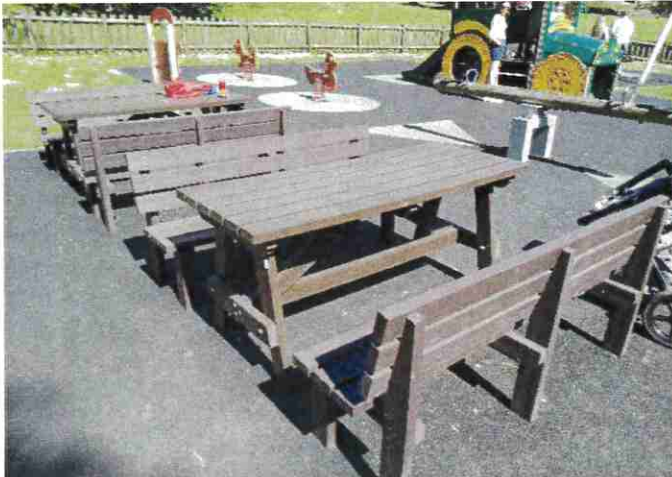
**Item:** Ancillary Items - Seating Area  
**Manufacturer:** Unknown

**Finding:** There is some evidence of fire damage to the item  
**Action:** Monitor for any further deterioration and repair as required

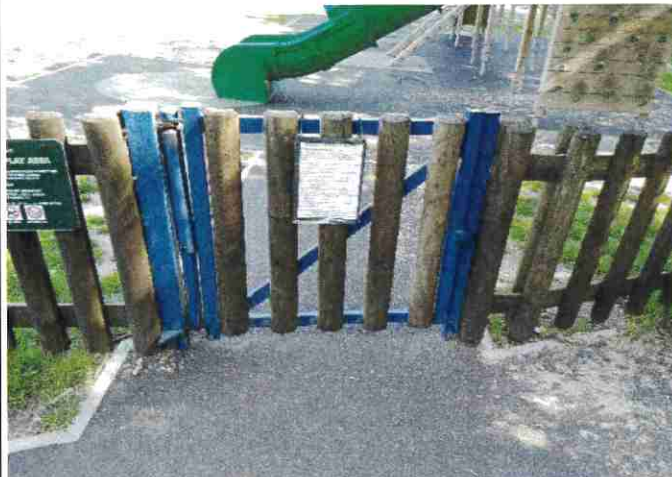
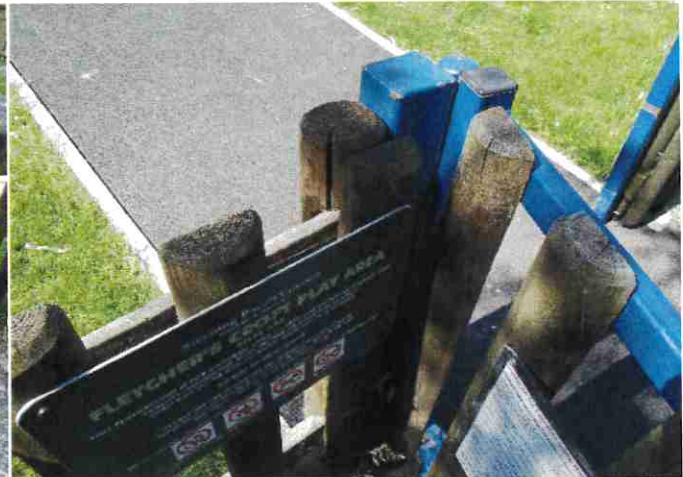
**Item:** Gates - Gate - Self Closing  
**Manufacturer:** Wicksteed Playgrounds

**Finding:** There are openings that are less than 12mm that could trap or crush fingers  
**Action:** Where possible a 12mm gap should be maintained on both sides or between the gate leaves

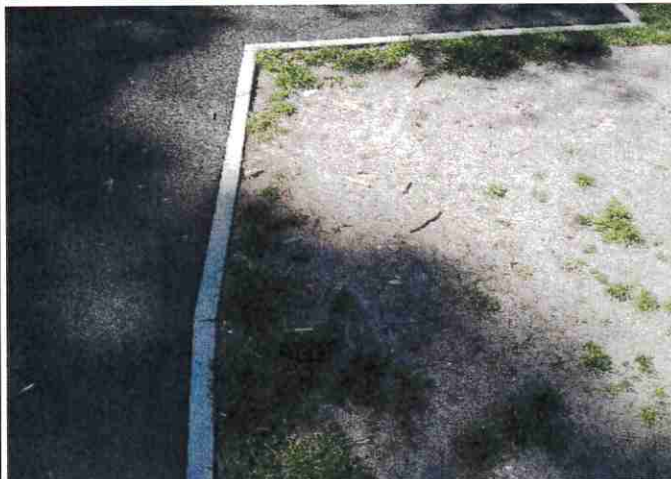
**Item:** Surface - Grass  
**Manufacturer:** Unknown

**Finding:** There are trip hazards at the edges of the surface

**Action:** Reinstate surrounding surface levels to remove the trip points

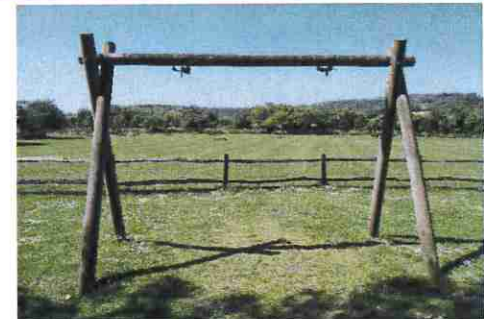
**Item:** Swing Frame  
**Manufacturer:** Unknown  
**Surface Type:** Grass Matrix Tiles  
**Item Quantity:** 1  
**Equipment Compliance:** N/A  
**Surface Area Compliance:** N/A

A number of fixing(s) have worked loose - Secure all loose fixings

The item of equipment is missing its chain/seat removed from site and the inspector was unable to assess the condition of it - Consider replacement of missing item or upgrading unit

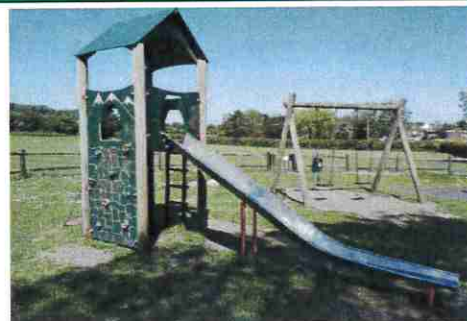
**Item:** Slide Unit  
**Manufacturer:** Unknown  
**Surface Type:** Grass Matrix Tiles  
**Item Quantity:** 1  
**Equipment Compliance:** N/A  
**Surface Area Compliance:** N/A

The ropes/nets are worn/damaged in places - Monitor for any further deterioration and repair or replace as required

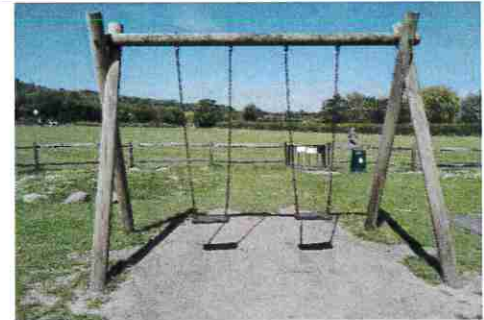
**Item:** 1 Bay 2 Seat (Flat)  
**Manufacturer:** Unknown  
**Surface Type:** Grass Matrix Tiles  
**Item Quantity:** 1  
**Equipment Compliance:** N/A  
**Surface Area Compliance:** N/A

A number of chain support top bar fixing(s) have worked loose - Secure all loose fixings

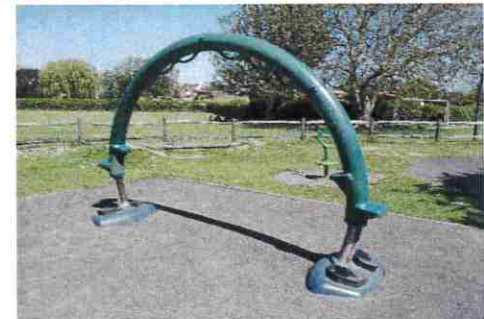
**Item:** Rock n Cross  
**Manufacturer:** Big Toys  
**Surface Type:** Wet Pour  
**Item Quantity:** 1  
**Equipment Compliance:** N/A  
**Surface Area Compliance:** N/A

There are significant gaps (over 30mm) between the surface and the edging or between the joints in the surface; these are large enough for a small foot to enter - Repair surfacing or upgrade

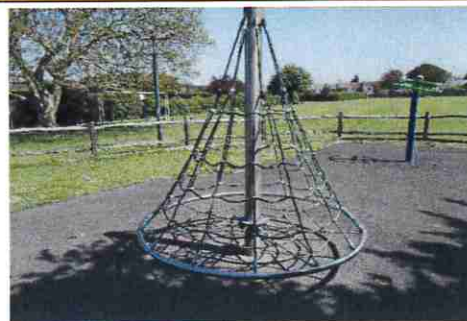
**Item:** Rotating Net  
**Manufacturer:** Wicksteed Playgrounds  
**Surface Type:** Wet Pour  
**Item Quantity:** 1  
**Equipment Compliance:** N/A  
**Surface Area Compliance:** N/A

The surfacing is severely damaged - Repair damaged areas of surfacing or upgrade

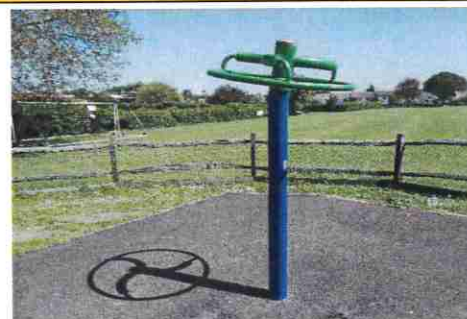
**Item:** Overhead Rotator  
**Manufacturer:** Wicksteed Playgrounds  
**Surface Type:** Wet Pour  
**Item Quantity:** 1  
**Equipment Compliance:** N/A  
**Surface Area Compliance:** N/A

The surfacing is severely damaged - Repair damaged areas of surfacing or upgrade

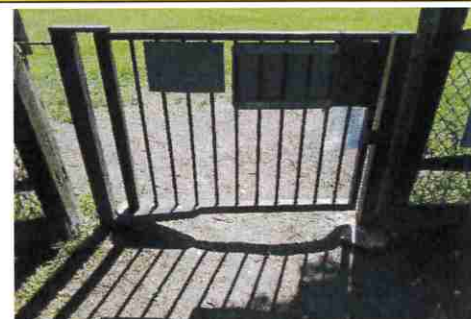
**Item:** Gate - Self Closing  
**Manufacturer:** Wicksteed Playgrounds  
**Surface Type:** Soil  
**Item Quantity:** 1  
**Equipment Compliance:** N/A  
**Surface Area Compliance:** N/A

The surface has subsided at both gates in some areas - Repair as required

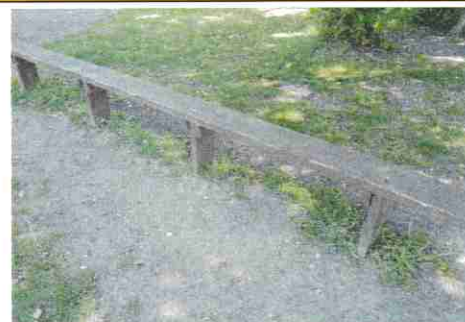
Item: Bench  
Manufacturer: Unknown  
Surface Type: Grass  
Item Quantity: 1  
Equipment Compliance: N/A  
Surface Area Compliance: N/A

There are areas or parts of the timber on the structure that have rotted - Replace all affected timbers

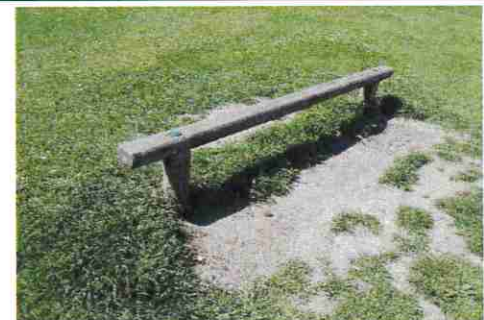
**Item:** Balance Beam  
**Manufacturer:** Wicksteed Playgrounds  
**Surface Type:** Grass  
**Item Quantity:** 1  
**Equipment Compliance:** N/A  
**Surface Area Compliance:** N/A

The surface has eroded in some areas - Reinstate the surface

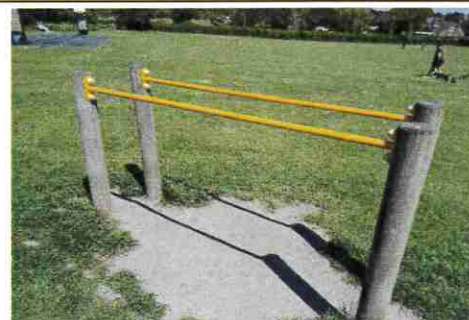
**Item:** Parallel Bars  
**Manufacturer:** Fawns Recreational Services Ltd  
**Surface Type:** Grass  
**Item Quantity:** 1  
**Equipment Compliance:** N/A  
**Surface Area Compliance:** N/A

A number of fixing(s) have worked loose - Secure all loose fixings

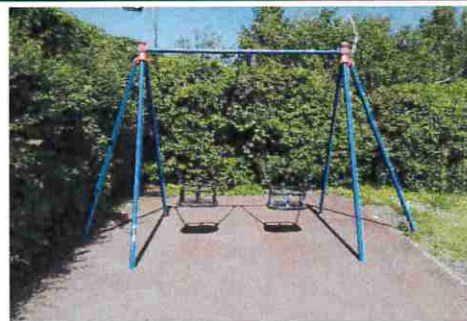
**Item:** 1 Bay 2 Seat (Cradle)  
**Manufacturer:** Wicksteed Playgrounds  
**Surface Type:** Wet Pour  
**Item Quantity:** 1  
**Equipment Compliance:** N/A  
**Surface Area Compliance:** N/A

The seats are too close to the frame as defined in BS EN 1176 Part 2; this is a low risk failure and no remedial action is required - Monitor - No remedial work recommended

The surfacing around the item is damaged - Repair the damaged areas of surfacing or upgrade

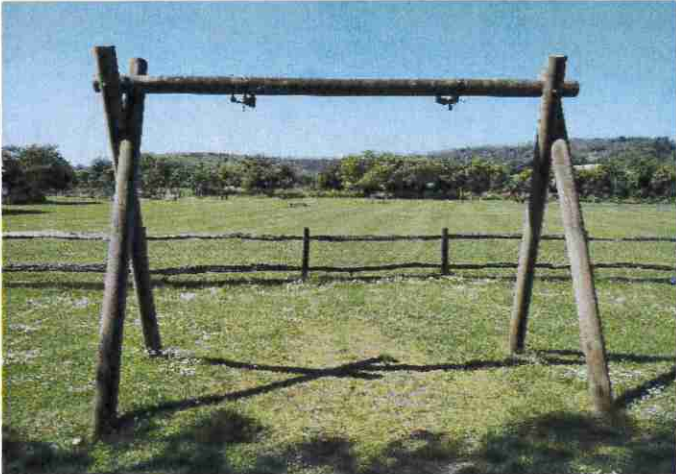
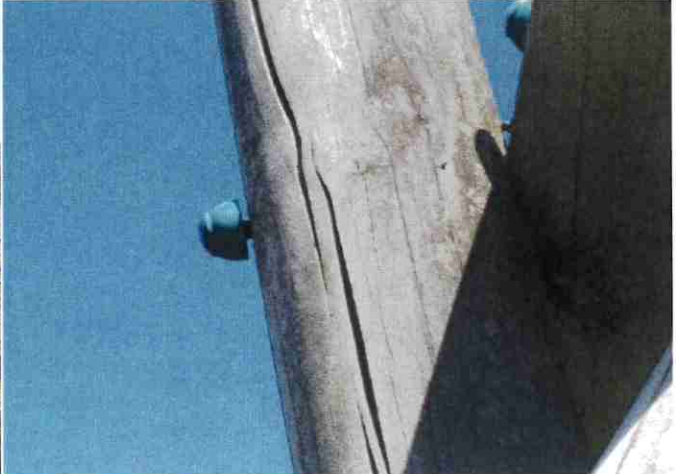
| 15 - Moderate Risk (Finding 1) | | | |
|---|---|---|---|
| <b>Item:</b> | Swings - Swing Frame | <b>Risk Level:</b> | M - Moderate Risk |
| <b>Finding:</b> A number of fixing(s) have worked loose | | <b>Action:</b> Secure all loose fixings | |

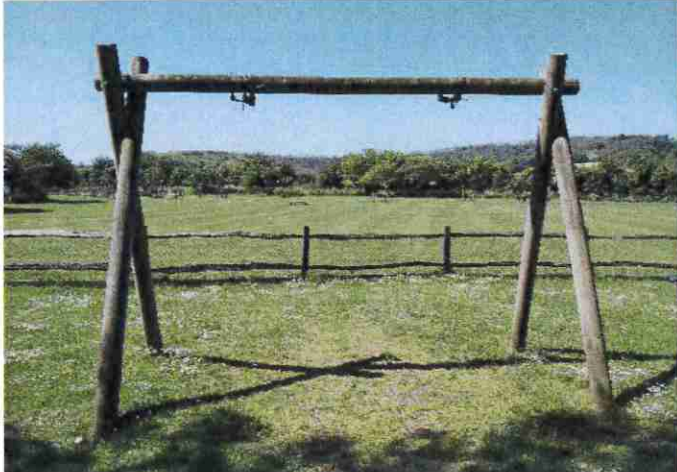
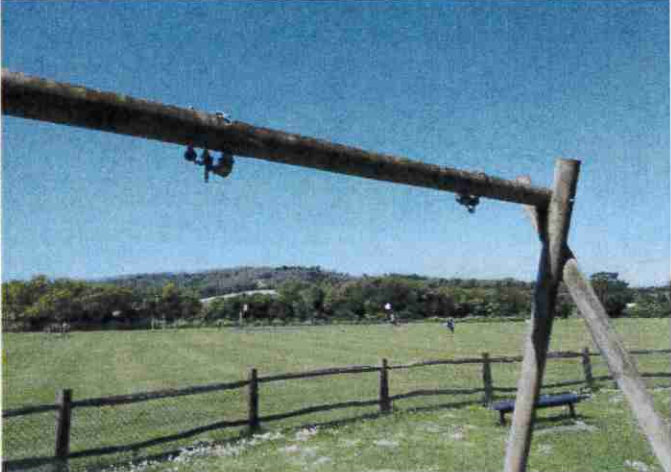
| 0 - Risk Assessment not Undertaken (Finding 2) | | | |
|---|---|---|---|
| <b>Item:</b> | Swings - Swing Frame | <b>Risk Level:</b> | N - Risk Assessment not Undertaken |
| <b>Finding:</b> The item of equipment is missing its chain/seat removed from site and the inspector was unable to assess the condition of it | | <b>Action:</b> Consider replacement of missing item or upgrading unit | |

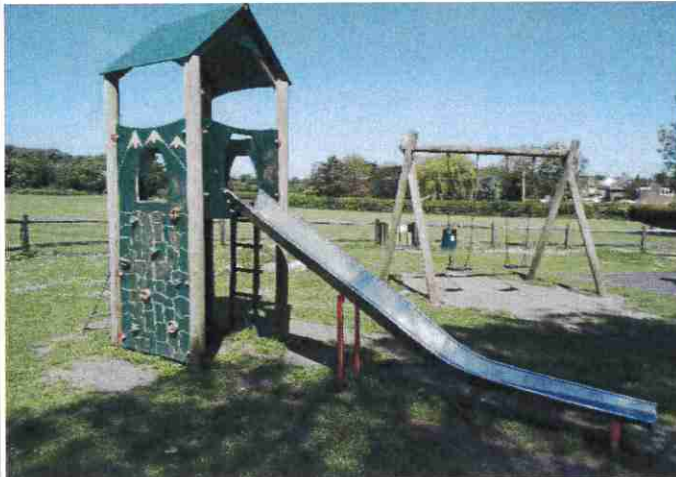
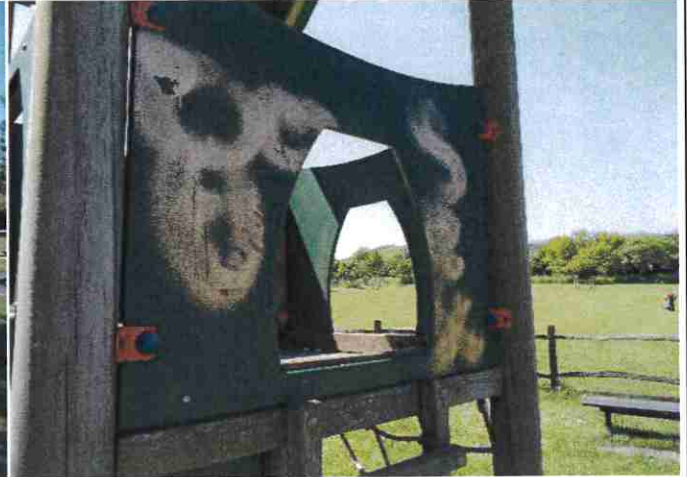
**Item:** Other - Slide Unit  
**Manufacturer:** Unknown

**Finding:** There is some graffiti present

**Action:** Remove the graffiti

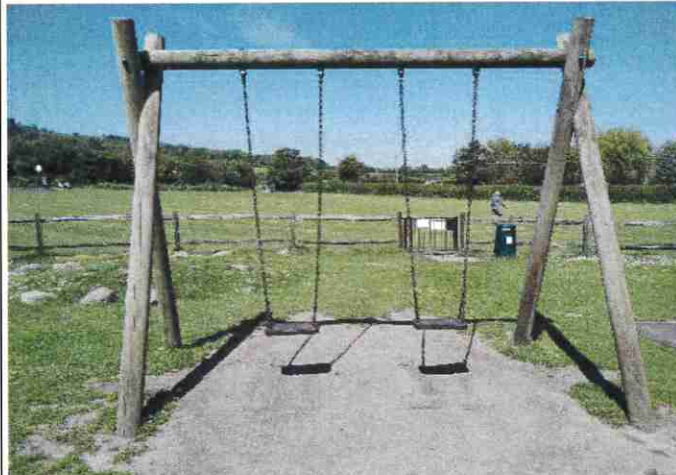
**Item:** Swings - 1 Bay 2 Seat (Flat)  
**Manufacturer:** Unknown

**Finding:** A number of chain support top bar fixing(s) have worked loose

**Action:** Secure all loose fixings

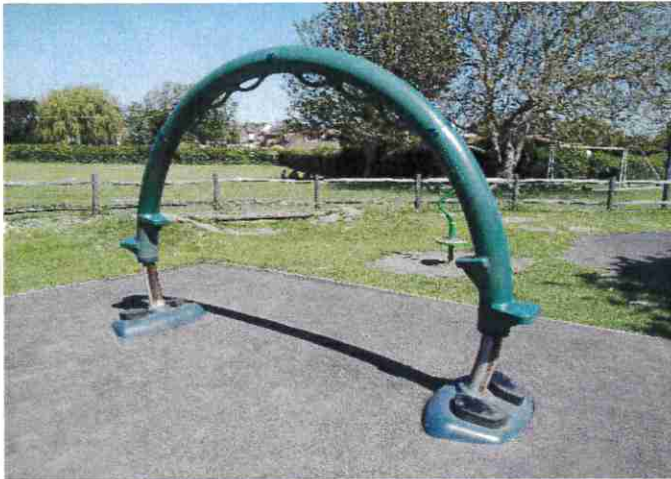
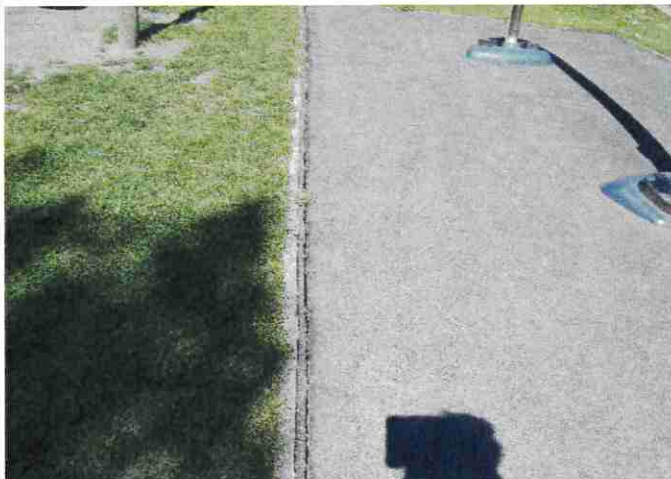
**Item:** Rocking Equipment - Rock n Cross  
**Manufacturer:** Big Toys

**Finding:** There are significant gaps (over 30mm) between the surface and the edging or between the joints in the surface; these are large enough for a small foot to enter

**Action:** Repair surfacing or upgrade
