## Annual Inspection

Steyping Parish Council

Abbey Road Play Area

Inspection Ref: 1389657  
Property Ref: 1254964-413932

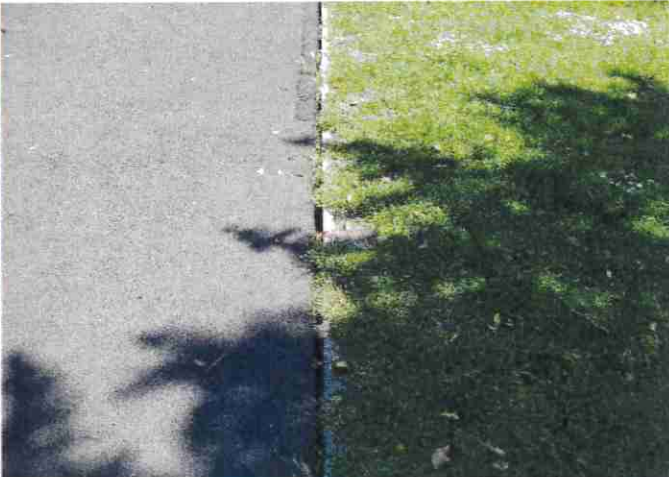
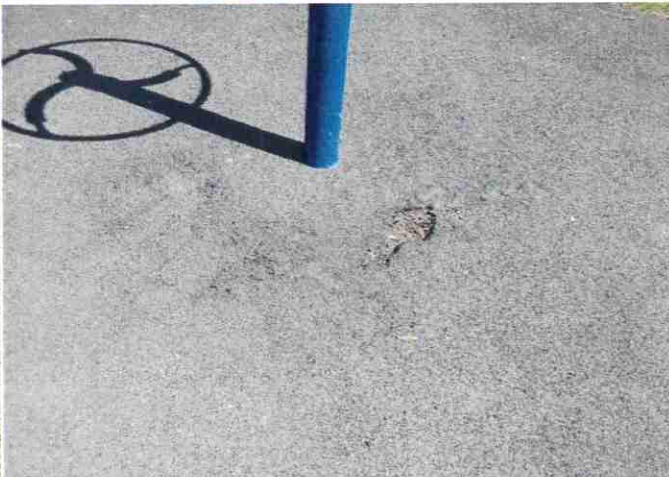
| 12 - Moderate Risk (Finding 1) | | | |
|---|---|---|---|
| <b>Item:</b> | Rotor Play - Overhead Rotator | <b>Risk Level:</b> | M - Moderate Risk |
| <b>Finding:</b> The surfacing is severely damaged | | <b>Action:</b> Repair damaged areas of surfacing or upgrade | |

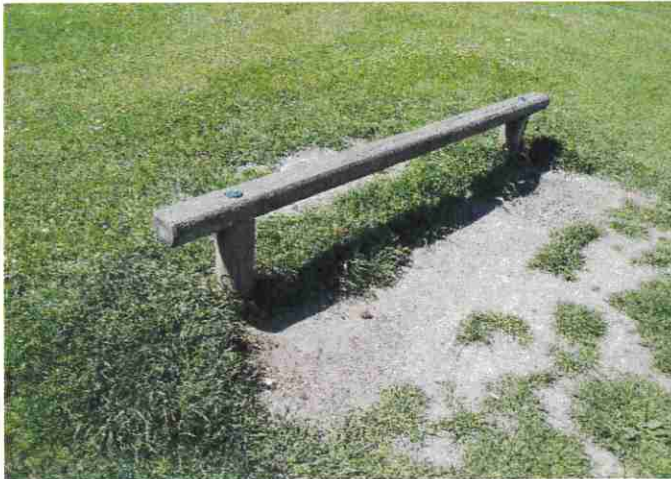
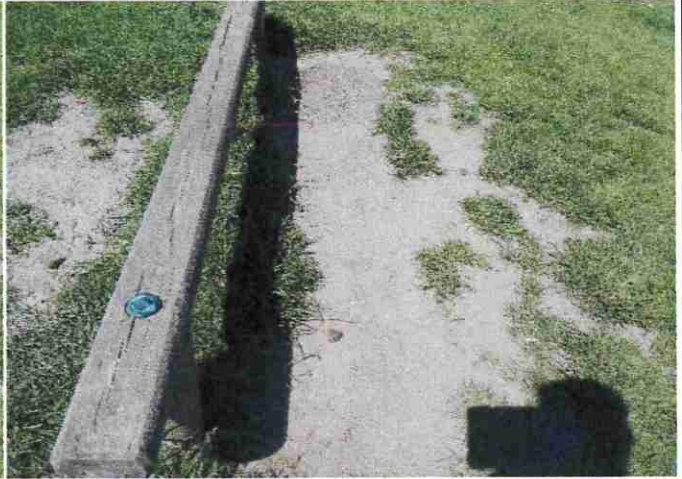
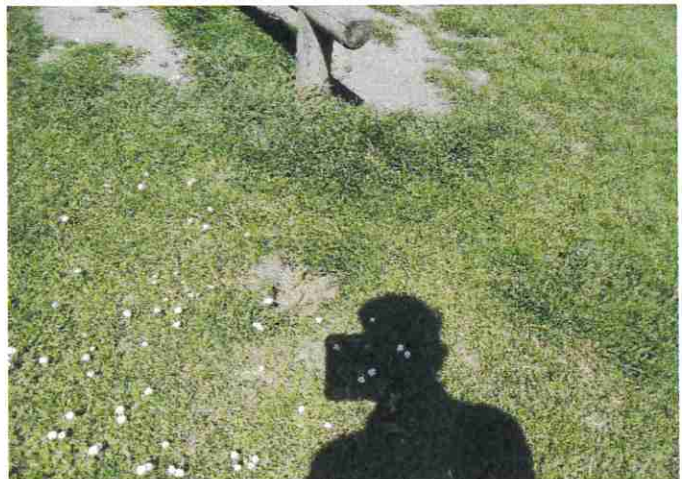
**Item:** Activity Equipment - Balance Beam  
**Manufacturer:** Wicksteed Playgrounds

**Finding:** The surface has eroded in some areas

**Action:** Reinstate the surface

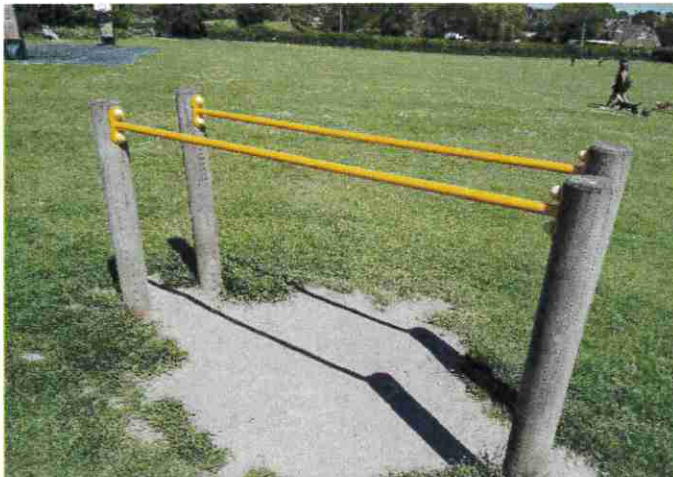
**Item:** Activity Equipment - Parallel Bars  
**Manufacturer:** Fawns Recreational Services Ltd

**Finding:** A number of fixing(s) have worked loose

**Action:** Secure all loose fixings

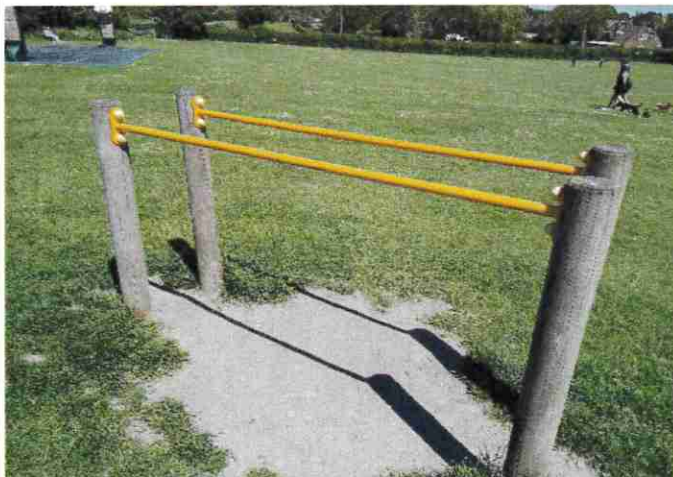
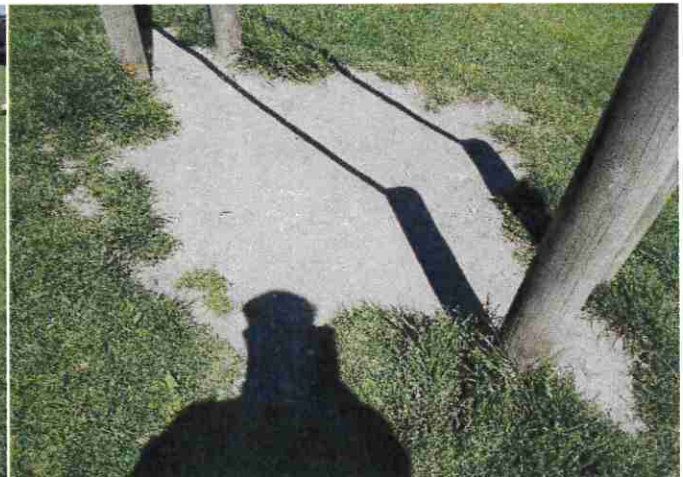
**Item:** Activity Equipment - Parallel Bars  
**Manufacturer:** Fawns Recreational Services Ltd

**Risk Level:** M - Moderate Risk  
**Surface:** Grass

**Finding:** The surface has eroded in some areas

**Action:** Reinstate the surface or upgrade

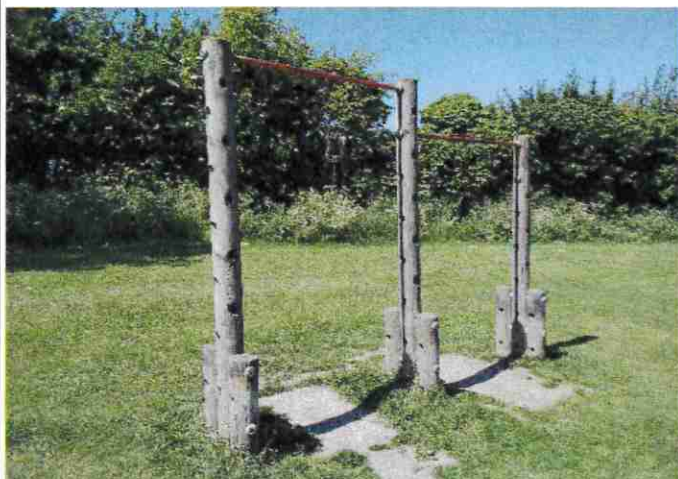
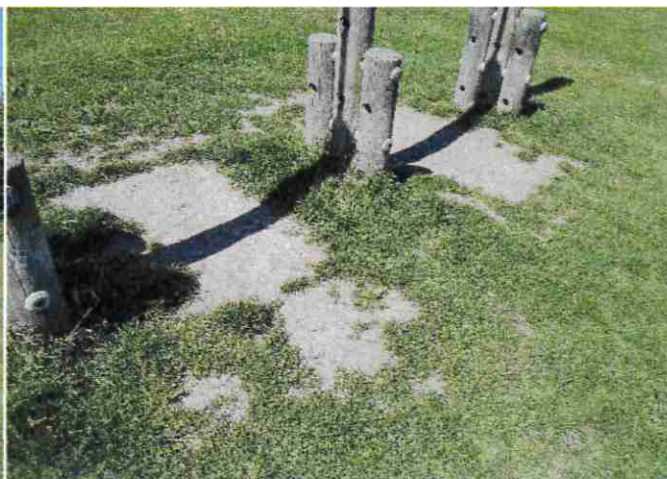
**Item:** Activity Equipment - Somersault Bars  
**Manufacturer:** Wicksteed Playgrounds

**Risk Level:** L - Low Risk  
**Surface:** Grass

**Finding:** The surface has eroded in some areas

**Action:** Reinstate the surface

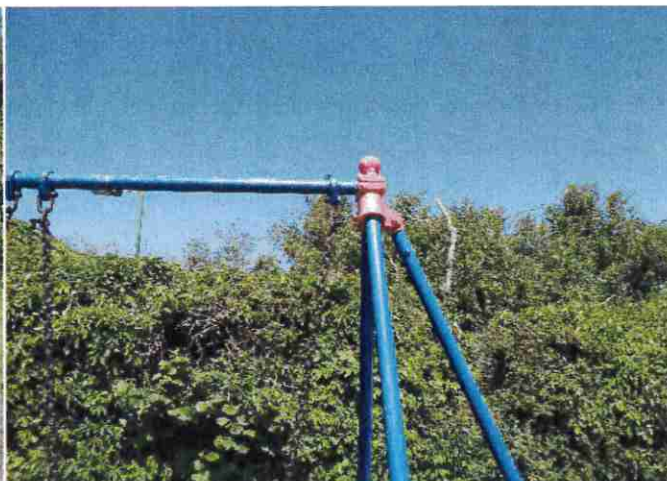
**Item:** Swings - 1 Bay 2 Seat (Cradle)  
**Manufacturer:** Wicksteed Playgrounds

**Risk Level:** V - Very Low Risk  
**Surface:** Wet Pour

**Finding:** The seats are too close to the frame as defined in BS EN 1176 Part 2; this is a low risk failure and no remedial action is required

**Action:** Monitor - No remedial work recommended

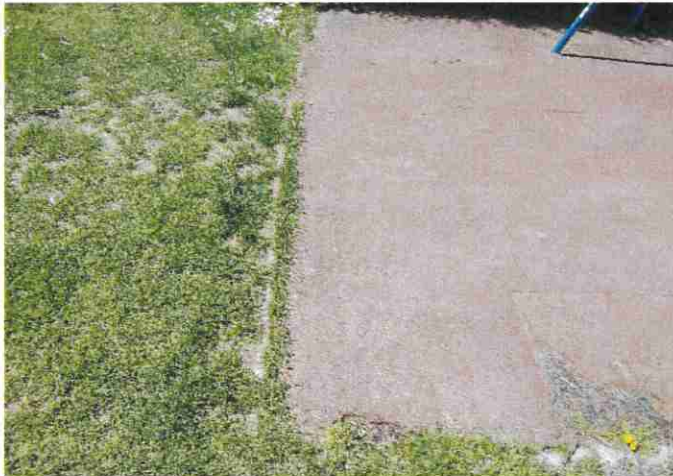
**Item:** Swings - 1 Bay 2 Seat (Cradle)  
**Manufacturer:** Wicksteed Playgrounds

**Risk Level:** L - Low Risk  
**Surface:** Wet Pour

**Finding:** The surfacing around the item is damaged

**Action:** Repair the damaged areas of surfacing or upgrade

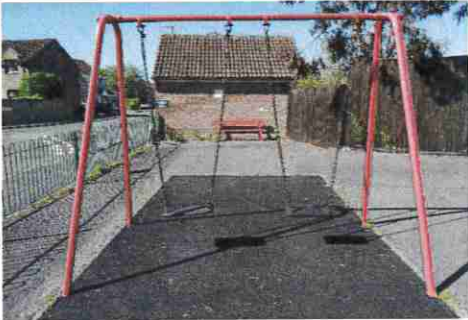
There is some notable evidence of chain wear - Monitor for any further deterioration and replace when 40% worn

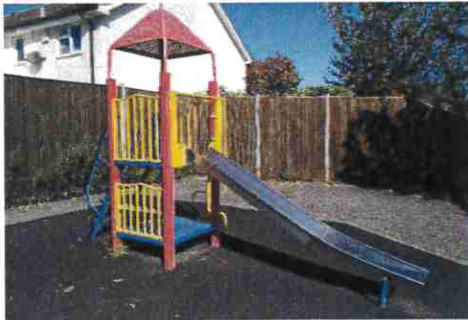
The unit is easily accessible and has an opening in the barrier to steep play elements in excess of 500mm in contravention of BS EN 1176 Part 1 - Monitor - No remedial work recommended

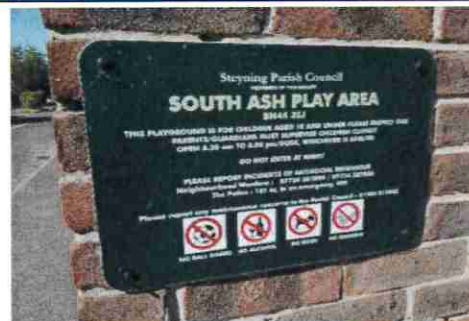
**Item:** Playground Sign  
**Manufacturer:** Unknown  
**Surface Type:** N/A  
**Item Quantity:** 1  
**Equipment Compliance:** N/A  
**Surface Area Compliance:** N/A

This item is satisfactory - no work required -

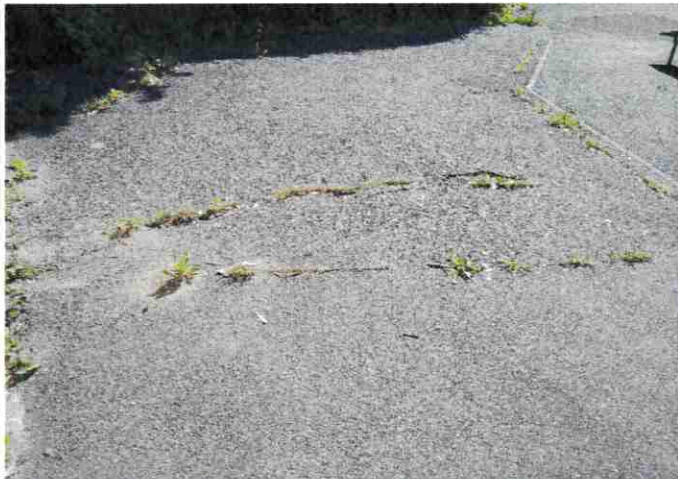
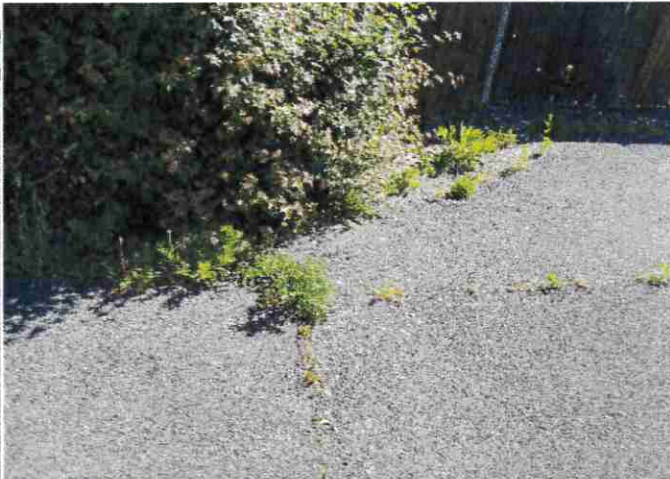
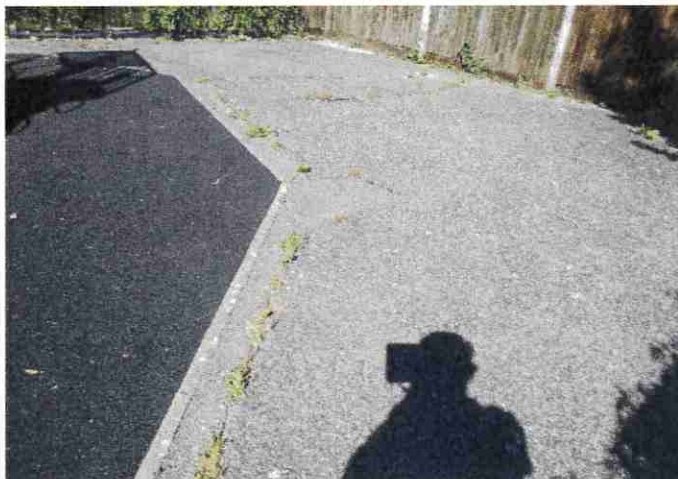
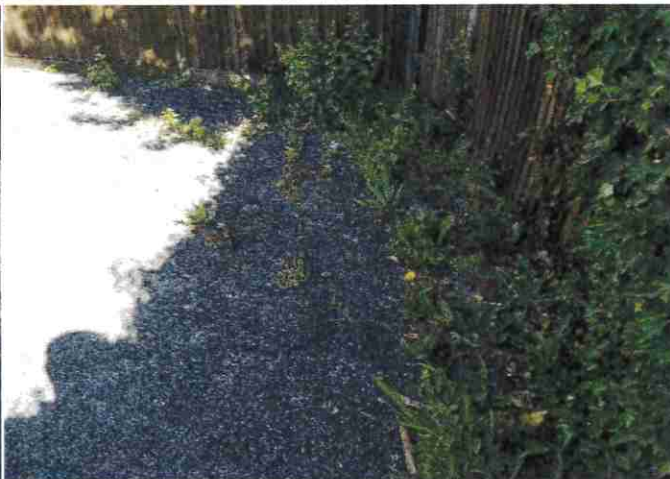
| 6 - Low Risk (Finding 1) | | | |
|---|---|---|---|
| <b>Item:</b> | Surface - Tarmac | <b>Risk Level:</b> | L - Low Risk |

| 6 - Low Risk (Finding 1) | | | |
|---|---|---|---|
| <b>Finding:</b> There are weeds/vegetation growth between or around the edges of the surfacing | | <b>Action:</b> Remove weeds/vegetation growth | |
