## COMMUNITY COMMITTEE MEETING HELD ON TUESDAY 4<sup>th</sup> FEBRUARY 2025 AT 7.30 PM AT THE STEYPING CENTRE

# DRAFT MINUTES

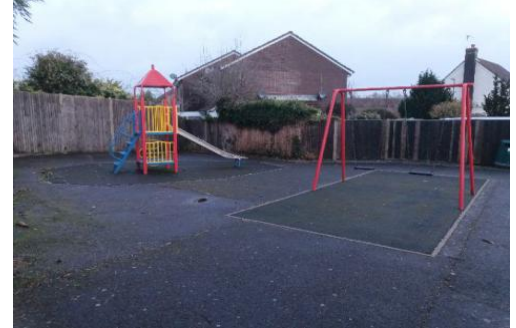
There is some minor damage to the surface due to tree roots - Monitor for any further deterioration and repair as required

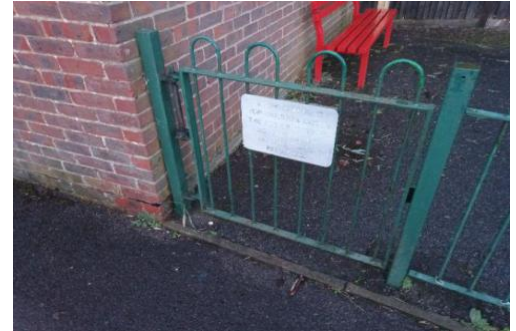
The gate is closing too quickly (less than 4 seconds) - Take corrective action to ensure that the gate closes in 4-8 seconds from 90 degrees

The gate rebounds when opened quickly and could strike the next user entering the area - Monitor use and adjust/replace as required

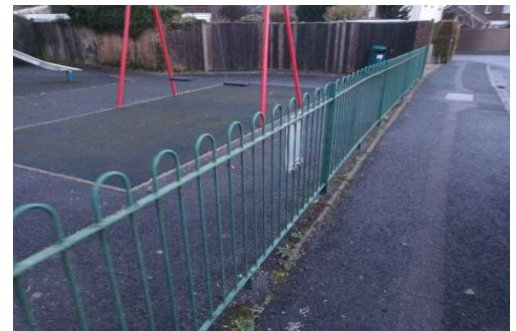
There is some damage to the fence sections - Monitor for any further deterioration and repair as required

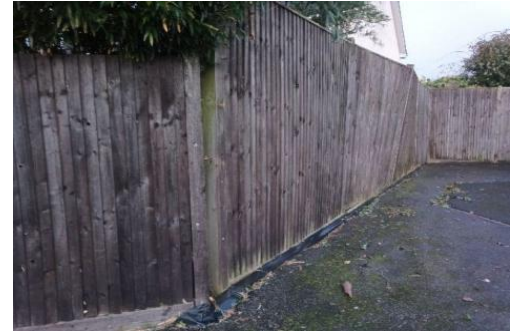
One of the tall posts is leaning and there is evidence of rot at the base - Replace affected post

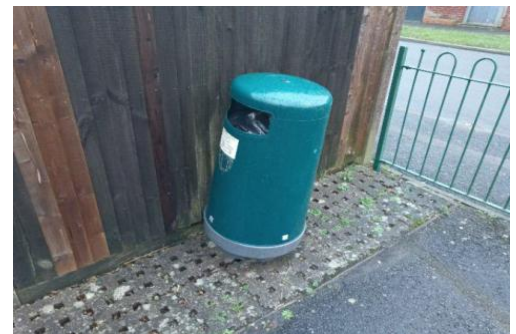
The item is slightly loose in its foundations - Monitor for any further deterioration and repair as required

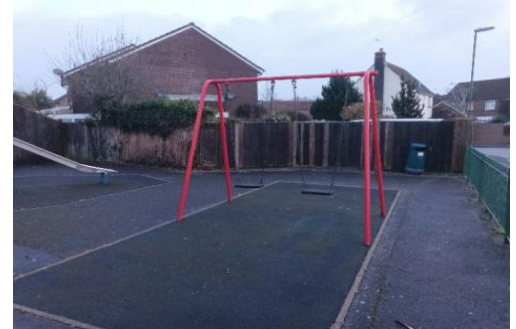
There are gaps opening between the surfacing and the edging surround or between the joints in the surfacing - Monitor for any further deterioration and repair as required

There is some wear to the shackles. - Monitor for any further deterioration and replace when 40% worn

The bush / bushes is / are worn or missing and the fixing lugs are wearing - Replace worn or missing bushes

The chain openings are in excess of the 8.6mm as recommended by BS EN 1176 - Monitor - No action given the risk assessment

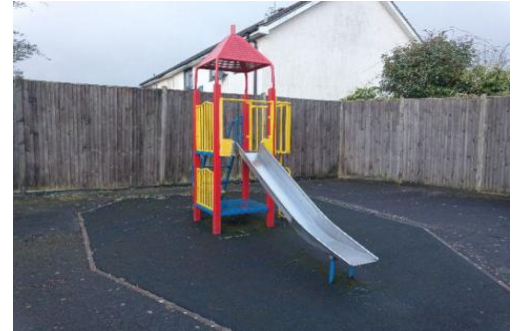
The opening providing access to the slide exceeds the width of the slide in contravention of BS EN 1176 Part 3 - Monitor - No action given the risk assessment

The surface is lifting at the edges and creating trip points - Repair perimeter of surfacing to remove trip points

There are gaps opening between the surfacing and the edging surround or between the joints in the surfacing - Monitor for any further deterioration and repair as required

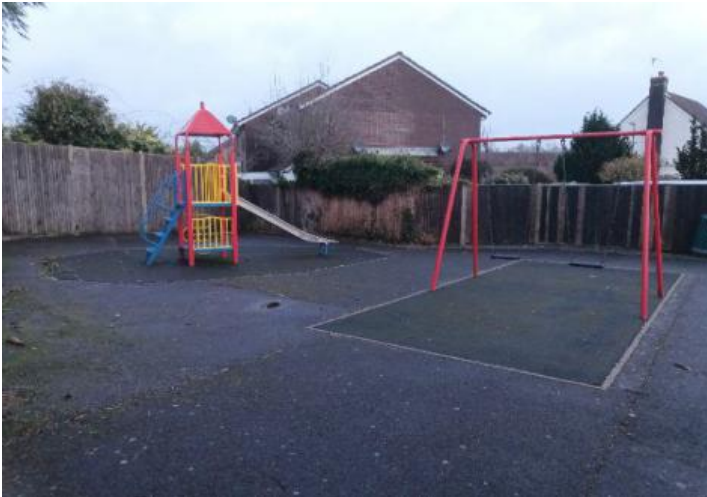
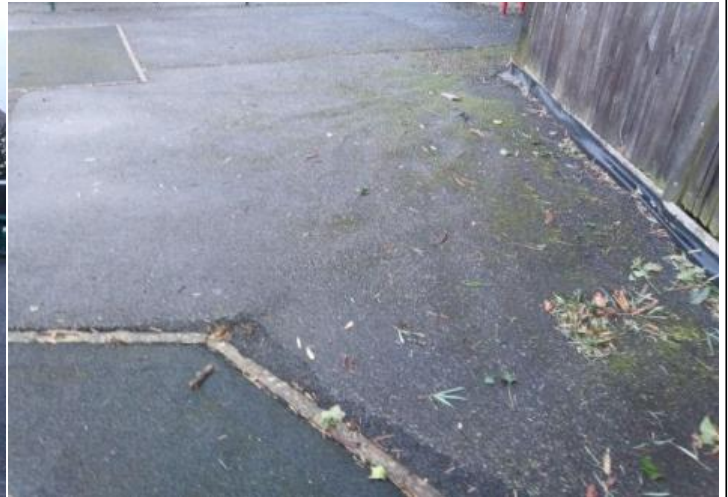
**Finding:** There is some minor damage to the surface due to tree roots  
**Action:** Monitor for any further deterioration and repair as required

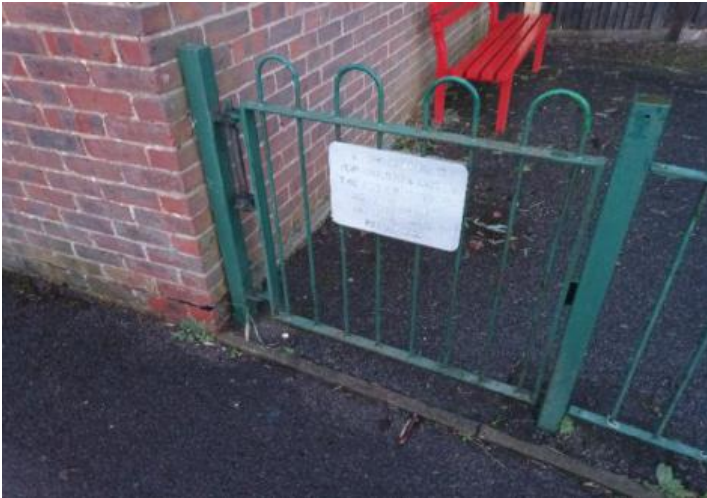
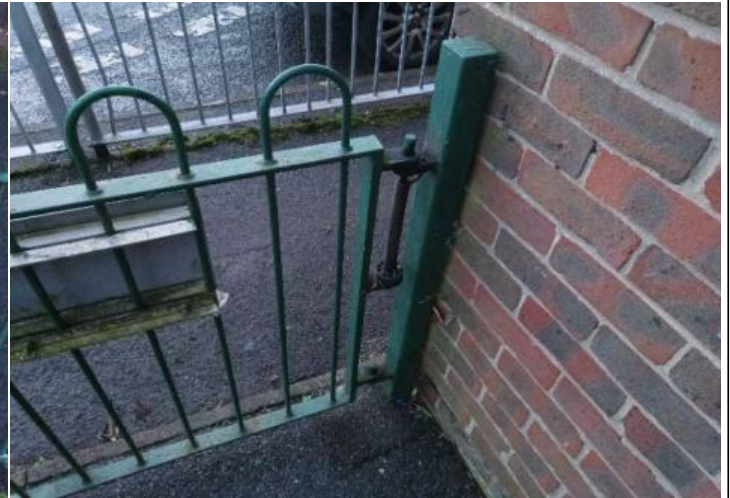
**Finding:** The gate is closing too quickly (less than 4 seconds)

**Action:** Take corrective action to ensure that the gate closes in 4-8 seconds from 90 degrees

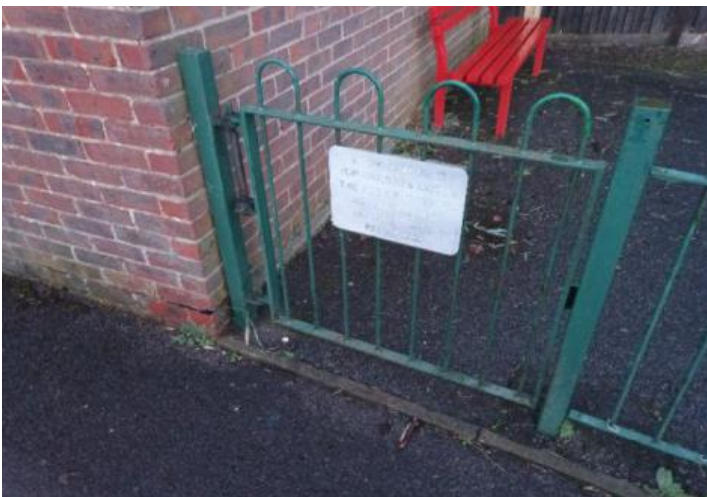
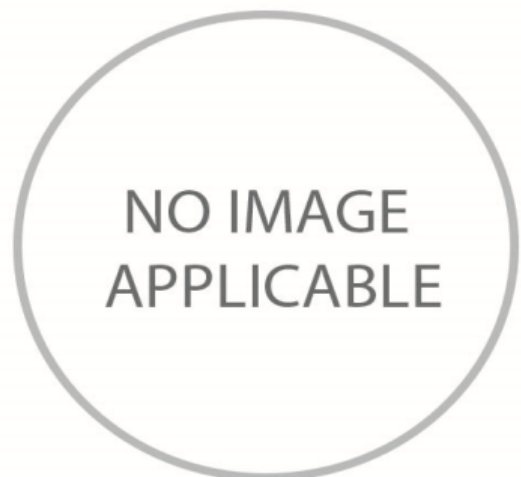
**Finding:** The gate rebounds when opened quickly and could strike the next user entering the area

**Action:** Monitor use and adjust/replace as required

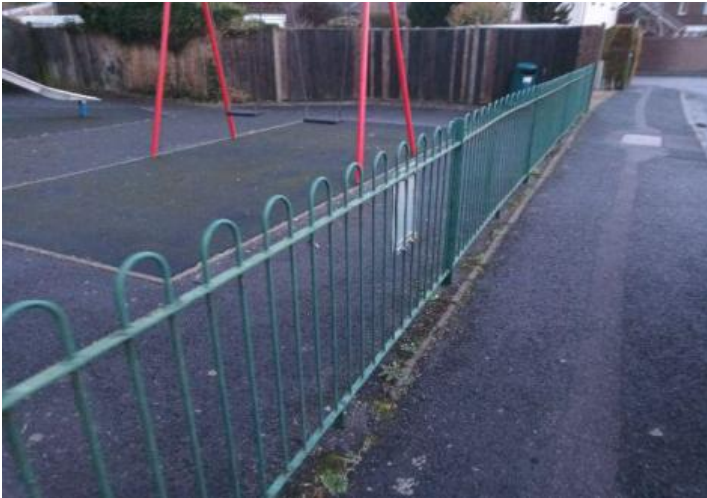
**Finding:** There is some damage to the fence sections

**Action:** Monitor for any further deterioration and repair as required

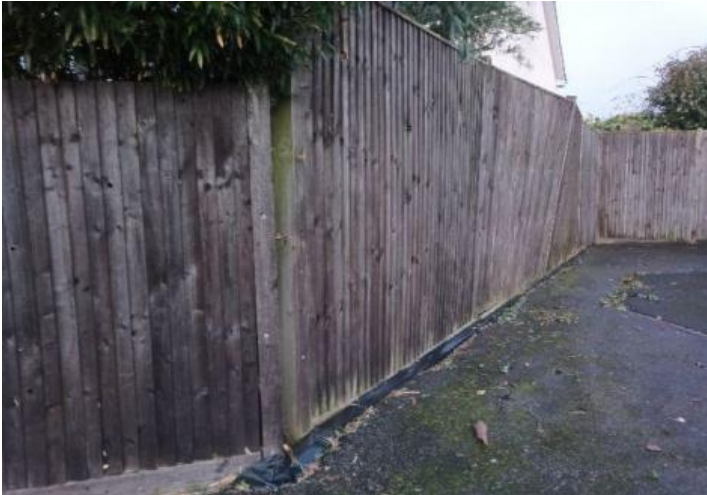
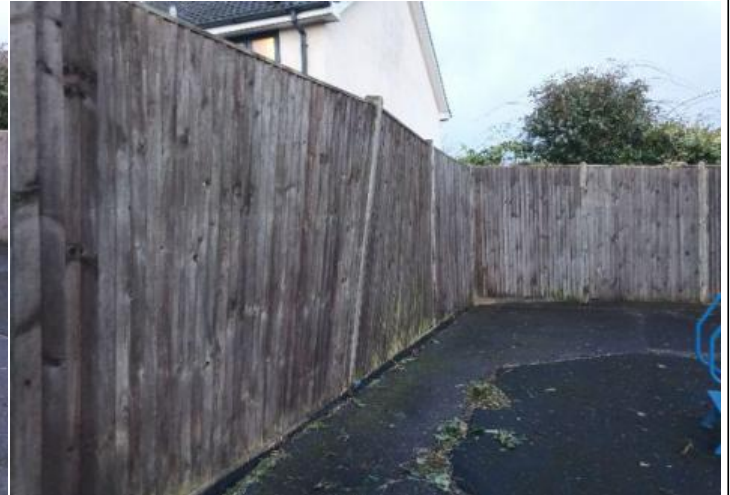
**Finding:** One of the tall posts is leaning and there is evidence of rot at the base

**Action:** Replace affected post

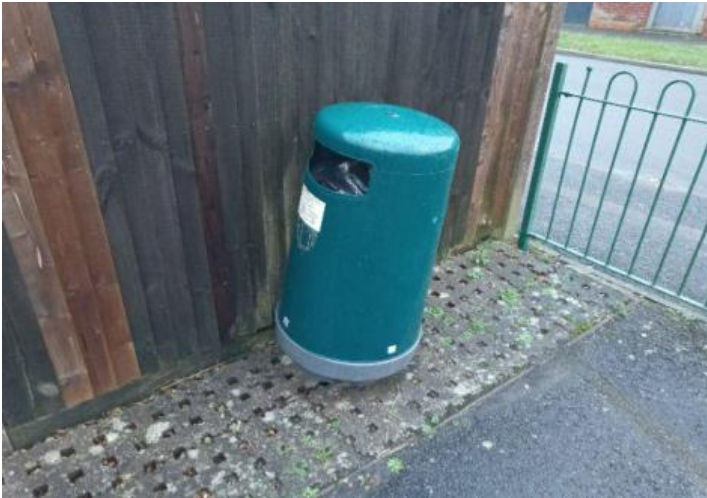
**Finding:** The item is slightly loose in its foundations

**Action:** Monitor for any further deterioration and repair as required

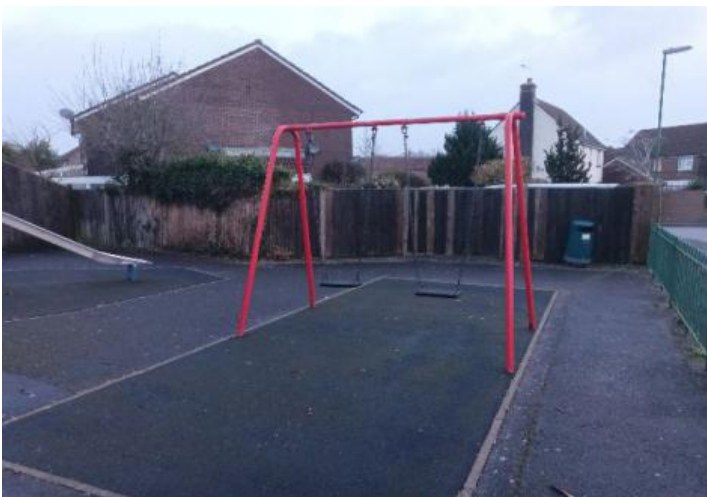
**Finding:** There are gaps opening between the surfacing and the edging surround or between the joints in the surfacing

**Action:** Monitor for any further deterioration and repair as required

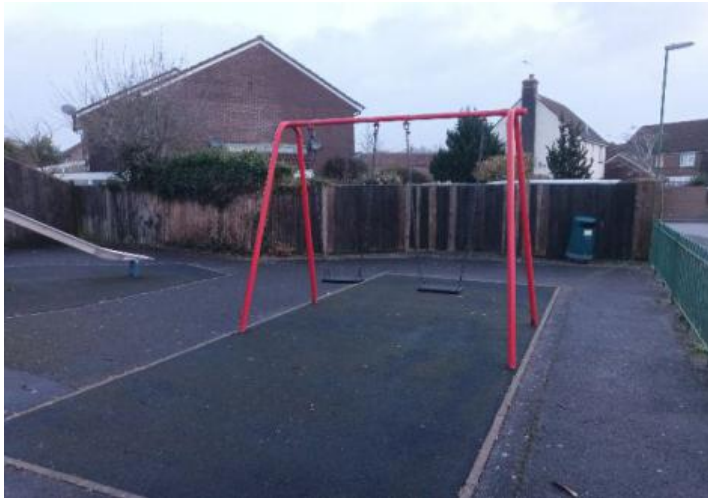
**Finding:** The bush / bushes is / are worn or missing and the fixing lugs are wearing  
**Action:** Replace worn or missing bushes

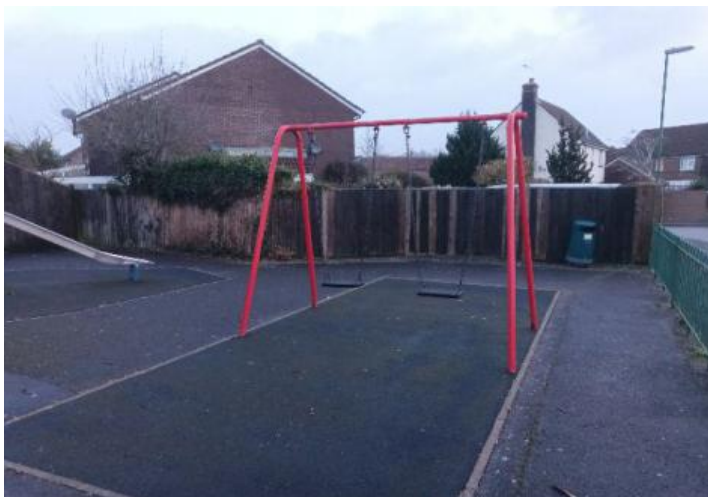
**Finding:** There is some wear to the shackles.

**Action:** Monitor for any further deterioration and replace when 40% worn

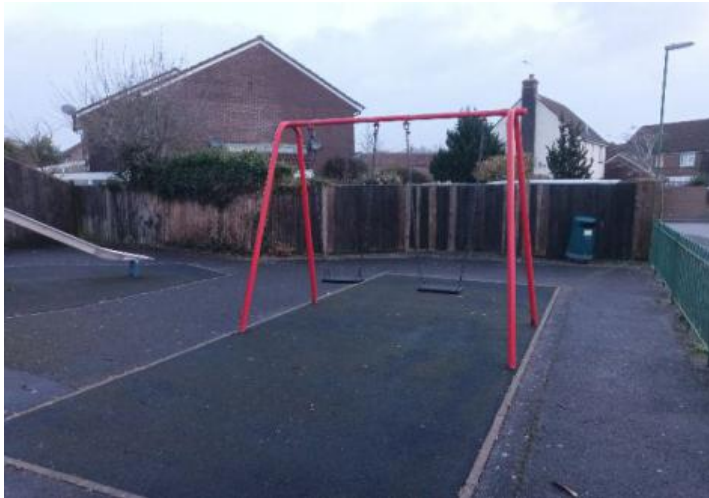
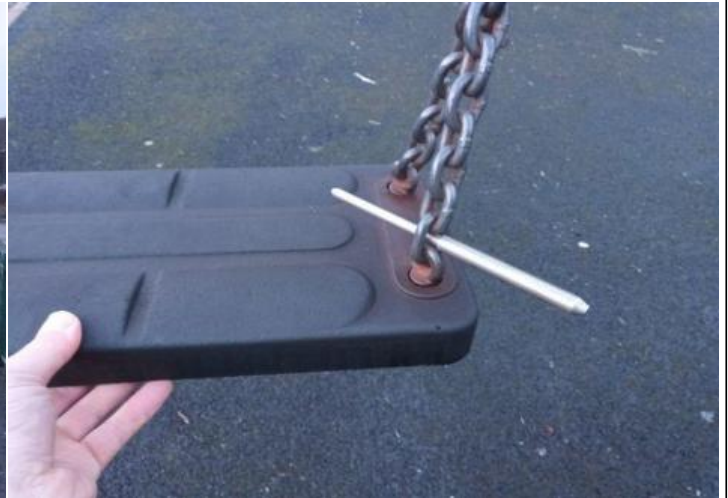
**Finding:** The chain openings are in excess of the 8.6mm as recommended by BS EN 1176  
**Action:** Monitor - No action given the risk assessment

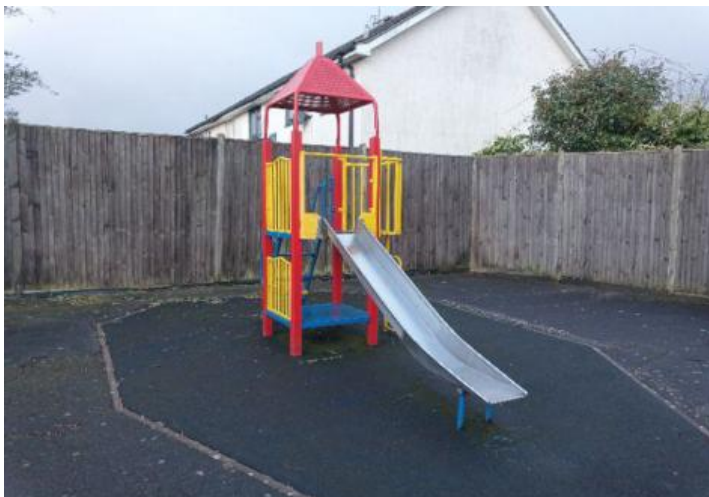
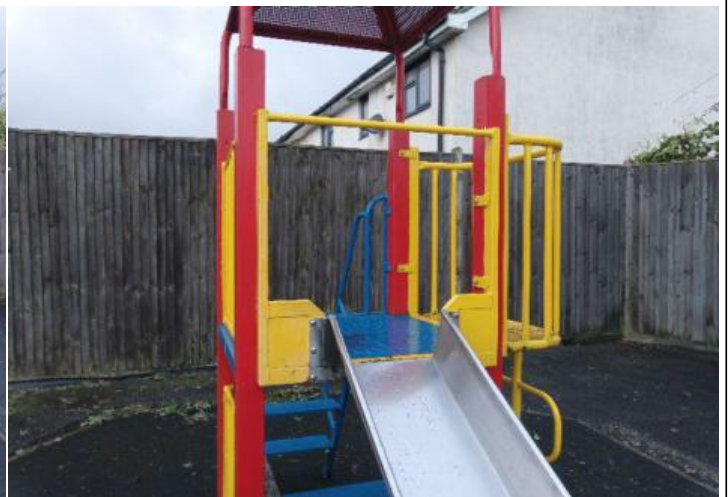
**Finding:** The opening providing access to the slide exceeds the width of the slide in contravention of BS EN 1176 Part 3  
**Action:** Monitor - No action given the risk assessment

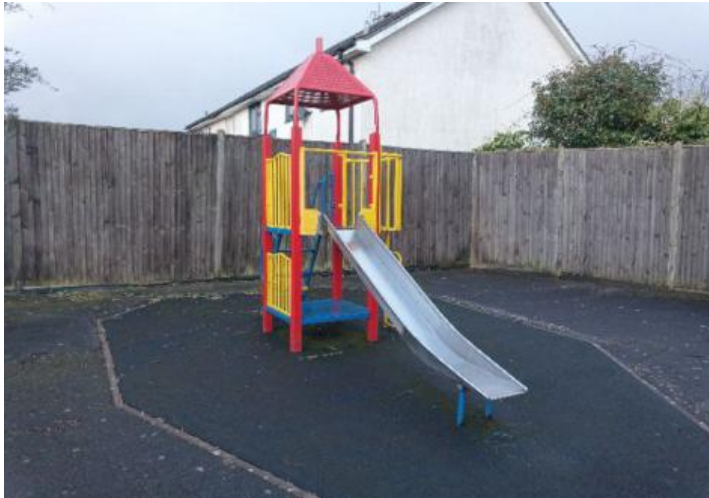
**Finding:** There are gaps opening between the surfacing and the edging surround or between the joints in the surfacing  
**Action:** Monitor for any further deterioration and repair as required

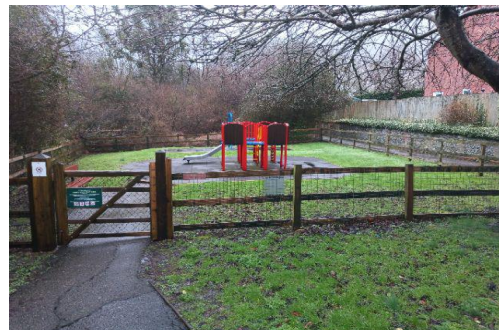
There is some minor damage to the surface - Monitor for any further deterioration and repair as required

There are trip hazards at the edges of the surface - Remove trip hazard

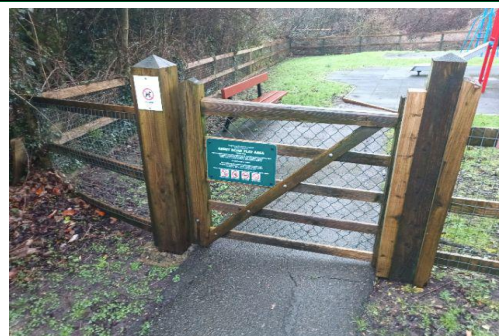
The gate is closing too quickly (less than 4 seconds) - Take corrective action to ensure that the gate closes in 4-8 seconds from 90 degrees

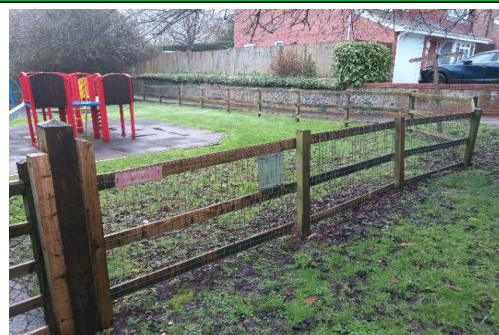
There are projecting bolt thread(s) present - Remove excess thread length and deburr or provide cap

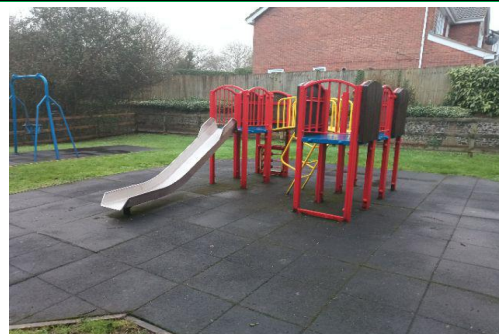
There are gaps opening between the surfacing and the edging surround or between the joints in the surfacing - Monitor for any further deterioration and repair as required

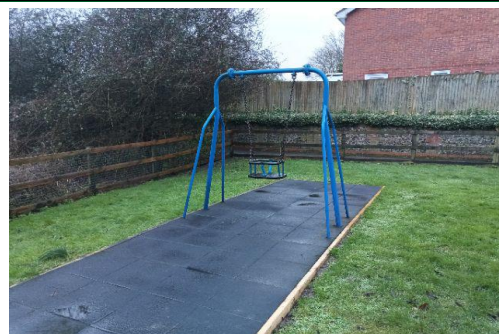
There are trip hazards at the edges of the surface - Remove trip hazard

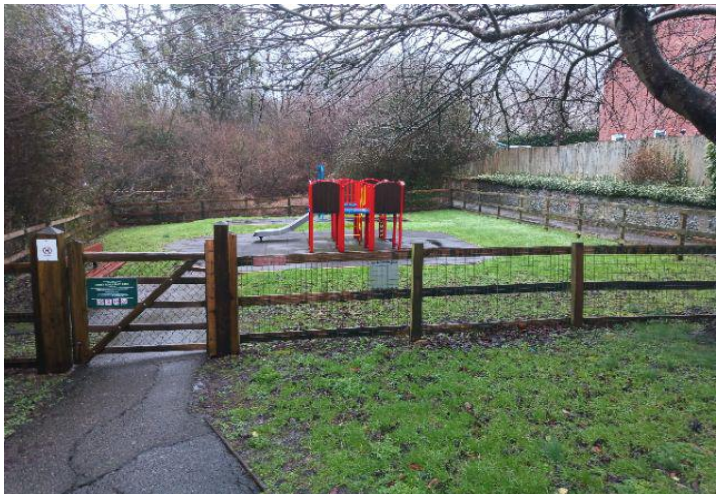
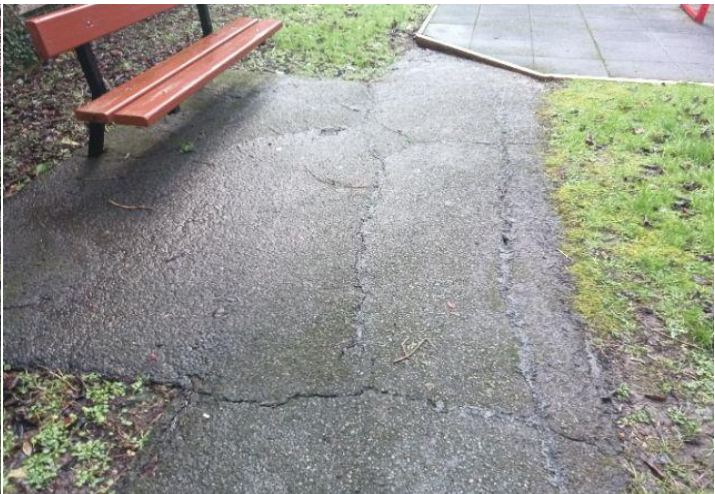
| 4 - Very Low Risk (Finding 1) | | | |
|---|---|---|---|
| <b>Finding:</b> There is some minor damage to the surface | | <b>Action:</b> Monitor for any further deterioration and repair as required | |

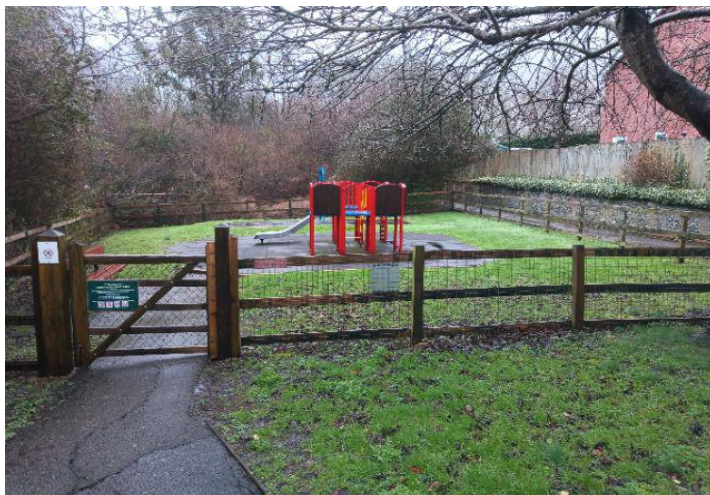
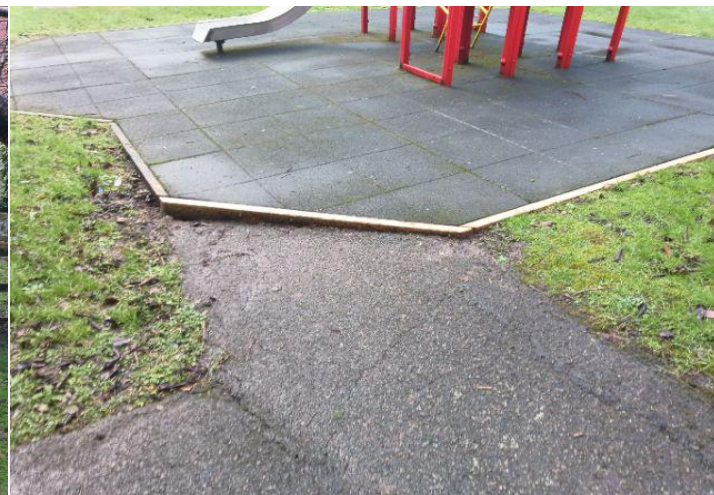
**i** 8 - Low Risk (Finding 2)

**Finding:** There are trip hazards at the edges of the surface **Action:** Remove trip hazard

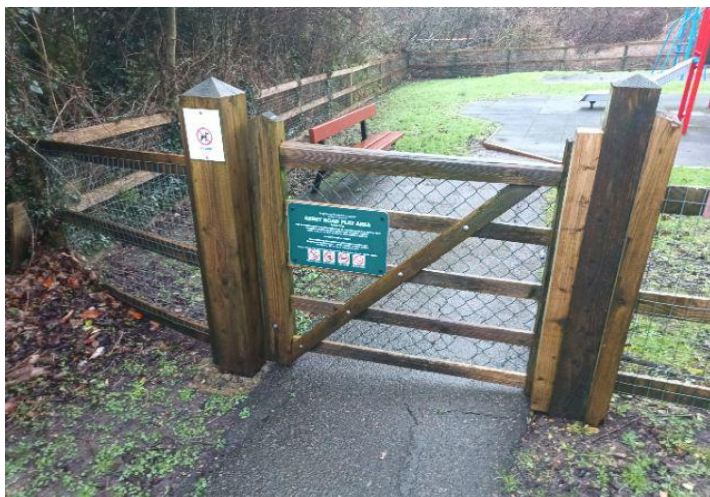
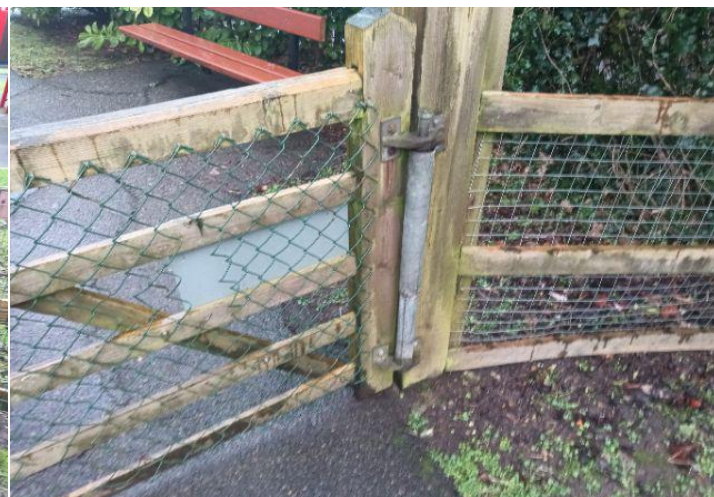
**i** 8 - Low Risk (Finding 1)

**Finding:** The gate is closing too quickly (less than 4 seconds) **Action:** Take corrective action to ensure that the gate closes in 4-8 seconds from 90 degrees

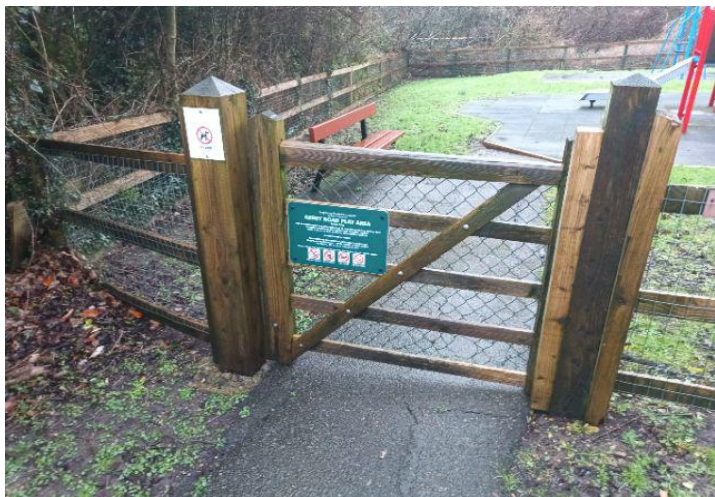
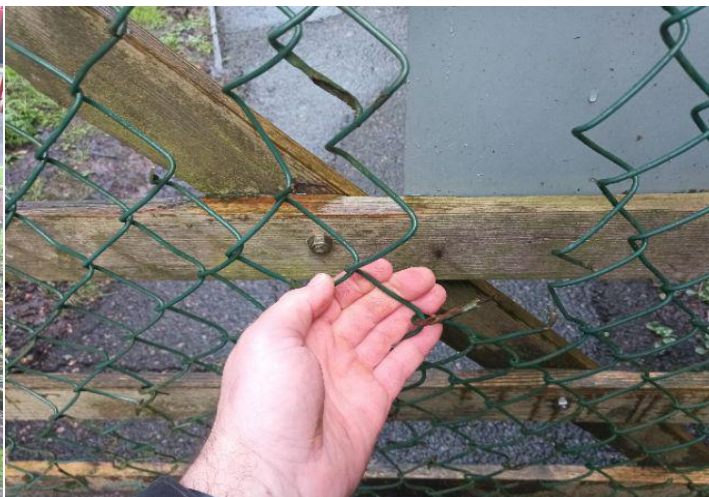
**i** 9 - Low Risk (Finding 2)

The mesh has been damaged leaving sharp rusty ends - Replace damaged mesh

**Finding:** The mesh has been damaged leaving sharp rusty ends

**Action:** Replace damaged mesh

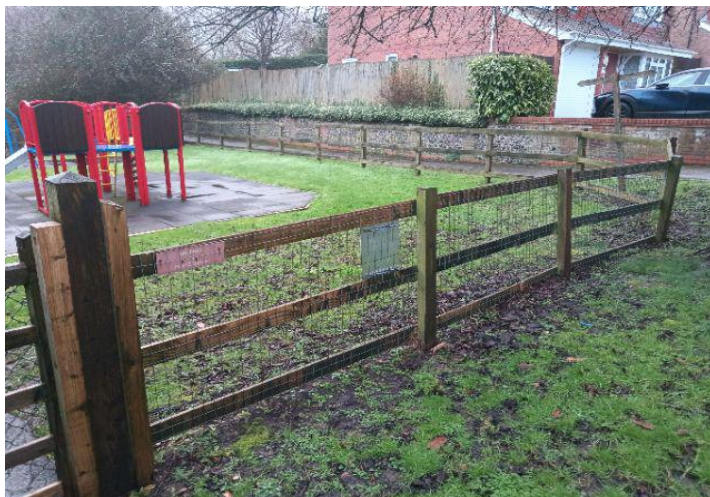
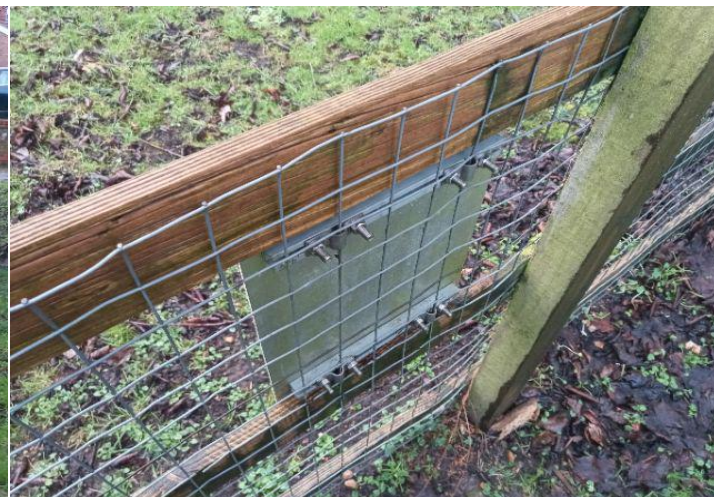
**i 8 - Low Risk (Finding 1)**

**Finding:** There are projecting bolt thread(s) present

**Action:** Remove excess thread length and deburr or provide cap

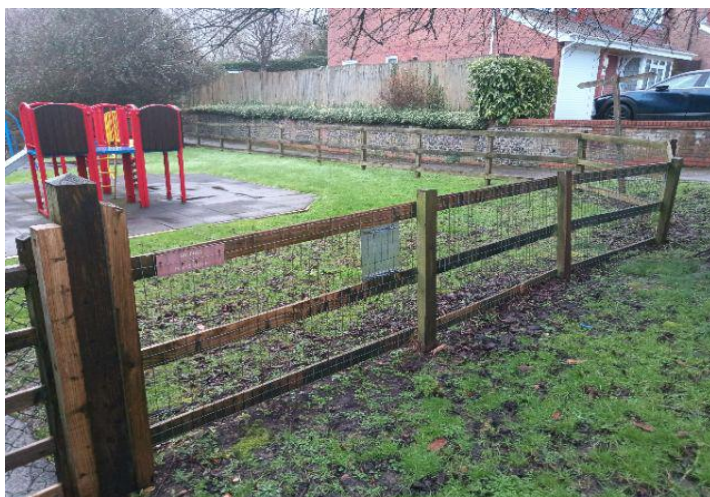
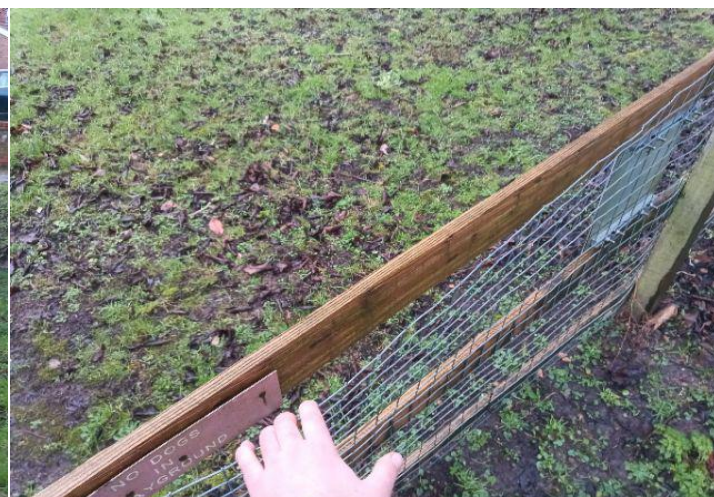
There are a number of fixings missing from the fence - Replace missing fixings

**Finding:** There are a number of fixings missing from the fence

**Action:** Replace missing fixings

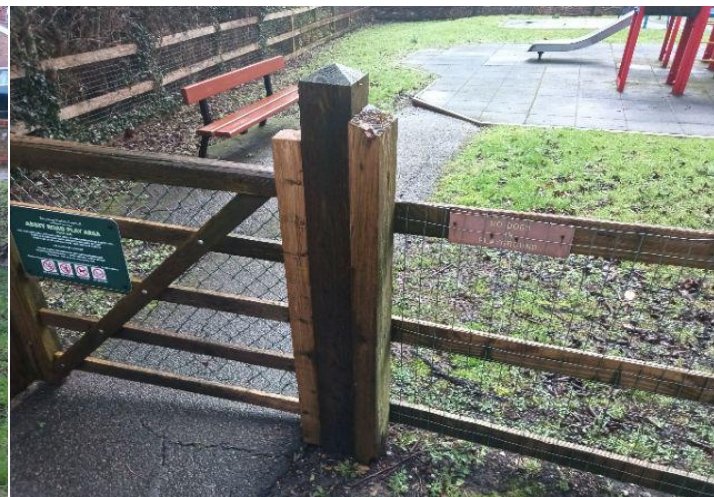
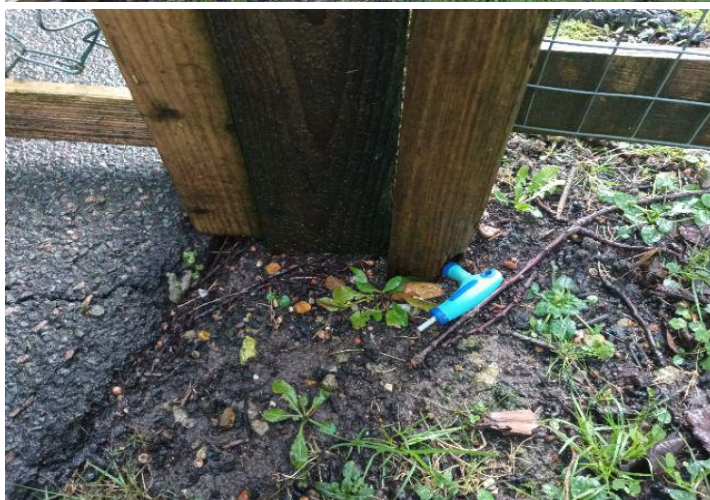
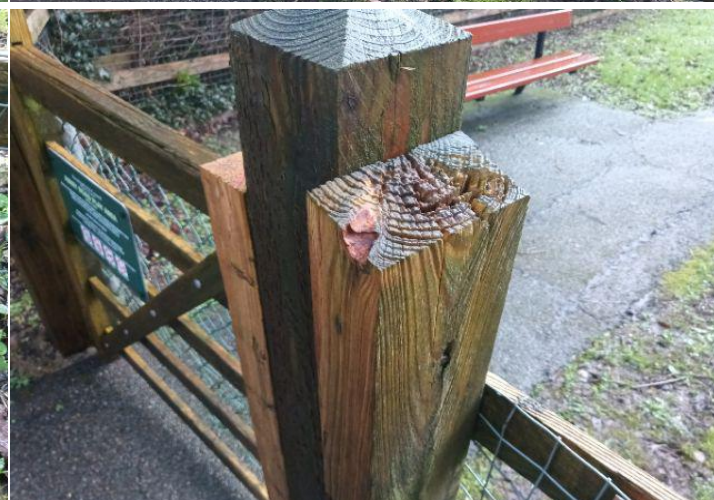
There are a number of loose and/or rotten posts around the fence - Replace/reset all affected posts

**Finding:** There are a number of loose and/or rotten posts around the fence

**Action:** Replace/reset all affected posts

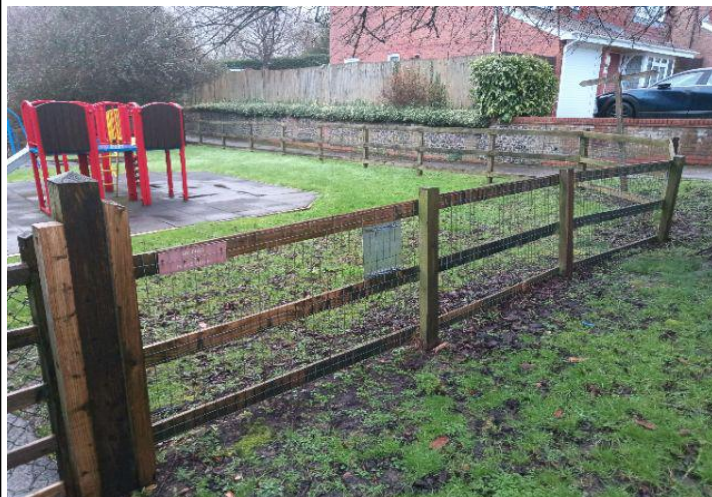
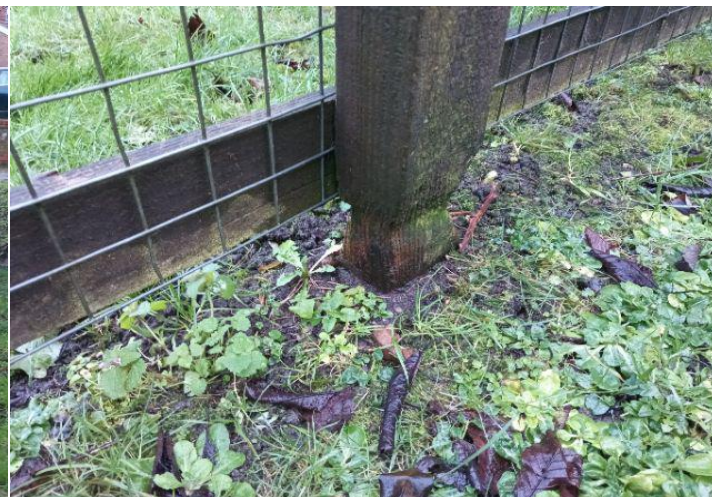
There is some strimmer / machinery damage apparent on the posts, this can penetrate the preservative applied to the timber and accelerate the rotting process - Monitor for any deterioration (rot) and replace as required

**Finding:** There is some strimmer / machinery damage apparent on the posts, this can penetrate the preservative applied to the timber and accelerate the rotting process

**Action:** Monitor for any deterioration (rot) and replace as required

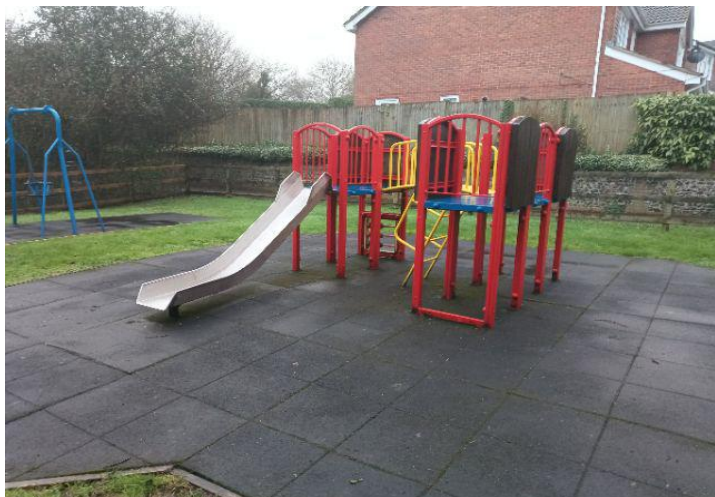
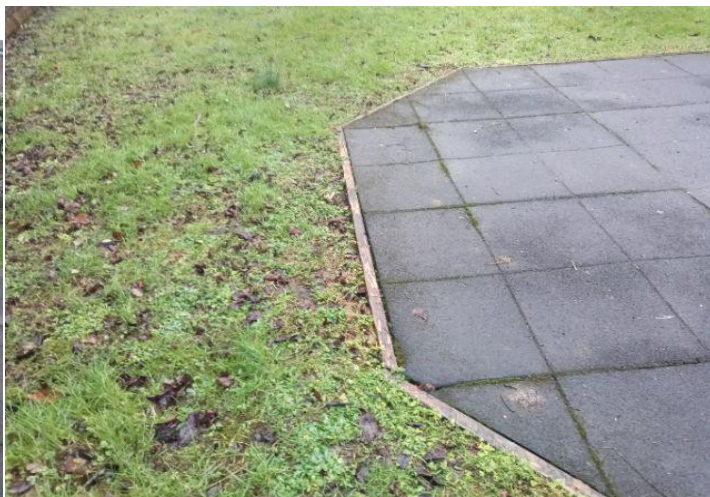
**Finding:** There are gaps opening between the surfacing and the edging surround or between the joints in the surfacing  
**Action:** Monitor for any further deterioration and repair as required

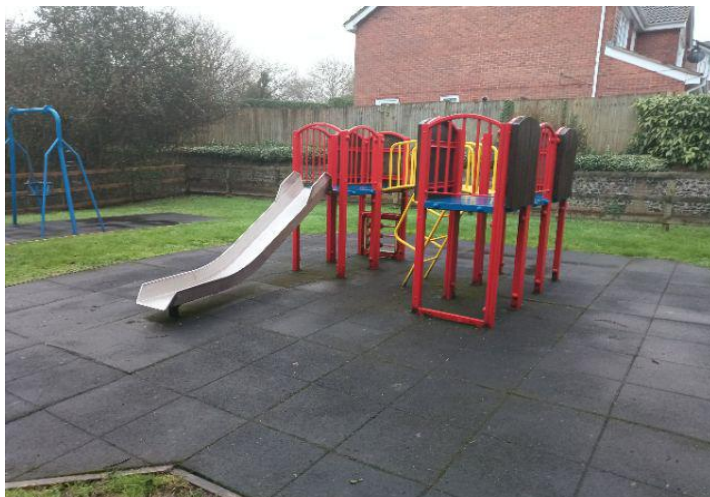
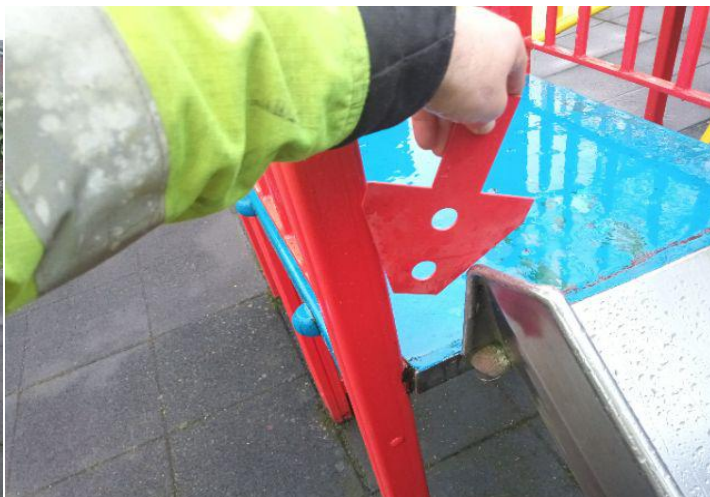
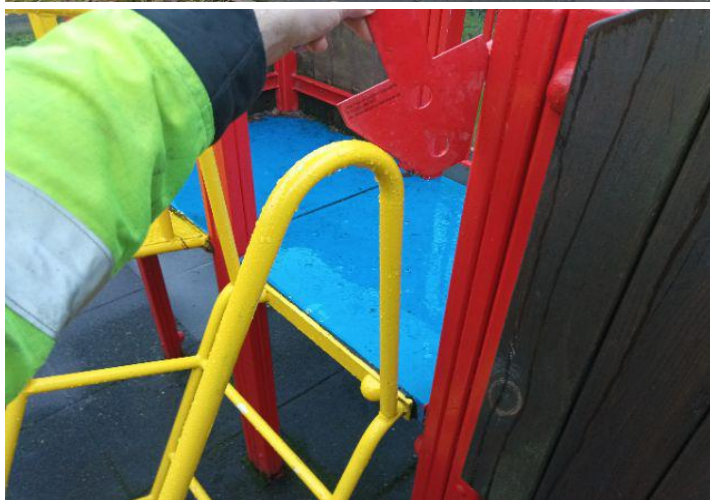
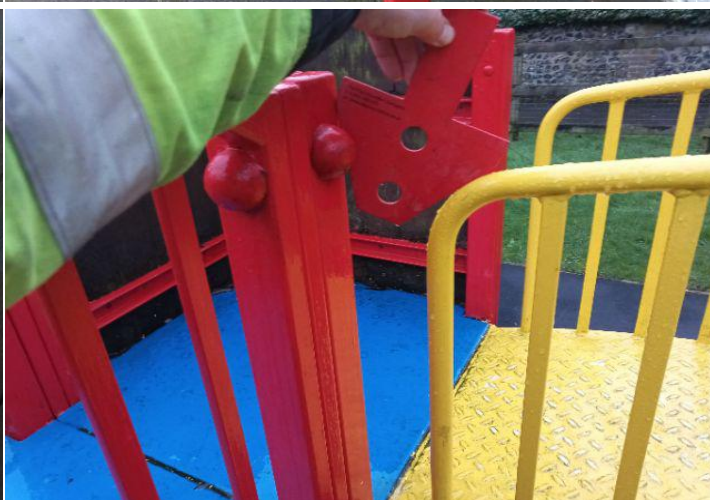
**i** 5 - Very Low Risk (Finding 2)

The item fails to meet the requirements of BS EN 1176 Part 1 4.2.7.2 head and neck entrapment in the barriers - Monitor - No action given the risk assessment

**Finding:** The item fails to meet the requirements of BS EN 1176 Part 1 4.2.7.2 head and neck entrapment in the barriers

**Action:** Monitor - No action given the risk assessment

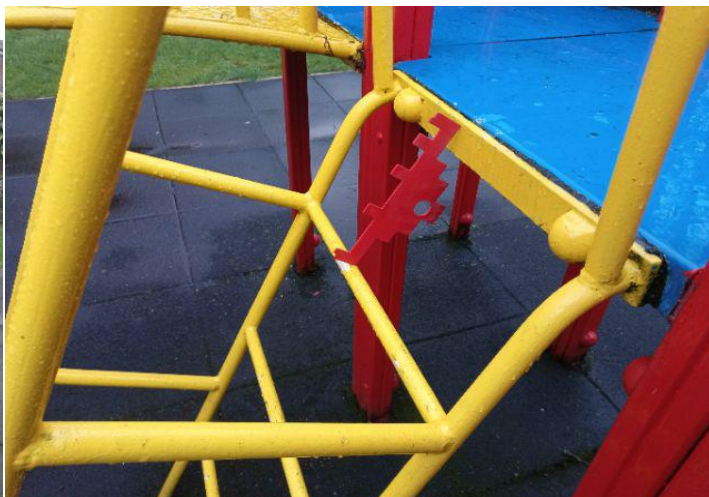
The item fails to meet the requirements of BS EN 1176 Part 1 4.2.7.2 head and neck entrapment in the barriers and/or steps - Monitor - No action given the risk assessment

**Finding:** The item fails to meet the requirements of BS EN 1176 Part 1 4.2.7.2 head and neck entrapment in the barriers and/or steps

**Action:** Monitor - No action given the risk assessment

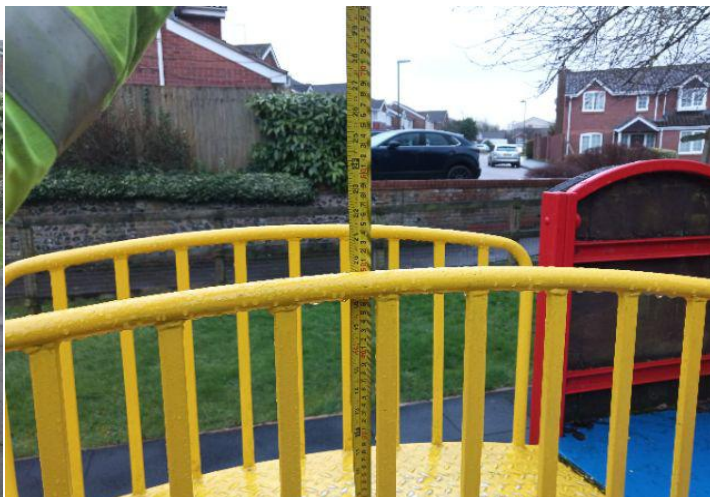
**i** 4 - Very Low Risk (Finding 4)

The height of the barrier(s) is insufficient and fails to meet the recommendations of BS EN 1176 Part 1 - Monitor - No action given the risk assessment

**Finding:** The height of the barrier(s) is insufficient and fails to meet the recommendations of BS EN 1176 Part 1

**Action:** Monitor - No action given the risk assessment

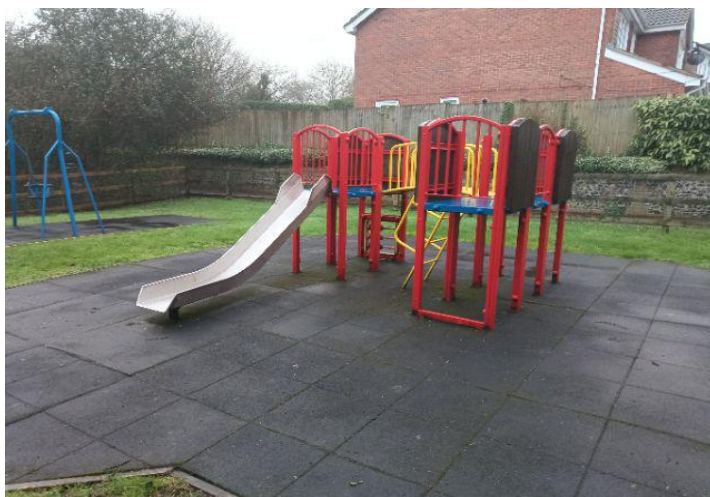
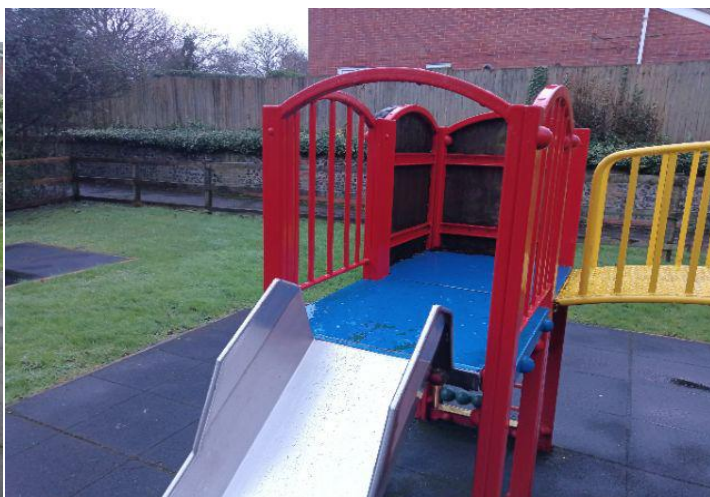
**Finding:** The opening providing access to the slide exceeds the width of the slide in contravention of BS EN 1176 Part 3

**Action:** Monitor - No action given the risk assessment

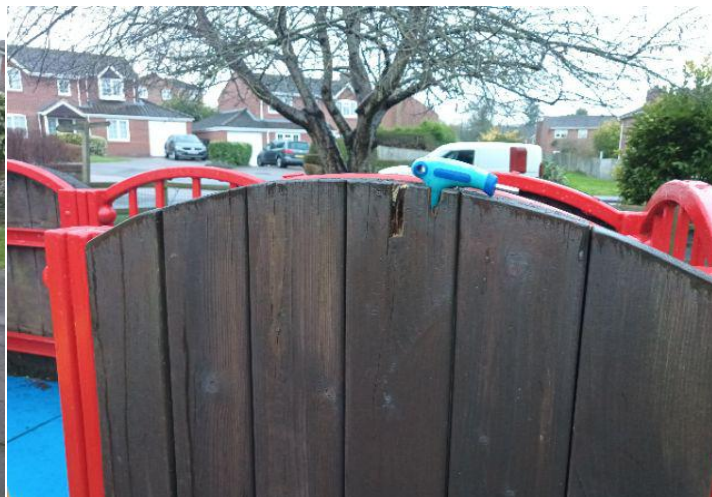
There are areas or parts of the timber on the structure that have rotted - Replace all affected timbers

**Finding:** There are areas or parts of the timber on the structure that have rotted

**Action:** Replace all affected timbers

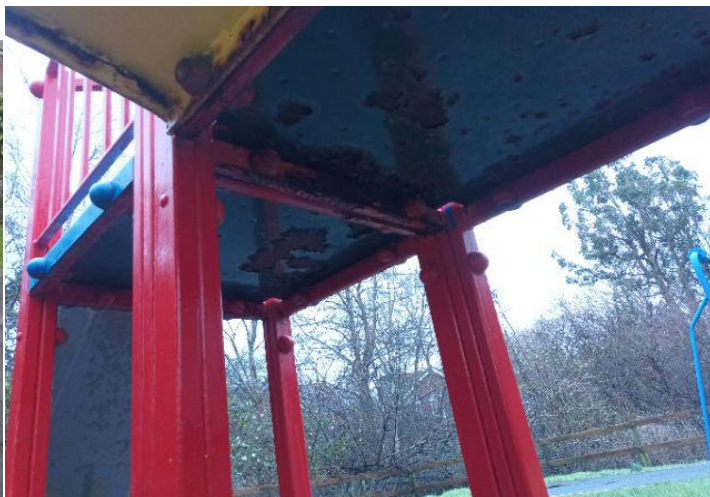
**i 6 - Low Risk (Finding 7)**

The paintwork on this item has been damaged or worn exposing the metal underneath which is rusting / corroding - Treat affected areas and repaint

**Finding:** The paintwork on this item has been damaged or worn exposing the metal underneath which is rusting / corroding

**Action:** Treat affected areas and repaint

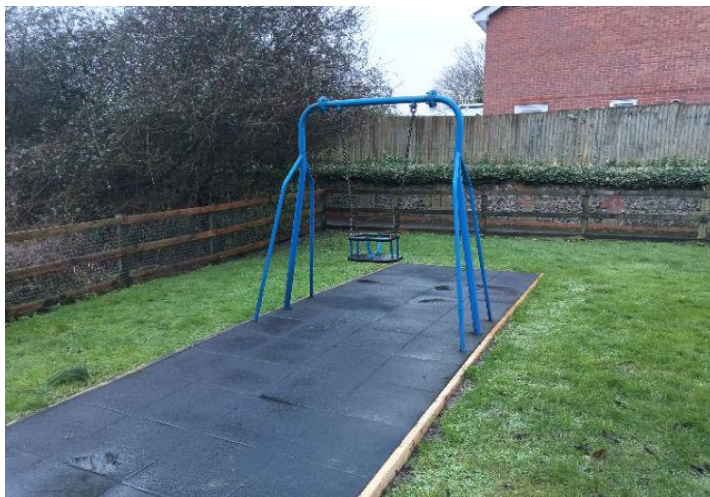
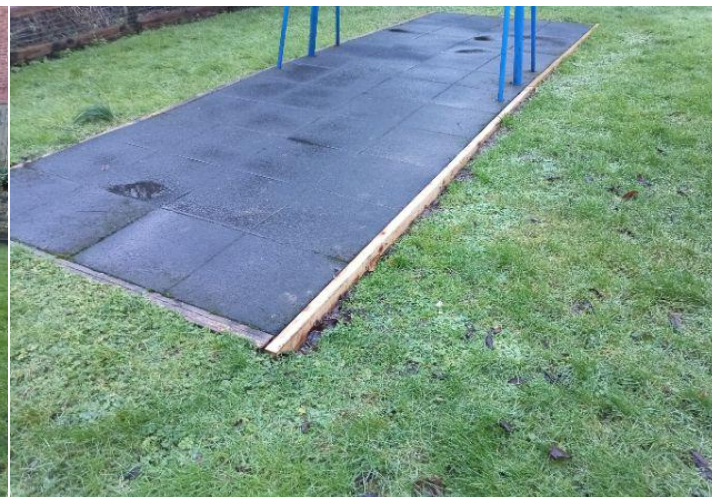
**Finding:** There are trip hazards at the edges of the surface **Action:** Remove trip hazard

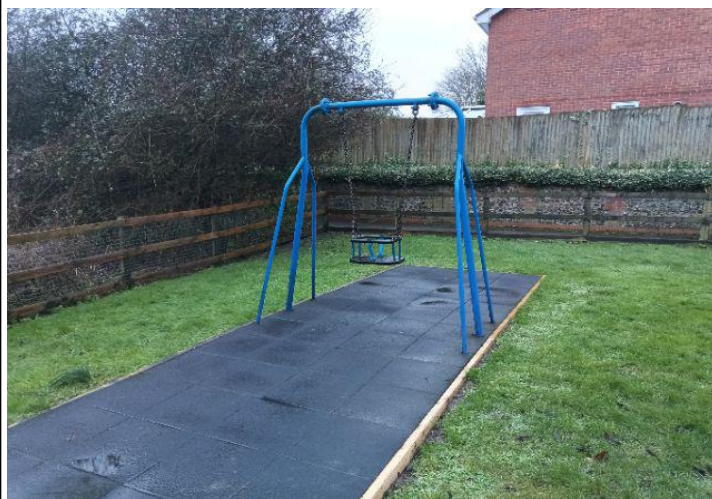
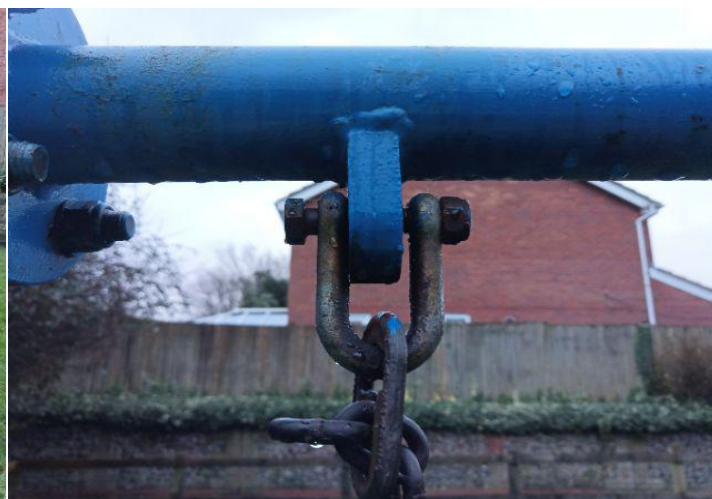
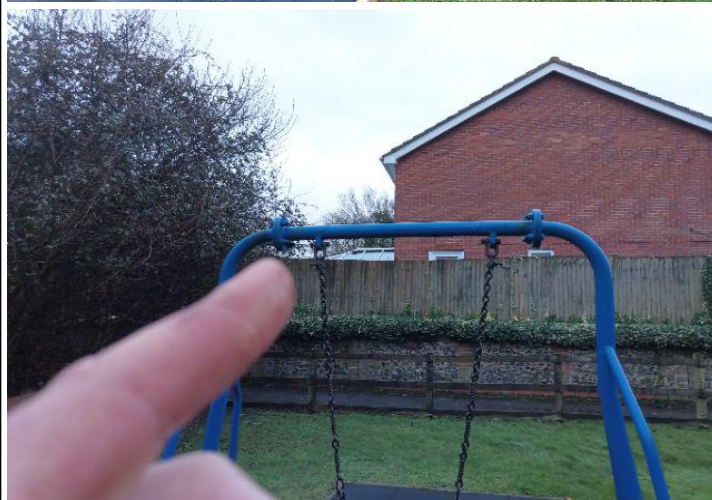
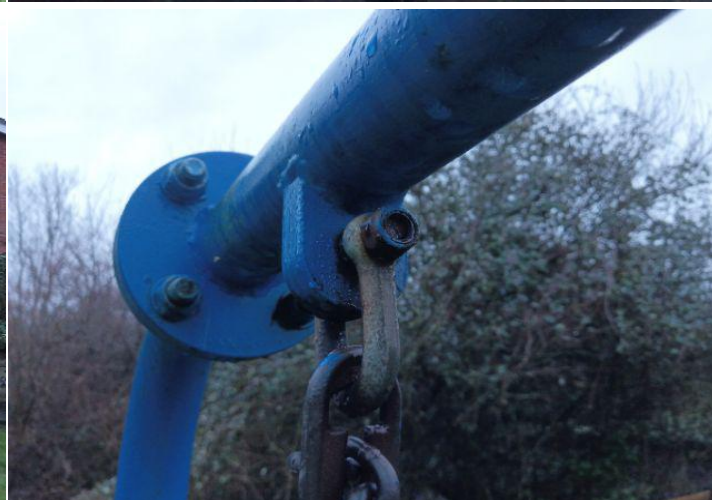
**i** 10 - Low Risk (Finding 2)

A number of fixing(s) have worked loose - Secure all loose fixings

**Finding:** A number of fixing(s) have worked loose

**Action:** Secure all loose fixings
