## COMMUNITY COMMITTEE MEETING HELD ON TUESDAY 4<sup>th</sup> FEBRUARY 2025 AT 7.30 PM AT THE STEYPING CENTRE

# DRAFT MINUTES

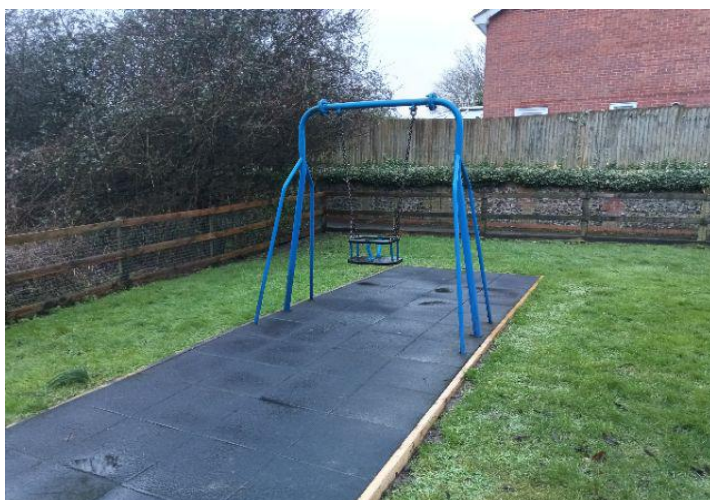
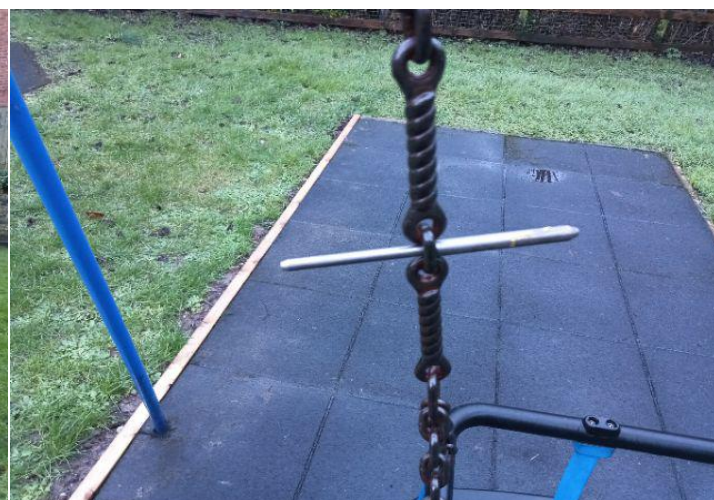
**Finding:** The chain openings are in excess of the 8.6mm as recommended by BS EN 1176

**Action:** Monitor - No action given the risk assessment

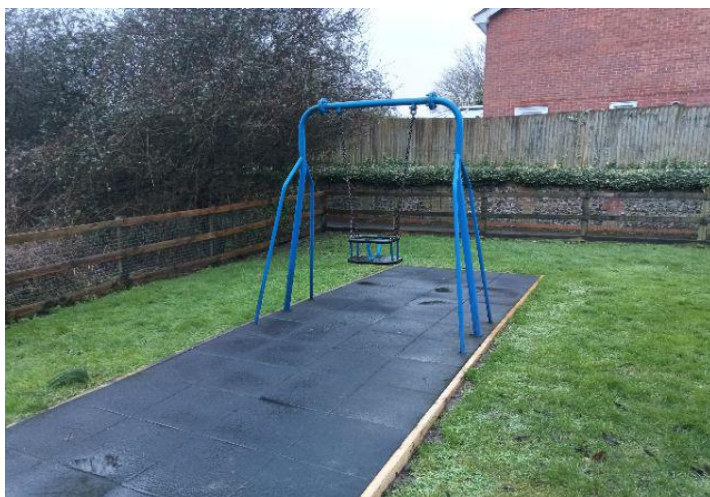
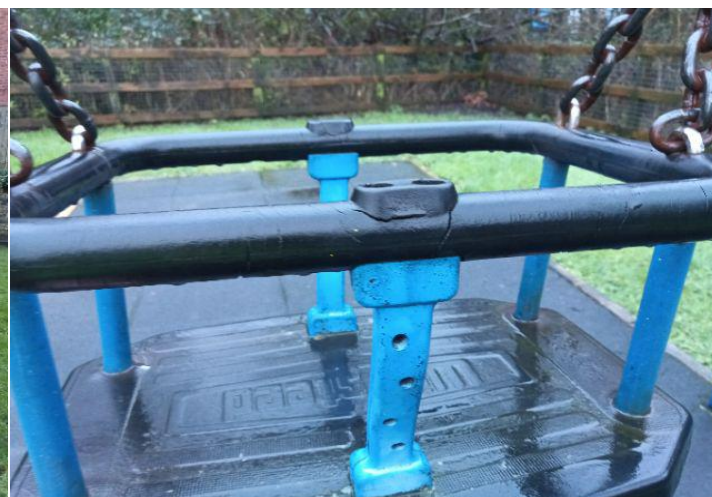
**Finding:** The seat has minor damage or wear

**Action:** Monitor for any further deterioration and replace as required

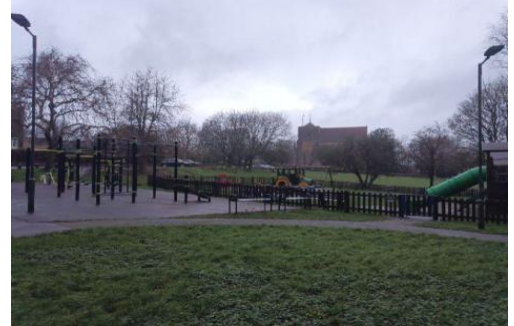
There are gaps opening between the surfacing and the edging surround or between the joints in the surfacing - Monitor for any further deterioration and repair as required

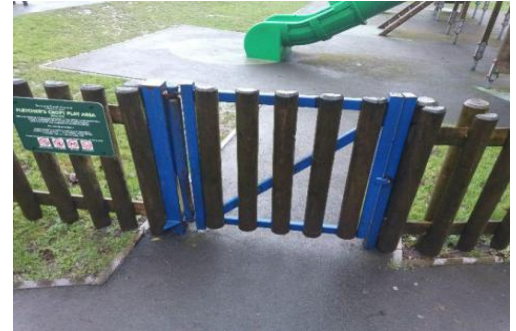
There are openings that are less than 12mm that could trap or crush fingers - Provide a 12mm gap throughout full range of motion at both sides of gate

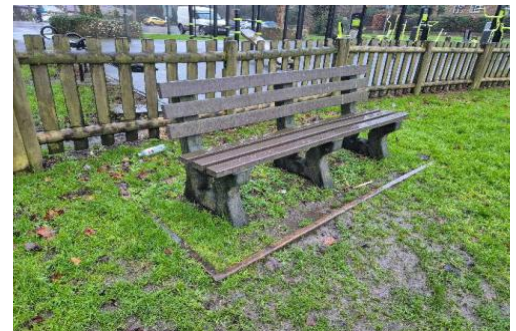
There are trip hazards present - Remove trip hazard

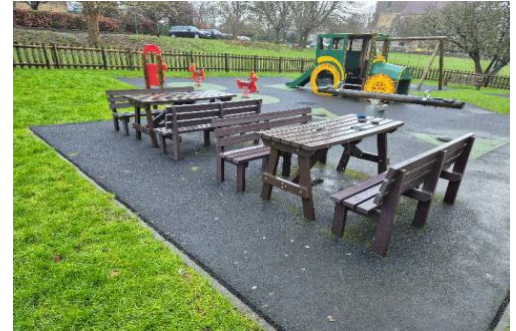
There are projecting screws present due to missing rail - Remove screws or replace missing rail

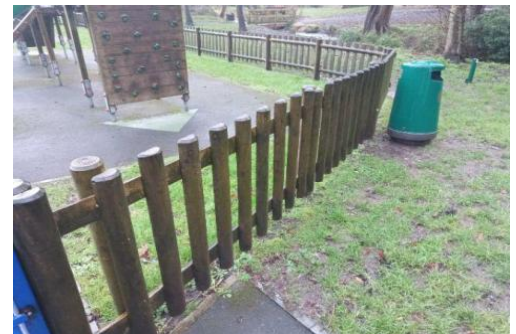
There is some strimmer / machinery damage apparent on the posts, this can penetrate the preservative applied to the timber and accelerate the rotting process - Monitor for any deterioration (rot) and replace as required

There are a number of loose and/or rotten posts around the fence - Replace all affected timbers

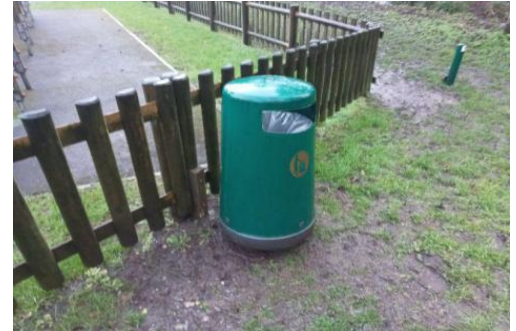
The bin is not securely fixed to the surface and there is some possibility of the item tipping or rolling over - Secure the bin to the ground

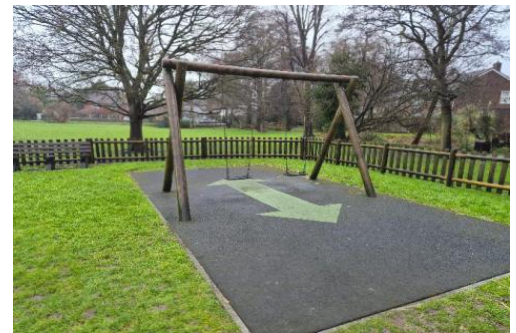
There is some notable evidence of chain wear - Monitor for any further deterioration and replace when 40% worn

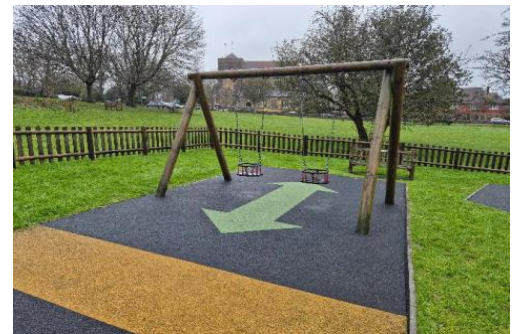
The seat has minor damage or wear - Monitor for any further deterioration and replace as required

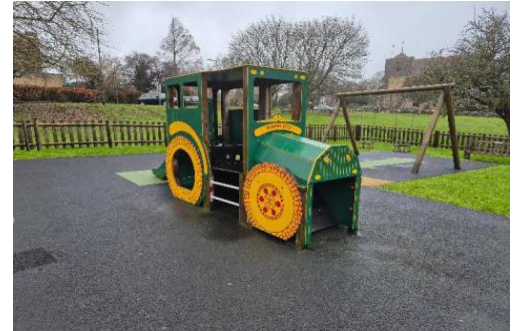
There is an opening in the barriers exceeding the width allowed (500mm) in BS EN 1176 Part 1 - Monitor - No action given the risk assessment

The height of the barrier(s) is insufficient and fails to meet the requirements of BS EN 1176 Part 1 - Monitor - No action given the risk assessment

There are a number of dents in the slide surface - Monitor for any further deterioration and repair as required

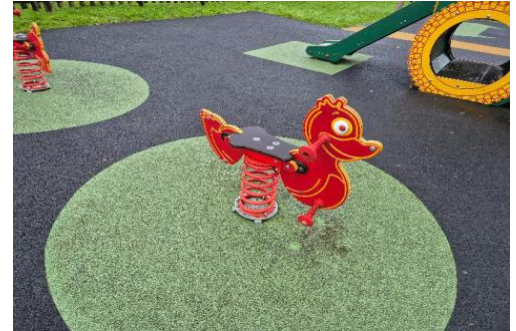
There is/are inserts missing - Replace missing inserts

The item has been damaged - Monitor for any further deterioration and replace as required

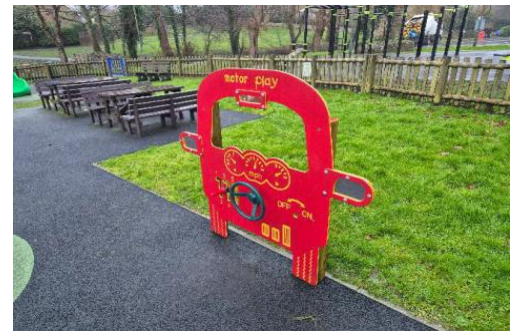
There is some strimmer / machinery damage apparent on the posts, this can penetrate the preservative applied to the timber and accelerate the rotting process - Monitor for any deterioration (rot) and replace as required

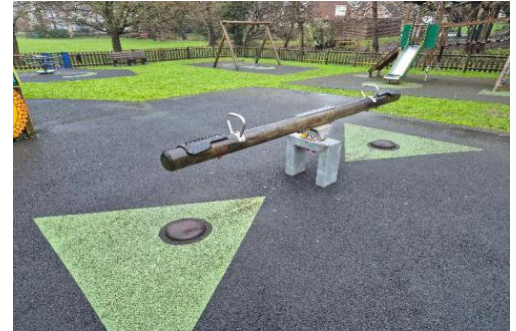
The timber on this item has severe rot - Remove and replace all affected timber sections

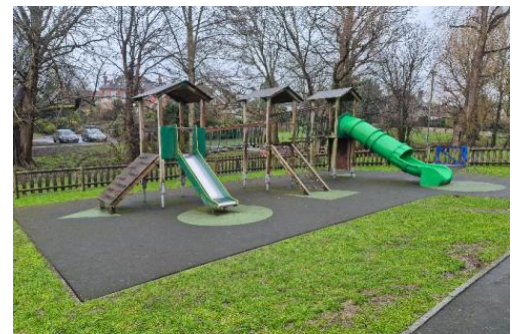
There are a number of dents in the slide surface - Monitor for any further deterioration and repair as required

There is algae growth on the surface of the equipment resulting in slippery conditions - Clean and treat appropriately

There is/are bolt cap covers missing or damaged on the item - Replace missing or damaged bolt cap covers

The safety surface around the area is beginning to wear - Monitor for any further deterioration and repair as required

The item has been damaged - Monitor for any further deterioration and replace as required

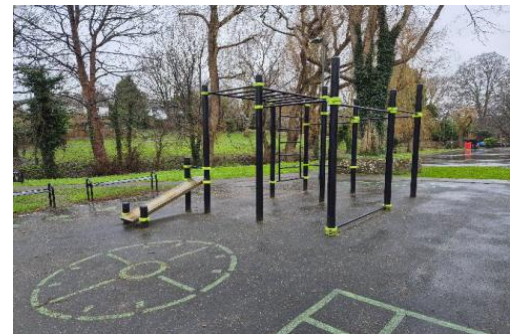
Parts of the timber are rough or splintered - Remove all rough or sharp edges

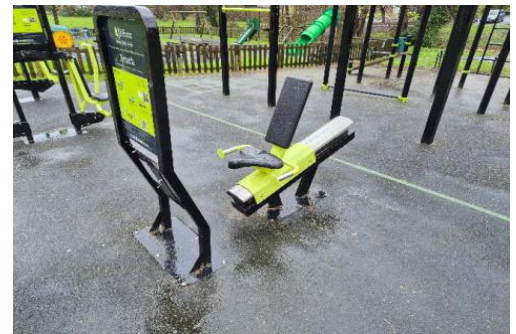
The item has been damaged - Monitor for any further deterioration and replace as required

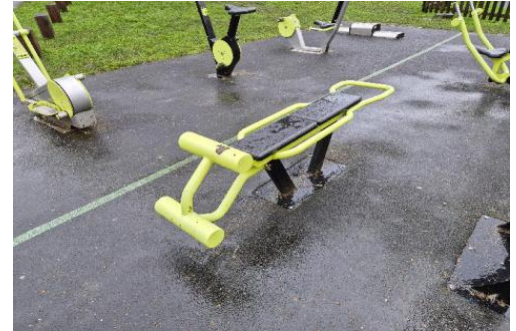
The paintwork on this item has been damaged or worn exposing the metal underneath which is rusting / corroding - Treat affected areas and repaint

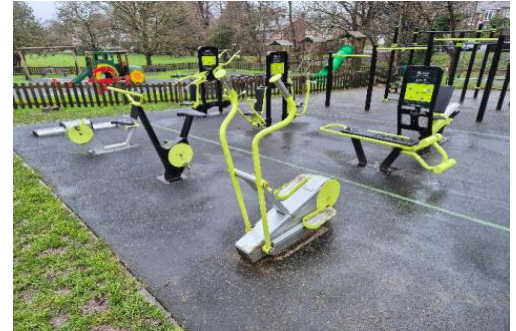
The tread surface does not have a 10mm high safeguard that extends around the front of the surface and at least 75% of the sides of the surface as required by BS EN 16630 - Monitor - No action given the risk assessment

The bearing is showing signs of wear - Monitor for any further deterioration and replace as required

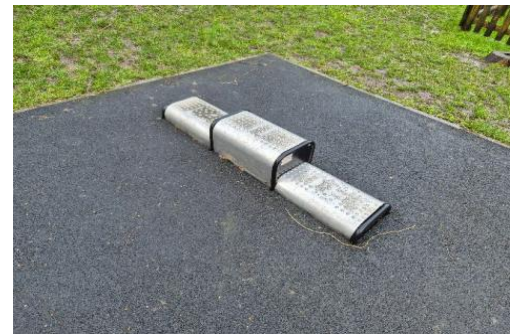
The training space of the recumbent cycle and the step up unit overlap in contravention of the requirements of BS EN 16630 - Monitor - No action given the risk assessment

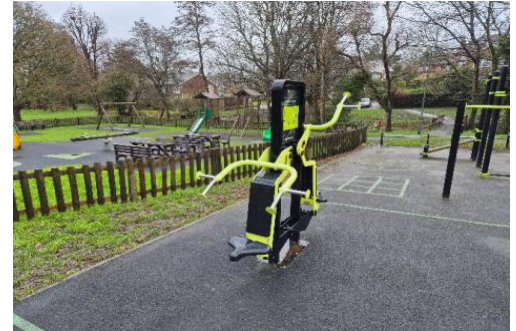
The paintwork on this item has been damaged or worn exposing the metal underneath which is rusting / corroding - Treat affected areas and repaint

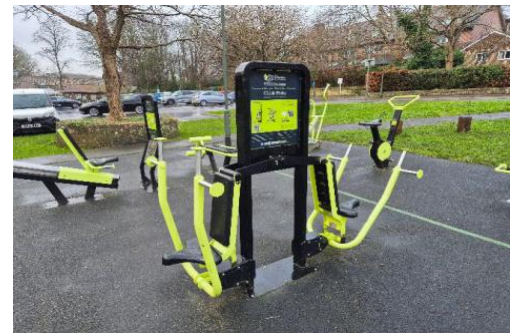
BS EN 16630 - 4.3.1 states that fitness equipment shall be designed so when at rest, the equipment shall automatically adjust so that the equipment is ready for the next user - Service the item

The paintwork on this item has been damaged or worn exposing the metal underneath which is rusting / corroding - Treat affected areas and repaint

There is some minor damage to the surface - Monitor for any further deterioration and repair as required

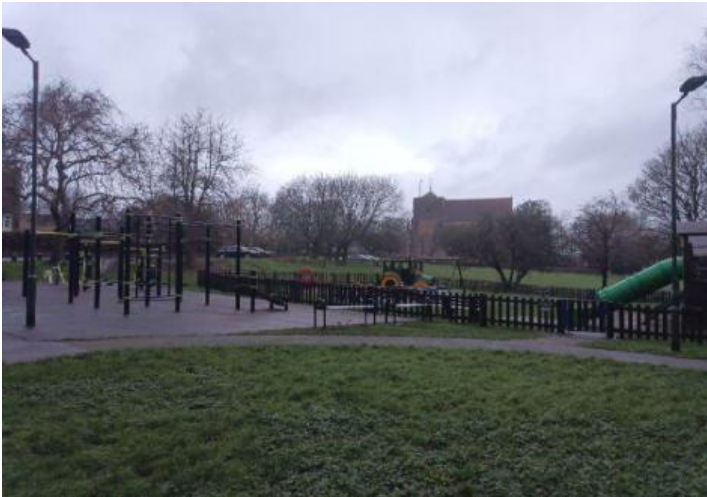
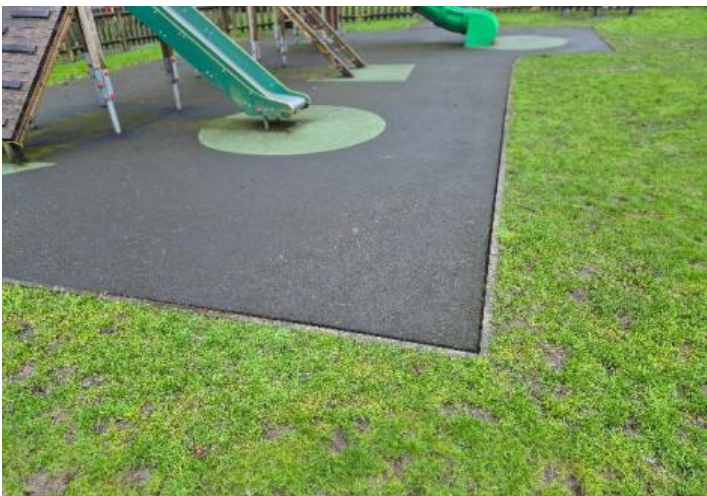
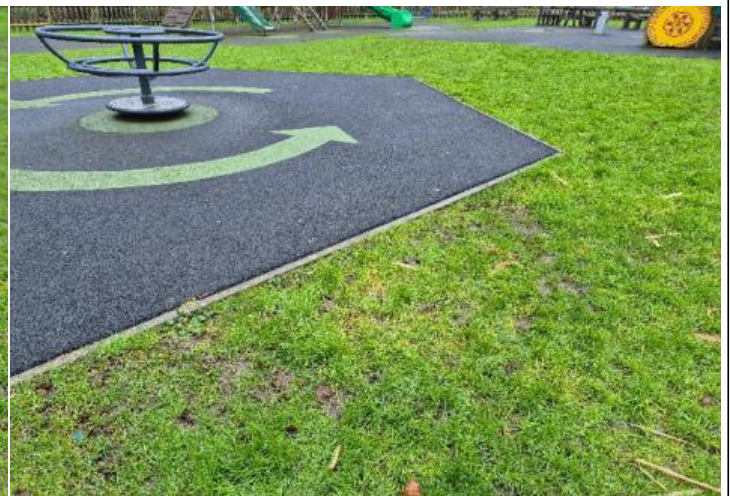
**Finding:** There are gaps opening between the surfacing and the edging surround or between the joints in the surfacing **Action:** Monitor for any further deterioration and repair as required

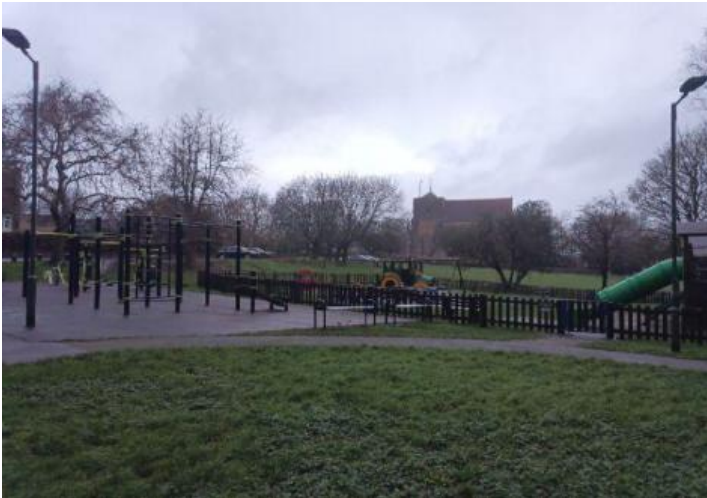
**Finding:** The surface has eroded in some areas and may be slippery in wet conditions  
**Action:** Reinstate the surface

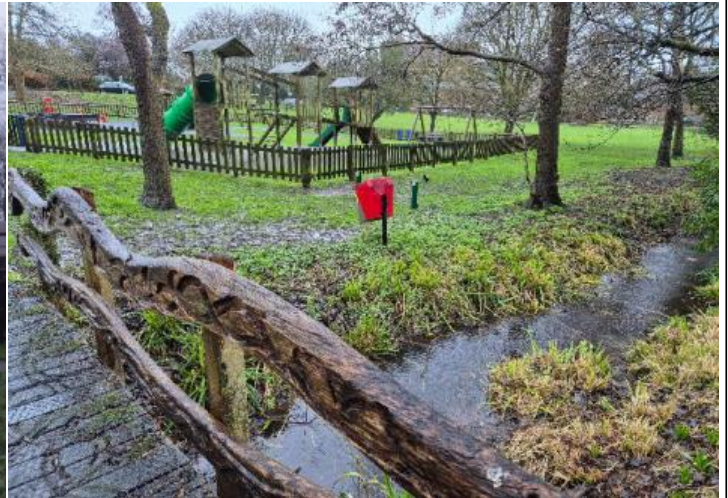
**Finding:** NOTE - There is a deep ditch in close proximity to the playground. Risk assessment of this is a specialist field and outside the scope of our inspection.

**Action:** Contact our official water safety partner the RLSS (Royal Life Saving Society) at [www.rlss.org.uk](http://www.rlss.org.uk) and / or ensure that the appropriate risk assessment is in place

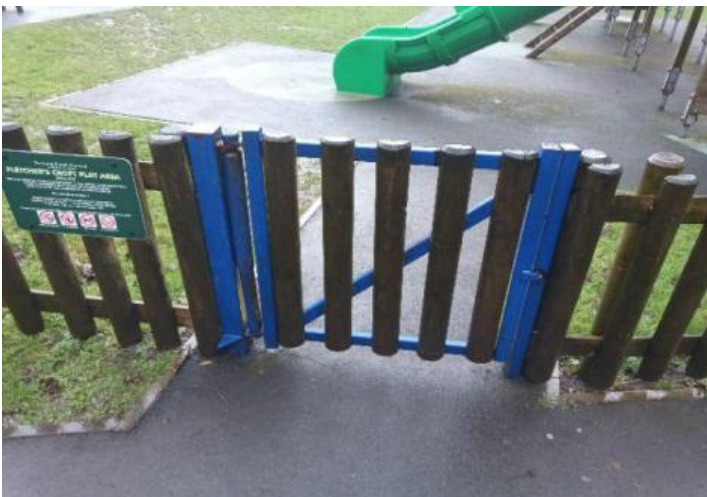
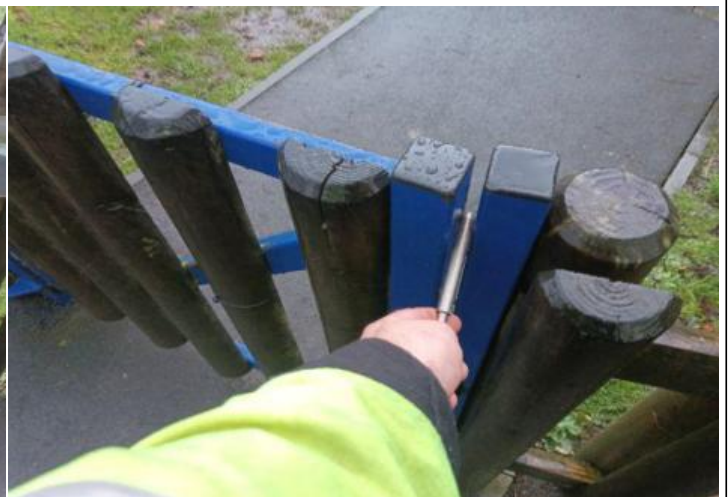
**Item:** Gates - Gate - Self Closing  
**Manufacturer:** Not Identified

**Finding:** There are openings that are less than 12mm that could trap or crush fingers

**Action:** Provide a 12mm gap throughout full range of motion at both sides of gate

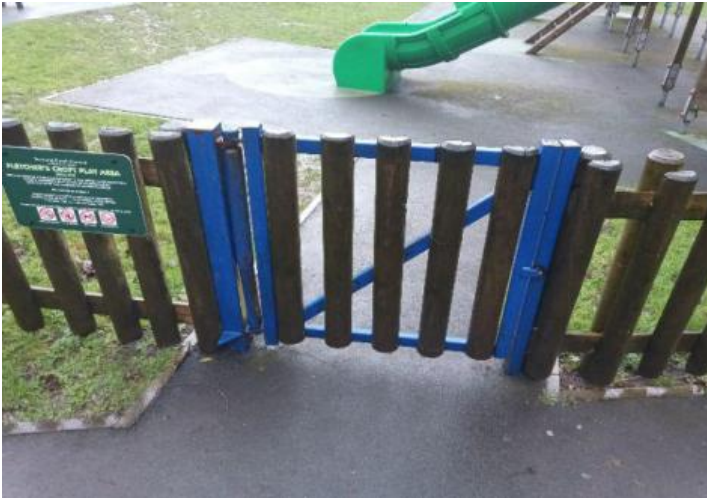
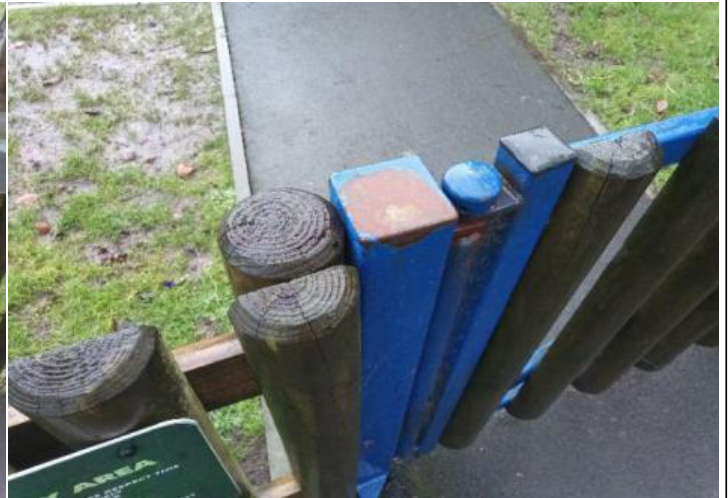
**Item:** Gates - Gate - Self Closing  
**Manufacturer:** Not Identified

**Finding:** The paintwork on this item has been damaged or worn exposing the metal underneath which is rusting / corroding

**Action:** Treat affected areas and repaint

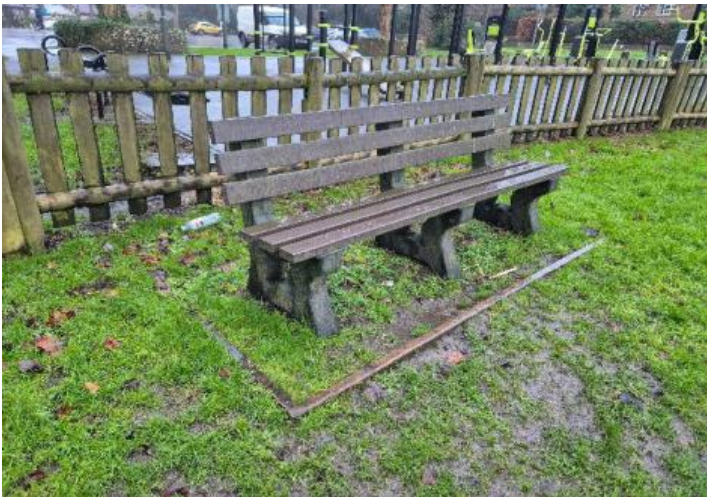
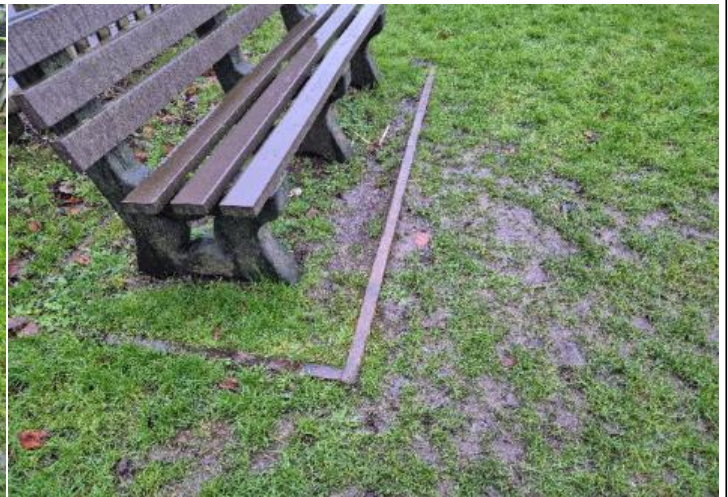
**Item:** Ancillary Items - Bench  
**Manufacturer:** Not Identified

**Finding:** There are trip hazards present

**Action:** Remove trip hazard

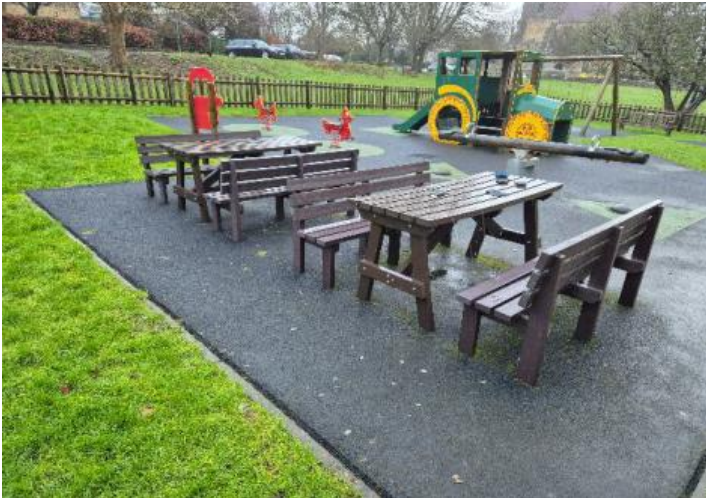
**Item:** Ancillary Items - Seating Area  
**Manufacturer:** Not Identified

**Finding:** There are projecting screws present due to missing rail

**Action:** Remove screws or replace missing rail

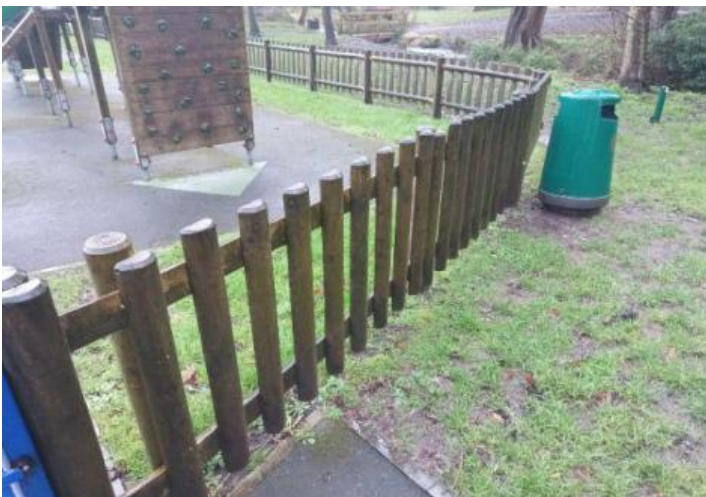
**Item:** Fences - Fencing - Timber  
**Manufacturer:** Not Identified

**Finding:** There is some strimmer / machinery damage apparent on the posts, this can penetrate the preservative applied to the timber and accelerate the rotting process

**Action:** Monitor for any deterioration (rot) and replace as required

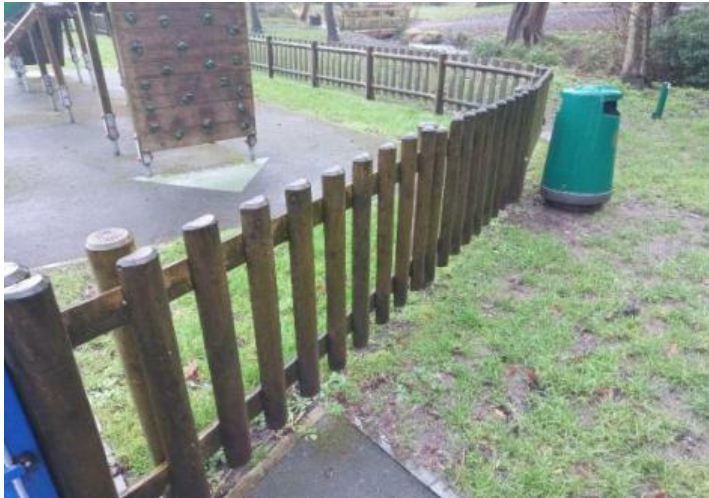
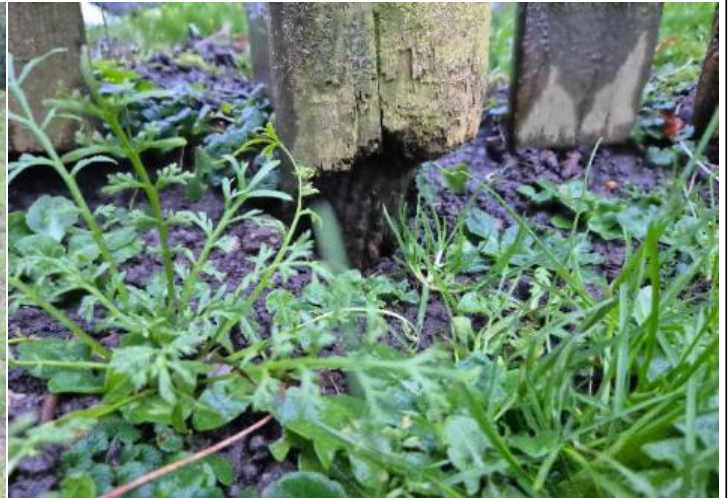
**Item:** Fences - Fencing - Timber  
**Manufacturer:** Not Identified

**Finding:** There are a number of loose and/or rotten posts around the fence

**Action:** Replace all affected timbers

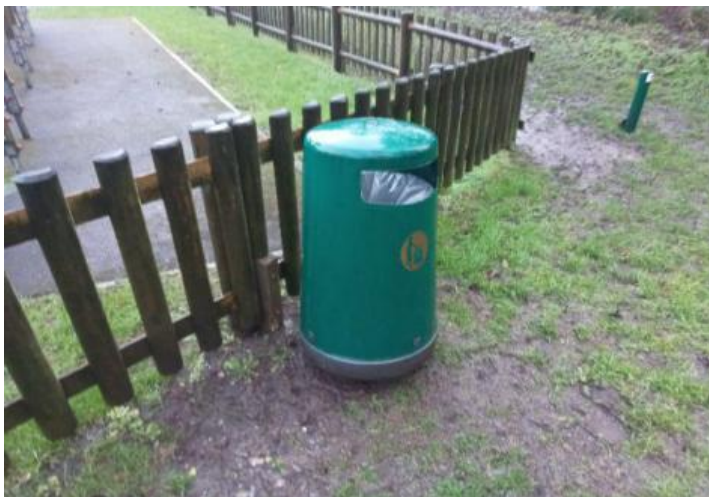
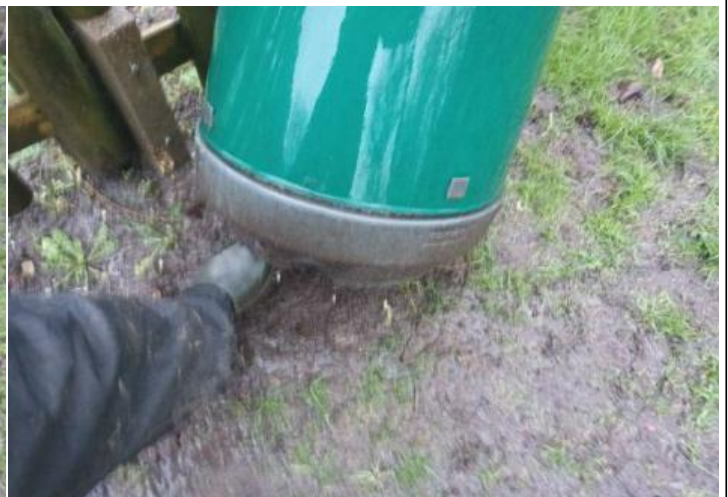
**Item:** Ancillary Items - Litter Bin  
**Manufacturer:** Glasdon

**Finding:** The bin is not securely fixed to the surface and there is some possibility of the item tipping or rolling over

**Action:** Secure the bin to the ground

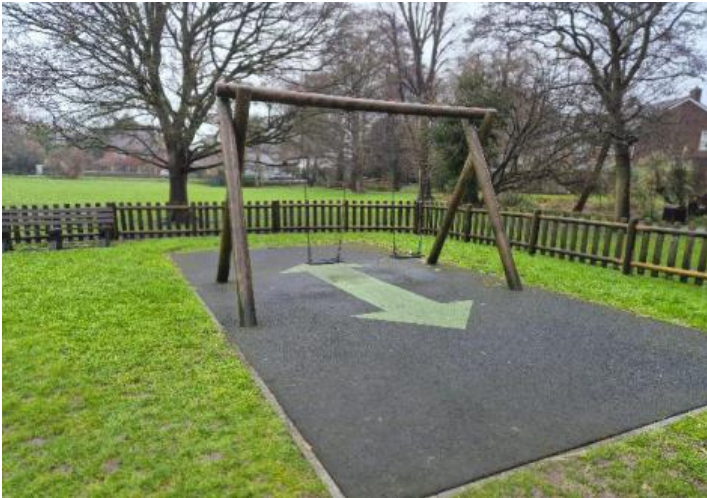
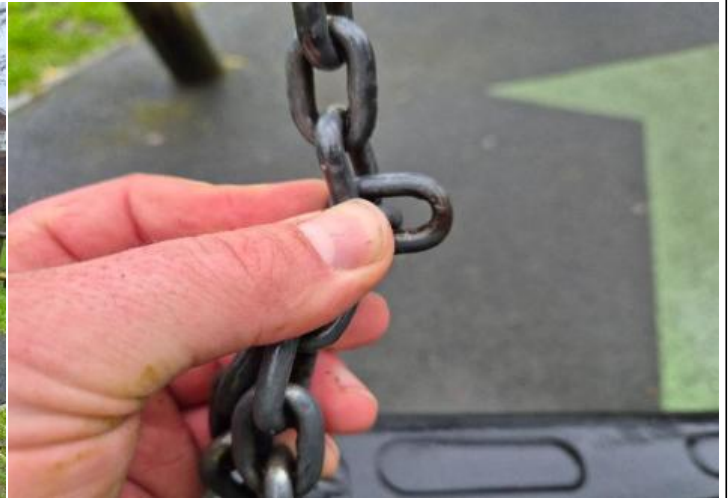
**Item:** Swings - 1 Bay 2 Seat (Flat)  
**Manufacturer:** Creative Play

**Finding:** There is some notable evidence of chain wear

**Action:** Monitor for any further deterioration and replace when 40% worn

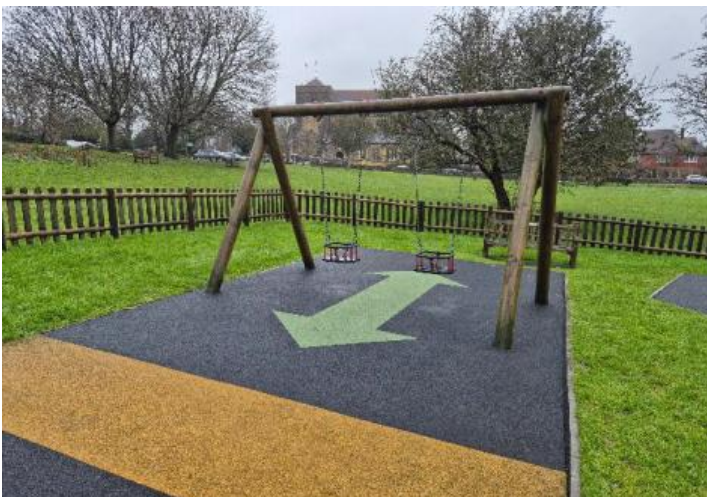
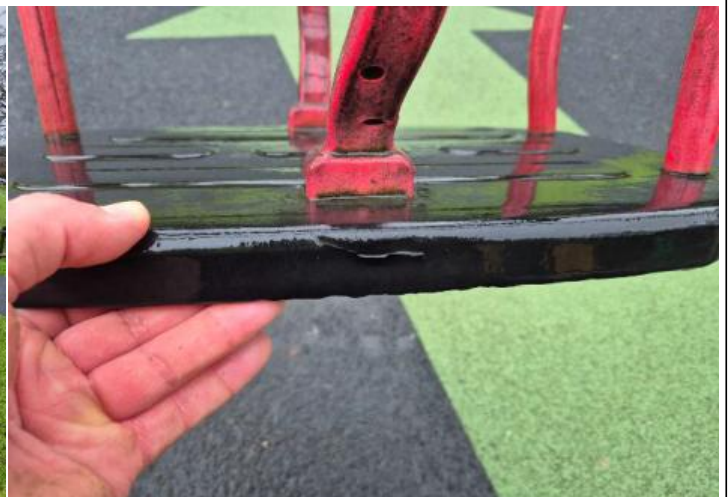
**Item:** Swings - 1 Bay 2 Seat (Cradle)  
**Manufacturer:** Creative Play

**Finding:** The seat has minor damage or wear

**Action:** Monitor for any further deterioration and replace as required

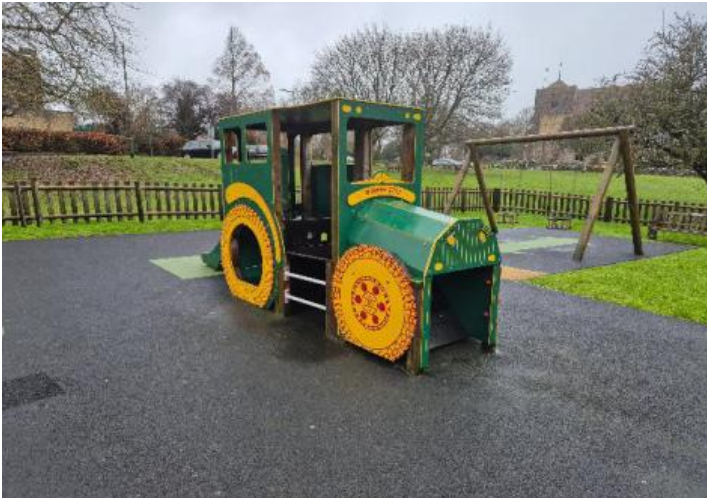
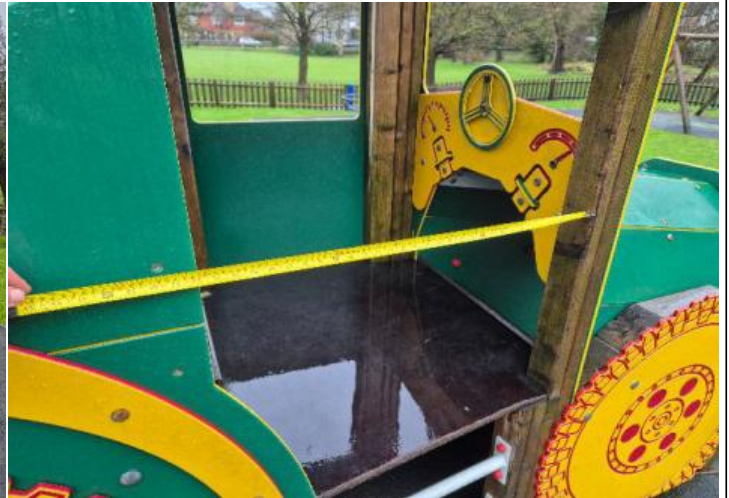
**Item:** Activity Equipment - Tractor  
**Manufacturer:** Creative Play

**Finding:** There is an opening in the barriers exceeding the width allowed (500mm) in BS EN 1176 Part 1

**Action:** Monitor - No action given the risk assessment

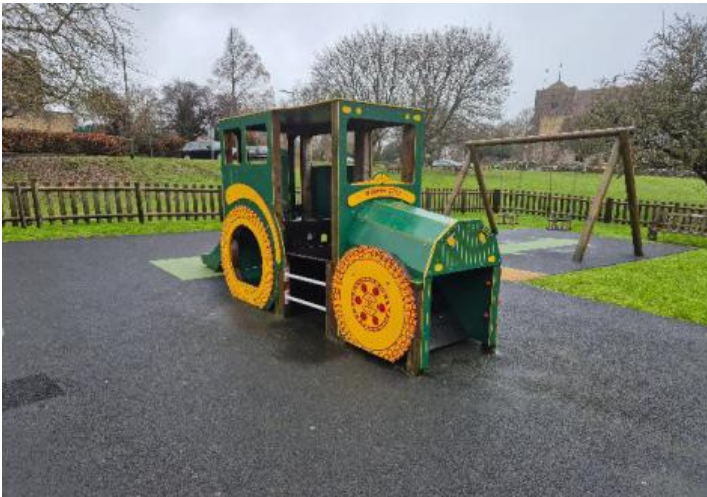
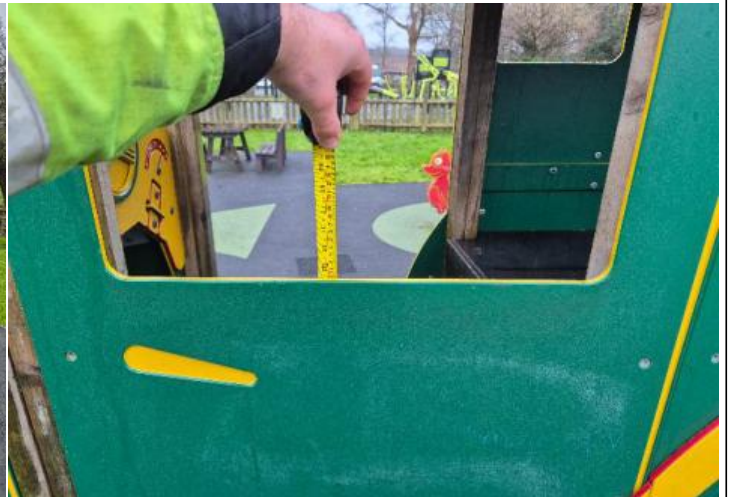
**Item:** Activity Equipment - Tractor  
**Manufacturer:** Creative Play

**Finding:** The height of the barrier(s) is insufficient and fails to meet the requirements of BS EN 1176 Part 1

**Action:** Monitor - No action given the risk assessment

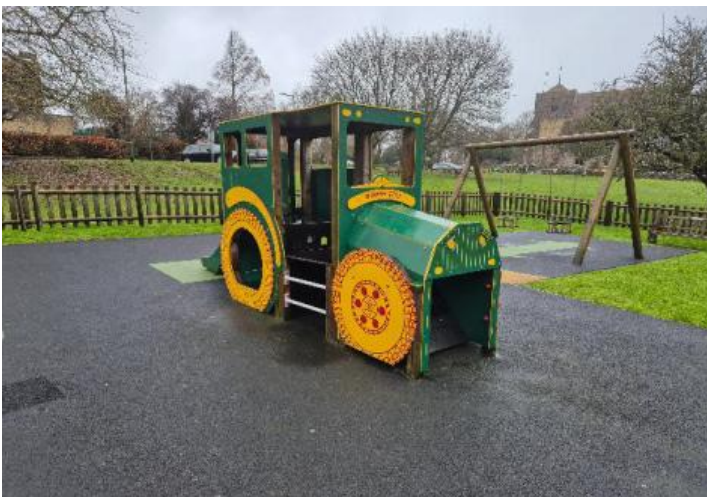
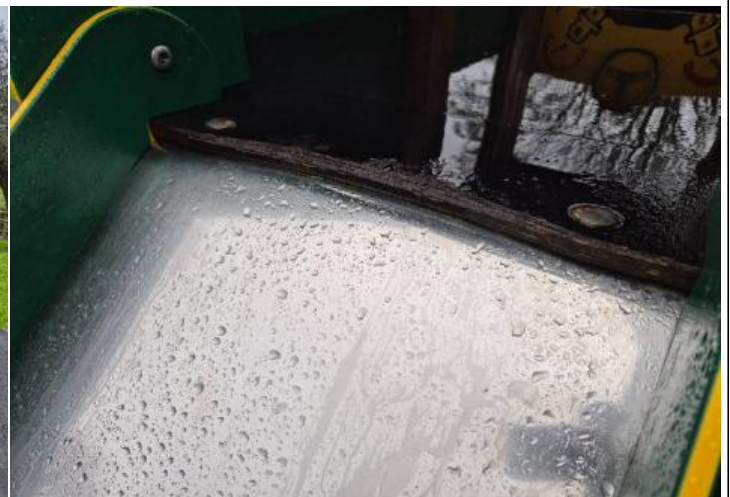
**Item:** Activity Equipment - Tractor  
**Manufacturer:** Creative Play

**Finding:** Parts of the timber are rough or splintered

**Action:** Remove all rough or sharp edges

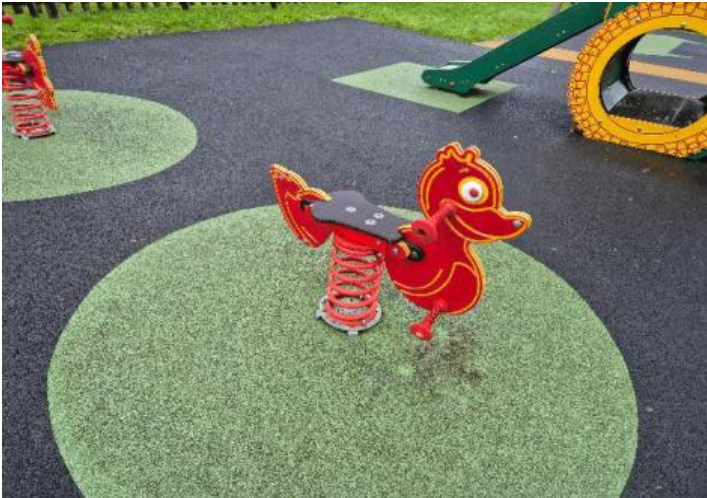
**Item:** Rocking Equipment - Spring Duck  
**Manufacturer:** Creative Play

**Finding:** There is/are inserts missing

**Action:** Replace missing inserts

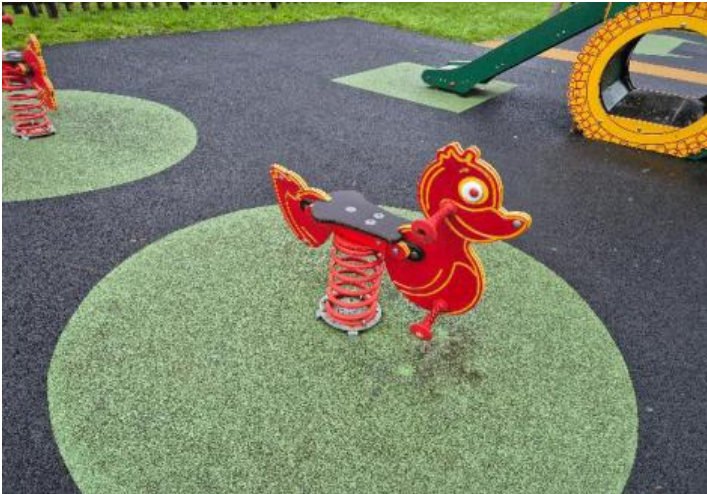
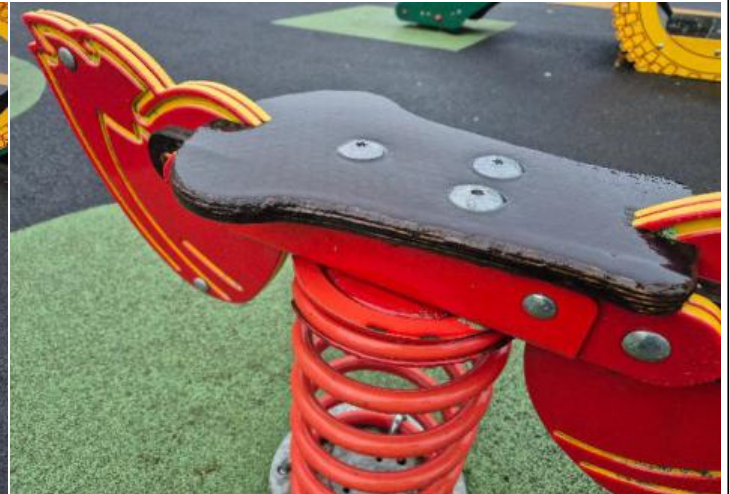
**Item:** Rocking Equipment - Spring Duck  
**Manufacturer:** Creative Play

**Finding:** Parts of the timber are rough or splintered

**Action:** Remove all rough or sharp edges

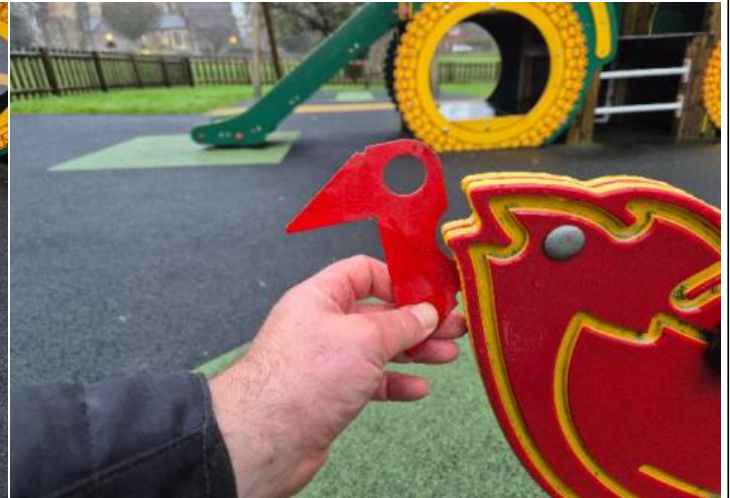
**Item:** Rocking Equipment - Spring Duck  
**Manufacturer:** Creative Play

**Finding:** The main body profile has a radius of less than 20mm in places, in contravention of BS EN 1176 Part 6

**Action:** Monitor - No action given the risk assessment

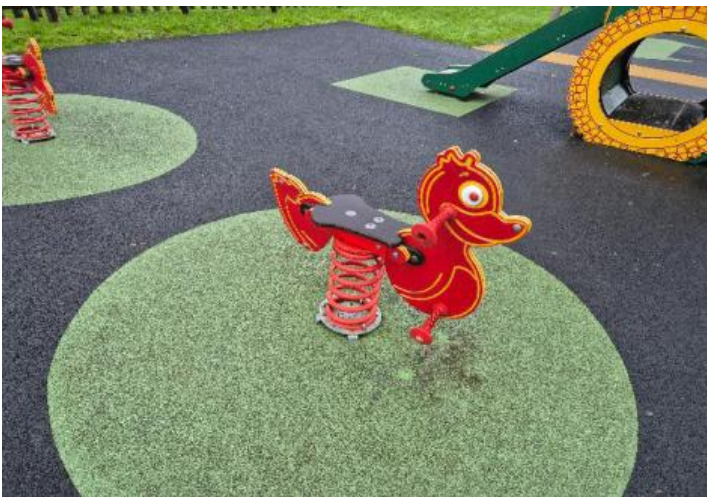
**Item:** Rocking Equipment - Spring Duck  
**Manufacturer:** Creative Play

**Finding:** The item has been damaged

**Action:** Monitor for any further deterioration and replace as required

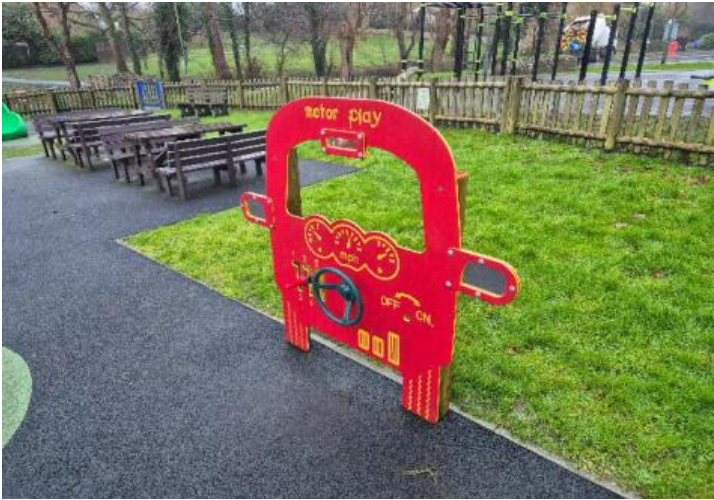
Item: Other - Play Panel  
Manufacturer: Creative Play

**Finding:** There is some strimmer / machinery damage apparent on the posts, this can penetrate the preservative applied to the timber and accelerate the rotting process

**Action:** Monitor for any deterioration (rot) and replace as required

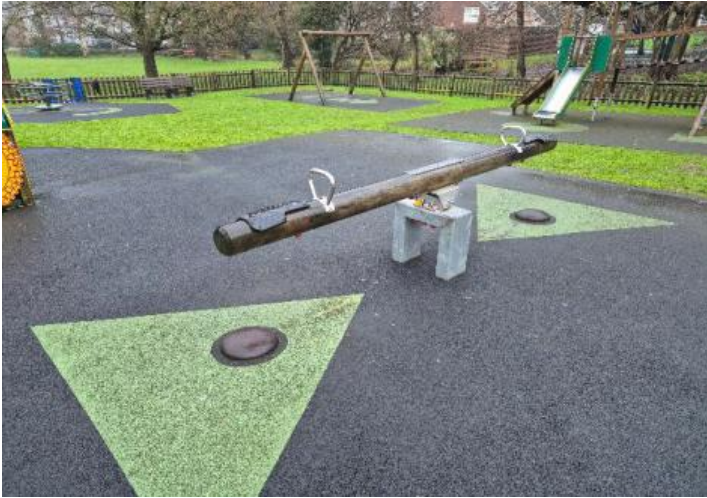
**Item:** Rocking Equipment - See Saw  
**Manufacturer:** Not Identified

**Finding:** The timber on this item has severe rot

**Action:** Remove and replace all affected timber sections

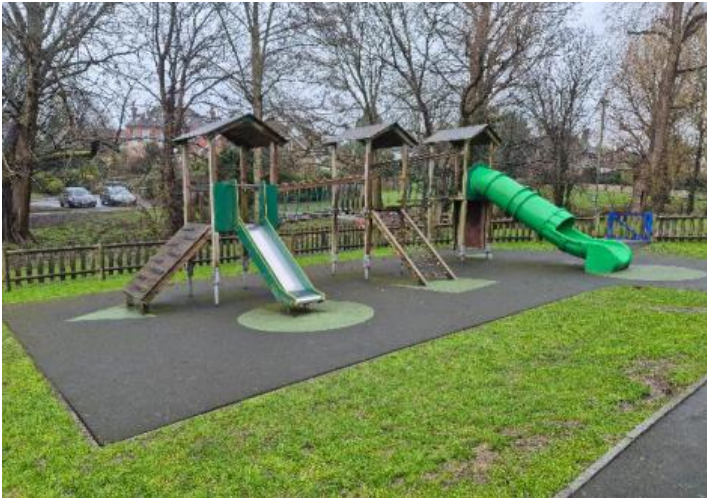
**Item:** Activity Equipment - Multi Play (Junior)  
**Manufacturer:** Creative Play

**Finding:** There are a number of dents in the slide surface

**Action:** Monitor for any further deterioration and repair as required

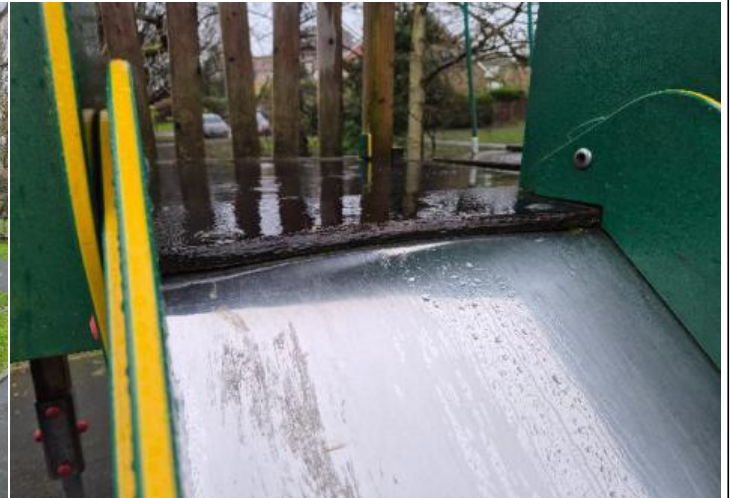
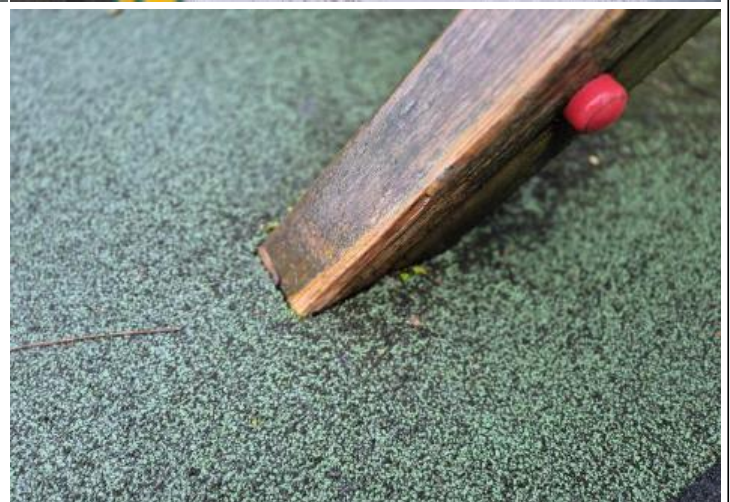
**Item:** Activity Equipment - Multi Play (Junior)  
**Manufacturer:** Creative Play

**Finding:** Parts of the timber are rough or splintered

**Action:** Remove all rough or sharp edges

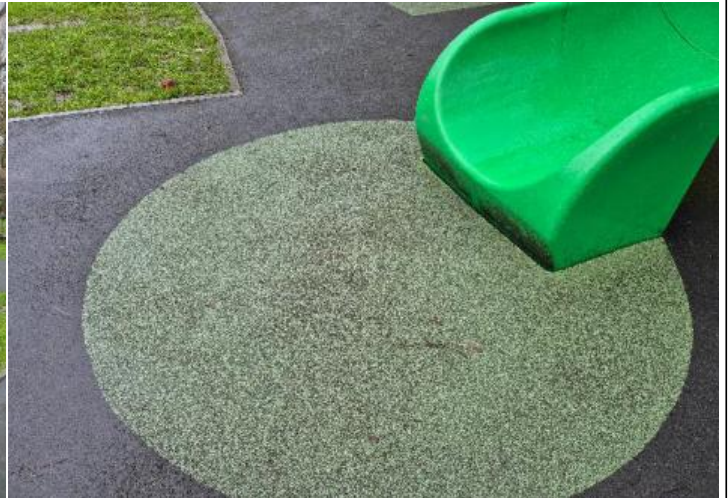
**Item:** Activity Equipment - Multi Play (Junior)  
**Manufacturer:** Creative Play

**Finding:** The safety surface around the area is beginning to wear  
**Action:** Monitor for any further deterioration and repair as required

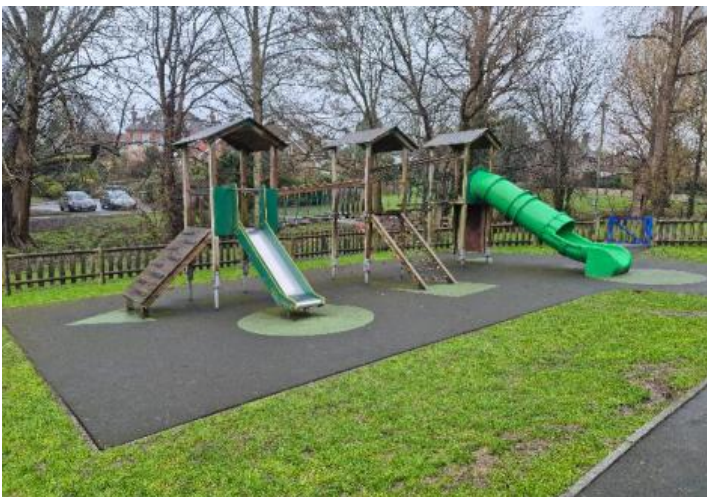
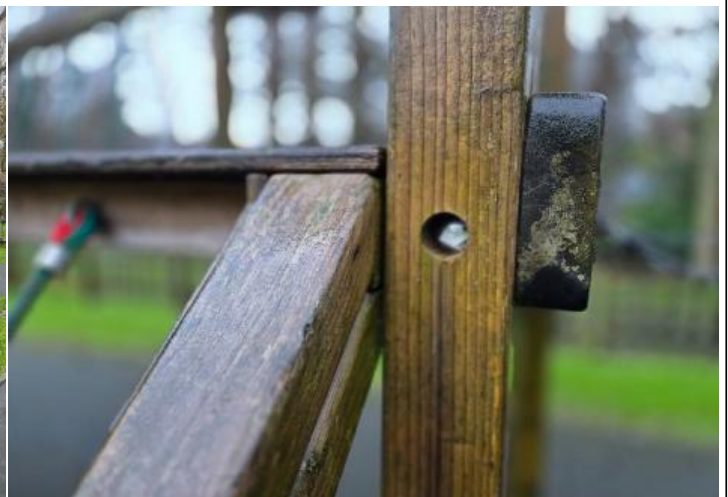
### 4 - Very Low Risk (Finding 5)

**Item:** Activity Equipment - Multi Play (Junior)  
**Manufacturer:** Creative Play

**Finding:** There is/are bolt cap covers missing or damaged on the item  
**Action:** Replace missing or damaged bolt cap covers

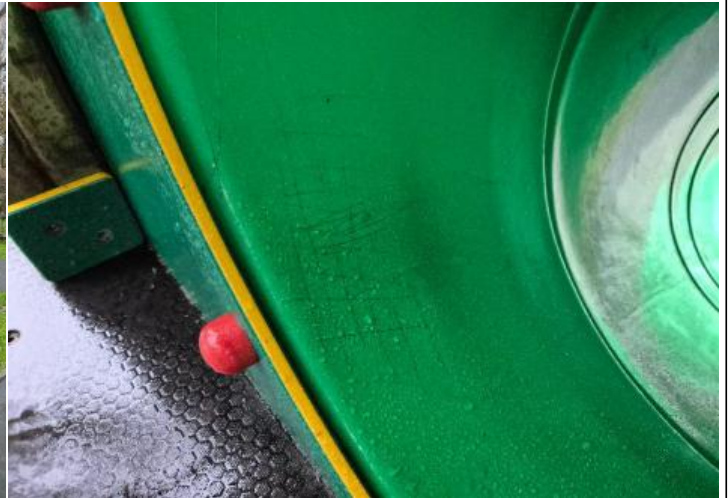
### 6 - Low Risk (Finding 6)

**Item:** Activity Equipment - Multi Play (Junior)  
**Manufacturer:** Creative Play

**Finding:** The item has been damaged

**Action:** Monitor for any further deterioration and replace as required

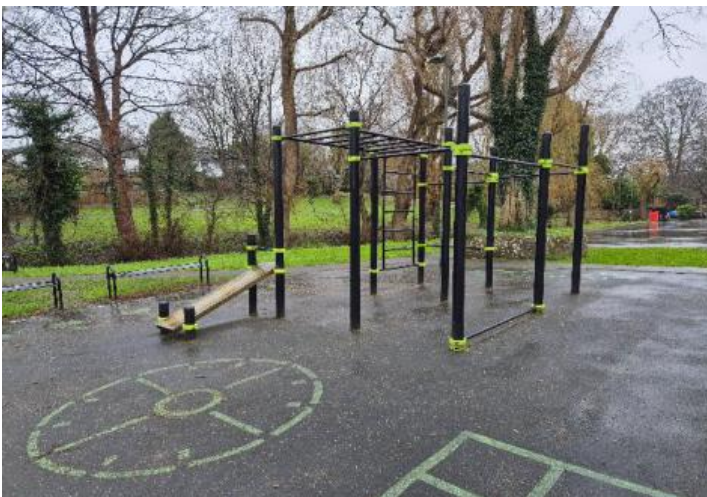
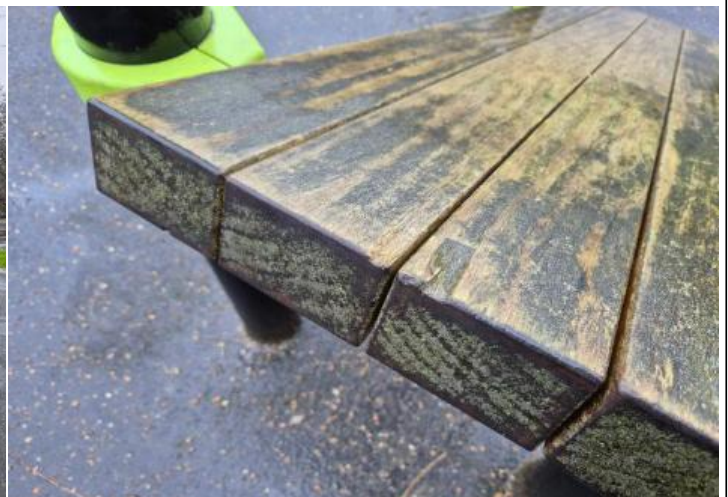
**Item:** Outdoor Fitness Equipment - Fit Point  
**Manufacturer:** Kenguru Fitness

**Finding:** Parts of the timber are rough or splintered

**Action:** Remove all rough or sharp edges
