## COMMUNITY COMMITTEE MEETING HELD ON TUESDAY 4<sup>th</sup> FEBRUARY 2025 AT 7.30 PM AT THE STEYPING CENTRE

# DRAFT MINUTES

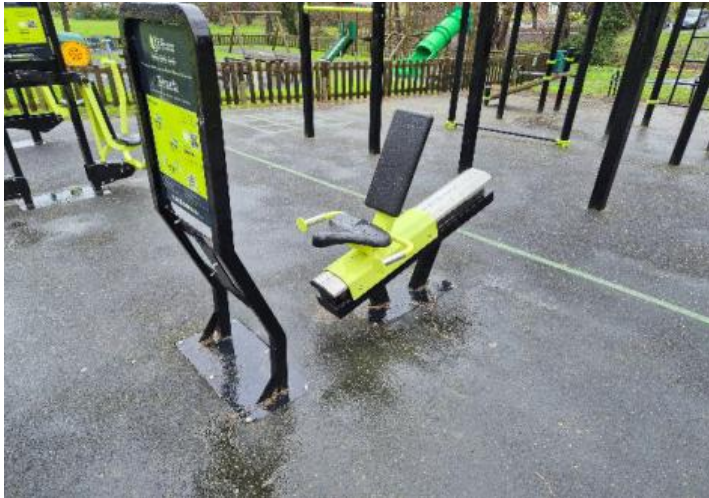
**Item:** Outdoor Fitness Equipment - Leg Press  
**Manufacturer:** The Great Outdoor Gym Company

**Finding:** The item has been damaged

**Action:** Monitor for any further deterioration and replace as required

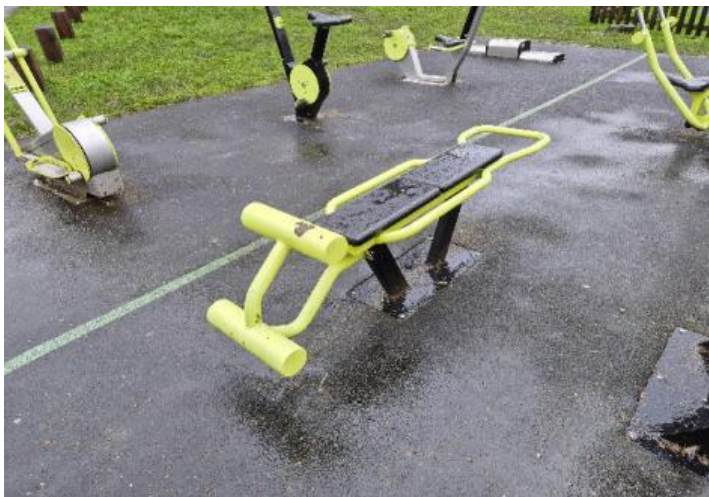
**Item:** Outdoor Fitness Equipment - Sit Up Station  
**Manufacturer:** The Great Outdoor Gym Company

**Finding:** The paintwork on this item has been damaged or worn exposing the metal underneath which is rusting / corroding

**Action:** Treat affected areas and repaint

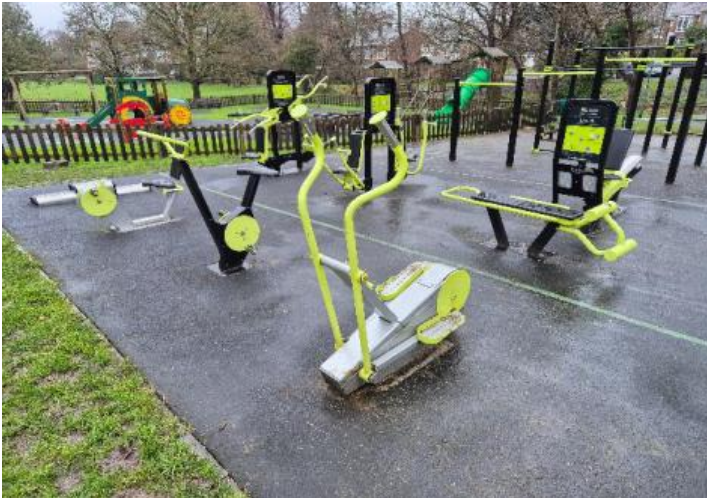
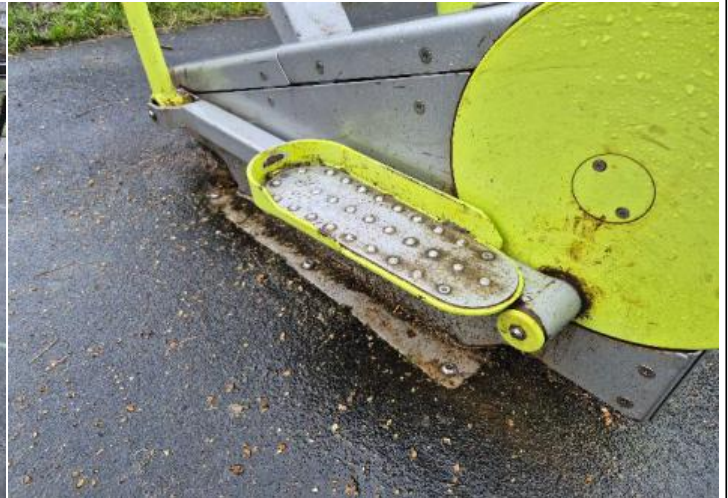
**Item:** Outdoor Fitness Equipment - Cross Trainer  
**Manufacturer:** The Great Outdoor Gym Company  
**Risk Level:** L - Low Risk  
**Surface:** Wet Pour

**Finding:** The tread surface does not have a 10mm high safeguard that extends around the front of the surface and at least 75% of the sides of the surface as required by BS EN 16630

**Action:** Monitor - No action given the risk assessment

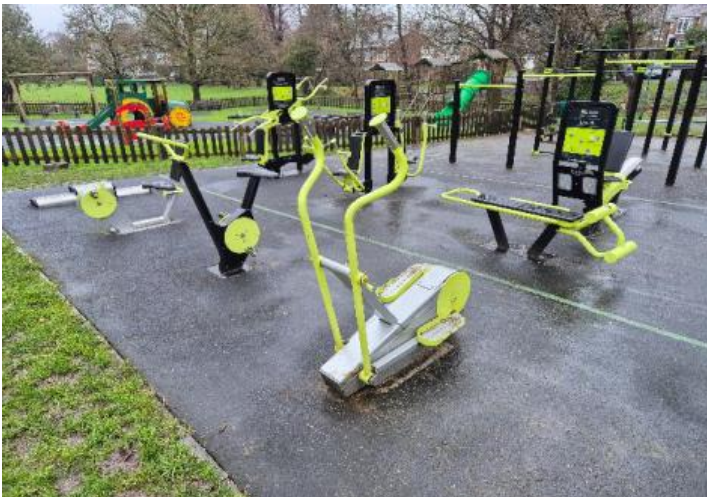
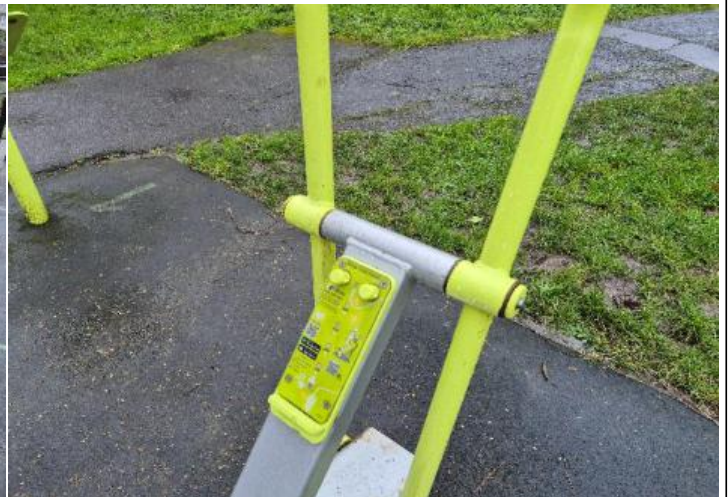
**Item:** Outdoor Fitness Equipment - Cross Trainer  
**Manufacturer:** The Great Outdoor Gym Company  
**Risk Level:** L - Low Risk  
**Surface:** Wet Pour

**Finding:** The bearing is showing signs of wear

**Action:** Monitor for any further deterioration and replace as required

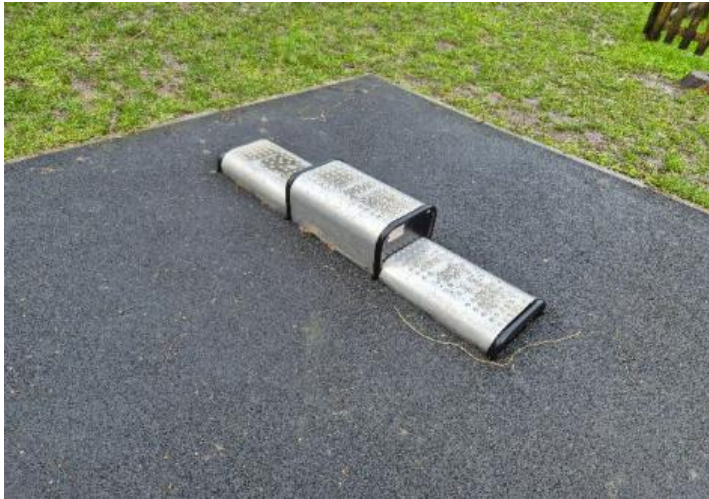
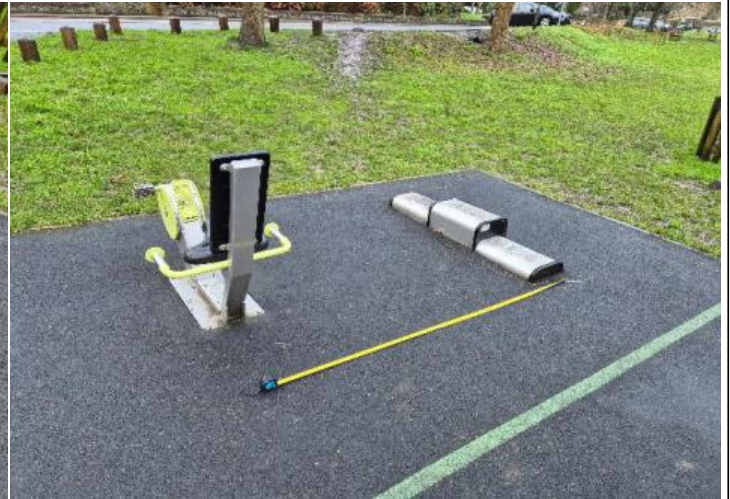
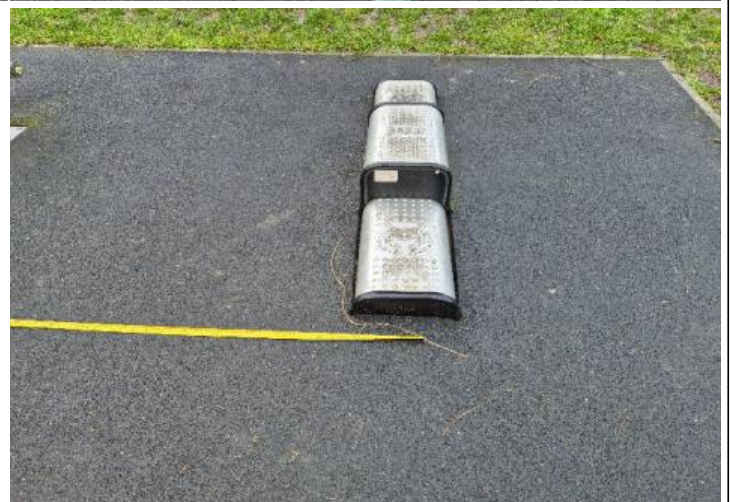
**Finding:** The training space of the recumbent cycle and the step up unit overlap in contravention of the requirements of BS EN 16630

**Action:** Monitor - No action given the risk assessment

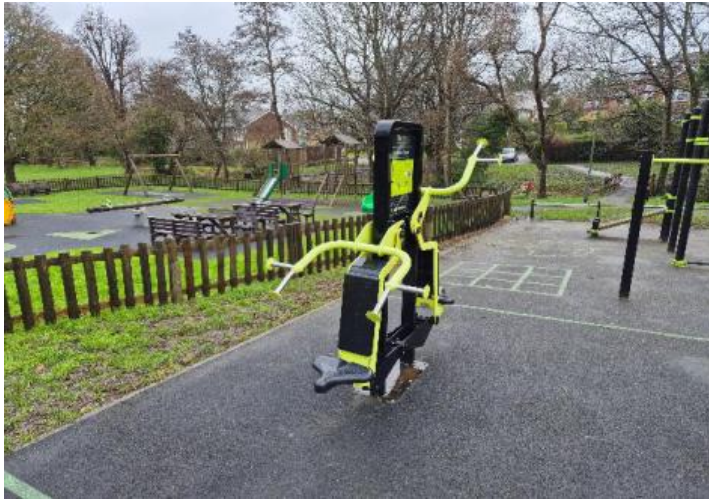
**Finding:** The paintwork on this item has been damaged or worn exposing the metal underneath which is rusting / corroding

**Action:** Treat affected areas and repaint

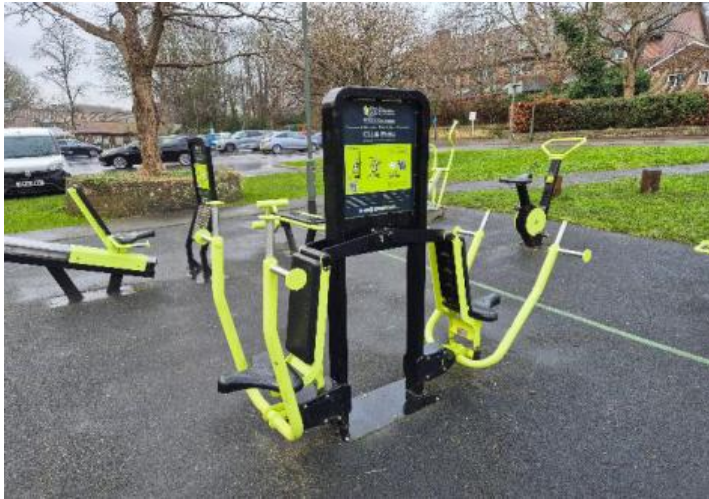
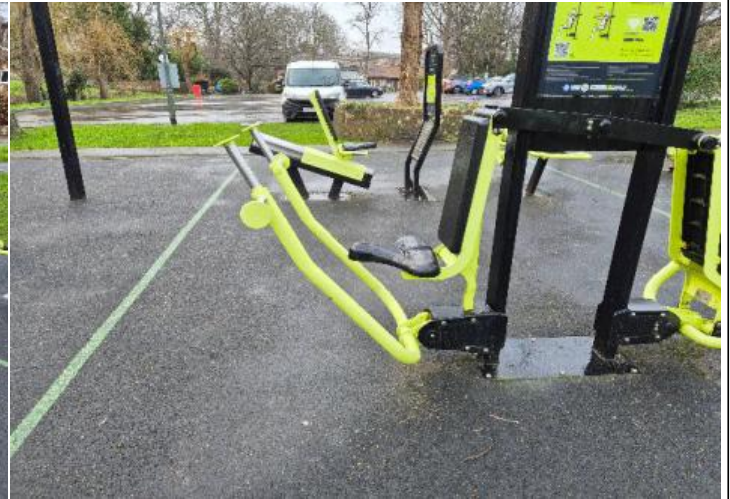
**Item:** Outdoor Fitness Equipment - Double Fitness Station  
**Manufacturer:** The Great Outdoor Gym Company

**Finding:** BS EN 16630 - 4.3.1 states that fitness equipment shall be designed so when at rest, the equipment shall automatically adjust so that the equipment is ready for the next user  
**Action:** Service the item

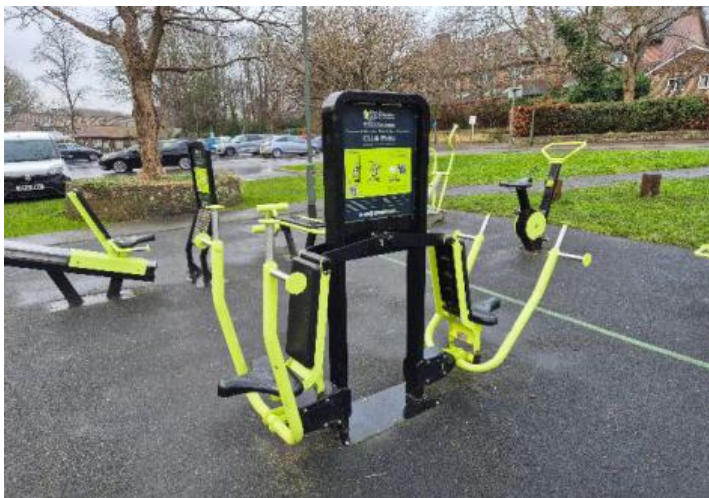
**Item:** Outdoor Fitness Equipment - Double Fitness Station  
**Manufacturer:** The Great Outdoor Gym Company

**Finding:** There is some minor damage to the surface  
**Action:** Monitor for any further deterioration and repair as required

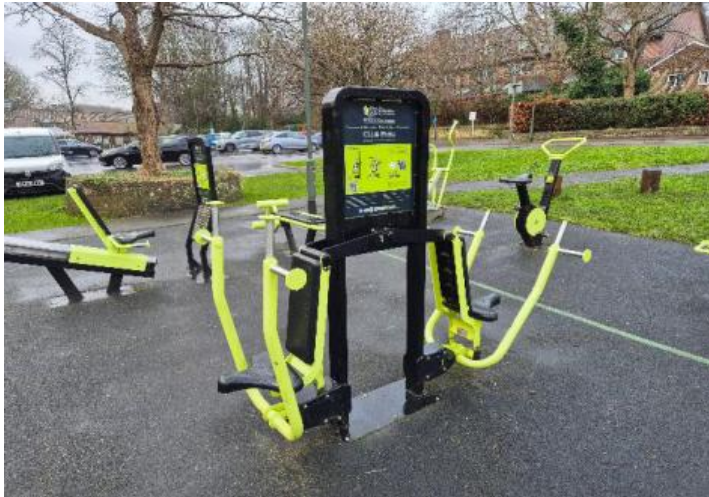
**Finding:** The paintwork on this item has been damaged or worn exposing the metal underneath which is rusting / corroding

**Action:** Treat affected areas and repaint

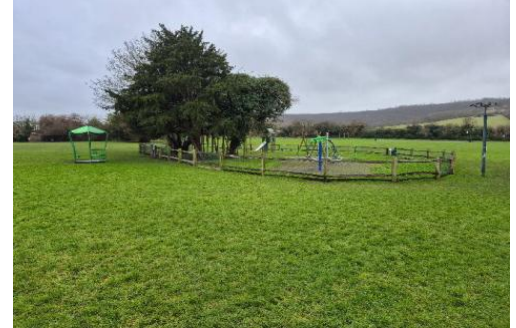
There are gaps opening between the surfacing and the edging surround or between the joints in the surfacing - Monitor for any further deterioration and repair as required

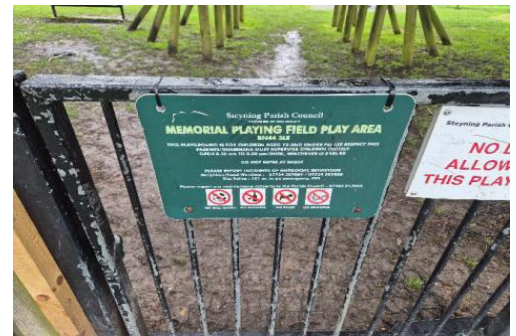
A number of fixing(s) have worked loose - Secure all loose fixings

Cable ties are present and there are sharp projecting ends - Replace with a more appropriate fixing method

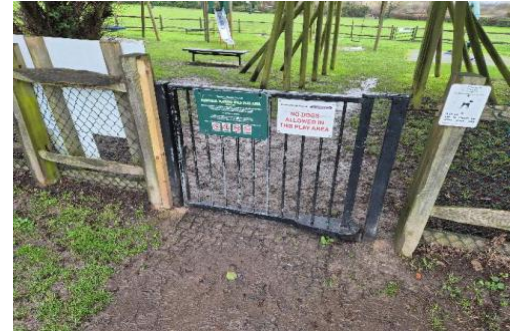
The area under the gate has eroded leaving uneven areas, or the concrete foundations exposed, resulting in trip hazards at the entrance/exit to the playground - Reinststate to level with surrounding surfaces

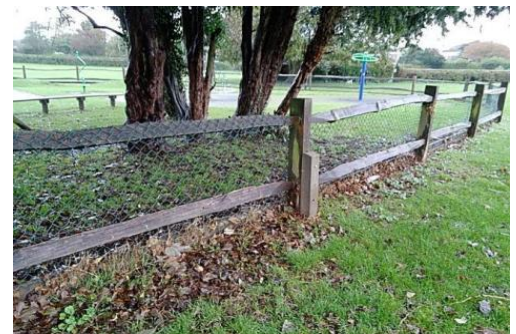
There are a number of fixings missing from the fence - Replace missing fixings

The fence is damaged in places leaving sharp protruding wires - Repair or replace all affected sections

There is some damage to the fence sections - Monitor for any further deterioration and repair as required

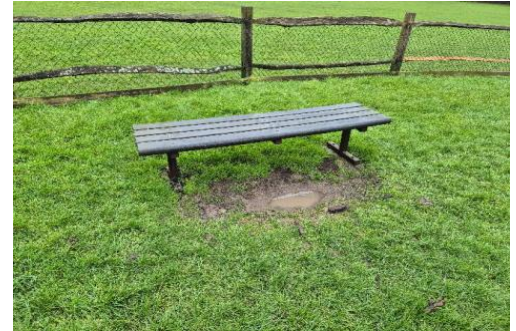
The surface has eroded in some areas and may be slippery in wet conditions - Reinstate the surface

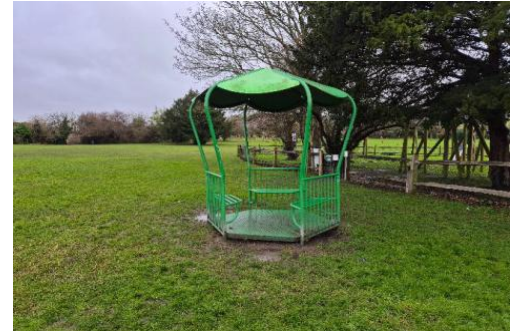
The surface has eroded in some areas and may be slippery in wet conditions - Reinstate the surface

There is/are inserts missing - Replace missing inserts

The paintwork on this item has been damaged or worn exposing the metal underneath which is rusting / corroding - Treat affected areas and repaint

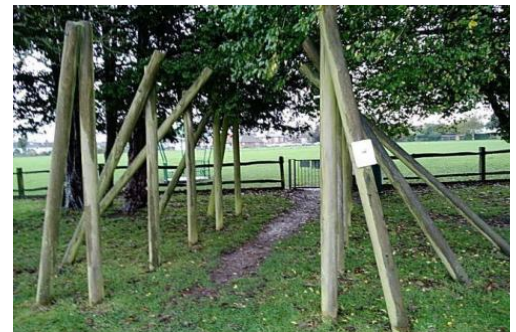
There is some strimmer / machinery damage apparent on the posts, this can penetrate the preservative applied to the timber and accelerate the rotting process - Monitor for any deterioration (rot) and replace as required

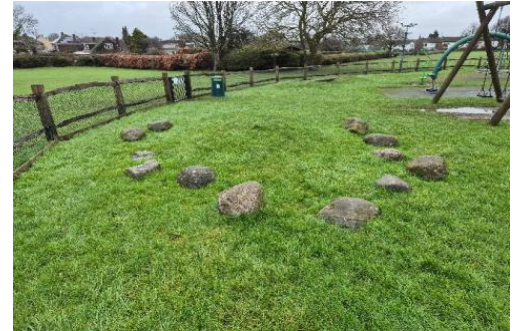
The boulder/s is / are unsecured and are small / light enough to be moved around the area or topple - Secure boulder/s in position

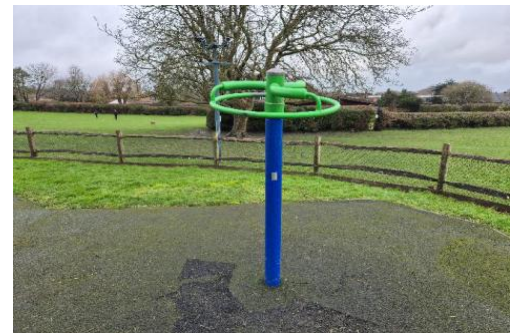
There is some minor damage to the surface - Monitor for any further deterioration and repair as required

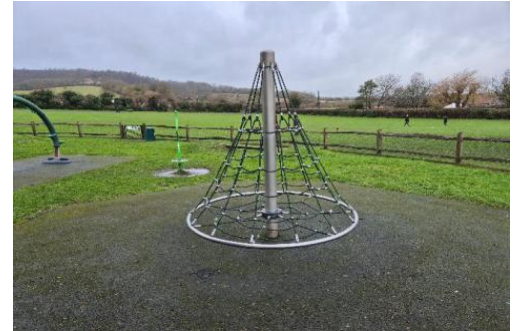
The clearance to the underside is less than 400mm and fails the requirements of BS EN 1176 Part 5 - Monitor - No action given the risk assessment

The ropes on this item have been taped and we are unable to fully assess the condition of the rope, ensure no wire strands are broken beneath the tape - Repair or replace as required

The ropes/nets are worn/damaged in places - Monitor for any further deterioration and repair or replace as required

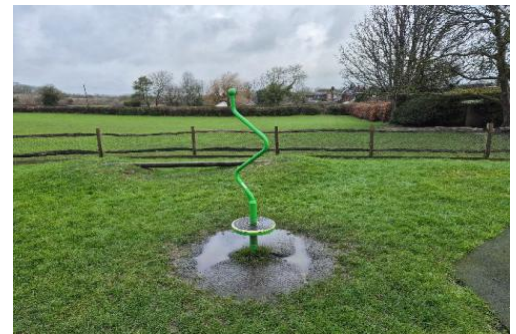
The surfacing dimensions are short and do not meet with the requirements of the current applicable standard - Monitor - No action given the risk assessment

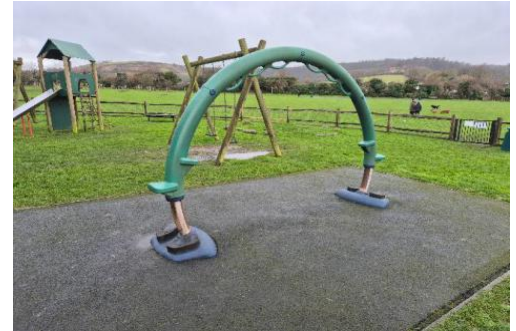
The paintwork on this item has been damaged or worn exposing the metal underneath which is rusting / corroding - Treat affected areas and repaint

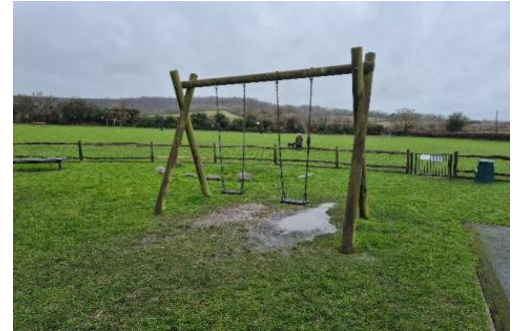
The surface has subsided in some areas - Monitor for any further deterioration and repair as required

There is some strimmer / machinery damage apparent on the posts, this can penetrate the preservative applied to the timber and accelerate the rotting process - Monitor for any deterioration (rot) and replace as required

The timber has a number of splits/shakes or air cracks and this may affect the stability or allow water ingress which will accelerate the rotting process - Monitor to ensure the splits do not cross through fixing points of the structure and/or cause any instability

The chain openings are in excess of the 8.6mm as recommended by BS EN 1176 - Monitor - No action given the risk assessment

There is/are bolt cap covers missing or damaged on the item - Replace missing or damaged bolt cap covers

This design of swing joint has been known to fail on the weld connecting the joint to the threaded stud - We would recommend that the joint be dismantled and checked on a regular basis or consulting with manufacturer on whether a Secondary Safety Device can be fitted

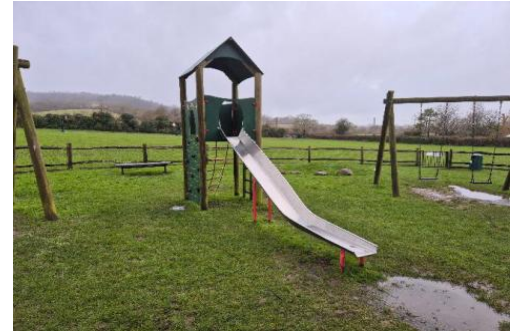
There is offensive graffiti present - Remove as soon as practicable

There is some strimmer / machinery damage apparent on the posts, this can penetrate the preservative applied to the timber and accelerate the rotting process - Monitor for any deterioration (rot) and replace as required

A number of fixing(s) have worked loose - Secure all loose fixings

There is/are finger entrapment/s at the top of the net climber and the item fails to meet the requirements of BS EN 1176 Part 1 4.2.7.6 Entrapment of fingers - Monitor - No action given the risk assessment

The paintwork on this item has been damaged or worn exposing the metal underneath which is rusting / corroding - Treat affected areas and repaint

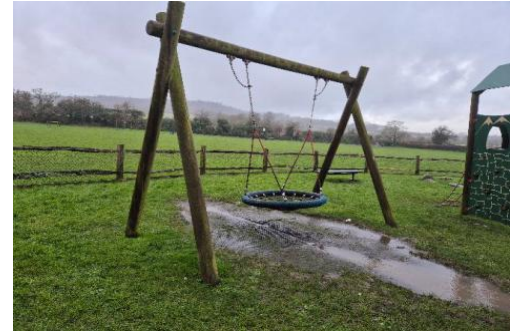
The surface has subsided in some areas - Monitor for any further deterioration and repair as required

There is/are bolt cap covers missing or damaged on the item - Replace missing or damaged bolt cap covers

A number of fixing(s) have worked loose - Secure all loose fixings

There is some strimmer / machinery damage apparent on the posts, this can penetrate the preservative applied to the timber and accelerate the rotting process - Monitor for any deterioration (rot) and replace as required

The ropes/nets are worn/damaged in places - Monitor for any further deterioration and repair or replace as required

The timber has a number of splits/shakes or air cracks and this may affect the stability or allow water ingress which will accelerate the rotting process - Monitor to ensure the splits do not cross through fixing points of the structure and/or cause any instability

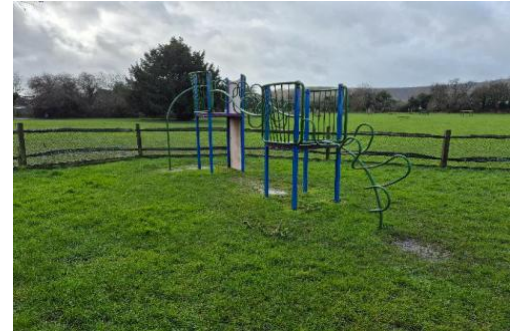
There are gaps opening between the grass mat tiles - Provide additional ties or secure / reinstate surface

The item has been damaged - Monitor for any further deterioration and replace as required

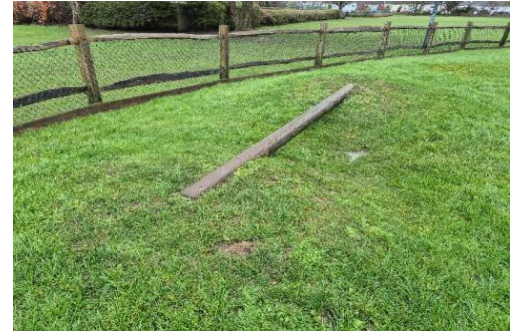
There is algae growth on the surface of the equipment resulting in slippery conditions - Clean and treat appropriately

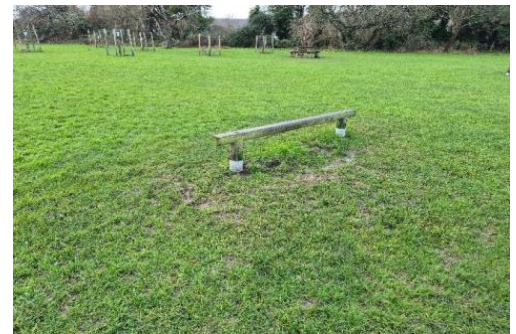
The surface has eroded in some areas and may be slippery in wet conditions - Reinstate the surface

There is algae growth on the surface of the equipment resulting in slippery conditions - Clean and treat appropriately

The surface has eroded and the foundations are exposed - Reinstate surrounding surfaces to cover the foundations

There are steel strimmer guards fitted and the inspector could not fully inspect for rot - Remove cover and inspect for rot

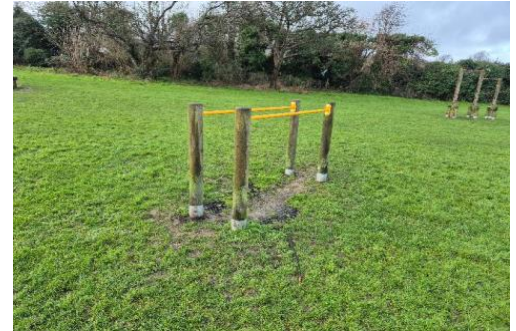
There are strimmer guards fitted and the inspector could not fully inspect for rot - Remove cover and inspect for rot

There are areas or parts of the timber on the structure that have rotted - Replace all affected timbers

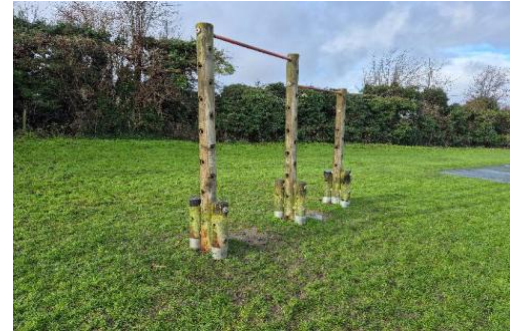
The grass mats are silted up and the soil is compacted; this may have an effect on the impact absorbing properties of the surface. Consideration should be given to HIC testing the surface to verify impact attenuating properties ( <https://playinspections.co.uk/inspection-services/safety-surface-testing/> ) - Contact our office for a quotation for this service

There is some evidence of rot in the timber - Monitor for any further deterioration and replace as required

The timber has a number of splits/shakes or air cracks and this may affect the stability or allow water ingress which will accelerate the rotting process - Monitor to ensure the splits do not cross through fixing points of the structure and/or cause any instability

There is some strimmer / machinery damage apparent on the posts, this can penetrate the preservative applied to the timber and accelerate the rotting process - Monitor for any deterioration (rot) and replace as required

The item has been damaged - Monitor for any further deterioration and replace as required

There are steel strimmer guards fitted and the inspector could not fully inspect for rot - Remove cover and inspect for rot

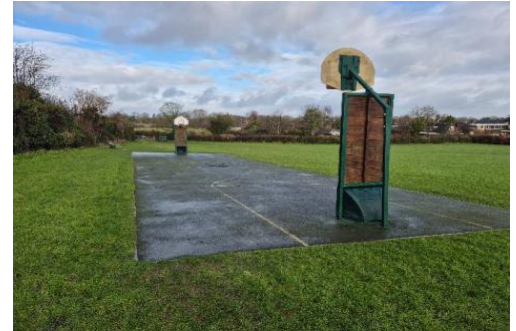
There is some graffiti present - Remove the graffiti

The free space between the backboard and the framework is less than 600mm and fails the requirements of BS EN15312:2007 +A1 2010 - Monitor - No action given the risk assessment

There is/are finger entrapments due to missing inserts/fixings and the item fails to meet the requirements of BS EN 15312 Clause 4.4.2.2 Entrapment of fingers - Replace missing fixings/inserts to remove the entrapments

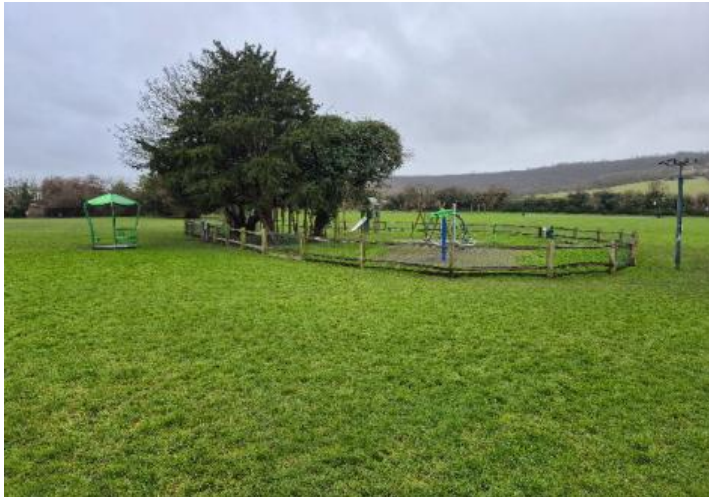
**Finding:** There are gaps opening between the surfacing and the edging surround or between the joints in the surfacing **Action:** Monitor for any further deterioration and repair as required

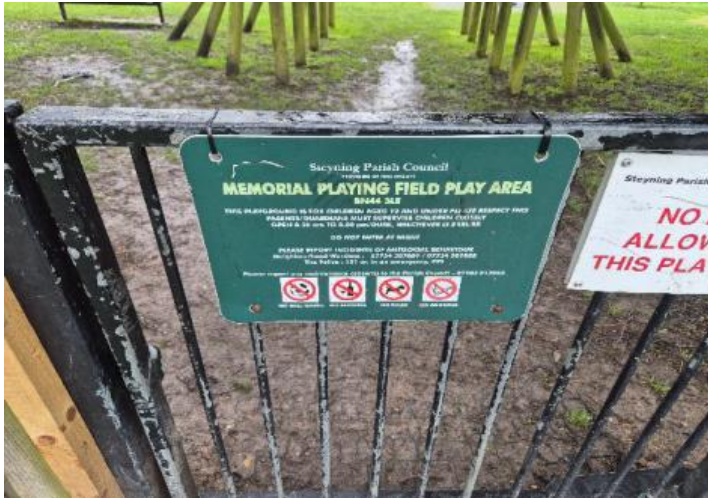
**Finding:** A number of fixing(s) have worked loose

**Action:** Secure all loose fixings

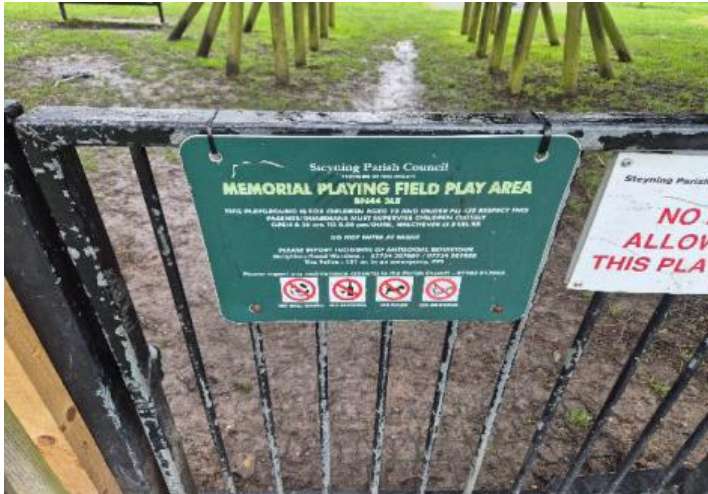
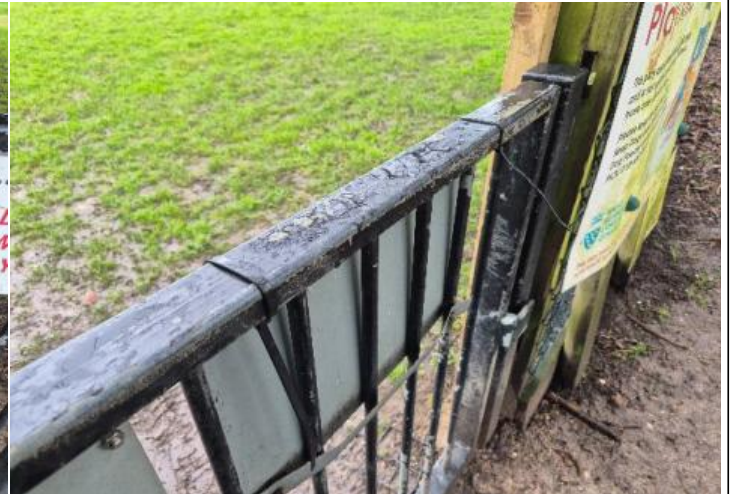
**Finding:** Cable ties are present and there are sharp projecting ends

**Action:** Replace with a more appropriate fixing method

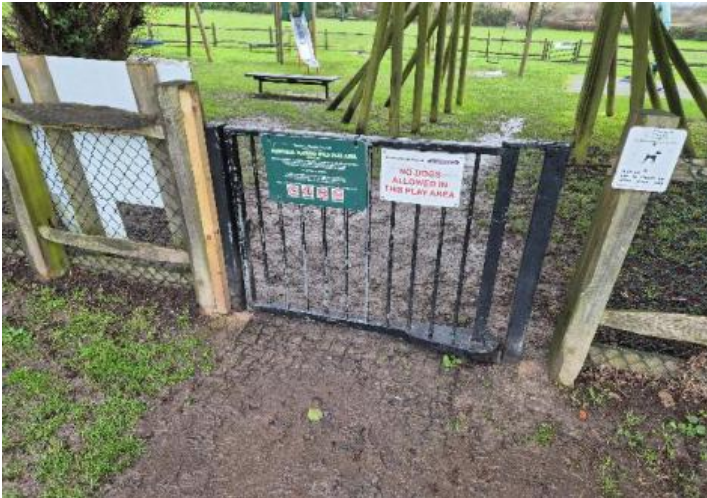
**Finding:** The area under the gate has eroded leaving uneven areas, or the concrete foundations exposed, resulting in trip hazards at the entrance/exit to the playground

**Action:** Reinststate to level with surrounding surfaces

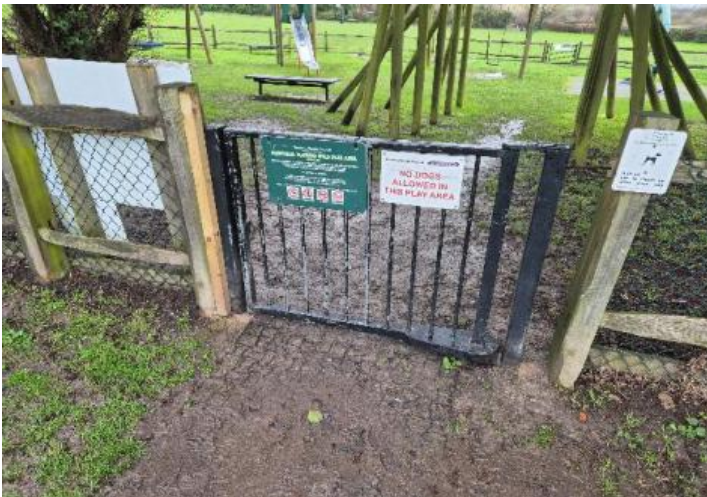
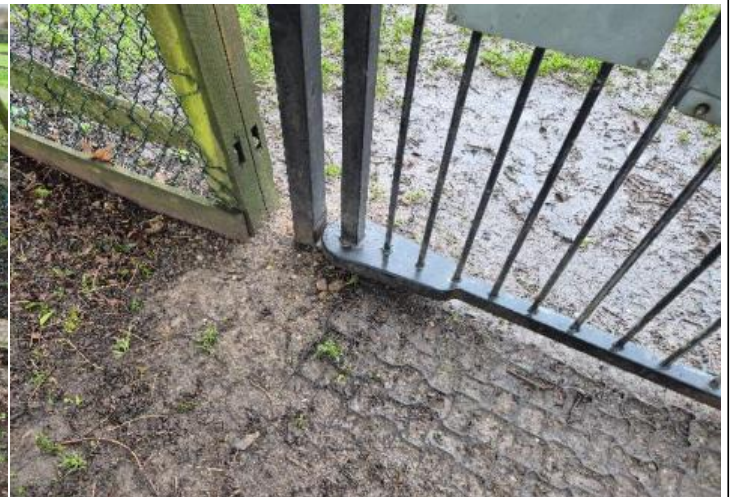
**Item:** Gates - Gate - Self Closing  
**Manufacturer:** I.A.E. Fencing

**Finding:** The gate is closing too quickly (less than 4 seconds)

**Action:** Take corrective action to ensure that the gate closes in 4-8 seconds from 90 degrees

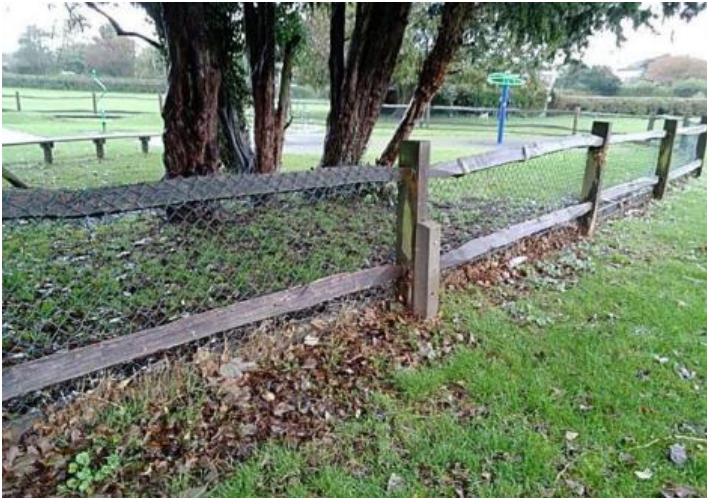
**Item:** Fences - Fence - Timber & Mesh Infill  
**Manufacturer:** Not Identified

**Finding:** There are a number of fixings missing from the fence

**Action:** Replace missing fixings

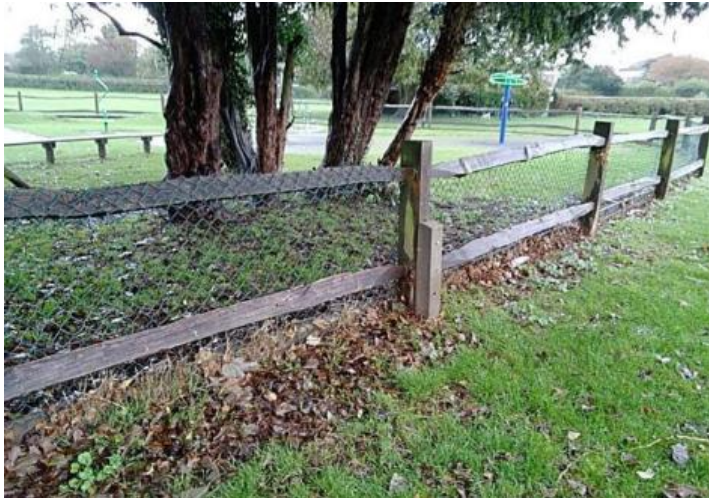
**Item:** Fences - Fence - Timber & Mesh Infill  
**Manufacturer:** Not Identified

**Finding:** The fence is damaged in places leaving sharp protruding wires

**Action:** Repair or replace all affected sections

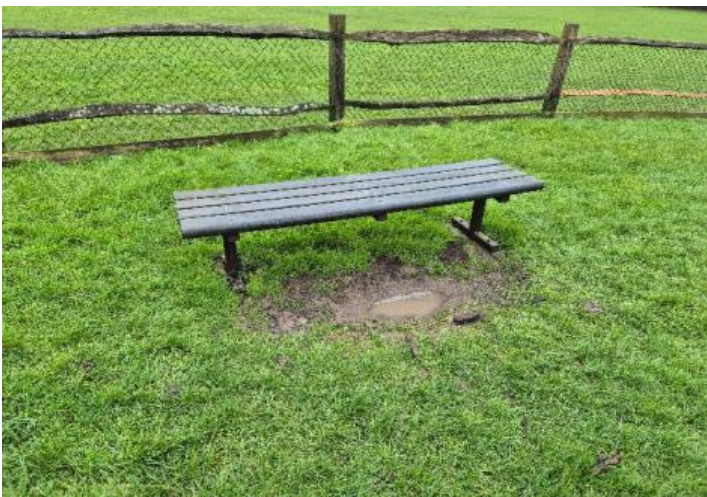
**Item:** Ancillary Items - Bench  
**Manufacturer:** Not Identified

**Finding:** The surface has eroded in some areas and may be slippery in wet conditions

**Action:** Reinststate the surface

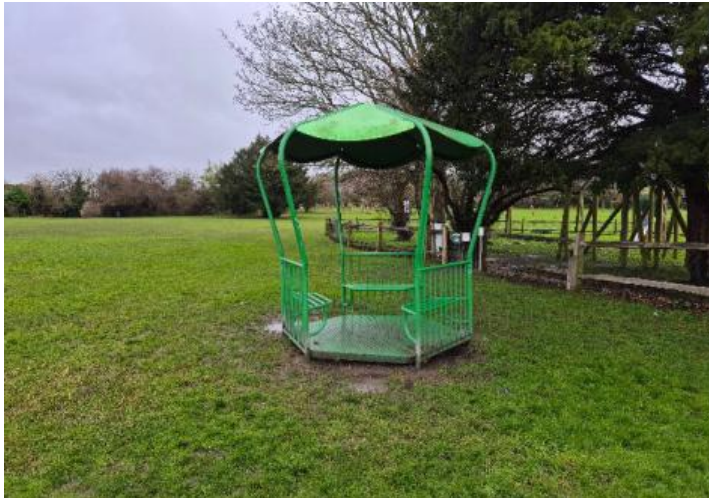
**Item:** Ancillary Items - Shelter  
**Manufacturer:** Wicksteed Playgrounds

**Finding:** The surface has eroded in some areas and may be slippery in wet conditions  
**Action:** Reinstate the surface

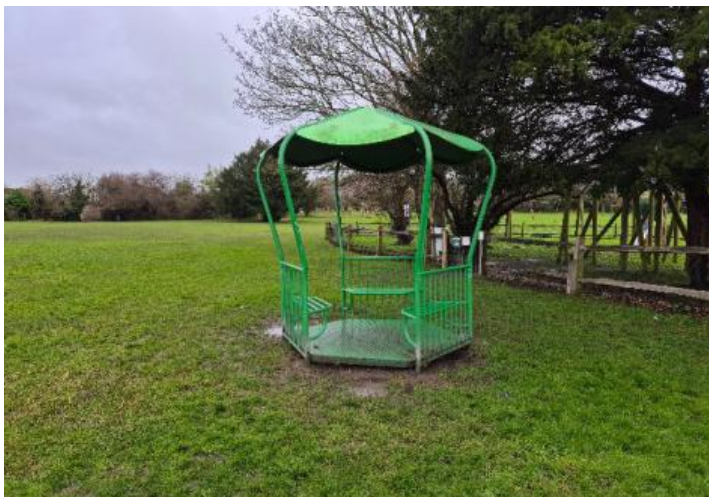
**Item:** Ancillary Items - Shelter  
**Manufacturer:** Wicksteed Playgrounds

**Finding:** There is/are inserts missing  
**Action:** Replace missing inserts

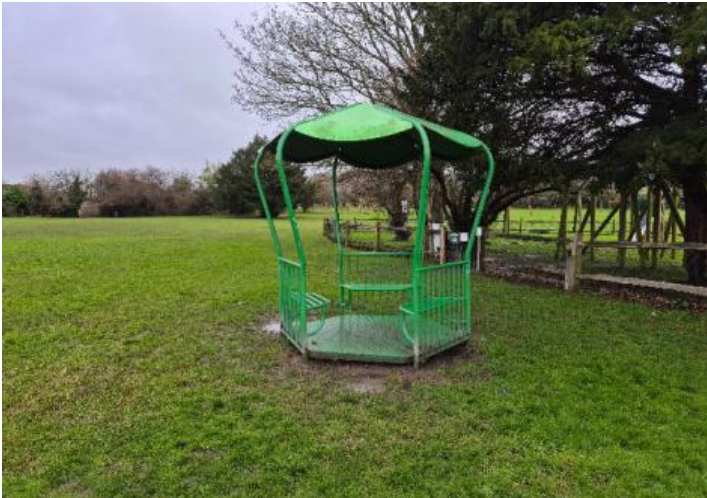
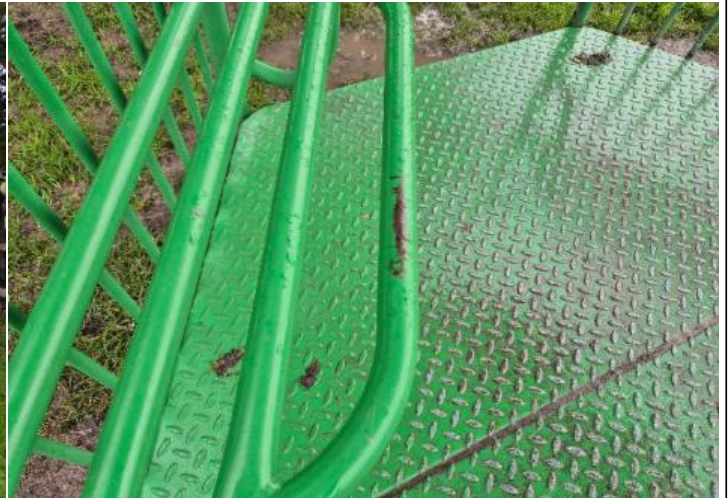
**Item:** Ancillary Items - Shelter  
**Manufacturer:** Wicksteed Playgrounds

**Finding:** The paintwork on this item has been damaged or worn exposing the metal underneath which is rusting / corroding

**Action:** Treat affected areas and repaint

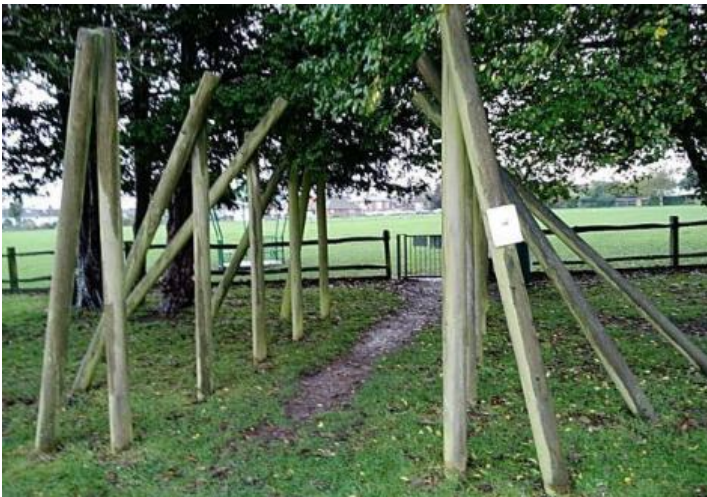
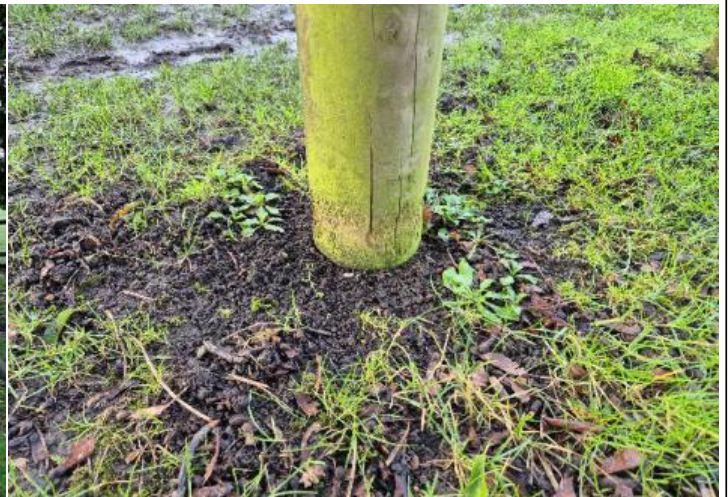
**Item:** Ancillary Items - Entrance Feature  
**Manufacturer:** Not Identified

**Finding:** There is some strimmer / machinery damage apparent on the posts, this can penetrate the preservative applied to the timber and accelerate the rotting process

**Action:** Monitor for any deterioration (rot) and replace as required

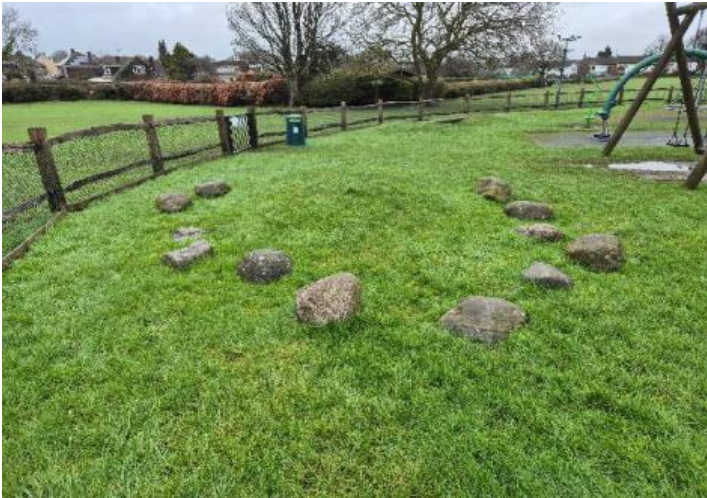
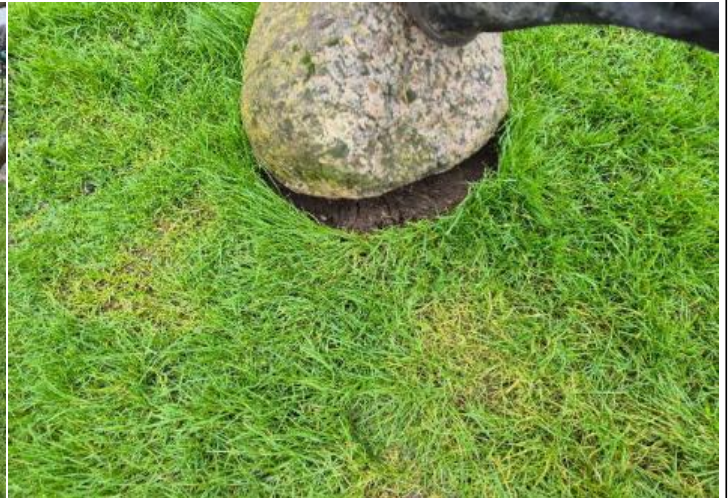
**Item:** Other - Boulders  
**Manufacturer:** Natural Feature

**Finding:** The boulder/s is / are unsecured and are small / light enough to be moved around the area or topple

**Action:** Secure boulder/s in position

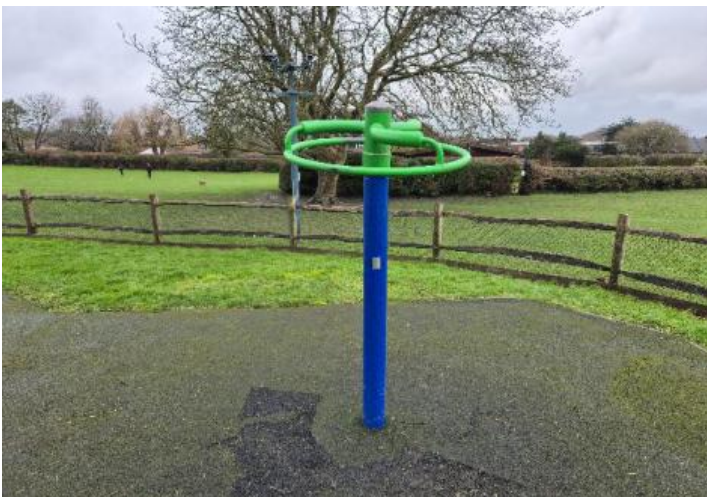
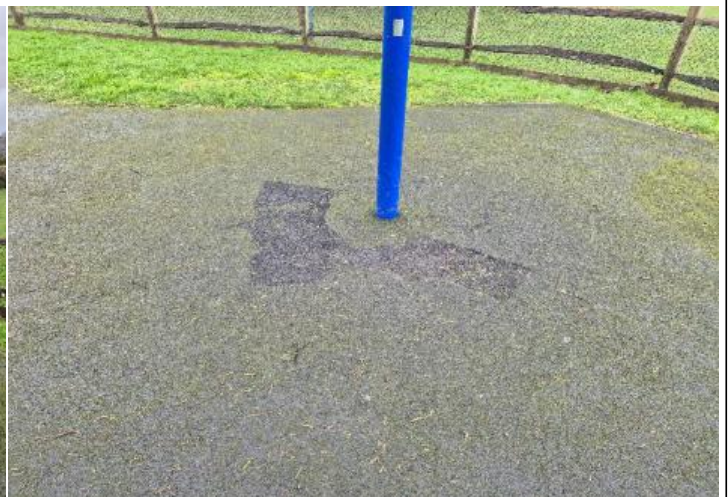
**Item:** Rotor Play - Overhead Rotator  
**Manufacturer:** Wicksteed Playgrounds

**Finding:** There is some minor damage to the surface

**Action:** Monitor for any further deterioration and repair as required

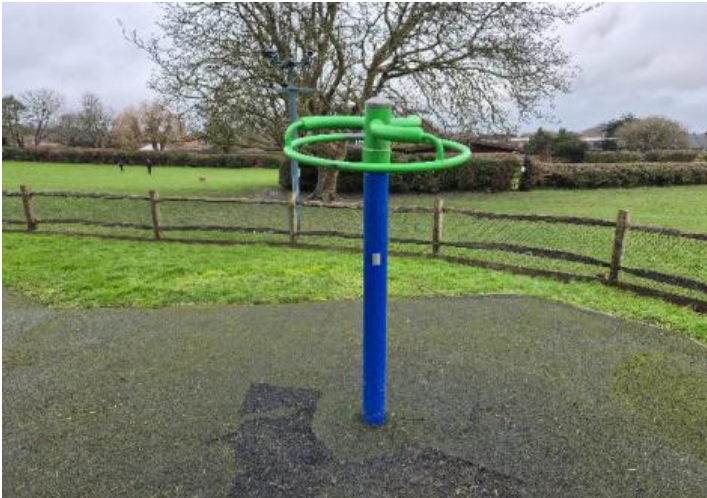
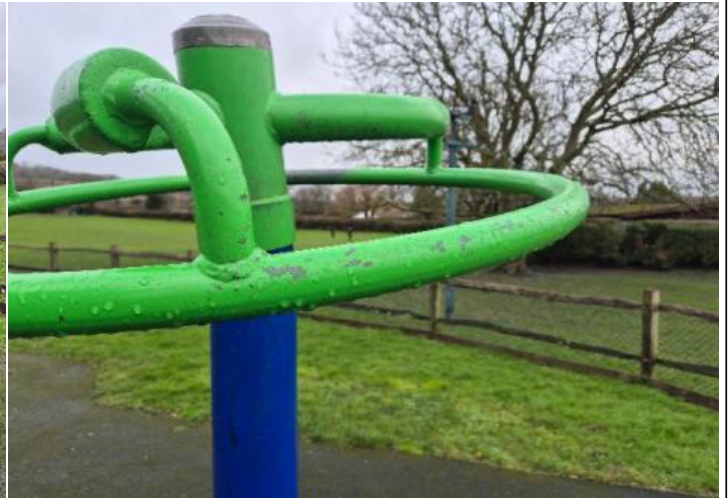
**Item:** Rotor Play - Overhead Rotator  
**Manufacturer:** Wicksteed Playgrounds

**Finding:** The paint is flaking off the metalwork

**Action:** Rub down and re-paint

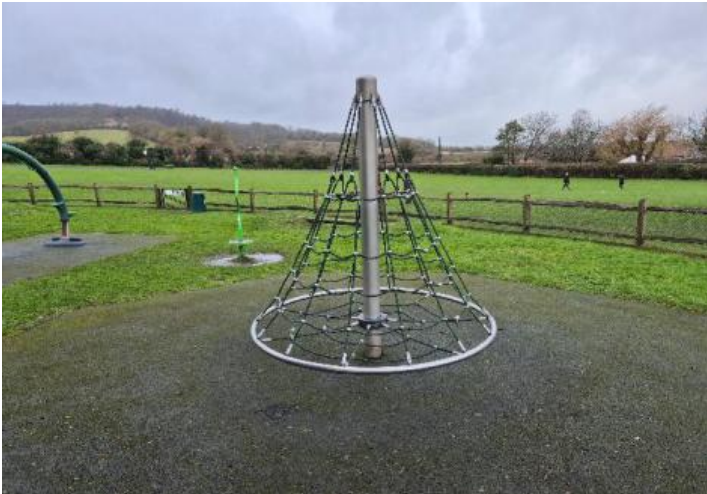
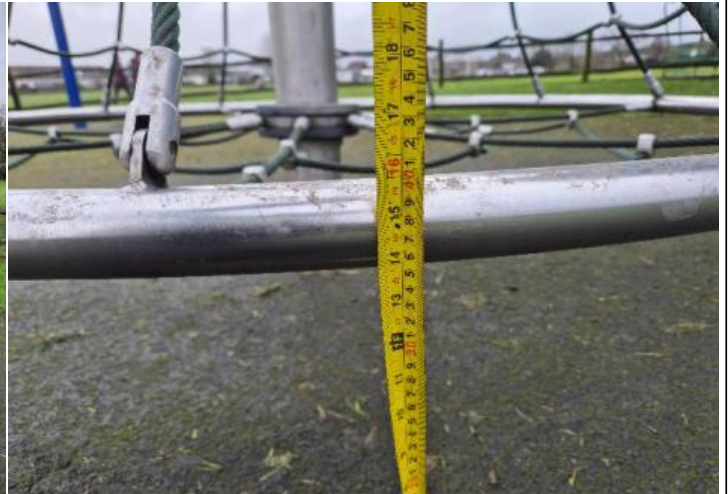
**Item:** Rotor Play - Rotating Net  
**Manufacturer:** Wicksteed Playgrounds

**Finding:** The clearance to the underside is less than 400mm and fails the requirements of BS EN 1176 Part 5

**Action:** Monitor - No action given the risk assessment

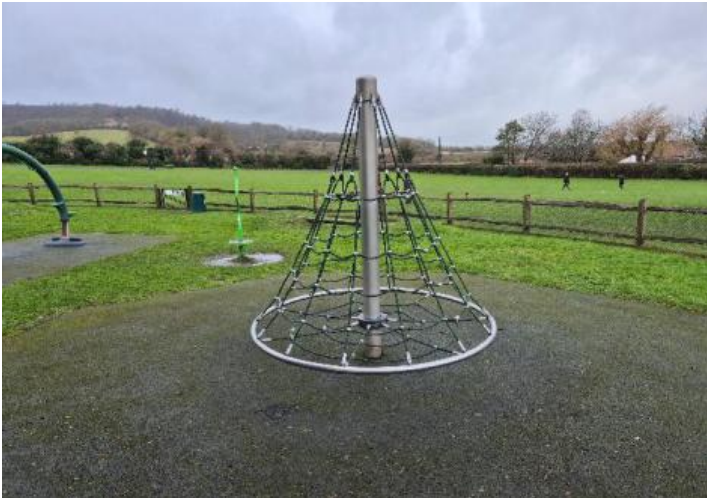
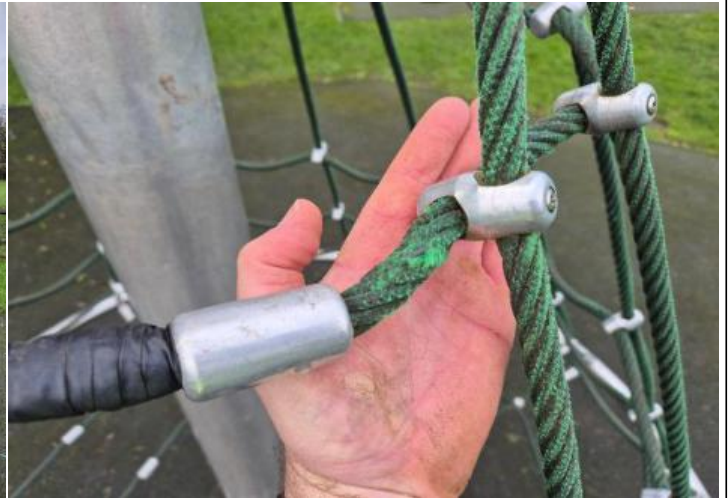
**Item:** Rotor Play - Rotating Net  
**Manufacturer:** Wicksteed Playgrounds

**Finding:** The ropes/nets are worn/damaged in places

**Action:** Monitor for any further deterioration and repair or replace as required

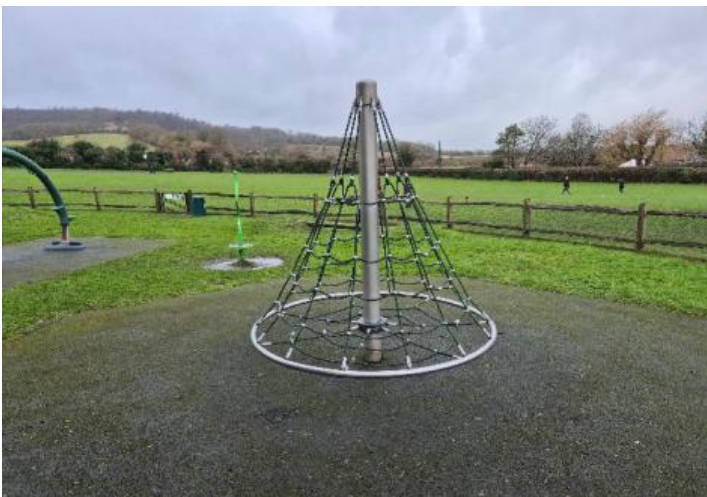
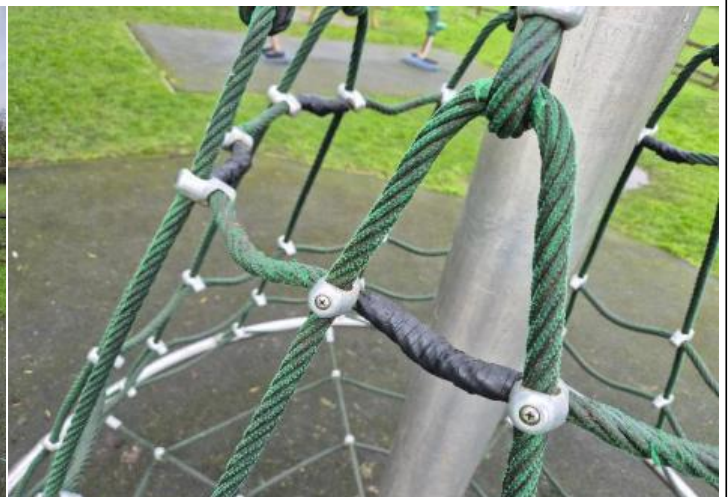
**Item:** Rotor Play - Rotating Net  
**Manufacturer:** Wicksteed Playgrounds

**Finding:** The ropes on this item have been taped and we are unable to fully assess the condition of the rope, ensure no wire strands are broken beneath the tape

**Action:** Repair or replace as required

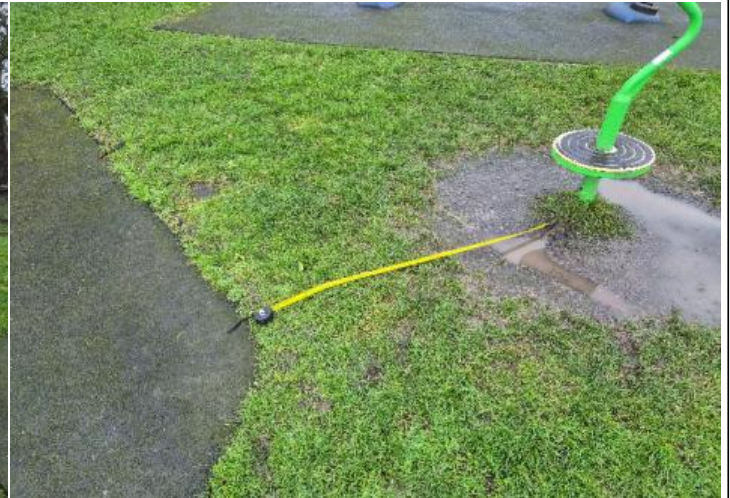
**Item:** Rotor Play - Spinning Pole  
**Manufacturer:** Wicksteed Playgrounds

**Finding:** The surfacing dimensions are short and do not meet with the requirements of the current applicable standard

**Action:** Monitor - No action given the risk assessment
