## COMMUNITY COMMITTEE MEETING HELD ON TUESDAY 4<sup>th</sup> FEBRUARY 2025 AT 7.30 PM AT THE STEYPING CENTRE

# DRAFT MINUTES

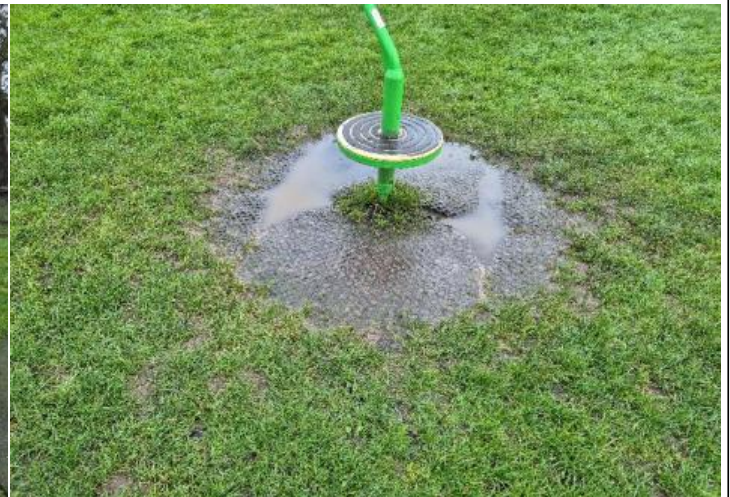
**Item:** Rotor Play - Spinning Pole  
**Manufacturer:** Wicksteed Playgrounds

**Finding:** The grass mats are silted up, the soil is compacted and the area will become very slippery when the soil is wet.

**Action:** Reinststate as required

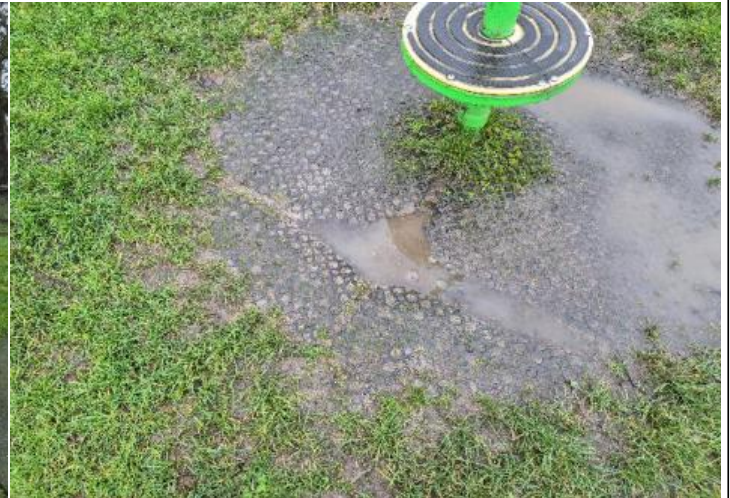
**Item:** Rotor Play - Spinning Pole  
**Manufacturer:** Wicksteed Playgrounds

**Finding:** There are gaps opening between the grass mat tiles

**Action:** Provide additional ties or secure / reinstate surface

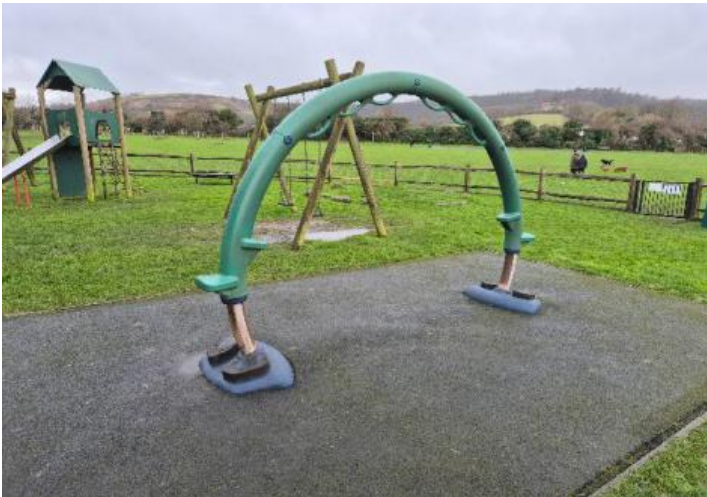
**Item:** Rocking Equipment - Rock n Cross  
**Manufacturer:** Big Toys

**Finding:** The paintwork on this item has been damaged or worn exposing the metal underneath which is rusting / corroding

**Action:** Treat affected areas and repaint

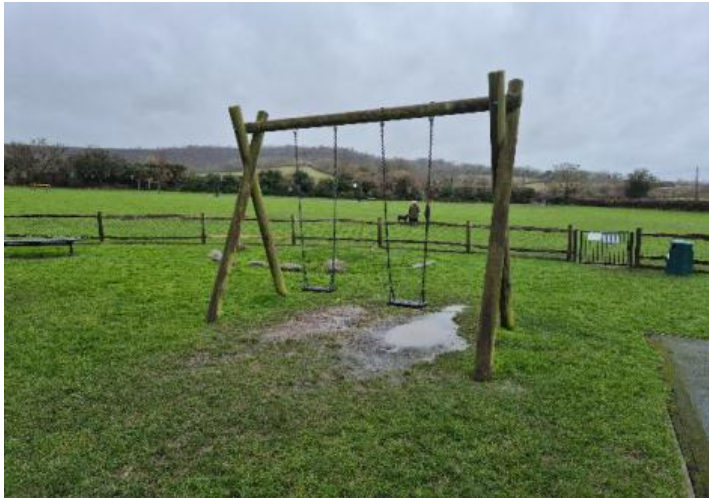
**Item:** Swings - 1 Bay 2 Seat (Flat)  
**Manufacturer:** Not Identified

**Finding:** The surface has subsided in some areas

**Action:** Monitor for any further deterioration and repair as required

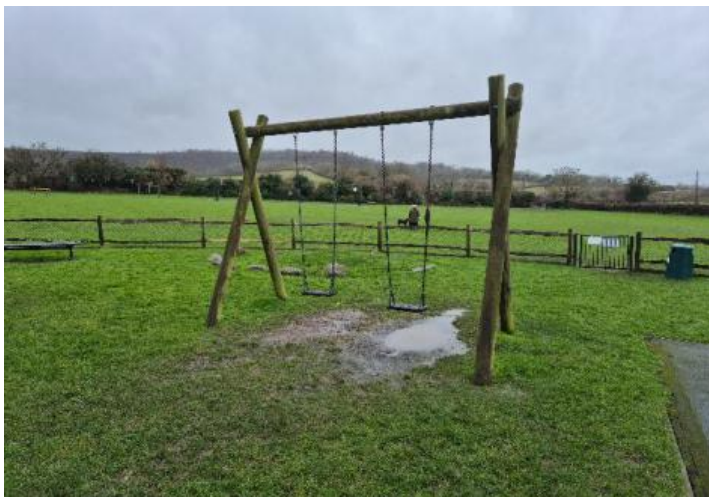
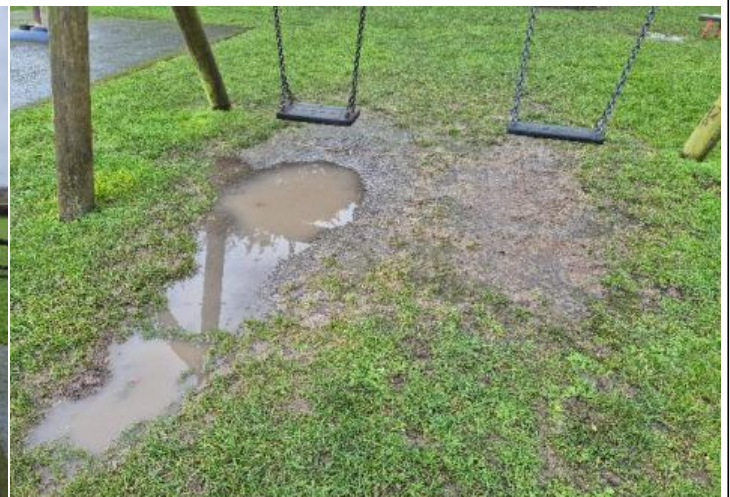
**Item:** Swings - 1 Bay 2 Seat (Flat)  
**Manufacturer:** Not Identified

**Finding:** The grass mats are silted up, the soil is compacted and the area will become very slippery when the soil is wet.

**Action:** Reinstate as required

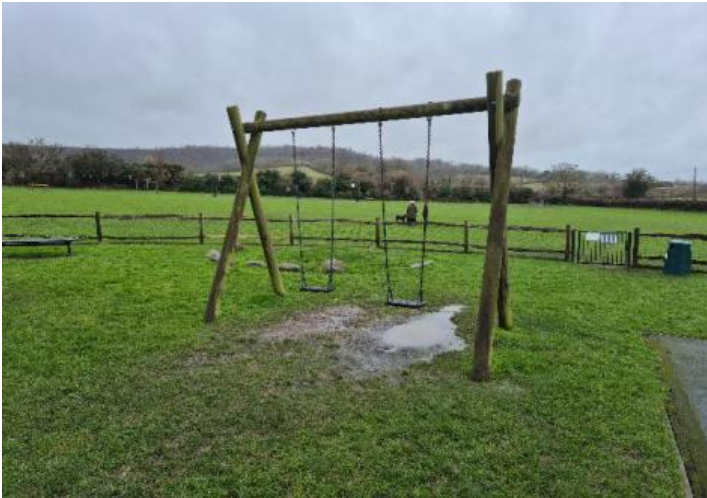
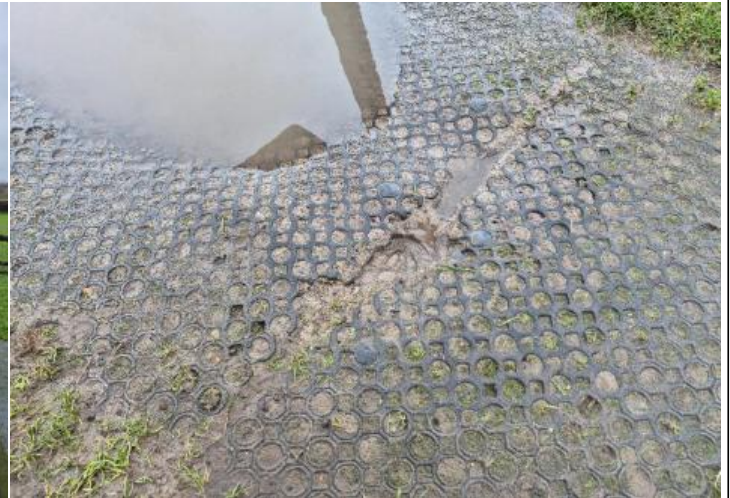
**Item:** Swings - 1 Bay 2 Seat (Flat)  
**Manufacturer:** Not Identified

**Finding:** Fixing Pins have been installed in the impact areas of the grass mats  
**Action:** Remove pins from impact areas

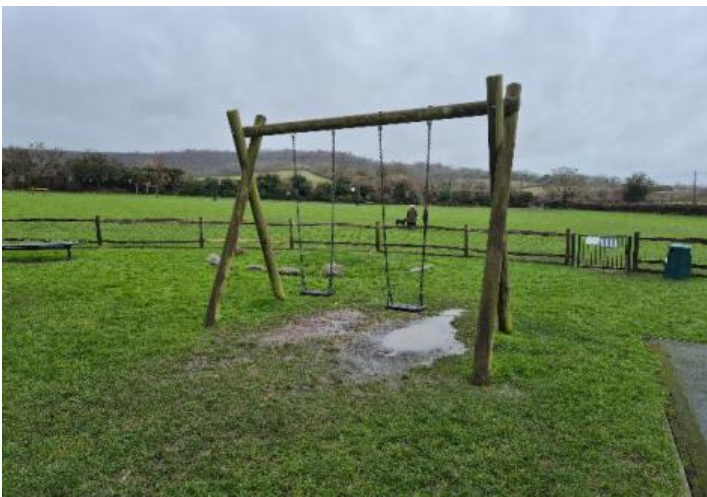
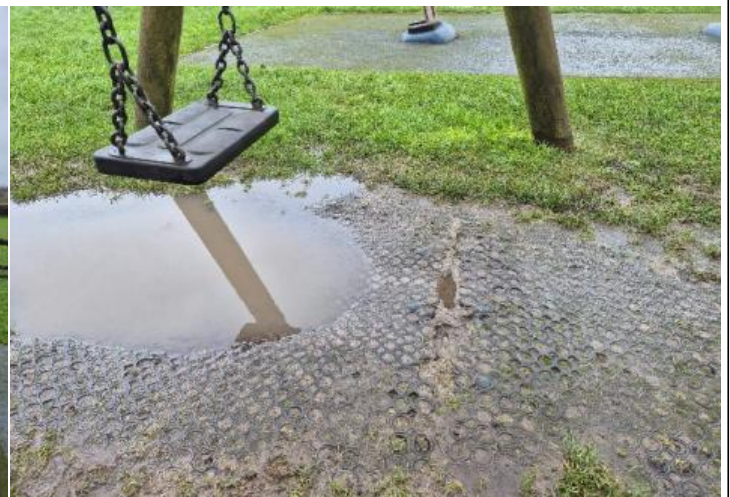
**Item:** Swings - 1 Bay 2 Seat (Flat)  
**Manufacturer:** Not Identified

**Finding:** There are gaps opening between the grass mat tiles  
**Action:** Provide additional ties or secure / reinstate surface

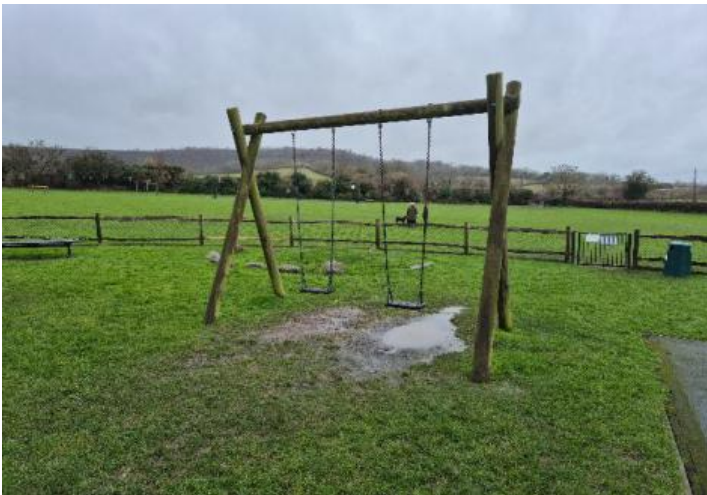
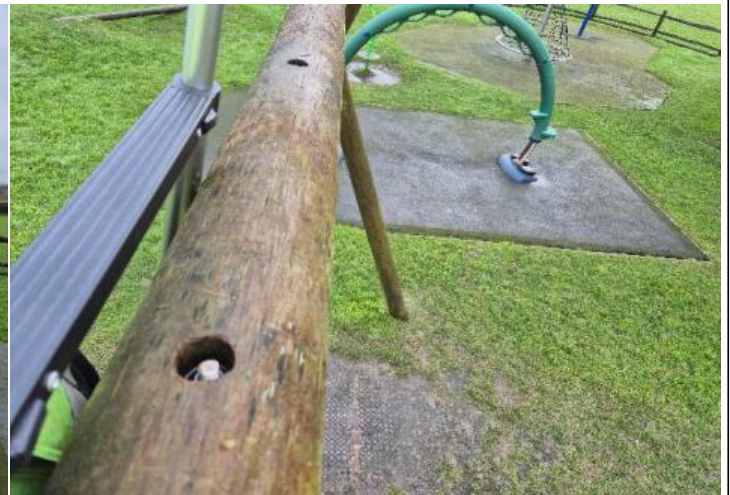
**Item:** Swings - 1 Bay 2 Seat (Flat)  
**Manufacturer:** Not Identified

**Finding:** There is/are bolt cap covers missing or damaged on the item

**Action:** Replace missing or damaged bolt cap covers

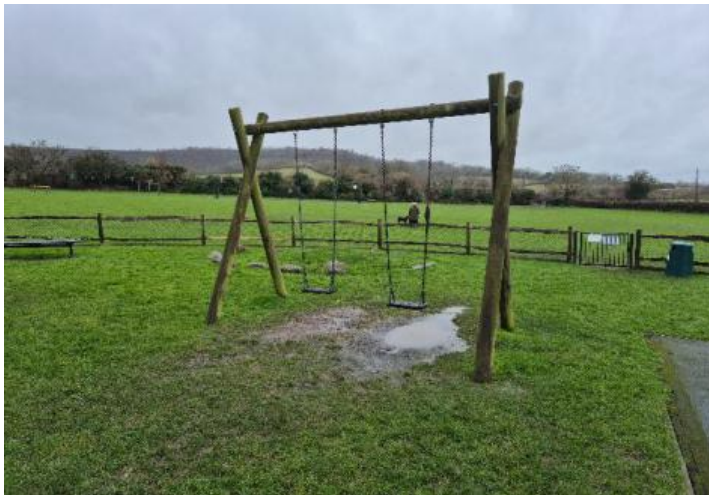
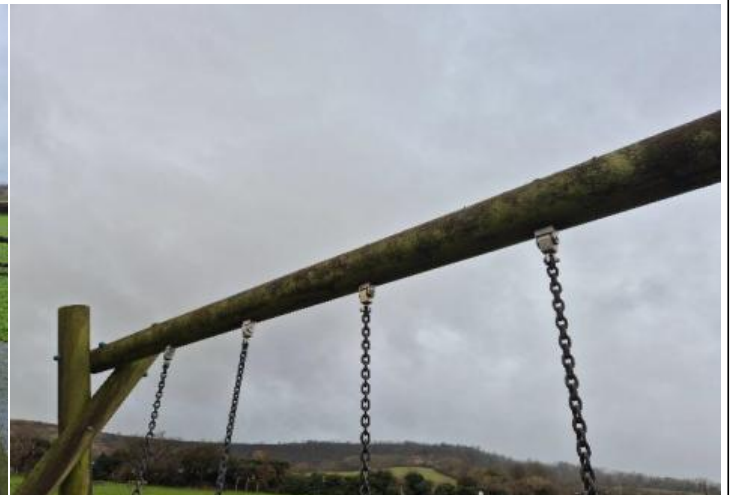
**Item:** Swings - 1 Bay 2 Seat (Flat)  
**Manufacturer:** Not Identified

**Finding:** This design of swing joint has been known to fail on the weld connecting the joint to the threaded stud

**Action:** We would recommend that the joint be dismantled and checked on a regular basis or consulting with manufacturer on whether a Secondary Safety Device can be fitted

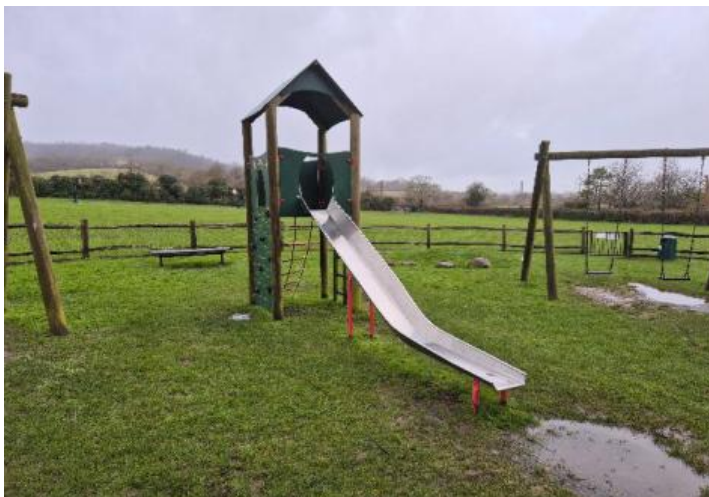
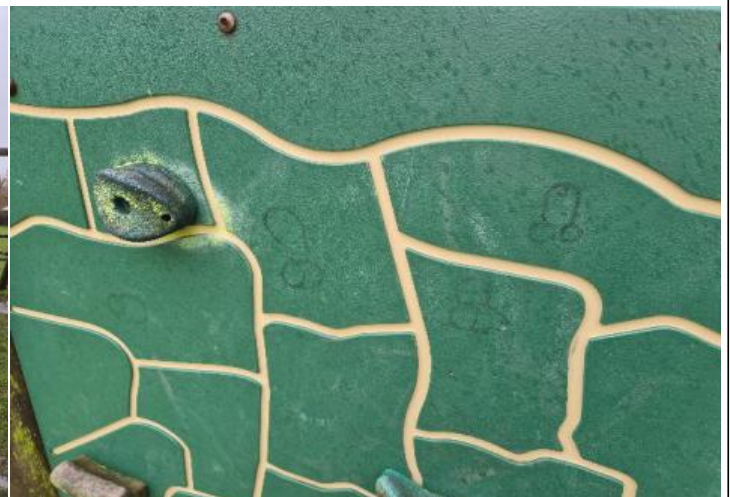
**Item:** Activity Equipment - Multi Play (Junior)  
**Manufacturer:** Not Identified

**Finding:** There is offensive graffiti present

**Action:** Remove as soon as practicable

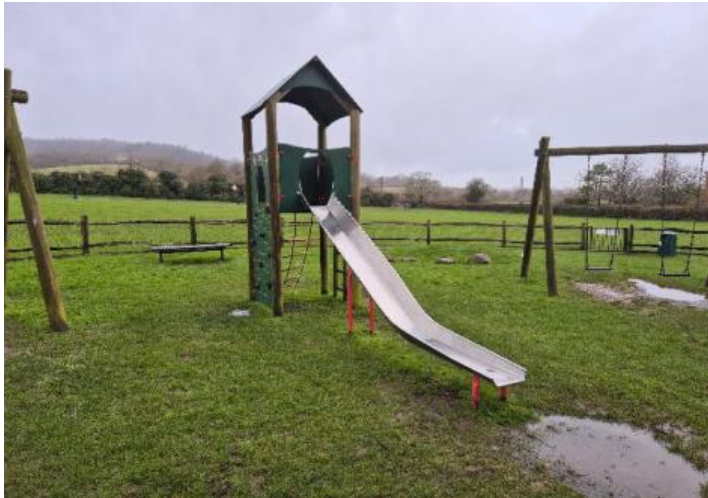
**Item:** Activity Equipment - Multi Play (Junior)  
**Manufacturer:** Not Identified

**Finding:** There is some strimmer / machinery damage apparent on the posts, this can penetrate the preservative applied to the timber and accelerate the rotting process

**Action:** Monitor for any deterioration (rot) and replace as required

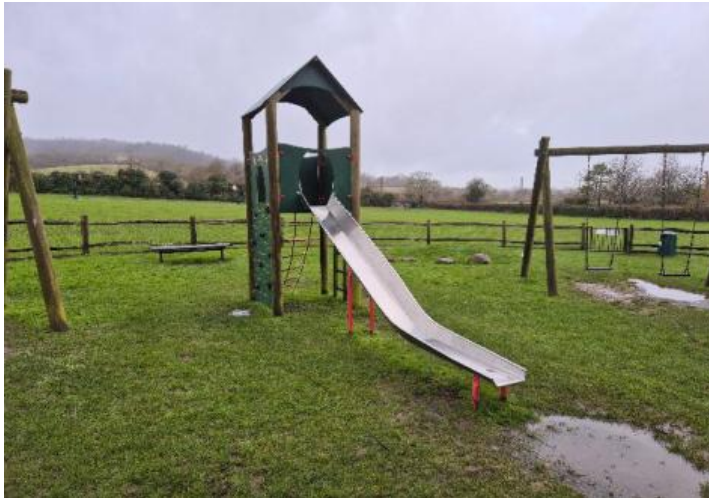
**Item:** Activity Equipment - Multi Play (Junior)  
**Manufacturer:** Not Identified

**Finding:** A number of fixing(s) have worked loose

**Action:** Secure all loose fixings

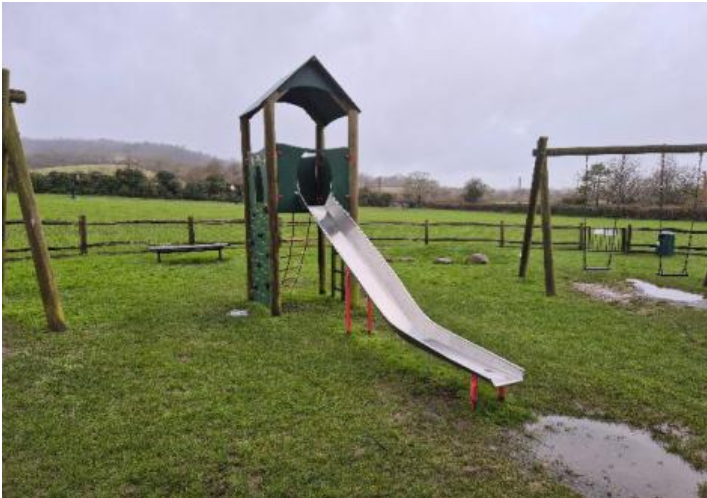
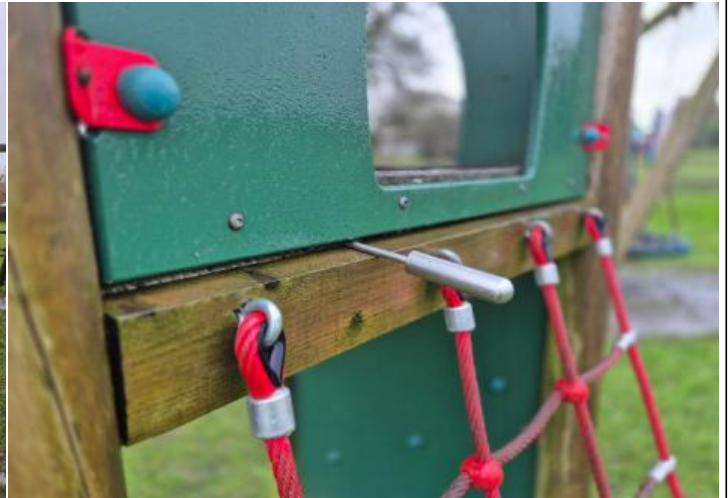
**Item:** Activity Equipment - Multi Play (Junior)  
**Manufacturer:** Not Identified

**Finding:** There is/are finger entrapment/s at the top of the net climber and the item fails to meet the requirements of BS EN 1176 Part 1 4.2.7.6 Entrapment of fingers

**Action:** Monitor - No action given the risk assessment

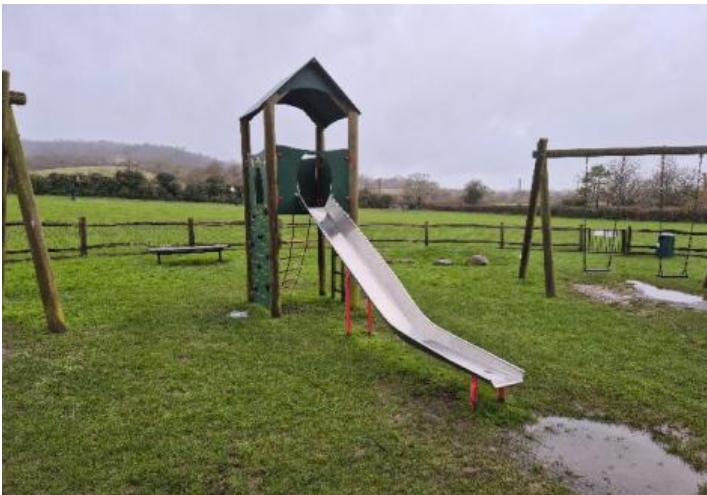
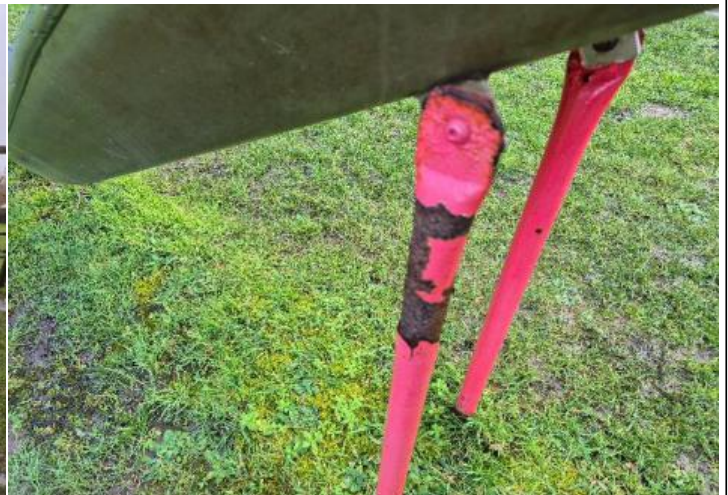
**Item:** Activity Equipment - Multi Play (Junior)  
**Manufacturer:** Not Identified

**Finding:** The paintwork on this item has been damaged or worn exposing the metal underneath which is rusting / corroding

**Action:** Treat affected areas and repaint

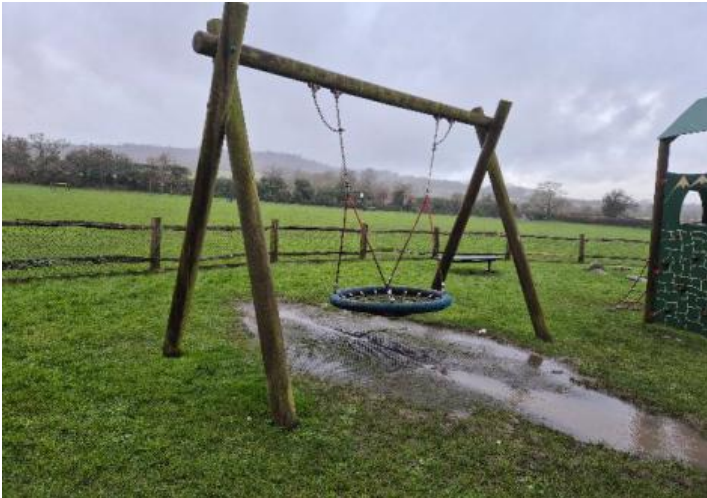
**Item:** Swings - Basket Swing - Type 1  
**Manufacturer:** Not Identified

**Finding:** The surface has subsided in some areas

**Action:** Monitor for any further deterioration and repair as required

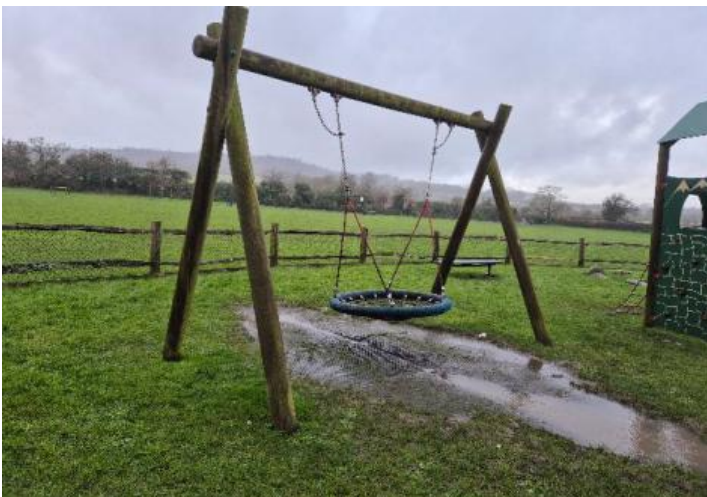
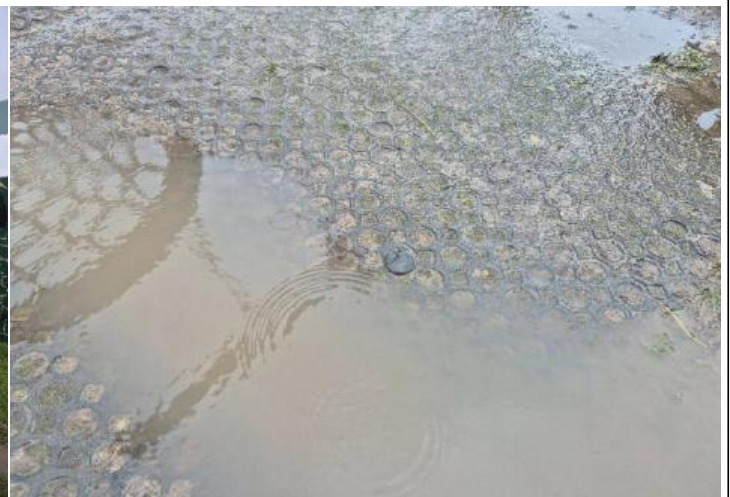
**Item:** Swings - Basket Swing - Type 1  
**Manufacturer:** Not Identified

**Finding:** Fixing Pins have been installed in the impact areas of the grass mats

**Action:** Remove pins from impact areas

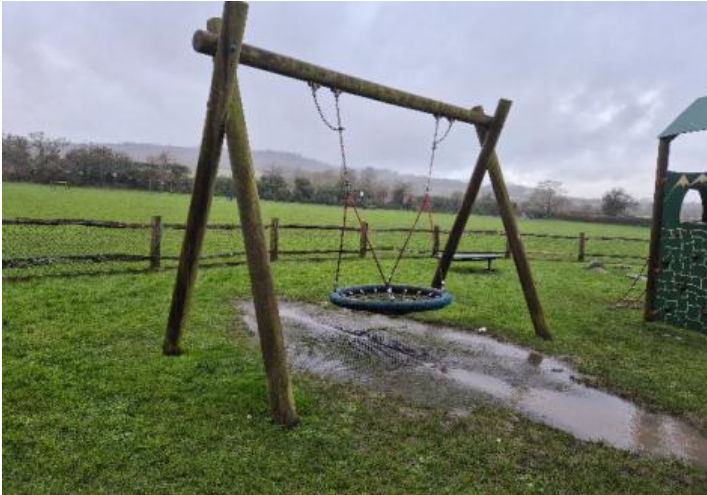
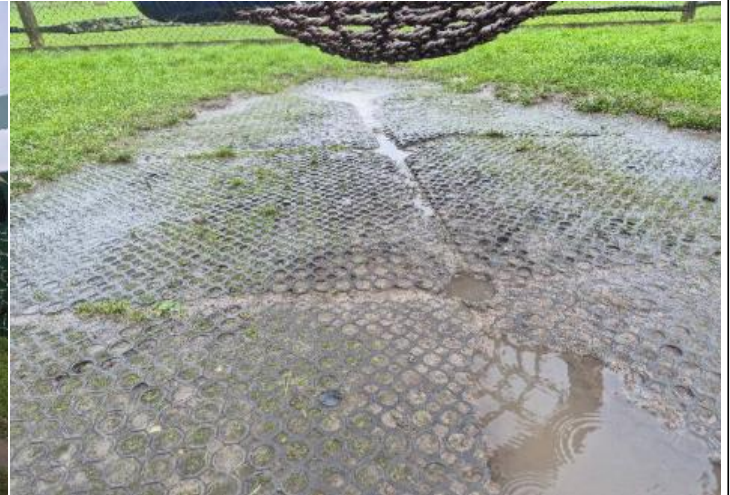
**Item:** Swings - Basket Swing - Type 1  
**Manufacturer:** Not Identified

**Finding:** There are gaps opening between the grass mat tiles

**Action:** Provide additional ties or secure / reinstate surface

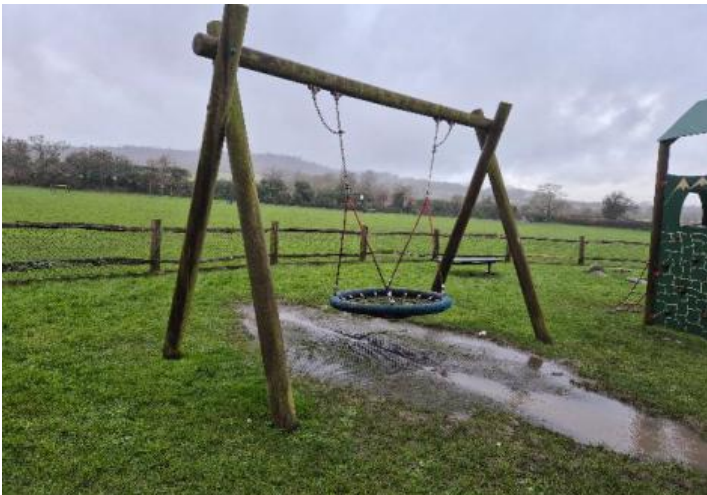
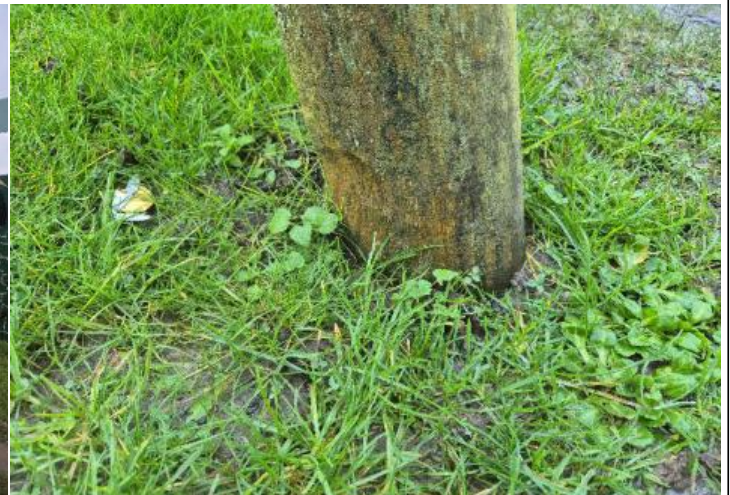
**Item:** Swings - Basket Swing - Type 1  
**Manufacturer:** Not Identified

**Finding:** There is some strimmer / machinery damage apparent on the posts, this can penetrate the preservative applied to the timber and accelerate the rotting process

**Action:** Monitor for any deterioration (rot) and replace as required

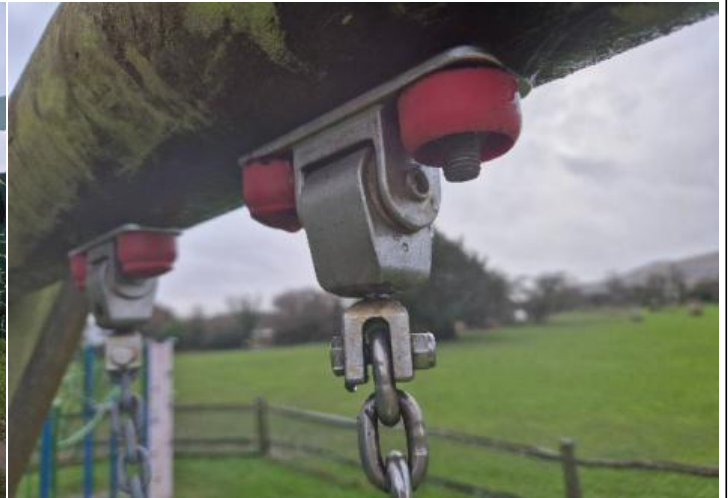
**Item:** Swings - Basket Swing - Type 1  
**Manufacturer:** Not Identified

**Finding:** There is/are bolt cap covers missing or damaged on the item

**Action:** Replace missing or damaged bolt cap covers

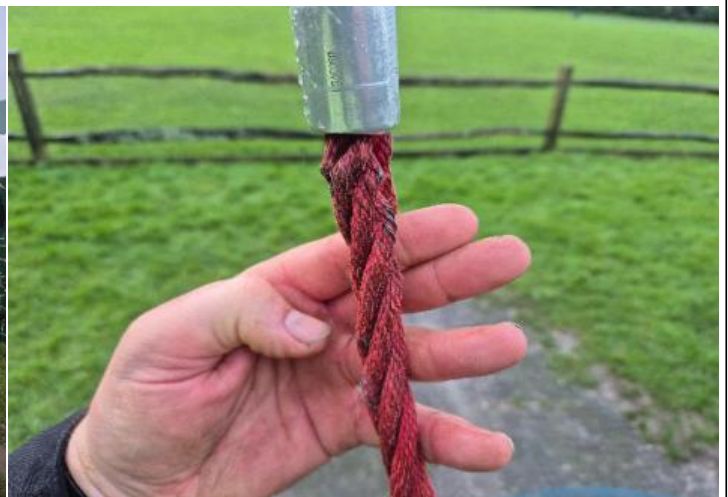
**Item:** Swings - Basket Swing - Type 1  
**Manufacturer:** Not Identified

**Finding:** The ropes/nets are worn/damaged in places

**Action:** Monitor for any further deterioration and repair or replace as required

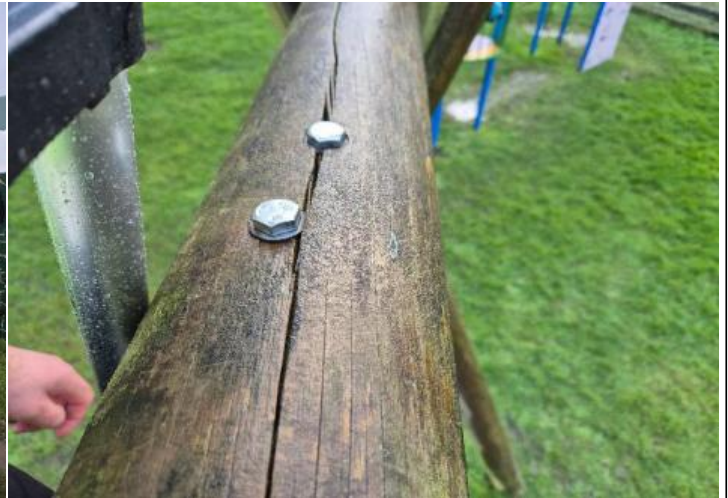
**Item:** Swings - Basket Swing - Type 1  
**Manufacturer:** Not Identified

**Finding:** The timber has a number of splits/shakes or air cracks and this may affect the stability or allow water ingress which will accelerate the rotting process

**Action:** Monitor to ensure the splits do not cross through fixing points of the structure and/or cause any instability

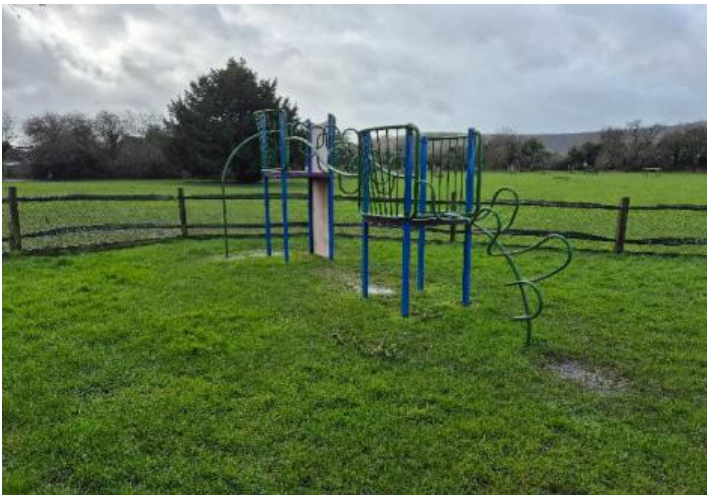
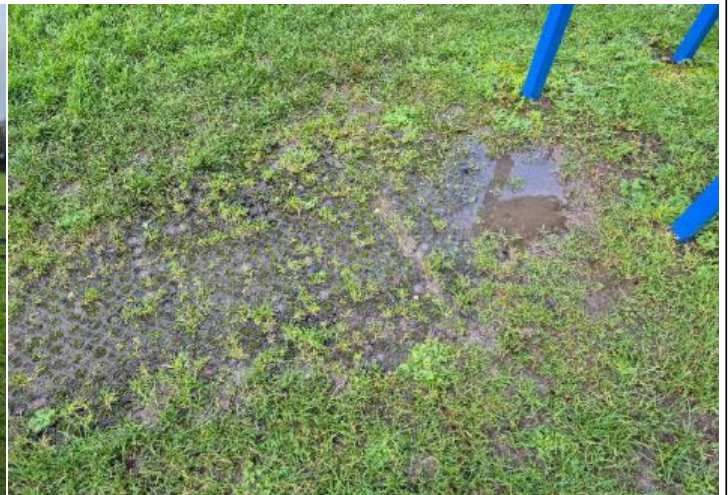
**Item:** Activity Equipment - Multi Play (Junior)  
**Manufacturer:** Wicksteed Playgrounds

**Finding:** There are gaps opening between the grass mat tiles

**Action:** Provide additional ties or secure / reinstate surface

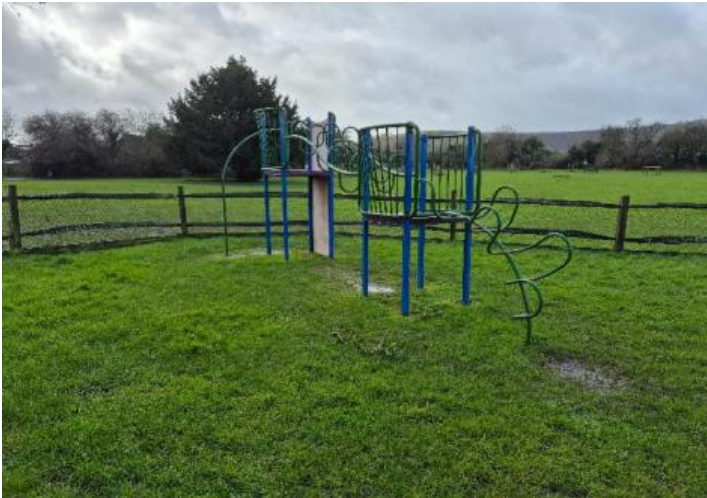
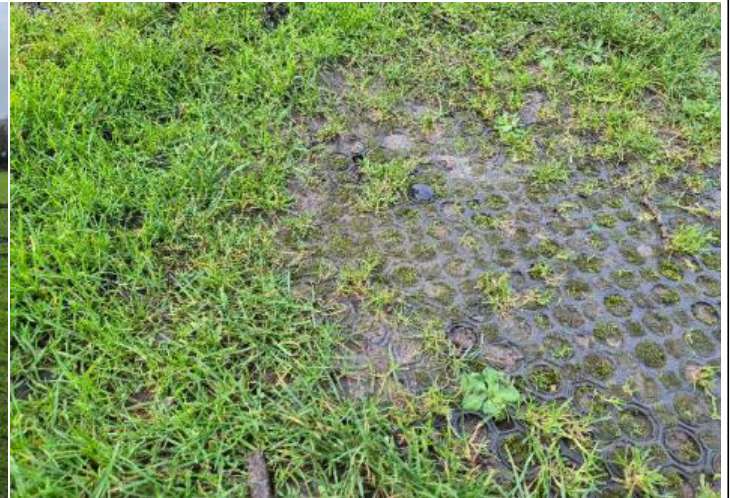
**Item:** Activity Equipment - Multi Play (Junior)  
**Manufacturer:** Wicksteed Playgrounds

**Finding:** Fixing Pins have been installed in the impact areas of the grass mats  
**Action:** Remove pins from impact areas

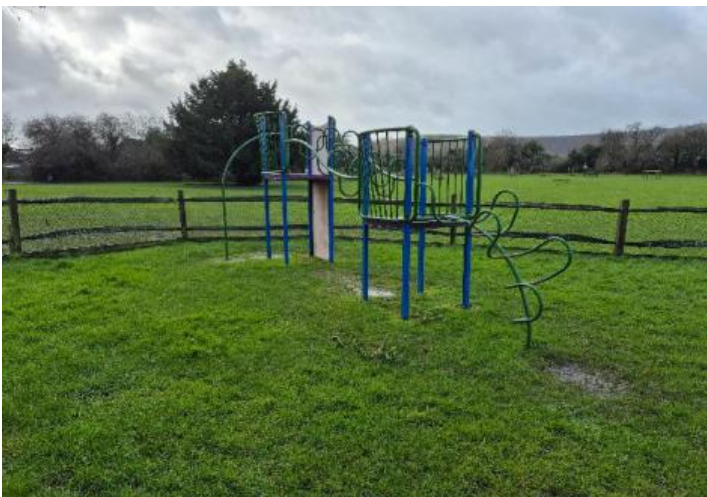
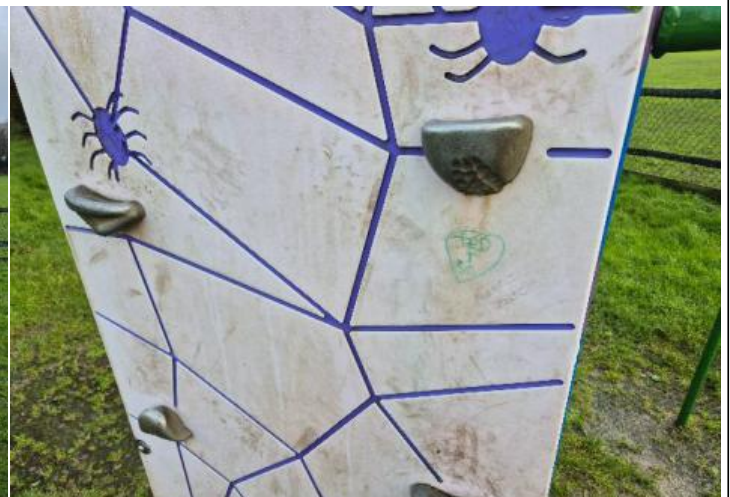
**Item:** Activity Equipment - Multi Play (Junior)  
**Manufacturer:** Wicksteed Playgrounds

**Finding:** There is some graffiti present

**Action:** Remove the graffiti

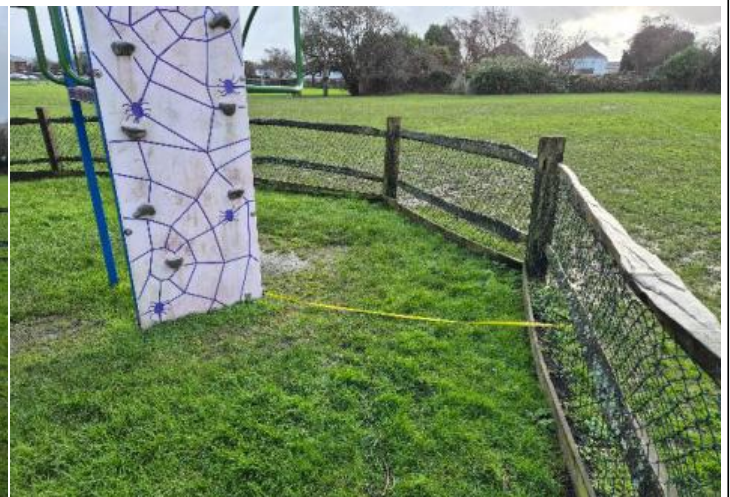
**Item:** Activity Equipment - Multi Play (Junior)  
**Manufacturer:** Wicksteed Playgrounds

**Finding:** The fence forms a hard object within the falling space of the equipment and there is also insufficient surfacing provided in contravention of BS EN 1176 Part 1

**Action:** Monitor - No action given the risk assessment

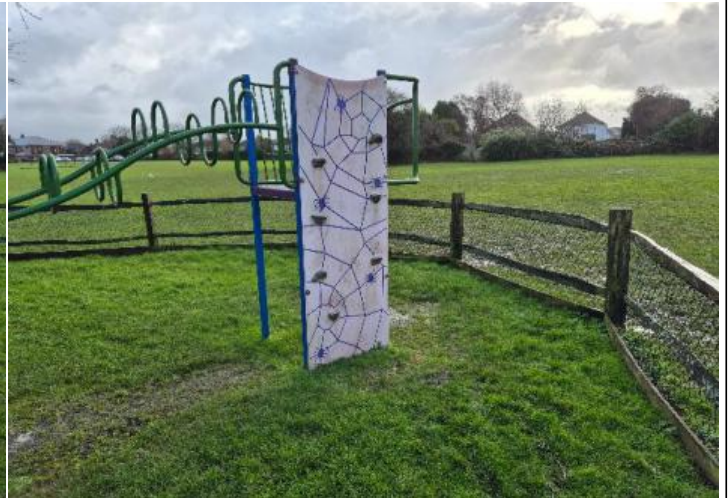
**Item:** Activity Equipment - Multi Play (Junior)  
**Manufacturer:** Wicksteed Playgrounds

**Finding:** The grass mats are silted up and the soil is compacted; this may have an effect on the impact absorbing properties of the surface. Consideration should be given to HIC testing the surface to verify impact attenuating properties ( <https://playinspections.co.uk/inspection-services/safety-surface-testing/> )

**Action:** Contact our office for a quotation for this service

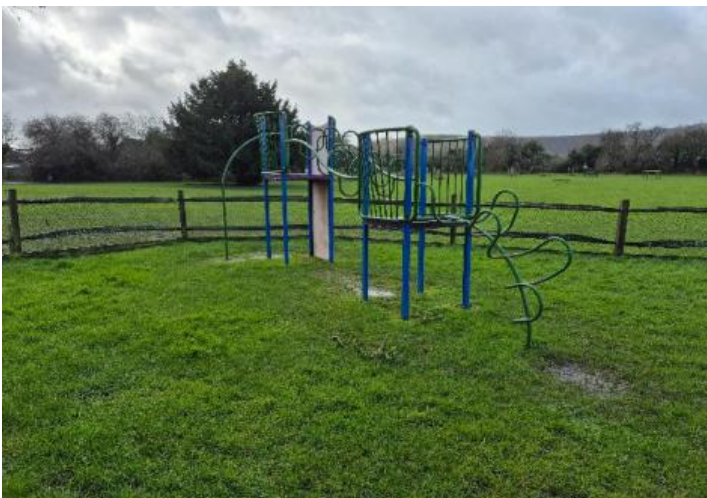
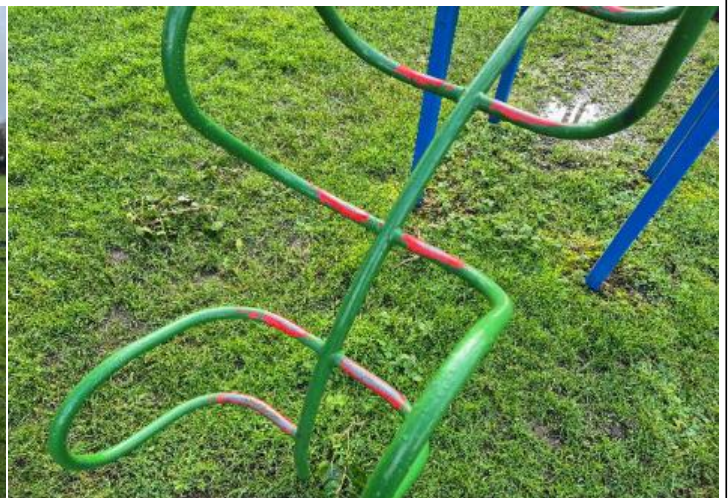
**Item:** Activity Equipment - Multi Play (Junior)  
**Manufacturer:** Wicksteed Playgrounds

**Finding:** The paint is flaking off the metalwork

**Action:** Rub down and re-paint

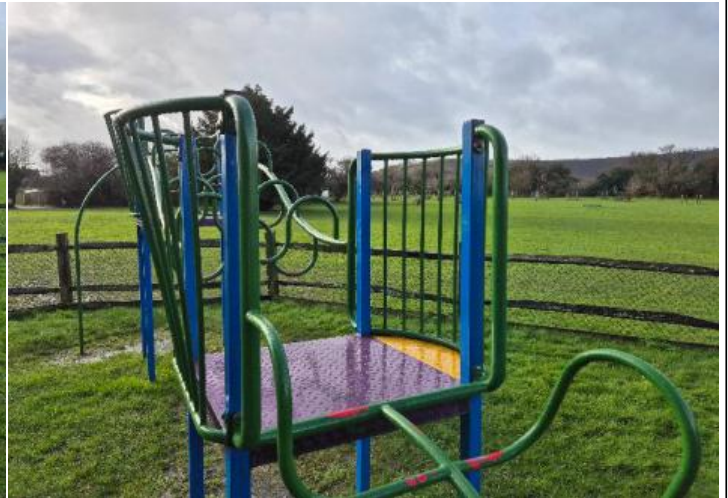
**Item:** Activity Equipment - Multi Play (Junior)  
**Manufacturer:** Wicksteed Playgrounds

**Finding:** There is an opening in the barriers exceeding the width allowed (500mm) in BS EN 1176 Part 1, and no guardrail has been provided

**Action:** Monitor - No action given the risk assessment

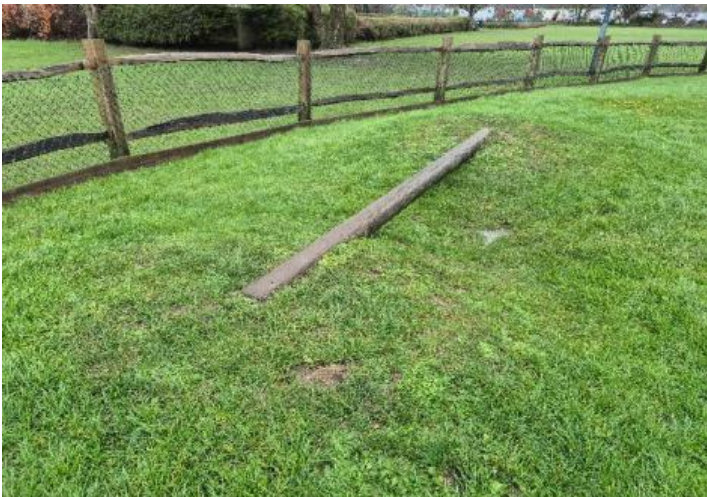
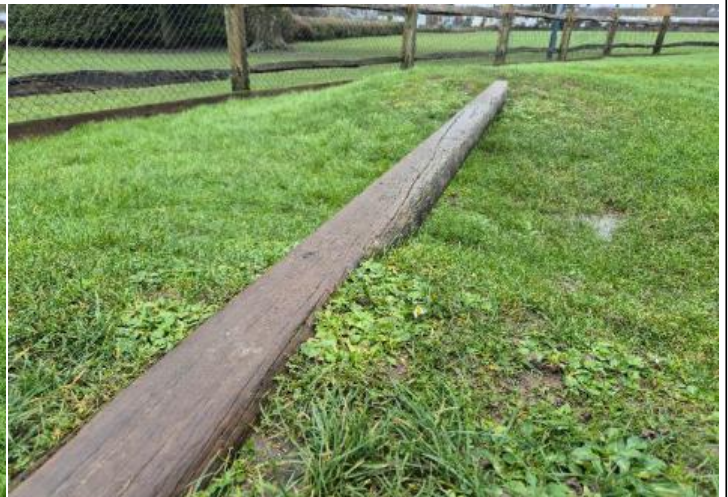
**Item:** Activity Equipment - Balance Beam  
**Manufacturer:** Not Identified

**Finding:** There is algae growth on the surface of the equipment resulting in slippery conditions

**Action:** Clean and treat appropriately

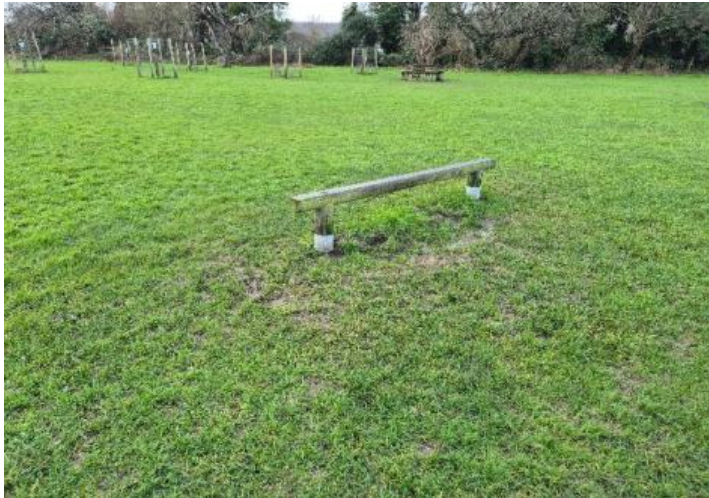
**Item:** Activity Equipment - Balance Beam  
**Manufacturer:** Wicksteed Playgrounds

**Finding:** The surface has eroded in some areas and may be slippery in wet conditions  
**Action:** Reinstate the surface

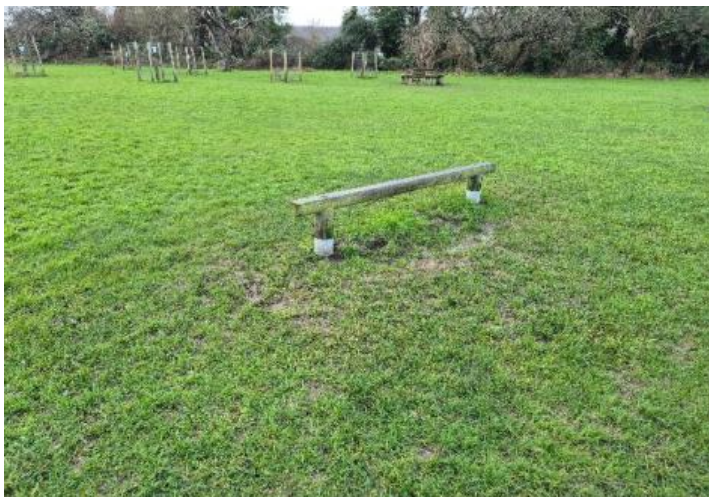
**Item:** Activity Equipment - Balance Beam  
**Manufacturer:** Wicksteed Playgrounds

**Finding:** There is algae growth on the surface of the equipment resulting in slippery conditions

**Action:** Clean and treat appropriately

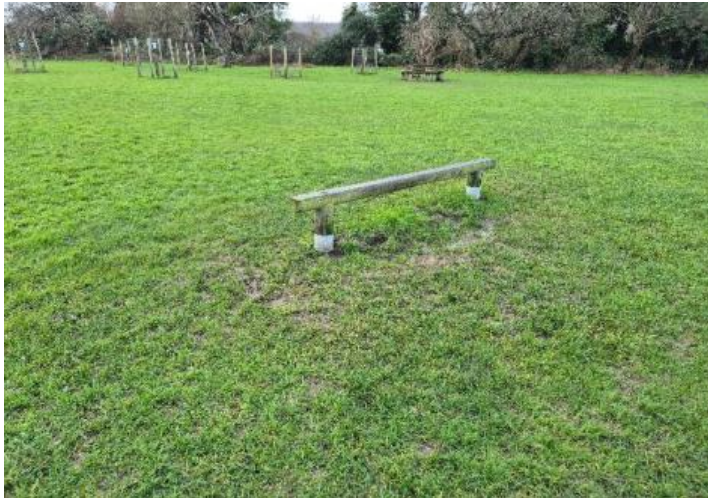
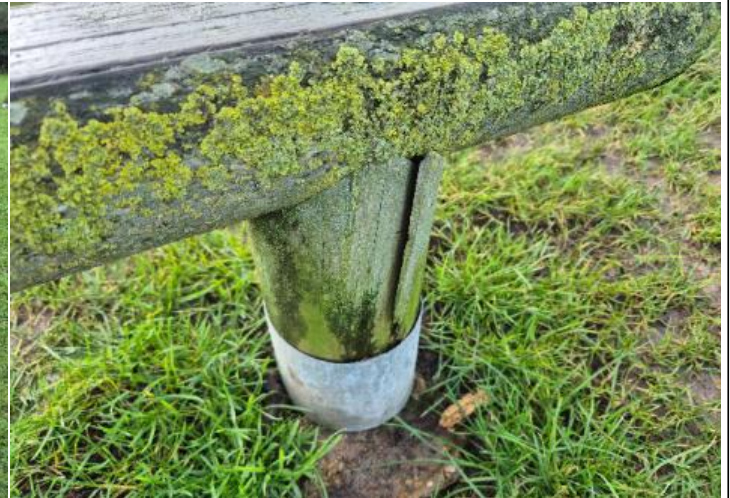
**Item:** Activity Equipment - Balance Beam  
**Manufacturer:** Wicksteed Playgrounds

**Finding:** Parts of the timber are rough or splintered

**Action:** Remove all rough or sharp edges

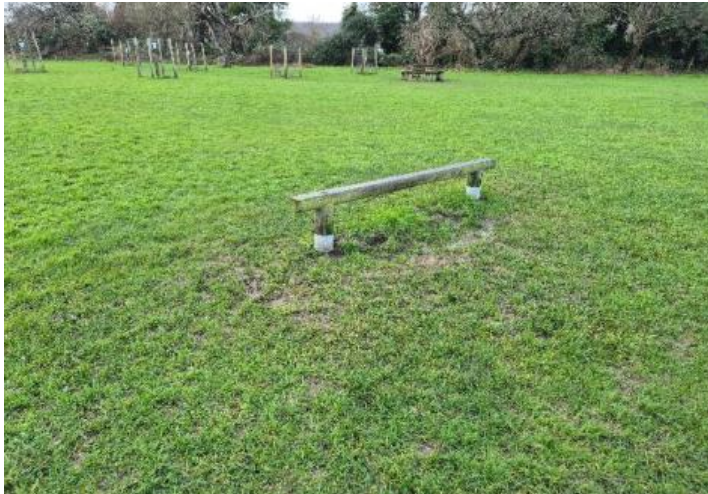
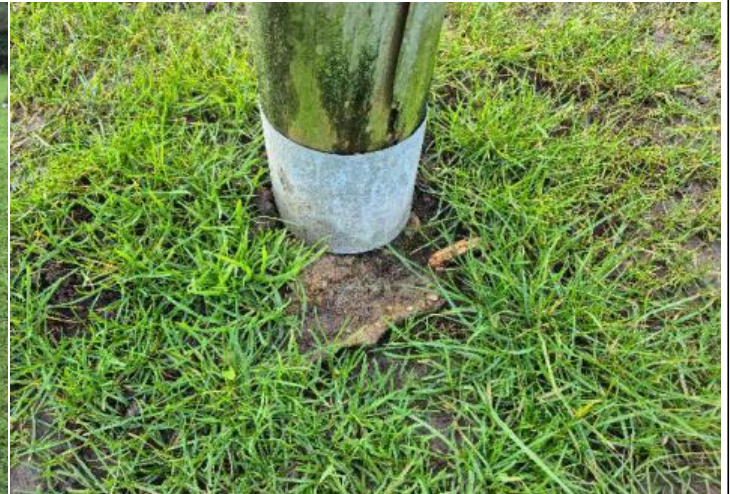
**Item:** Activity Equipment - Balance Beam  
**Manufacturer:** Wicksteed Playgrounds

**Finding:** The surface has eroded and the foundations are exposed

**Action:** Reinstate surrounding surfaces to cover the foundations

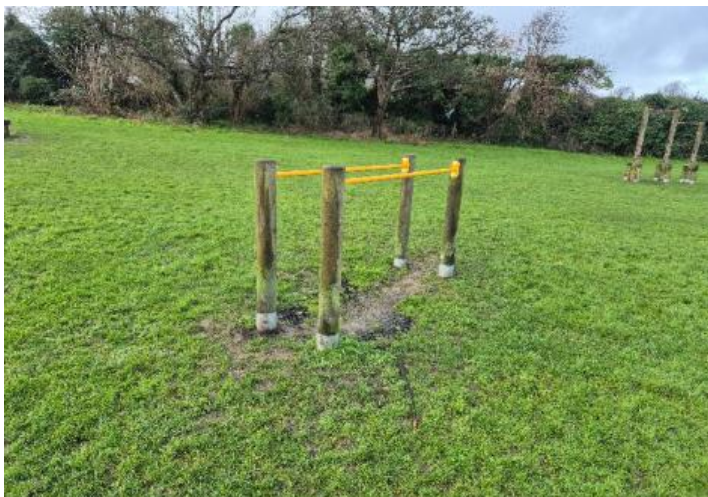
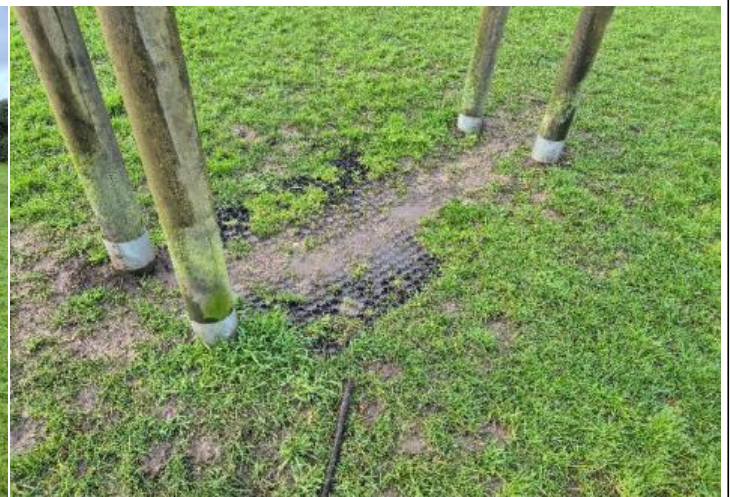
**Item:** Activity Equipment - Parallel Bars  
**Manufacturer:** Fawns Recreational Services Ltd

**Finding:** The grass mats are silted up, the soil is compacted and the area will become very slippery when the soil is wet.

**Action:** Reinstate as required

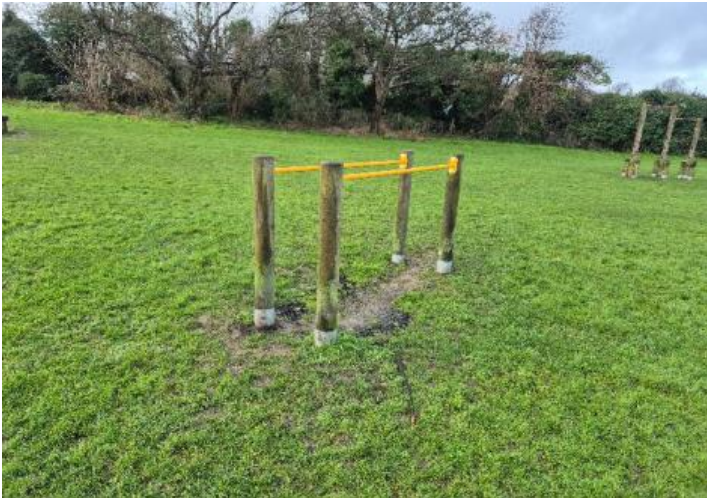
**Item:** Activity Equipment - Parallel Bars  
**Manufacturer:** Fawns Recreational Services Ltd

**Finding:** There are areas or parts of the timber on the structure that have rotted

**Action:** Replace all affected timbers

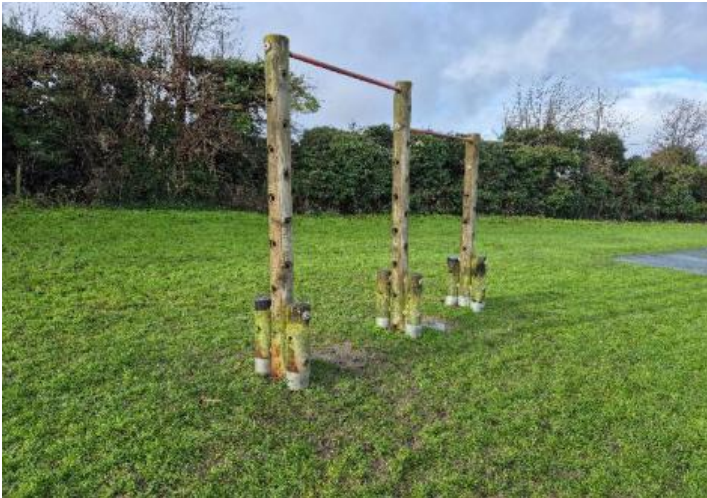
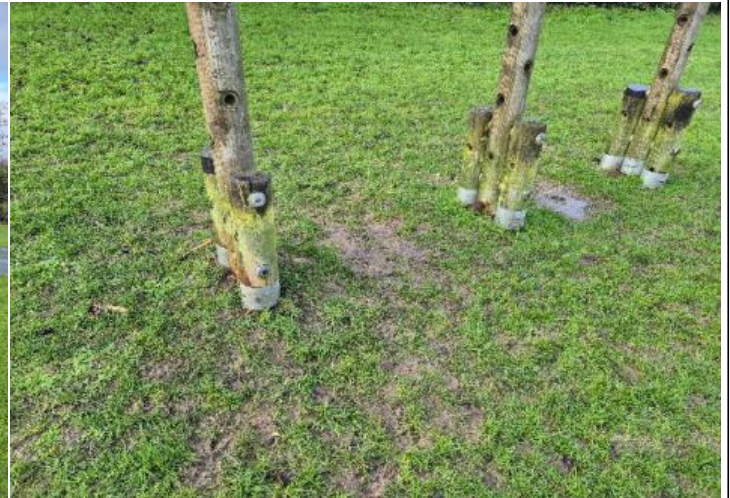
**Item:** Activity Equipment - Somersault Bars  
**Manufacturer:** Wicksteed Playgrounds

**Finding:** The grass mats are silted up and the soil is compacted; this may have an effect on the impact absorbing properties of the surface. Consideration should be given to HIC testing the surface to verify impact attenuating properties ( <https://playinspections.co.uk/inspection-services/safety-surface-testing/> )

**Action:** Contact our office for a quotation for this service

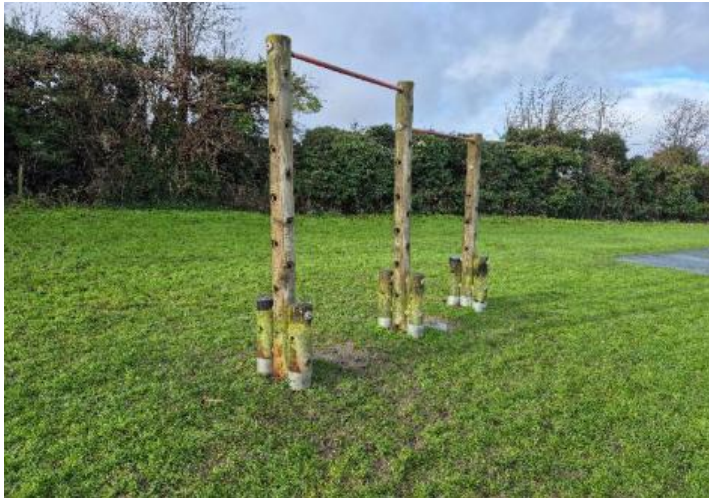
**Item:** Activity Equipment - Somersault Bars  
**Manufacturer:** Wicksteed Playgrounds

**Finding:** There is some strimmer / machinery damage apparent on the posts, this can penetrate the preservative applied to the timber and accelerate the rotting process

**Action:** Monitor for any deterioration (rot) and replace as required
