## COMMUNITY COMMITTEE MEETING HELD ON TUESDAY 4<sup>th</sup> FEBRUARY 2025 AT 7.30 PM AT THE STEYPING CENTRE

# DRAFT MINUTES

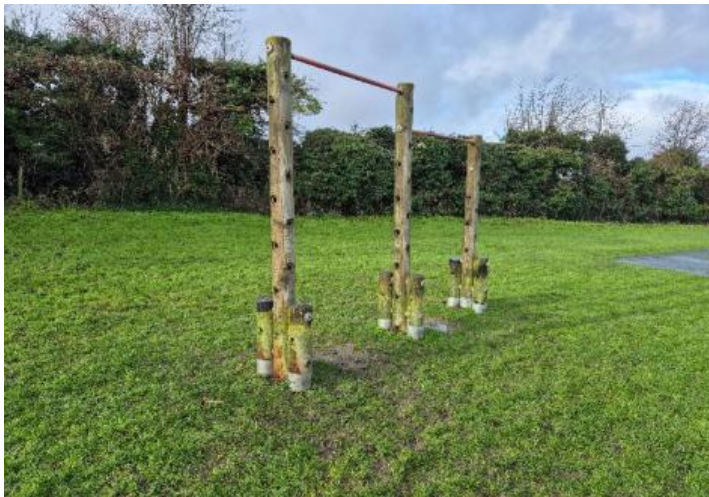
**Item:** Activity Equipment - Somersault Bars  
**Manufacturer:** Wicksteed Playgrounds

**Finding:** There is some evidence of rot in the timber

**Action:** Monitor for any further deterioration and replace as required

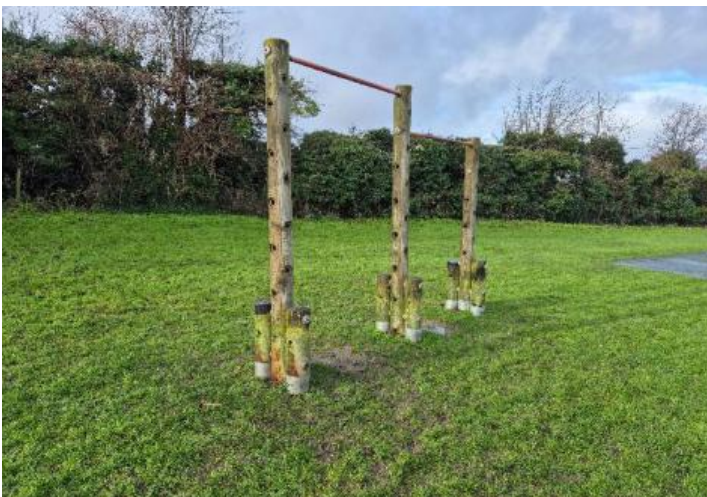
**Item:** Activity Equipment - Somersault Bars  
**Manufacturer:** Wicksteed Playgrounds

**Finding:** The timber has a number of splits/shakes or air cracks and this may affect the stability or allow water ingress which will accelerate the rotting process

**Action:** Monitor to ensure the splits do not cross through fixing points of the structure and/or cause any instability

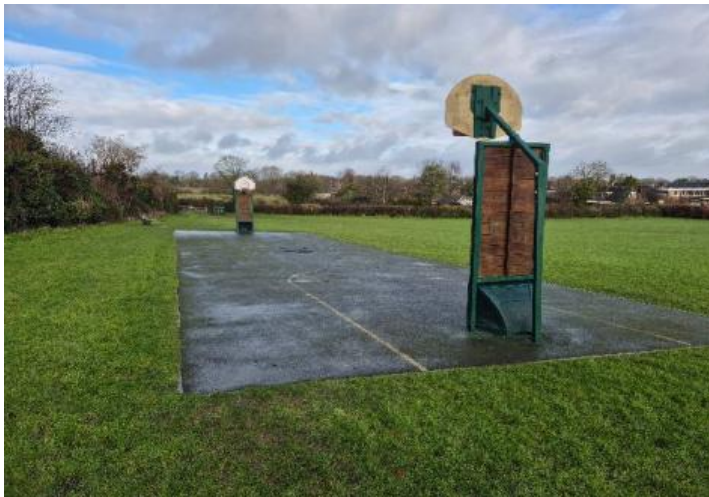
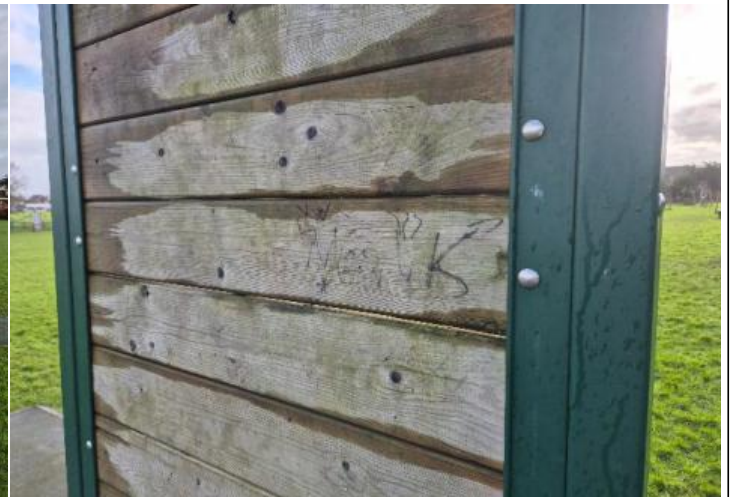
**Item:** Multi Use Games Area - Multi Use Games Area (MUGA)  
**Manufacturer:** Agorespace

**Finding:** There is some graffiti present

**Action:** Remove the graffiti

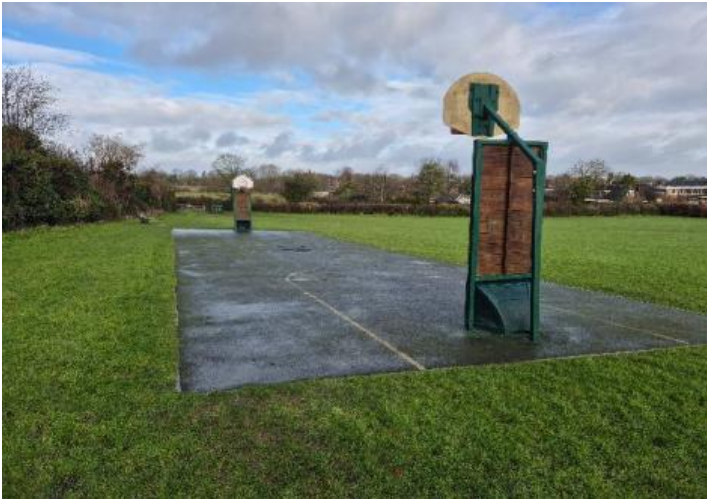
**Item:** Multi Use Games Area - Multi Use Games Area (MUGA)  
**Manufacturer:** Agorespace

**Finding:** The free space between the backboard and the framework is less than 600mm and fails the requirements of BS EN15312:2007 +A1 2010

**Action:** Monitor - No action given the risk assessment

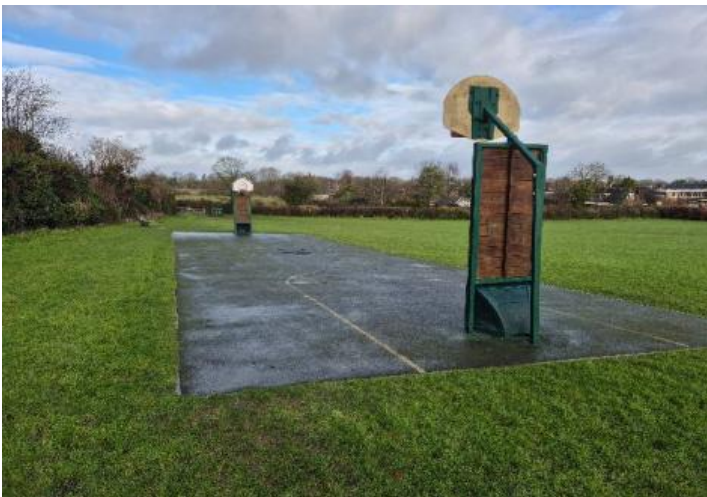
**Item:** Multi Use Games Area - Multi Use Games Area (MUGA)  
**Manufacturer:** Agorespace

**Finding:** There is/are finger entrapments due to missing inserts/fixings and the item fails to meet the requirements of BS EN 15312 Clause 4.4.2.2 Entrapment of fingers

**Action:** Replace missing fixings/inserts to remove the entrapments

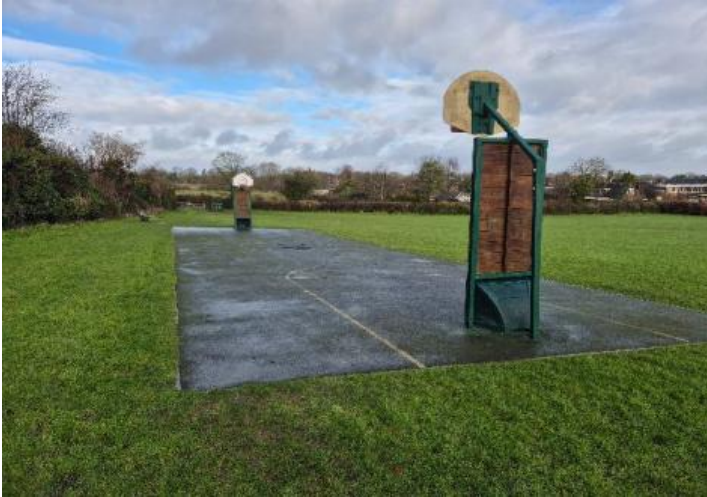
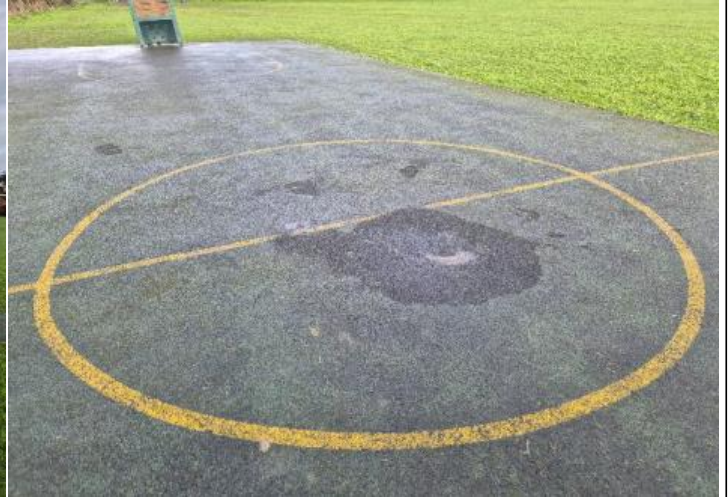
**Item:** Multi Use Games Area - Multi Use Games Area (MUGA)  
**Manufacturer:** Agorespace

**Finding:** There is some minor damage to the surface

**Action:** Monitor for any further deterioration and repair as required

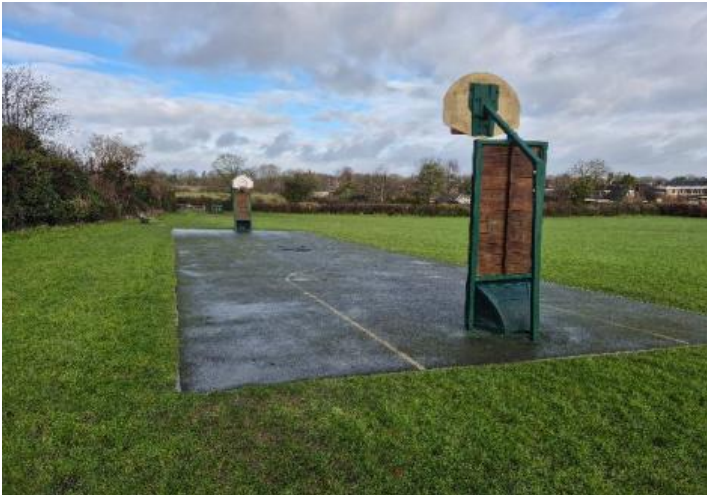
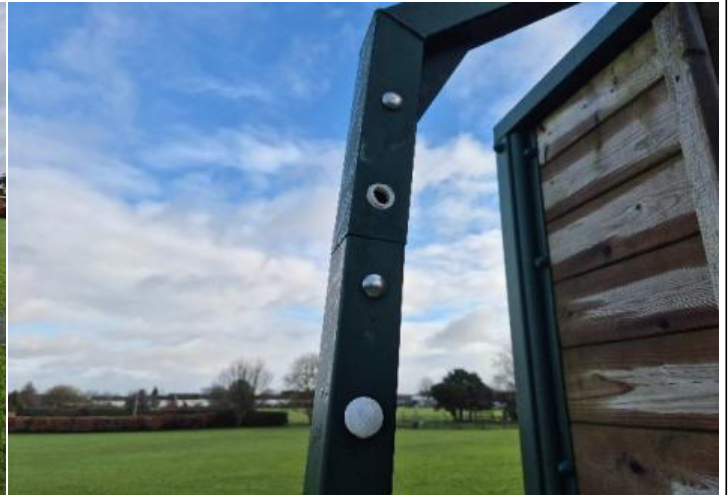
**Item:** Multi Use Games Area - Multi Use Games Area (MUGA)  
**Manufacturer:** Agorespace

**Finding:** There is or are fixings missing on the item

**Action:** Replace all missing fixings

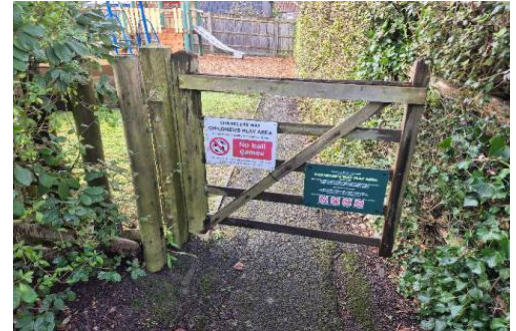
**Item:** Gate - Pedestrian  
**Manufacturer:** Not Identified  
**Surface Type:** Tarmac  
**Item Quantity:** 1  
**Equipment Compliance:** N/A  
**Surface Area Compliance:** N/A

There are openings that are less than 12mm that could trap or crush fingers - Provide a 12mm gap throughout full range of motion at both sides of gate

There is some evidence of rot in the timber - Monitor for any further deterioration and replace as required

There is or are fixings missing on the item - Replace all missing fixings

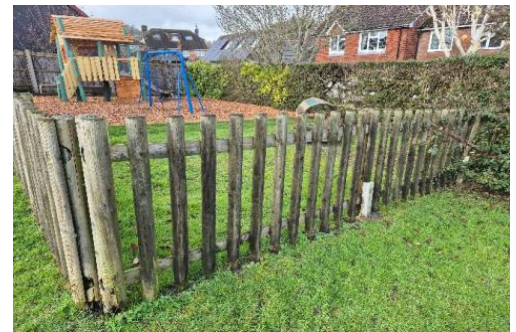
**Item:** Fencing - Timber  
**Manufacturer:** Not Identified  
**Surface Type:** Grass  
**Item Quantity:** 1  
**Equipment Compliance:** N/A  
**Surface Area Compliance:** N/A

There is some strimmer / machinery damage apparent on the posts, this can penetrate the preservative applied to the timber and accelerate the rotting process - Monitor for any deterioration (rot) and replace as required

There are a number of loose and/or rotten posts around the fence - Monitor for any further deterioration and reset as required

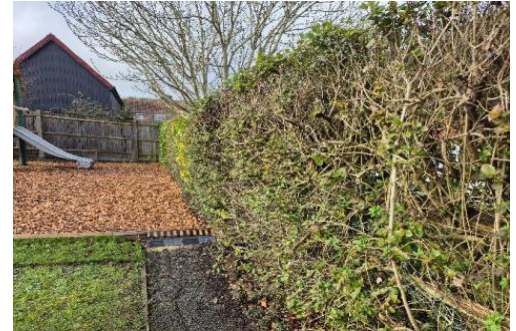
**Item:** Hedge  
**Manufacturer:** Natural Feature  
**Surface Type:** Soil  
**Item Quantity:** 1  
**Equipment Compliance:** N/A  
**Surface Area Compliance:** N/A

There are projecting twigs present - Prune and maintain

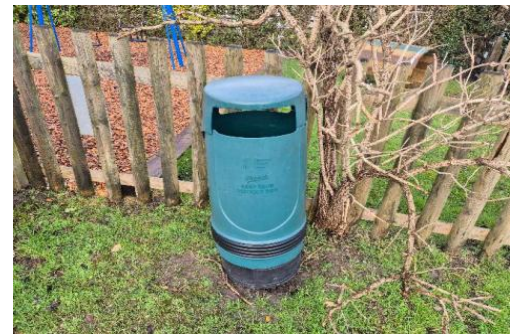
**Item:** Litter Bin  
**Manufacturer:** Glasdon  
**Surface Type:** Grass  
**Item Quantity:** 1  
**Equipment Compliance:** N/A  
**Surface Area Compliance:** N/A

The item has been damaged - Repair or replace the item / affected part

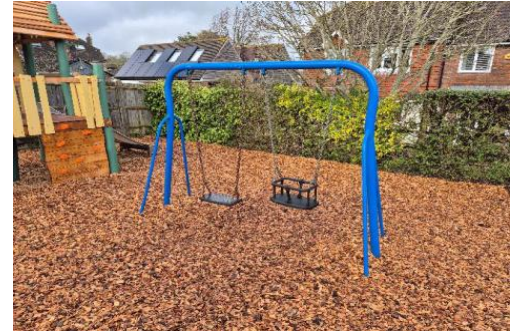
**Item:** 1 Bay Mixed Seat, 1 Cradle, 1 Flat  
**Manufacturer:** Not Identified  
**Surface Type:** Woodchip  
**Item Quantity:** 1  
**Equipment Compliance:** No  
**Surface Area Compliance:** Yes

The loosefill surfacing has displaced from under or around the equipment - Regulate surface levels and maintain

The chain openings are in excess of the 8.6mm as recommended by BS EN 1176 - Monitor - No action given the risk assessment

The seat has minor damage or wear - Monitor for any further deterioration and replace as required

The swing seat connectors have some wear present - Monitor for further deterioration and replace when 40% worn

The seats are too close to each other as defined in BS EN 1176 Part 2; this is a low risk failure and no remedial action is required - Monitor - No action given the risk assessment

The bush / bushes is / are worn or missing - Replace worn or missing bushes

The fixings have corroded excessively - Replace all corroded fixings

There is some notable evidence of chain wear - Monitor for any further deterioration and replace when 40% worn

The seat clearance from finished surface level to the underside of the seat is too low and does not meet the requirements of BS EN 1176 Part 2 (350mm minimum clearance required) - Adjust seat height/s (400mm-500mm is recommended)

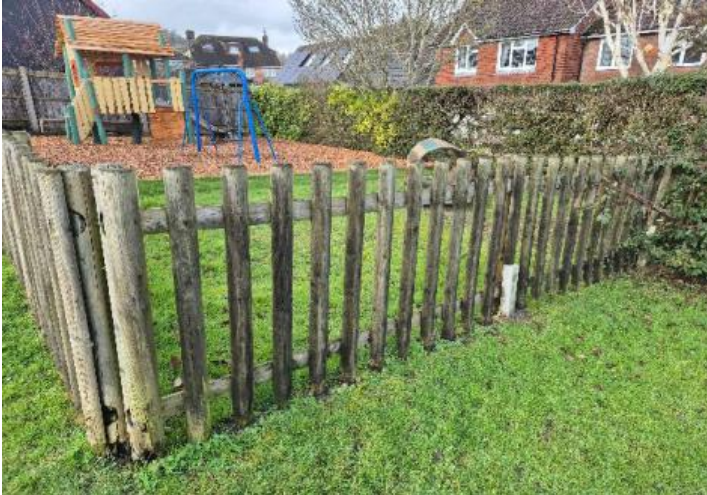
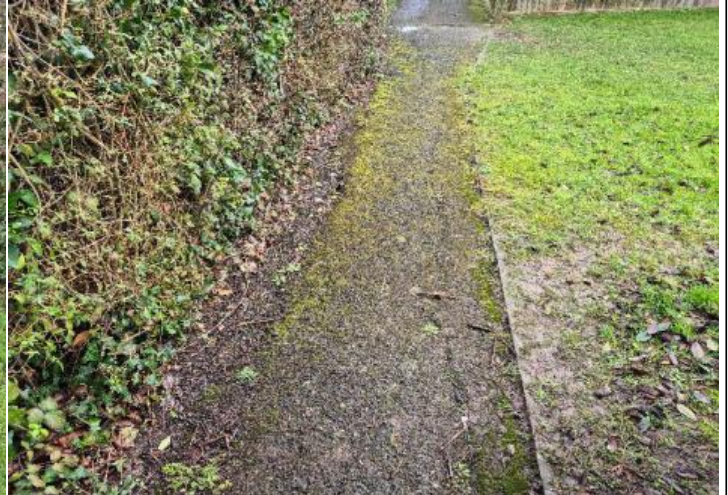
**Item:** Ancillary Items - Site General  
**Manufacturer:** Owner/Operator

**Finding:** There is algae, silt or moss growth on the surface resulting in slippery conditions  
**Action:** Clean and treat appropriately

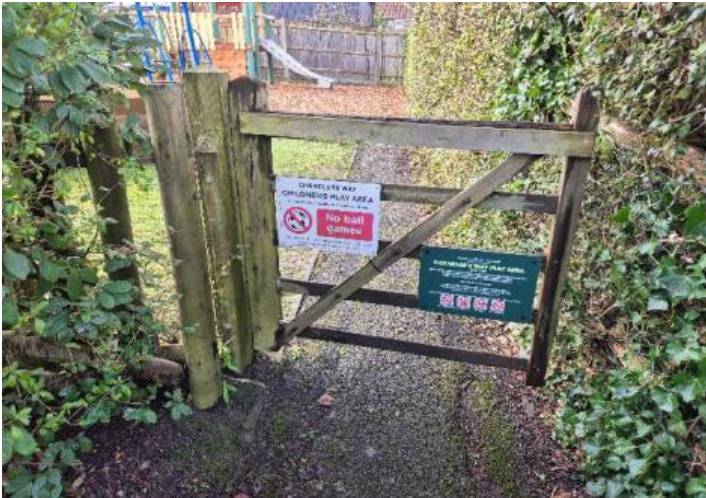
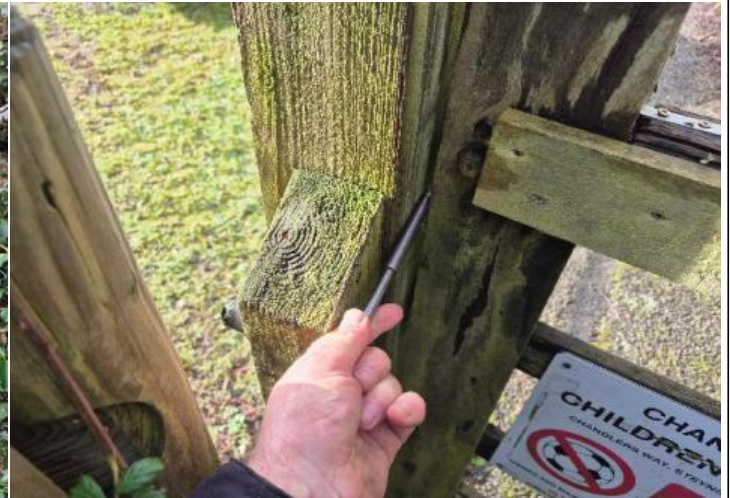
**Item:** Gates - Gate - Pedestrian  
**Manufacturer:** Not Identified

**Finding:** There are openings that are less than 12mm that could trap or crush fingers

**Action:** Provide a 12mm gap throughout full range of motion at both sides of gate

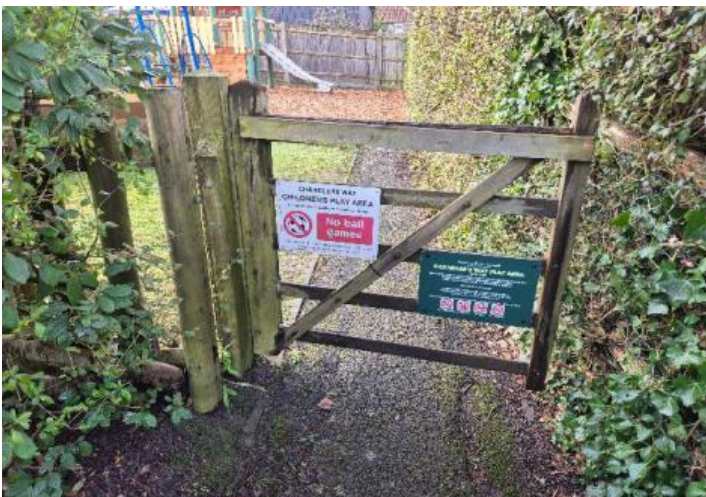
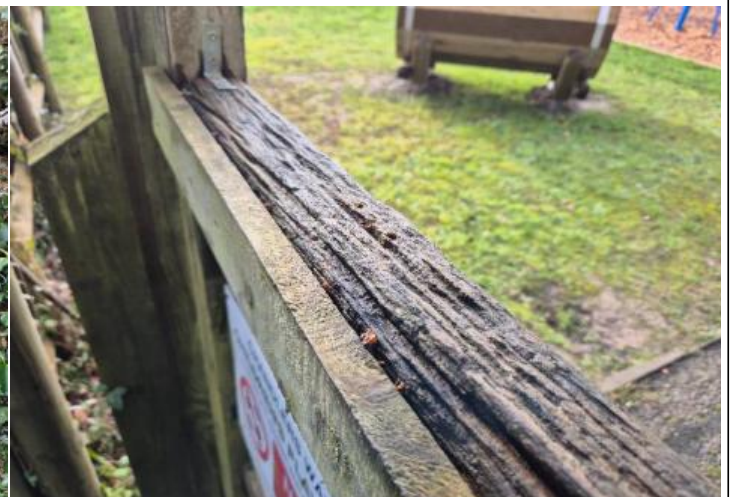
**Item:** Gates - Gate - Pedestrian  
**Manufacturer:** Not Identified

**Finding:** There is some evidence of rot in the timber

**Action:** Monitor for any further deterioration and replace as required

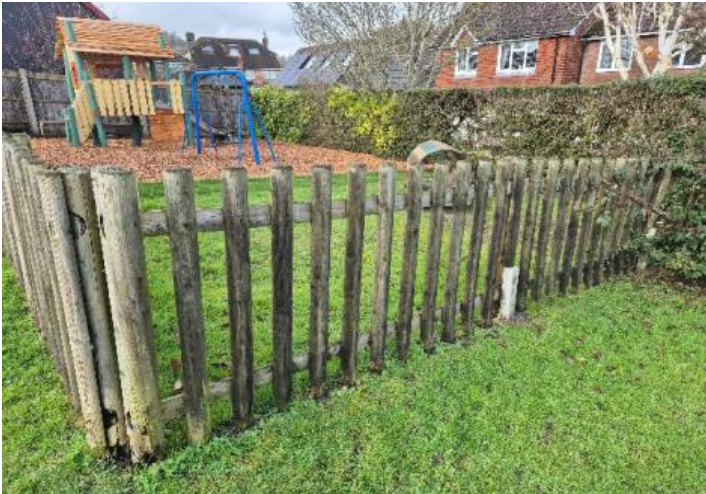
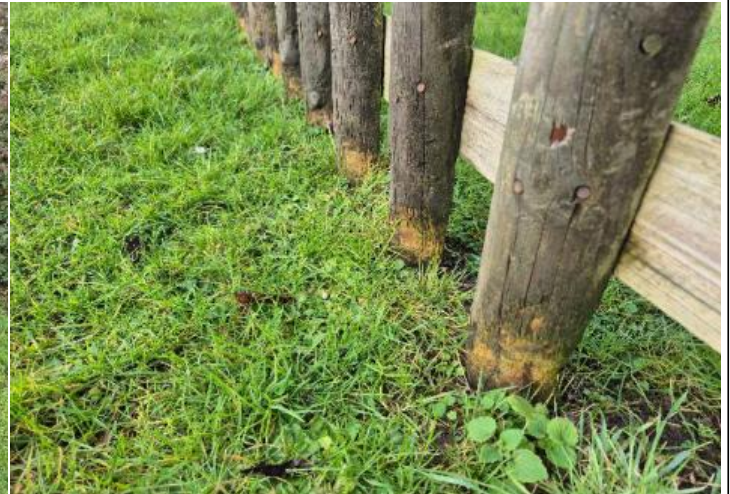
**Item:** Fences - Fencing - Timber  
**Manufacturer:** Not Identified

**Finding:** There is some strimmer / machinery damage apparent on the posts, this can penetrate the preservative applied to the timber and accelerate the rotting process

**Action:** Monitor for any deterioration (rot) and replace as required

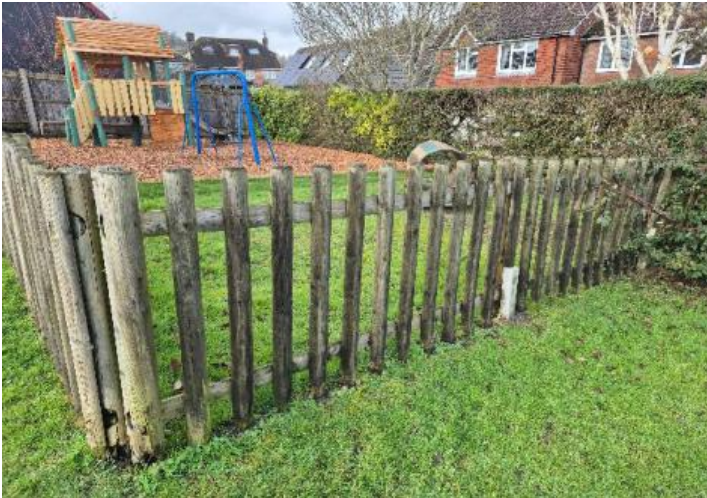
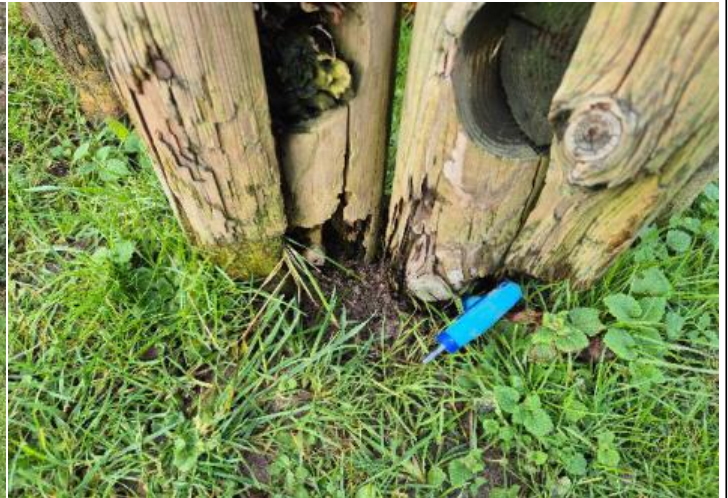
**Item:** Fences - Fencing - Timber  
**Manufacturer:** Not Identified

**Finding:** There are a number of loose and/or rotten posts around the fence

**Action:** Monitor for any further deterioration and reset as required

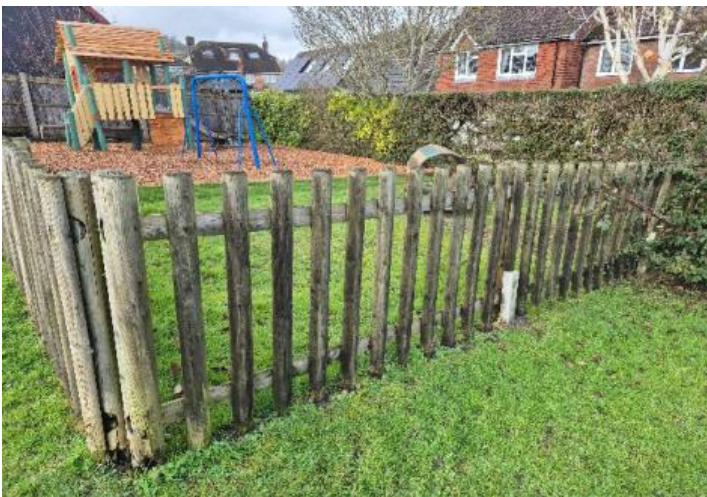
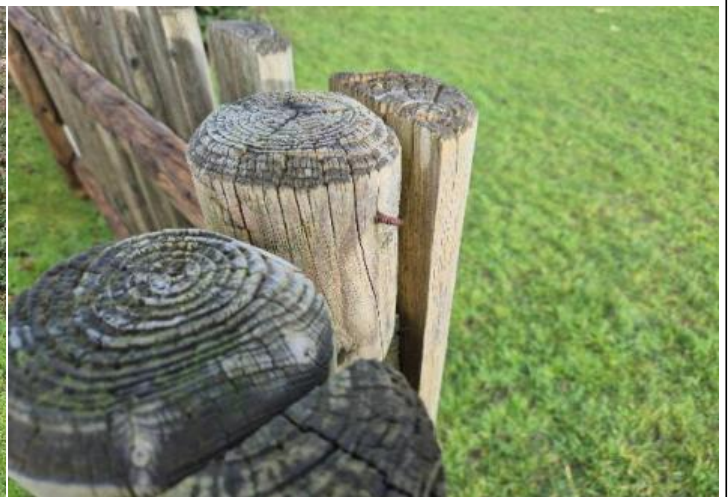
**Item:** Fences - Fencing - Timber  
**Manufacturer:** Not Identified

**Finding:** There are projecting nail ends present

**Action:** Remove redundant fixings

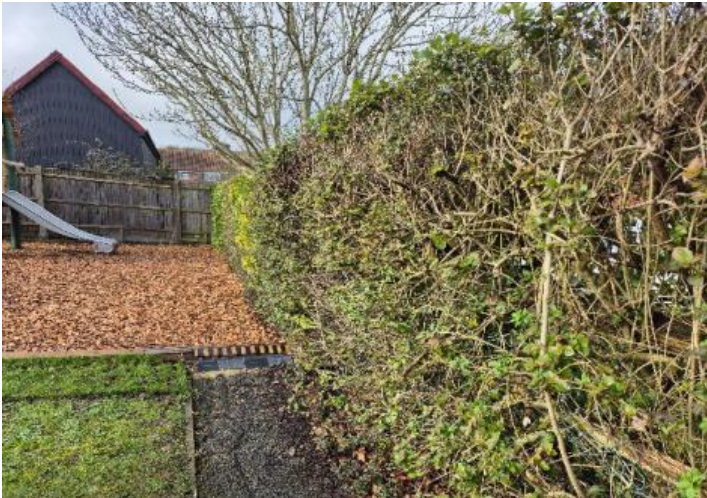
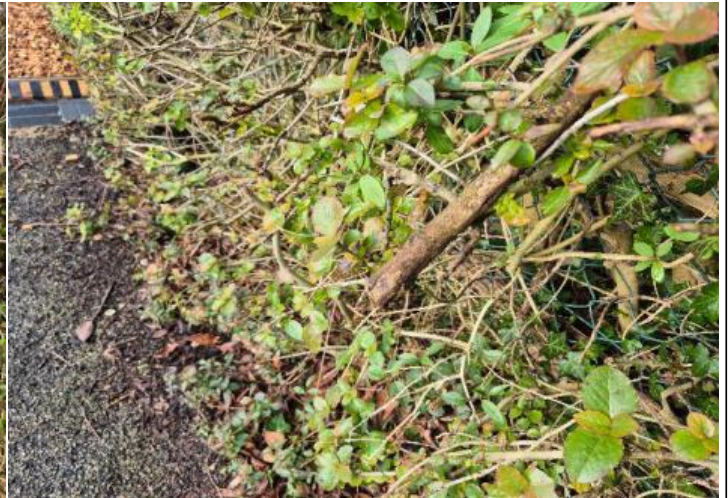
**Item:** Ancillary Items - Hedge  
**Manufacturer:** Natural Feature

**Finding:** There are projecting twigs present

**Action:** Prune and maintain

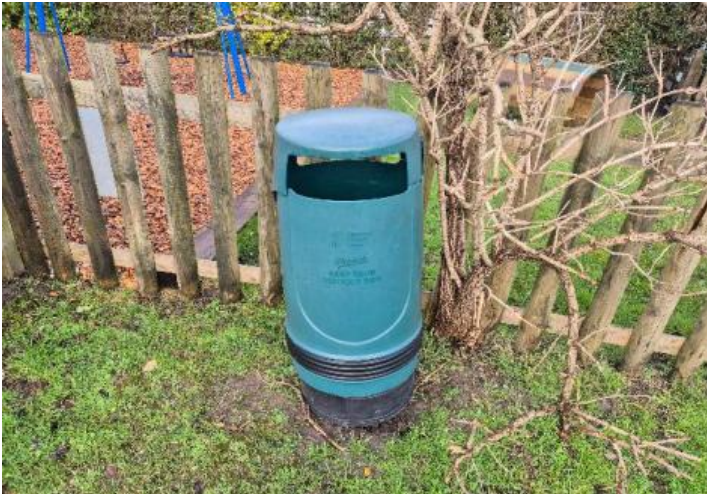
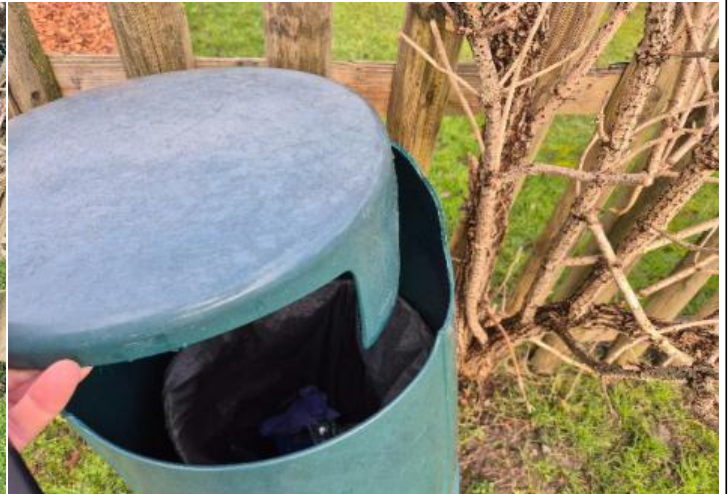
**Item:** Ancillary Items - Litter Bin  
**Manufacturer:** Glasdon

**Finding:** The item has been damaged

**Action:** Repair or replace the item / affected part

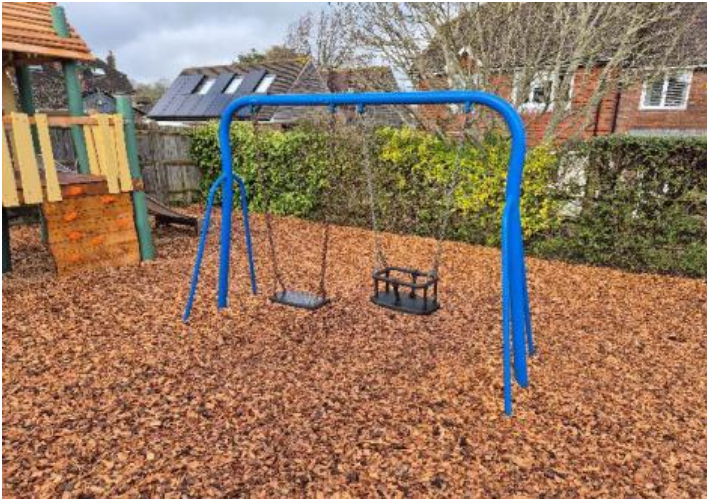
**Finding:** The loosefill surfacing has displaced from under or around the equipment

**Action:** Regulate surface levels and maintain

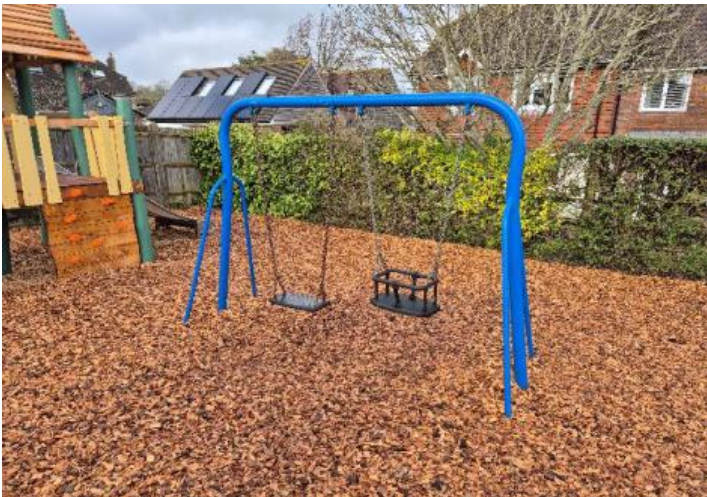
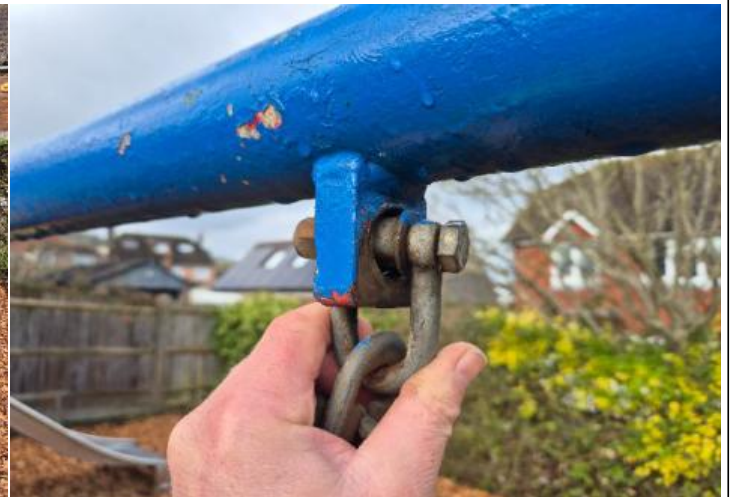
**Finding:** The bush / bushes is / are worn or missing

**Action:** Replace worn or missing bushes

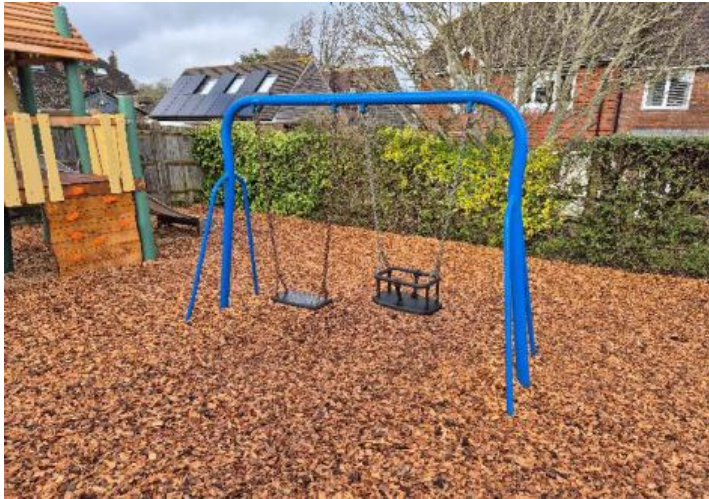
**Finding:** The chain openings are in excess of the 8.6mm as recommended by BS EN 1176  
**Action:** Monitor - No action given the risk assessment

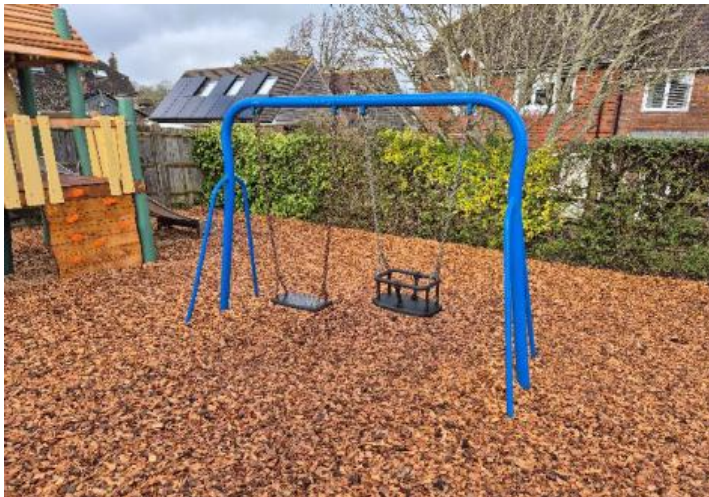
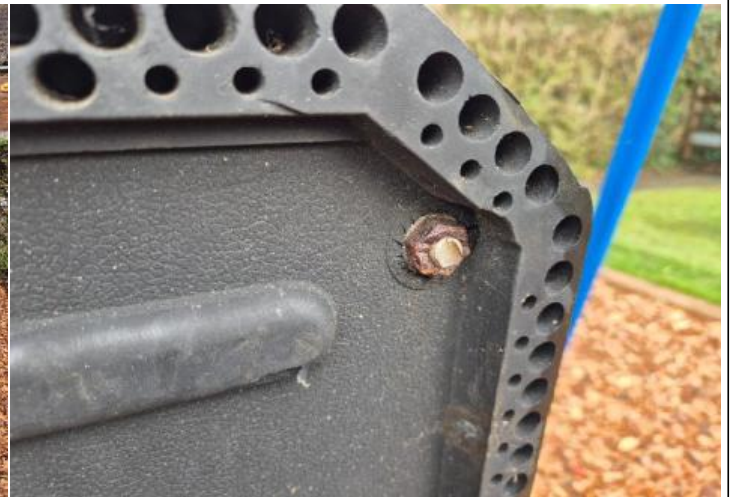
### 8 - Low Risk (Finding 4)

**Finding:** The fixings have corroded excessively  
**Action:** Replace all corroded fixings

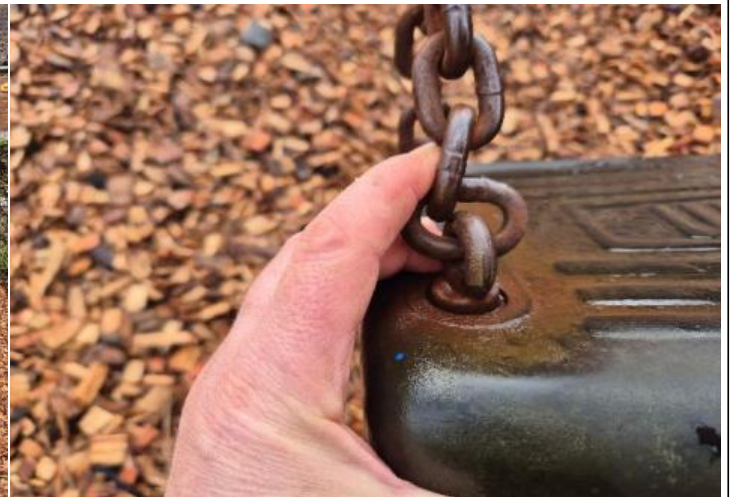
**Finding:** There is some notable evidence of chain wear

**Action:** Monitor for any further deterioration and replace when 40% worn

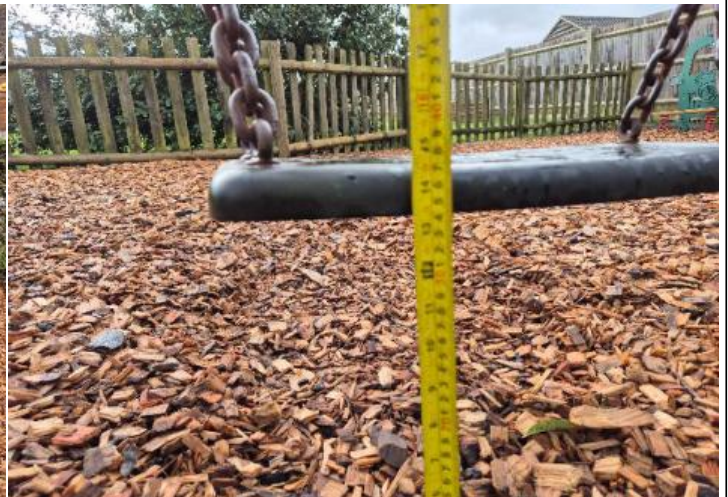
**Finding:** The seat clearance from finished surface level to the underside of the seat is too low and does not meet the requirements of BS EN 1176 Part 2 (350mm minimum clearance required)

**Action:** Adjust seat height/s (400mm-500mm is recommended)
