## COMMUNITY COMMITTEE MEETING HELD ON TUESDAY 3<sup>rd</sup> MARCH 2026 AT 7.30 PM AT THE STEYPING CENTRE

# DRAFT MINUTES

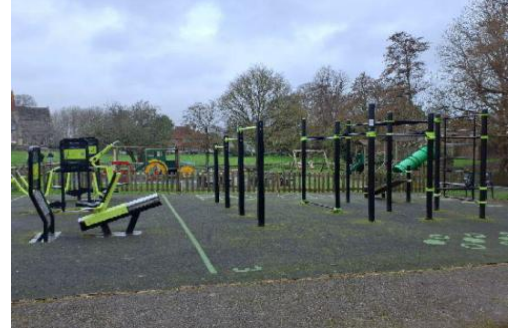
**Item:** Site General  
**Manufacturer:** Owner/Operator  
**Surface Type:** N/A  
**Item Quantity:** 1  
**Equipment Compliance:** N/A  
**Surface Area Compliance:** N/A

There is algae, silt or moss growth on the surface resulting in slippery conditions - Clean and treat appropriately

There are trip hazards at the edges of the surface - Remove trip hazard

The surface is lifting at the edges and creating trip points - Repair perimeter of surfacing to remove trip points

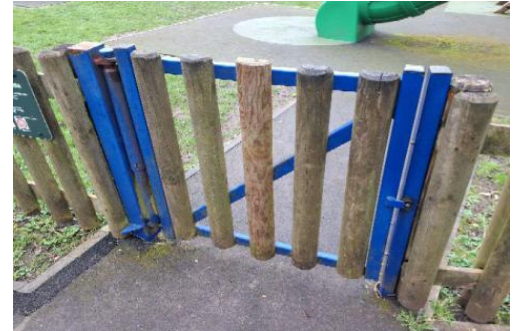
**Item:** Gate - Self Closing  
**Manufacturer:** Not Identified  
**Surface Type:** Wet Pour  
**Item Quantity:** 2  
**Equipment Compliance:** N/A  
**Surface Area Compliance:** N/A

There are openings that are less than 12mm that could trap or crush fingers - Provide a 12mm gap throughout full range of motion at both sides of gate

The paintwork on this item has been damaged or worn exposing the metal underneath which is rusting / corroding - Treat affected areas and repaint

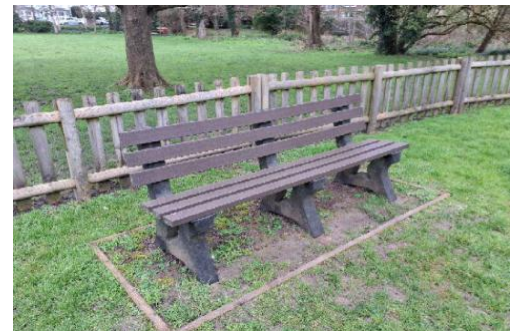
**Item:** Bench  
**Manufacturer:** Not Identified  
**Surface Type:** Concrete  
**Item Quantity:** 2  
**Equipment Compliance:** N/A  
**Surface Area Compliance:** N/A

There are trip hazards present - Remove trip hazard

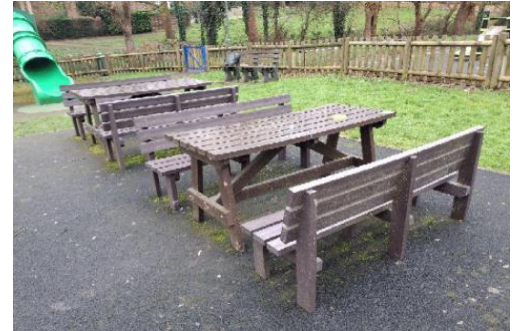
**Item:** Seating Area  
**Manufacturer:** Not Identified  
**Surface Type:** Wet Pour  
**Item Quantity:** 1  
**Equipment Compliance:** N/A  
**Surface Area Compliance:** N/A

There is some evidence of fire damage to the item - Monitor for any further deterioration and repair as required

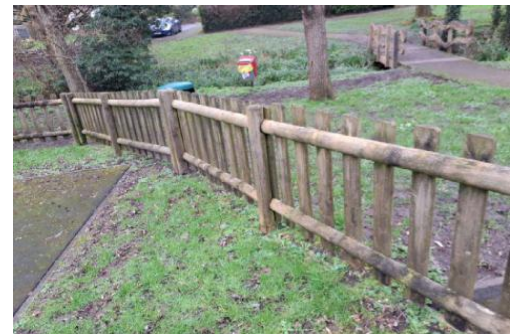
**Item:** Fencing - Timber  
**Manufacturer:** Not Identified  
**Surface Type:** Grass  
**Item Quantity:** 1  
**Equipment Compliance:** N/A  
**Surface Area Compliance:** N/A

There is some strimmer / machinery damage apparent on the posts, this can penetrate the preservative applied to the timber and accelerate the rotting process - Monitor for any deterioration (rot) and replace as required

A number of posts have rotted - Replace all affected timber

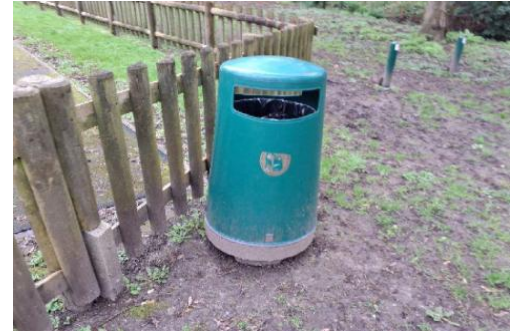
**Item:** Litter Bin  
**Manufacturer:** Glasdon  
**Surface Type:** Grass  
**Item Quantity:** 1  
**Equipment Compliance:** N/A  
**Surface Area Compliance:** N/A

The bin is not securely fixed to the surface and there is some possibility of the item tipping or rolling over - Secure the bin to the ground

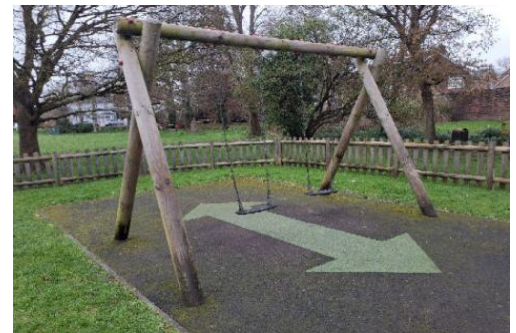
**Item:** 1 Bay 2 Seat (Flat)  
**Manufacturer:** Creative Play  
**Surface Type:** Wet Pour  
**Item Quantity:** 1  
**Equipment Compliance:** Yes  
**Surface Area Compliance:** Yes

A number of fixing(s) have worked loose on the suspension mounts - Secure all loose fixings

There is some minor damage to the surface - Monitor for any further deterioration and repair as required

There is some notable evidence of chain wear - Monitor for any further deterioration and replace when 40% worn

There is/are bolt cap covers missing or damaged on the item - Replace missing or damaged bolt cap covers

The seat has minor damage or wear - Monitor for any further deterioration and replace as required

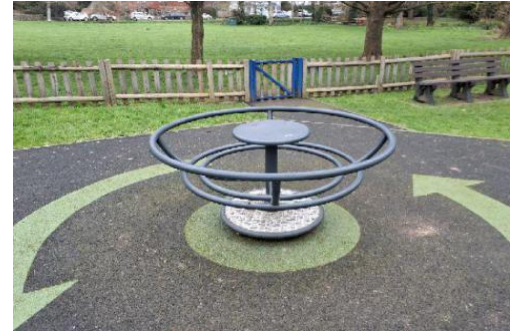
**Item:** Misc Item  
**Manufacturer:** Creative Play  
**Surface Type:** Wet Pour  
**Item Quantity:** 1  
**Equipment Compliance:** Yes  
**Surface Area Compliance:** Yes

A number of fixing(s) have worked loose - Secure all loose fixings

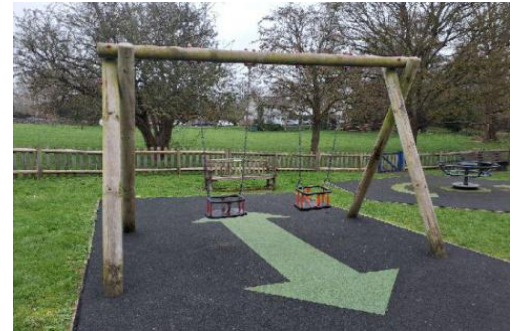
**Item:** 1 Bay 2 Seat (Cradle)  
**Manufacturer:** Creative Play  
**Surface Type:** Wet Pour  
**Item Quantity:** 1  
**Equipment Compliance:** Yes  
**Surface Area Compliance:** Yes

There is some notable evidence of chain wear - Monitor for any further deterioration and replace when 40% worn

The seat has minor damage or wear - Monitor for any further deterioration and replace as required

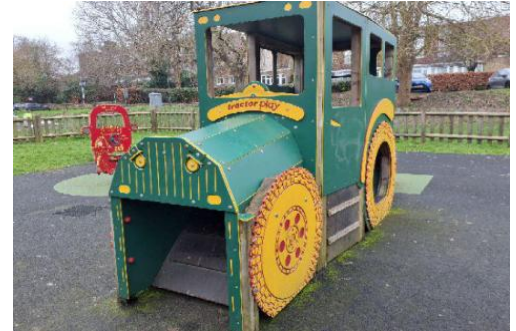
**Item:** Tractor  
**Manufacturer:** Creative Play  
**Surface Type:** Wet Pour  
**Item Quantity:** 1  
**Equipment Compliance:** No  
**Surface Area Compliance:** Yes

There is some evidence of rot in the timber - Monitor for any further deterioration and replace as required

The paintwork on this item has been damaged or worn exposing the metal underneath which is rusting / corroding - Treat affected areas and repaint

There are a number of dents in the slide surface - Monitor for any further deterioration and repair as required

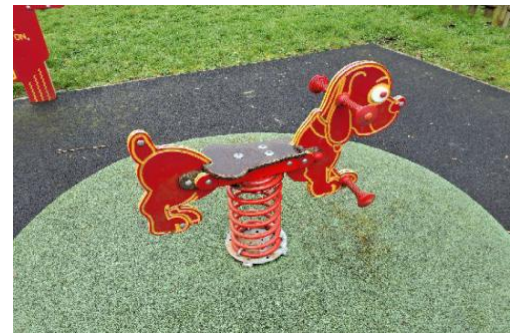
**Item:** Spring Dog  
**Manufacturer:** Creative Play  
**Surface Type:** Wet Pour  
**Item Quantity:** 1  
**Equipment Compliance:** Yes  
**Surface Area Compliance:** Yes

Parts of the timber are rough or splintered - Remove all rough or sharp edges

The paintwork on the spring has been damaged or worn exposing the metal underneath which is rusting - Treat any rusting components and repaint

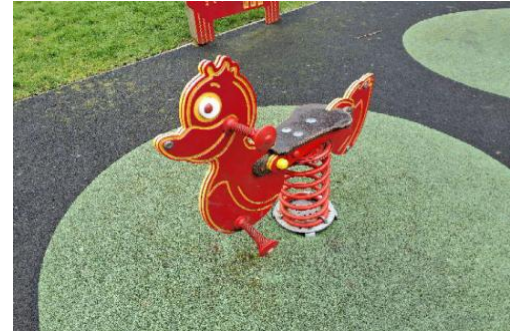
**Item:** Spring Duck  
**Manufacturer:** Creative Play  
**Surface Type:** Wet Pour  
**Item Quantity:** 1  
**Equipment Compliance:** No  
**Surface Area Compliance:** Yes

Parts of the timber are rough or splintered - Remove all rough or sharp edges

The paintwork on the spring has been damaged or worn exposing the metal underneath which is rusting - Treat any rusting components and repaint

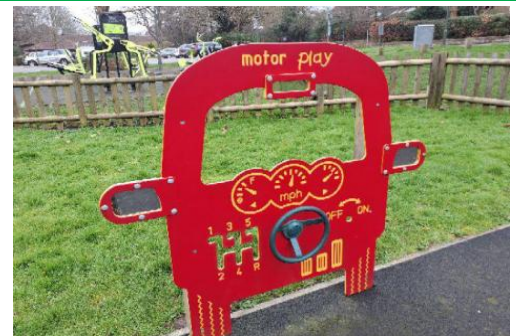
**Item:** Play Panel  
**Manufacturer:** Creative Play  
**Surface Type:** Wet Pour  
**Item Quantity:** 1  
**Equipment Compliance:** Yes  
**Surface Area Compliance:** N/A

There is some strimmer / machinery damage apparent on the posts, this can penetrate the preservative applied to the timber and accelerate the rotting process - Monitor for any deterioration (rot) and replace as required

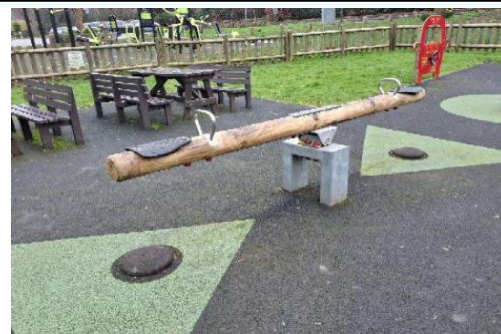
**Item:** See Saw  
**Manufacturer:** Not Identified  
**Surface Type:** Wet Pour  
**Item Quantity:** 1  
**Equipment Compliance:** Yes  
**Surface Area Compliance:** Yes

The seat has been severely damaged - Repair / replace the seat as required

A number of fixing(s) have worked loose - Secure all loose fixings

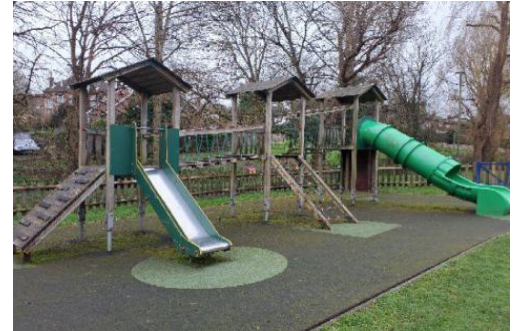
**Item:** Multi Play (Junior)  
**Manufacturer:** Creative Play  
**Surface Type:** Wet Pour  
**Item Quantity:** 1  
**Equipment Compliance:** No  
**Surface Area Compliance:** Yes

There are a number of dents in the slide surface - Monitor for any further deterioration and repair as required

BS EN 1176 Part 3 recommends that slides should be constructed to ensure that gaps between joints are eliminated and sharp objects cannot become lodged - Monitor for any further deterioration and repair as required

A number of fixing(s) have worked loose on the rope connectors - Secure all loose fixings

There are areas or parts of the timber on the structure that have rotted - Replace all affected timbers

There is some wear to the shackles. - Monitor for any further deterioration and replace when 40% worn

There is some evidence of rot in the timber - Monitor for any further deterioration and replace as required

There are areas or parts of the timber at the top of the slide that have rotted - Replace all affected timbers

There are areas or parts of the timber on the platforms that have rotted - Replace all affected timbers

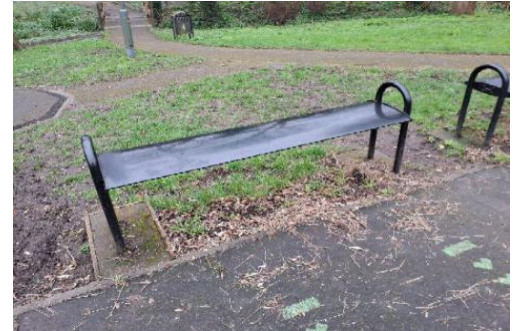
**Item:** Bench  
**Manufacturer:** Not Identified  
**Surface Type:** Grass  
**Item Quantity:** 2  
**Equipment Compliance:** N/A  
**Surface Area Compliance:** N/A

There are trip hazards at the edges of the surface - Remove trip hazard

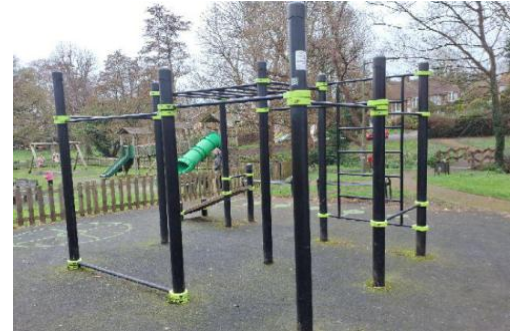
**Item:** Calisthenics Unit  
**Manufacturer:** Kenguru Fitness  
**Surface Type:** Wet Pour  
**Item Quantity:** 1  
**Equipment Compliance:** No  
**Surface Area Compliance:** Yes

There is a head and neck entrapment in the framework in contravention of the requirements of BS EN 16630:2015 clause 4.3.6.1 - Monitor - No action given the risk assessment

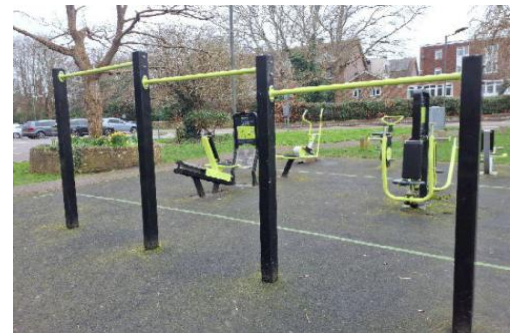
**Item:** Pull Up Station  
**Manufacturer:** The Great Outdoor Gym Company  
**Surface Type:** Wet Pour  
**Item Quantity:** 1  
**Equipment Compliance:** Yes  
**Surface Area Compliance:** Yes

The paintwork on this item has been damaged or worn exposing the metal underneath which is rusting / corroding - Treat affected areas and repaint

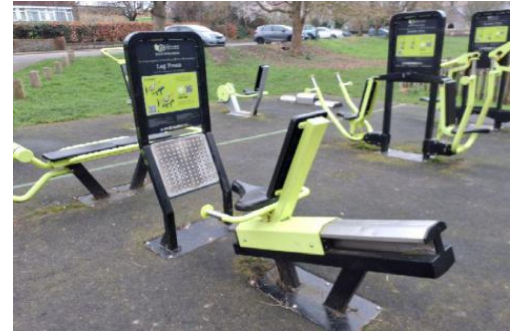
**Item:** Leg Press  
**Manufacturer:** The Great Outdoor Gym Company  
**Surface Type:** Wet Pour  
**Item Quantity:** 1  
**Equipment Compliance:** Yes  
**Surface Area Compliance:** Yes

The item has been damaged - Monitor for any further deterioration and replace as required

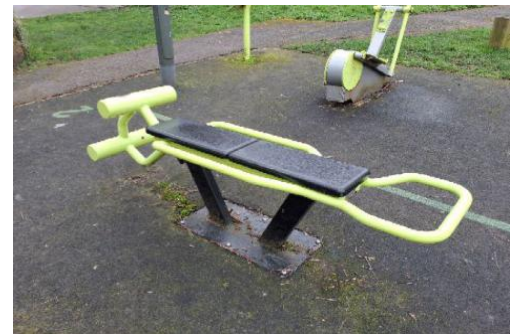
**Item:** Sit Up Station  
**Manufacturer:** The Great Outdoor Gym Company  
**Surface Type:** Wet Pour  
**Item Quantity:** 1  
**Equipment Compliance:** Yes  
**Surface Area Compliance:** Yes

The paintwork on this item has been damaged or worn exposing the metal underneath which is rusting / corroding - Treat affected areas and repaint

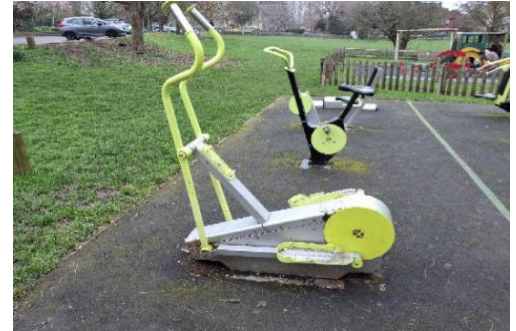
**Item:** Cross Trainer  
**Manufacturer:** The Great Outdoor Gym Company  
**Surface Type:** Wet Pour  
**Item Quantity:** 1  
**Equipment Compliance:** Yes  
**Surface Area Compliance:** Yes

The bearing is showing signs of wear - Monitor for any further deterioration and replace as required

The LED panel is not operating correctly - Repair or replace as required

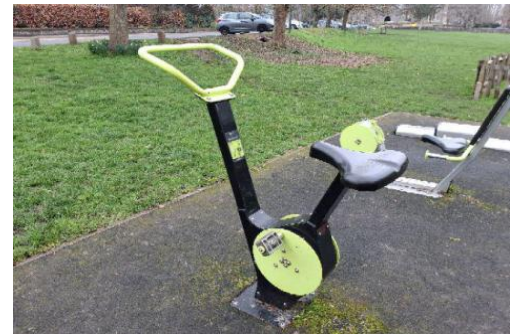
**Item:** Cycle  
**Manufacturer:** The Great Outdoor Gym Company  
**Surface Type:** Wet Pour  
**Item Quantity:** 1  
**Equipment Compliance:** Yes  
**Surface Area Compliance:** Yes

The paintwork on this item has been damaged or worn exposing the metal underneath which is rusting / corroding - Treat affected areas and repaint

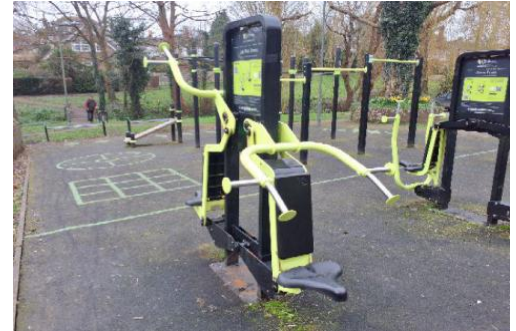
**Item:** Double Fitness Station  
**Manufacturer:** The Great Outdoor Gym Company  
**Surface Type:** Wet Pour  
**Item Quantity:** 1  
**Equipment Compliance:** Yes  
**Surface Area Compliance:** Yes

The paintwork on this item has been damaged or worn exposing the metal underneath which is rusting / corroding - Treat affected areas and repaint

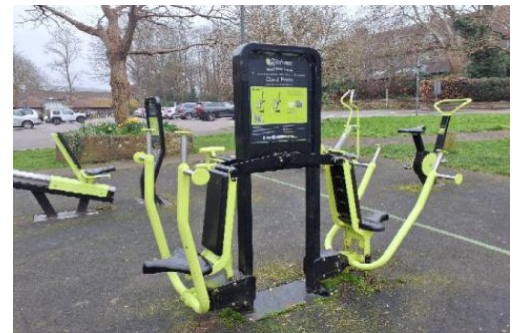
**Item:** Double Fitness Station  
**Manufacturer:** The Great Outdoor Gym Company  
**Surface Type:** Wet Pour  
**Item Quantity:** 1  
**Equipment Compliance:** No  
**Surface Area Compliance:** Yes

The bushes are showing signs of wear - Monitor for any further deterioration and replace as required

The paintwork on this item has been damaged or worn exposing the metal underneath which is rusting / corroding - Treat affected areas and repaint

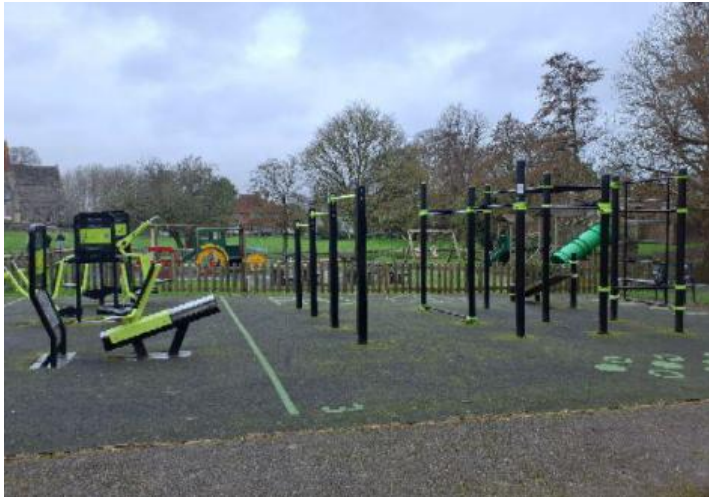
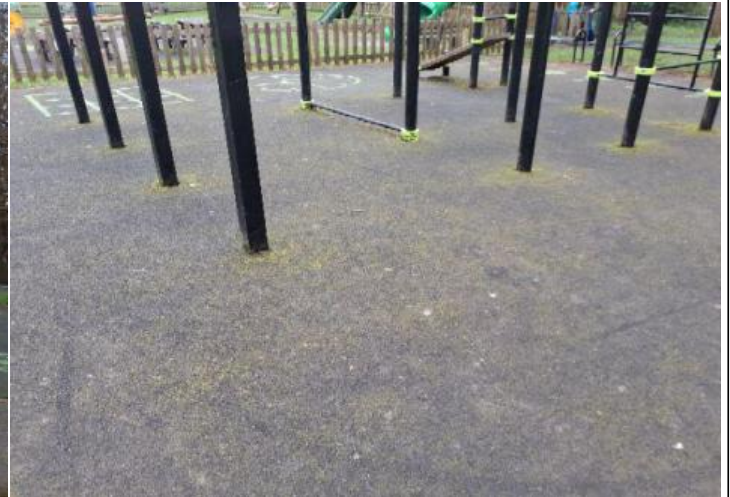
**Item:** Ancillary Items - Site General  
**Manufacturer:** Owner/Operator

**Finding:** There is algae, silt or moss growth on the surface resulting in slippery conditions  
**Action:** Clean and treat appropriately

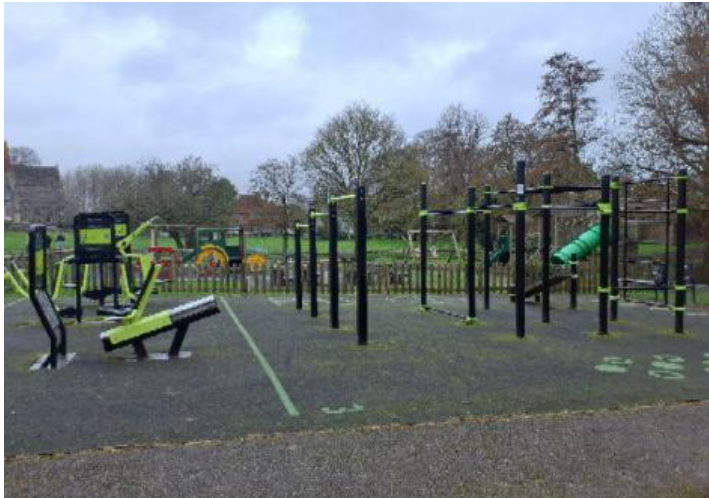
**Item:** Ancillary Items - Site General  
**Manufacturer:** Owner/Operator

**Finding:** The surface is lifting at the edges and creating trip points **Action:** Repair perimeter of surfacing to remove trip points

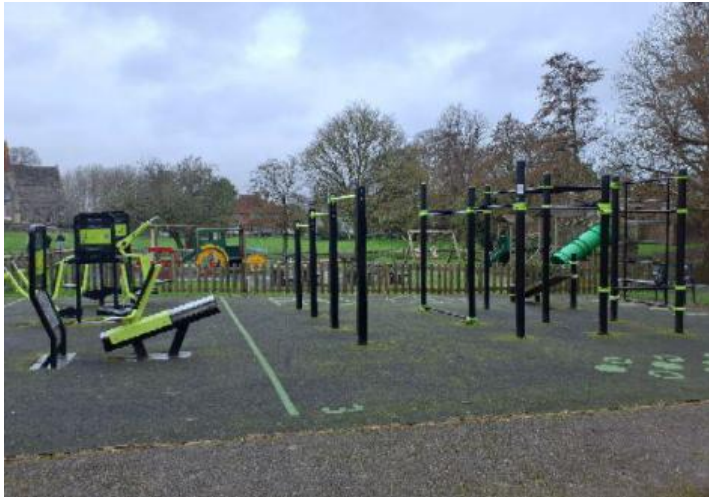
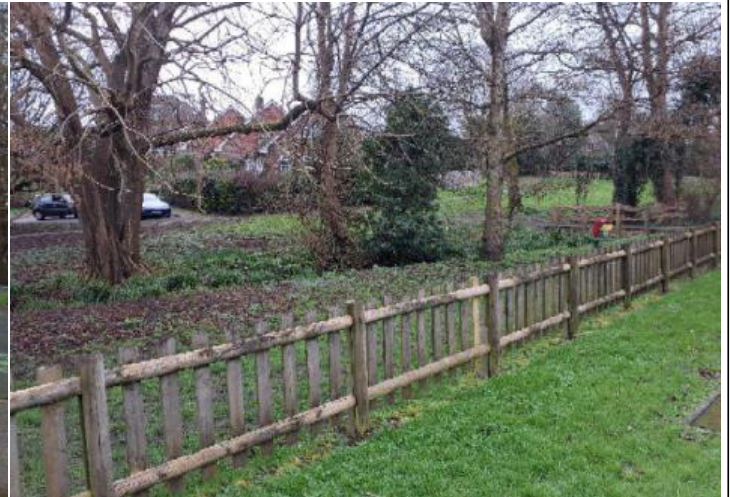
**Finding:** NOTE - There is a body of water or a water basin in close proximity to the playground. Risk assessment of this is a specialist field and outside the scope of our inspection. **Action:** Contact our official water safety partner the RLSS (Royal Life Saving Society) at [www.rlss.org.uk](http://www.rlss.org.uk) and / or ensure that the appropriate risk assessment is in place

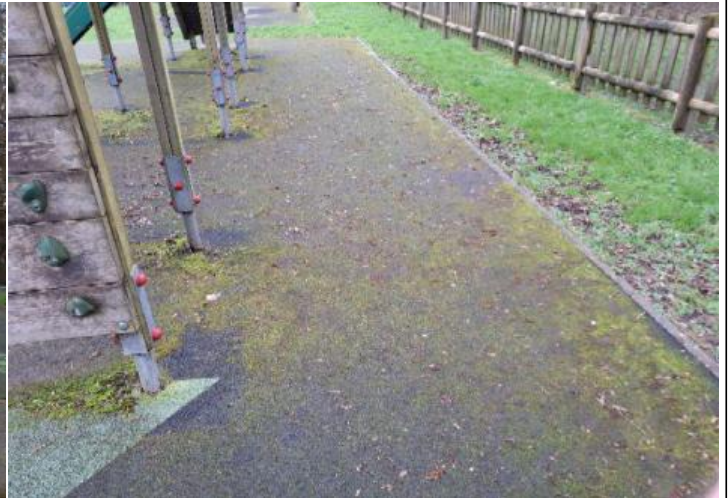
**Finding:** There is some tree debris on the surfacing

**Action:** Remove and maintain

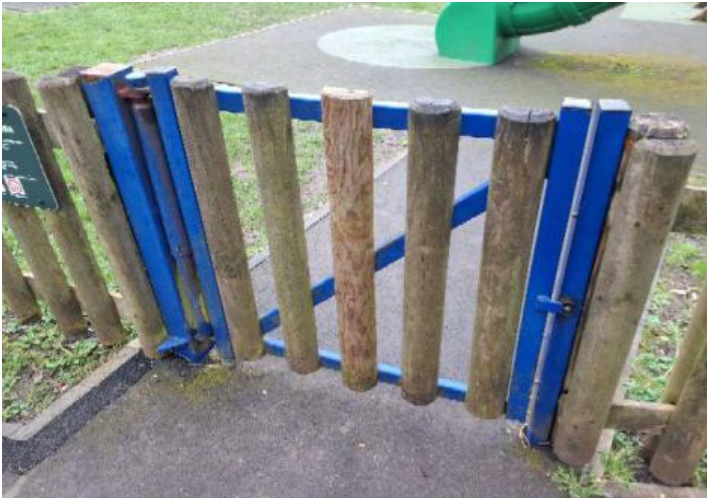
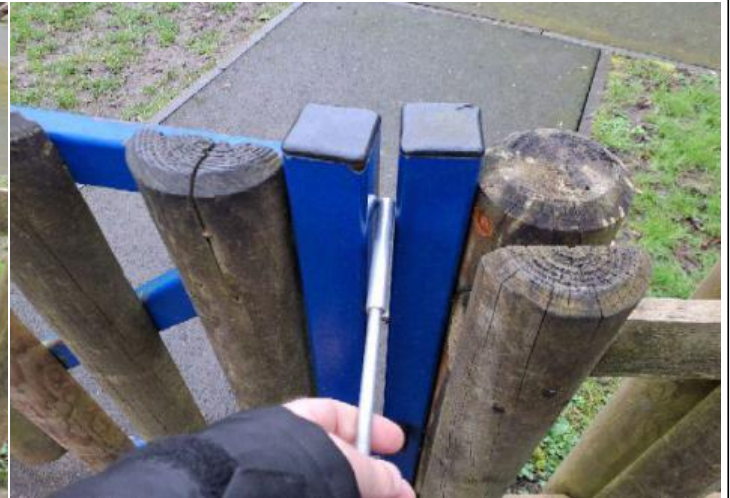
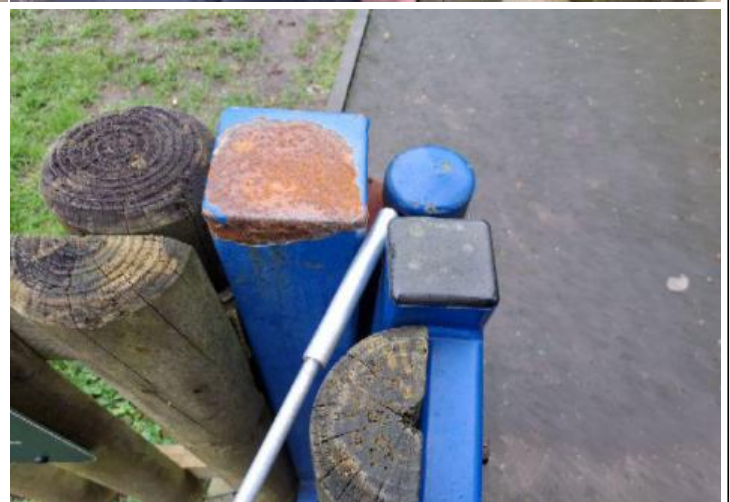
**Finding:** There are openings that are less than 12mm that could trap or crush fingers

**Action:** Provide a 12mm gap throughout full range of motion at both sides of gate

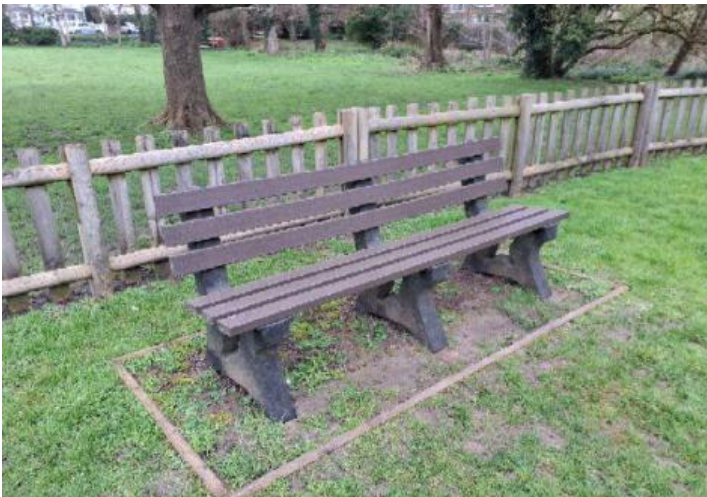
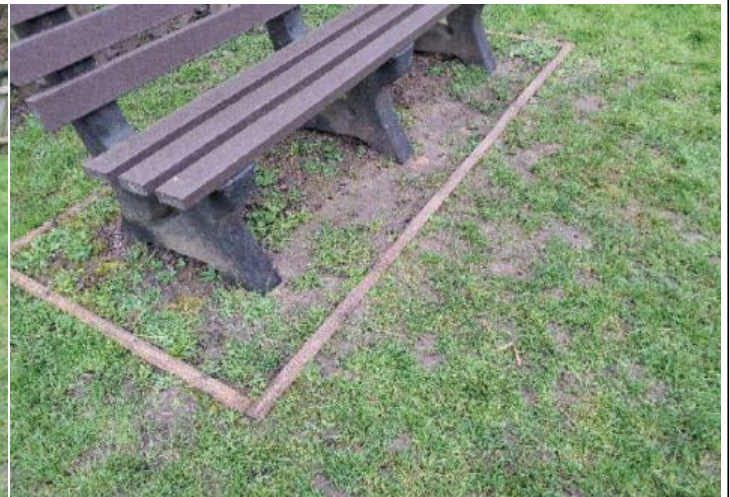
**Finding:** There are trip hazards present

**Action:** Remove trip hazard

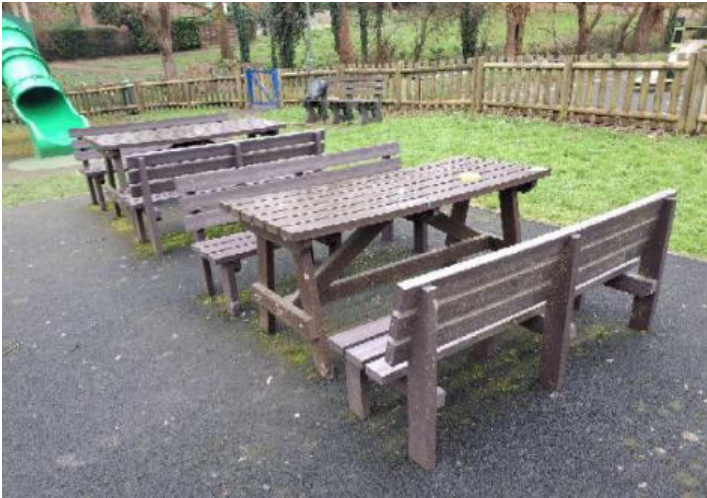
**Finding:** There is some evidence of fire damage to the item **Action:** Monitor for any further deterioration and repair as required

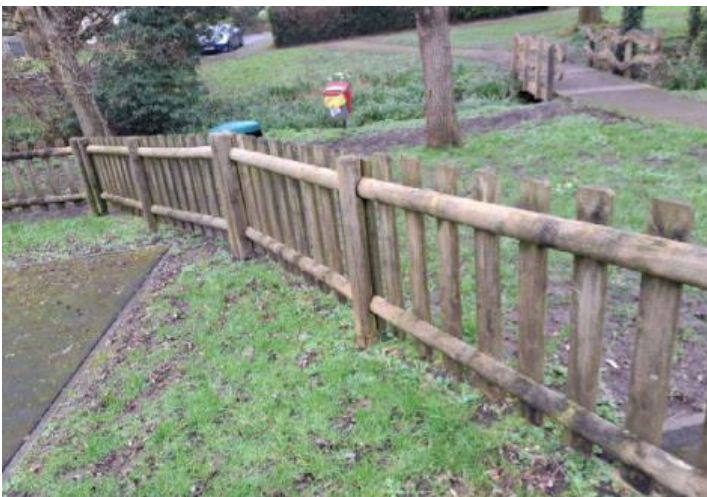
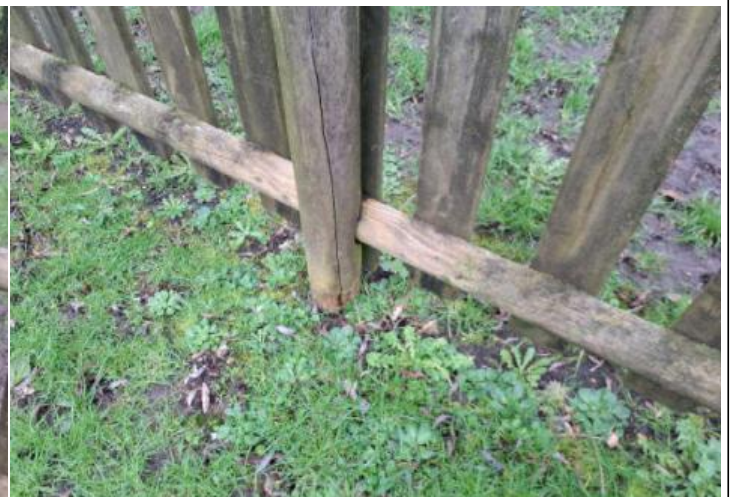
**Finding:** There is some strimmer / machinery damage apparent on the posts, this can penetrate the preservative applied to the timber and accelerate the rotting process **Action:** Monitor for any deterioration (rot) and replace as required

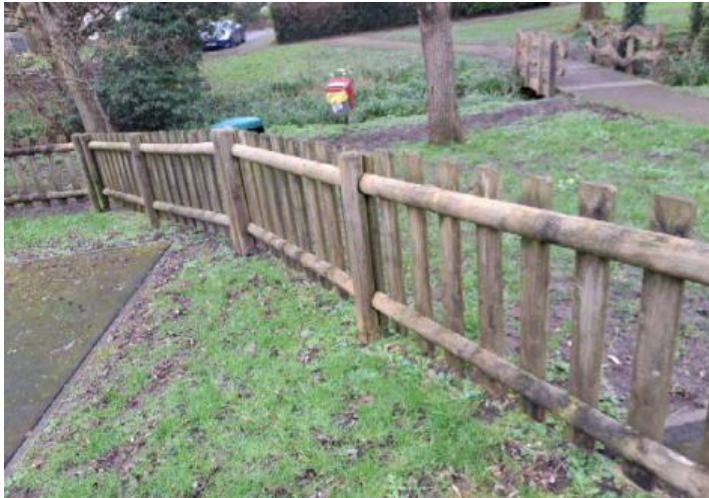
**Finding:** A number of posts have rotted

**Action:** Replace all affected timber

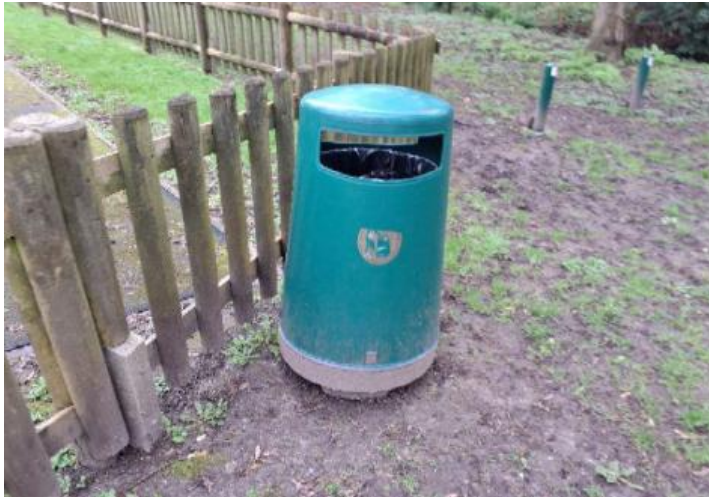
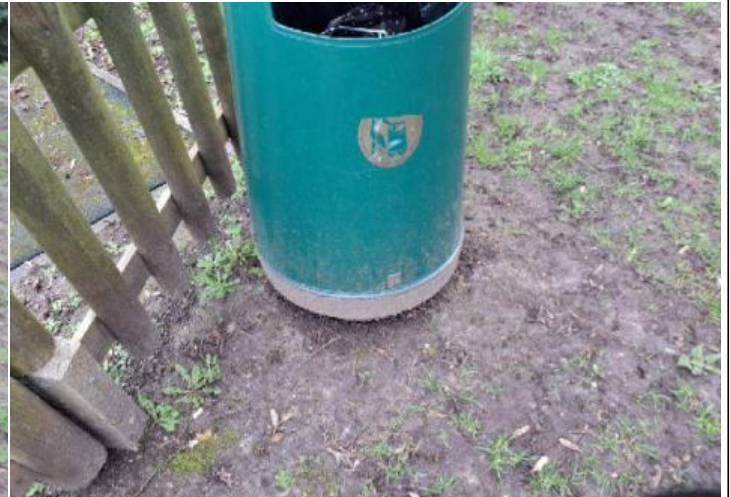
**Finding:** The bin is not securely fixed to the surface and there is some possibility of the item tipping or rolling over

**Action:** Secure the bin to the ground

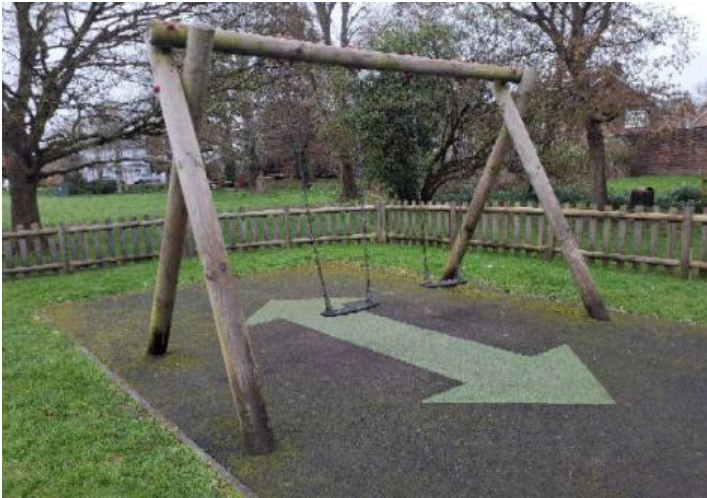
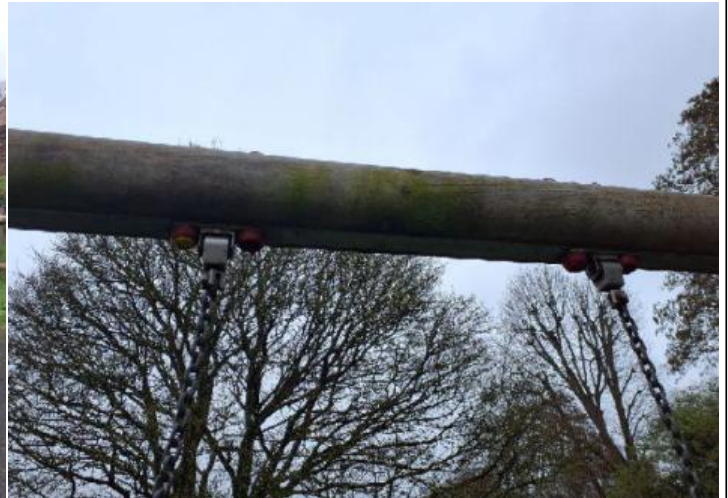
**Finding:** A number of fixing(s) have worked loose on the suspension mounts

**Action:** Secure all loose fixings

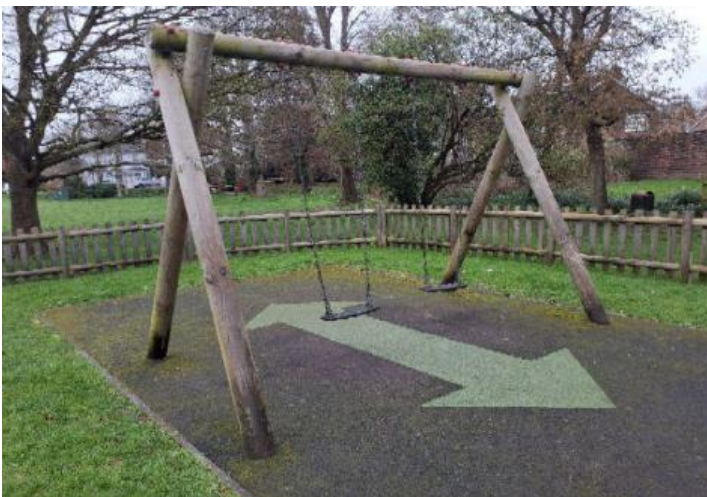
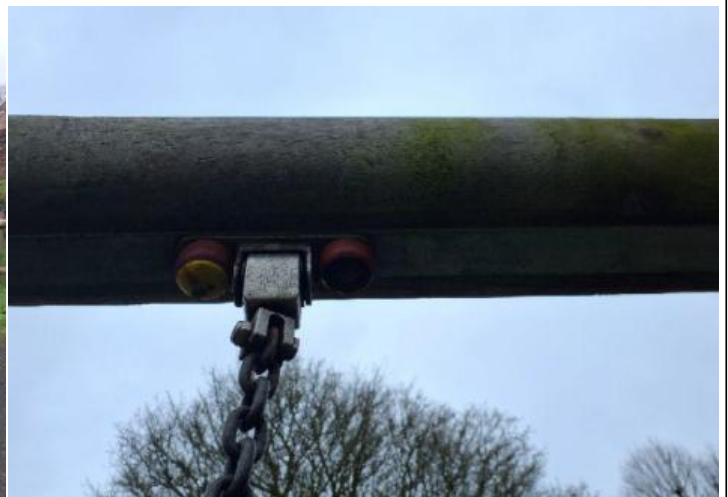
**Finding:** There is/are bolt cap covers missing or damaged on the item

**Action:** Replace missing or damaged bolt cap covers

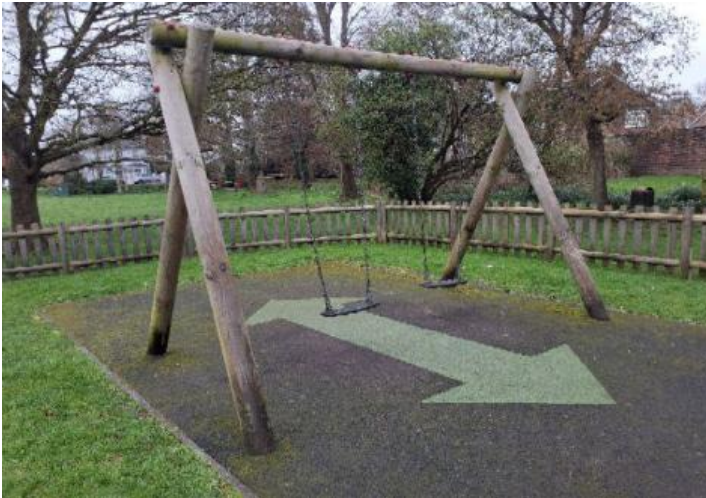
**Finding:** There is some minor damage to the surface

**Action:** Monitor for any further deterioration and repair as required

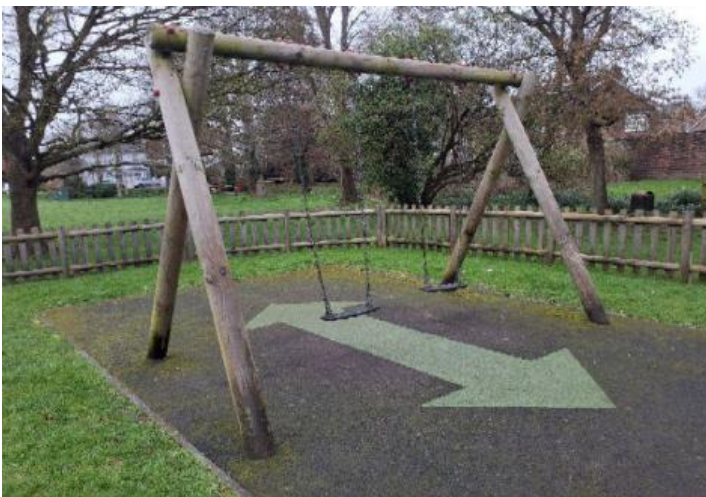
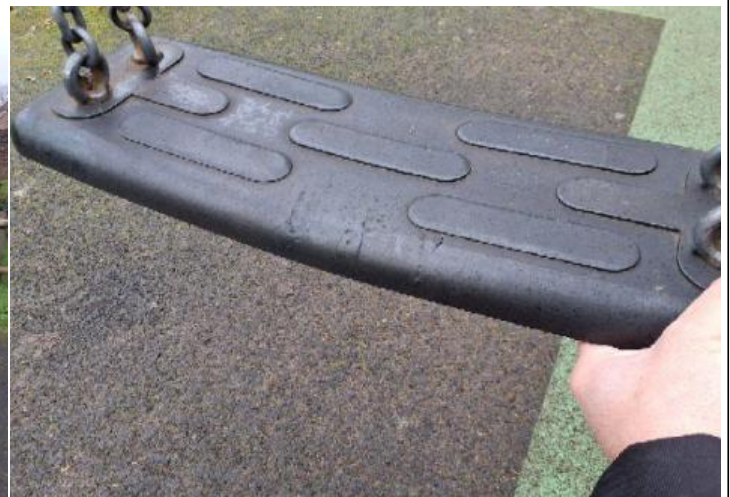
**Finding:** The seat has minor damage or wear

**Action:** Monitor for any further deterioration and replace as required

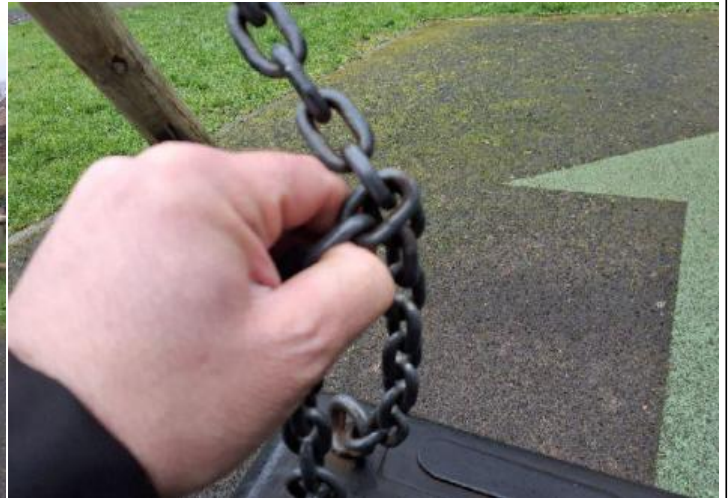
**Finding:** There is some notable evidence of chain wear

**Action:** Monitor for any further deterioration and replace when 40% worn

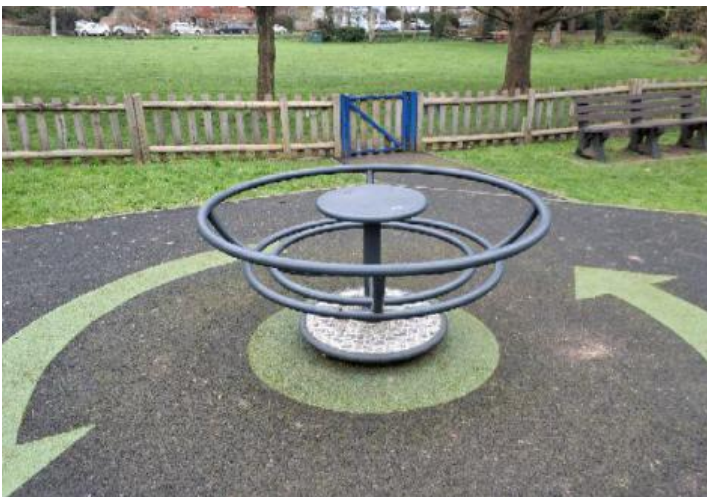
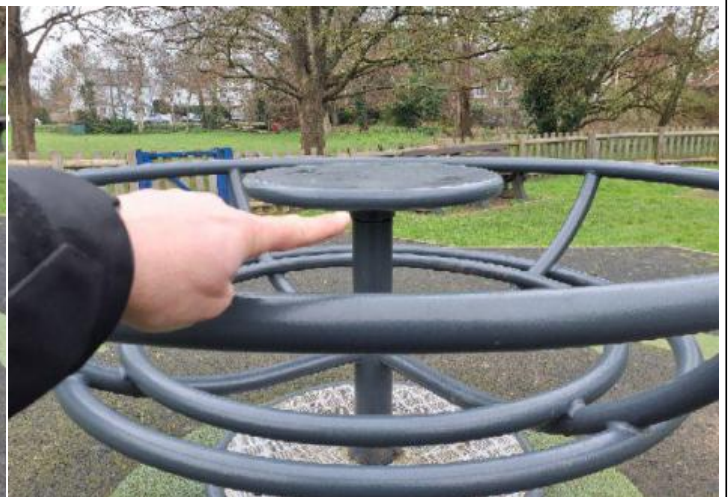
**Finding:** A number of fixing(s) have worked loose

**Action:** Secure all loose fixings

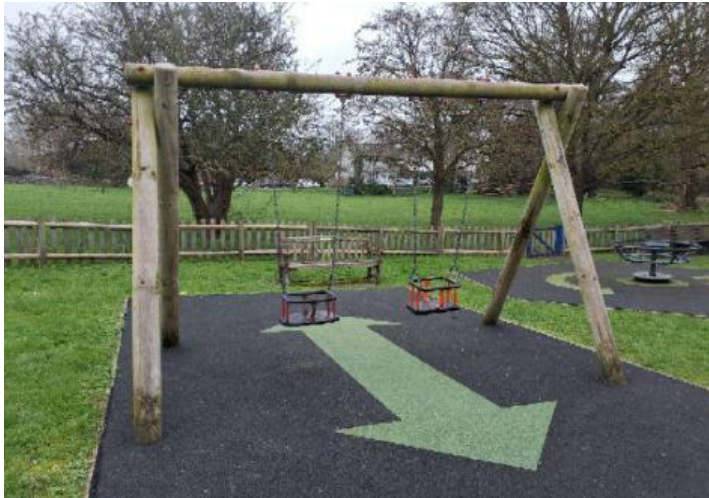
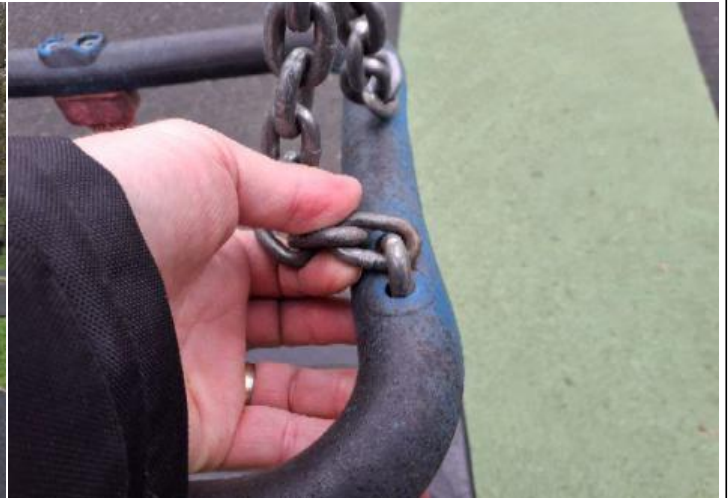
**Finding:** There is some notable evidence of chain wear

**Action:** Monitor for any further deterioration and replace when 40% worn

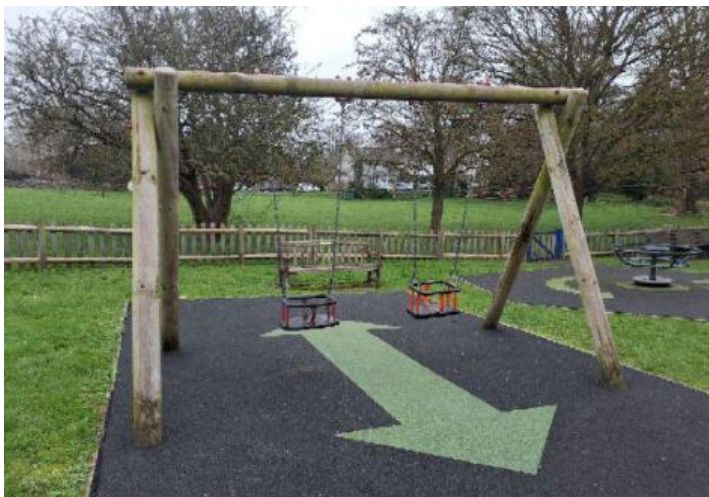
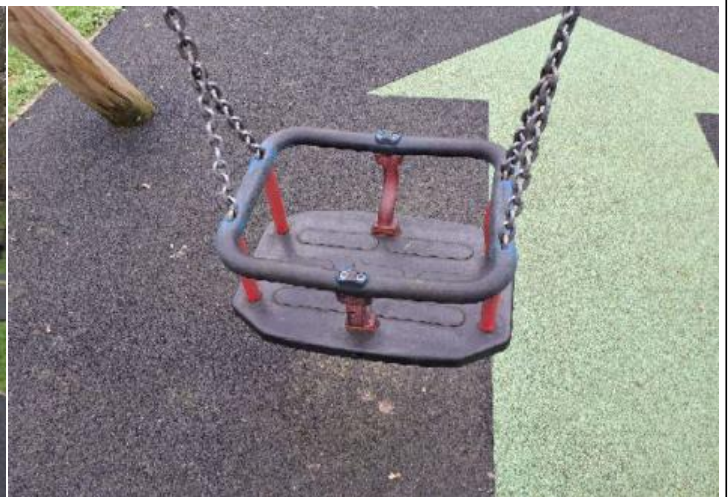
**Finding:** The seat has minor damage or wear

**Action:** Monitor for any further deterioration and replace as required

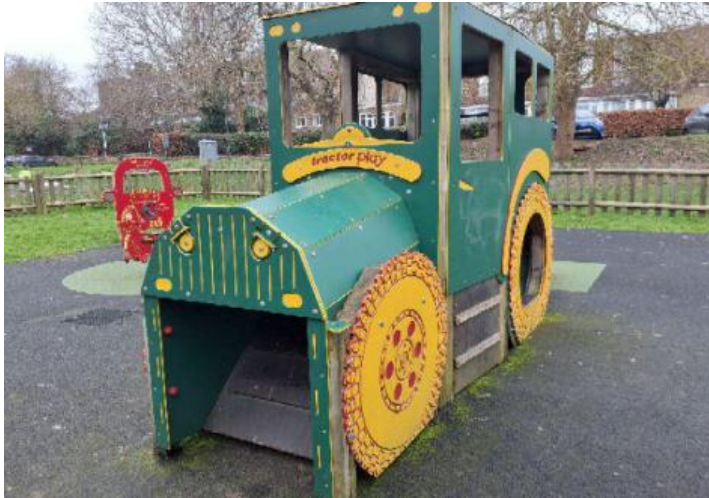
**Finding:** There is some evidence of rot in the timber

**Action:** Monitor for any further deterioration and replace as required

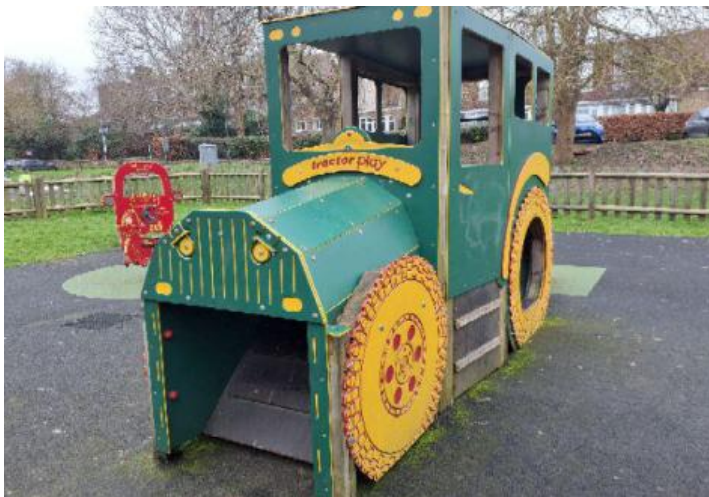
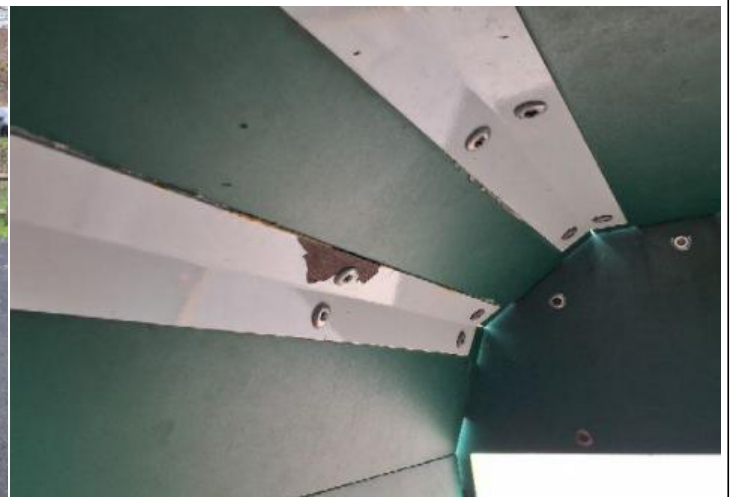
**Finding:** The paintwork on this item has been damaged or worn exposing the metal underneath which is rusting / corroding

**Action:** Treat affected areas and repaint

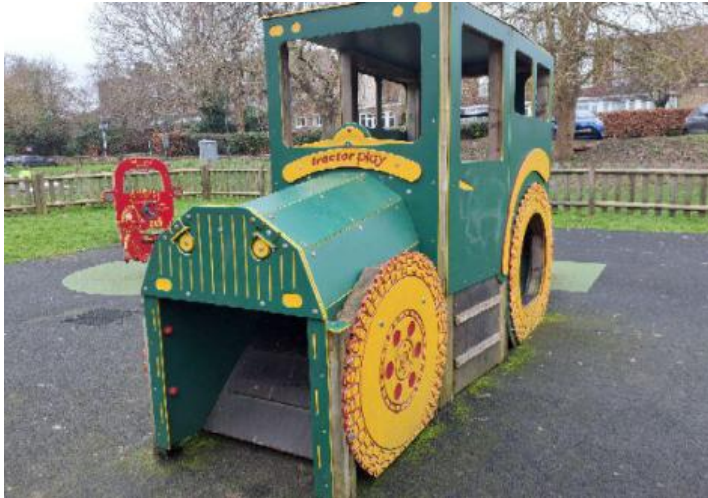
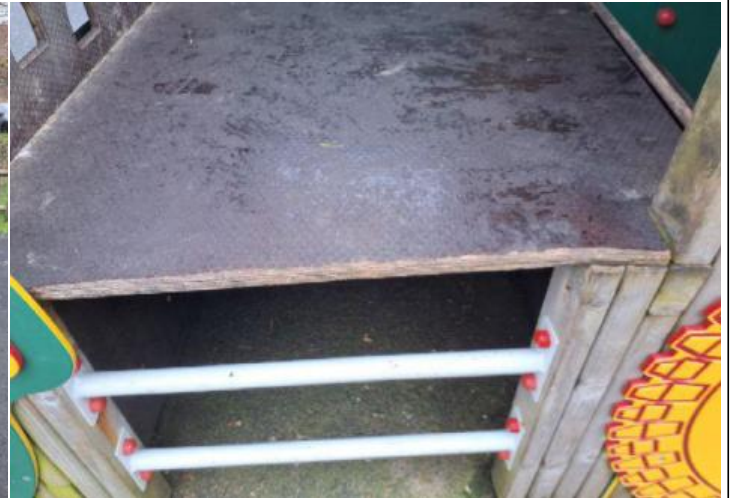
**Finding:** Parts of the timber are rough or splintered

**Action:** Remove all rough or sharp edges

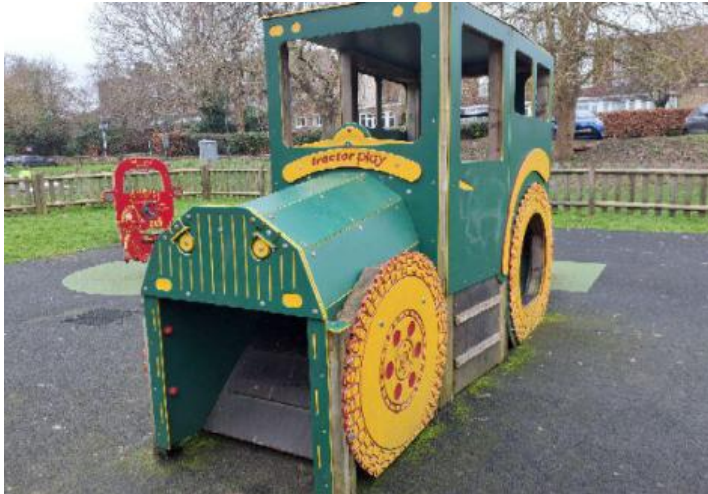
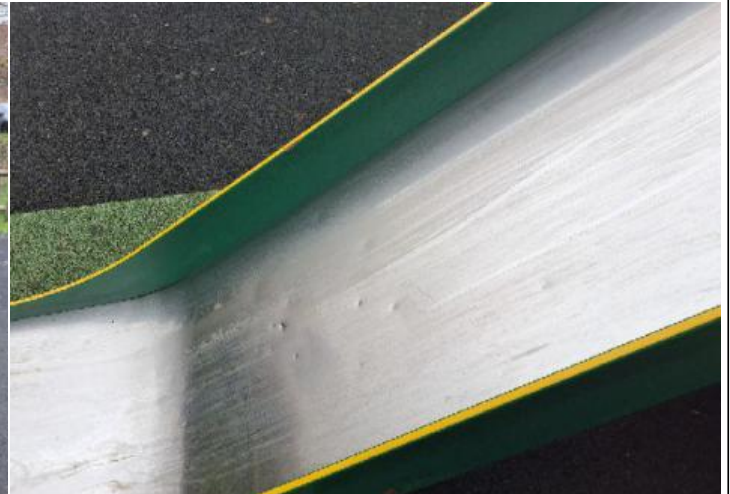
**Finding:** There are a number of dents in the slide surface

**Action:** Monitor for any further deterioration and repair as required

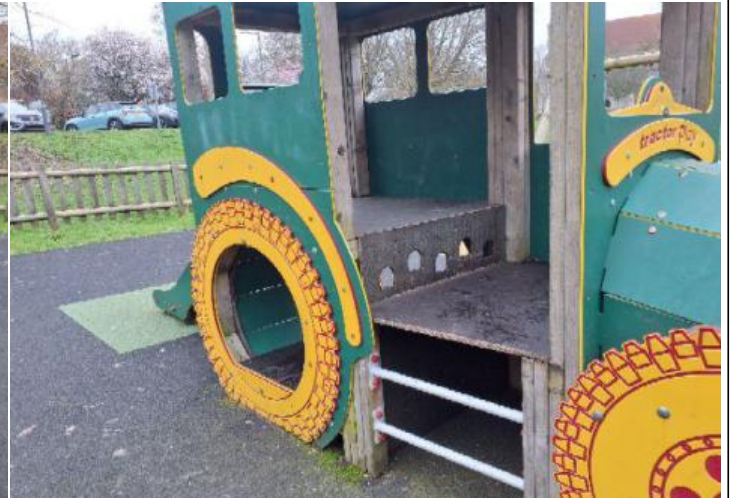
**Finding:** The unit is easily accessible and should have the appropriate barriers installed to meet the requirements of BS EN 1176 Part 1 as the height of the unit exceeds 600mm

**Action:** Monitor - No action given the risk assessment

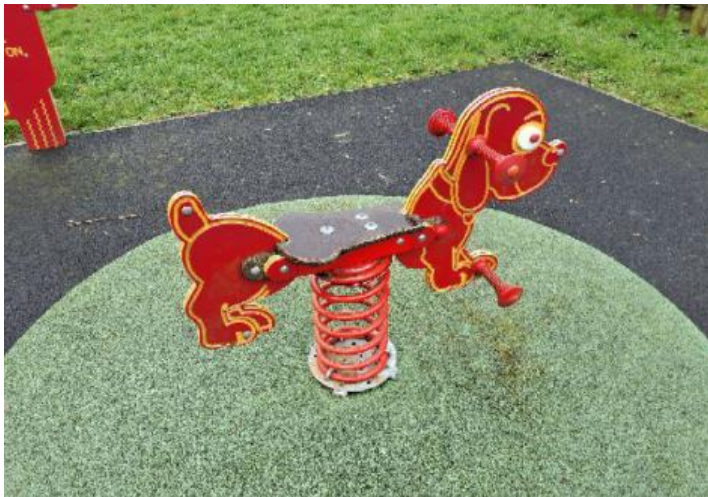
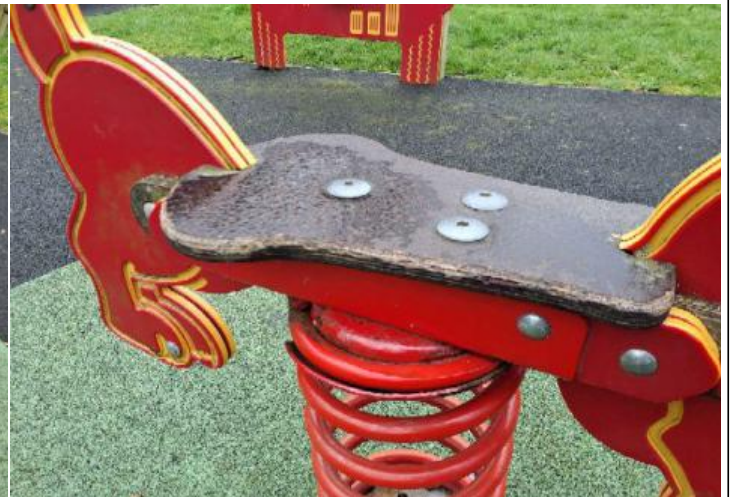
**Finding:** Parts of the timber are rough or splintered

**Action:** Remove all rough or sharp edges

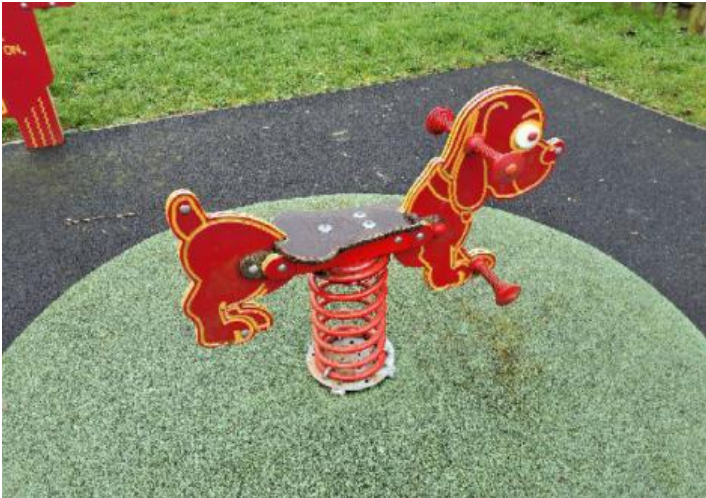
**Finding:** The paintwork on the spring has been damaged or worn exposing the metal underneath which is rusting  
**Action:** Treat any rusting components and repaint
