## COMMUNITY COMMITTEE MEETING HELD ON TUESDAY 3<sup>rd</sup> MARCH 2026 AT 7.30 PM AT THE STEYPING CENTRE

# DRAFT MINUTES

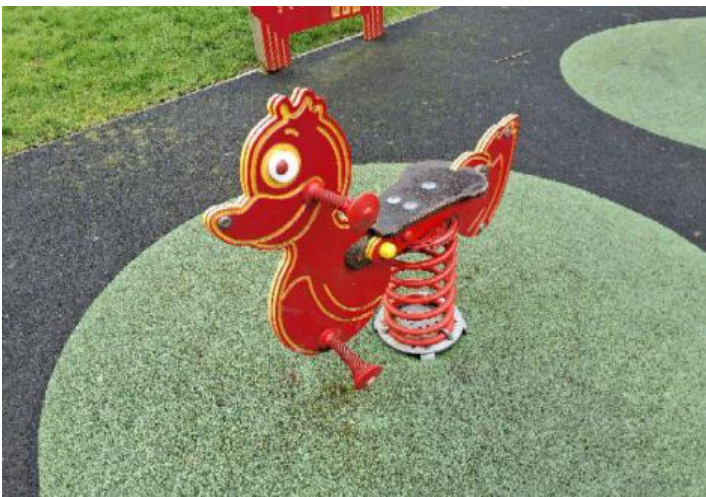
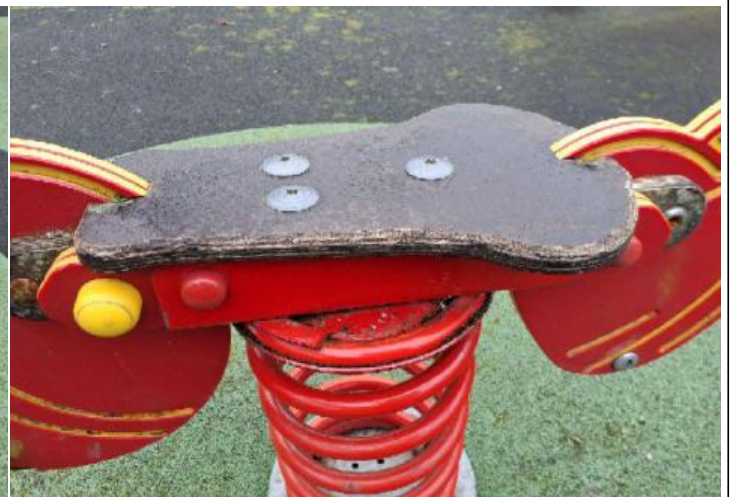
**Item:** Rocking Equipment - Spring Duck  
**Manufacturer:** Creative Play

**Finding:** Parts of the timber are rough or splintered  
**Action:** Remove all rough or sharp edges

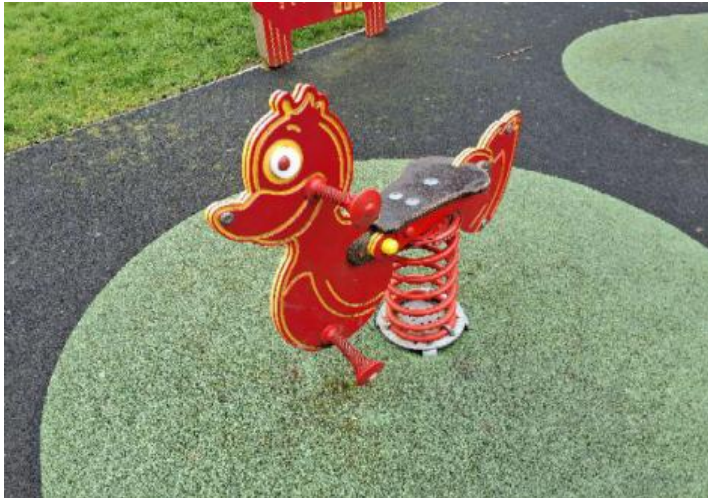
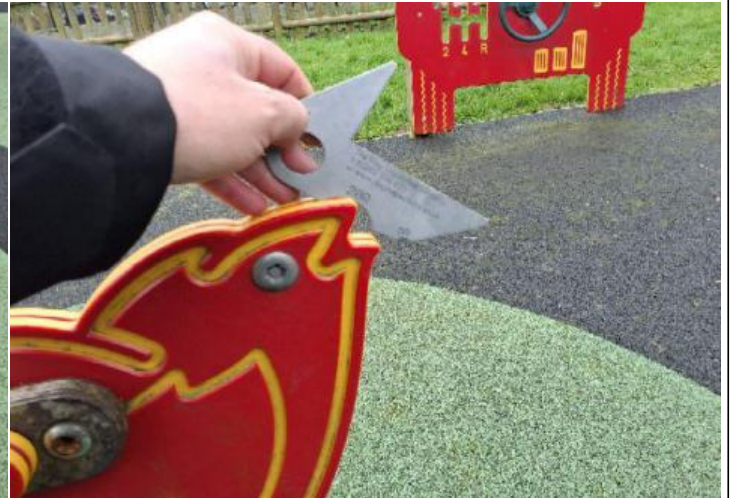
**Item:** Rocking Equipment - Spring Duck  
**Manufacturer:** Creative Play

**Finding:** The main body profile has a radius of less than 20mm in places, in contravention of BS EN 1176 Part 6

**Action:** Monitor - No action given the risk assessment

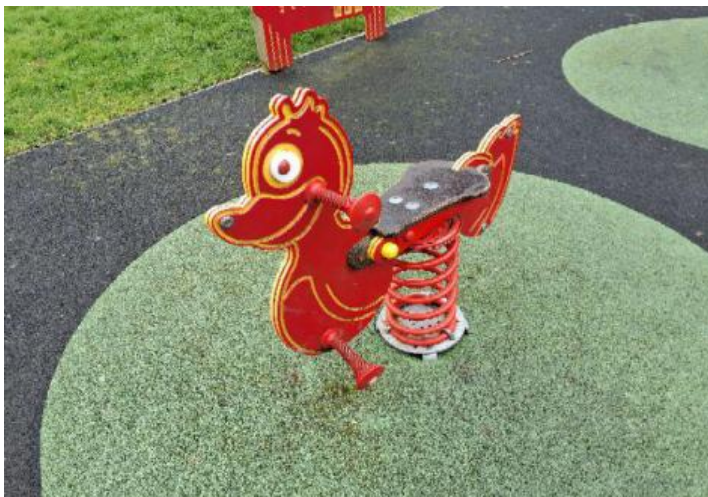
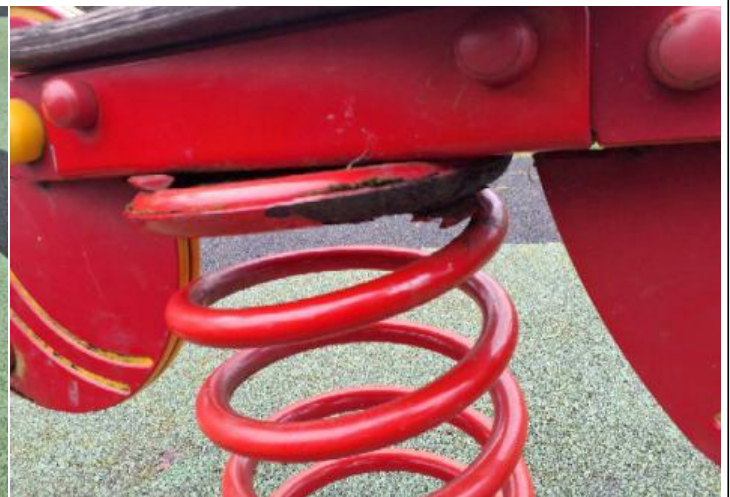
**Item:** Rocking Equipment - Spring Duck  
**Manufacturer:** Creative Play

**Finding:** The paintwork on the spring has been damaged or worn exposing the metal underneath which is rusting

**Action:** Treat any rusting components and repaint

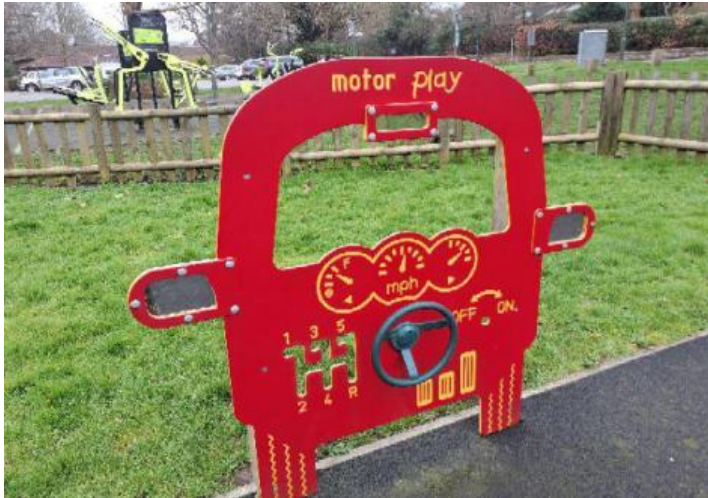
**Item:** Other - Play Panel  
**Manufacturer:** Creative Play

**Finding:** There is some strimmer / machinery damage apparent on the posts, this can penetrate the preservative applied to the timber and accelerate the rotting process

**Action:** Monitor for any deterioration (rot) and replace as required

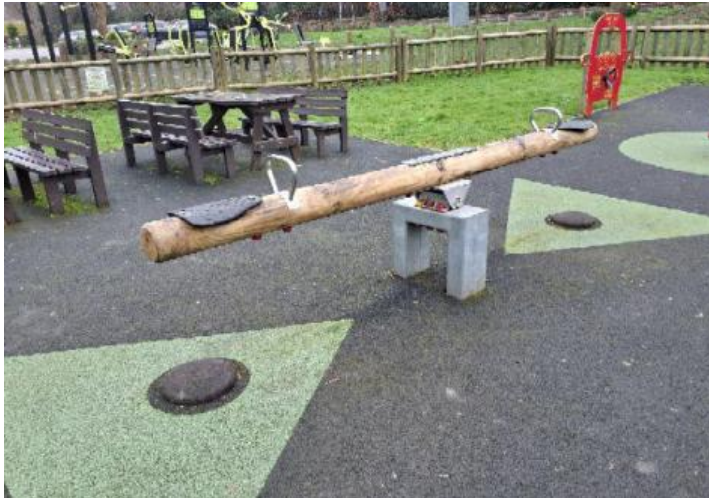
**Item:** Rocking Equipment - See Saw  
**Manufacturer:** Not Identified

**Finding:** The seat has been severely damaged

**Action:** Repair / replace the seat as required

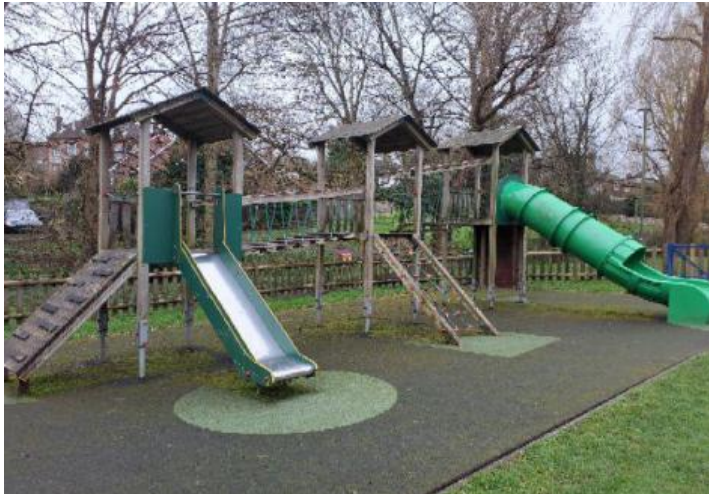
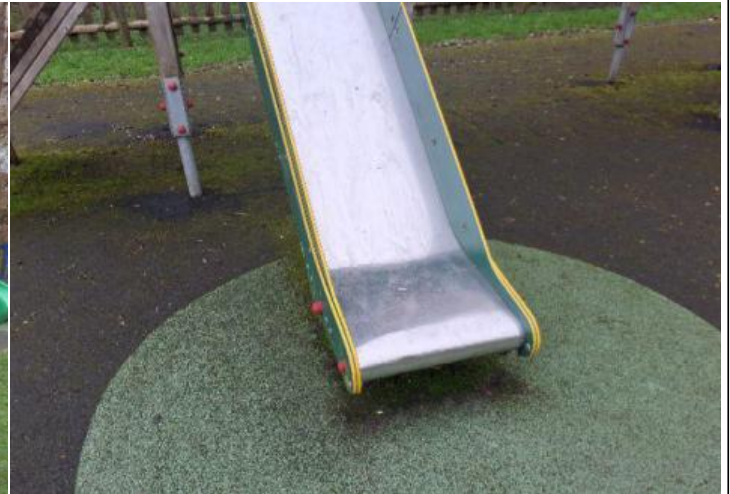
**Item:** Activity Equipment - Multi Play (Junior)  
**Manufacturer:** Creative Play

**Finding:** There are a number of dents in the slide surface

**Action:** Monitor for any further deterioration and repair as required

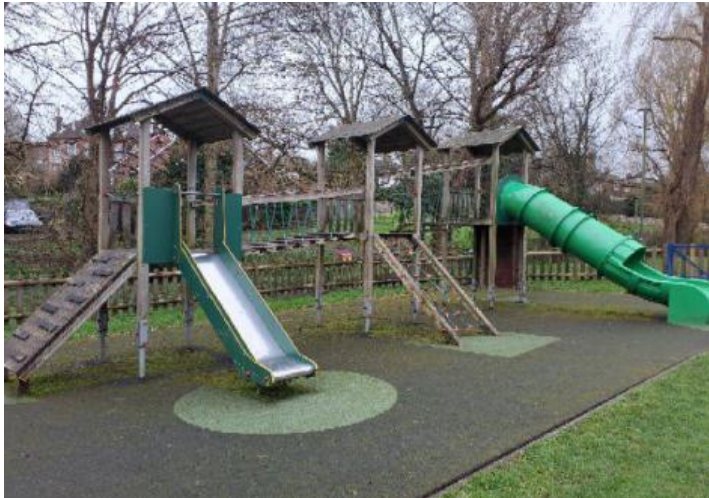
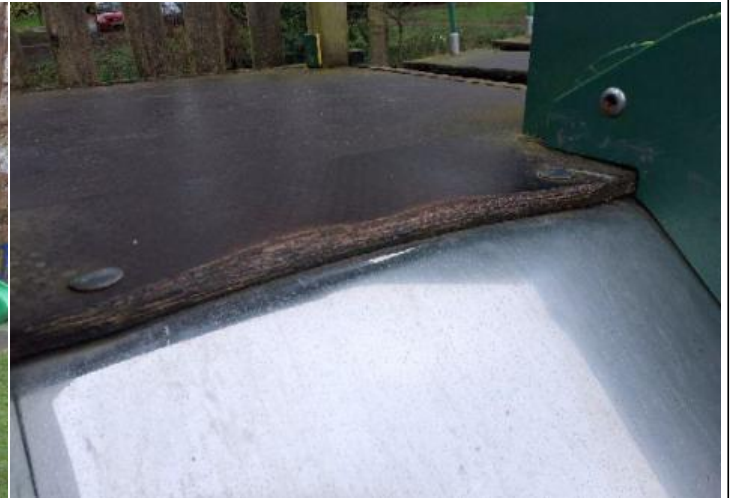
**Item:** Activity Equipment - Multi Play (Junior)  
**Manufacturer:** Creative Play

**Finding:** Parts of the timber are rough or splintered

**Action:** Remove all rough or sharp edges

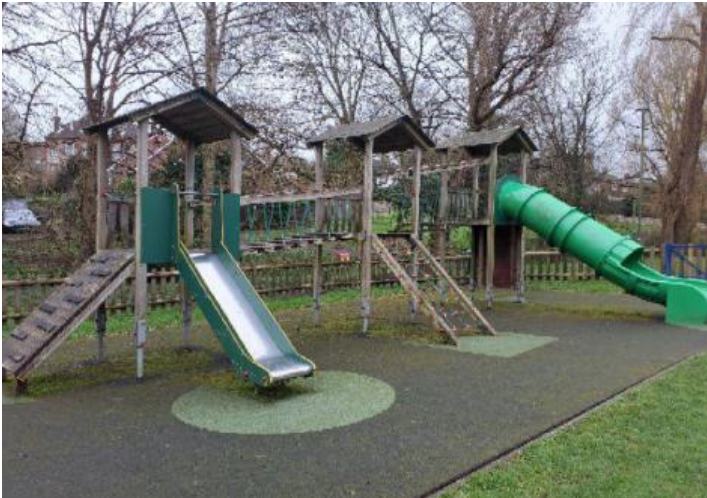
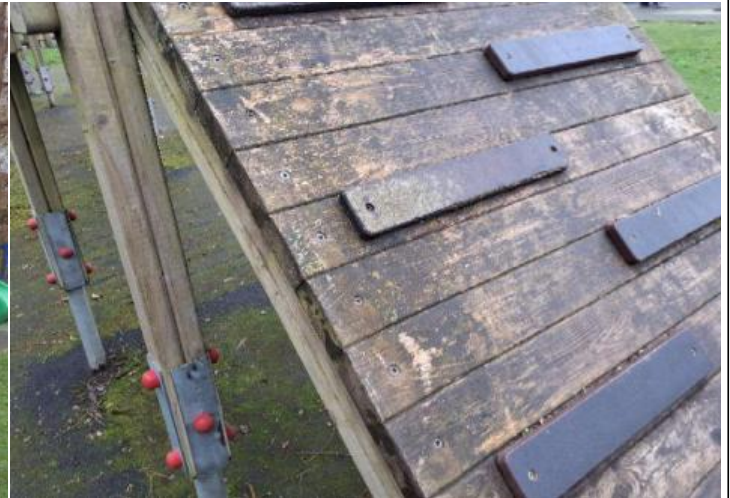
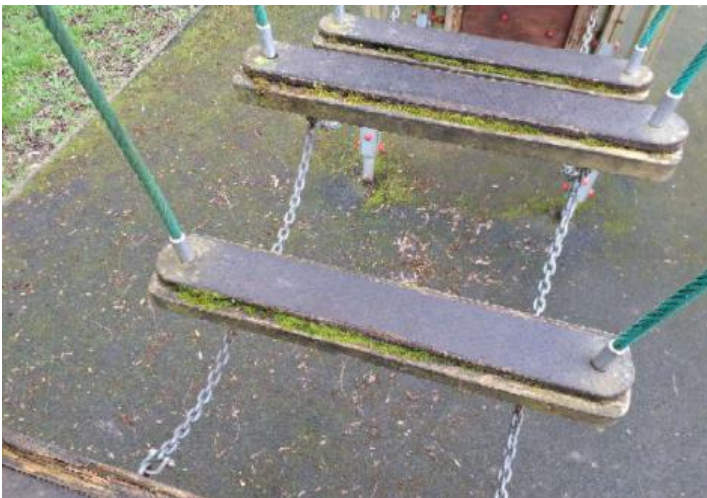
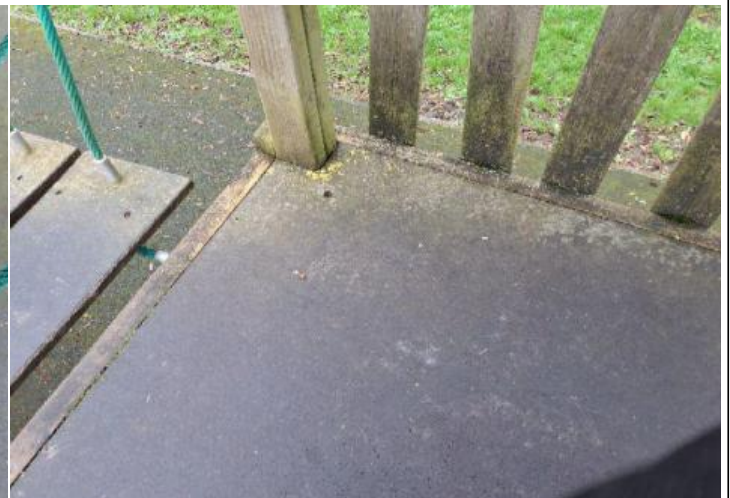
**Item:** Activity Equipment - Multi Play (Junior)  
**Manufacturer:** Creative Play

**Finding:** There is algae or moss on the surface of the equipment

**Action:** Clean and treat appropriately

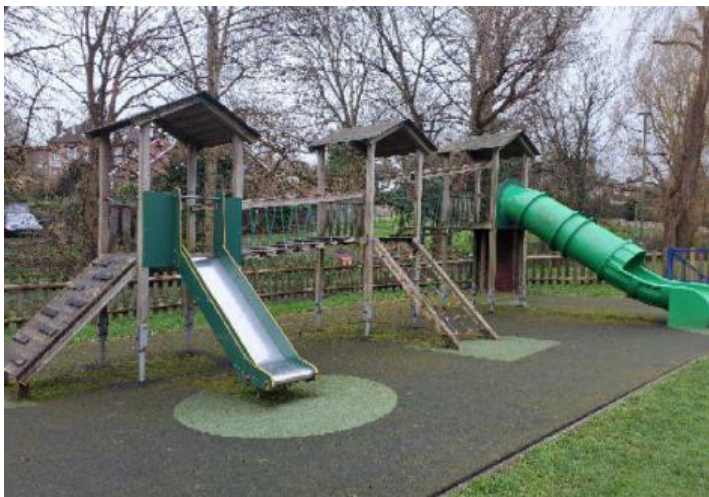
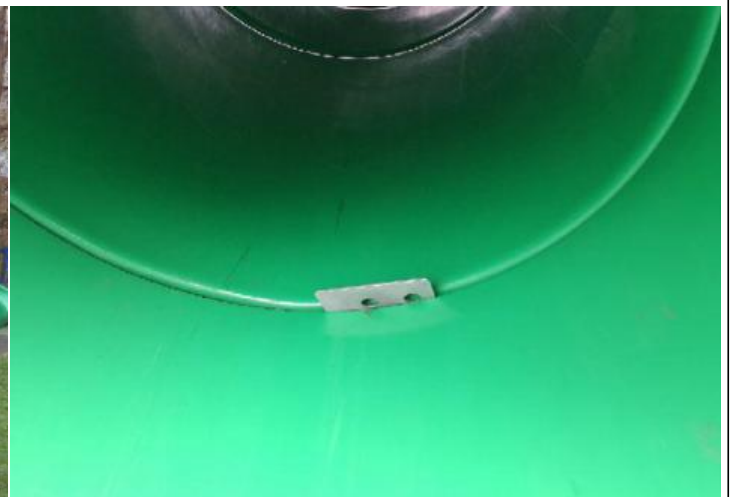
**Item:** Activity Equipment - Multi Play (Junior)  
**Manufacturer:** Creative Play

**Finding:** BS EN 1176 Part 3 recommends that slides should be constructed to ensure that gaps between joints are eliminated and sharp objects cannot become lodged

**Action:** Monitor for any further deterioration and repair as required

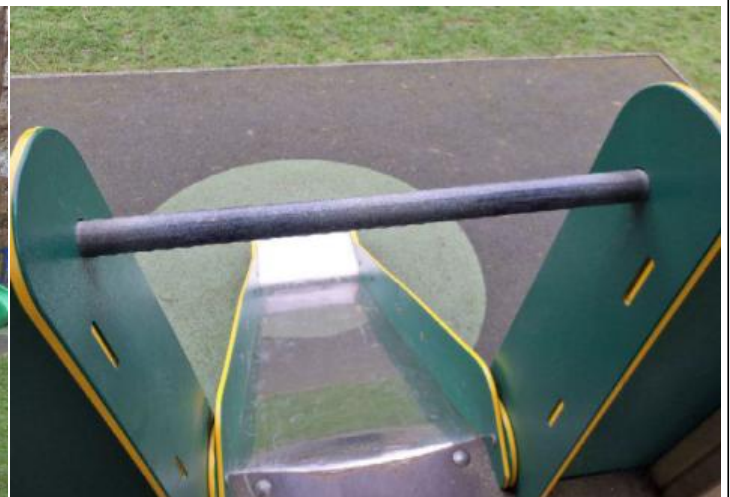
**Item:** Activity Equipment - Multi Play (Junior)  
**Manufacturer:** Creative Play

**Finding:** The slide bar rotates unexpectedly

**Action:** Tighten fixings to secure

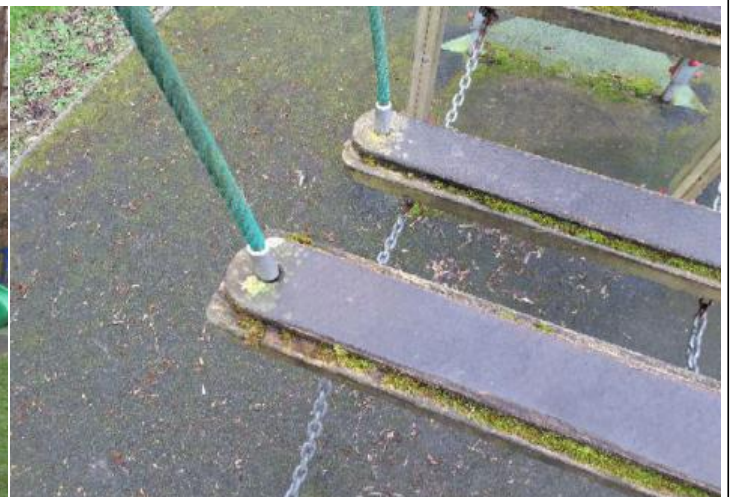
**Item:** Activity Equipment - Multi Play (Junior)  
**Manufacturer:** Creative Play

**Finding:** A number of fixing(s) have worked loose on the rope connectors  
**Action:** Secure all loose fixings

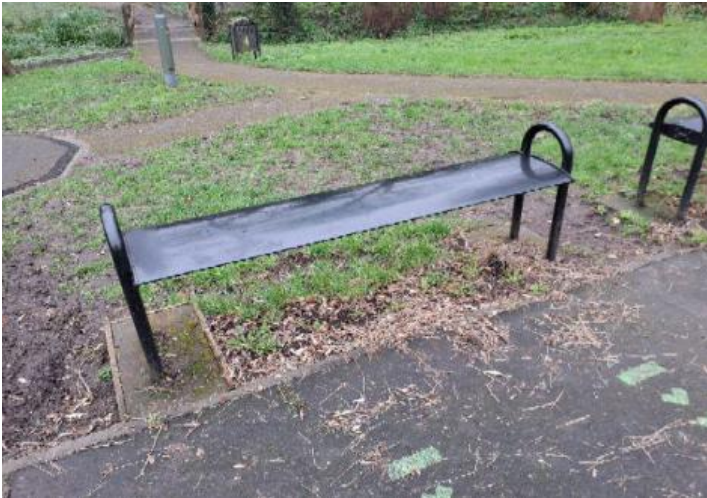
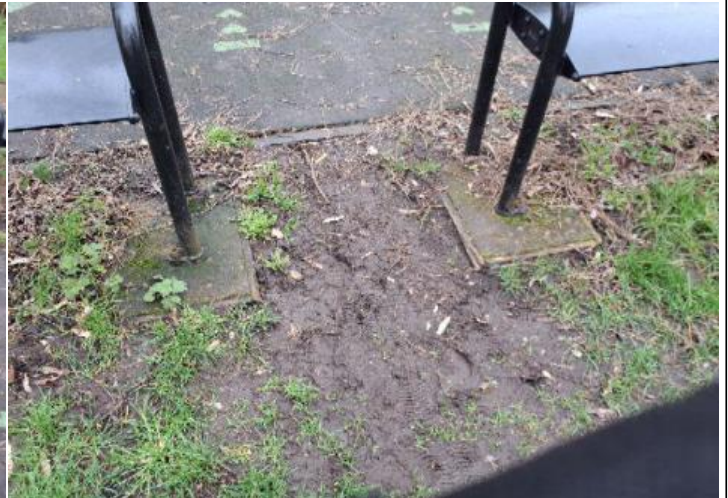
**Item:** Ancillary Items - Bench  
**Manufacturer:** Not Identified

**Finding:** There are trip hazards at the edges of the surface **Action:** Remove trip hazard

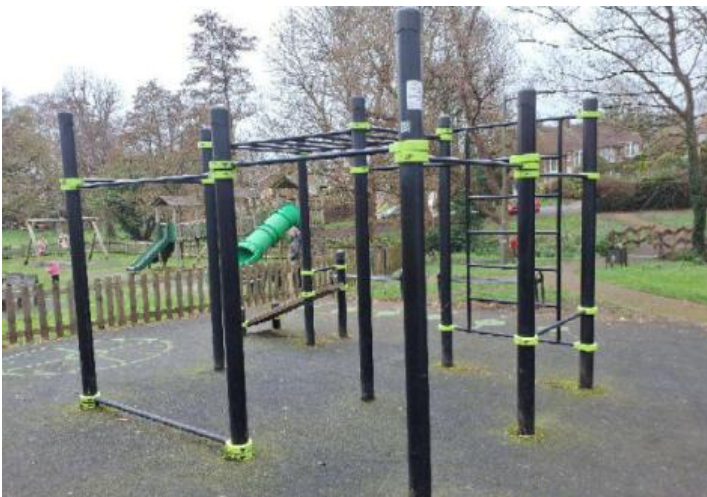
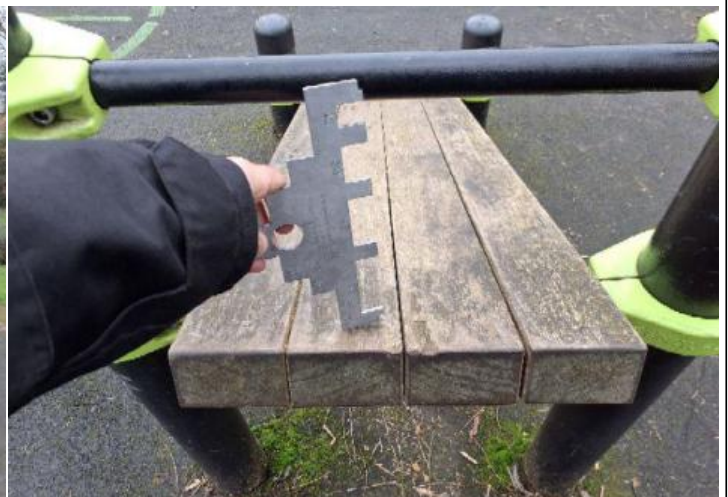
**Item:** Outdoor Fitness Equipment - Calisthenics Unit  
**Manufacturer:** Kenguru Fitness

**Finding:** There is a head and neck entrapment in the framework in contravention of the requirements of BS EN 16630:2015 clause 4.3.6.1

**Action:** Monitor - No action given the risk assessment

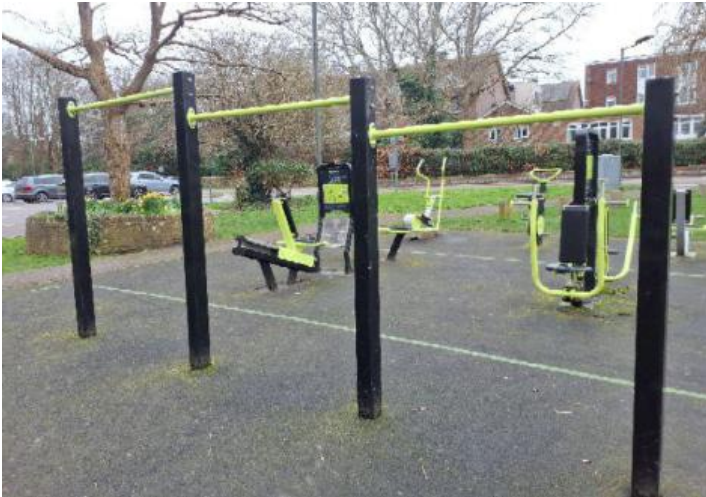
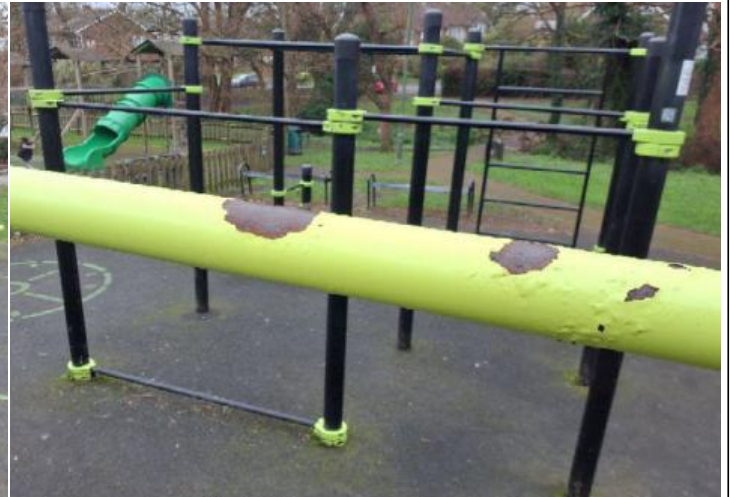
**Item:** Outdoor Fitness Equipment - Pull Up Station  
**Manufacturer:** The Great Outdoor Gym Company

**Finding:** The paintwork on this item has been damaged or worn exposing the metal underneath which is rusting / corroding

**Action:** Treat affected areas and repaint

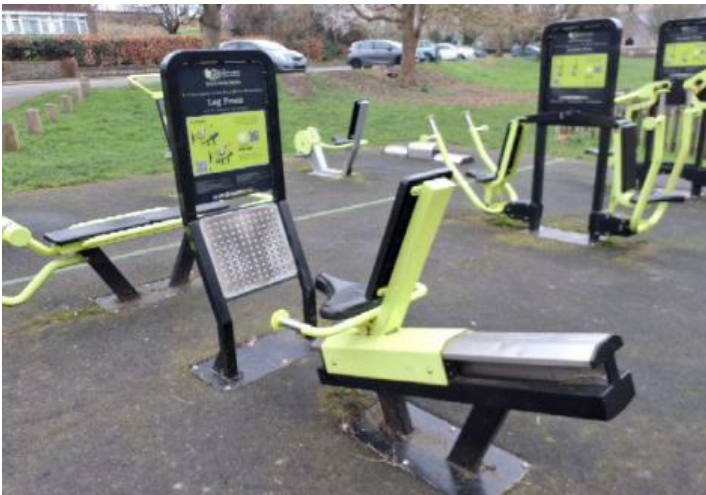
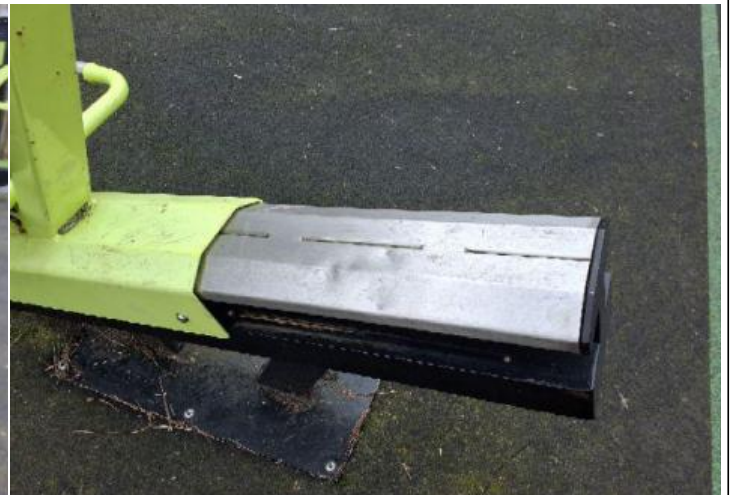
**Item:** Outdoor Fitness Equipment - Leg Press  
**Manufacturer:** The Great Outdoor Gym Company

**Finding:** The item has been damaged

**Action:** Monitor for any further deterioration and replace as required

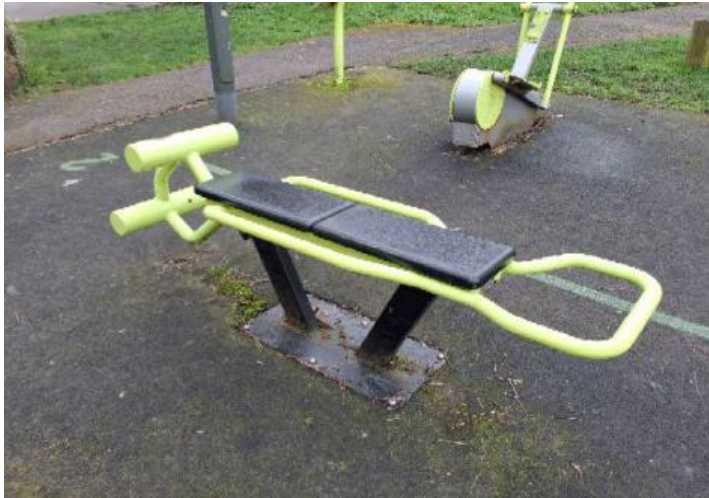
**Item:** Outdoor Fitness Equipment - Sit Up Station  
**Manufacturer:** The Great Outdoor Gym Company  
**Risk Level:** L - Low Risk  
**Surface:** Wet Pour

**Finding:** The paintwork on this item has been damaged or worn exposing the metal underneath which is rusting / corroding  
**Action:** Treat affected areas and repaint

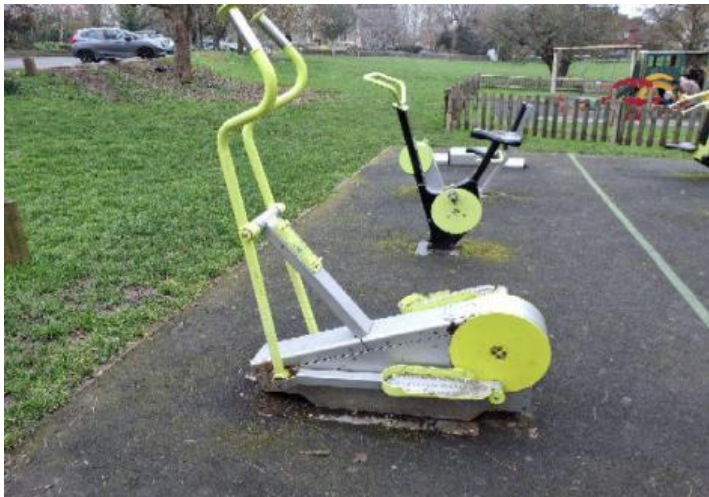
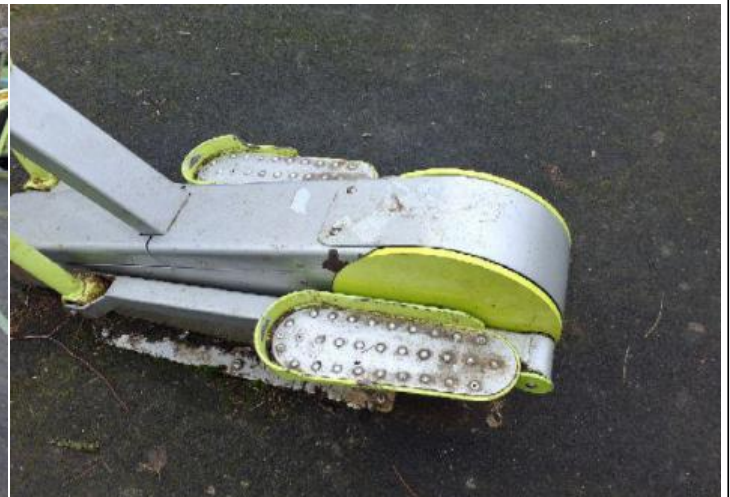
**Item:** Outdoor Fitness Equipment - Cross Trainer  
**Manufacturer:** The Great Outdoor Gym Company  
**Risk Level:** L - Low Risk  
**Surface:** Wet Pour

**Finding:** The bearing is showing signs of wear  
**Action:** Monitor for any further deterioration and replace as required

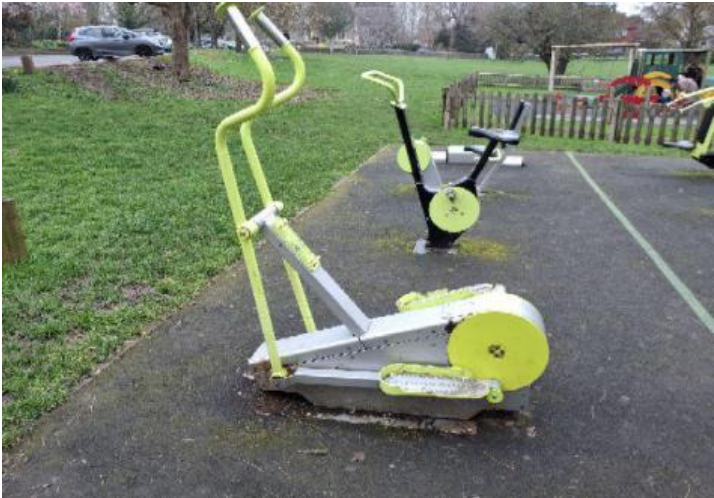
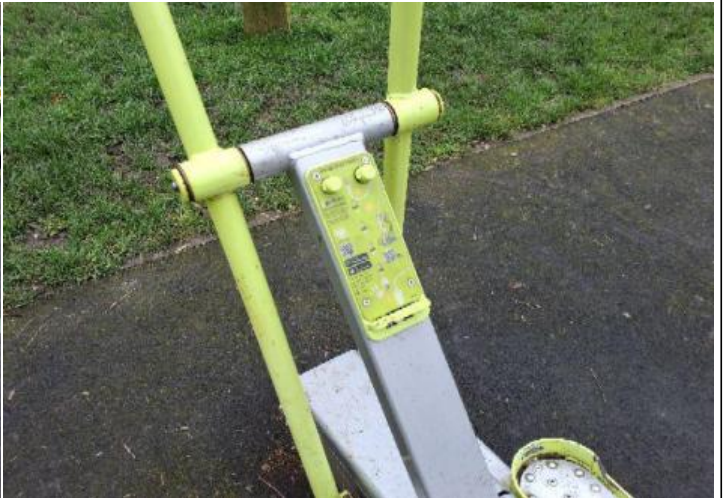
**Item:** Outdoor Fitness Equipment - Cross Trainer  
**Manufacturer:** The Great Outdoor Gym Company  
**Risk Level:** V - Very Low Risk  
**Surface:** Wet Pour

**Finding:** The LED panel is not operating correctly

**Action:** Repair or replace as required

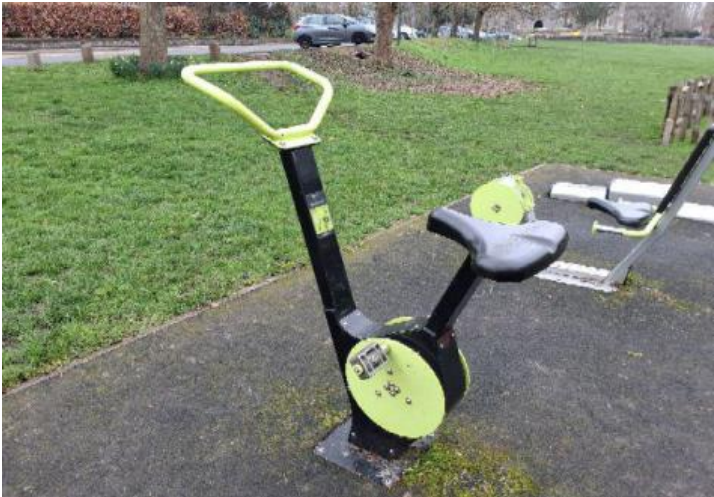
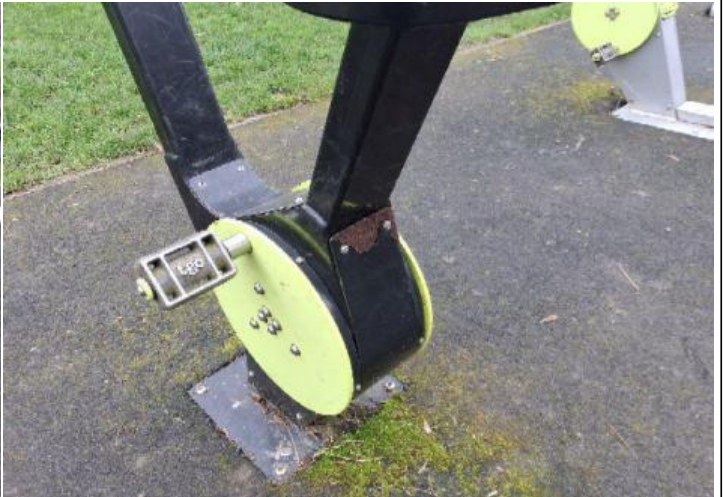
**Item:** Outdoor Fitness Equipment - Cycle  
**Manufacturer:** The Great Outdoor Gym Company  
**Risk Level:** L - Low Risk  
**Surface:** Wet Pour

**Finding:** The paintwork on this item has been damaged or worn exposing the metal underneath which is rusting / corroding

**Action:** Treat affected areas and repaint

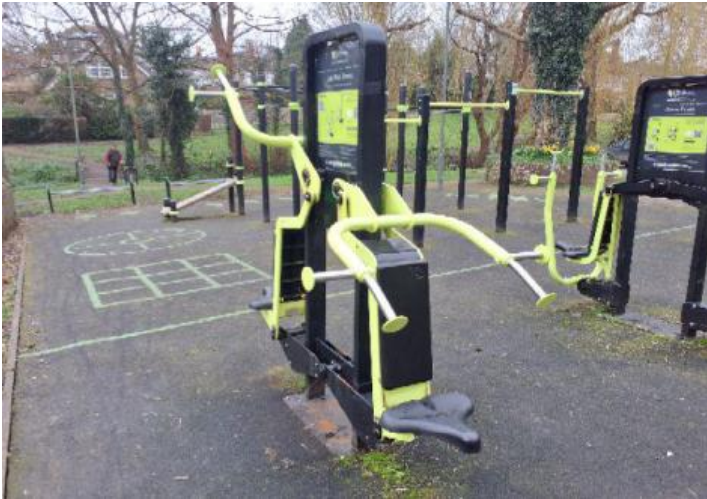
**Item:** Outdoor Fitness Equipment - Double Fitness Station  
**Manufacturer:** The Great Outdoor Gym Company

**Finding:** The paintwork on this item has been damaged or worn exposing the metal underneath which is rusting / corroding

**Action:** Treat affected areas and repaint

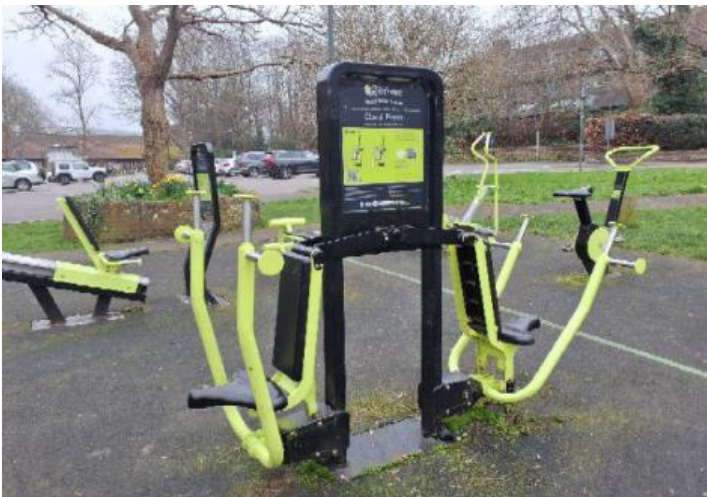
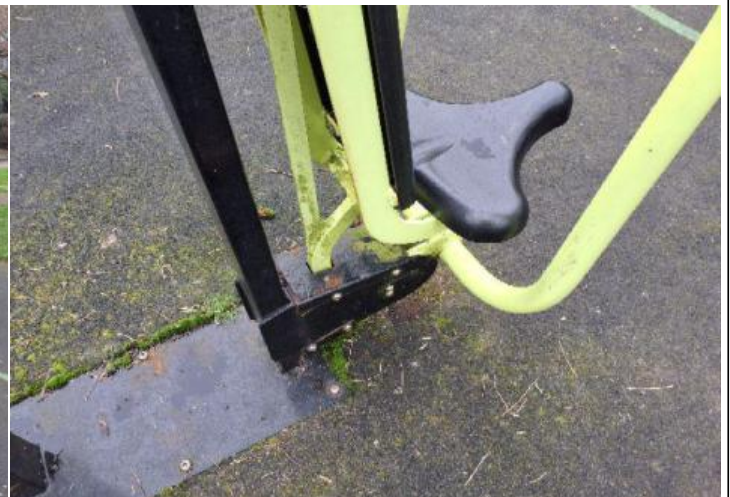
**Item:** Outdoor Fitness Equipment - Double Fitness Station  
**Manufacturer:** The Great Outdoor Gym Company

**Finding:** The bushes are showing signs of wear

**Action:** Monitor for any further deterioration and replace as required

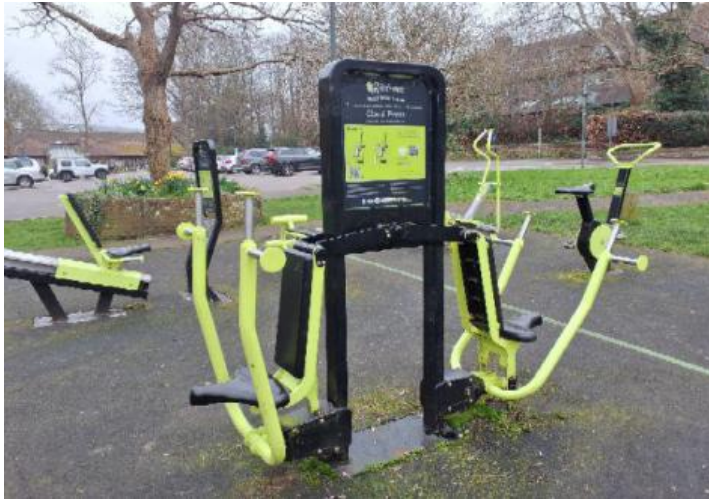
**Item:** Outdoor Fitness Equipment - Double Fitness Station  
**Manufacturer:** The Great Outdoor Gym Company

**Finding:** The paintwork on this item has been damaged or worn exposing the metal underneath which is rusting / corroding

**Action:** Treat affected areas and repaint

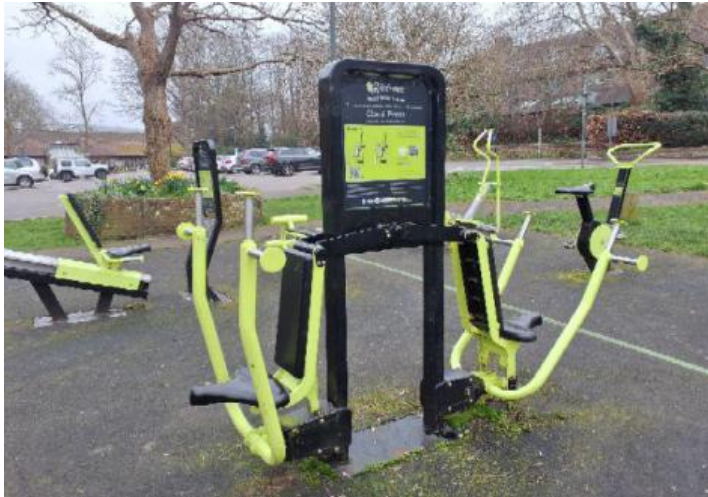
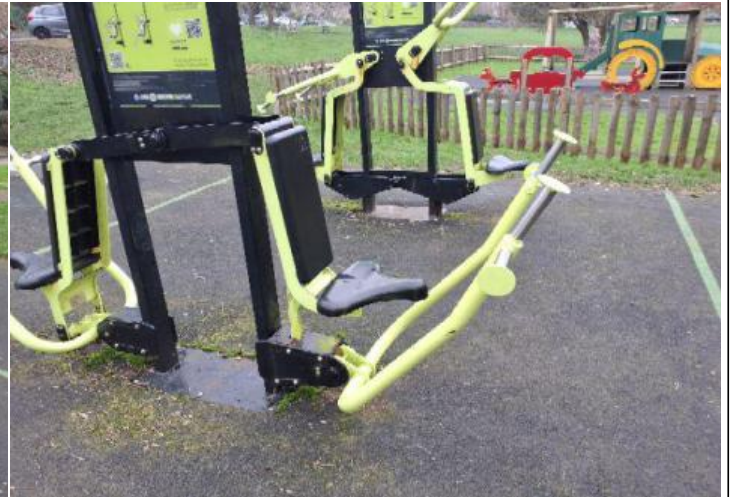
**Finding:** BS EN 16630 - 4.3.1 states that fitness equipment shall be designed so when at rest, the equipment shall automatically adjust so that the equipment is ready for the next user  
**Action:** Service the item

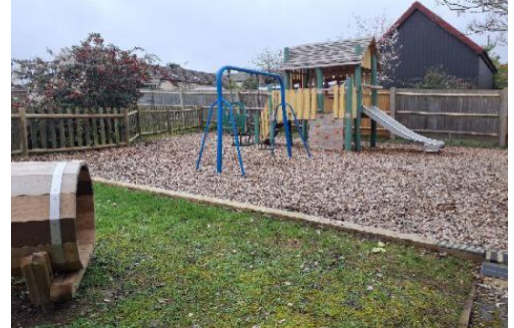
The depth of the loose fill surfacing is lower than the recommended depth specified in BS EN 1176; the free height of fall of the equipment is less than 2.0m and a minimum of 300mm depth should be provided (including an extra 100mm to allow for compaction and displacement as per BS EN 1176 Part 1 - Table 4) - Top up loose fill surfacing to recommended levels

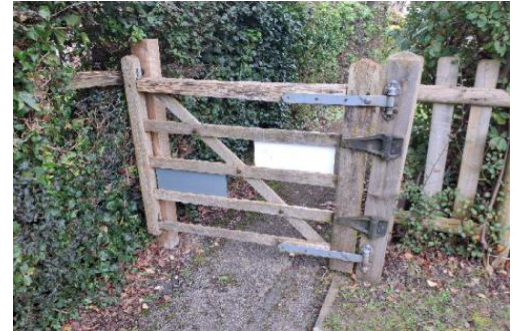
A number of fixing(s) have worked loose - Secure all loose fixings

There are areas or parts of the timber on the structure that have rotted - Replace all affected timbers

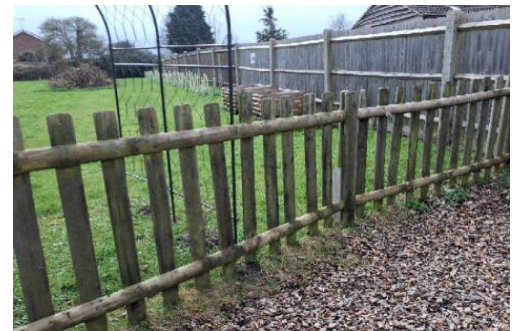
There is some strimmer / machinery damage apparent on the posts, this can penetrate the preservative applied to the timber and accelerate the rotting process - Monitor for any deterioration (rot) and replace as required

A number of posts have rotted at ground level - Replace all affected timber

The fence is severely damaged in places - Repair or replace all affected sections

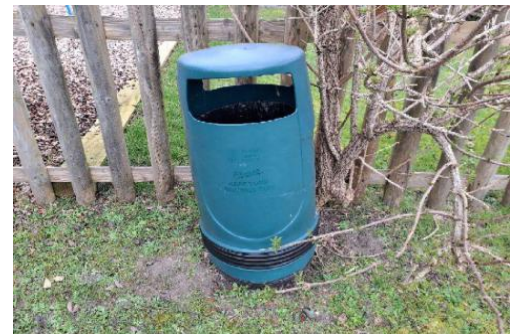
The item has been severely damaged - Repair or replace the item / affected part

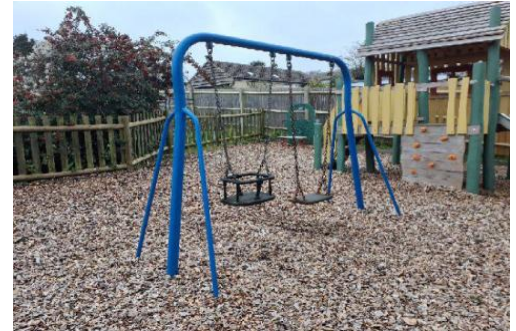
The seat clearance from finished surface level to the underside of the seat is too low and does not meet the requirements of BS EN 1176 Part 2 (350mm minimum clearance required) - Adjust seat height/s (400mm-500mm is recommended)

The seats are too close to each other as defined in BS EN 1176 Part 2; this is a low risk failure and no remedial action is required - Monitor - No action given the risk assessment

There is some notable evidence of chain wear - Monitor for any further deterioration and replace when 40% worn

The swing seat connectors have some wear present - Monitor for further deterioration and replace when 40% worn

There is some wear to the shackles. - Monitor for any further deterioration and replace when 40% worn

The fixings have corroded excessively - Replace all corroded fixings

The chain openings are in excess of the 8.6mm as recommended by BS EN 1176 - Monitor - No action given the risk assessment

The bush / bushes is / are worn or missing - Replace worn or missing bushes

The seat has minor damage or wear - Monitor for any further deterioration and replace as required

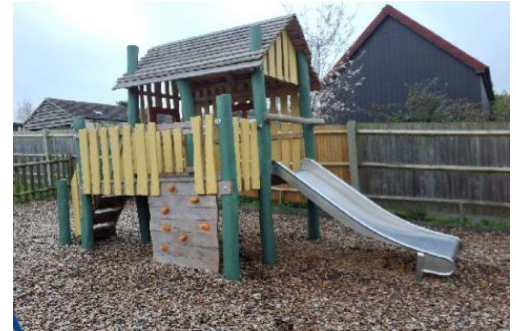
The slide runout is inclined at more than the 10 degrees recommended by BS EN 1176 Part 3 for a Type 1 slide - Monitor - No action given the risk assessment

The timber has a number of splits/shakes or air cracks and this may affect the stability or allow water ingress which will accelerate the rotting process. Timber splits may also create rough / splintering edges. - Monitor, sand down any rough edges and ensure the splits do not cross through fixing points of the structure and/or cause any instability

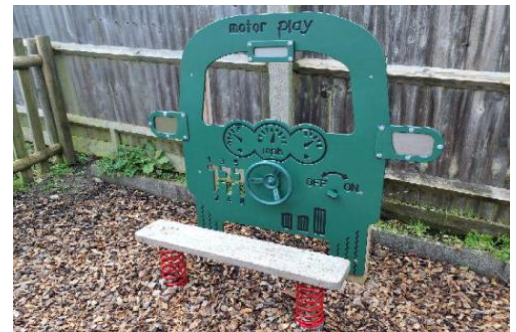
A spring board has been used as the seat and the play panel forms a hard object within the falling space of the board - Monitor - No action given the risk assessment

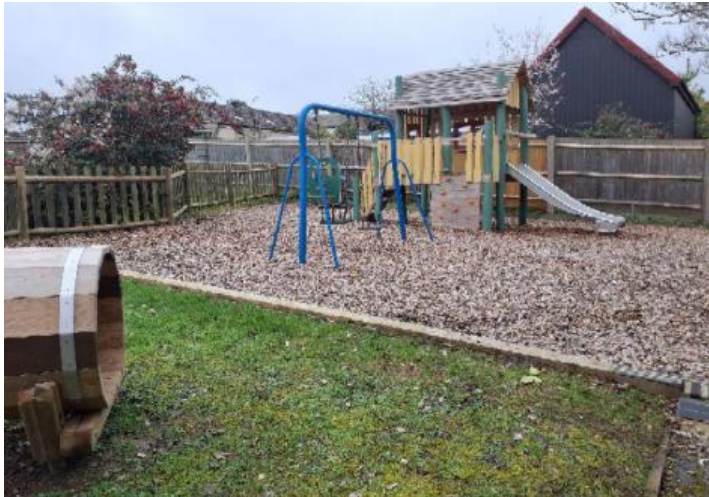
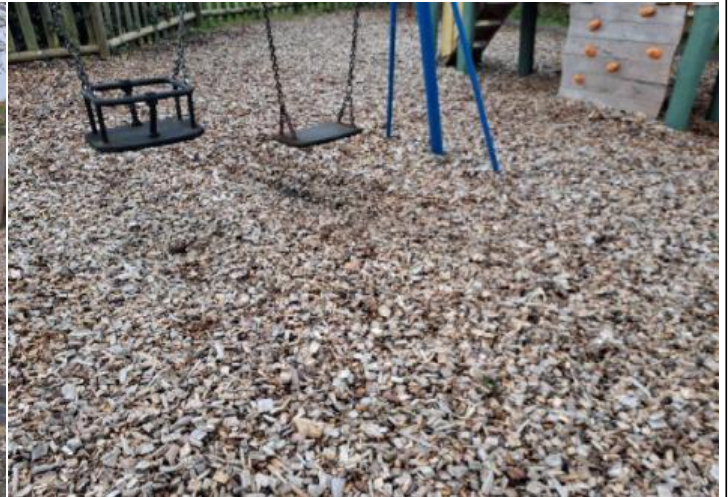
**Finding:** The depth of the loose fill surfacing is lower than the recommended depth specified in BS EN 1176; the free height of fall of the equipment is less than 2.0m and a minimum of 300mm depth should be provided (including an extra 100mm to allow for compaction and displacement as per BS EN 1176 Part 1 - Table 4)

**Action:** Top up loose fill surfacing to recommended levels

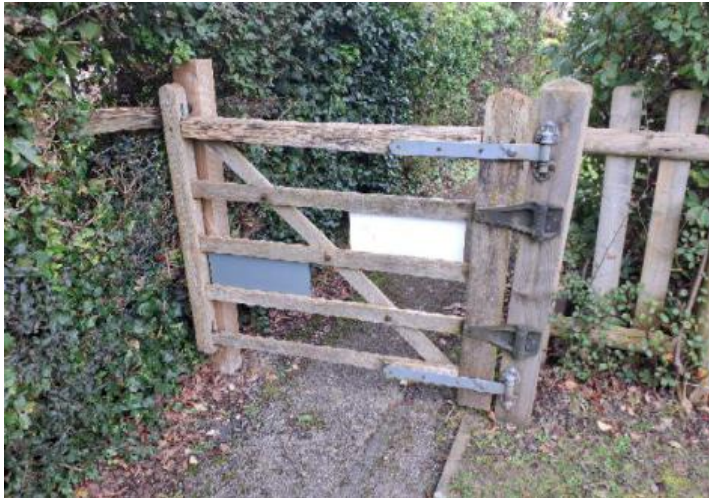
**Finding:** A number of fixing(s) have worked loose

**Action:** Secure all loose fixings

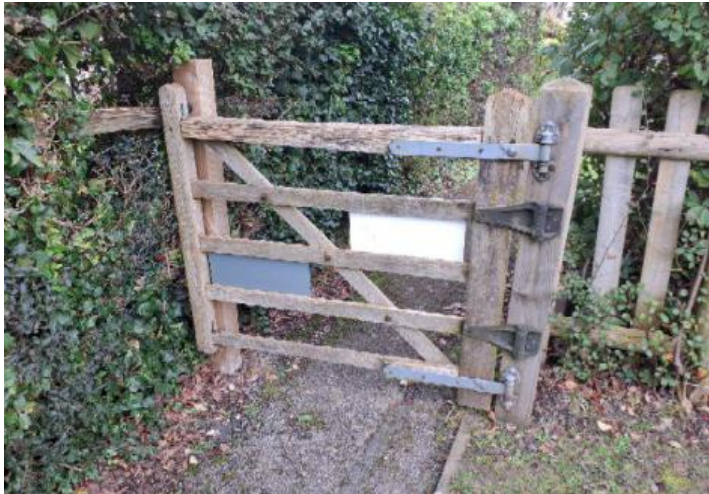
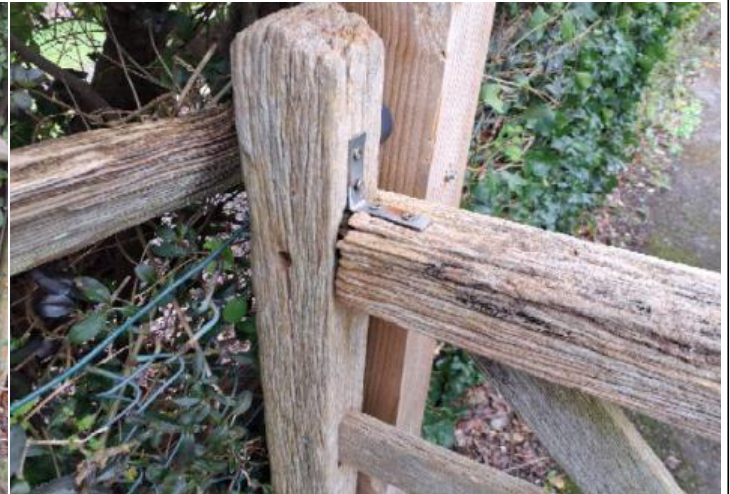
**Finding:** There are areas or parts of the timber on the structure that have rotted

**Action:** Replace all affected timbers

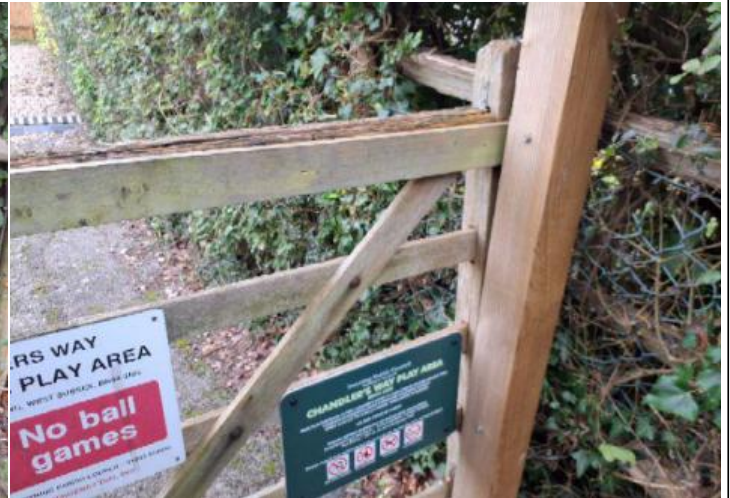
**Finding:** The gate is closing too quickly (less than 4 seconds)

**Action:** Take corrective action to ensure that the gate closes in 4-8 seconds from 90 degrees

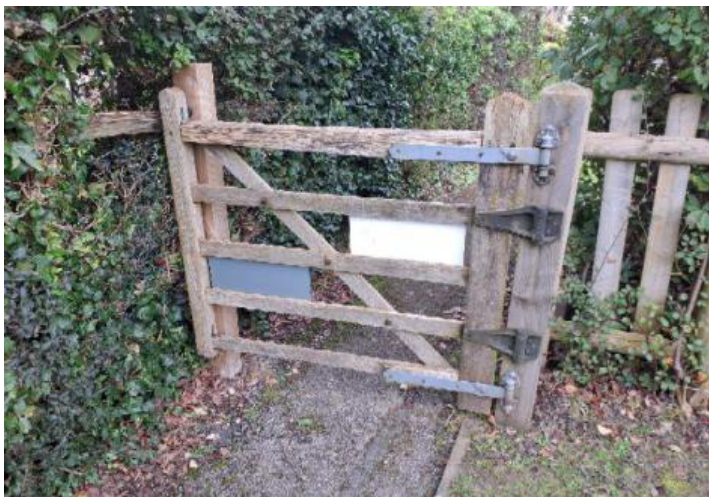
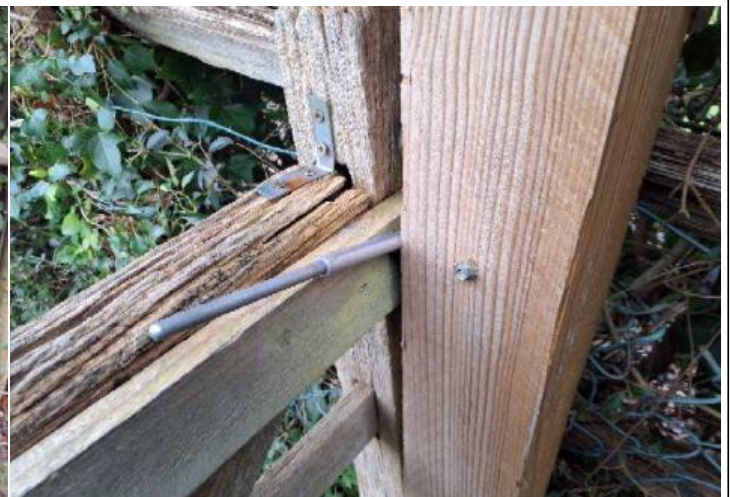
**Finding:** There are openings that are less than 12mm that could trap or crush fingers

**Action:** Provide a 12mm gap throughout full range of motion at both sides of gate

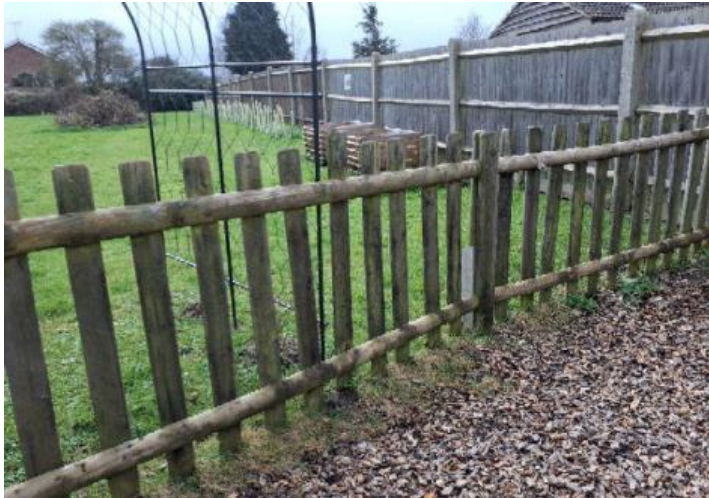
**Finding:** There is some strimmer / machinery damage apparent on the posts, this can penetrate the preservative applied to the timber and accelerate the rotting process

**Action:** Monitor for any deterioration (rot) and replace as required

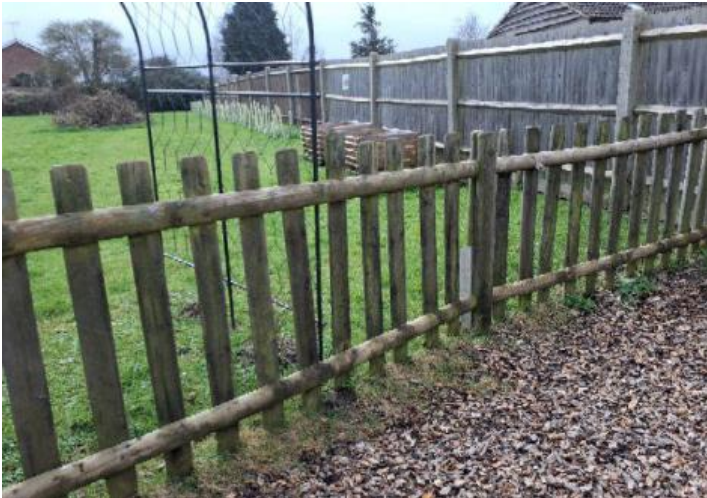
**Finding:** A number of posts have rotted at ground level

**Action:** Replace all affected timber

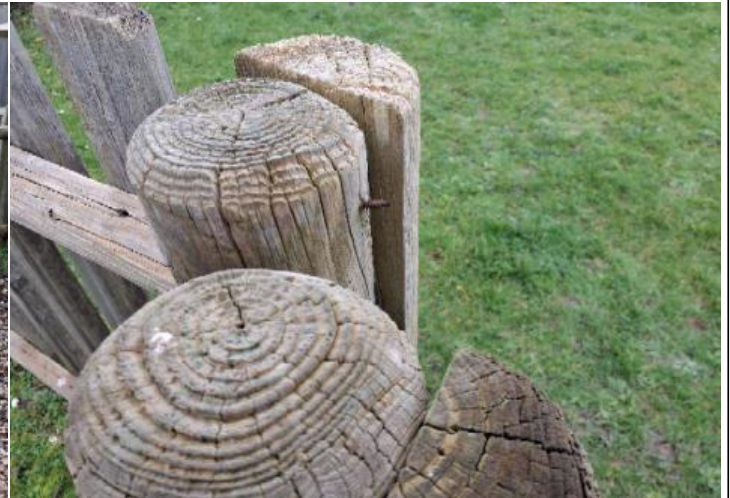
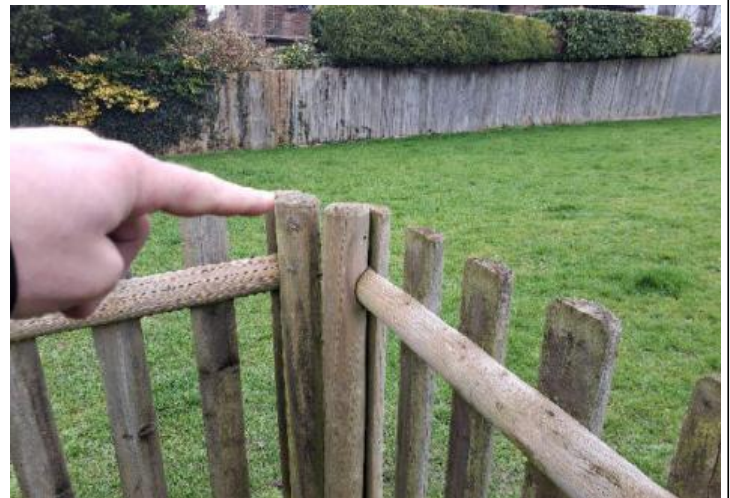
**Finding:** There are projecting nail ends present

**Action:** Remove and provide more appropriate fixings if required
