## COMMUNITY COMMITTEE MEETING HELD ON TUESDAY 3<sup>rd</sup> MARCH 2026 AT 7.30 PM AT THE STEYPING CENTRE

# DRAFT MINUTES

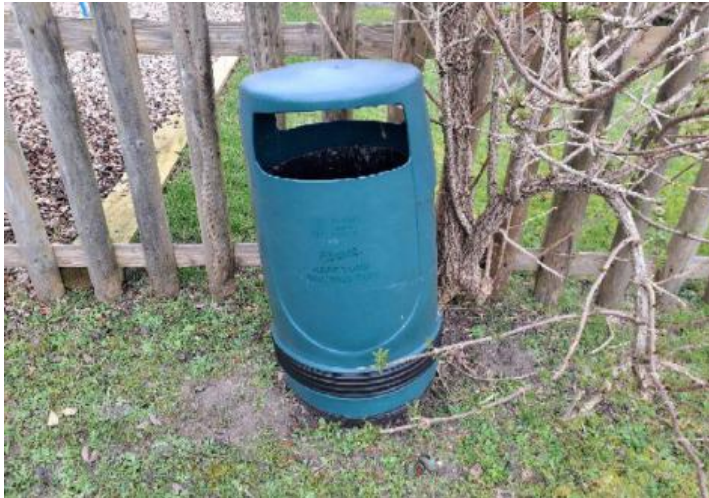
**Finding:** The item has been severely damaged

**Action:** Repair or replace the item / affected part

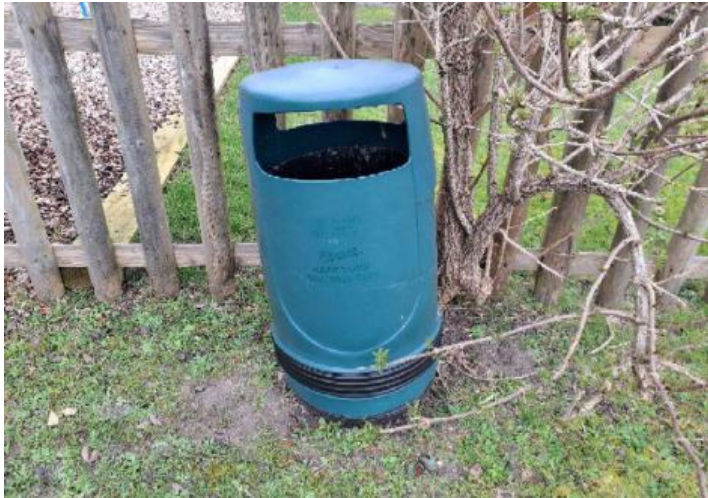
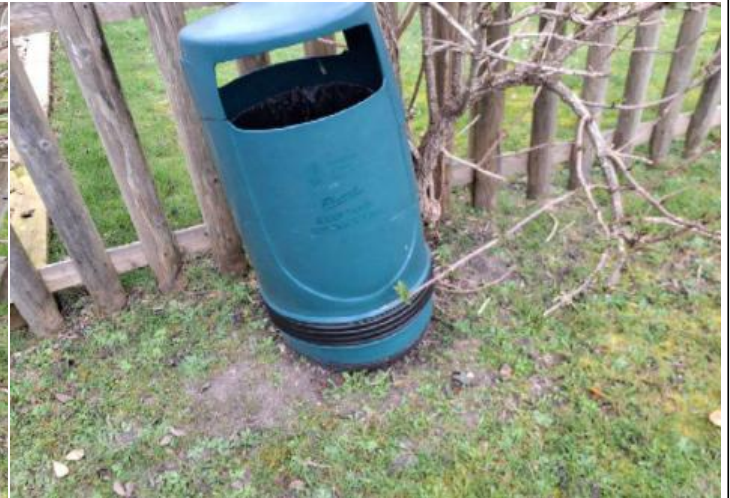
**Finding:** The lid or door of the litter bin is not secured

**Action:** Ensure the lid or door is kept locked

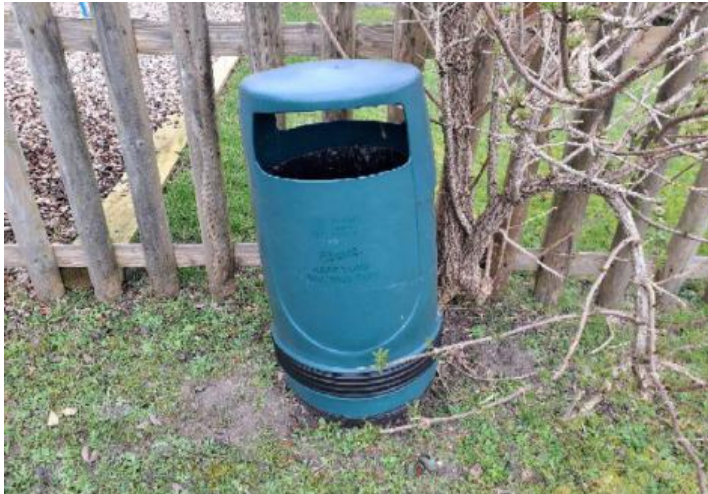
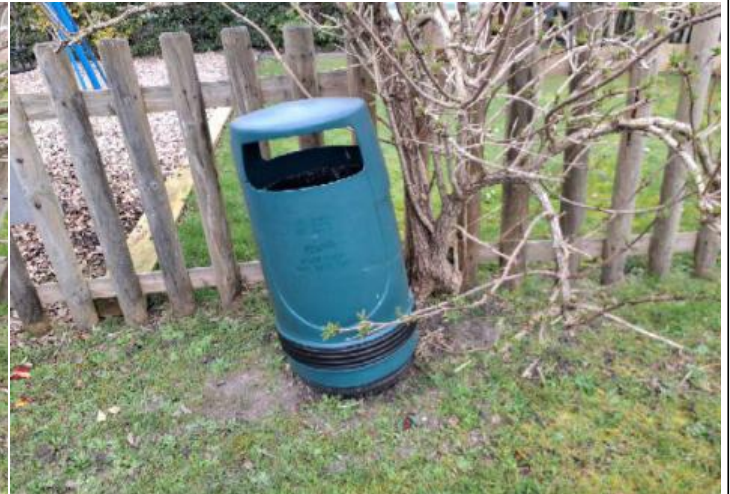
**Finding:** The adjacent foliage is overhanging

**Action:** Cut back and maintain

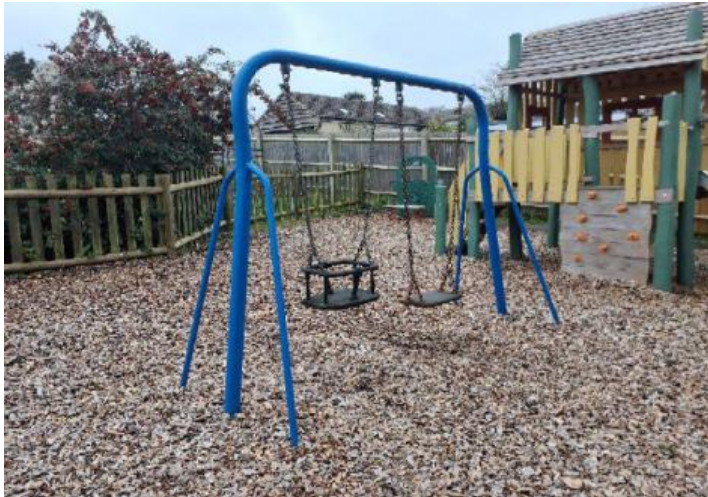
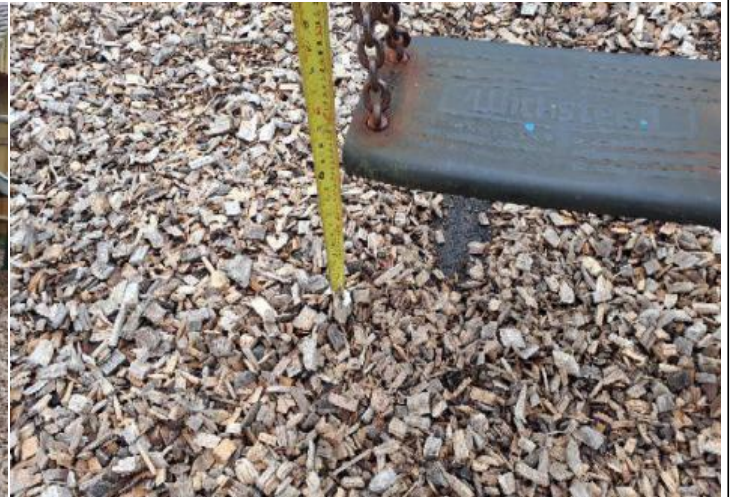
**Finding:** The seat clearance from finished surface level to the underside of the seat is too low and does not meet the requirements of BS EN 1176 Part 2 (350mm minimum clearance required)

**Action:** Adjust seat height/s (400mm-500mm is recommended)

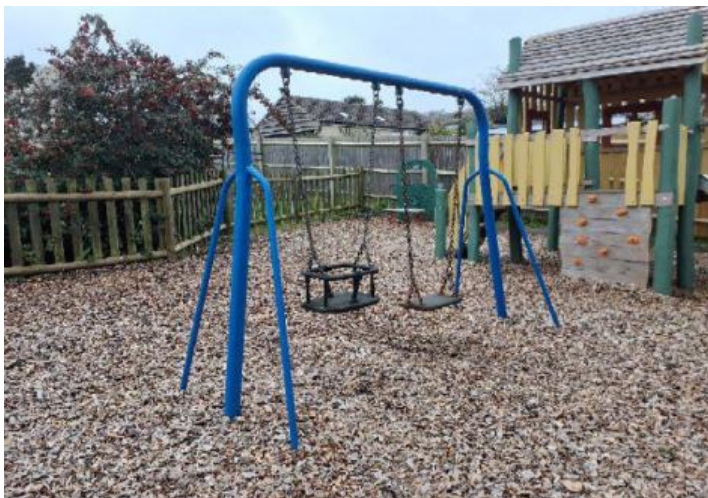
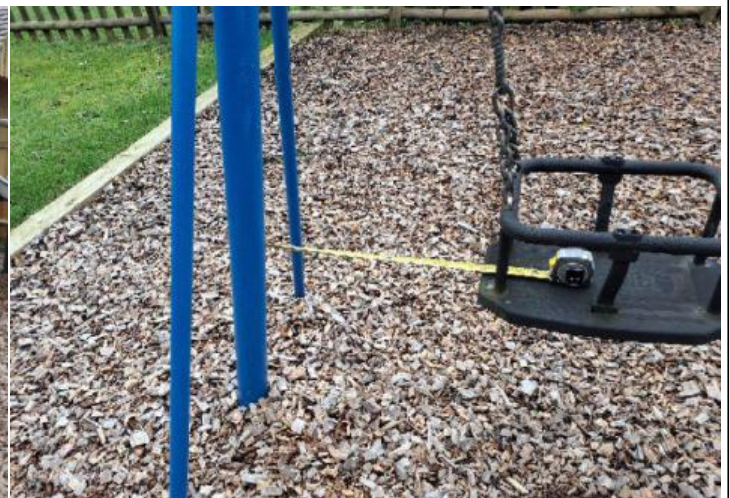
**Finding:** The seat/s is / are too close to the frame as defined in BS EN 1176 Part 2

**Action:** Monitor - No action given the risk assessment

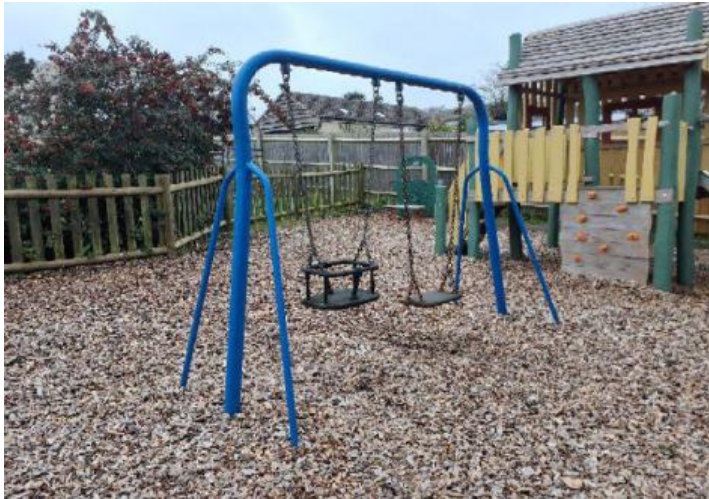
**Finding:** The seats are too close to each other as defined in BS EN 1176 Part 2; this is a low risk failure and no remedial action is required  
**Action:** Monitor - No action given the risk assessment

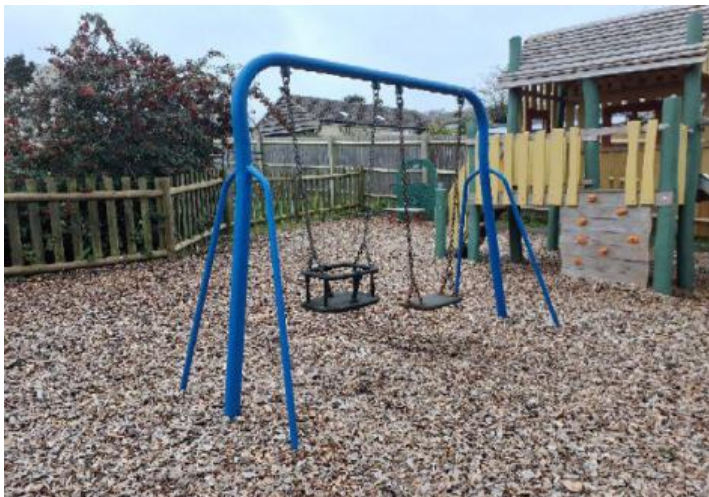
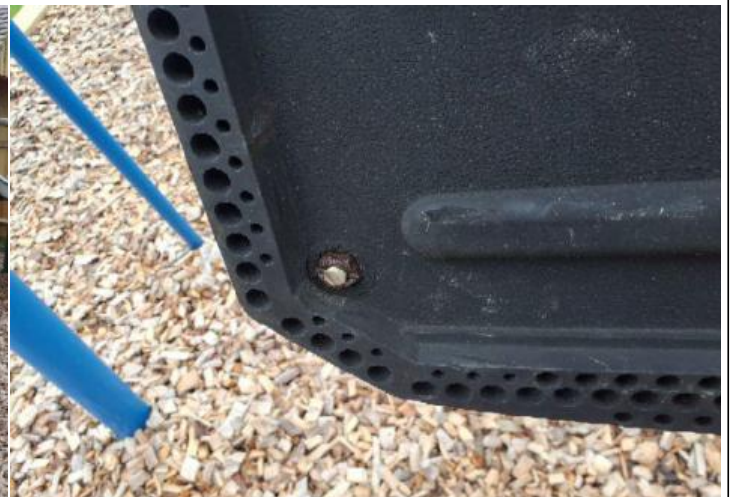
### 8 - Low Risk (Finding 4)

**Finding:** The fixings have corroded excessively  
**Action:** Replace all corroded fixings

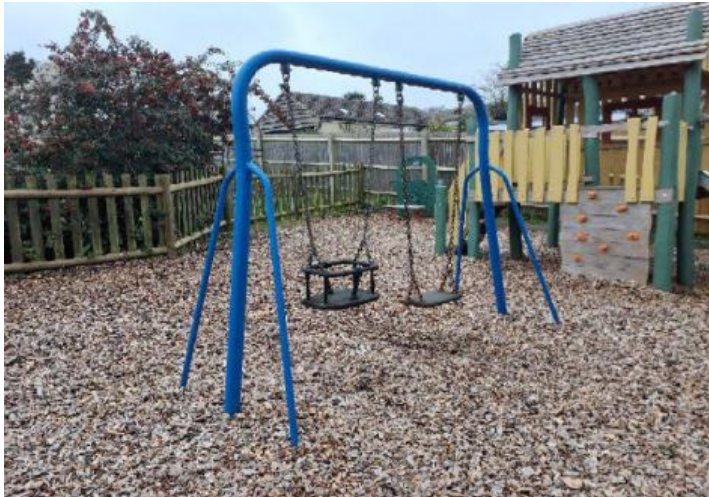
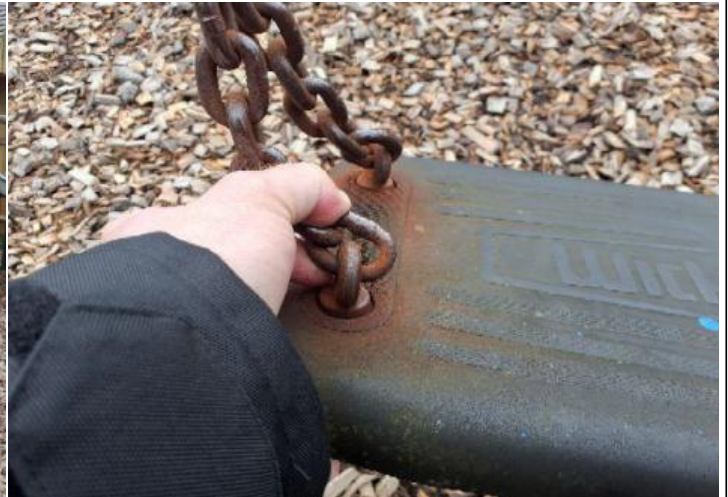
### 6 - Low Risk (Finding 5)

**Finding:** There is some notable evidence of chain wear

**Action:** Monitor for any further deterioration and replace when 40% worn

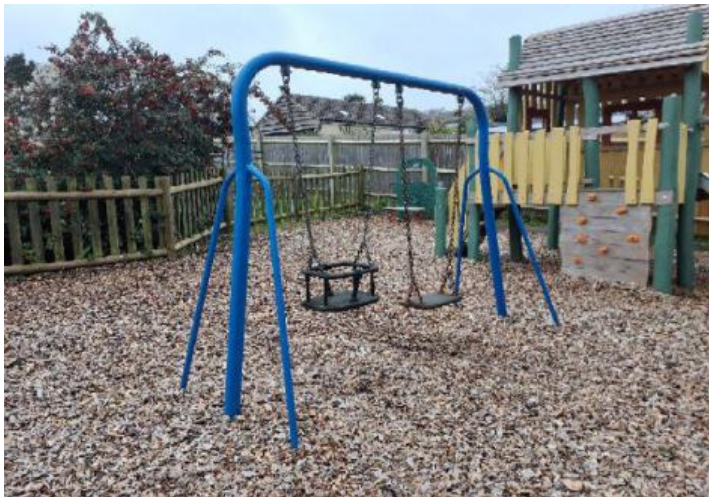
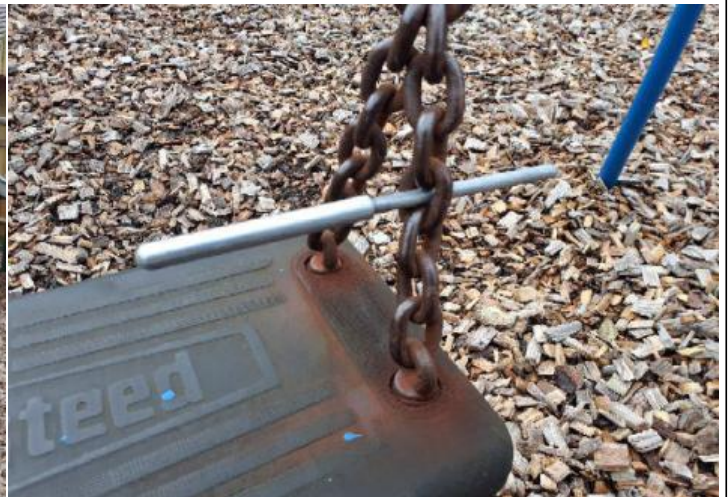
**Item:** Swings - 1 Bay Mixed Seat, 1 Cradle, 1 Flat  
**Manufacturer:** Not Identified

**Finding:** The chain openings are in excess of the 8.6mm as recommended by BS EN 1176

**Action:** Monitor - No action given the risk assessment

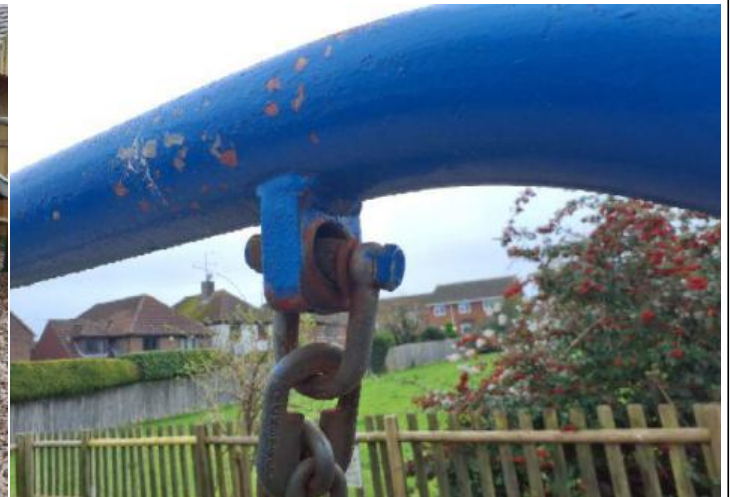
**Item:** Swings - 1 Bay Mixed Seat, 1 Cradle, 1 Flat  
**Manufacturer:** Not Identified

**Finding:** The bush / bushes is / are worn or missing

**Action:** Replace worn or missing bushes

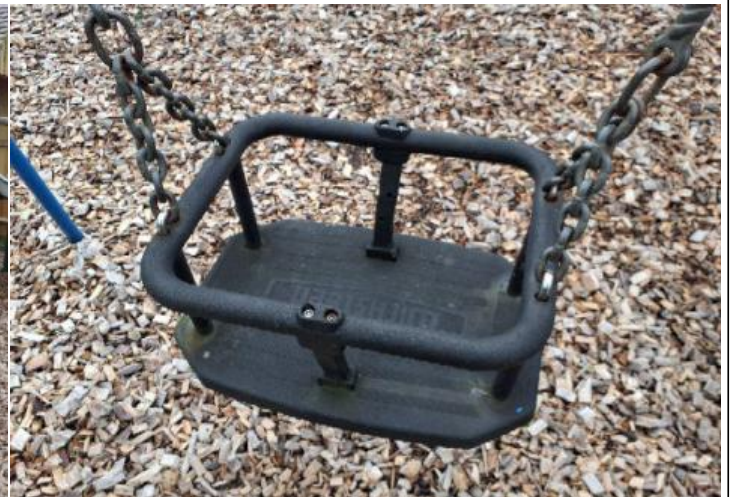
**Item:** Swings - 1 Bay Mixed Seat, 1 Cradle, 1 Flat  
**Manufacturer:** Not Identified

**Finding:** The seat has minor damage or wear

**Action:** Monitor for any further deterioration and replace as required

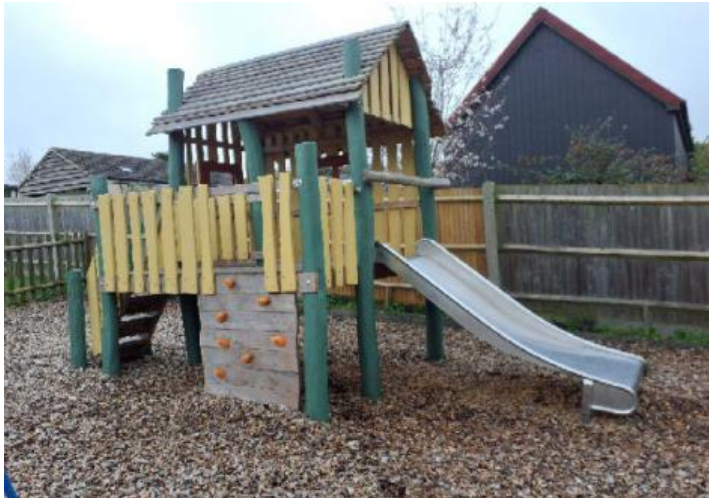
**Item:** Activity Equipment - Multi Play (Junior)  
**Manufacturer:** Dylan Group Ltd

**Finding:** The slide runout is inclined at more than the 10 degrees recommended by BS EN 1176 Part 3 for a Type 1 slide

**Action:** Monitor - No action given the risk assessment

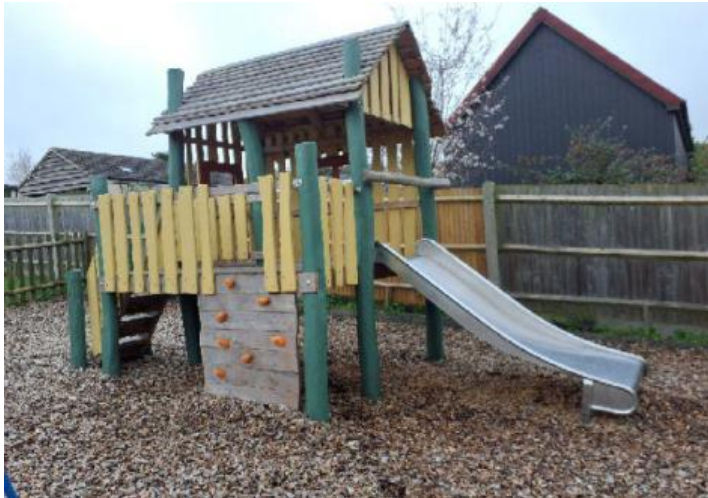
**Item:** Activity Equipment - Multi Play (Junior)  
**Manufacturer:** Dylan Group Ltd

**Finding:** The timber has a number of splits/shakes or air cracks and this may affect the stability or allow water ingress which will accelerate the rotting process. Timber splits may also create rough / splintering edges.

**Action:** Monitor, sand down any rough edges and ensure the splits do not cross through fixing points of the structure and/or cause any instability

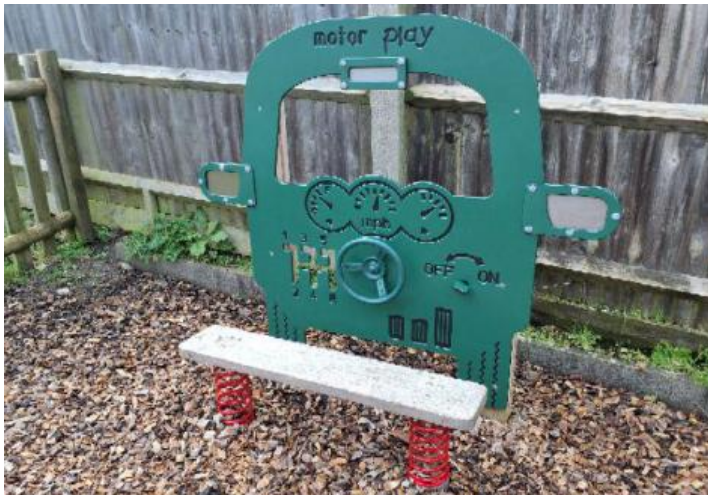
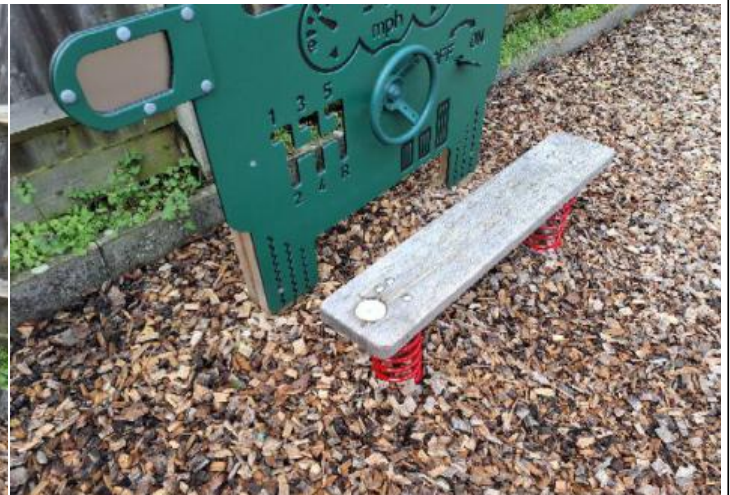
**Item:** Activity Equipment - Play Panel  
**Manufacturer:** Dylan Group Ltd

**Finding:** A spring board has been used as the seat and the play panel forms a hard object within the falling space of the board

**Action:** Monitor - No action given the risk assessment

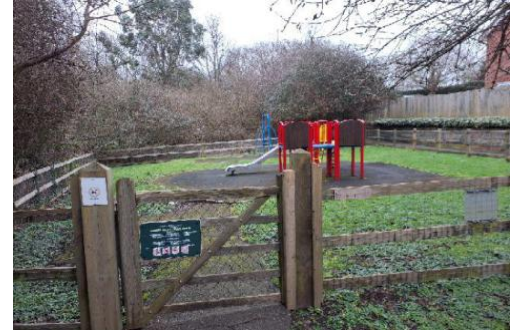
**Item:** Site General  
**Manufacturer:** Owner/Operator  
**Surface Type:** N/A  
**Item Quantity:** 1  
**Equipment Compliance:** N/A  
**Surface Area Compliance:** N/A

There are trip hazards at the edges of the surface - Remove trip hazard

There is algae, silt or moss growth on the surface resulting in slippery conditions - Clean and treat appropriately

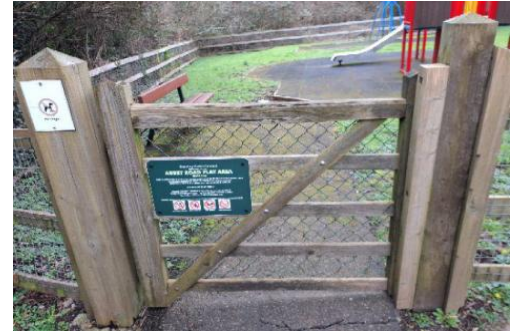
**Item:** Gate - Self Closing  
**Manufacturer:** Not Identified  
**Surface Type:** Tarmac  
**Item Quantity:** 1  
**Equipment Compliance:** N/A  
**Surface Area Compliance:** N/A

There is some evidence of rot in the timber - Monitor for any further deterioration and replace as required

The mesh is damaged and there are sharp wire strands protruding - Repair or replace

There are areas or parts of the timber on the structure that have rotted - Replace all affected timbers

The item is slightly loose in its foundations - Monitor for any further deterioration and repair as required

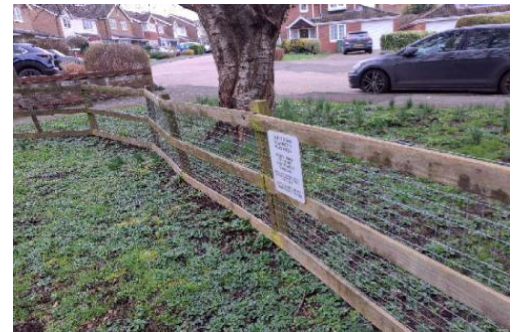
**Item:** Fence - Timber & Mesh Infill  
**Manufacturer:** Not Identified  
**Surface Type:** Grass  
**Item Quantity:** 1  
**Equipment Compliance:** N/A  
**Surface Area Compliance:** N/A

There is some evidence of rot in the timber - Monitor for any further deterioration and replace as required

There is some strimmer / machinery damage apparent on the posts, this can penetrate the preservative applied to the timber and accelerate the rotting process - Monitor for any deterioration (rot) and replace as required

The item has been damaged - Monitor for any further deterioration and replace as required

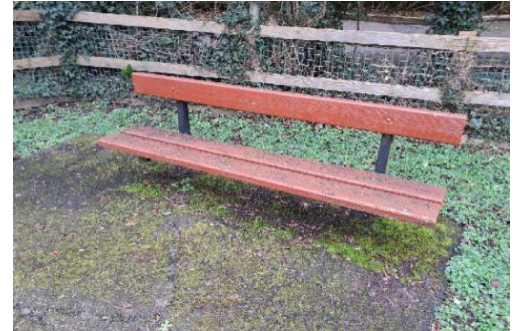
**Item:** Bench  
**Manufacturer:** Not Identified  
**Surface Type:** Bitmac  
**Item Quantity:** 2  
**Equipment Compliance:** N/A  
**Surface Area Compliance:** N/A

The timber stain is in poor condition - Prepare all affected parts and re-stain with an appropriate preservative

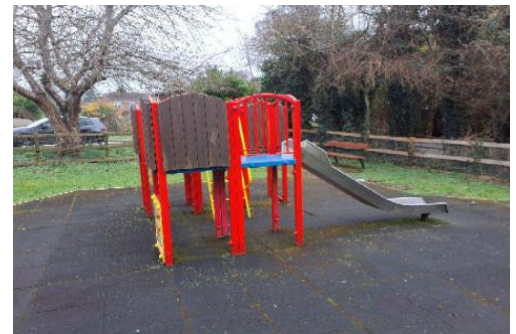
**Item:** Multi Play (Junior)  
**Manufacturer:** Not Identified  
**Surface Type:** Rubber Tiles  
**Item Quantity:** 1  
**Equipment Compliance:** No  
**Surface Area Compliance:** Yes

The item fails to meet the requirements of BS EN 1176 Part 1 4.2.7.2 head and neck entrapment in the barriers and/or steps - Monitor - No action given the risk assessment

There are areas or parts of the timber on the barriers that have rotted - Replace all affected timbers

The paintwork on this item has been damaged or worn exposing the metal underneath which is rusting / corroding - Treat affected areas and repaint

The item has missing component(s) - Consider replacing missing components

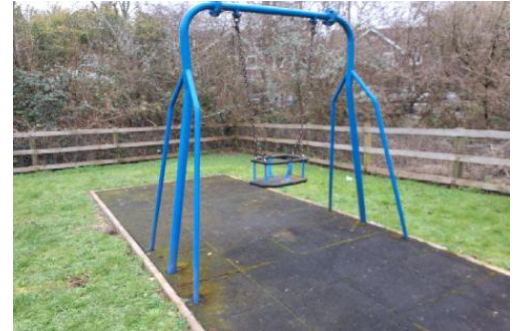
**Item:** 1 Bay 1 Seat (Cradle) - Type 1  
**Manufacturer:** Not Identified  
**Surface Type:** Rubber Tiles  
**Item Quantity:** 1  
**Equipment Compliance:** No  
**Surface Area Compliance:** Yes

The seat has minor damage or wear - Monitor for any further deterioration and replace as required

The chain openings are in excess of the 8.6mm as recommended by BS EN 1176 - Monitor - No action given the risk assessment

The chain links are worn excessively and require renewing - Replace worn chains

Crucifix or T connectors should have at least two complete chain links through the connector to meet with the manufacturers recommendations - Rectify installation to ensure at least two complete links are through the connectors

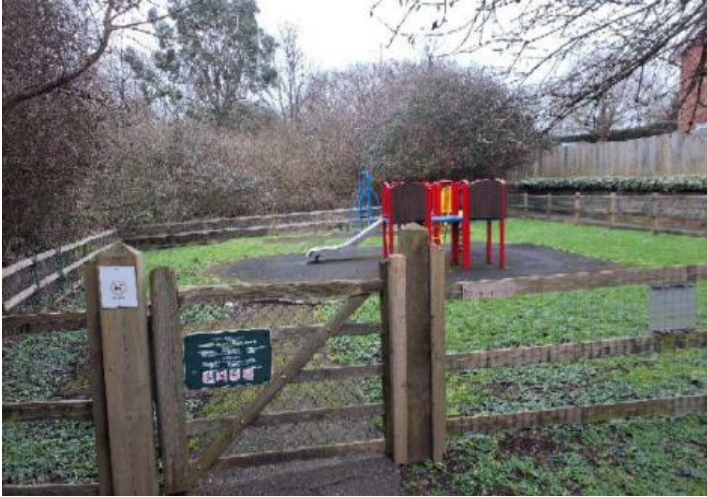
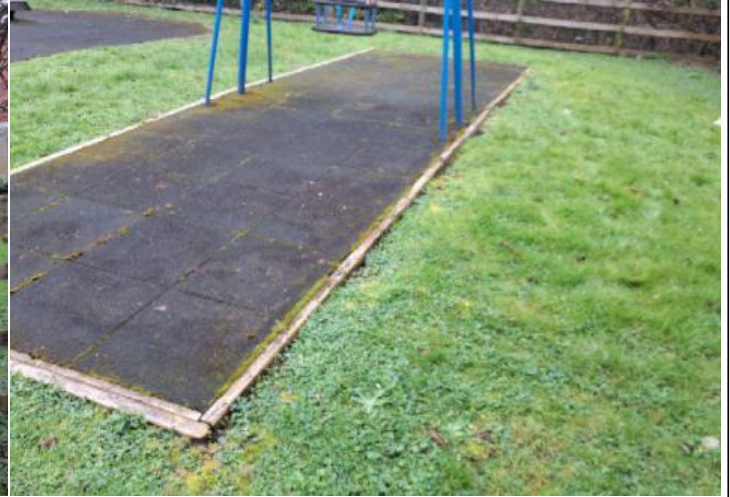
**Item:** Ancillary Items - Site General  
**Manufacturer:** Owner/Operator

**Finding:** There are trip hazards at the edges of the surface **Action:** Remove trip hazard

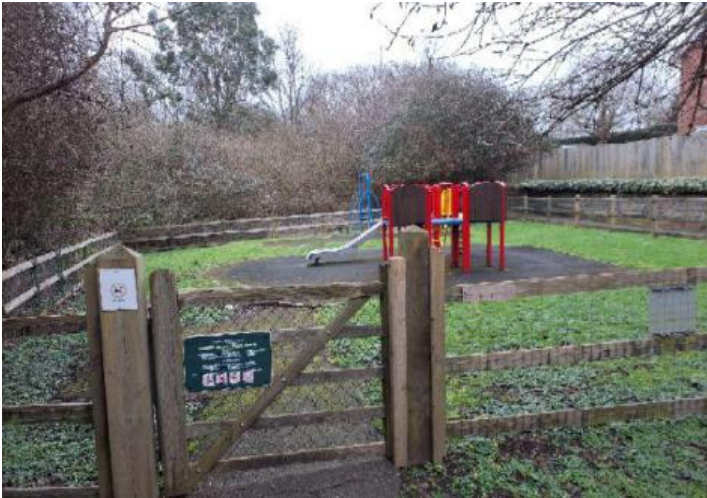
**Item:** Ancillary Items - Site General  
**Manufacturer:** Owner/Operator

**Finding:** There is algae, silt or moss growth on the surface resulting in slippery conditions

**Action:** Clean and treat appropriately

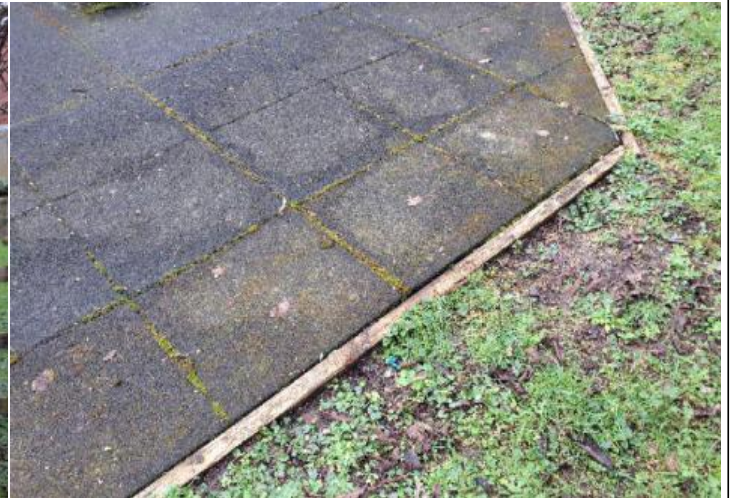
**Item:** Ancillary Items - Site General  
**Manufacturer:** Owner/Operator

**Finding:** The tiles can easily be lifted or are lifting along the edges of the area  
**Action:** Lift and re-glue tiles to secure

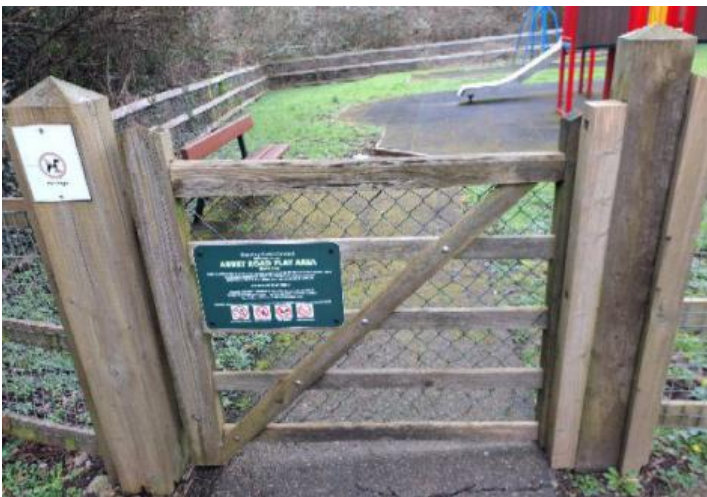
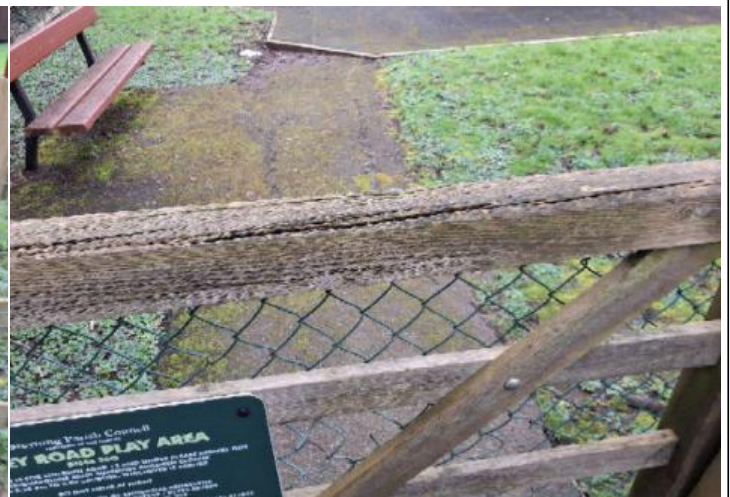
**Item:** Gates - Gate - Self Closing  
**Manufacturer:** Not Identified

**Finding:** There is some evidence of rot in the timber  
**Action:** Monitor for any further deterioration and replace as required

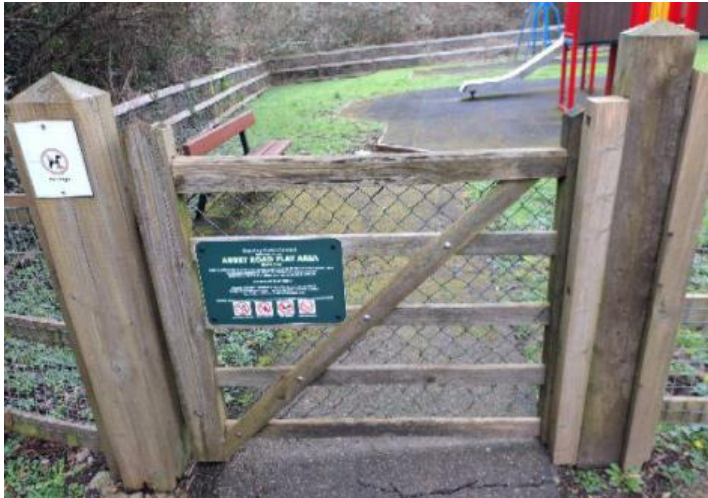
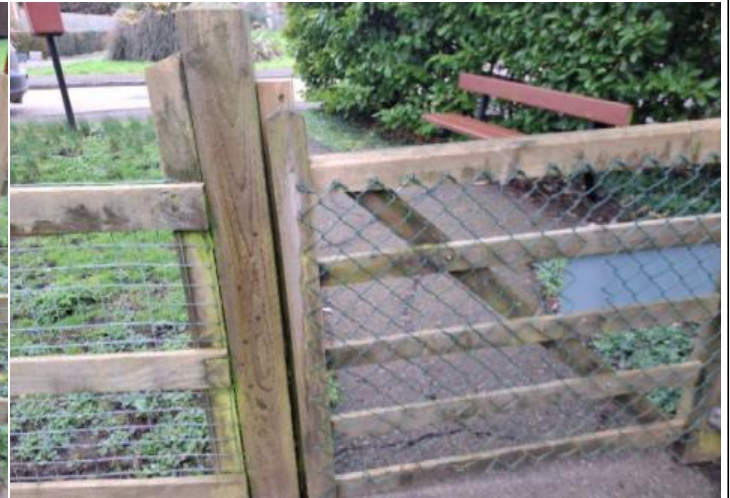
**Item:** Gates - Gate - Self Closing  
**Manufacturer:** Not Identified

**Finding:** The gate is closing too quickly (less than 4 seconds)

**Action:** Take corrective action to ensure that the gate closes in 4-8 seconds from 90 degrees

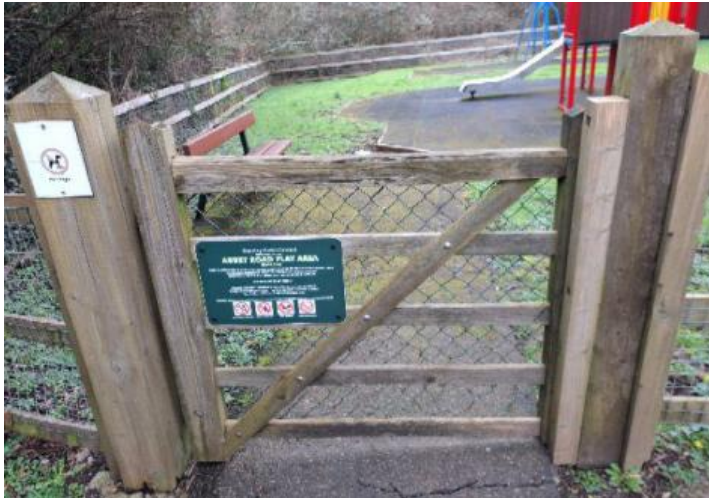
**Item:** Gates - Gate - Self Closing  
**Manufacturer:** Not Identified

**Finding:** The mesh is damaged and there are sharp wire strands protruding

**Action:** Repair or replace

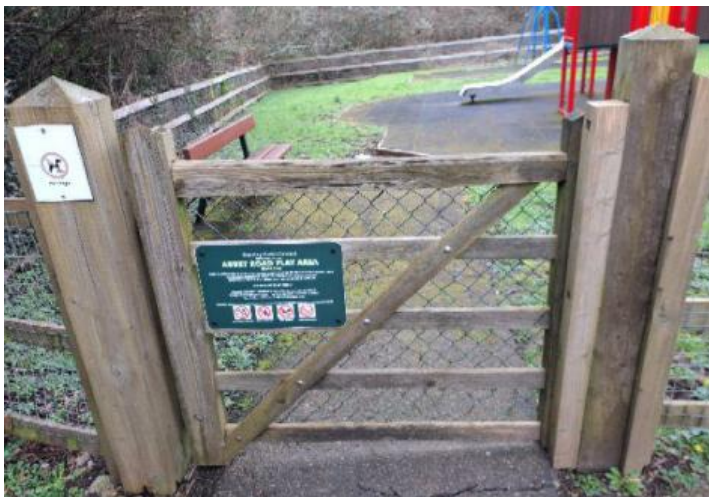
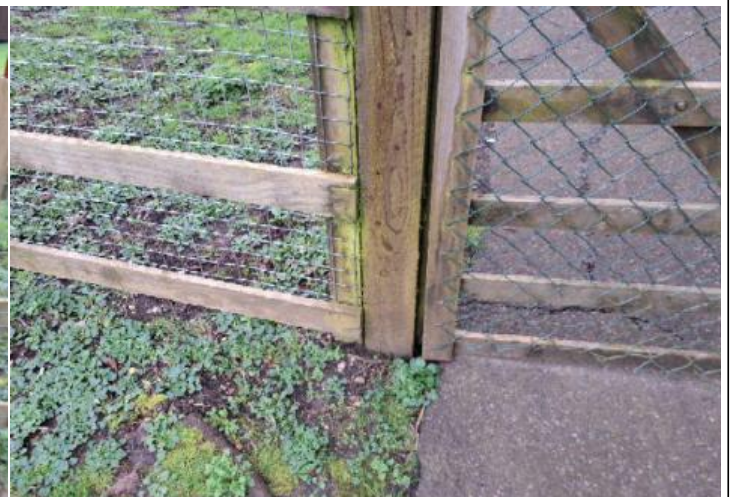
**Item:** Gates - Gate - Self Closing  
**Manufacturer:** Not Identified

**Finding:** The item is slightly loose in its foundations

**Action:** Monitor for any further deterioration and repair as required

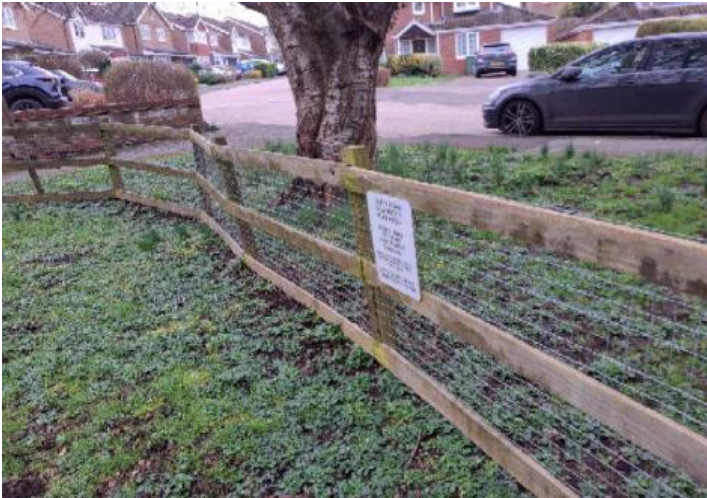
**Item:** Fences - Fence - Timber & Mesh Infill  
**Manufacturer:** Not Identified

**Finding:** There is some evidence of rot in the timber

**Action:** Monitor for any further deterioration and replace as required

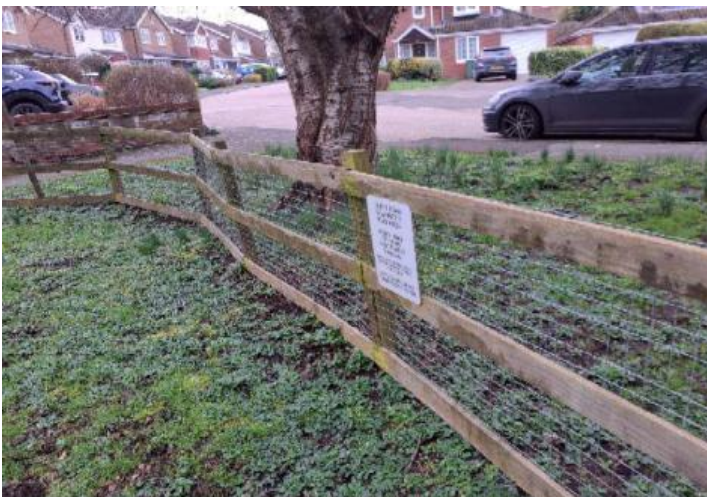
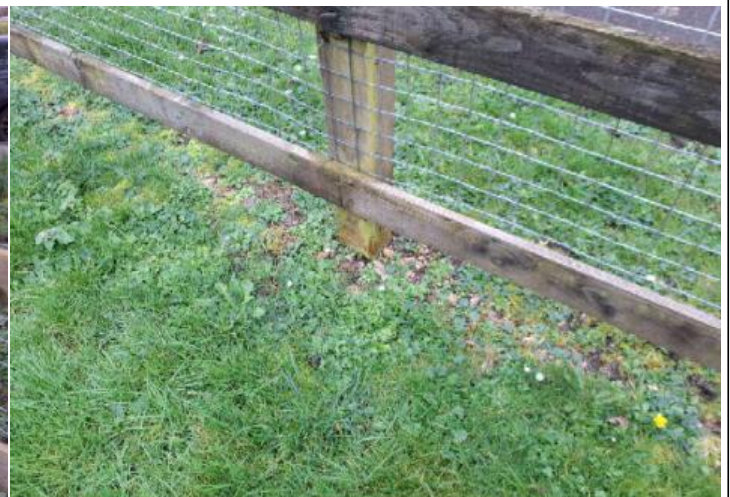
**Item:** Fences - Fence - Timber & Mesh Infill  
**Manufacturer:** Not Identified

**Finding:** There is some strimmer / machinery damage apparent on the posts, this can penetrate the preservative applied to the timber and accelerate the rotting process

**Action:** Monitor for any deterioration (rot) and replace as required

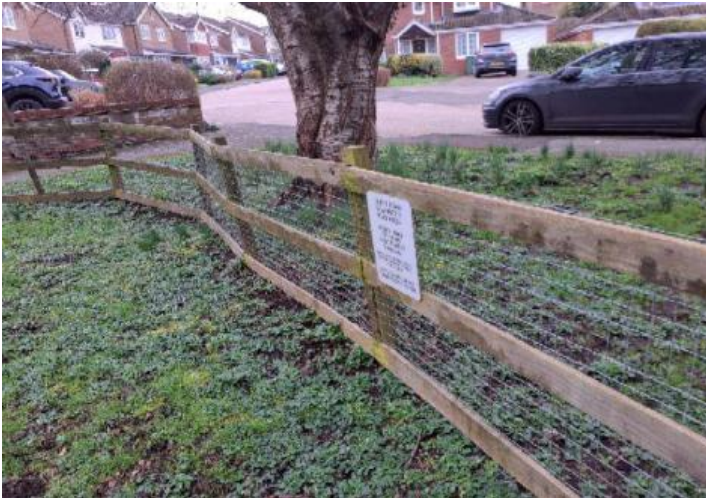
**Item:** Fences - Fence - Timber & Mesh Infill  
**Manufacturer:** Not Identified

**Finding:** The item has been damaged

**Action:** Monitor for any further deterioration and replace as required

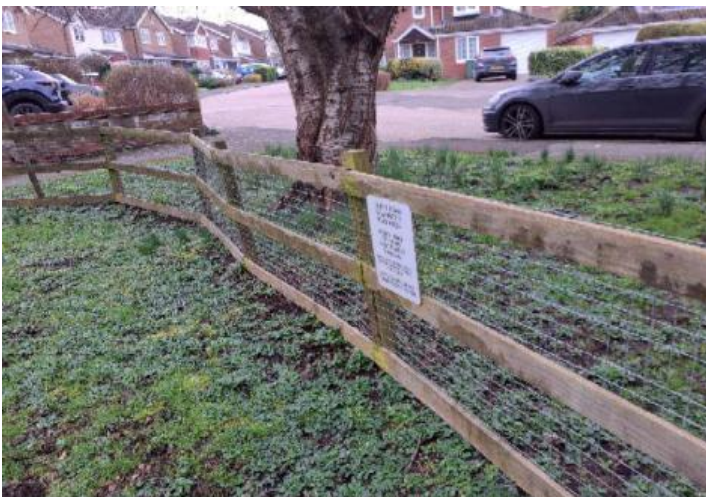
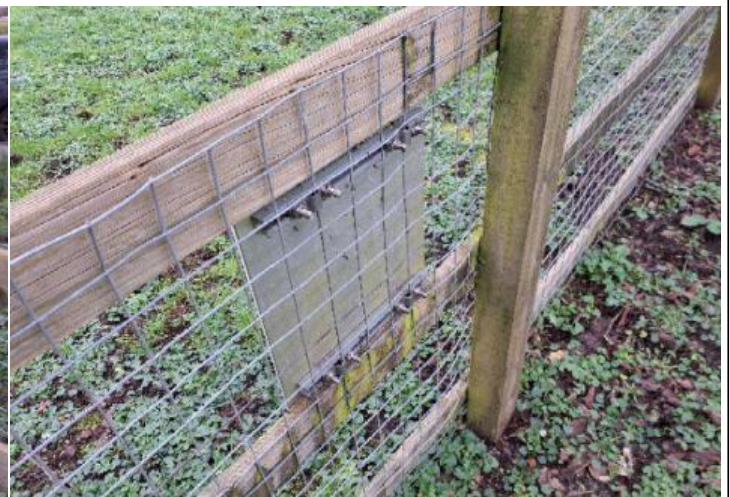
**Item:** Fences - Fence - Timber & Mesh Infill  
**Manufacturer:** Not Identified

**Finding:** There are projecting bolt thread(s) present

**Action:** Remove excess thread length and deburr or provide cap

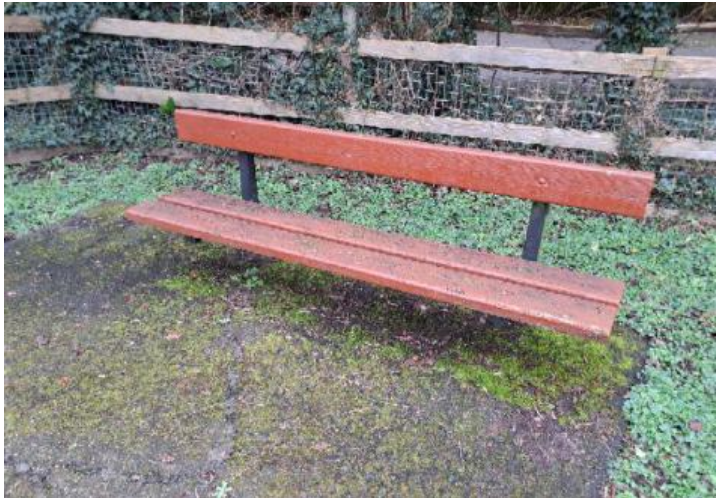
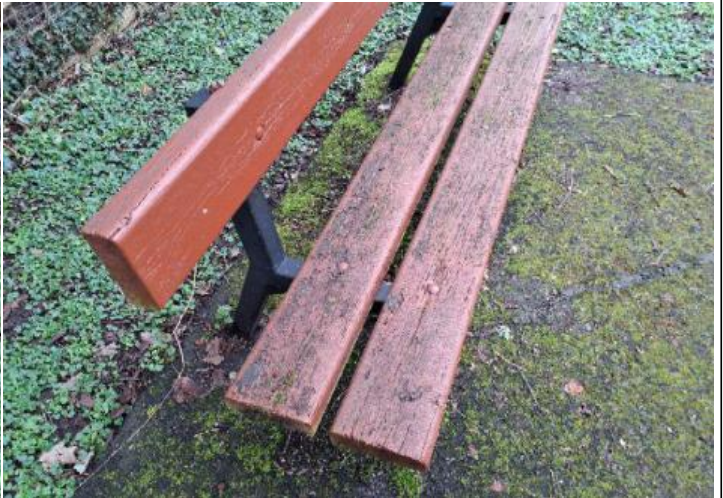
**Item:** Ancillary Items - Bench  
**Manufacturer:** Not Identified

**Finding:** The timber stain is in poor condition

**Action:** Prepare all affected parts and re-stain with an appropriate preservative

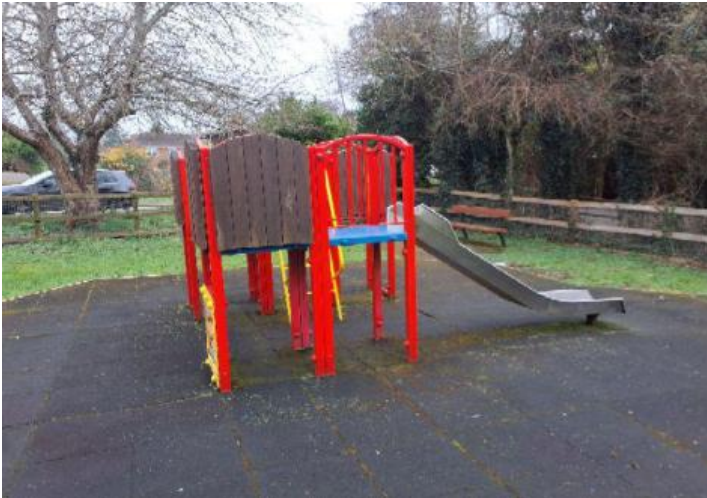
**Item:** Activity Equipment - Multi Play (Junior)  
**Manufacturer:** Not Identified

**Finding:** The item fails to meet the requirements of BS EN 1176 Part 1 4.2.7.2 head and neck entrapment in the barriers and/or steps

**Action:** Monitor - No action given the risk assessment

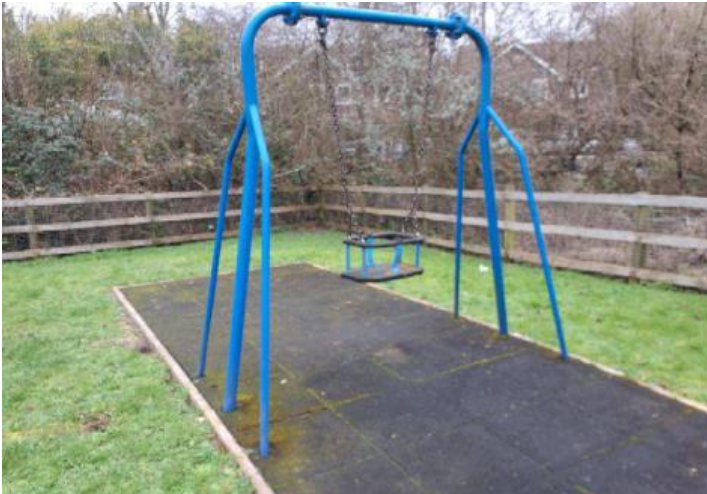
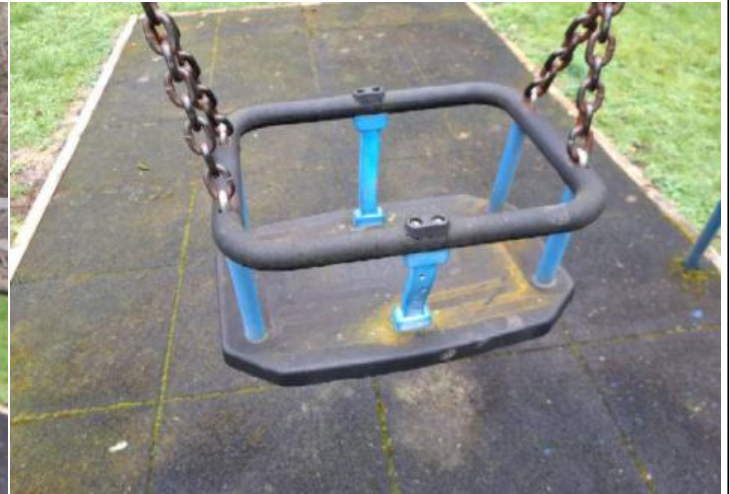
**Item:** Swings - 1 Bay 1 Seat (Cradle) - Type 1  
**Manufacturer:** Not Identified

**Finding:** The seat has minor damage or wear

**Action:** Monitor for any further deterioration and replace as required

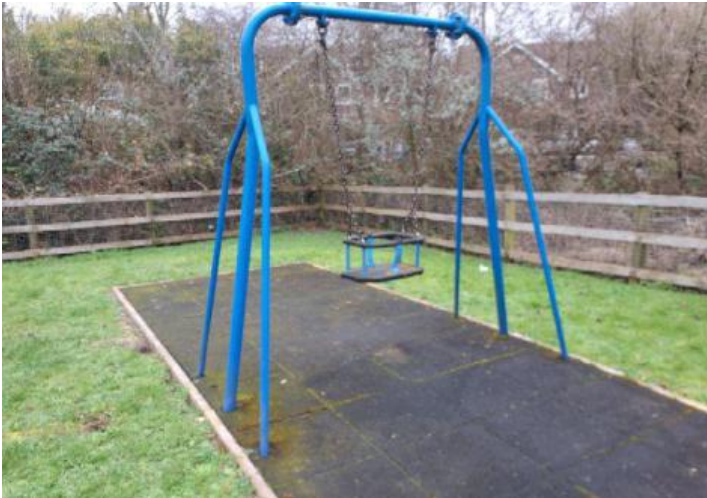
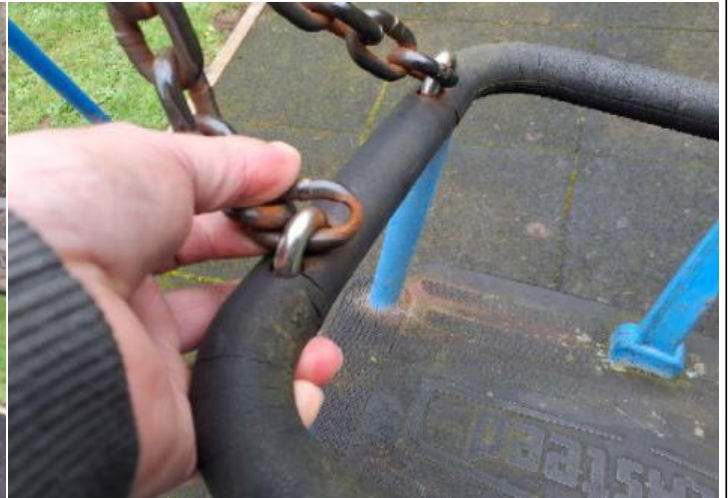
**Item:** Swings - 1 Bay 1 Seat (Cradle) - Type 1  
**Manufacturer:** Not Identified

**Finding:** The chain links are worn excessively and require renewing

**Action:** Replace worn chains

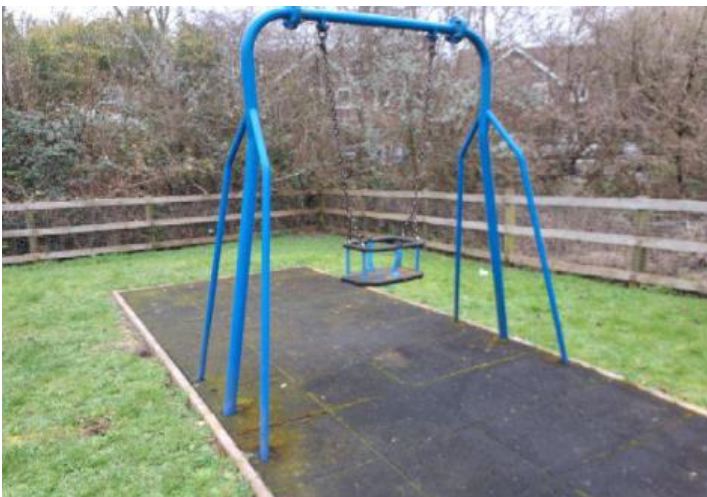
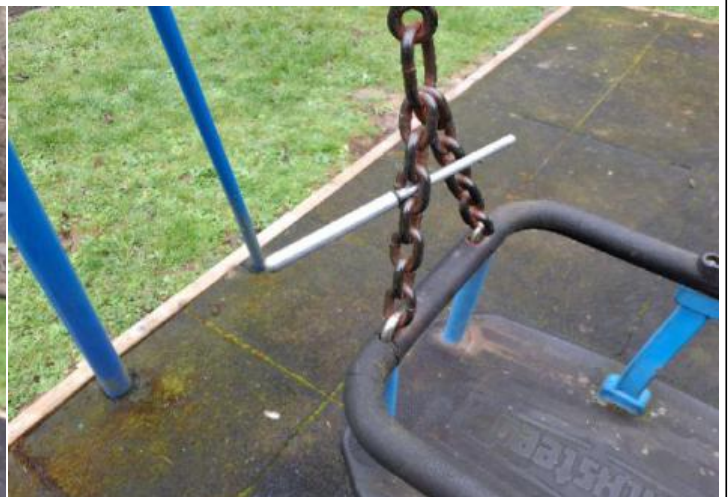
**Item:** Swings - 1 Bay 1 Seat (Cradle) - Type 1  
**Manufacturer:** Not Identified

**Finding:** The chain openings are in excess of the 8.6mm as recommended by BS EN 1176

**Action:** Monitor - No action given the risk assessment

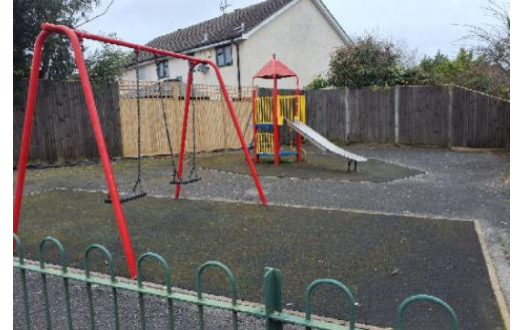
**Item:** Site General  
**Manufacturer:** Owner/Operator  
**Surface Type:** N/A  
**Item Quantity:** 1  
**Equipment Compliance:** N/A  
**Surface Area Compliance:** N/A

There is algae, silt or moss growth on the surface resulting in slippery conditions - Clean and treat appropriately

There are gaps opening between the surfacing and the edging surround or between the joints in the surfacing - Monitor for any further deterioration and repair as required

There are trip hazards at the edges of the surface - Remove trip hazard

The safety surface around the area is beginning to wear - Monitor for any further deterioration and repair as required

The bitumen surface is worn or damaged - Repair the bitumen to provide a uniform surface

Parts of the timber edging has rotted - Replace all affected timber

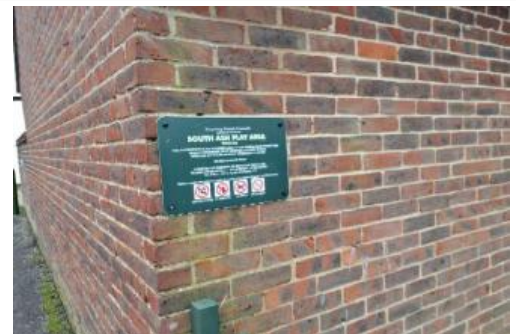
**Item:** Playground Sign  
**Manufacturer:** Not Identified  
**Surface Type:** N/A  
**Item Quantity:** 1  
**Equipment Compliance:** N/A  
**Surface Area Compliance:** N/A

This item is satisfactory - no work required -

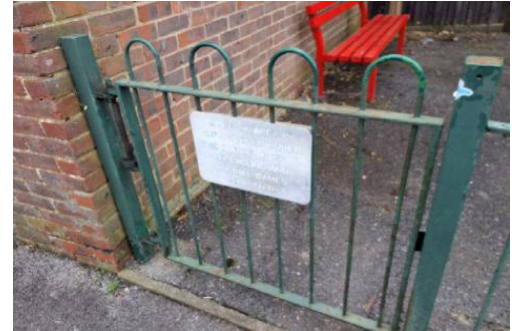
**Item:** Gate - Self Closing  
**Manufacturer:** Steelway/Fensecure  
**Surface Type:** Tarmac  
**Item Quantity:** 1  
**Equipment Compliance:** N/A  
**Surface Area Compliance:** N/A

The paintwork on this item has been damaged or worn exposing the metal underneath which is rusting / corroding - Treat affected areas and repaint

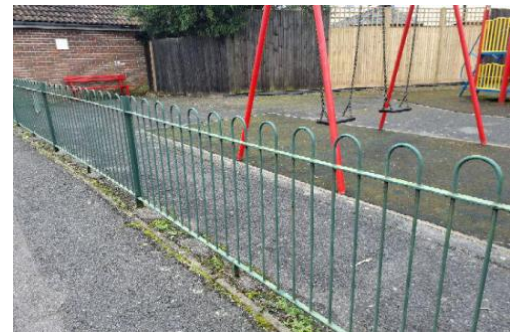
**Item:** Fence - Bow Top  
**Manufacturer:** Not Identified  
**Surface Type:** Tarmac  
**Item Quantity:** 1  
**Equipment Compliance:** N/A  
**Surface Area Compliance:** N/A

There is some damage to the fence sections - Monitor for any further deterioration and repair as required

The paintwork on this item has been damaged or worn exposing the metal underneath which is rusting / corroding - Treat affected areas and repaint

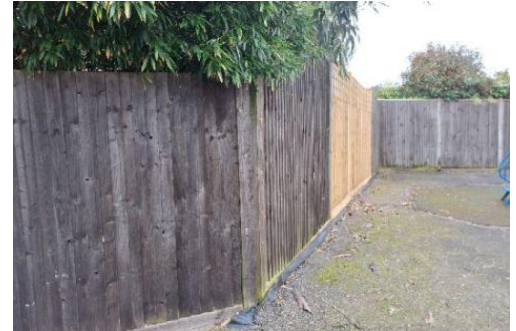
**Item:** Fencing - Timber  
**Manufacturer:** Not Identified  
**Surface Type:** Tarmac  
**Item Quantity:** 1  
**Equipment Compliance:** N/A  
**Surface Area Compliance:** N/A

A number of posts have rotted at ground level - Replace all affected timber

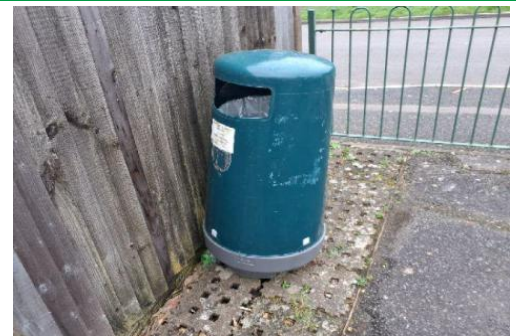
**Item:** Litter Bin  
**Manufacturer:** Glasdon  
**Surface Type:** Concrete  
**Item Quantity:** 1  
**Equipment Compliance:** N/A  
**Surface Area Compliance:** N/A

The item is slightly loose in its foundations - Monitor for any further deterioration and repair as required

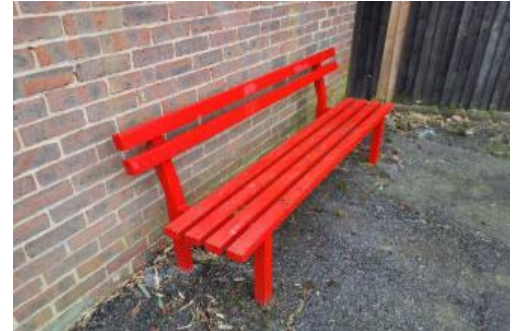
**Item:** Bench  
**Manufacturer:** Not Identified  
**Surface Type:** Bitmac  
**Item Quantity:** 1  
**Equipment Compliance:** N/A  
**Surface Area Compliance:** N/A

This item is satisfactory - no work required -
