## COMMUNITY COMMITTEE MEETING HELD ON TUESDAY 3<sup>rd</sup> MARCH 2026 AT 7.30 PM AT THE STEYPING CENTRE

# DRAFT MINUTES

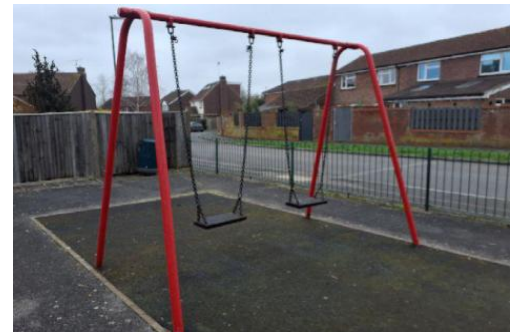
**Item:** 1 Bay 2 Seat (Flat)  
**Manufacturer:** Not Identified  
**Surface Type:** Wet Pour  
**Item Quantity:** 1  
**Equipment Compliance:** No  
**Surface Area Compliance:** No

The seat has minor damage or wear - Monitor for any further deterioration and replace as required

The chain openings are in excess of the 8.6mm as recommended by BS EN 1176 - Monitor - No action given the risk assessment

There is some notable evidence of chain wear - Monitor for any further deterioration and replace when 40% worn

The bushes are worn or missing and the shackles and crossbar lugs are severely worn - Replace crossbar and all worn / missing components

The surfacing width under the seat/s is / are less than 875mm when measured from the centre of the seat outwards, and fail the requirements of BS EN 1176 Part 2 - Monitor - No action given the risk assessment

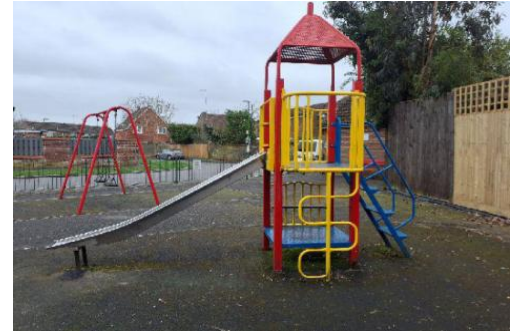
**Item:** Multi Play (Junior)  
**Manufacturer:** Not Identified  
**Surface Type:** Wet Pour  
**Item Quantity:** 1  
**Equipment Compliance:** No  
**Surface Area Compliance:** Yes

The end of the slide runout does not turn down into the ground with a radius of at least 50mm or reverse at an angle of at least 100 degrees in contravention of the recommendations of BS EN 1176 for a Type 1 slide - Monitor - No action given the risk assessment

The paintwork on this item has been damaged or worn exposing the metal underneath which is rusting / corroding - Treat affected areas and repaint

The surface is lifting at the edges and creating trip points - Repair perimeter of surfacing to remove trip points

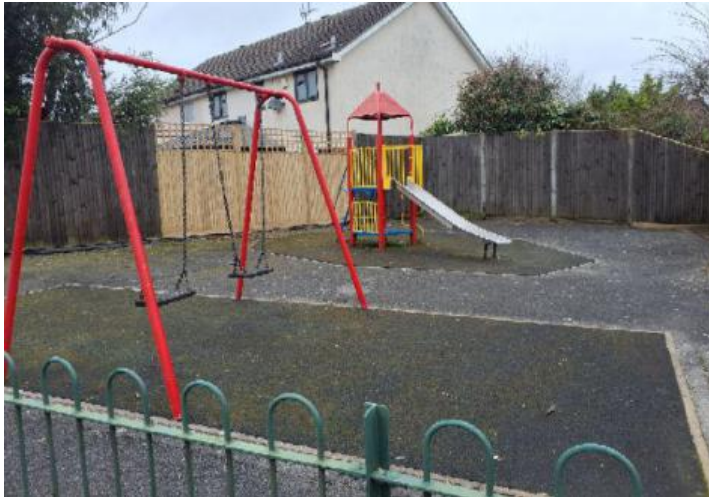
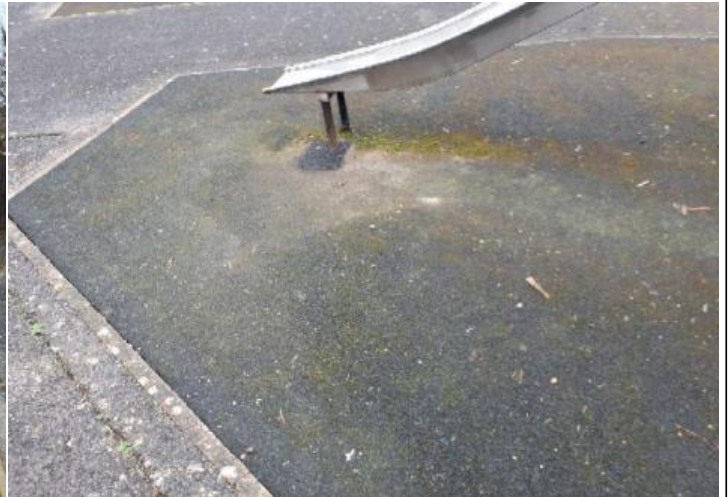
**Item:** Ancillary Items - Site General  
**Manufacturer:** Owner/Operator

**Finding:** There is algae, silt or moss growth on the surface resulting in slippery conditions  
**Action:** Clean and treat appropriately

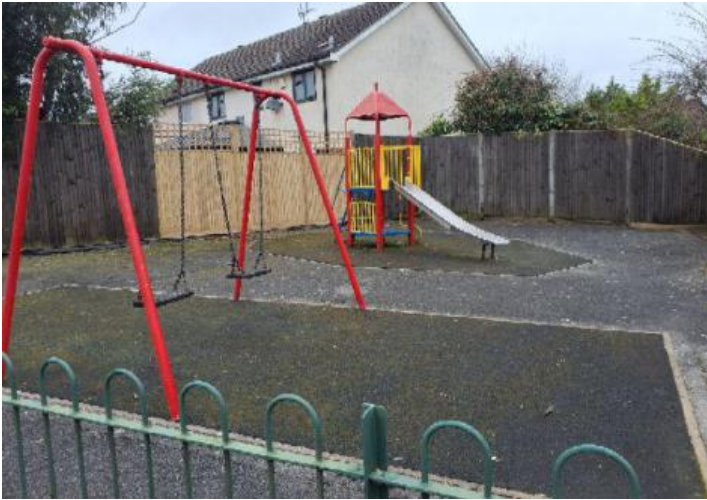
**Item:** Ancillary Items - Site General  
**Manufacturer:** Owner/Operator

**Finding:** The safety surface around the area is beginning to wear

**Action:** Monitor for any further deterioration and repair as required

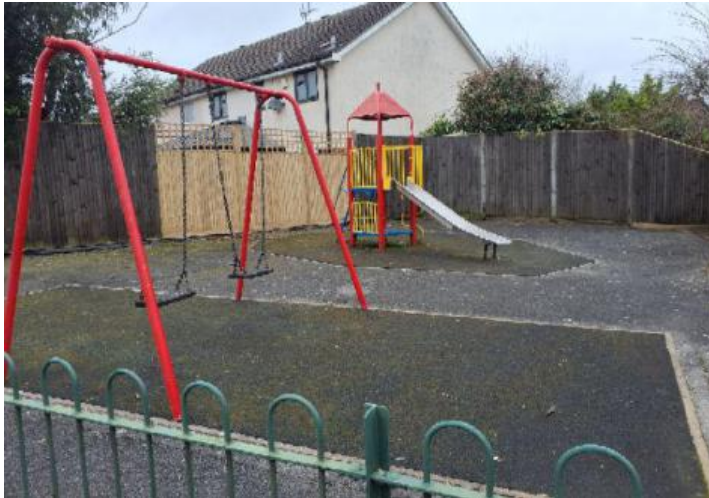
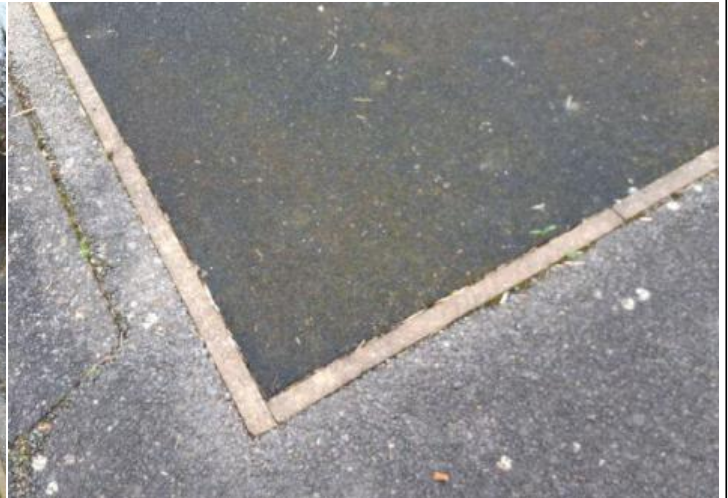
**Item:** Ancillary Items - Site General  
**Manufacturer:** Owner/Operator

**Finding:** There are gaps opening between the surfacing and the edging surround or between the joints in the surfacing  
**Action:** Monitor for any further deterioration and repair as required

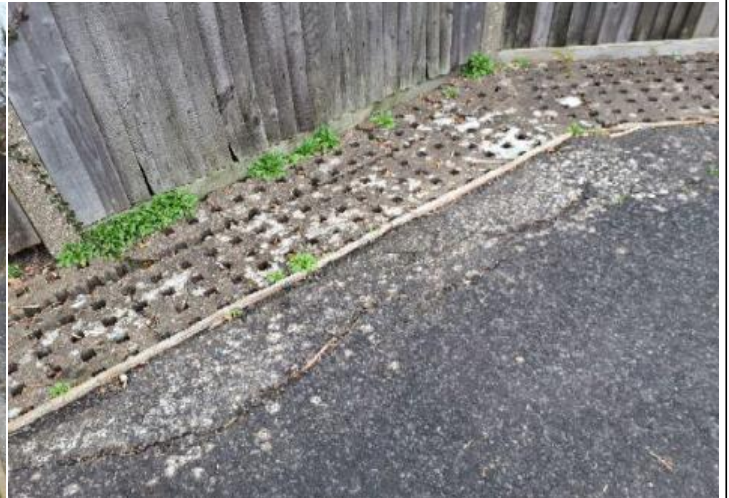
**Item:** Ancillary Items - Site General  
**Manufacturer:** Owner/Operator

**Finding:** There are trip hazards at the edges of the surface **Action:** Remove trip hazard

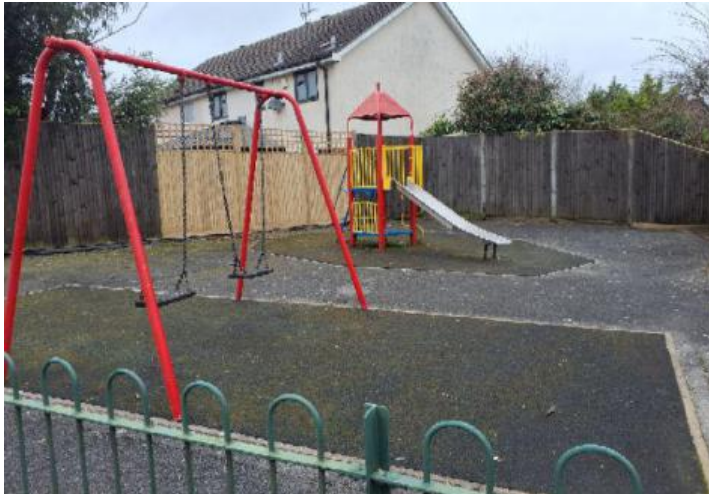
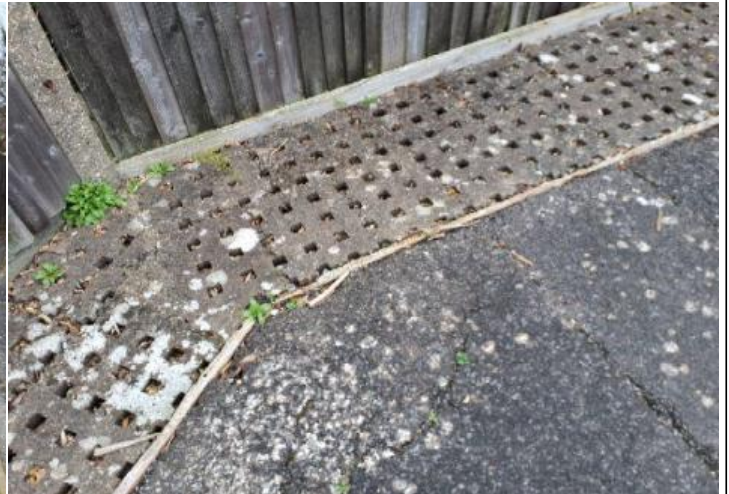
**Item:** Ancillary Items - Site General  
**Manufacturer:** Owner/Operator

**Finding:** Parts of the timber edging has rotted **Action:** Replace all affected timber

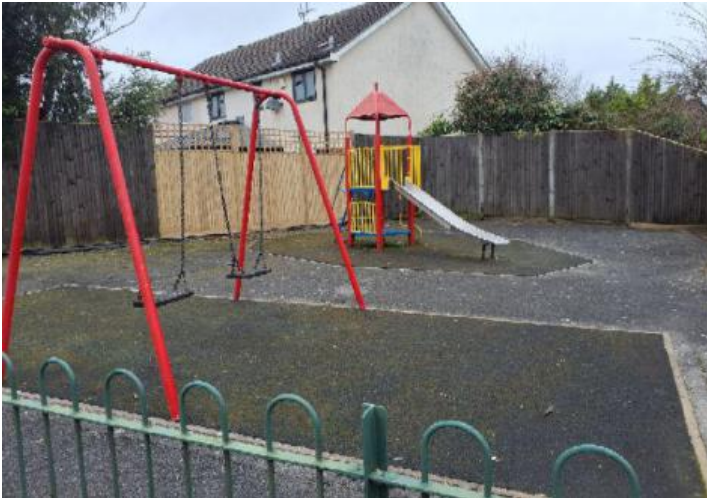
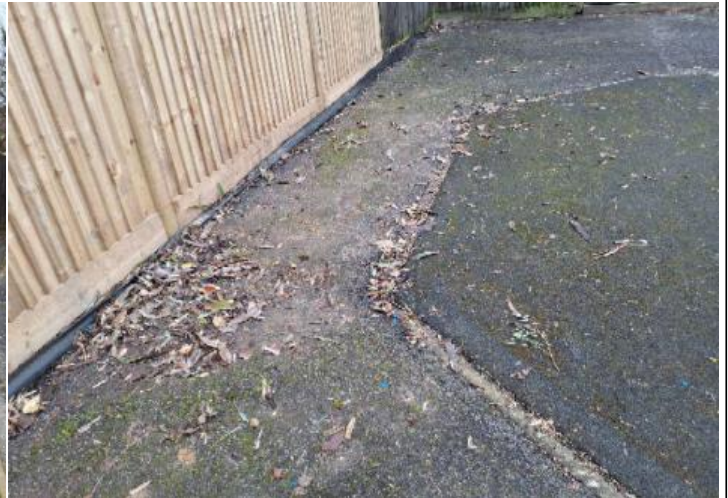
**Item:** Ancillary Items - Site General  
**Manufacturer:** Owner/Operator

**Finding:** There is some tree debris on the surfacing

**Action:** Remove and maintain

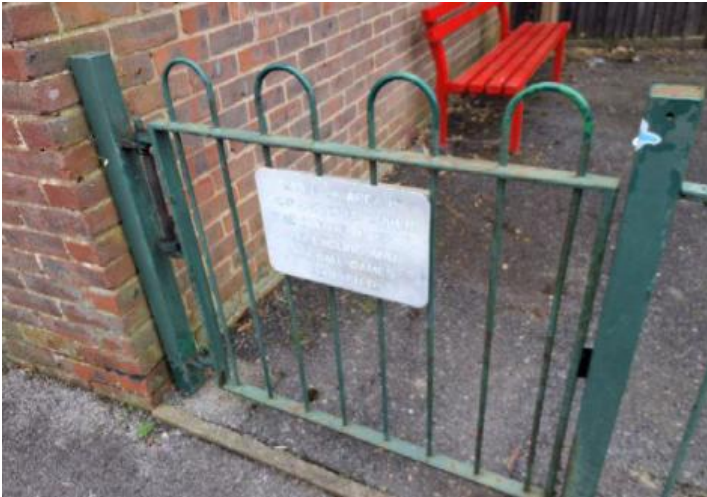
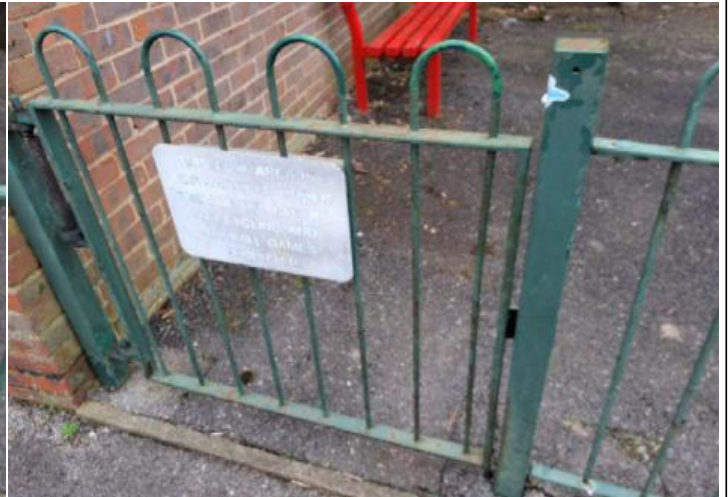
**Item:** Gates - Gate - Self Closing  
**Manufacturer:** Steelway/Fensecure

**Finding:** The paintwork on this item has been damaged or worn exposing the metal underneath which is rusting / corroding

**Action:** Treat affected areas and repaint

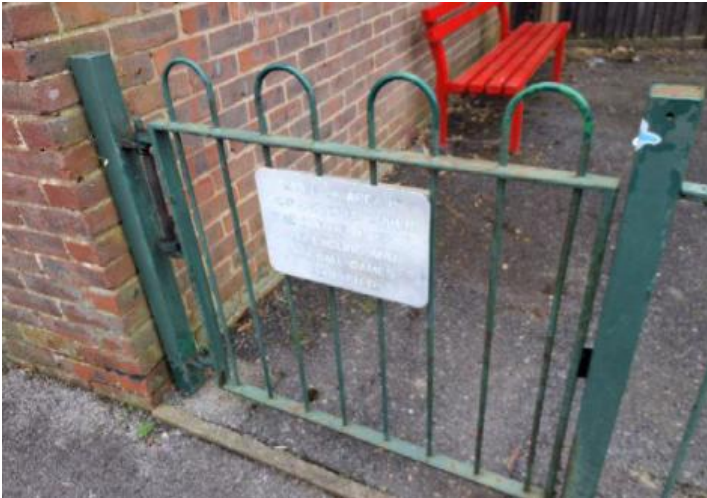
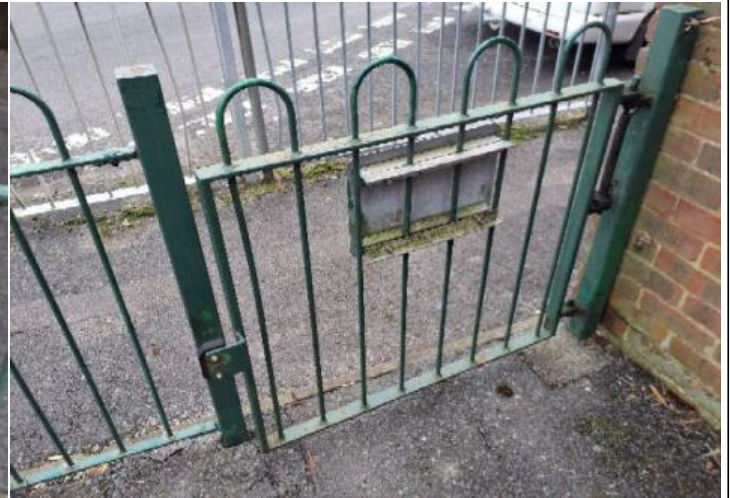
**Item:** Gates - Gate - Self Closing  
**Manufacturer:** Steelway/Fensecure

**Finding:** The gate is closing too quickly (less than 4 seconds)

**Action:** Take corrective action to ensure that the gate closes in 4-8 seconds from 90 degrees

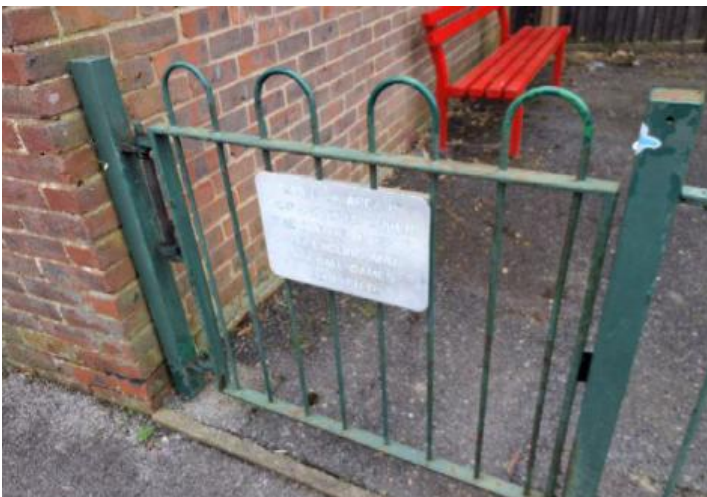
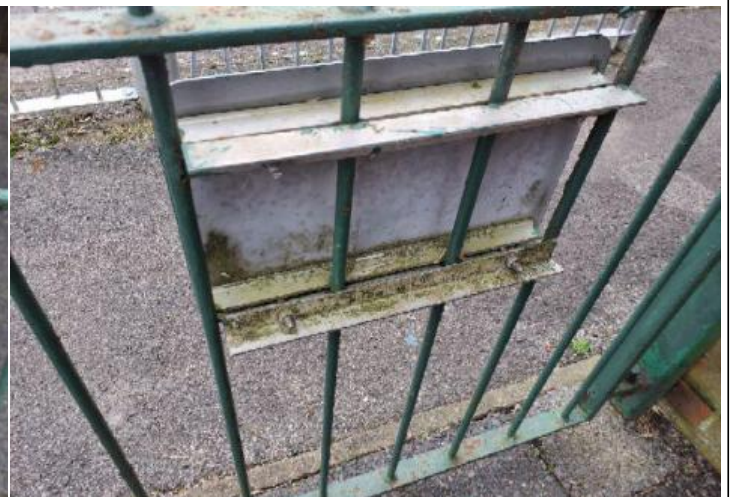
**Item:** Gates - Gate - Self Closing  
**Manufacturer:** Steelway/Fensecure

**Finding:** There are projecting bolt thread(s) present

**Action:** Remove excess thread length and deburr or provide cap

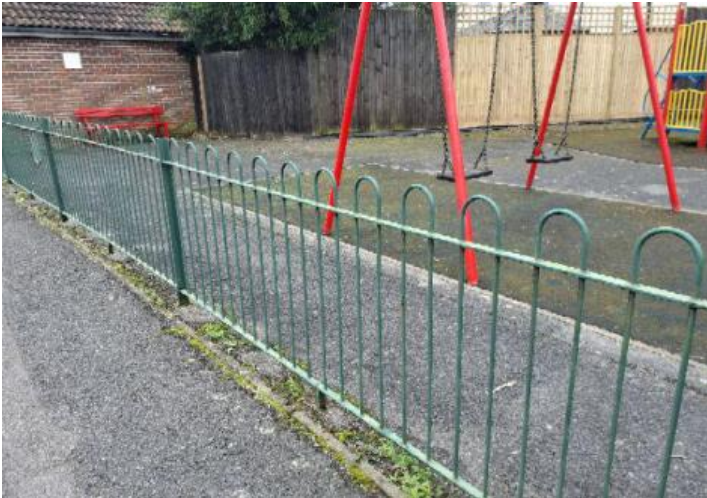
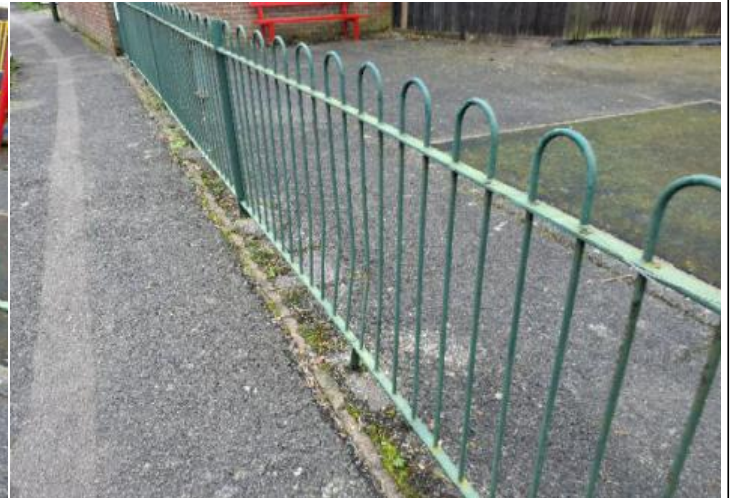
**Item:** Fences - Fence - Bow Top  
**Manufacturer:** Not Identified

**Finding:** There is some damage to the fence sections

**Action:** Monitor for any further deterioration and repair as required

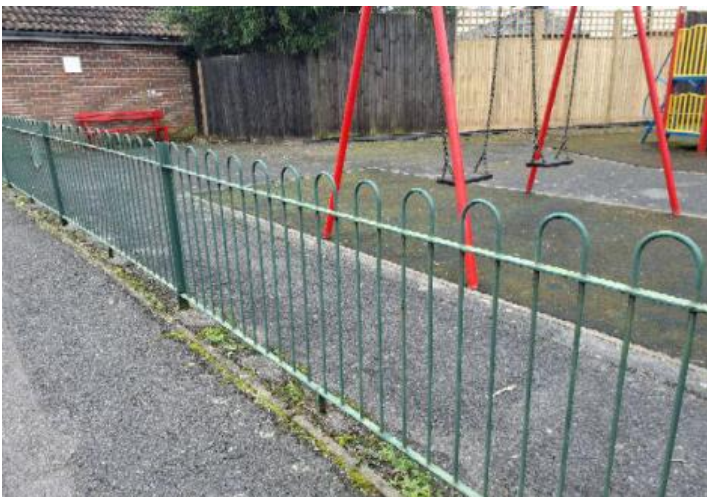
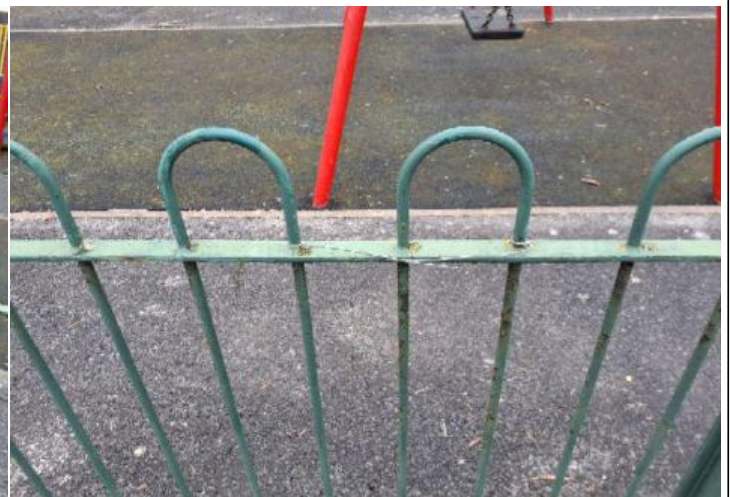
**Item:** Fences - Fence - Bow Top  
**Manufacturer:** Not Identified

**Finding:** Cable ties are present and there are sharp projecting ends

**Action:** Remove

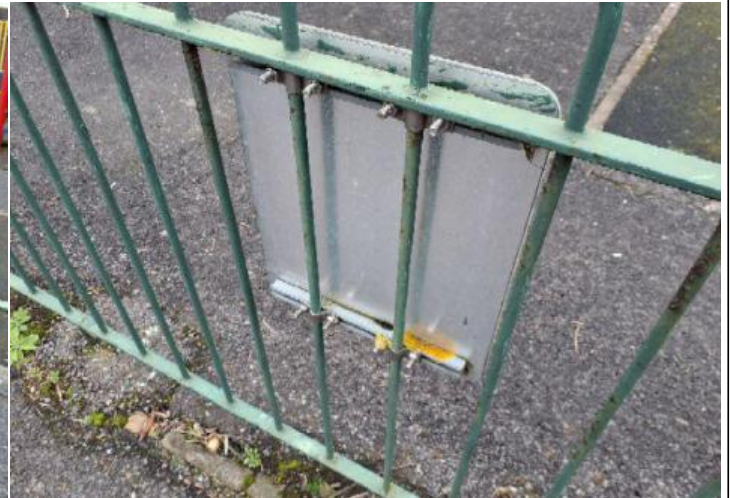
**Item:** Fences - Fence - Bow Top  
**Manufacturer:** Not Identified

**Finding:** There are projecting bolt thread(s) present

**Action:** Remove excess thread length and deburr or provide cap

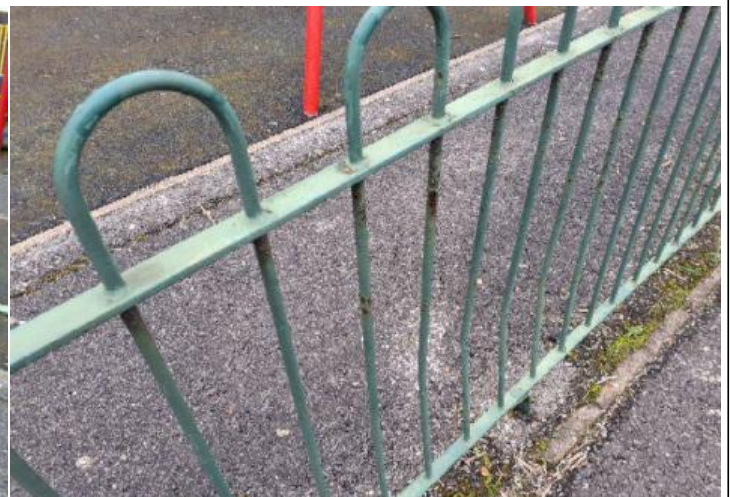
**Item:** Fences - Fence - Bow Top  
**Manufacturer:** Not Identified

**Finding:** The paintwork on this item has been damaged or worn exposing the metal underneath which is rusting / corroding

**Action:** Treat affected areas and repaint

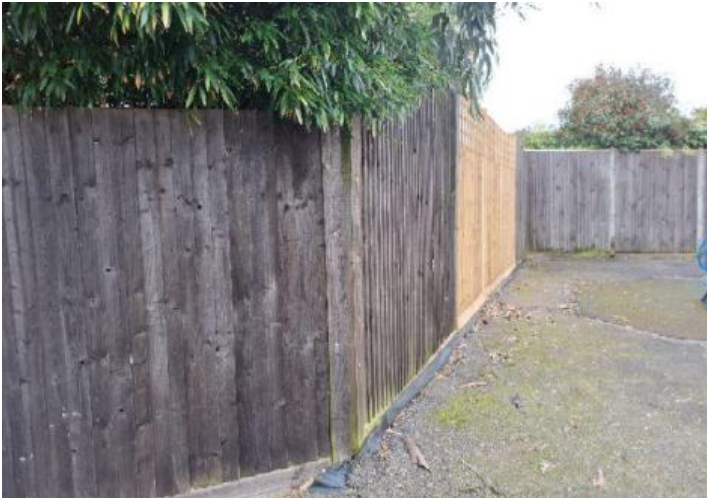
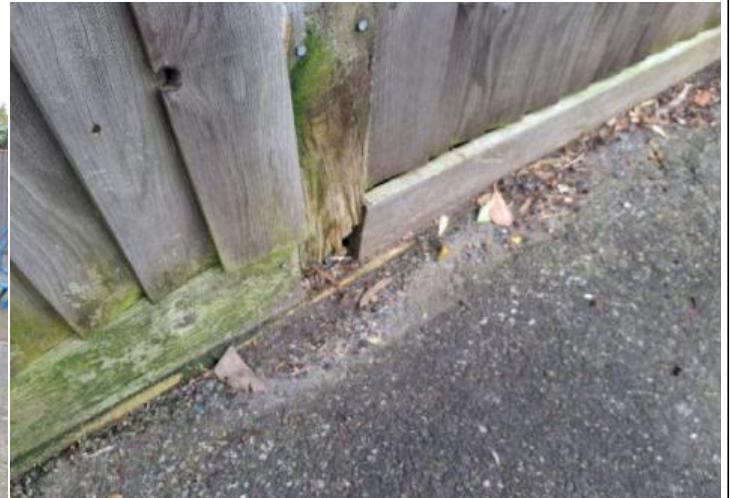
**Item:** Fences - Fencing - Timber  
**Manufacturer:** Not Identified

**Finding:** A number of posts have rotted at ground level

**Action:** Replace all affected timber

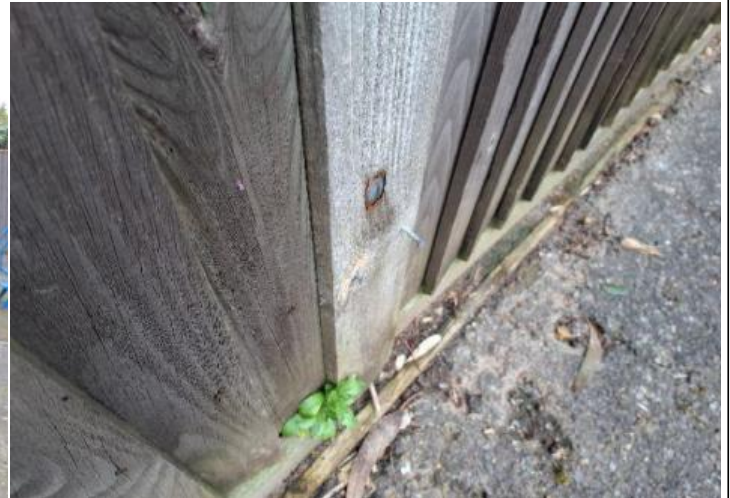
**Item:** Fences - Fencing - Timber  
**Manufacturer:** Not Identified

**Finding:** There are projecting nail ends present

**Action:** Remove and provide more appropriate fixings if required

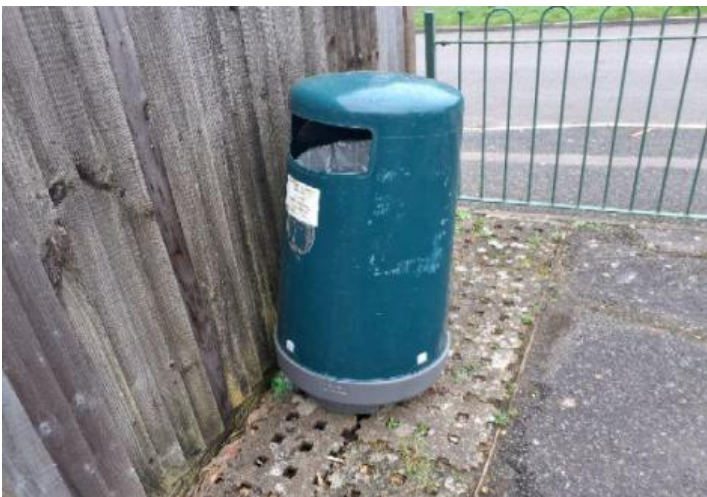
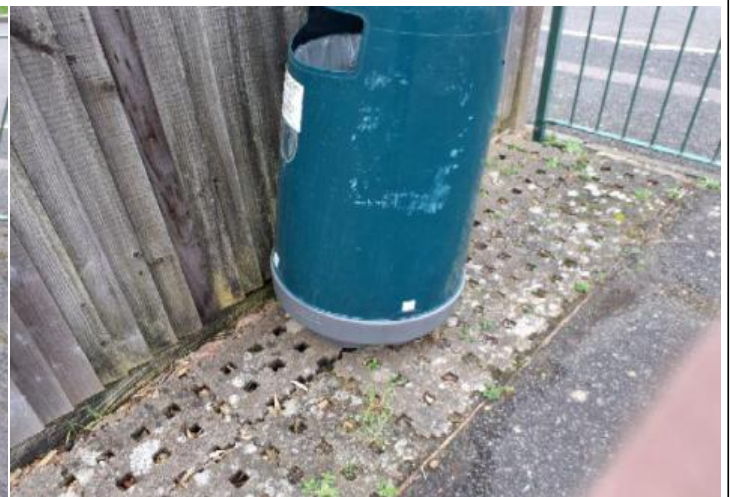
**Item:** Ancillary Items - Litter Bin  
**Manufacturer:** Glasdon

**Finding:** The item is slightly loose in its foundations

**Action:** Monitor for any further deterioration and repair as required

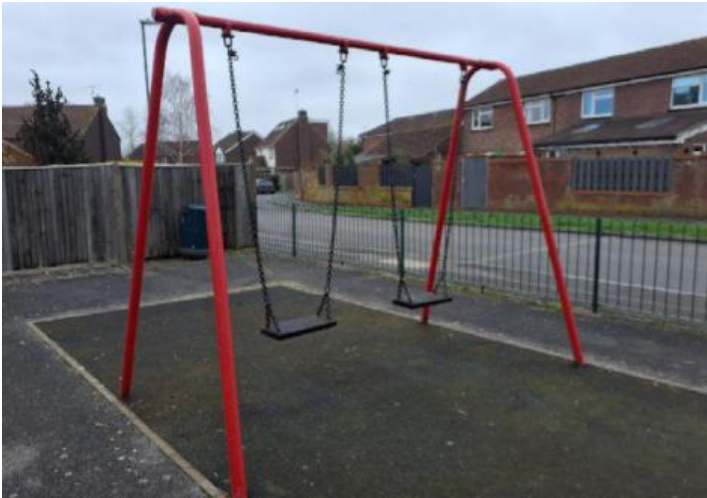
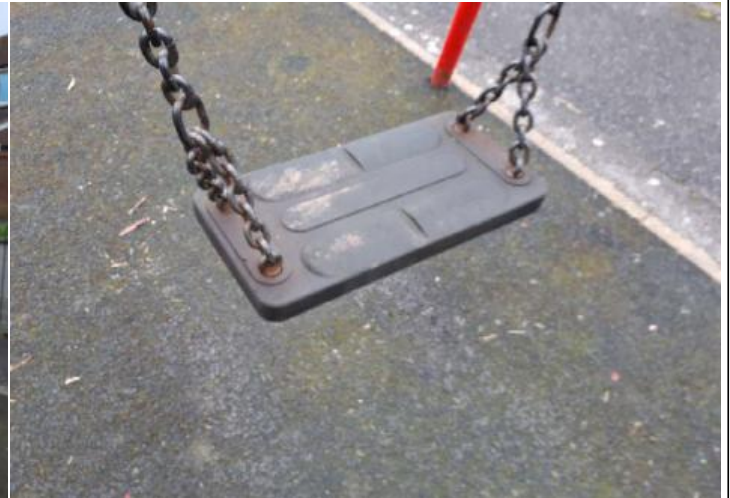
**Item:** Swings - 1 Bay 2 Seat (Flat)  
**Manufacturer:** Not Identified

**Finding:** The seat has minor damage or wear

**Action:** Monitor for any further deterioration and replace as required

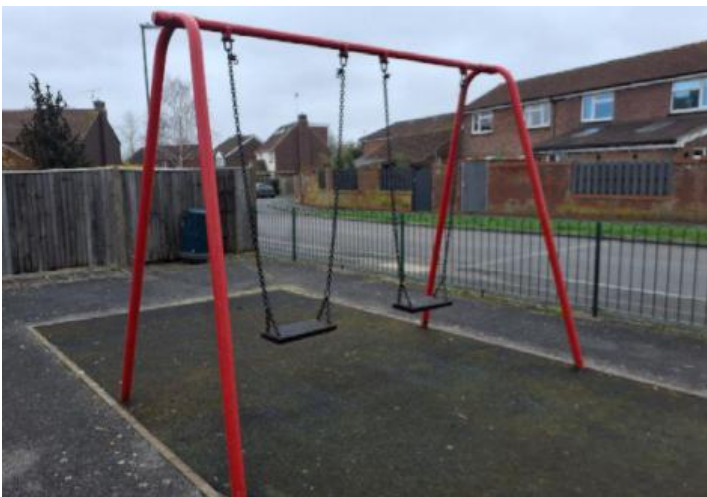
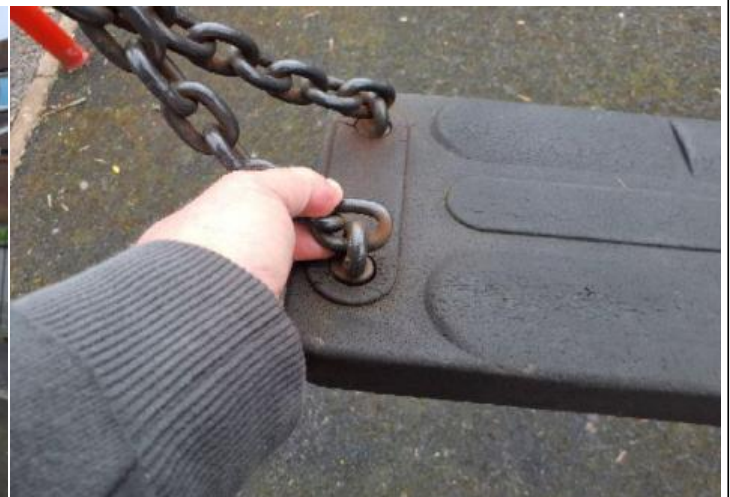
**Item:** Swings - 1 Bay 2 Seat (Flat)  
**Manufacturer:** Not Identified

**Finding:** There is some notable evidence of chain wear

**Action:** Monitor for any further deterioration and replace when 40% worn

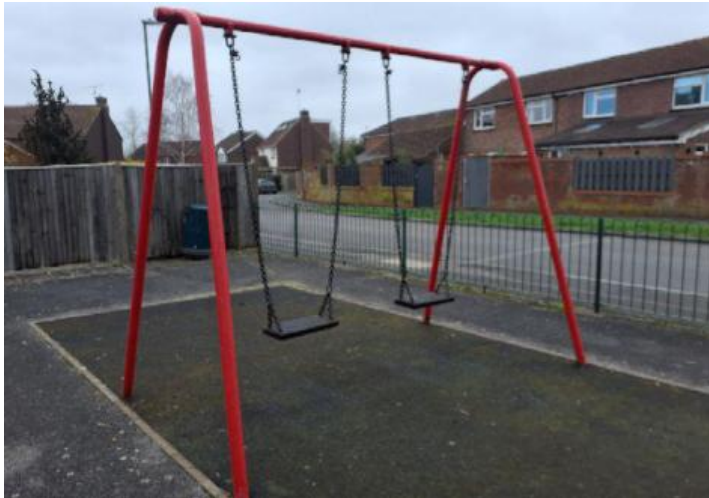
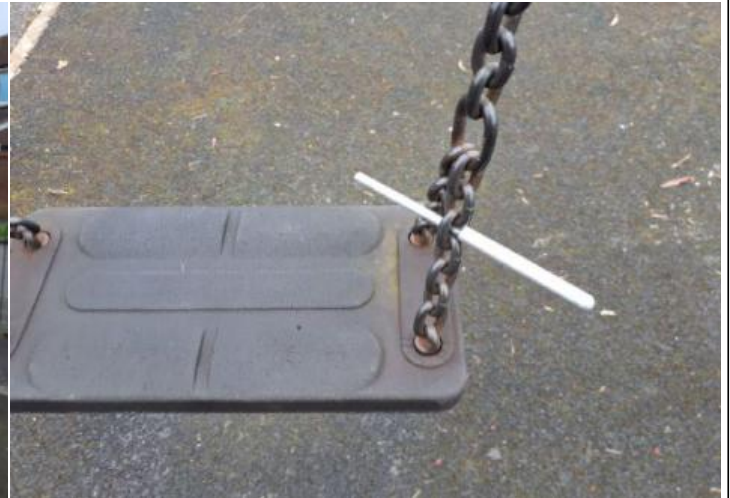
**Item:** Swings - 1 Bay 2 Seat (Flat)  
**Manufacturer:** Not Identified

**Finding:** The chain openings are in excess of the 8.6mm as recommended by BS EN 1176 **Action:** Monitor - No action given the risk assessment

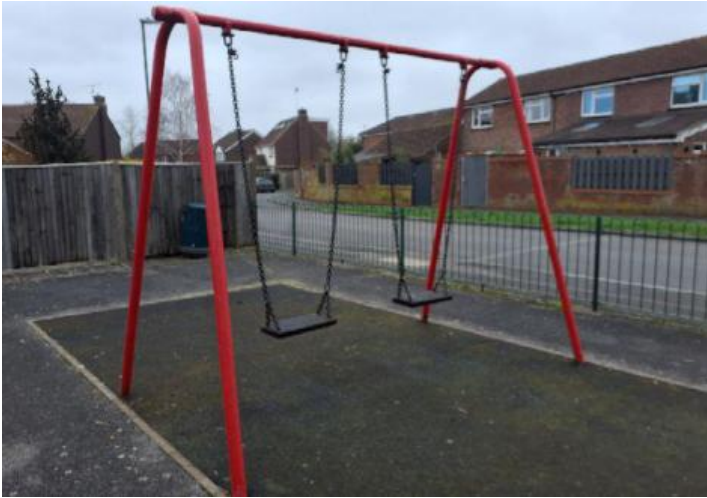
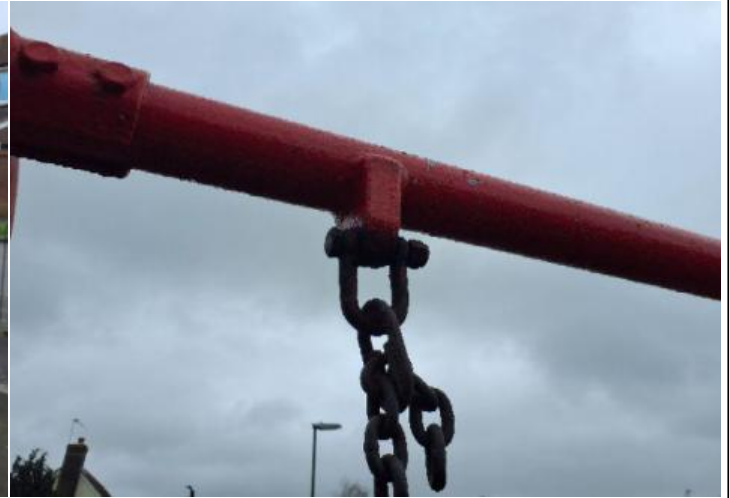
**Item:** Swings - 1 Bay 2 Seat (Flat)  
**Manufacturer:** Not Identified

**Finding:** The bushes are worn or missing and the shackles and crossbar lugs are severely worn

**Action:** Replace crossbar and all worn / missing components

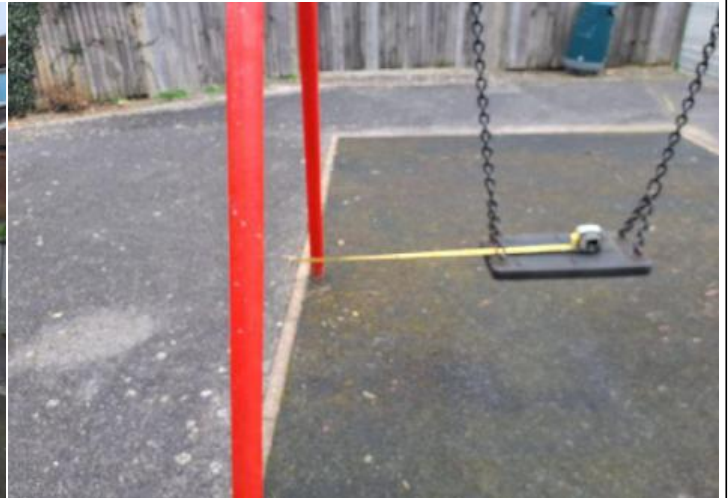
**Item:** Swings - 1 Bay 2 Seat (Flat)  
**Manufacturer:** Not Identified

**Finding:** The seat/s is / are too close to the frame as defined in BS EN 1176 Part 2

**Action:** Monitor - No action given the risk assessment

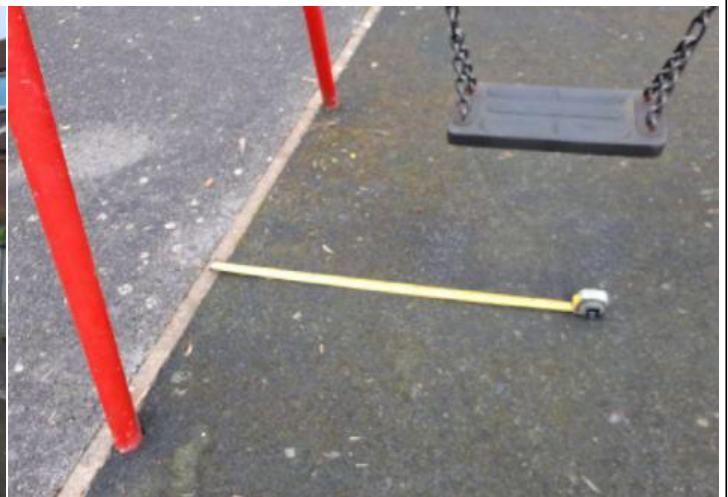
**Item:** Swings - 1 Bay 2 Seat (Flat)  
**Manufacturer:** Not Identified

**Finding:** The surfacing width under the seat/s is / are less than 875mm when measured from the centre of the seat outwards, and fail the requirements of BS EN 1176 Part 2

**Action:** Monitor - No action given the risk assessment

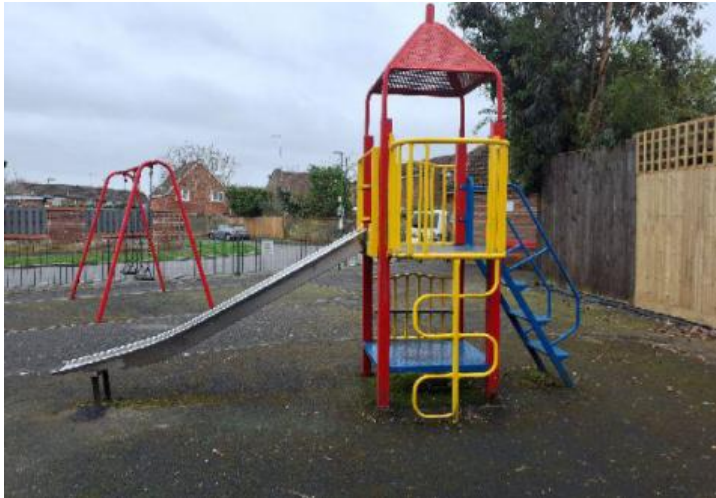
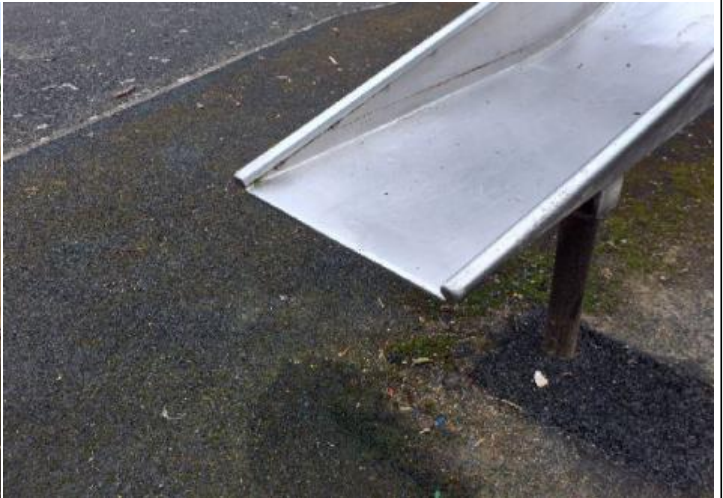
**Item:** Activity Equipment - Multi Play (Junior)  
**Manufacturer:** Not Identified

**Finding:** The end of the slide runout does not turn down into the ground with a radius of at least 50mm or reverse at an angle of at least 100 degrees in contravention of the recommendations of BS EN 1176 for a Type 1 slide  
**Action:** Monitor - No action given the risk assessment

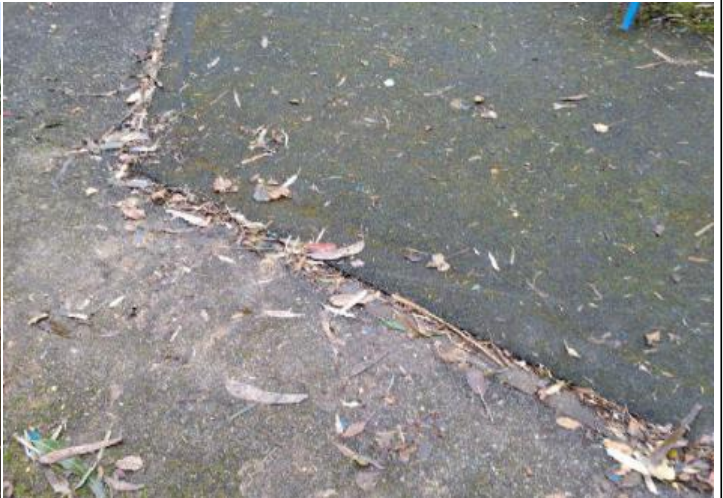
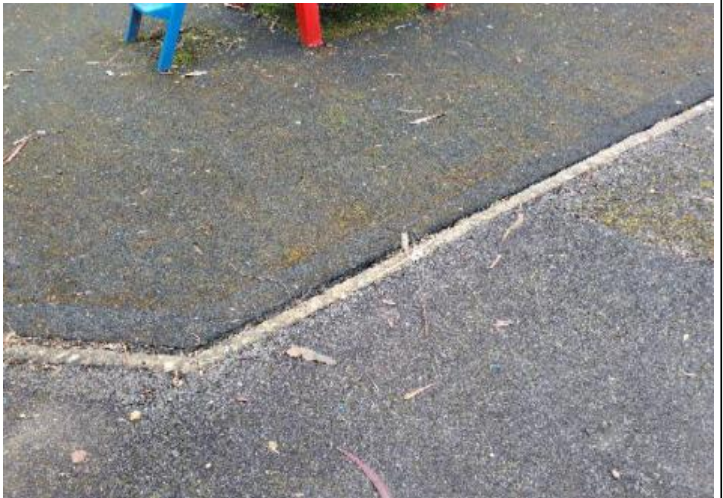
**Item:** Activity Equipment - Multi Play (Junior)  
**Manufacturer:** Not Identified

**Finding:** The surface is lifting at the edges and creating trip points  
**Action:** Repair perimeter of surfacing to remove trip points

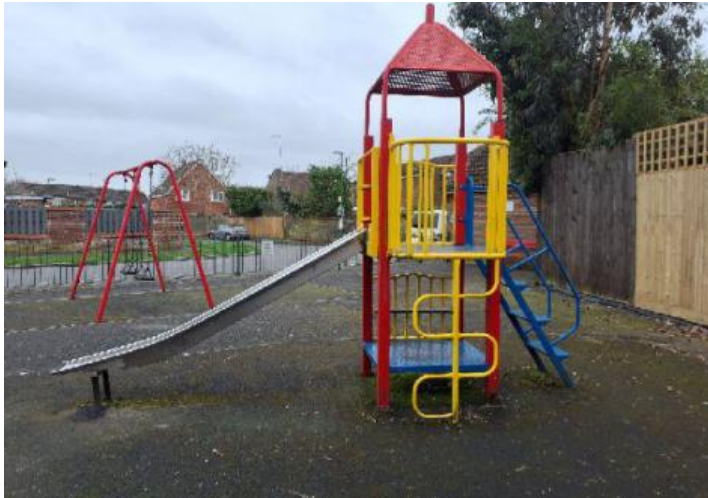
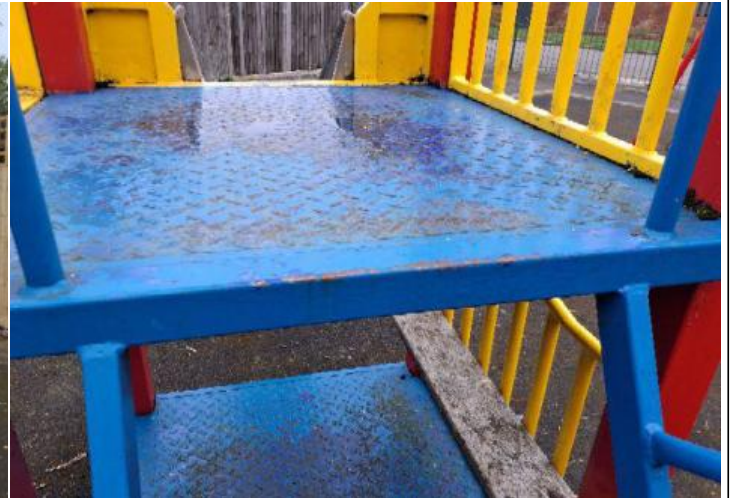
**Item:** Activity Equipment - Multi Play (Junior)  
**Manufacturer:** Not Identified

**Finding:** The paintwork on this item has been damaged or worn exposing the metal underneath which is rusting / corroding

**Action:** Treat affected areas and repaint

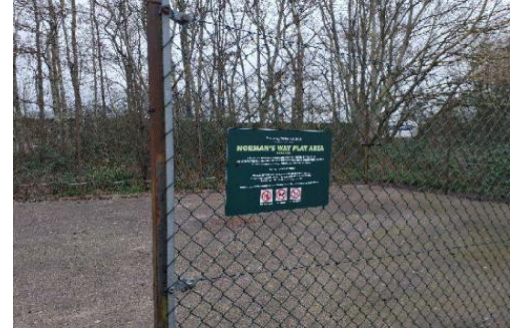
**Item:** Sign  
**Manufacturer:** Not Identified  
**Surface Type:** N/A  
**Item Quantity:** 1  
**Equipment Compliance:** N/A  
**Surface Area Compliance:** N/A

There are projecting bolt thread(s) present - Remove excess thread length and deburr or provide cap

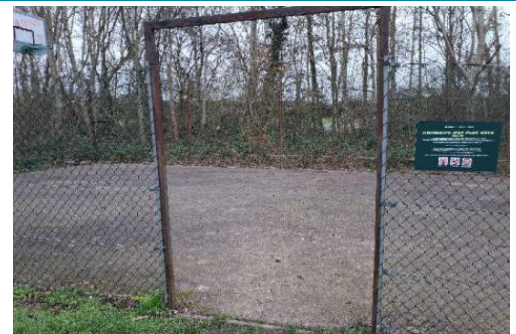
**Item:** Gate - Pedestrian  
**Manufacturer:** Not Identified  
**Surface Type:** Bitmac  
**Item Quantity:** 1  
**Equipment Compliance:** N/A  
**Surface Area Compliance:** N/A

The gate is missing from the site - Replace as required

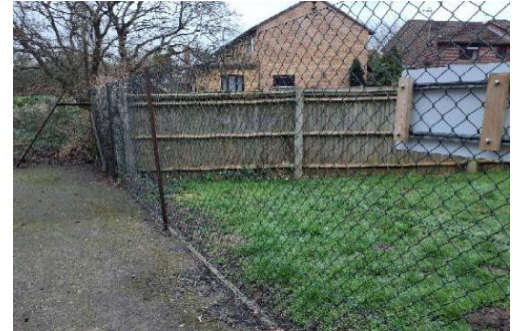
**Item:** Fence - Chainlink  
**Manufacturer:** Not Identified  
**Surface Type:** Bitmac  
**Item Quantity:** 1  
**Equipment Compliance:** N/A  
**Surface Area Compliance:** N/A

The paintwork on this item has been damaged or worn exposing the metal underneath which is rusting / corroding - Treat affected areas and repaint

The fence is severely damaged in places - Repair or replace all affected sections

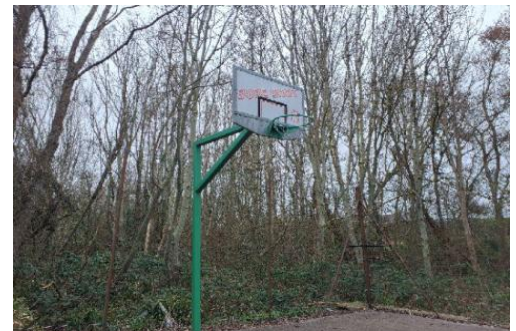
**Item:** Basketball Goal  
**Manufacturer:** Sure Shot  
**Surface Type:** Bitmac  
**Item Quantity:** 1  
**Equipment Compliance:** Yes  
**Surface Area Compliance:** N/A

There is some tree debris on the surfacing - Remove and maintain

There is moderate damage to the surface - Repair the damaged areas of surfacing

There is algae, silt or moss growth on the surface resulting in slippery conditions - Clean and treat appropriately

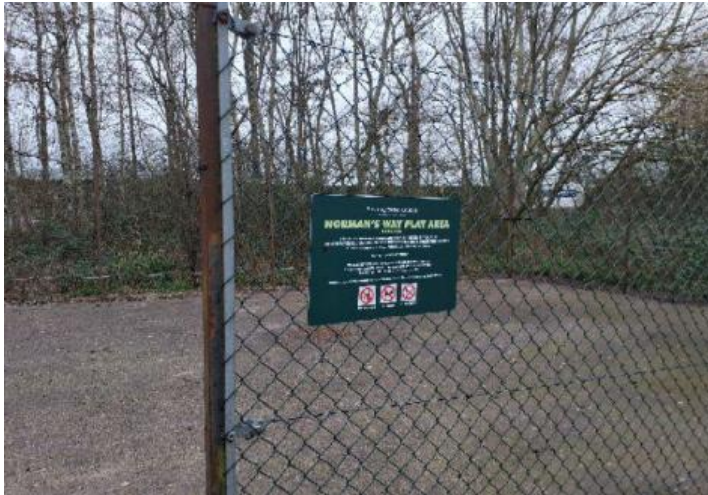
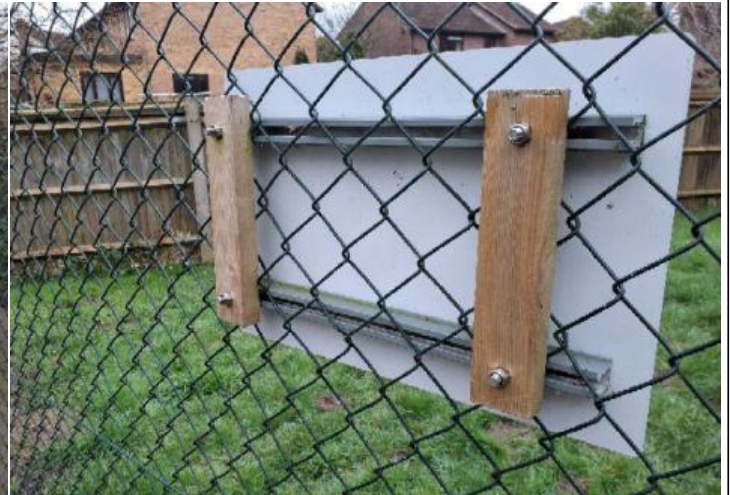
**Item:** Ancillary Items - Sign  
**Manufacturer:** Not Identified

**Finding:** There are projecting bolt thread(s) present

**Action:** Remove excess thread length and deburr or provide cap

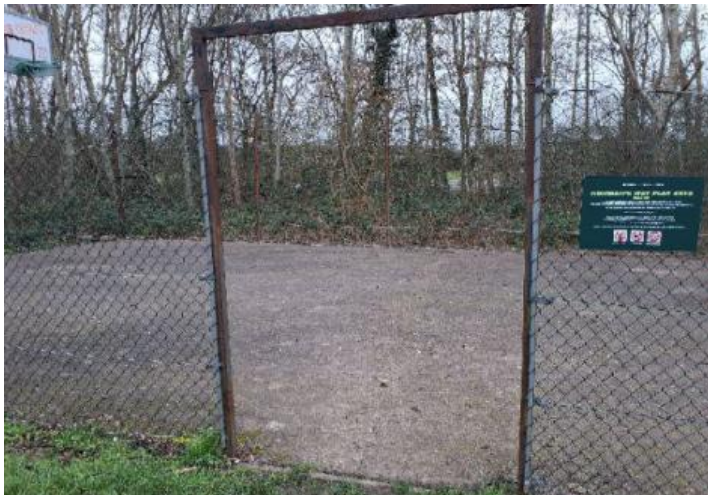
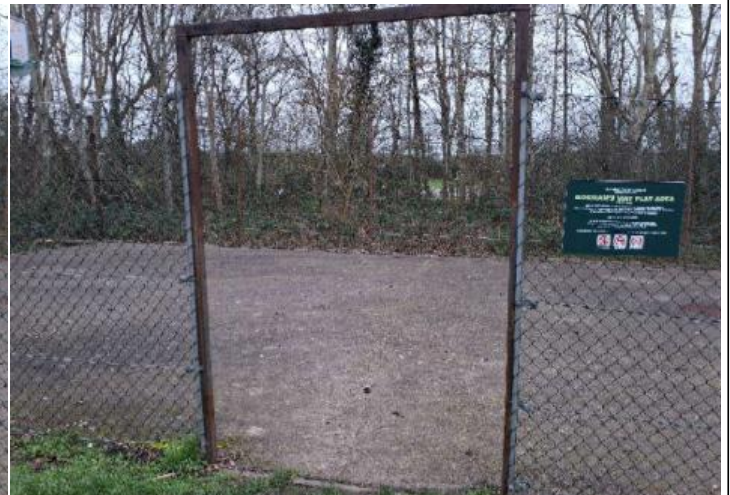
**Item:** Gates - Gate - Pedestrian  
**Manufacturer:** Not Identified

**Finding:** The gate is missing from the site

**Action:** Replace as required

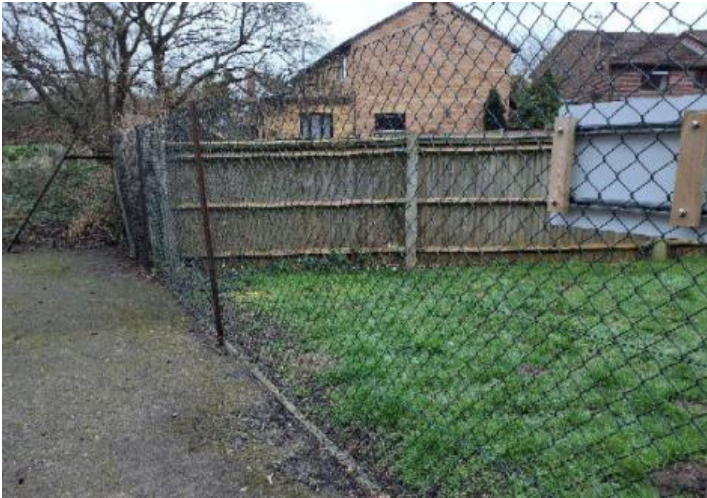
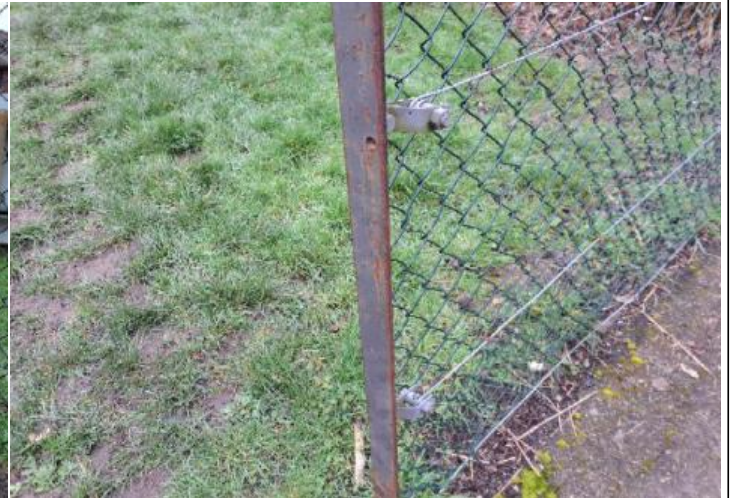
**Item:** Fences - Fence - Chainlink  
**Manufacturer:** Not Identified

**Finding:** The paintwork on this item has been damaged or worn exposing the metal underneath which is rusting / corroding

**Action:** Treat affected areas and repaint

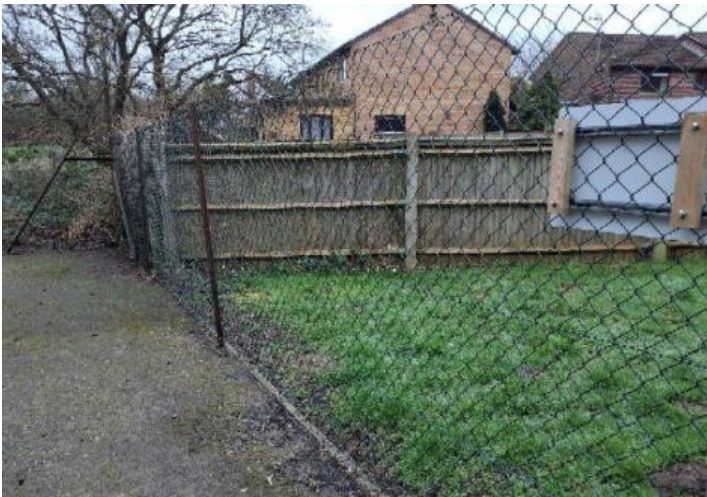
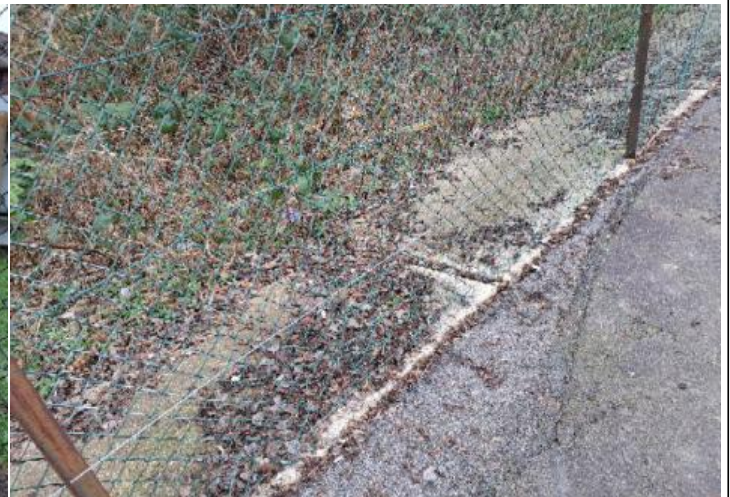
**Item:** Fences - Fence - Chainlink  
**Manufacturer:** Not Identified

**Finding:** The fence is severely damaged in places

**Action:** Repair or replace all affected sections

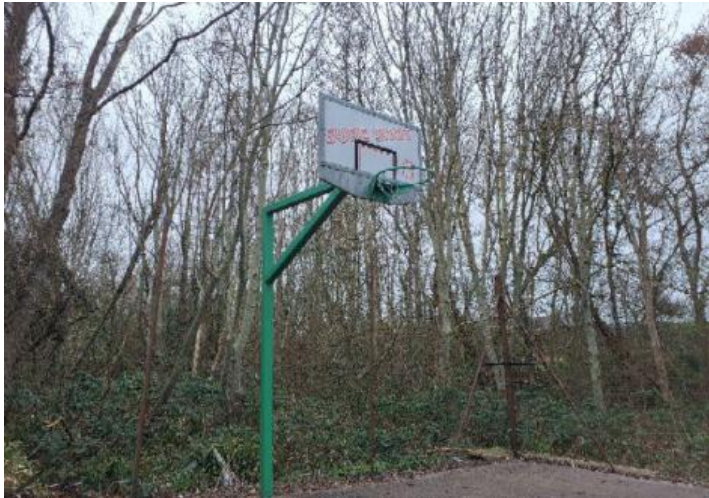
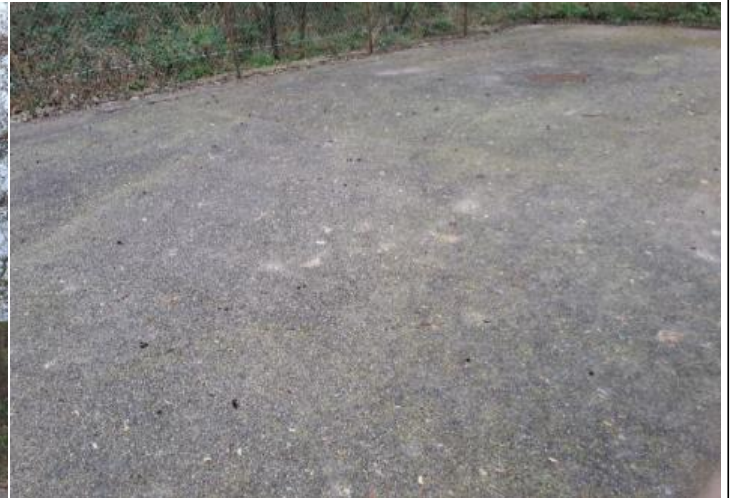
**Item:** Multi Use Games Area - Basketball Goal  
**Manufacturer:** Sure Shot

**Finding:** There is some tree debris on the surfacing

**Action:** Remove and maintain
