## COMMUNITY COMMITTEE MEETING HELD ON TUESDAY 3<sup>rd</sup> MARCH 2026 AT 7.30 PM AT THE STEYPING CENTRE

# DRAFT MINUTES

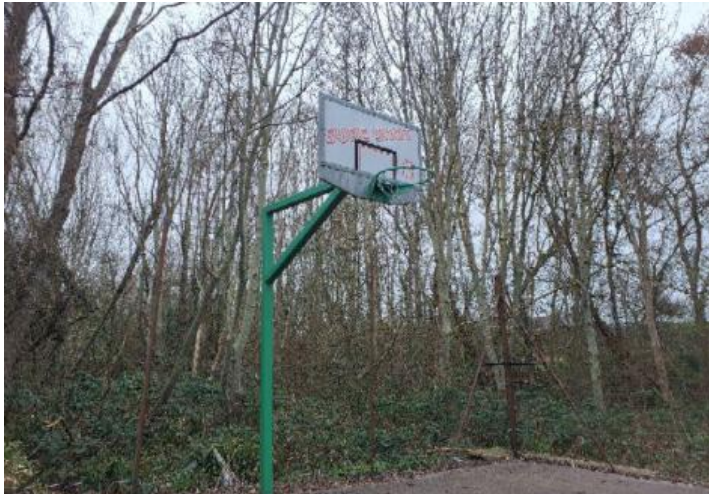
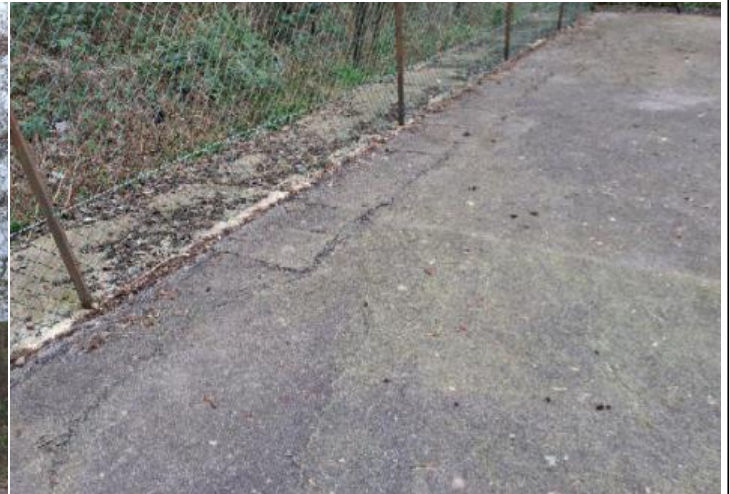
**Item:** Multi Use Games Area - Basketball Goal  
**Manufacturer:** Sure Shot

**Finding:** There is moderate damage to the surface

**Action:** Repair the damaged areas of surfacing

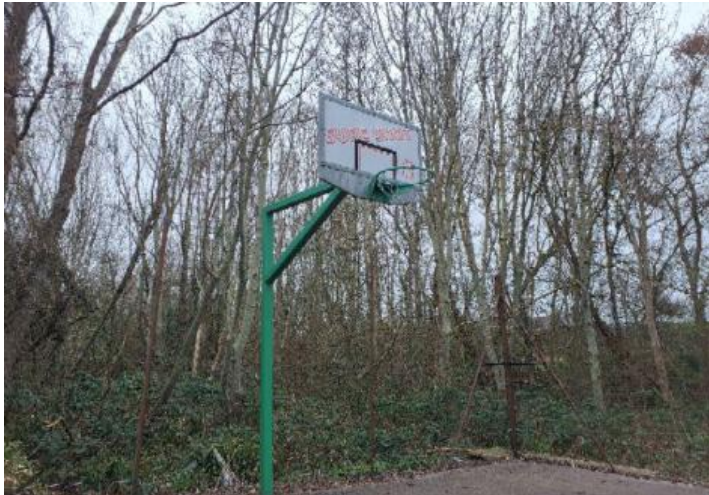
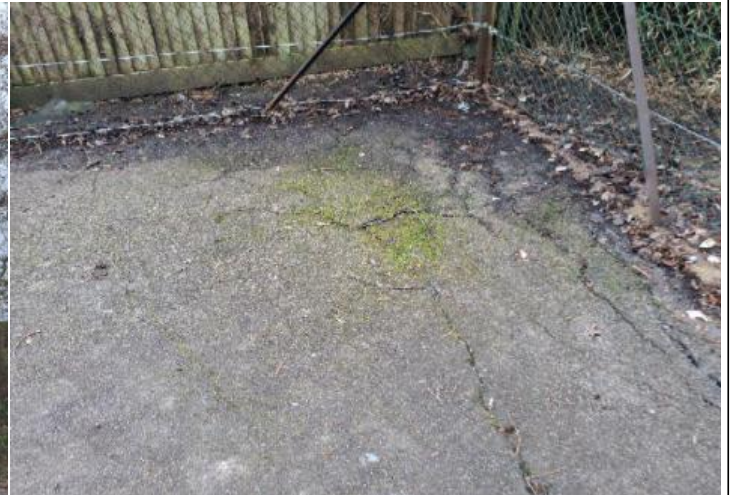
**Item:** Multi Use Games Area - Basketball Goal  
**Manufacturer:** Sure Shot

**Finding:** There is algae, silt or moss growth on the surface resulting in slippery conditions

**Action:** Clean and treat appropriately

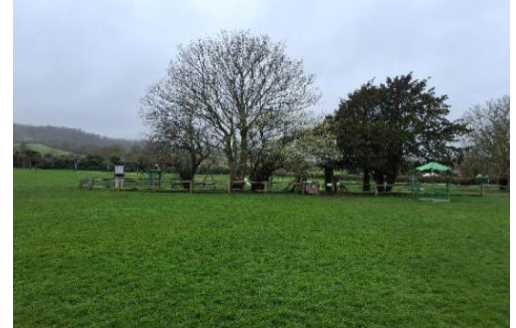
**Item:** Site General  
**Manufacturer:** Owner/Operator  
**Surface Type:** N/A  
**Item Quantity:** 1  
**Equipment Compliance:** N/A  
**Surface Area Compliance:** N/A

There is algae, silt or moss growth on the surface resulting in slippery conditions - Clean and treat appropriately

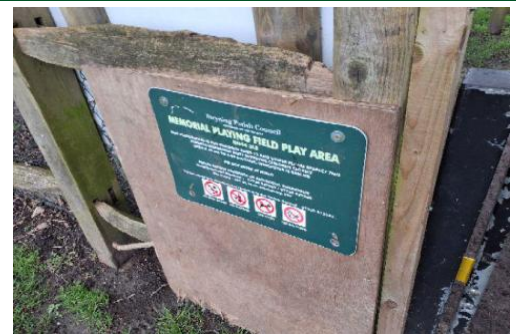
**Item:** Playground Sign  
**Manufacturer:** Not Identified  
**Surface Type:** N/A  
**Item Quantity:** 2  
**Equipment Compliance:** N/A  
**Surface Area Compliance:** N/A

The plywood has delaminated in some places - Remove all rough or splintered edges.

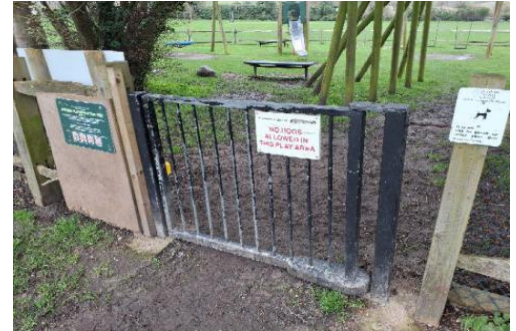
**Item:** Gate - Self Closing  
**Manufacturer:** I.A.E. Fencing  
**Surface Type:** Soil  
**Item Quantity:** 2  
**Equipment Compliance:** N/A  
**Surface Area Compliance:** N/A

The area around the item has eroded and may become slippery - Reinstate eroded area

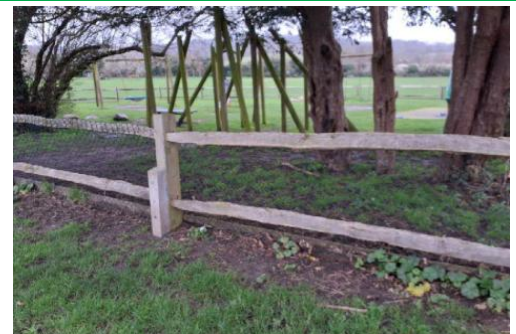
**Item:** Fence - Timber & Mesh Infill  
**Manufacturer:** Not Identified  
**Surface Type:** Grass  
**Item Quantity:** 1  
**Equipment Compliance:** N/A  
**Surface Area Compliance:** N/A

The fence is severely damaged in places - Repair or replace all affected sections

There is some evidence of rot in the timber - Monitor for any further deterioration and replace as required

There is some strimmer / machinery damage apparent on the posts, this can penetrate the preservative applied to the timber and accelerate the rotting process - Monitor for any deterioration (rot) and replace as required

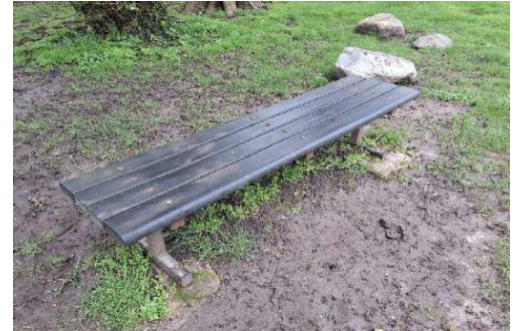
**Item:** Bench  
**Manufacturer:** Not Identified  
**Surface Type:** Grass  
**Item Quantity:** 2  
**Equipment Compliance:** N/A  
**Surface Area Compliance:** N/A

The area around the item has eroded and may become slippery - Reinstate eroded area

The paintwork on this item has been damaged or worn exposing the metal underneath which is rusting / corroding - Treat affected areas and repaint

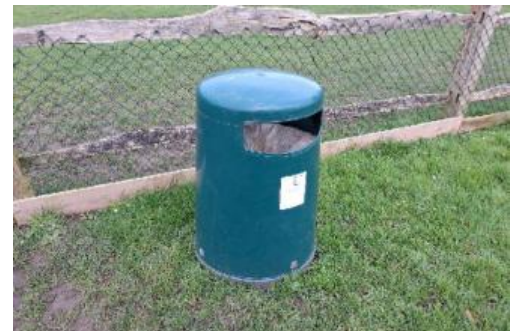
**Item:** Litter Bin  
**Manufacturer:** Glasdon  
**Surface Type:** Grass  
**Item Quantity:** 2  
**Equipment Compliance:** N/A  
**Surface Area Compliance:** N/A

This item is satisfactory - no work required -

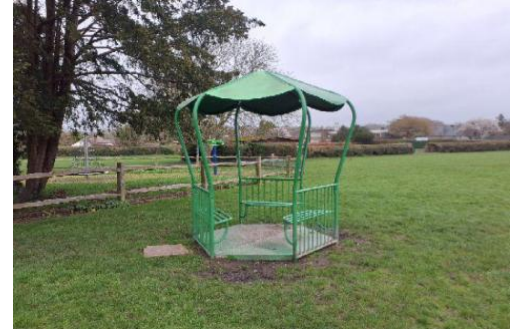
**Item:** Shelter  
**Manufacturer:** Wicksteed Playgrounds  
**Surface Type:** Grass  
**Item Quantity:** 1  
**Equipment Compliance:** N/A  
**Surface Area Compliance:** N/A

The area around the item has eroded and may become slippery - Reinstate eroded area

There is/are inserts missing - Replace missing inserts

There is surface corrosion / rust present on the item - Consider treating the item

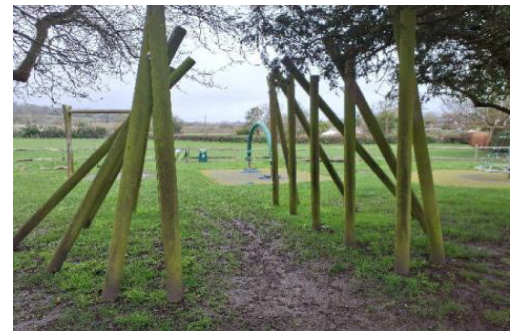
**Item:** Entrance Feature  
**Manufacturer:** Not Identified  
**Surface Type:** Grass  
**Item Quantity:** 1  
**Equipment Compliance:** N/A  
**Surface Area Compliance:** N/A

There is some strimmer / machinery damage apparent on the posts, this can penetrate the preservative applied to the timber and accelerate the rotting process - Monitor for any deterioration (rot) and replace as required

The timber has a number of splits/shakes or air cracks and this may affect the stability or allow water ingress which will accelerate the rotting process. Timber splits may also create rough / splintering edges. - Monitor, sand down any rough edges and ensure the splits do not cross through fixing points of the structure and/or cause any instability

There is some evidence of rot in the timber - Monitor for any further deterioration and replace as required

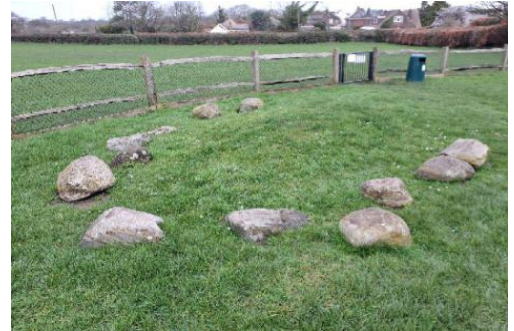
**Item:** Boulders  
**Manufacturer:** Natural Feature  
**Surface Type:** Grass  
**Item Quantity:** 1  
**Equipment Compliance:** N/A  
**Surface Area Compliance:** N/A

The boulder/s is / are unsecured and are small / light enough to be moved around the area or topple - Secure boulder/s in position

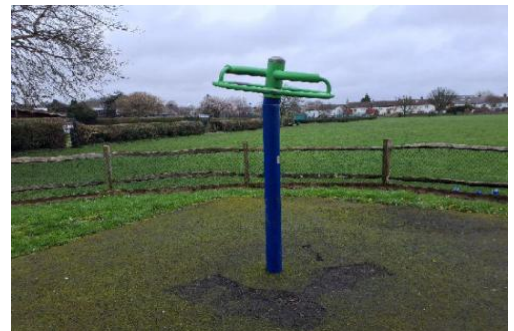
**Item:** Overhead Rotator  
**Manufacturer:** Wicksteed Playgrounds  
**Surface Type:** Wet Pour  
**Item Quantity:** 1  
**Equipment Compliance:** Yes  
**Surface Area Compliance:** Yes

There is moderate damage to the surface - Repair the damaged areas of surfacing

The paintwork on this item has been damaged or worn exposing the metal underneath which is rusting / corroding - Treat affected areas and repaint

There are significant gaps (over 30mm) between the surface and the edging or between the joints in the surface; these are large enough for a small foot to enter - Repair surfacing

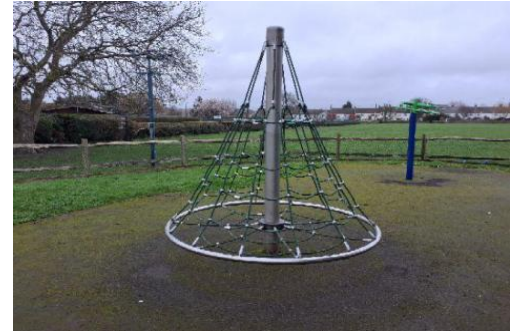
**Item:** Rotating Net  
**Manufacturer:** Wicksteed Playgrounds  
**Surface Type:** Wet Pour  
**Item Quantity:** 1  
**Equipment Compliance:** No  
**Surface Area Compliance:** Yes

The clearance to the underside is less than 400mm and fails the requirements of BS EN 1176 Part 5 - Monitor - No action given the risk assessment

The ropes on this item have been taped and we are unable to fully assess the condition of the rope, ensure no wire strands are broken beneath the tape - Repair or replace as required

There is some minor damage to the surface - Monitor for any further deterioration and repair as required

The surface has subsided in some areas - Monitor for any further deterioration and repair as required

The ropes/nets are worn/damaged in places - Monitor for any further deterioration and repair or replace as required

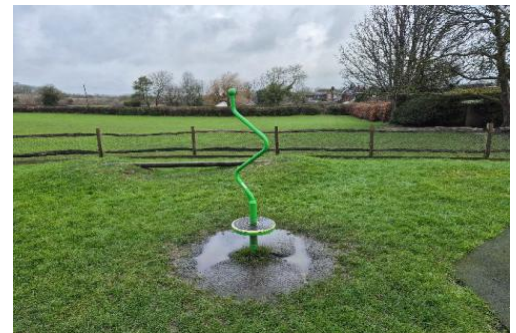
**Item:** Spinning Pole  
**Manufacturer:** Wicksteed Playgrounds  
**Surface Type:** Grass Matrix Tiles  
**Item Quantity:** 1  
**Equipment Compliance:** Yes  
**Surface Area Compliance:** No

The paintwork on this item has been damaged or worn exposing the metal underneath which is rusting / corroding - Treat affected areas and repaint

The surface has subsided in some areas - Repair all damaged areas

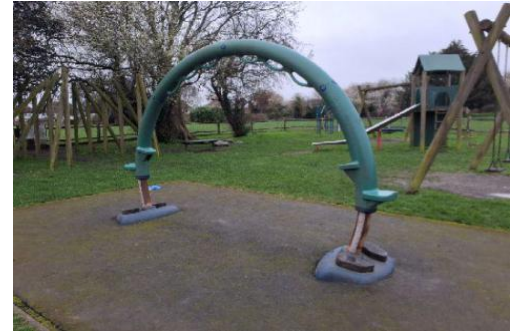
**Item:** Rock n Cross  
**Manufacturer:** Big Toys  
**Surface Type:** Wet Pour  
**Item Quantity:** 1  
**Equipment Compliance:** Yes  
**Surface Area Compliance:** Yes

The paintwork on this item has been damaged or worn exposing the metal underneath which is rusting / corroding - Treat affected areas and repaint

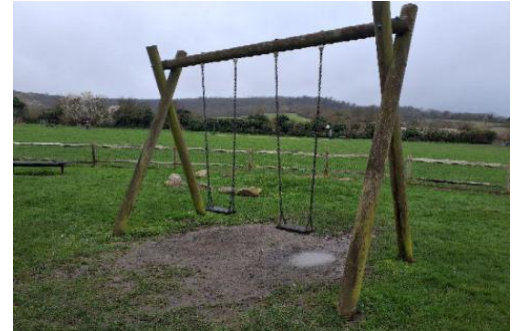
**Item:** 1 Bay 2 Seat (Flat)  
**Manufacturer:** Not Identified  
**Surface Type:** Grass Matrix Tiles  
**Item Quantity:** 1  
**Equipment Compliance:** No  
**Surface Area Compliance:** Yes

There is some notable evidence of chain wear - Monitor for any further deterioration and replace when 40% worn

The seat has minor damage or wear - Monitor for any further deterioration and replace as required

Hard fixing pins have been installed in the grass mat tiles within the impact area of the equipment. Grass mat pins should only be installed at the perimeter of the tiles, and outside of any equipment impact areas. NOTE - where grass mat wear pads have been provided and the impact area includes surrounding surfaces, the grass mats should be tucked into the turf, and not pinned - Remove pins from impact areas

The surface has subsided in some areas - Monitor for any further deterioration and repair as required

The chain openings are in excess of the 8.6mm as recommended by BS EN 1176 - Monitor - No action given the risk assessment

This design of swing joint has been known to fail on the weld connecting the joint to the threaded stud - We would recommend that the joint be dismantled and checked on a regular basis or consulting with manufacturer on whether a Secondary Safety Device can be fitted

There is some evidence of rot in the timber - Monitor for any further deterioration and replace as required

There is moderate damage to the surface - Repair the damaged areas of surfacing

There is some strimmer / machinery damage apparent on the posts, this can penetrate the preservative applied to the timber and accelerate the rotting process - Monitor for any deterioration (rot) and replace as required

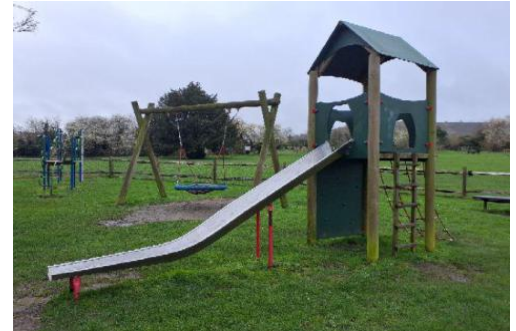
**Item:** Multi Play (Junior)  
**Manufacturer:** Not Identified  
**Surface Type:** Grass Matrix Tiles  
**Item Quantity:** 1  
**Equipment Compliance:** No  
**Surface Area Compliance:** Yes

The paintwork on this item has been damaged or worn exposing the metal underneath which is rusting / corroding - Treat affected areas and repaint

There is some strimmer / machinery damage apparent on the posts, this can penetrate the preservative applied to the timber and accelerate the rotting process - Monitor for any deterioration (rot) and replace as required

There is some evidence of rot in the timber - Monitor for any further deterioration and replace as required

There is/are finger entrapment/s in the frame and the item fails to meet the requirements of BS EN 1176 Part 1 4.2.7.6 Entrapment of fingers - Monitor - No action given the risk assessment

There are a number of dents in the slide surface - Monitor for any further deterioration and repair as required

The timber has a number of splits/shakes or air cracks and this may affect the stability or allow water ingress which will accelerate the rotting process. Timber splits may also create rough / splintering edges. - Monitor, sand down any rough edges and ensure the splits do not cross through fixing points of the structure and/or cause any instability

The fixings have corroded excessively - Replace all corroded fixings

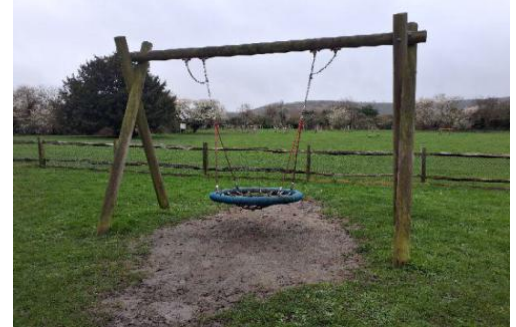
**Item:** Basket Swing - Type 1  
**Manufacturer:** Not Identified  
**Surface Type:** Grass Matrix Tiles  
**Item Quantity:** 1  
**Equipment Compliance:** Yes  
**Surface Area Compliance:** Yes

Hard fixing pins have been installed in the grass mat tiles within the impact area of the equipment. Grass mat pins should only be installed at the perimeter of the tiles, and outside of any equipment impact areas. NOTE - where grass mat wear pads have been provided and the impact area includes surrounding surfaces, the grass mats should be tucked into the turf, and not pinned - Remove pins from impact areas

There is some evidence of rot in the timber - Monitor for any further deterioration and replace as required

There is some strimmer / machinery damage apparent on the posts, this can penetrate the preservative applied to the timber and accelerate the rotting process - Monitor for any deterioration (rot) and replace as required

A number of fixing(s) have worked loose - Secure all loose fixings

The seat has been turned over by users, twisting the chains; this will accelerate wear on the fixtures / connections - Release the chains and check for damage

A number of fixing(s) have worked loose on the crossbar - Secure all loose fixings

The ropes/nets are worn/damaged in places - Monitor for any further deterioration and repair or replace as required

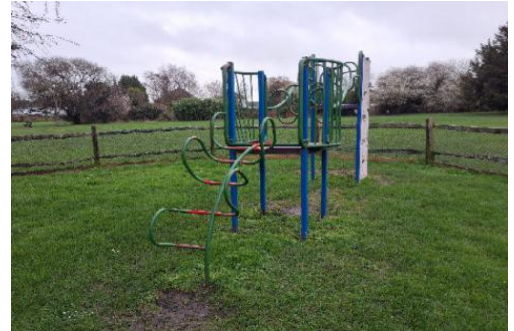
**Item:** Multi Play (Junior)  
**Manufacturer:** Wicksteed Playgrounds  
**Surface Type:** Grass Matrix Tiles  
**Item Quantity:** 1  
**Equipment Compliance:** No  
**Surface Area Compliance:** No

The paintwork on this item has been damaged or worn exposing the metal underneath which is rusting / corroding - Treat affected areas and repaint

A number of fixing(s) have worked loose - Secure all loose fixings

The item has been damaged - Monitor for any further deterioration and replace as required

Hard fixing pins have been installed in the grass mat tiles within the impact area of the equipment. Grass mat pins should only be installed at the perimeter of the tiles, and outside of any equipment impact areas. NOTE - where grass mat wear pads have been provided and the impact area includes surrounding surfaces, the grass mats should be tucked into the turf, and not pinned - Remove pins from impact areas

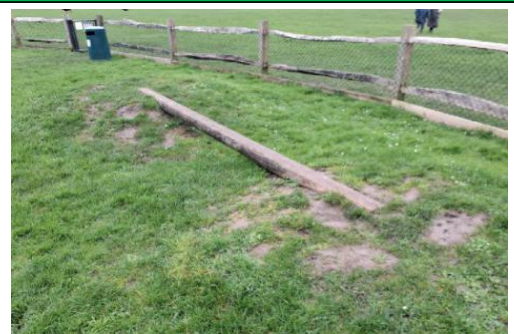
**Item:** Balance Beam  
**Manufacturer:** Not Identified  
**Surface Type:** Grass  
**Item Quantity:** 1  
**Equipment Compliance:** Yes  
**Surface Area Compliance:** Yes

There is some evidence of rot in the timber - Monitor for any further deterioration and replace as required

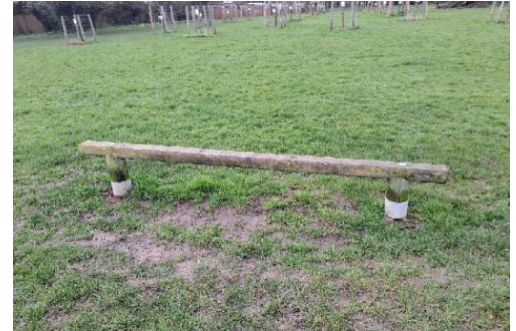
**Item:** Balance Beam  
**Manufacturer:** Wicksteed Playgrounds  
**Surface Type:** Grass  
**Item Quantity:** 1  
**Equipment Compliance:** Yes  
**Surface Area Compliance:** Yes

There is algae or moss on the surface of the equipment - Clean and treat appropriately

There are post protectors around the timber posts that are preventing the inspector from thoroughly testing for signs of decay and we are unable to verify the condition of the posts in these locations. NOTE - timber rot / decay is possible even with the post protectors in place - Refer to manufacturer inspection / maintenance recommendations

There is some evidence of rot in the timber - Monitor for any further deterioration and replace as required

The surface has eroded and the foundations are exposed - Reinstate surrounding surfaces to cover the foundations

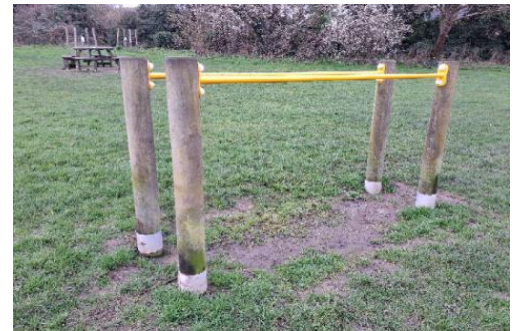
**Item:** Parallel Bars  
**Manufacturer:** Fawns Recreational Services Ltd  
**Surface Type:** Grass Matrix Tiles  
**Item Quantity:** 1  
**Equipment Compliance:** Yes  
**Surface Area Compliance:** Yes

There are post protectors around the timber posts that are preventing the inspector from thoroughly testing for signs of decay and we are unable to verify the condition of the posts in these locations. NOTE - timber rot / decay is possible even with the post protectors in place - Refer to manufacturer inspection / maintenance recommendations

There are areas or parts of the timber on the structure that have rotted - Replace all affected timbers

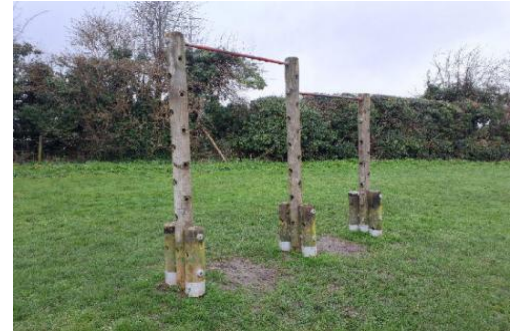
**Item:** Somersault Bars  
**Manufacturer:** Wicksteed Playgrounds  
**Surface Type:** Grass  
**Item Quantity:** 1  
**Equipment Compliance:** Yes  
**Surface Area Compliance:** Yes

There are post protectors around the timber posts that are preventing the inspector from thoroughly testing for signs of decay and we are unable to verify the condition of the posts in these locations. NOTE - timber rot / decay is possible even with the post protectors in place - Refer to manufacturer inspection / maintenance recommendations

There are areas or parts of the timber on the structure that have rotted and the remaining timber is showing signs of rot - Replace all rotted timbers

The paintwork on this item has been damaged or worn exposing the metal underneath which is rusting / corroding - Treat affected areas and repaint

There is some strimmer / machinery damage apparent on the posts, this can penetrate the preservative applied to the timber and accelerate the rotting process - Monitor for any deterioration (rot) and replace as required

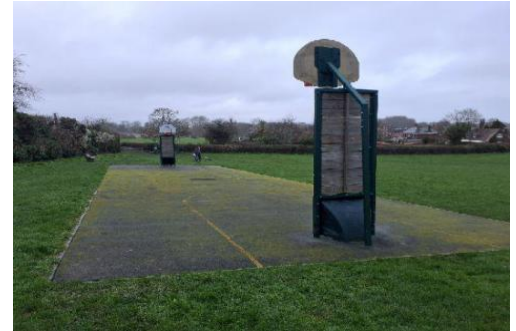
**Item:** Multi Use Games Area (MUGA)  
**Manufacturer:** Agorespace  
**Surface Type:** Wet Pour  
**Item Quantity:** 1  
**Equipment Compliance:** No  
**Surface Area Compliance:** N/A

A clearly visible facility sign should be provided in a prominent position with the wording as detailed BS EN 15312- the equipment is not intended for children less than 3 years old- the warning - Do not climb on the framework or nets- the warning - Do not hang on the ring (if provided)- the warning - Do not wear rings or other jewellery- name and telephone number of the administrator- number to call in case of accident - Provide signage to BS EN 15312

The item is loose in its foundations - Reinstall item to secure

There is some evidence of fire damage to the surfacing - Repair all damaged areas

There is / are post or end caps missing / damaged on the item - Replace missing / damaged post or end caps

There is/are finger entrapments in the frame due to missing inserts and the item fails to meet the requirements of BS EN 15312 Clause 4.4.2.2 Entrapment of fingers - Replace all missing inserts

There is or are fixings missing on the item - Replace all missing fixings

There are trip hazards at the edges of the surface - Remove trip hazard

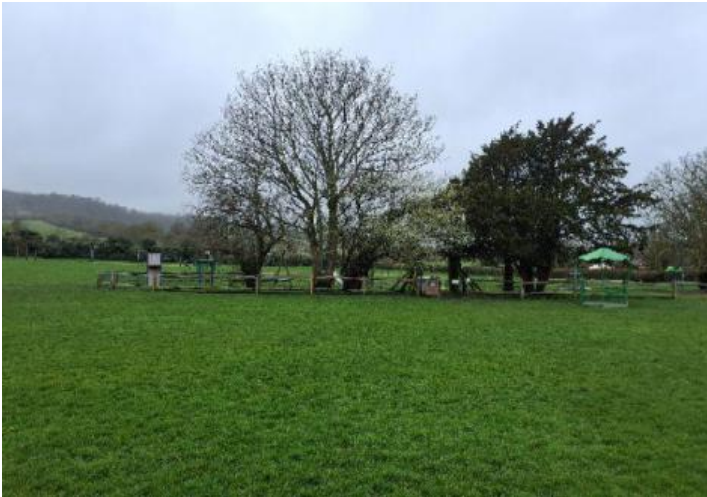
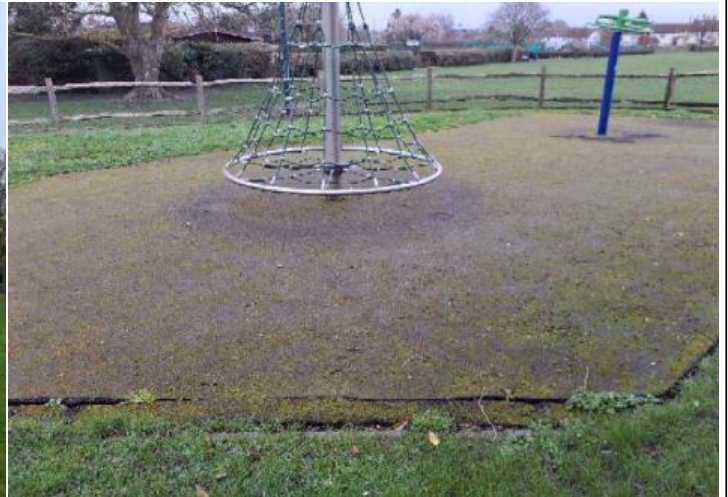
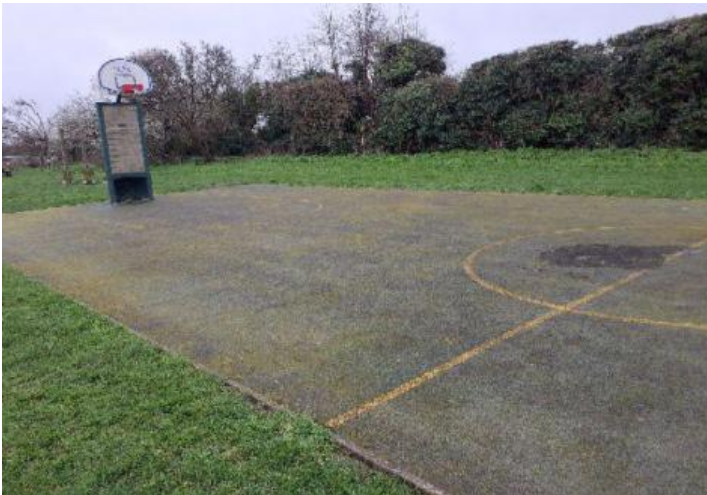
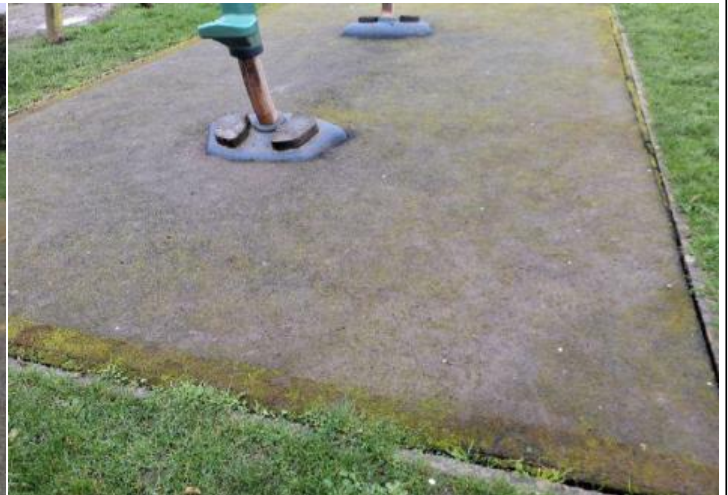
**Finding:** There is algae, silt or moss growth on the surface resulting in slippery conditions  
**Action:** Clean and treat appropriately

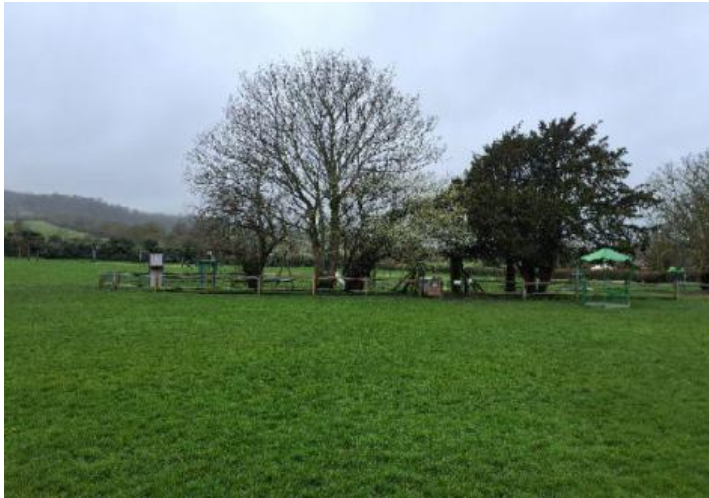
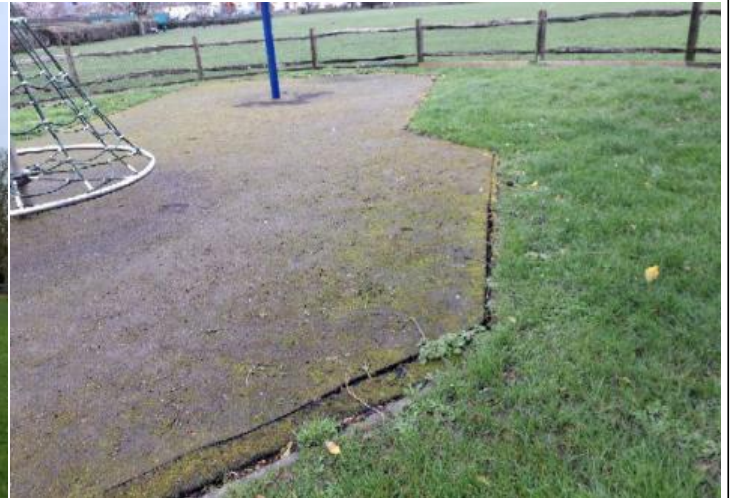
**Finding:** There is some tree debris on the surfacing

**Action:** Remove and maintain

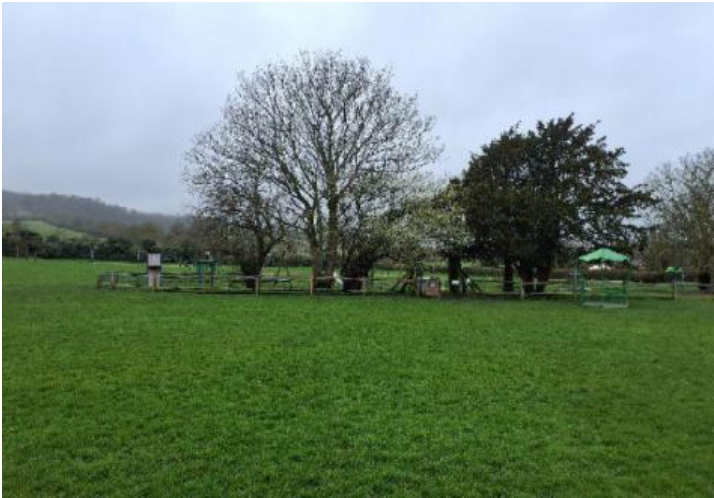
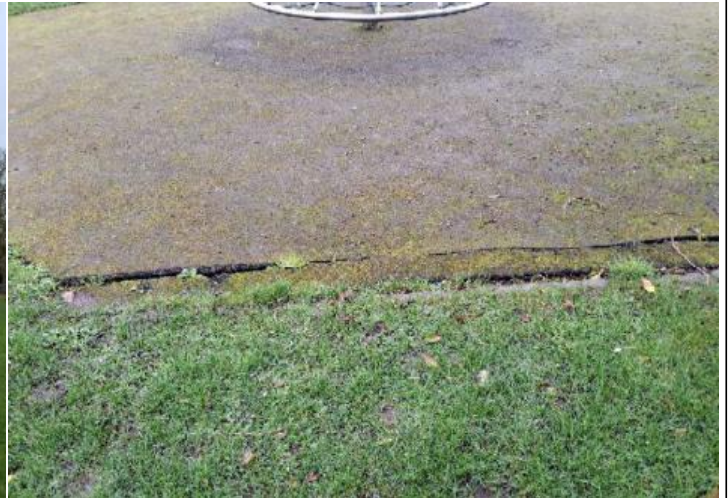
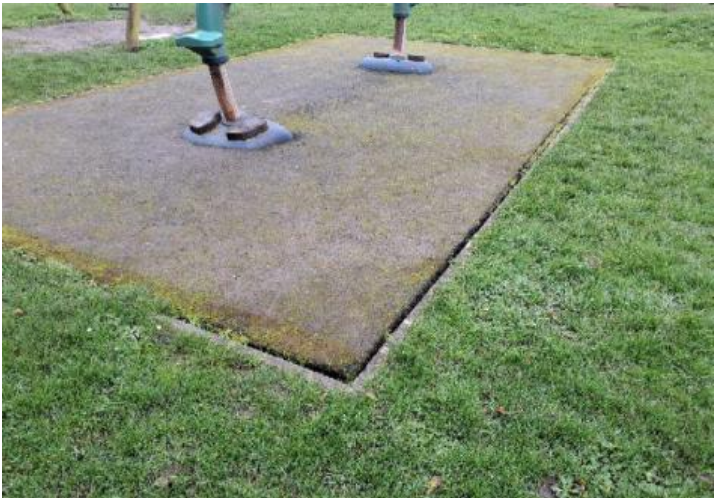
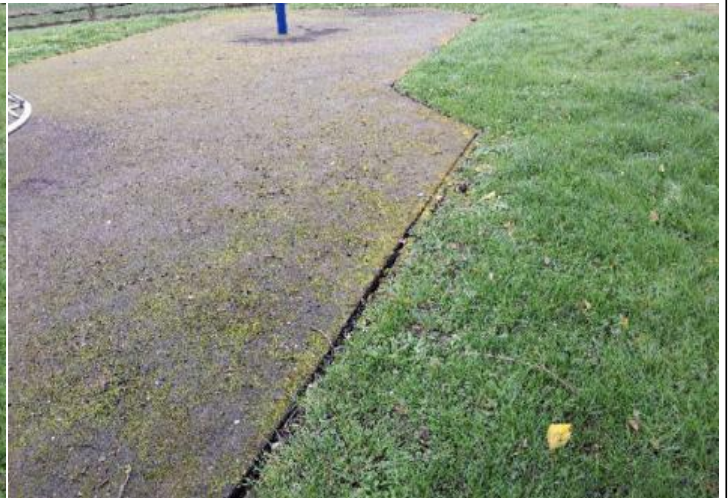
**Finding:** The surface is lifting at the edges and creating trip points **Action:** Repair perimeter of surfacing to remove trip points

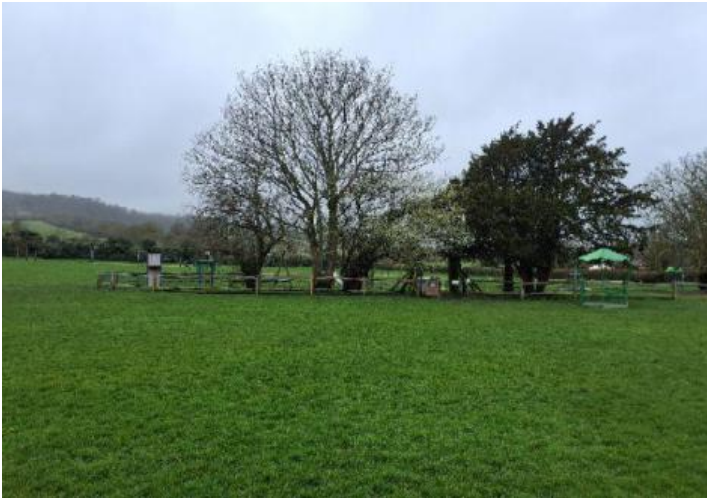
**Finding:** The safety surface around the area is beginning to wear  
**Action:** Monitor for any further deterioration and repair as required

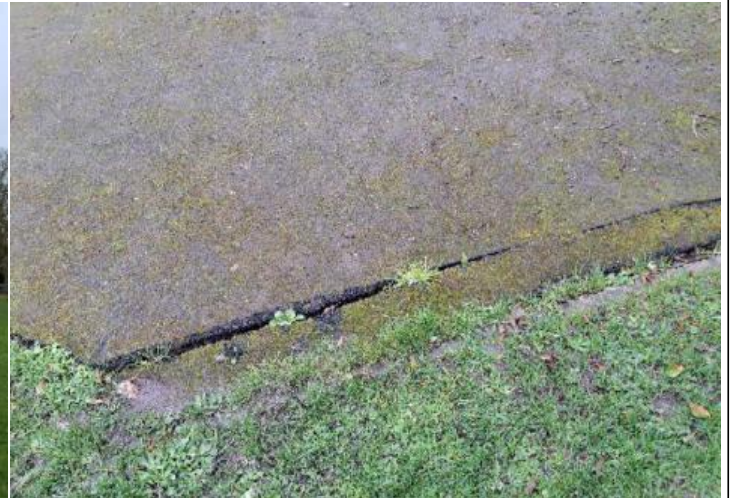
**Finding:** There is weed / vegetation growth within the surface

**Action:** Remove weed / vegetation growth

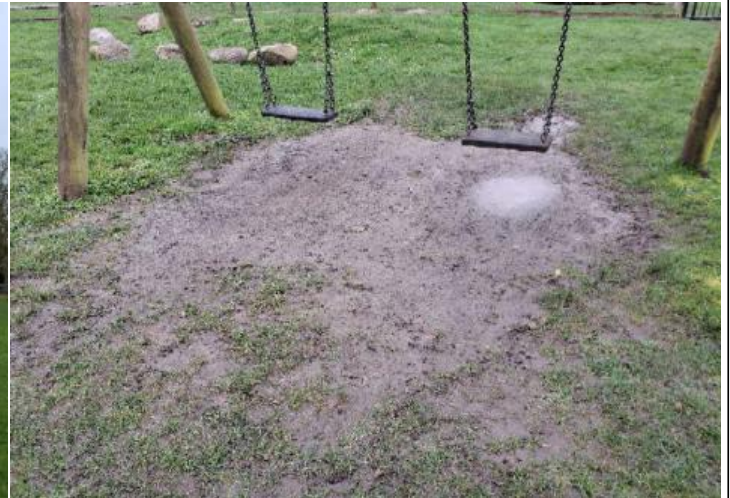
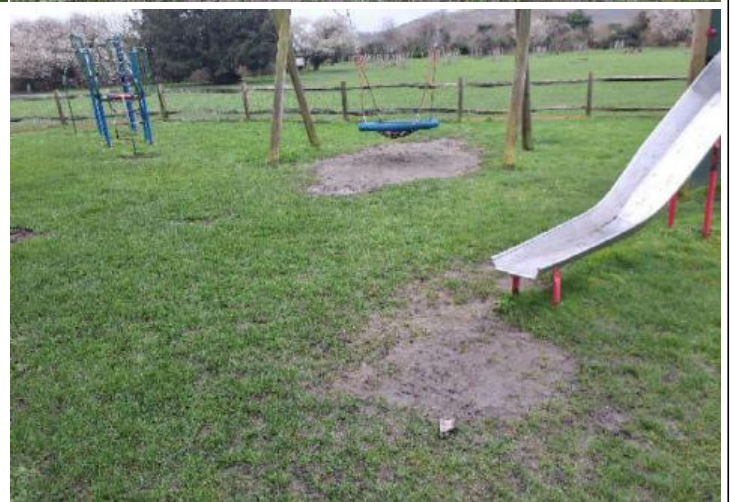
**Finding:** The grass mats are silted up and the soil is compacted; this may have an effect on the impact absorbing properties of the surface. Consideration should be given to HIC testing the surface to verify impact attenuating properties ( <https://playinspections.co.uk/inspection-services/safety-surface-testing/> )

**Action:** Contact our office for a quotation for this service

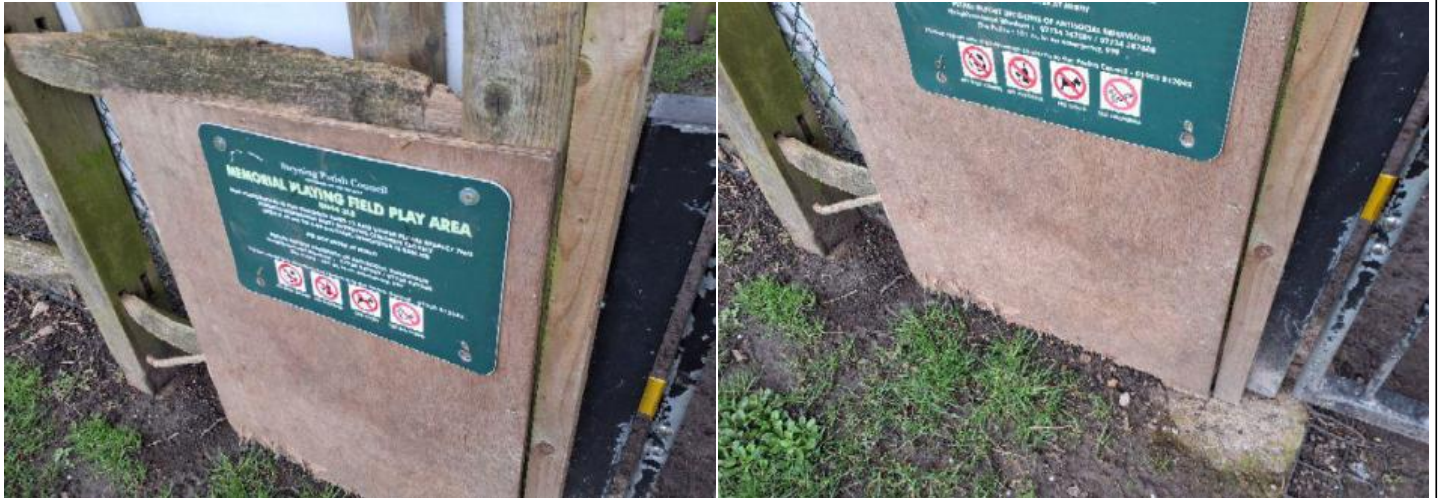
**Item:** Signs - Playground Sign  
**Manufacturer:** Not Identified

**Finding:** The plywood has delaminated in some places

**Action:** Remove all rough or splintered edges.

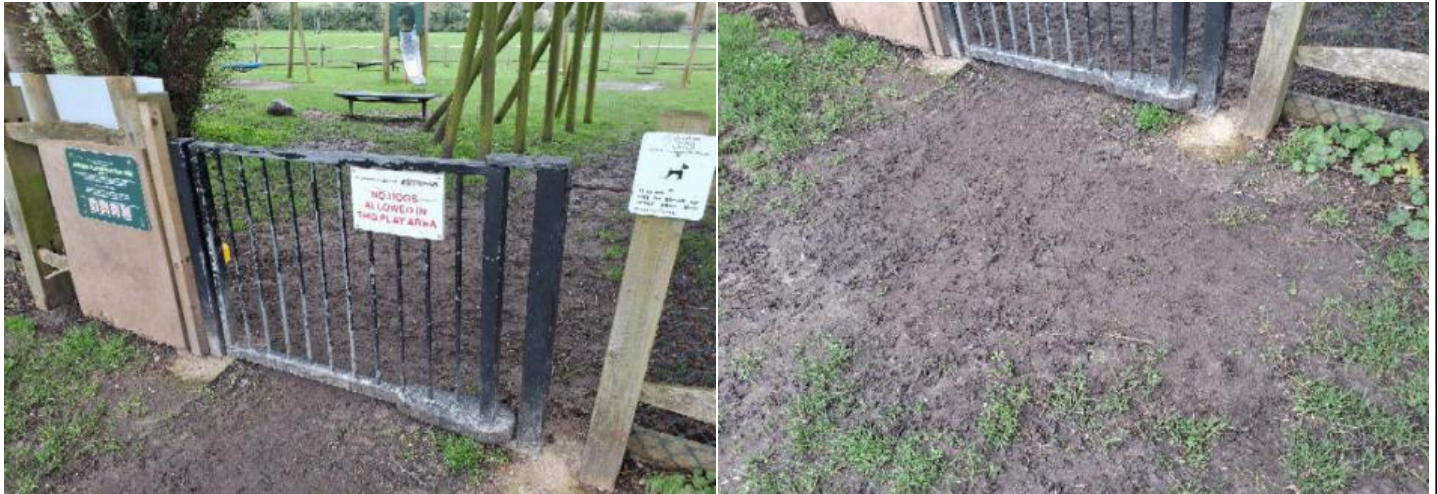
**Item:** Gates - Gate - Self Closing  
**Manufacturer:** I.A.E. Fencing

**Finding:** The area around the item has eroded and may become slippery

**Action:** Reinstate eroded area

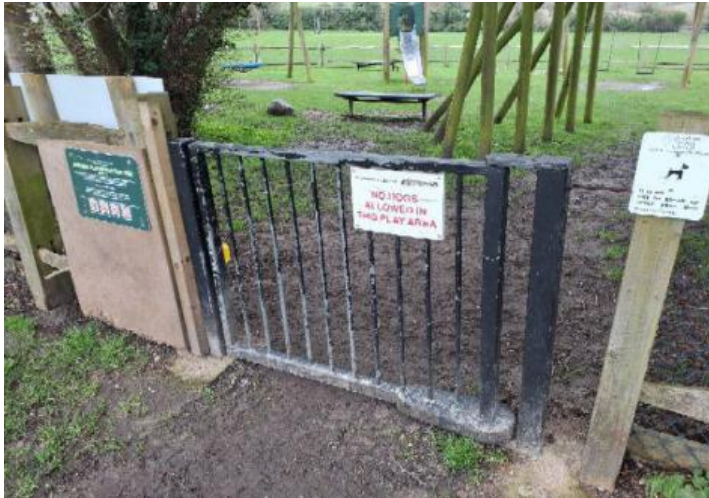
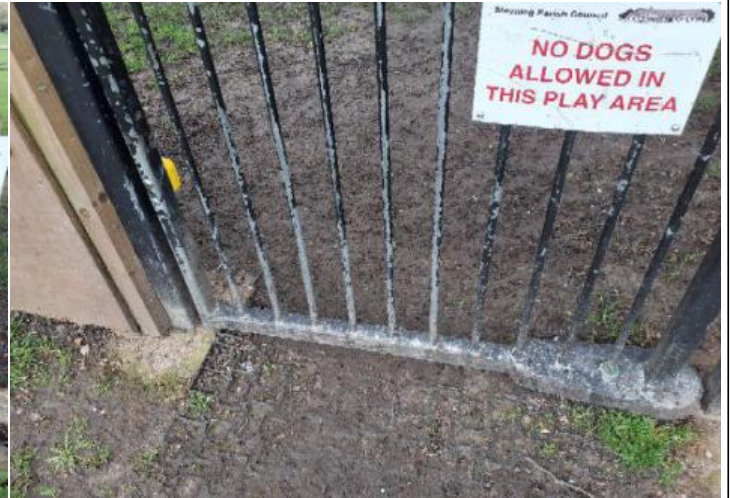
**Item:** Gates - Gate - Self Closing  
**Manufacturer:** I.A.E. Fencing

**Finding:** The paint is flaking off the metalwork

**Action:** Rub down and re-paint

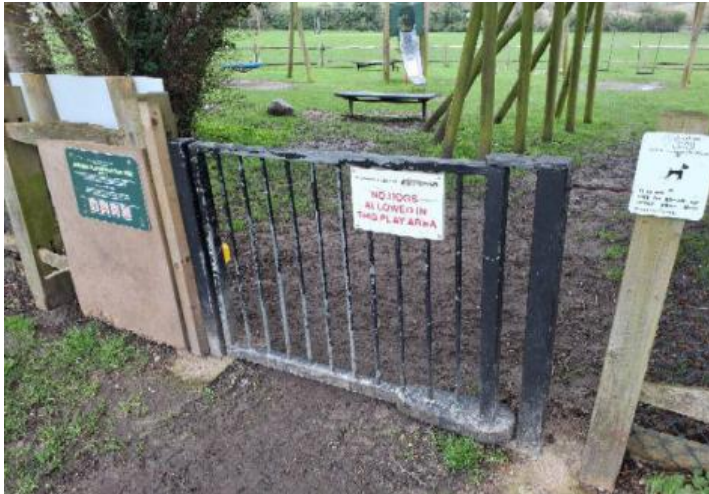
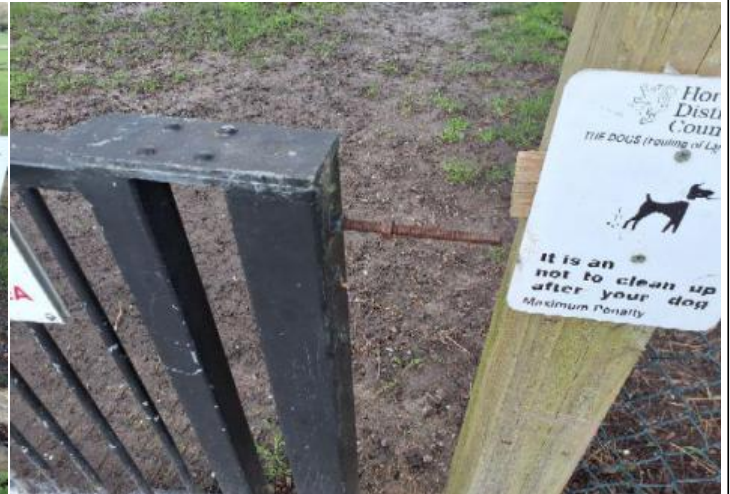
**Item:** Gates - Gate - Self Closing  
**Manufacturer:** I.A.E. Fencing

**Finding:** There are projecting bolt thread(s) present

**Action:** Remove excess thread length and deburr or provide cap

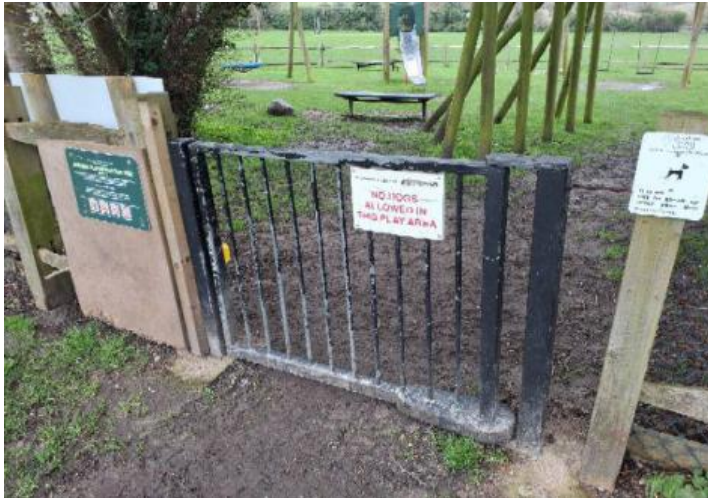
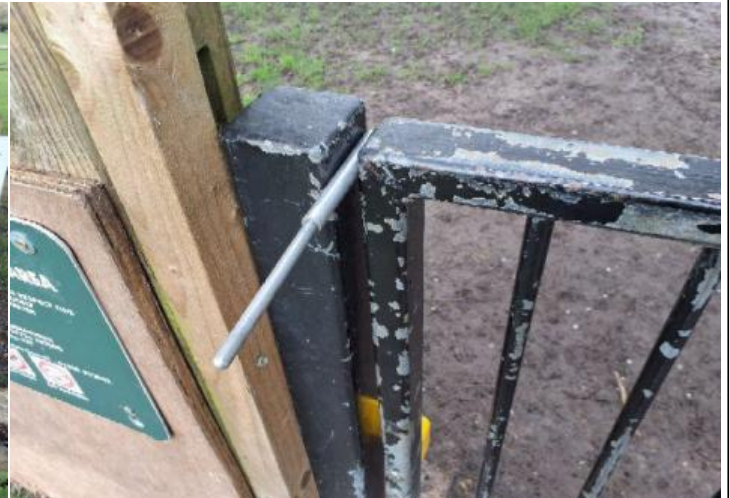
**Item:** Gates - Gate - Self Closing  
**Manufacturer:** I.A.E. Fencing

**Finding:** There are openings that are less than 12mm that could trap or crush fingers

**Action:** Provide a 12mm gap throughout full range of motion at both sides of gate

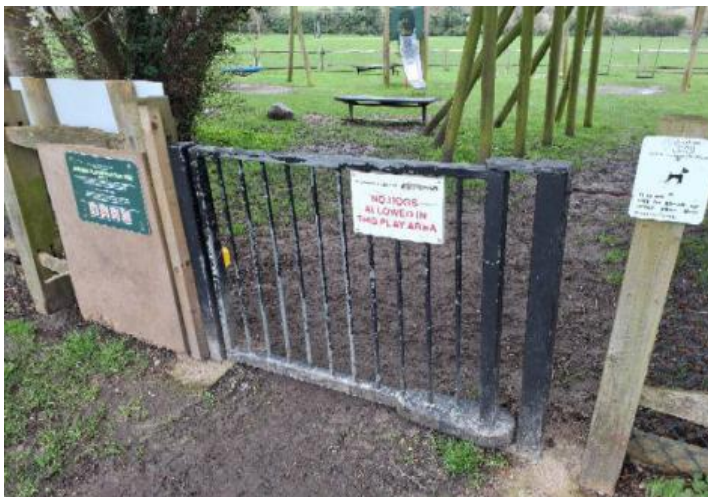
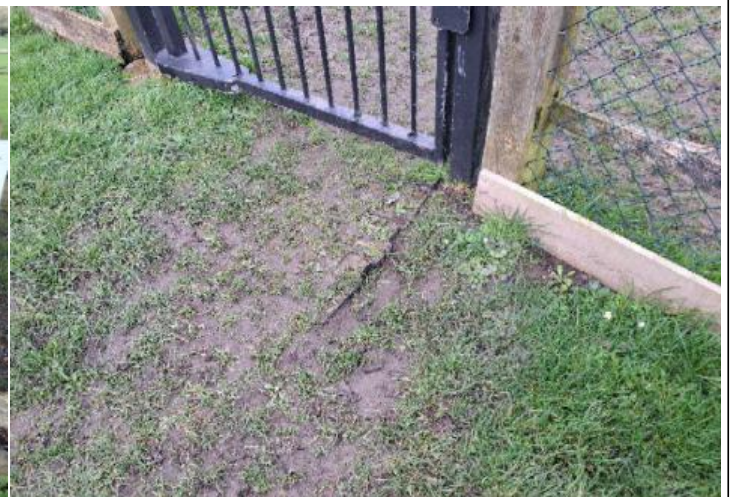
**Item:** Gates - Gate - Self Closing  
**Manufacturer:** I.A.E. Fencing

**Finding:** There are trip hazards at the edges of the surface

**Action:** Remove trip hazard

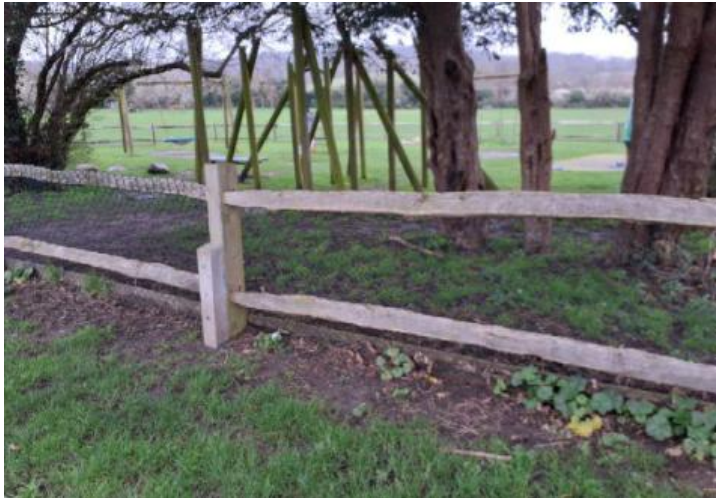
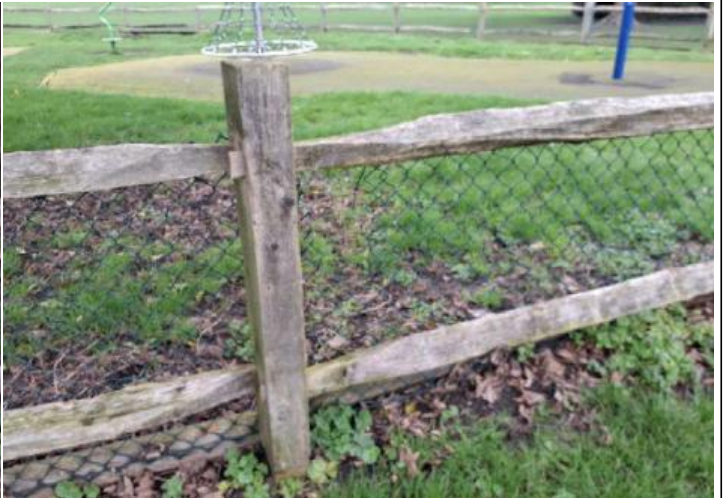
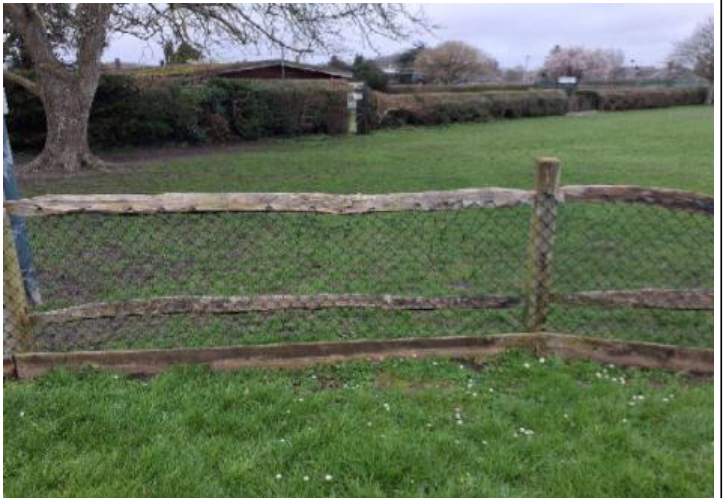
**Item:** Fences - Fence - Timber & Mesh Infill  
**Manufacturer:** Not Identified

**Finding:** The fence is severely damaged in places

**Action:** Repair or replace all affected sections

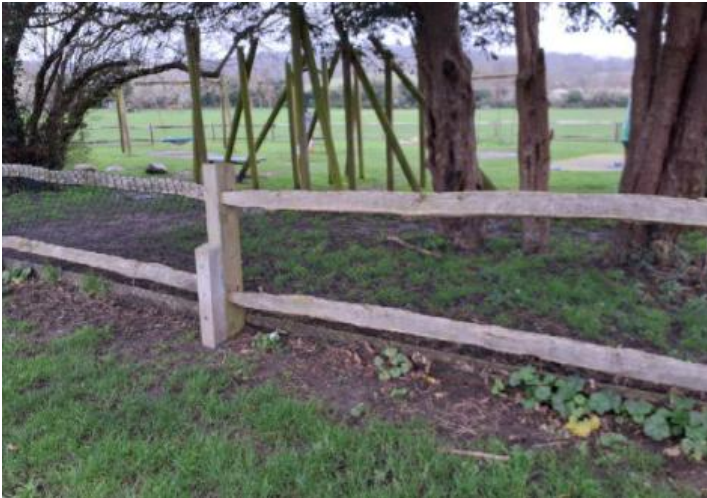
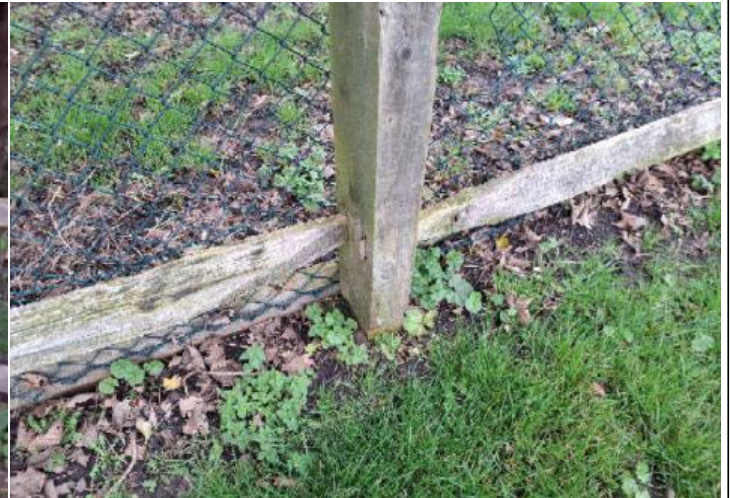
**Item:** Fences - Fence - Timber & Mesh Infill  
**Manufacturer:** Not Identified

**Finding:** There is some strimmer / machinery damage apparent on the posts, this can penetrate the preservative applied to the timber and accelerate the rotting process

**Action:** Monitor for any deterioration (rot) and replace as required

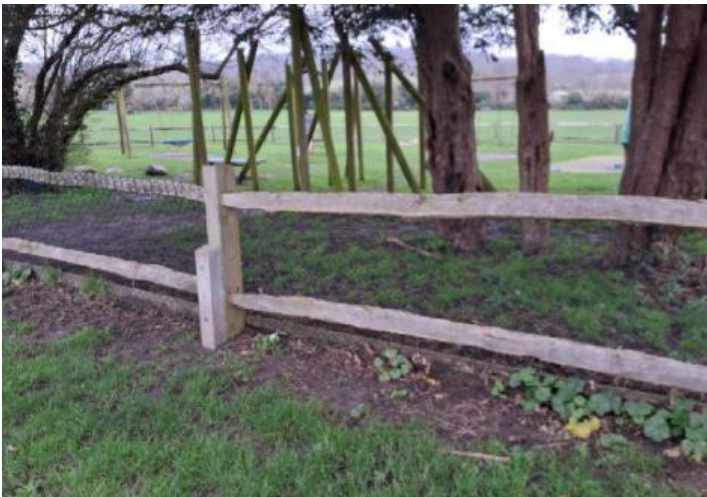
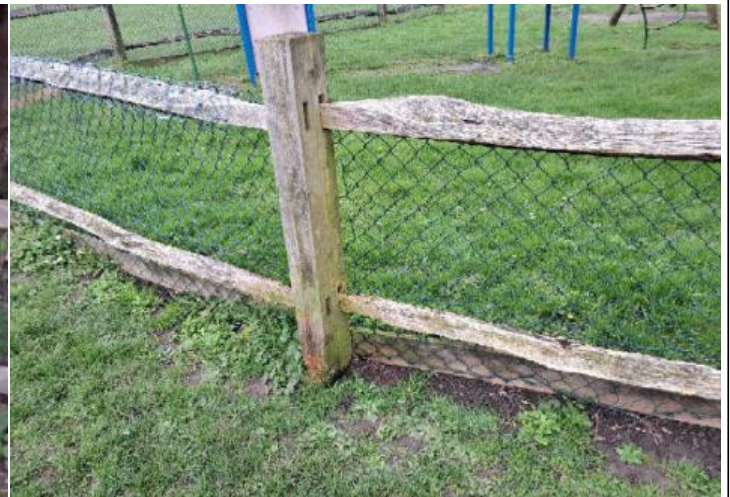
**Item:** Fences - Fence - Timber & Mesh Infill  
**Manufacturer:** Not Identified

**Finding:** There is some evidence of rot in the timber

**Action:** Monitor for any further deterioration and replace as required
