## COMMUNITY COMMITTEE MEETING HELD ON TUESDAY 3<sup>rd</sup> MARCH 2026 AT 7.30 PM AT THE STEYPING CENTRE

# DRAFT MINUTES

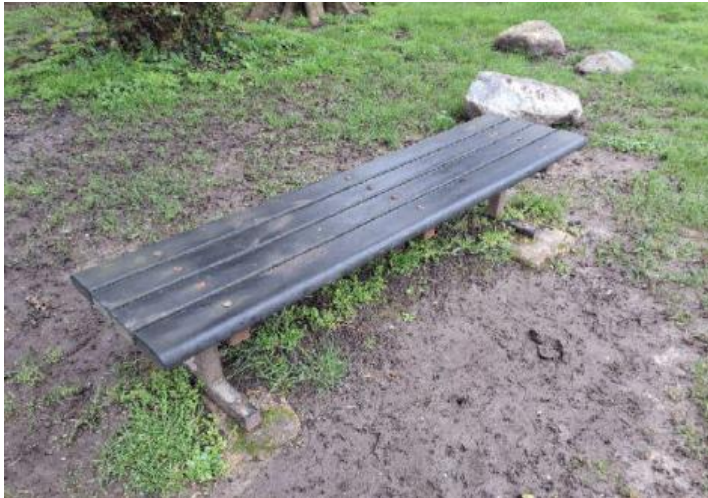
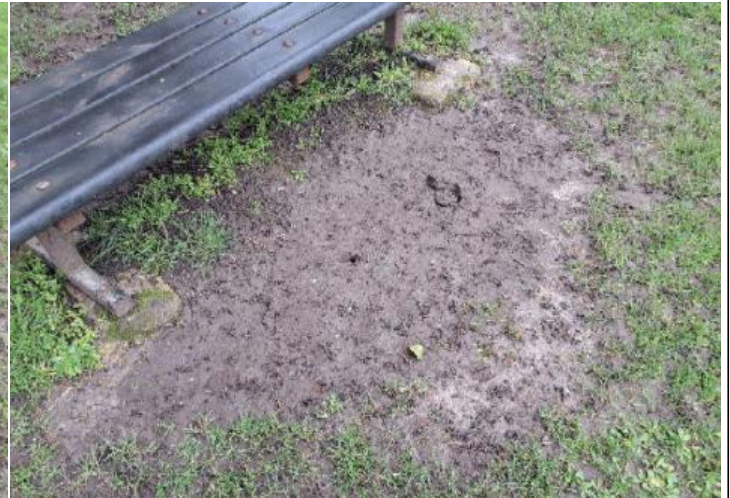
**Item:** Ancillary Items - Bench  
**Manufacturer:** Not Identified

**Finding:** The area around the item has eroded and may become slippery

**Action:** Reinstatate eroded area

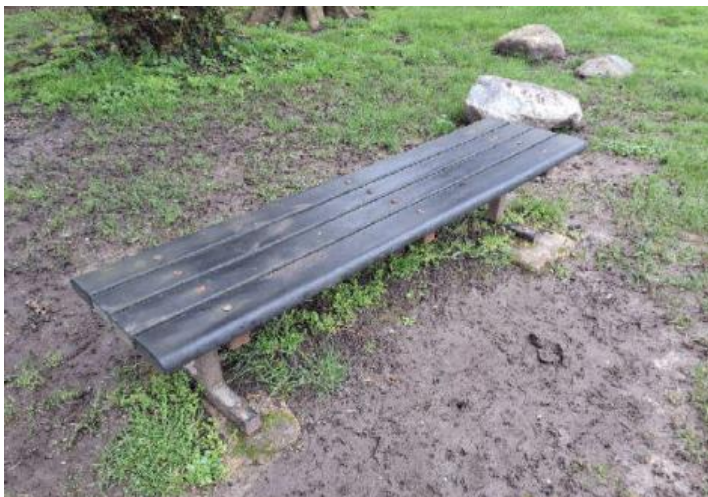
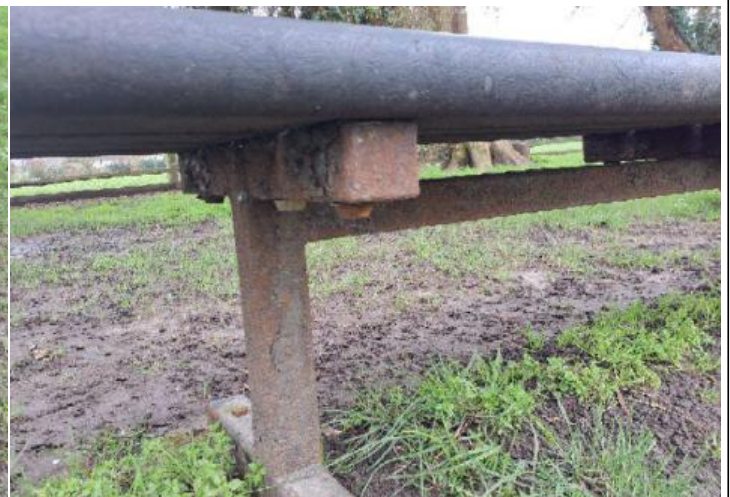
**Item:** Ancillary Items - Bench  
**Manufacturer:** Not Identified

**Finding:** The paintwork on this item has been damaged or worn exposing the metal underneath which is rusting / corroding

**Action:** Treat affected areas and repaint

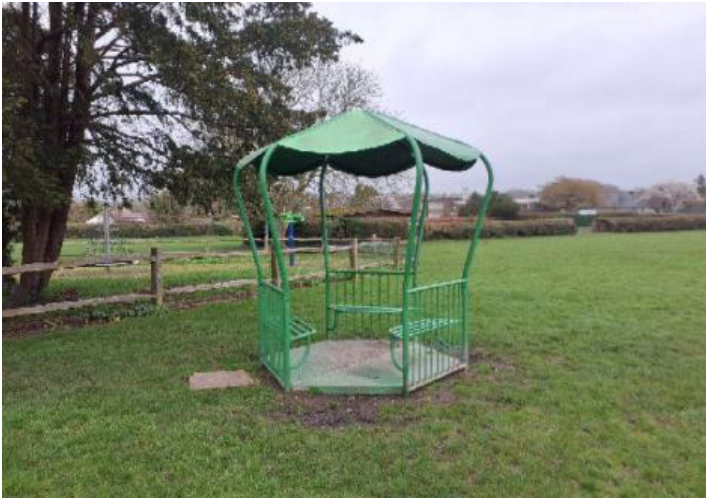
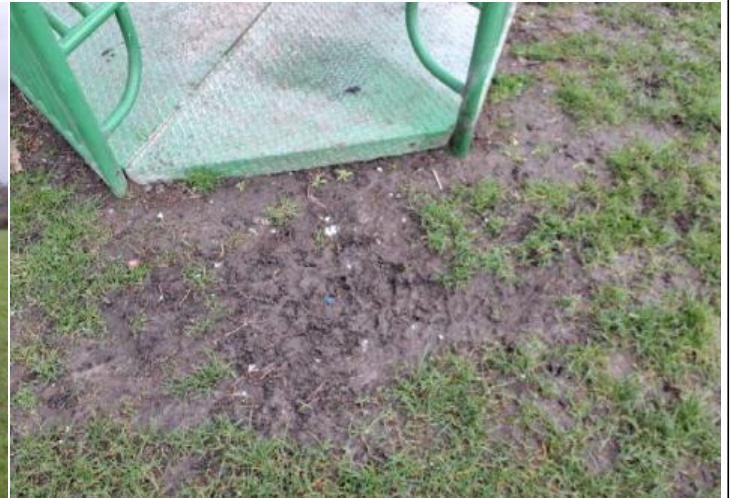
**Item:** Ancillary Items - Shelter  
**Manufacturer:** Wicksteed Playgrounds

**Finding:** The area around the item has eroded and may become slippery

**Action:** Reinststate eroded area

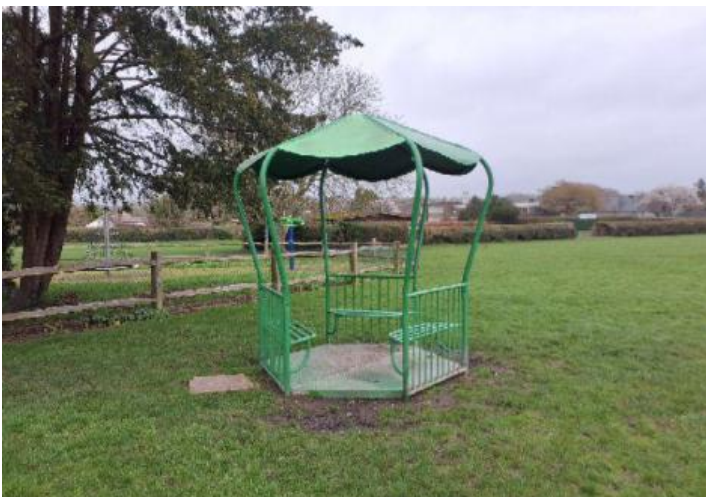
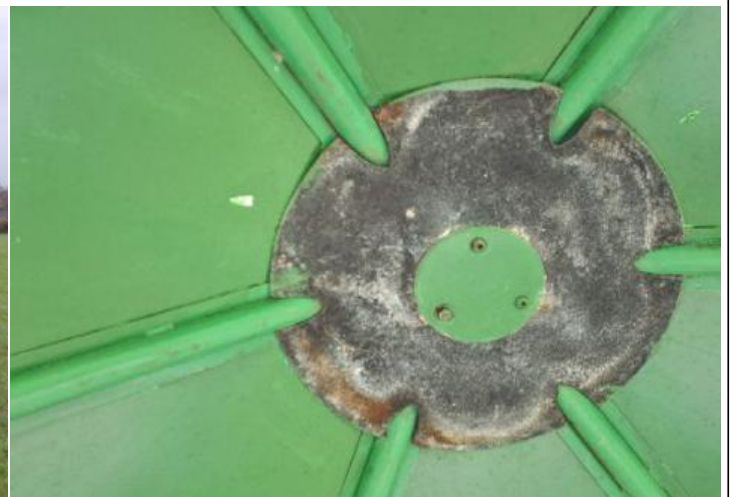
**Item:** Ancillary Items - Shelter  
**Manufacturer:** Wicksteed Playgrounds

**Finding:** There is surface corrosion / rust present on the item

**Action:** Consider treating the item

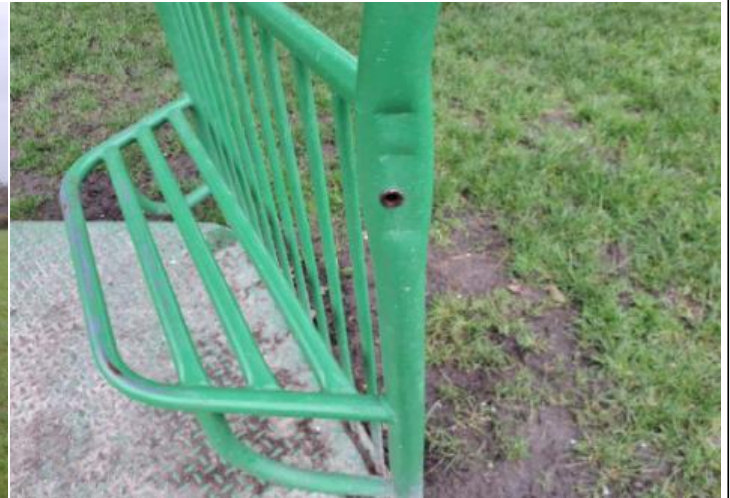
**Item:** Ancillary Items - Shelter  
**Manufacturer:** Wicksteed Playgrounds

**Finding:** There is/are inserts missing

**Action:** Replace missing inserts

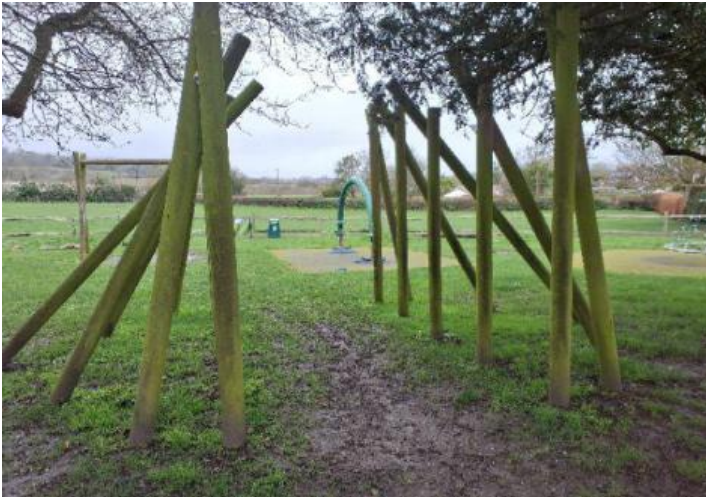
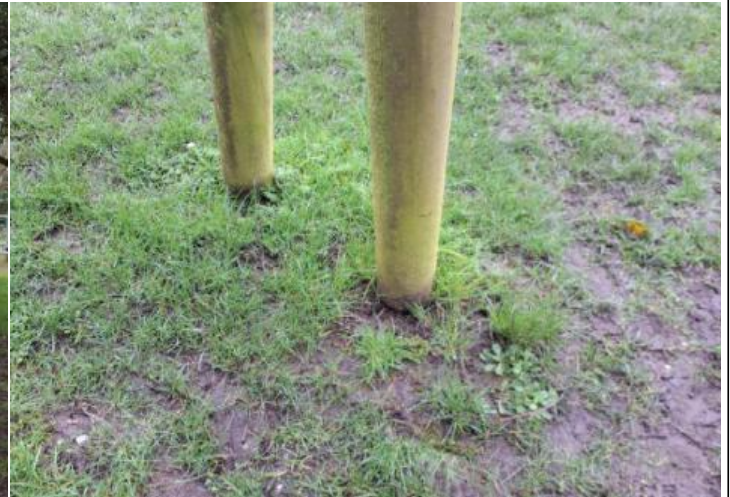
**Item:** Ancillary Items - Entrance Feature  
**Manufacturer:** Not Identified

**Finding:** There is some strimmer / machinery damage apparent on the posts, this can penetrate the preservative applied to the timber and accelerate the rotting process

**Action:** Monitor for any deterioration (rot) and replace as required

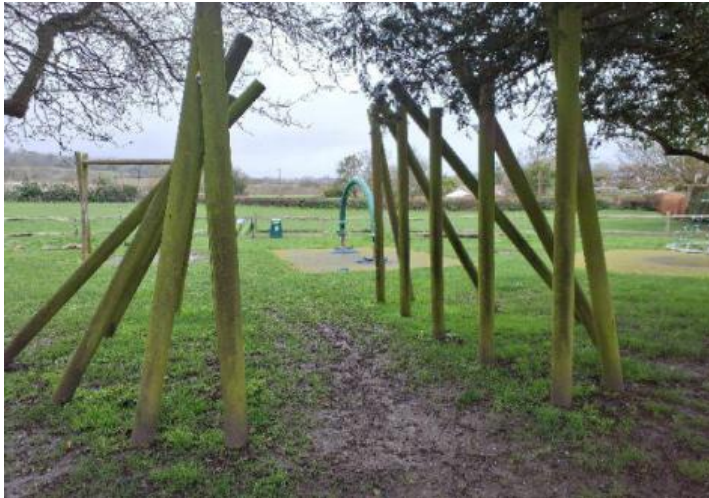
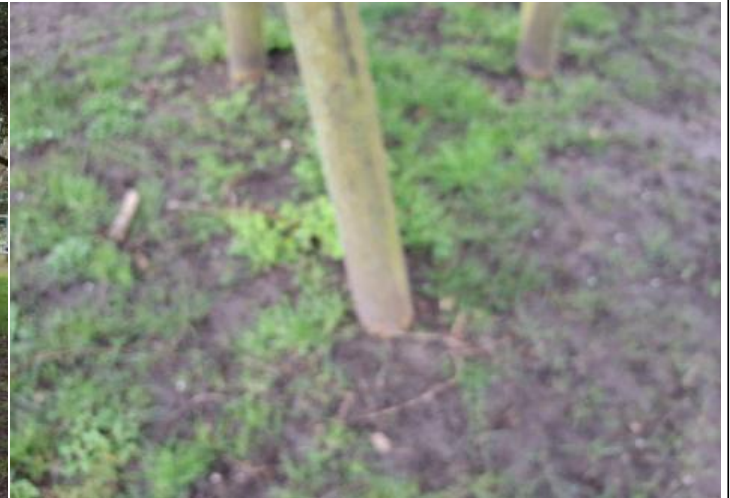
**Item:** Ancillary Items - Entrance Feature  
**Manufacturer:** Not Identified

**Finding:** There is some evidence of rot in the timber

**Action:** Monitor for any further deterioration and replace as required

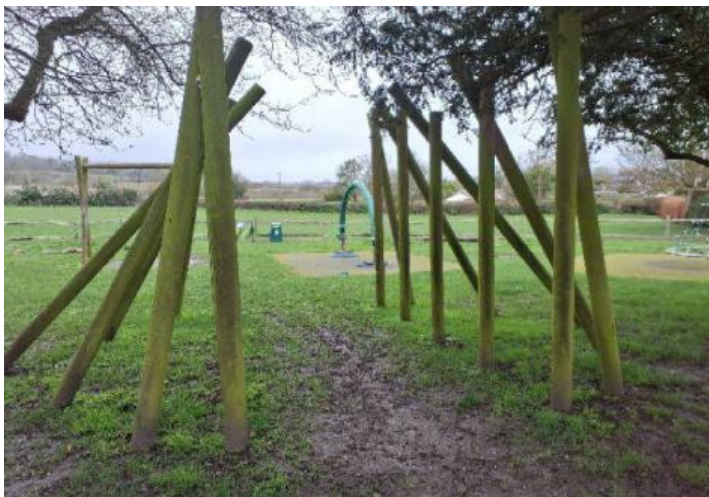
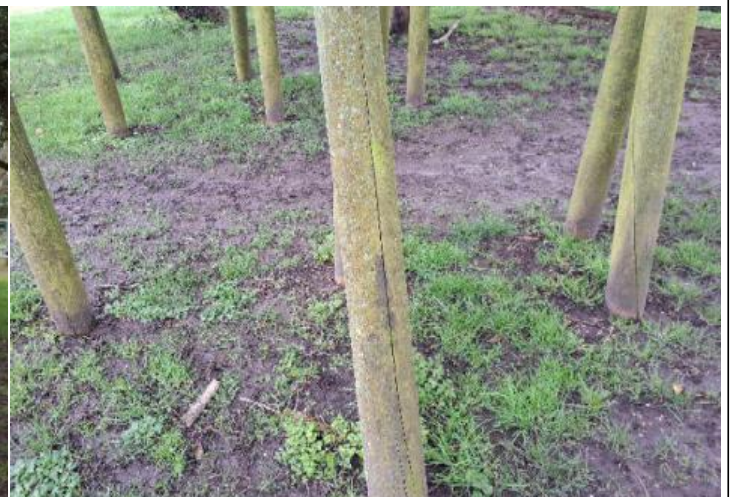
**Item:** Ancillary Items - Entrance Feature  
**Manufacturer:** Not Identified

**Finding:** The timber has a number of splits/shakes or air cracks and this may affect the stability or allow water ingress which will accelerate the rotting process. Timber splits may also create rough / splintering edges.

**Action:** Monitor, sand down any rough edges and ensure the splits do not cross through fixing points of the structure and/or cause any instability

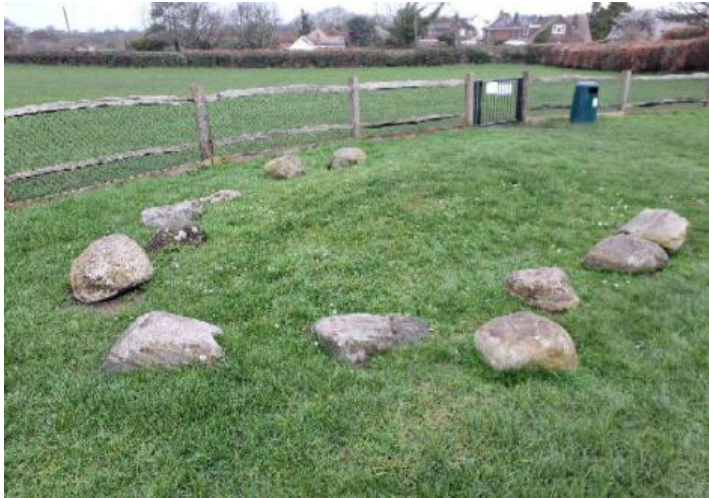
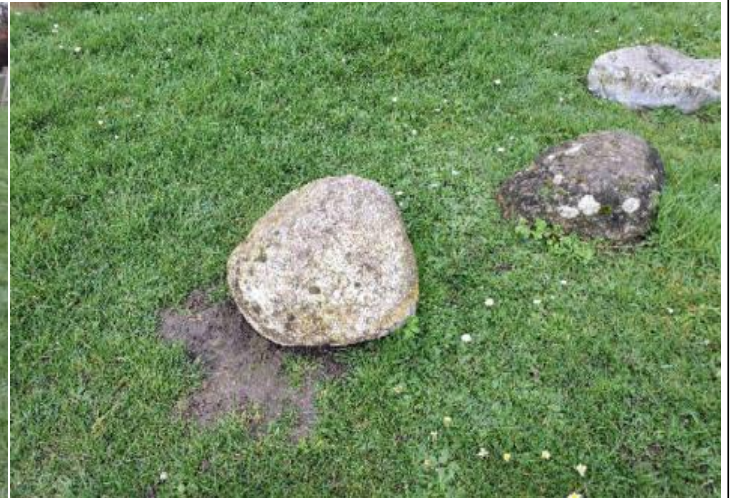
**Item:** Other - Boulders  
**Manufacturer:** Natural Feature

**Finding:** The boulder/s is / are unsecured and are small / light enough to be moved around the area or topple

**Action:** Secure boulder/s in position

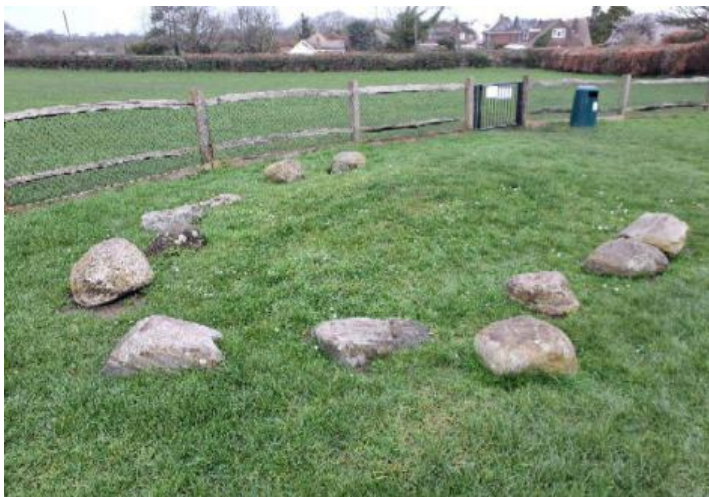
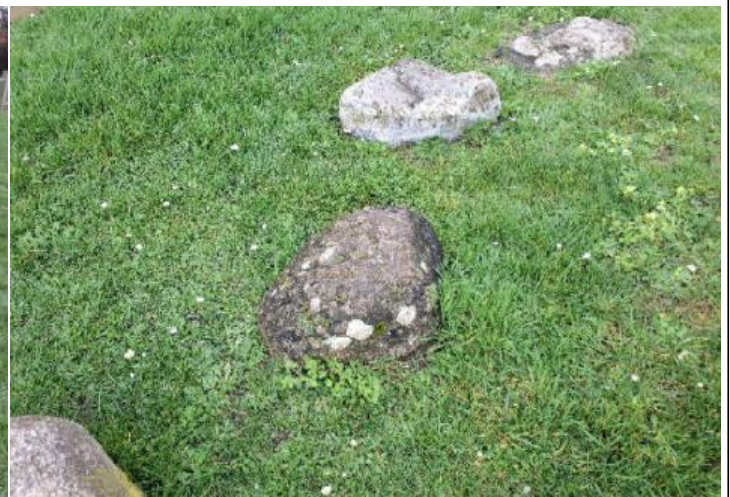
**Item:** Other - Boulders  
**Manufacturer:** Natural Feature

**Finding:** The rocks and/or boulders have moss/algae growth apparent

**Action:** Clean and maintain

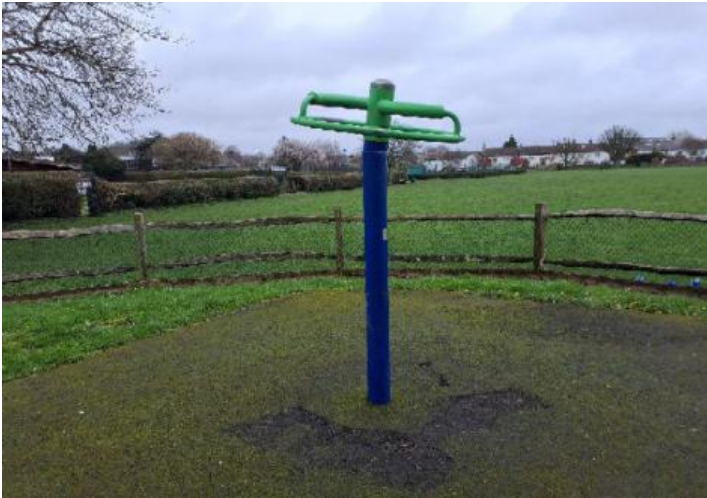
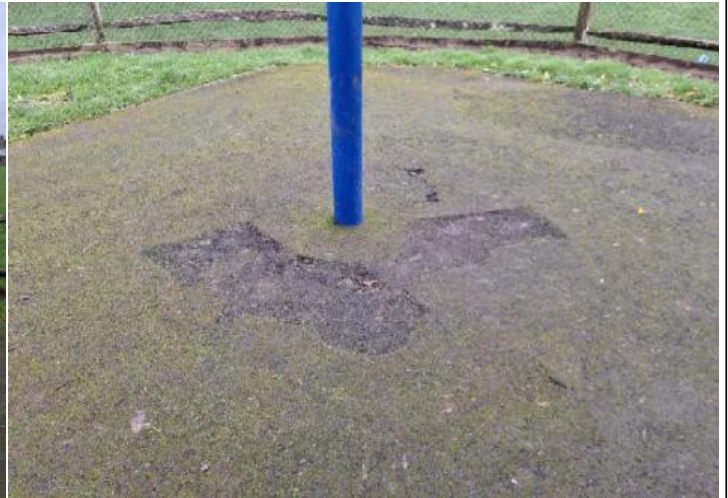
**Item:** Rotor Play - Overhead Rotator  
**Manufacturer:** Wicksteed Playgrounds

**Finding:** There is moderate damage to the surface

**Action:** Repair the damaged areas of surfacing

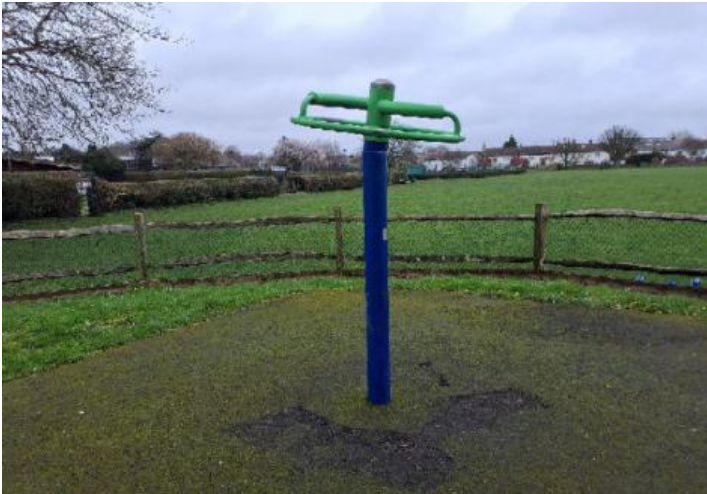
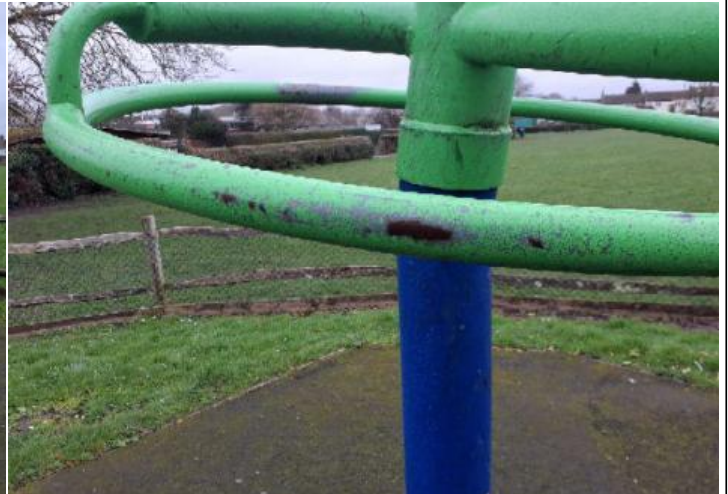
**Item:** Rotor Play - Overhead Rotator  
**Manufacturer:** Wicksteed Playgrounds

**Finding:** The paintwork on this item has been damaged or worn exposing the metal underneath which is rusting / corroding

**Action:** Treat affected areas and repaint

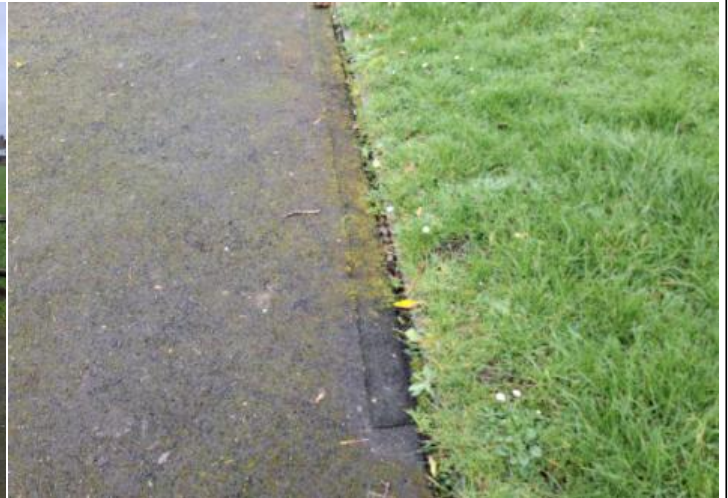
**Item:** Rotor Play - Overhead Rotator  
**Manufacturer:** Wicksteed Playgrounds

**Finding:** There are significant gaps (over 30mm) between the surface and the edging or between the joints in the surface; these are large enough for a small foot to enter

**Action:** Repair surfacing

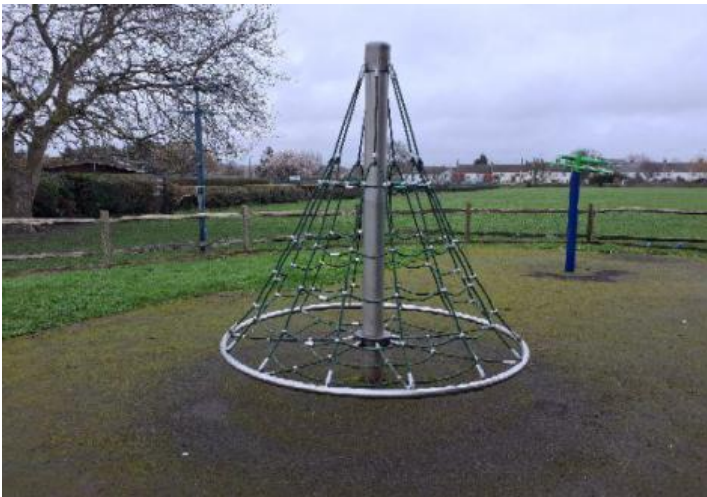
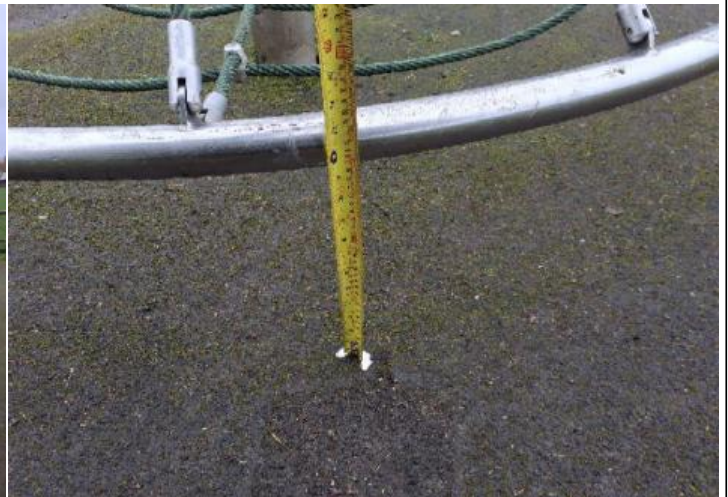
**Item:** Rotor Play - Rotating Net  
**Manufacturer:** Wicksteed Playgrounds

**Finding:** The clearance to the underside is less than 400mm and fails the requirements of BS EN 1176 Part 5

**Action:** Monitor - No action given the risk assessment

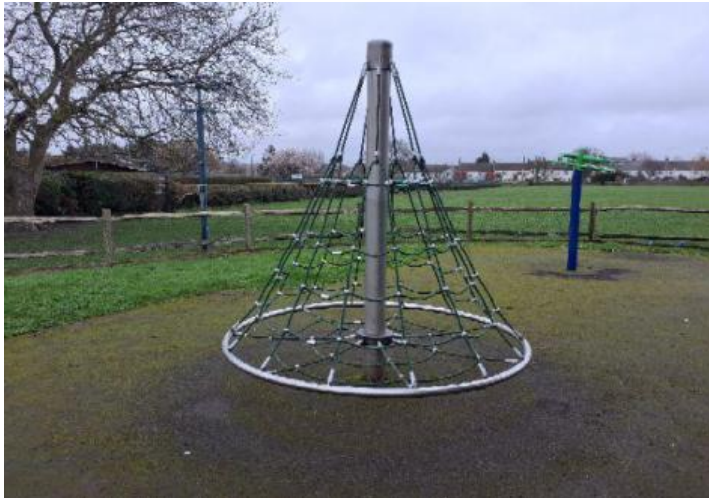
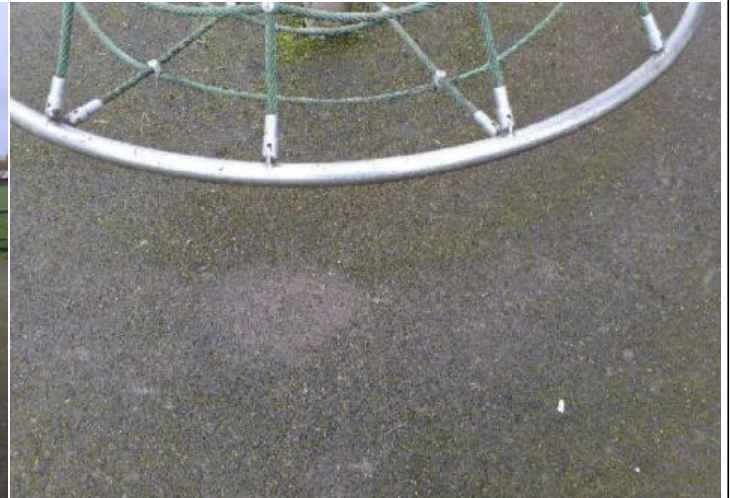
**Item:** Rotor Play - Rotating Net  
**Manufacturer:** Wicksteed Playgrounds

**Finding:** The surface has subsided in some areas

**Action:** Monitor for any further deterioration and repair as required

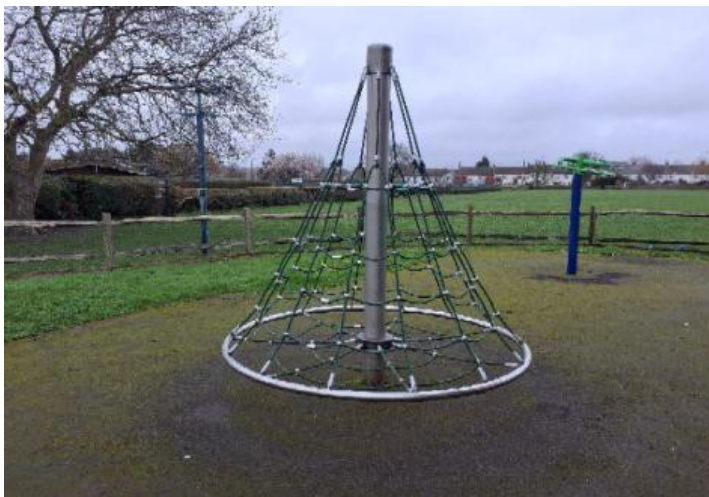
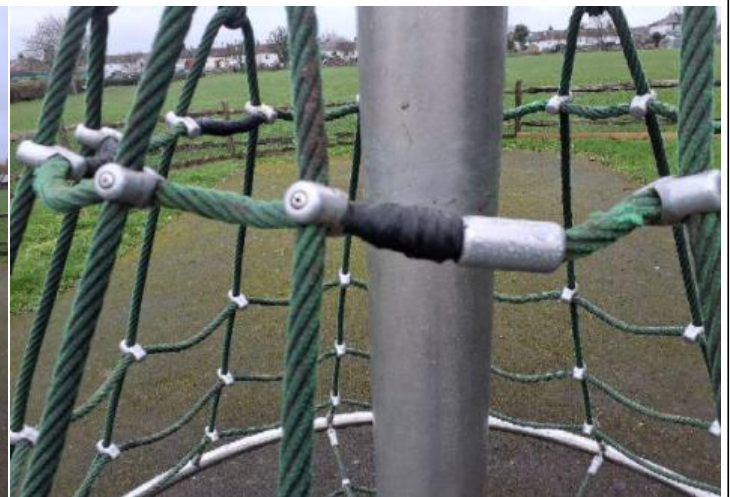
**Item:** Rotor Play - Rotating Net  
**Manufacturer:** Wicksteed Playgrounds

**Finding:** The ropes on this item have been taped and we are unable to fully assess the condition of the rope, ensure no wire strands are broken beneath the tape

**Action:** Repair or replace as required

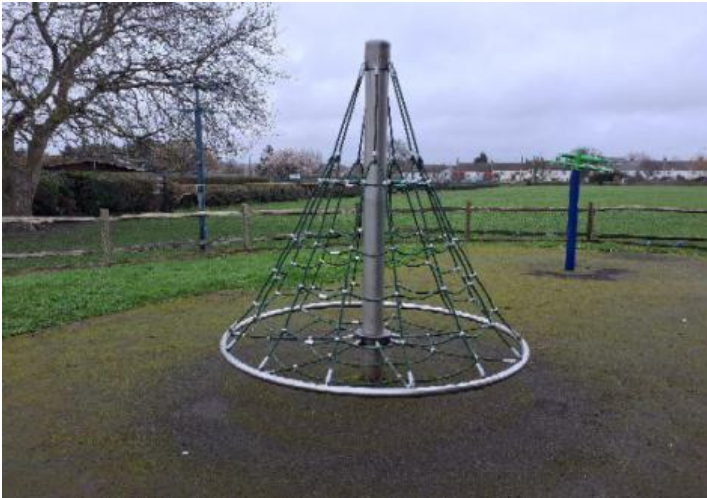
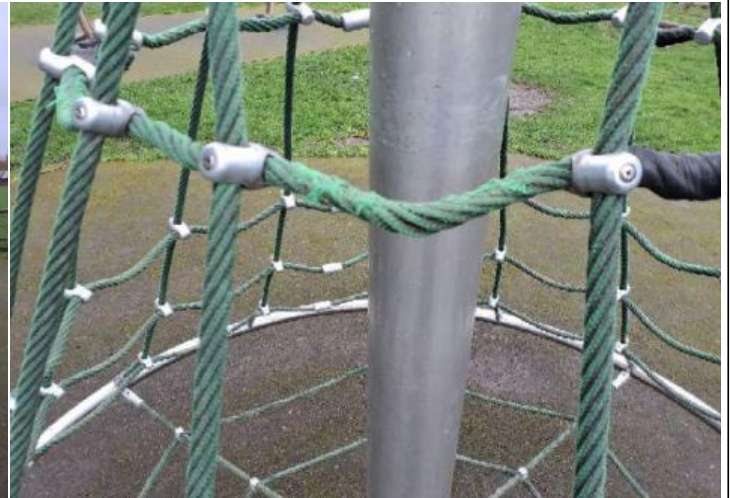
**Item:** Rotor Play - Rotating Net  
**Manufacturer:** Wicksteed Playgrounds

**Finding:** The ropes/nets are worn/damaged in places

**Action:** Monitor for any further deterioration and repair or replace as required

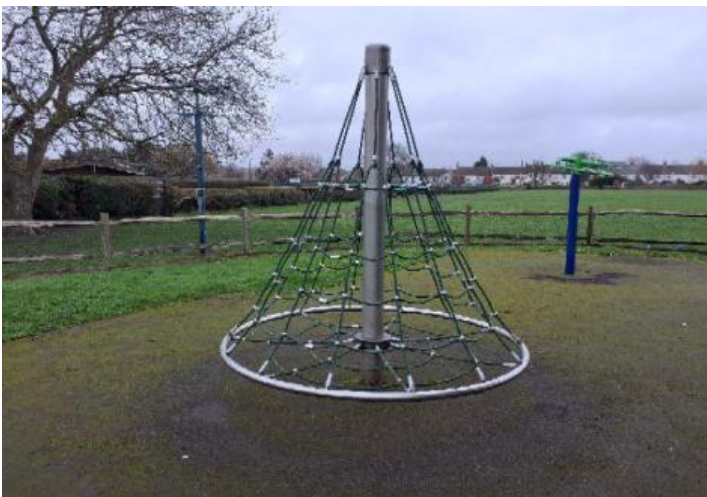
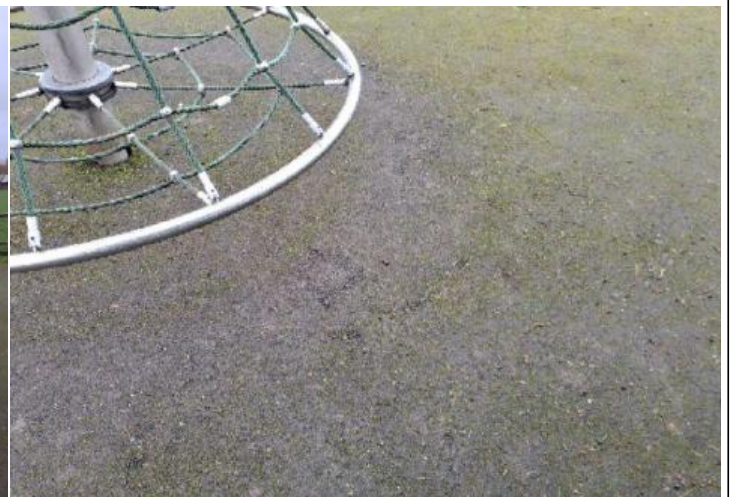
**Item:** Rotor Play - Rotating Net  
**Manufacturer:** Wicksteed Playgrounds

**Finding:** There is some minor damage to the surface

**Action:** Monitor for any further deterioration and repair as required

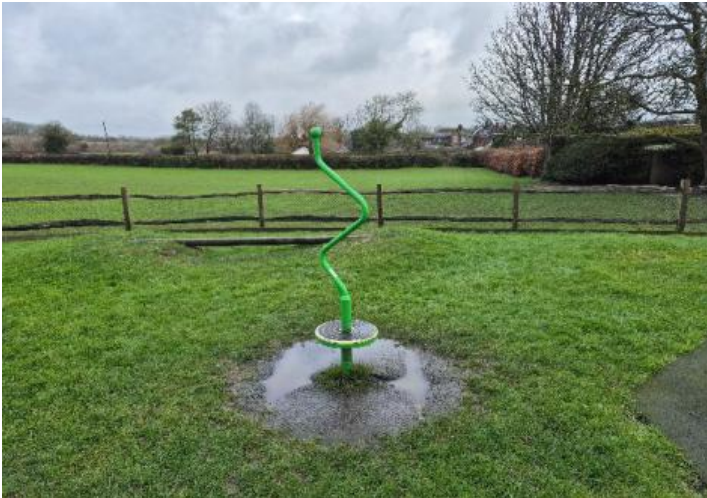
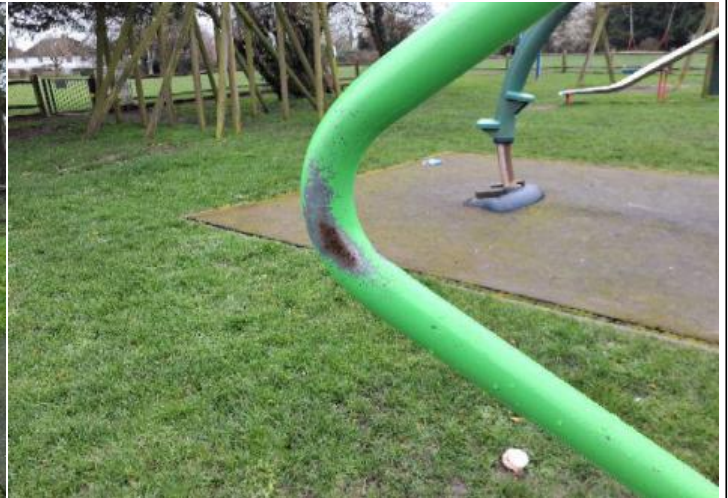
**Item:** Rotor Play - Spinning Pole  
**Manufacturer:** Wicksteed Playgrounds

**Finding:** The paintwork on this item has been damaged or worn exposing the metal underneath which is rusting / corroding

**Action:** Treat affected areas and repaint

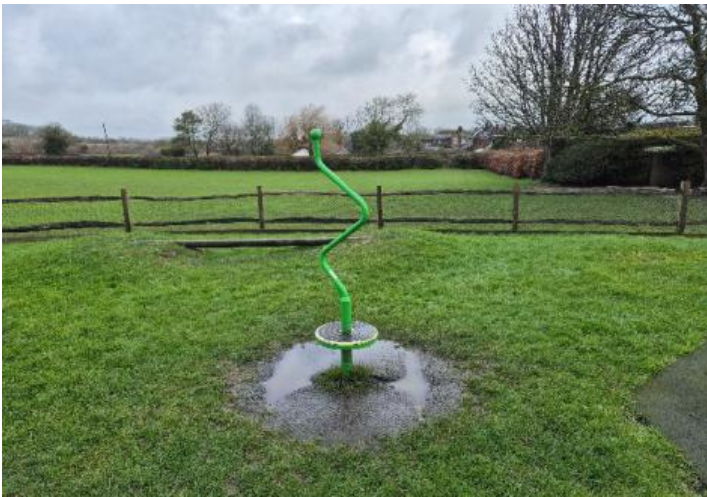
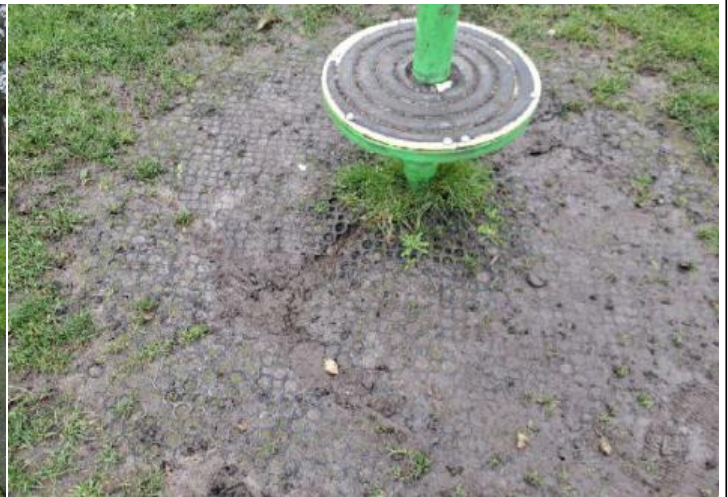
**Item:** Rotor Play - Spinning Pole  
**Manufacturer:** Wicksteed Playgrounds

**Finding:** There are gaps opening between the grass mat tiles

**Action:** Provide additional ties or secure / reinstate surface

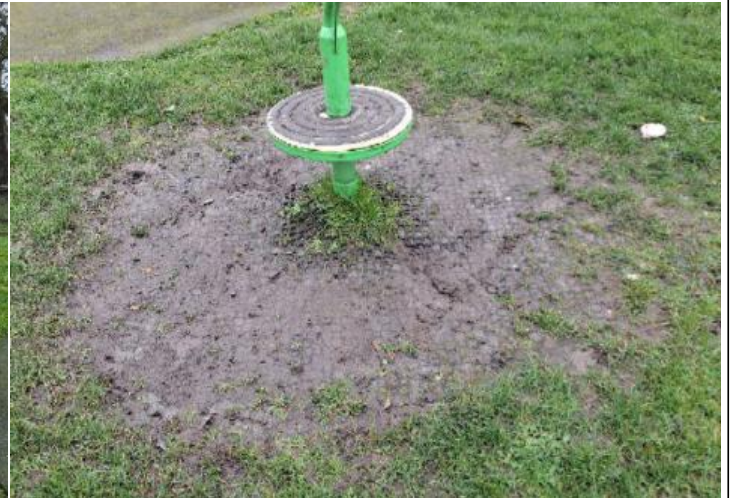
**Item:** Rotor Play - Spinning Pole  
**Manufacturer:** Wicksteed Playgrounds

**Finding:** The surface has subsided in some areas

**Action:** Repair all damaged areas

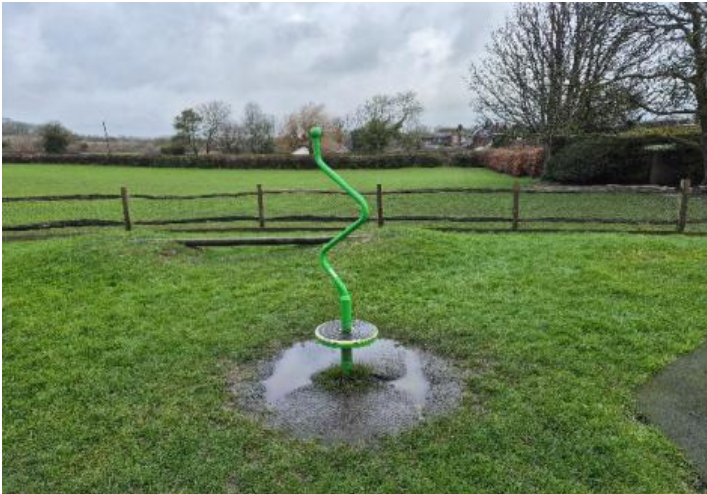
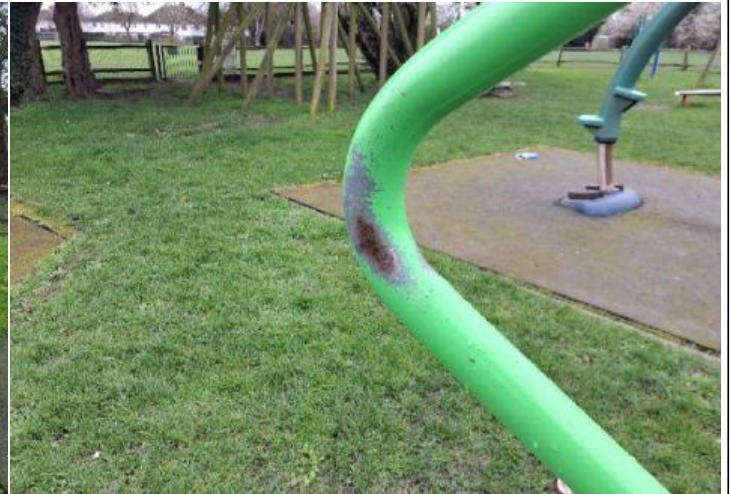
**Item:** Rotor Play - Spinning Pole  
**Manufacturer:** Wicksteed Playgrounds

**Finding:** The paintwork on this item has been damaged or worn exposing the metal underneath which is rusting / corroding

**Action:** Treat affected areas and repaint

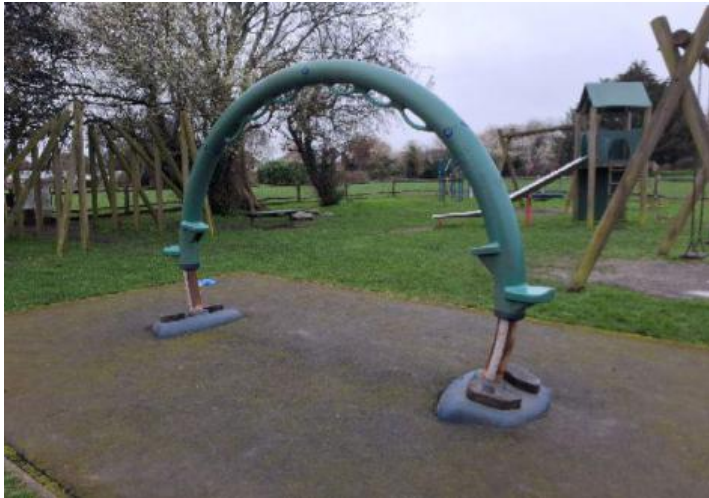
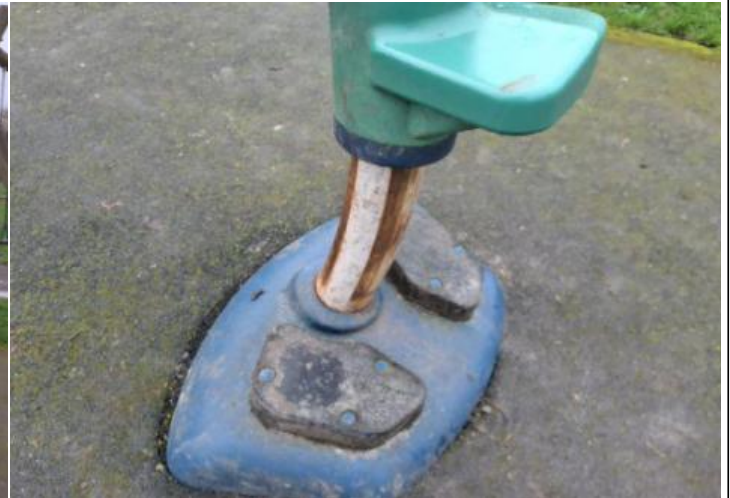
**Item:** Rocking Equipment - Rock n Cross  
**Manufacturer:** Big Toys

**Finding:** The paintwork on this item has been damaged or worn exposing the metal underneath which is rusting / corroding

**Action:** Treat affected areas and repaint

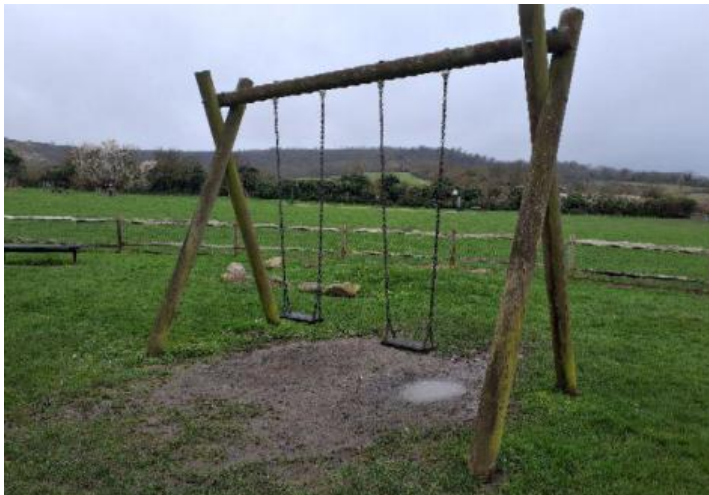
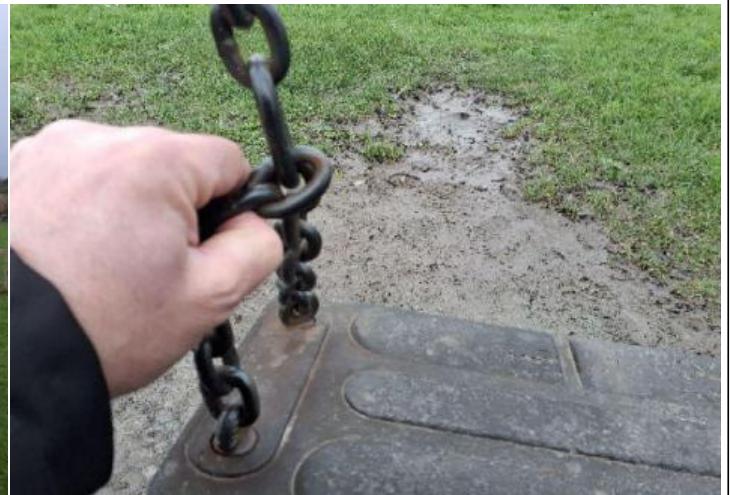
**Item:** Swings - 1 Bay 2 Seat (Flat)  
**Manufacturer:** Not Identified

**Finding:** There is some notable evidence of chain wear

**Action:** Monitor for any further deterioration and replace when 40% worn

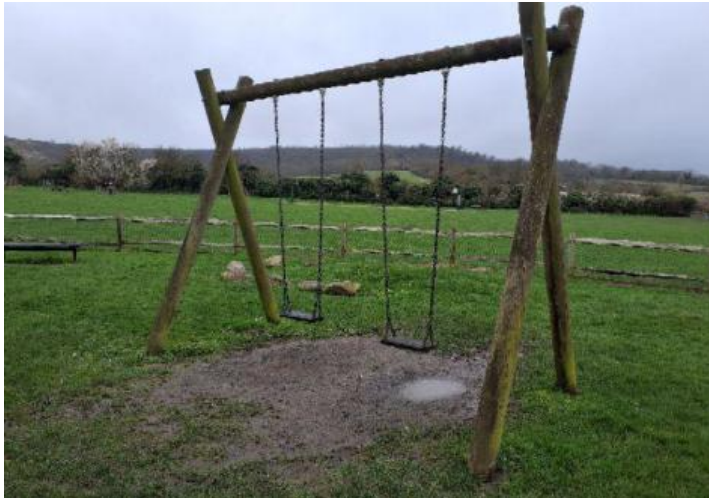
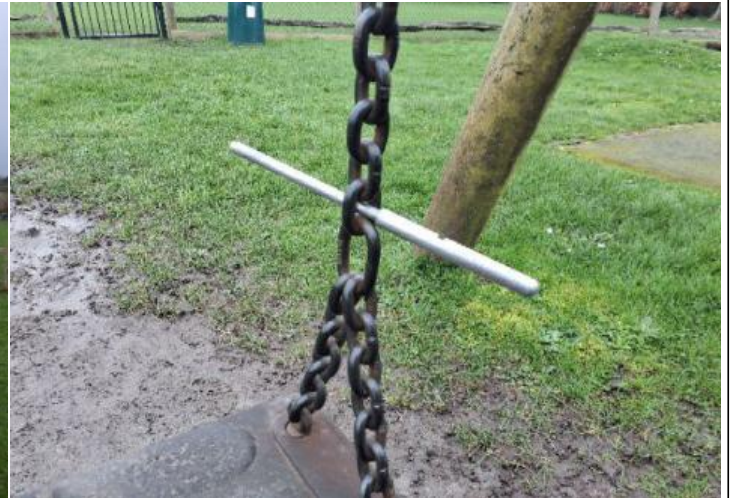
**Item:** Swings - 1 Bay 2 Seat (Flat)  
**Manufacturer:** Not Identified

**Finding:** The chain openings are in excess of the 8.6mm as recommended by BS EN 1176  
**Action:** Monitor - No action given the risk assessment

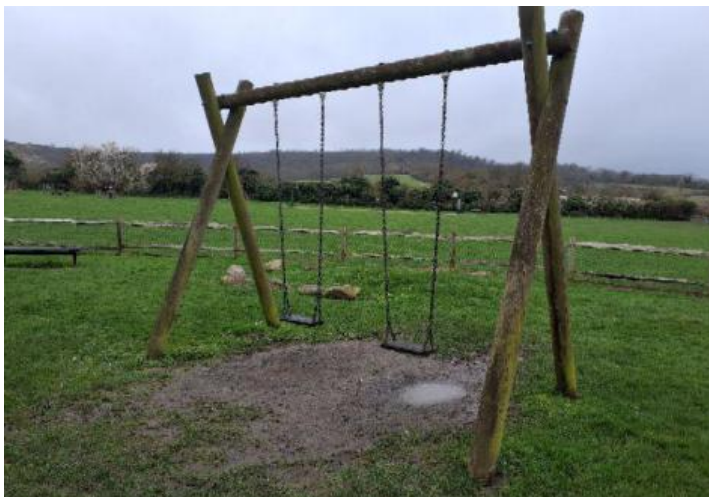
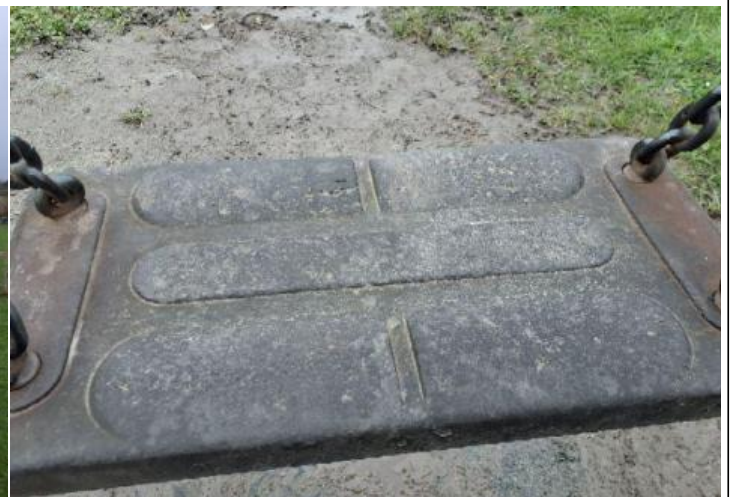
**Item:** Swings - 1 Bay 2 Seat (Flat)  
**Manufacturer:** Not Identified

**Finding:** The seat has minor damage or wear  
**Action:** Monitor for any further deterioration and replace as required

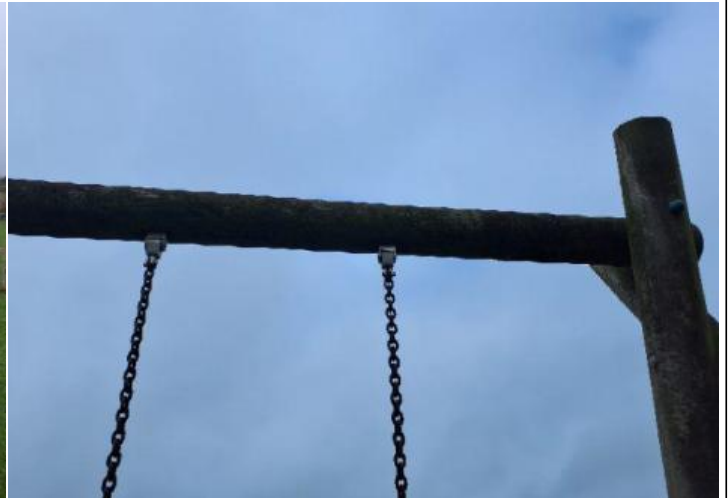
**Item:** Swings - 1 Bay 2 Seat (Flat)  
**Manufacturer:** Not Identified

**Finding:** This design of swing joint has been known to fail on the weld connecting the joint to the threaded stud

**Action:** We would recommend that the joint be dismantled and checked on a regular basis or consulting with manufacturer on whether a Secondary Safety Device can be fitted

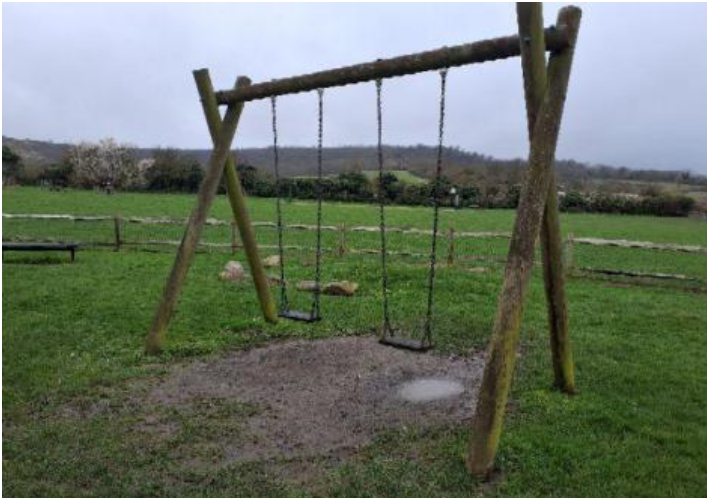
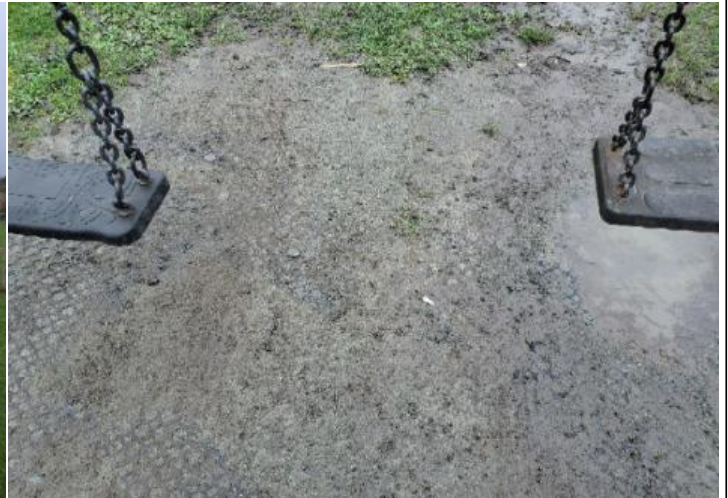
**Item:** Swings - 1 Bay 2 Seat (Flat)  
**Manufacturer:** Not Identified

**Finding:** Hard fixing pins have been installed in the grass mat tiles within the impact area of the equipment. Grass mat pins should only be installed at the perimeter of the tiles, and outside of any equipment impact areas. NOTE - where grass mat wear pads have been provided and the impact area includes surrounding surfaces, the grass mats should be tucked into the turf, and not pinned

**Action:** Remove pins from impact areas

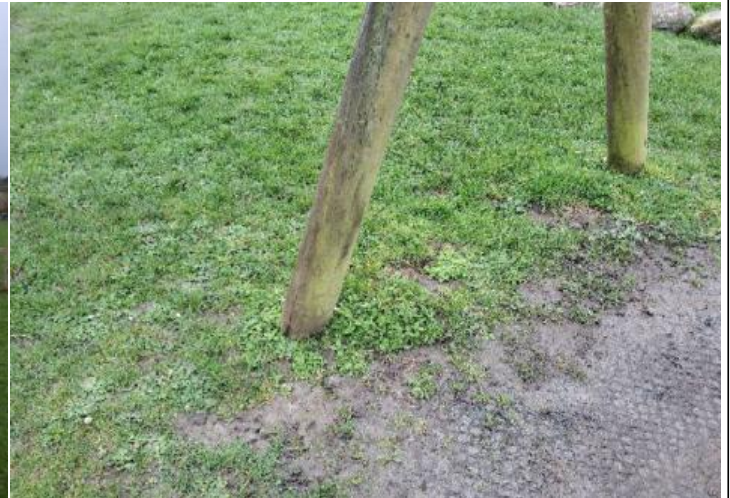
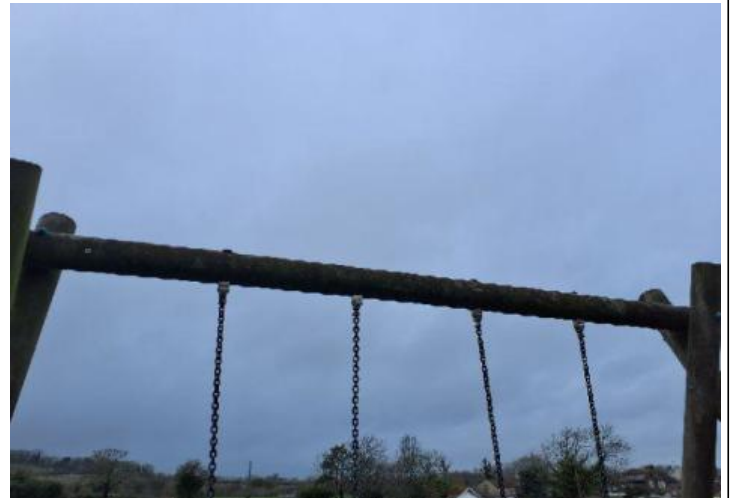
**Item:** Swings - 1 Bay 2 Seat (Flat)  
**Manufacturer:** Not Identified

**Finding:** There is some evidence of rot in the timber

**Action:** Monitor for any further deterioration and replace as required

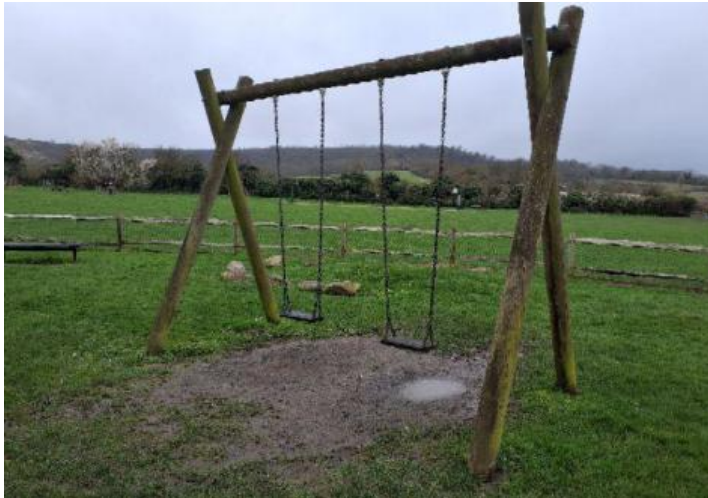
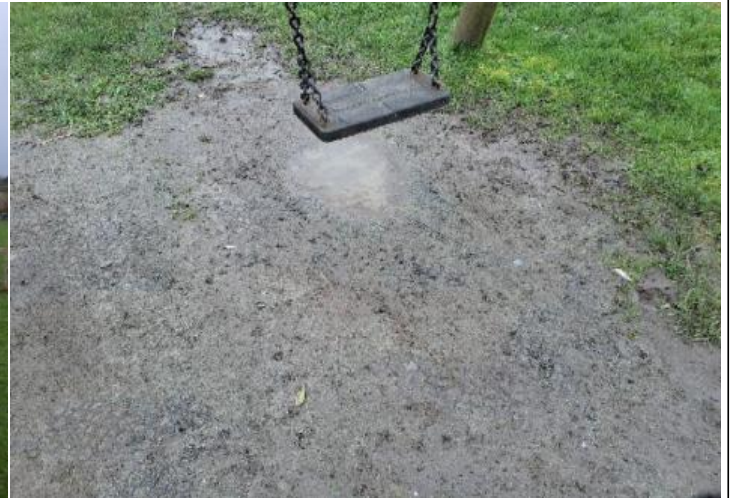
**Item:** Swings - 1 Bay 2 Seat (Flat)  
**Manufacturer:** Not Identified

**Finding:** The surface has subsided in some areas

**Action:** Monitor for any further deterioration and repair as required

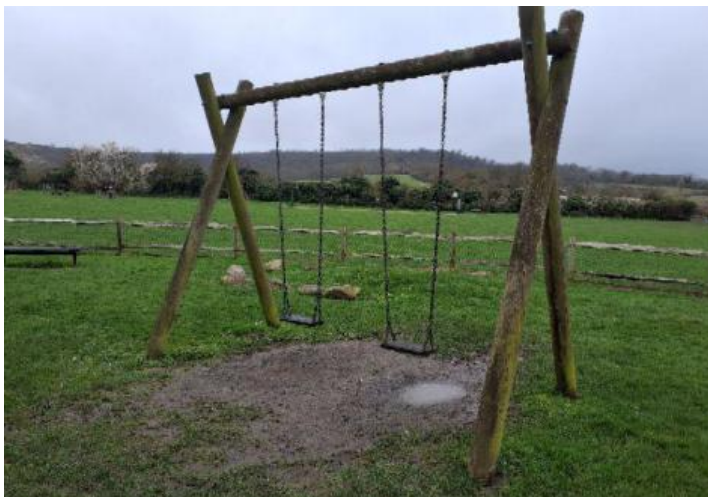
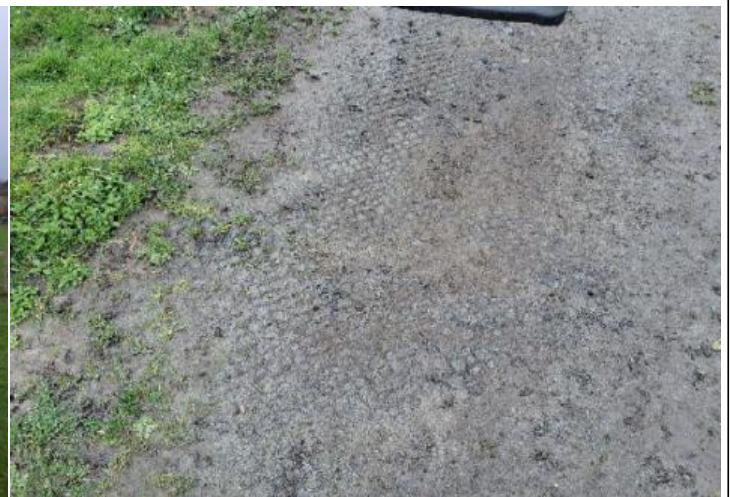
**Item:** Swings - 1 Bay 2 Seat (Flat)  
**Manufacturer:** Not Identified

**Finding:** There is moderate damage to the surface

**Action:** Repair the damaged areas of surfacing
