## COMMUNITY COMMITTEE MEETING HELD ON TUESDAY 3<sup>rd</sup> MARCH 2026 AT 7.30 PM AT THE STEYPING CENTRE

# DRAFT MINUTES

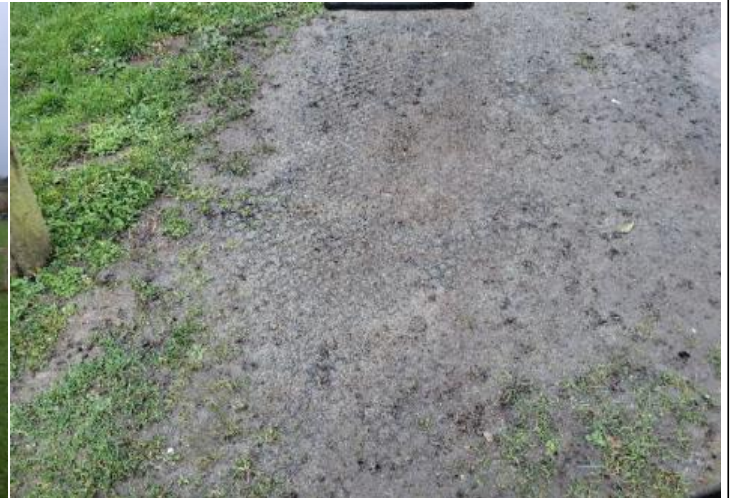
**Item:** Swings - 1 Bay 2 Seat (Flat)  
**Manufacturer:** Not Identified

**Finding:** The grass mat surfacing has numerous stones present within the surface and will not perform as intended in relation to Head Injury Criterion testing

**Action:** Lift mats and ensure stones are removed and ground is suitable prior to re-laying

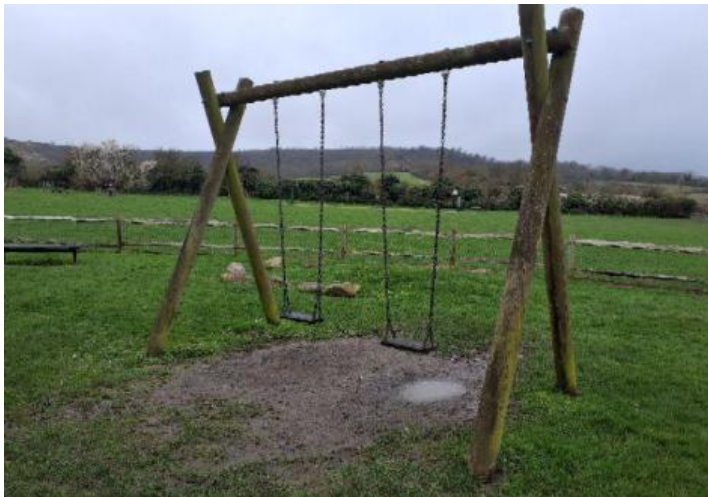
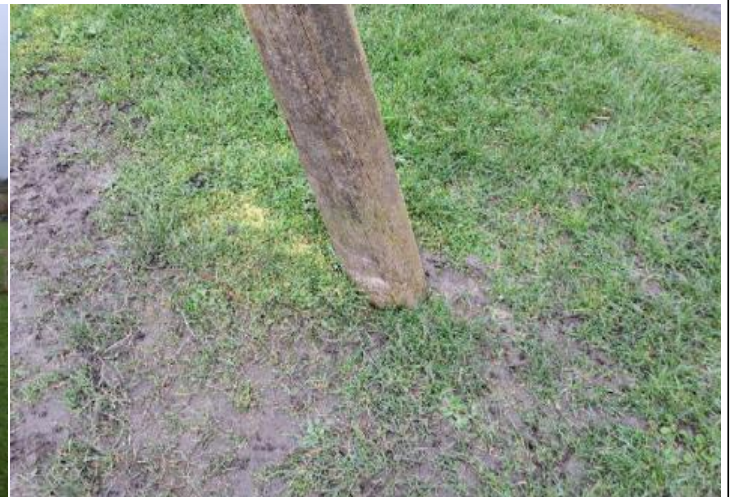
**Item:** Swings - 1 Bay 2 Seat (Flat)  
**Manufacturer:** Not Identified

**Finding:** There is some strimmer / machinery damage apparent on the posts, this can penetrate the preservative applied to the timber and accelerate the rotting process

**Action:** Monitor for any deterioration (rot) and replace as required

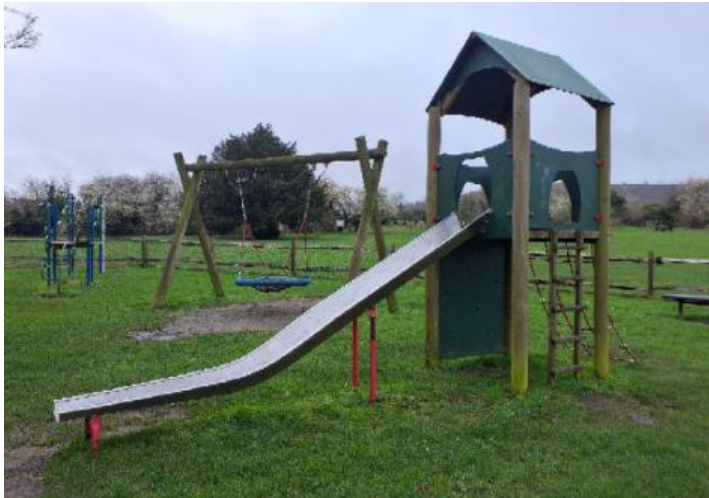
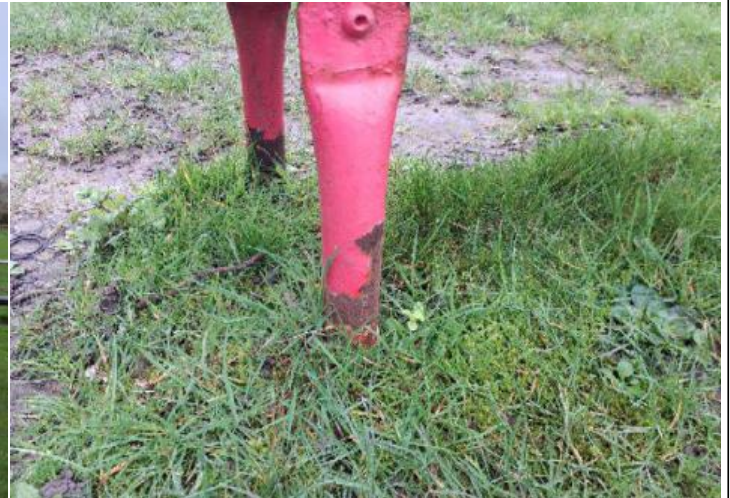
**Item:** Activity Equipment - Multi Play (Junior)  
**Manufacturer:** Not Identified

**Finding:** The paintwork on this item has been damaged or worn exposing the metal underneath which is rusting / corroding

**Action:** Treat affected areas and repaint

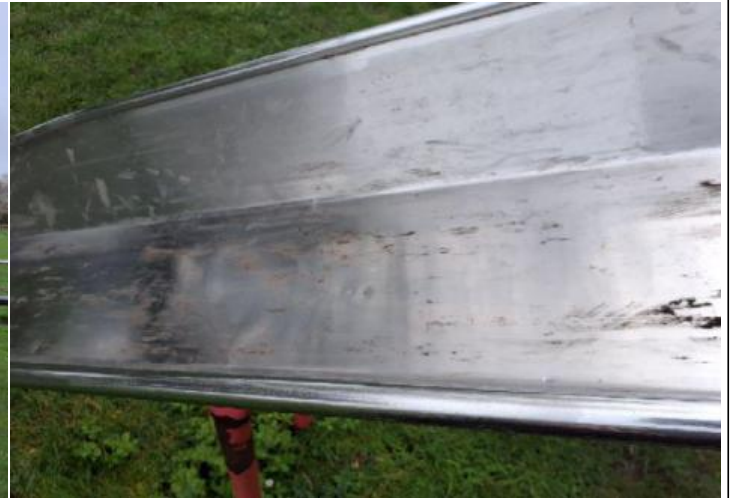
**Item:** Activity Equipment - Multi Play (Junior)  
**Manufacturer:** Not Identified

**Finding:** There are a number of dents in the slide surface

**Action:** Monitor for any further deterioration and repair as required

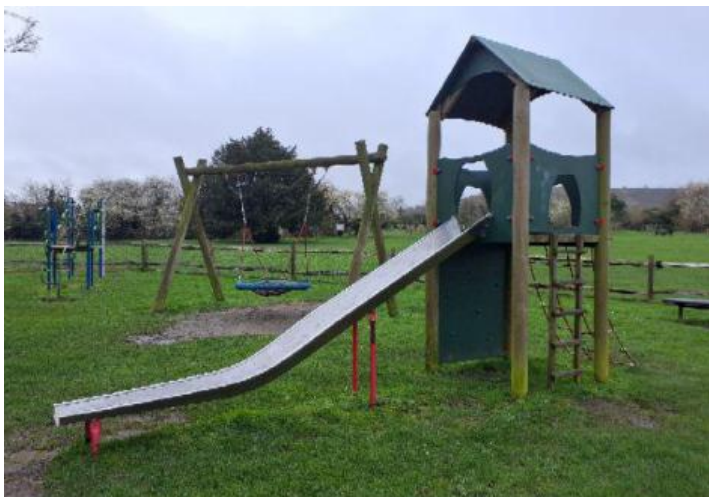
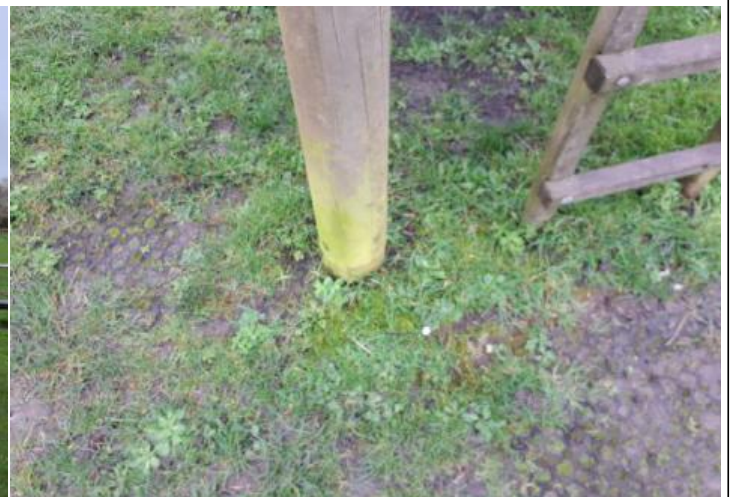
**Item:** Activity Equipment - Multi Play (Junior)  
**Manufacturer:** Not Identified

**Finding:** There is some strimmer / machinery damage apparent on the posts, this can penetrate the preservative applied to the timber and accelerate the rotting process

**Action:** Monitor for any deterioration (rot) and replace as required

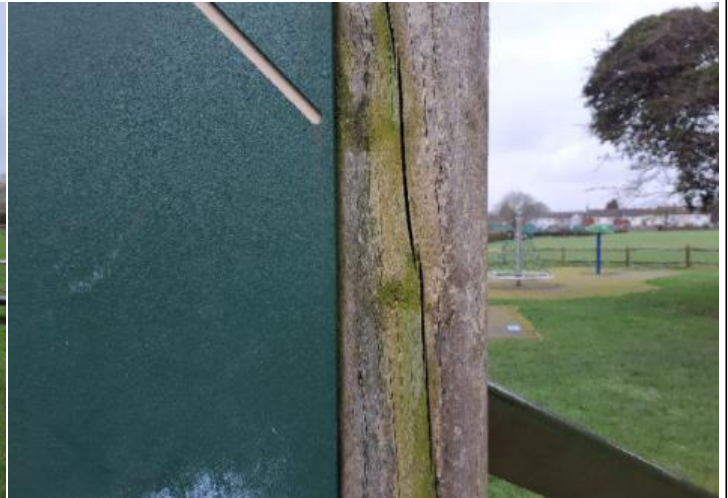
**Item:** Activity Equipment - Multi Play (Junior)  
**Manufacturer:** Not Identified

**Finding:** The timber has a number of splits/shakes or air cracks and this may affect the stability or allow water ingress which will accelerate the rotting process. Timber splits may also create rough / splintering edges.

**Action:** Monitor, sand down any rough edges and ensure the splits do not cross through fixing points of the structure and/or cause any instability

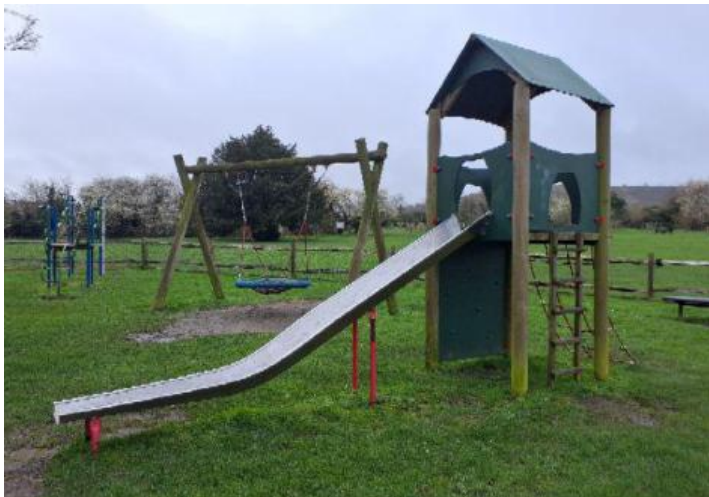
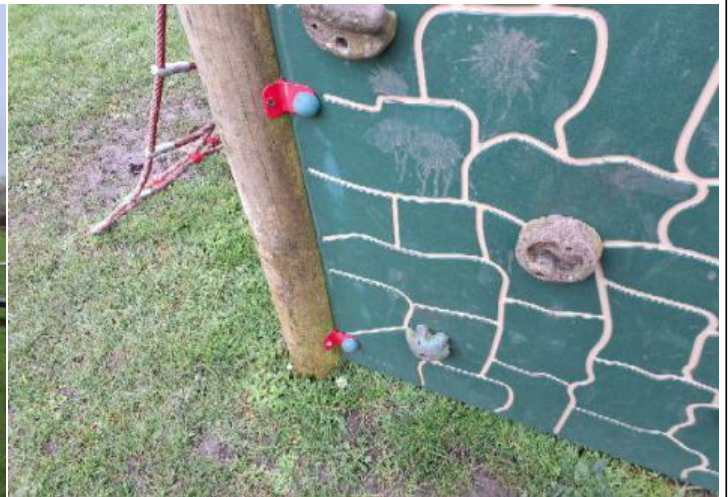
**Item:** Activity Equipment - Multi Play (Junior)  
**Manufacturer:** Not Identified

**Finding:** There is some evidence of rot in the timber

**Action:** Monitor for any further deterioration and replace as required

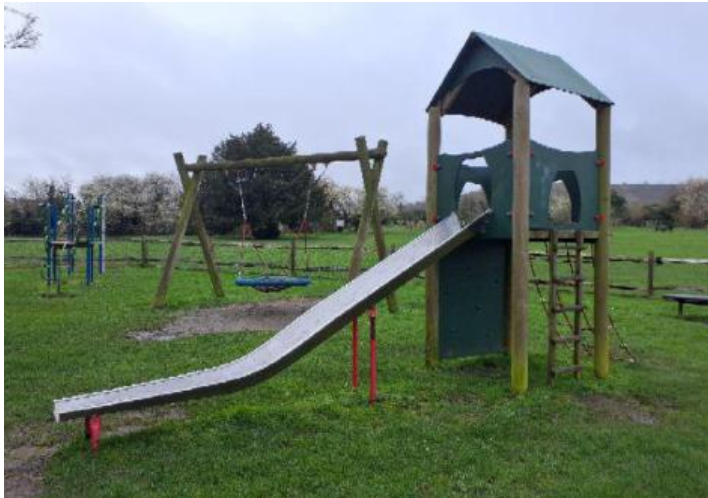
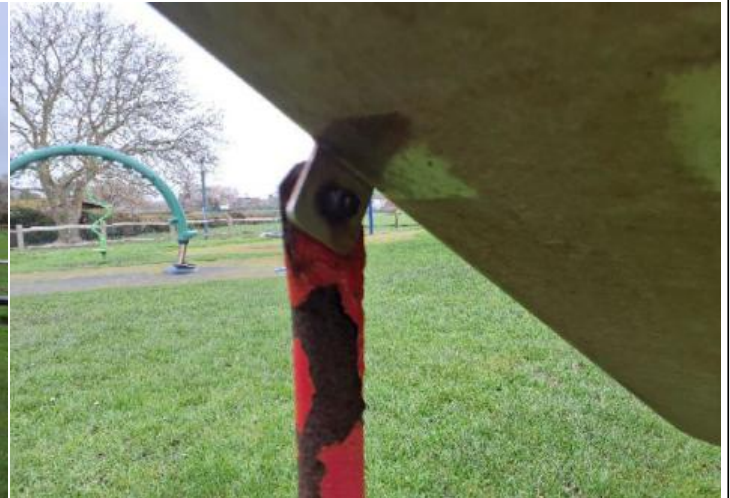
**Item:** Activity Equipment - Multi Play (Junior)  
**Manufacturer:** Not Identified

**Finding:** The fixings have corroded excessively

**Action:** Replace all corroded fixings

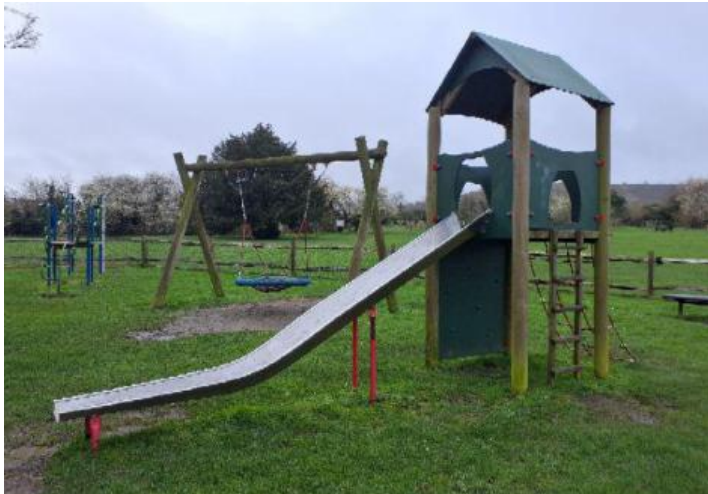
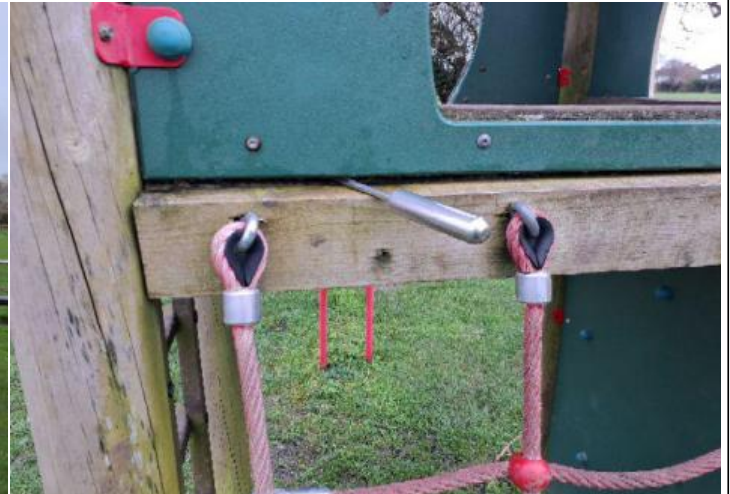
**Item:** Activity Equipment - Multi Play (Junior)  
**Manufacturer:** Not Identified

**Finding:** There is/are finger entrapment/s in the frame and the item fails to meet the requirements of BS EN 1176 Part 1 4.2.7.6 Entrapment of fingers

**Action:** Monitor - No action given the risk assessment

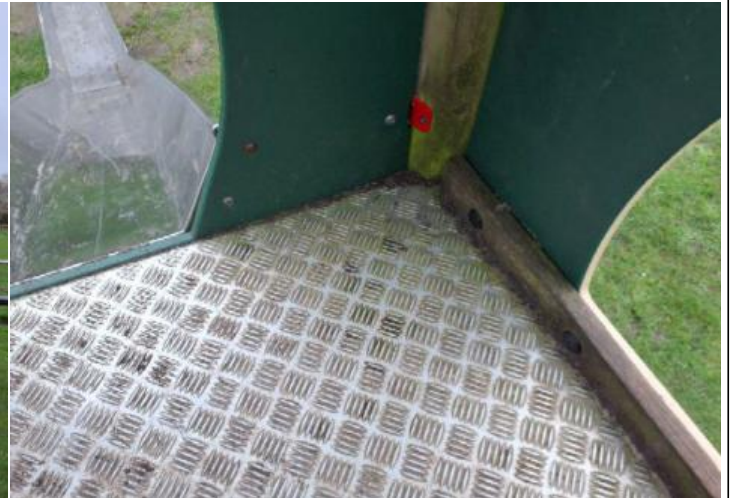
**Item:** Activity Equipment - Multi Play (Junior)  
**Manufacturer:** Not Identified

**Finding:** There is algae or moss on the surface of the equipment

**Action:** Clean and treat appropriately

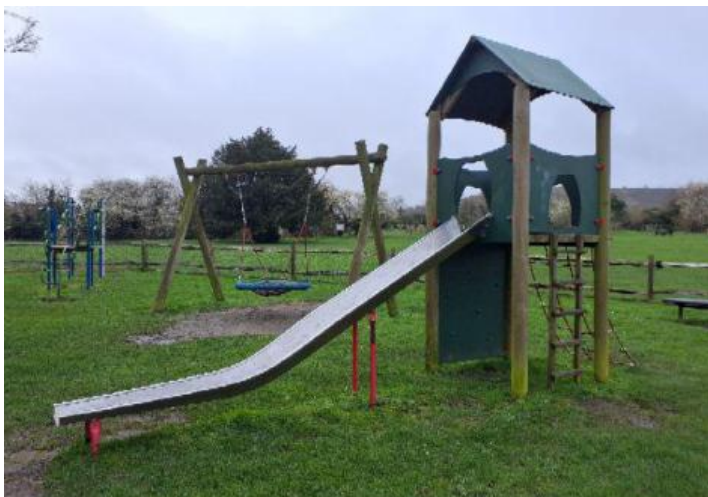
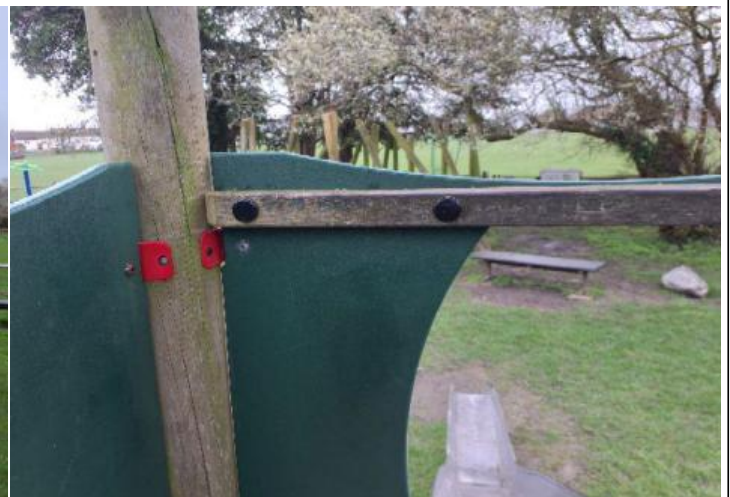
**Item:** Activity Equipment - Multi Play (Junior)  
**Manufacturer:** Not Identified

**Finding:** There is some graffiti present

**Action:** Remove the graffiti

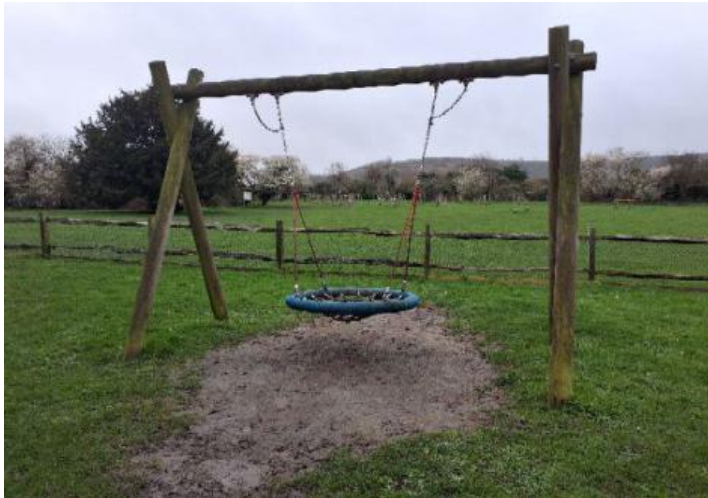
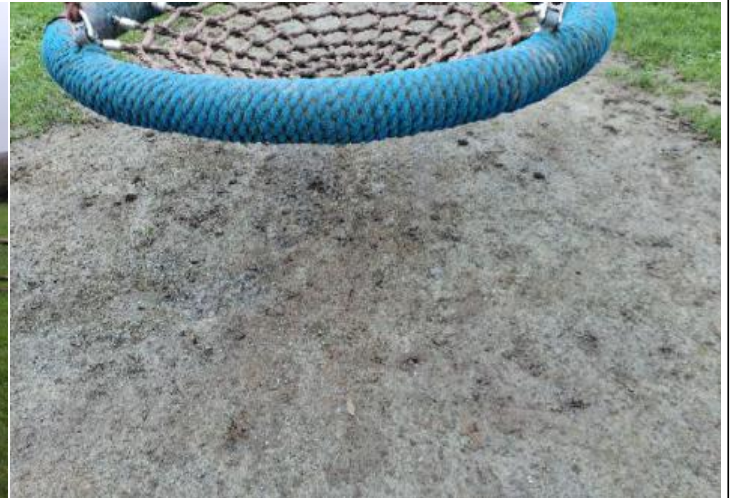
**Item:** Swings - Basket Swing - Type 1  
**Manufacturer:** Not Identified

**Finding:** Hard fixing pins have been installed in the grass mat tiles within the impact area of the equipment. Grass mat pins should only be installed at the perimeter of the tiles, and outside of any equipment impact areas. NOTE - where grass mat wear pads have been provided and the impact area includes surrounding surfaces, the grass mats should be tucked into the turf, and not pinned

**Action:** Remove pins from impact areas

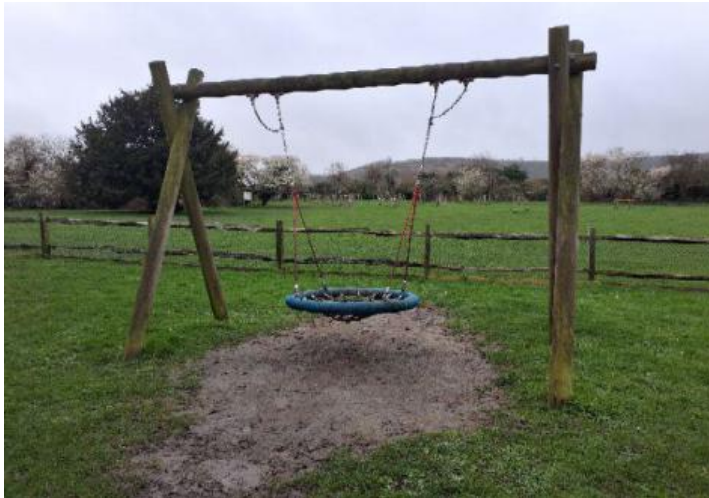
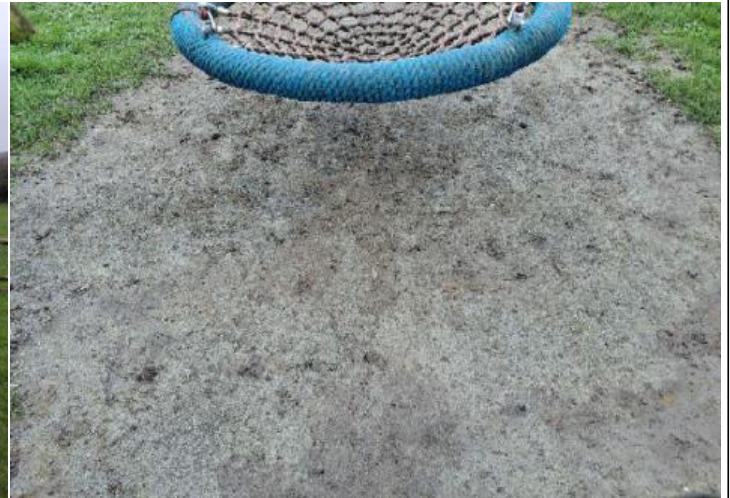
**Item:** Swings - Basket Swing - Type 1  
**Manufacturer:** Not Identified

**Finding:** The grass mat surfacing has numerous stones present within the surface and will not perform as intended in relation to Head Injury Criterion testing

**Action:** Lift mats and ensure stones are removed and ground is suitable prior to re-laying

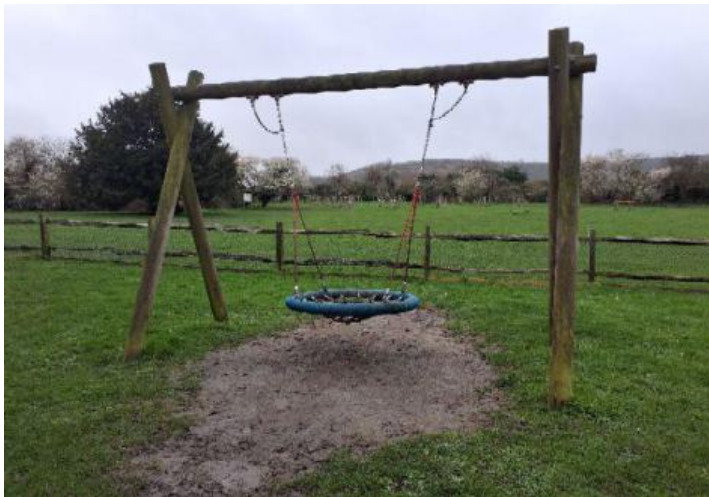
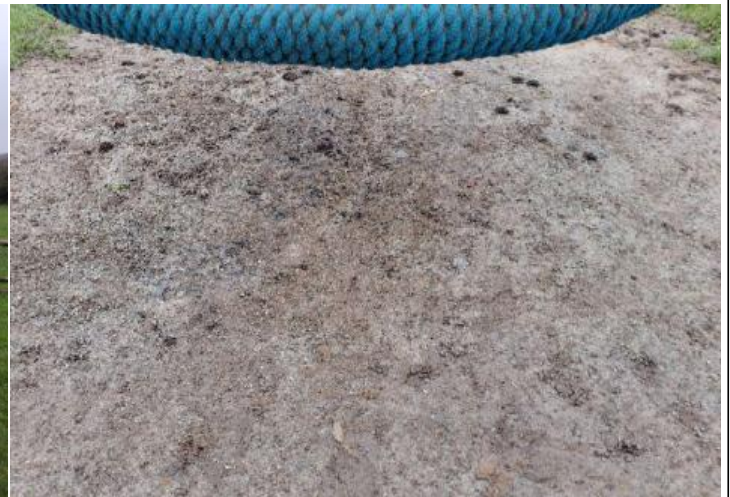
**Item:** Swings - Basket Swing - Type 1  
**Manufacturer:** Not Identified

**Finding:** There are gaps opening between the grass mat tiles

**Action:** Provide additional ties or secure / reinstate surface

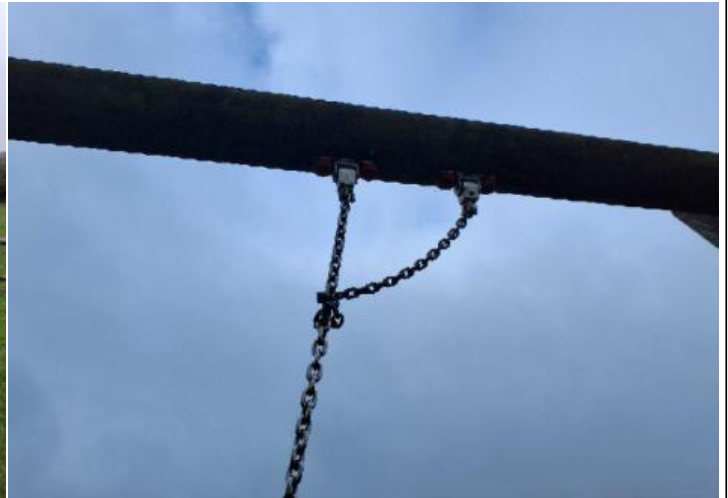
**Item:** Swings - Basket Swing - Type 1  
**Manufacturer:** Not Identified

**Finding:** The seat has been turned over by users, twisting the chains; this will accelerate wear on the fixtures / connections

**Action:** Release the chains and check for damage

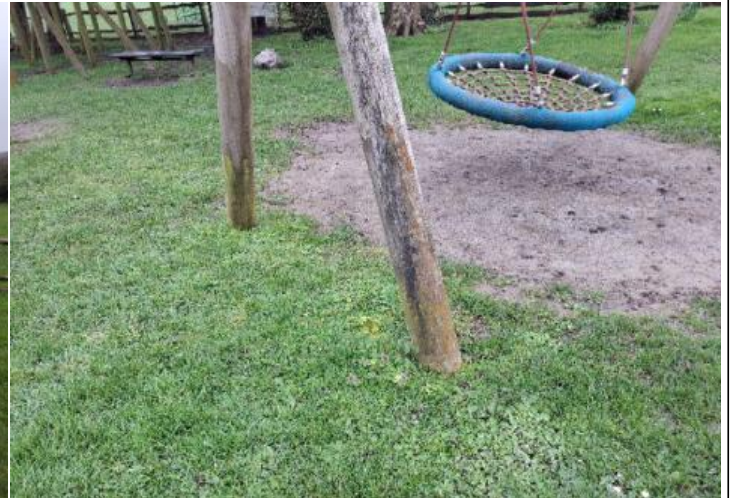
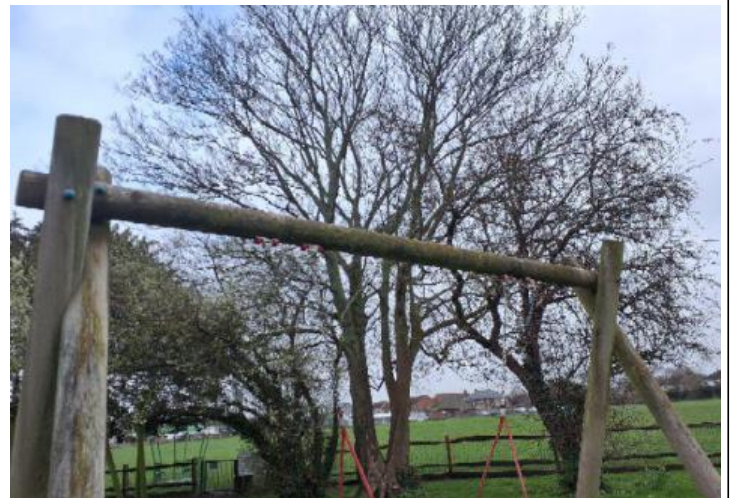
**Item:** Swings - Basket Swing - Type 1  
**Manufacturer:** Not Identified

**Finding:** There is some evidence of rot in the timber

**Action:** Monitor for any further deterioration and replace as required

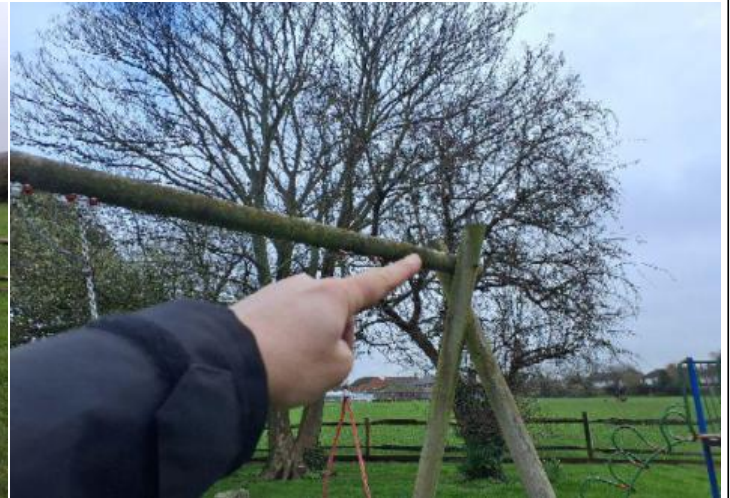
**Item:** Swings - Basket Swing - Type 1  
**Manufacturer:** Not Identified

**Finding:** A number of fixing(s) have worked loose on the crossbar

**Action:** Secure all loose fixings

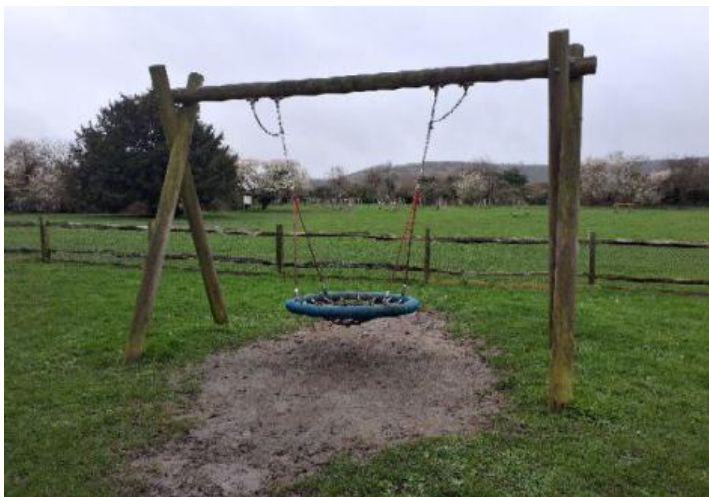
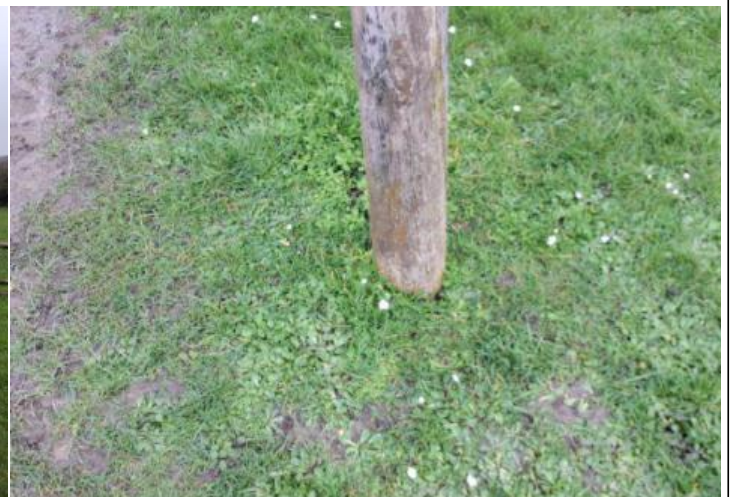
**Item:** Swings - Basket Swing - Type 1  
**Manufacturer:** Not Identified

**Finding:** There is some strimmer / machinery damage apparent on the posts, this can penetrate the preservative applied to the timber and accelerate the rotting process

**Action:** Monitor for any deterioration (rot) and replace as required

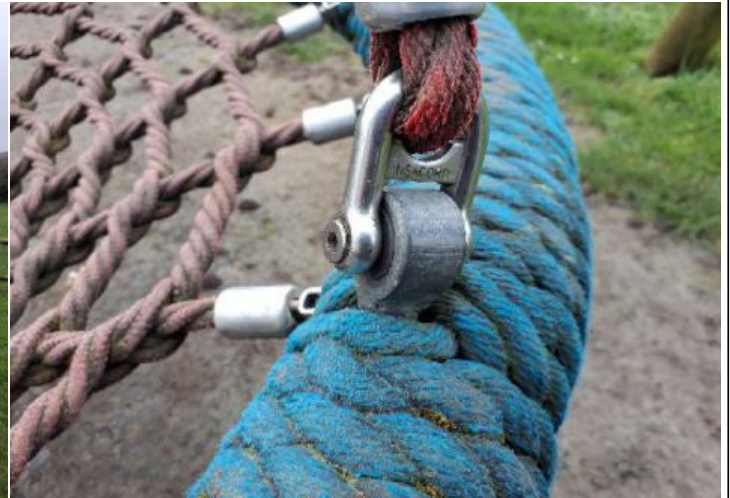
**Item:** Swings - Basket Swing - Type 1  
**Manufacturer:** Not Identified

**Finding:** A number of fixing(s) have worked loose

**Action:** Secure all loose fixings

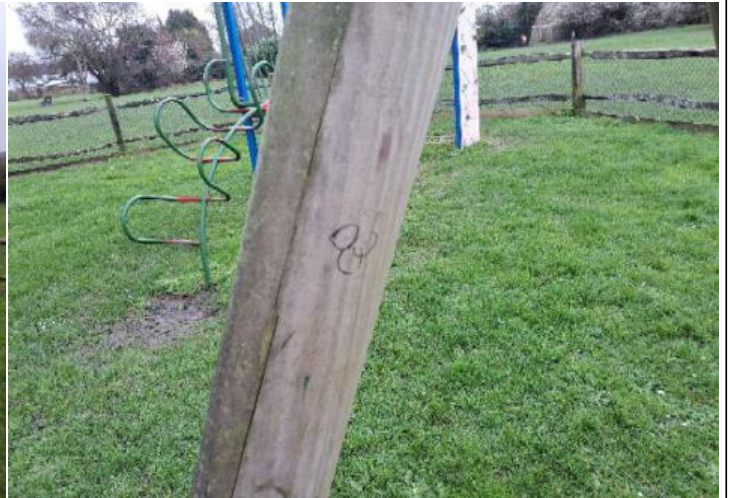
**Item:** Swings - Basket Swing - Type 1  
**Manufacturer:** Not Identified

**Finding:** There is offensive graffiti present

**Action:** Remove as soon as practicable

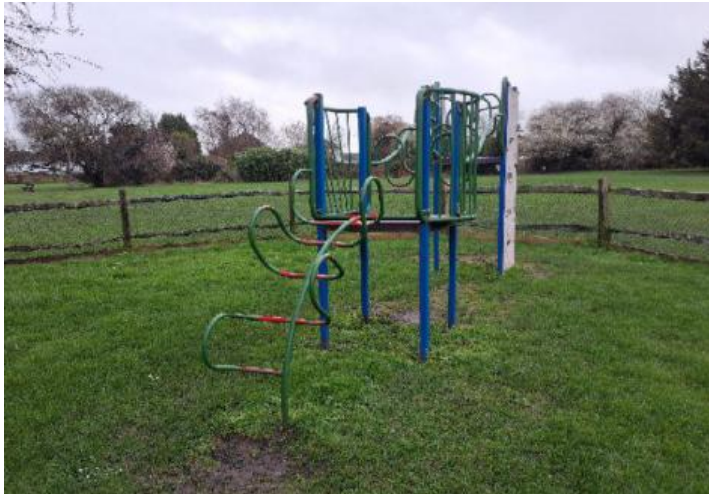
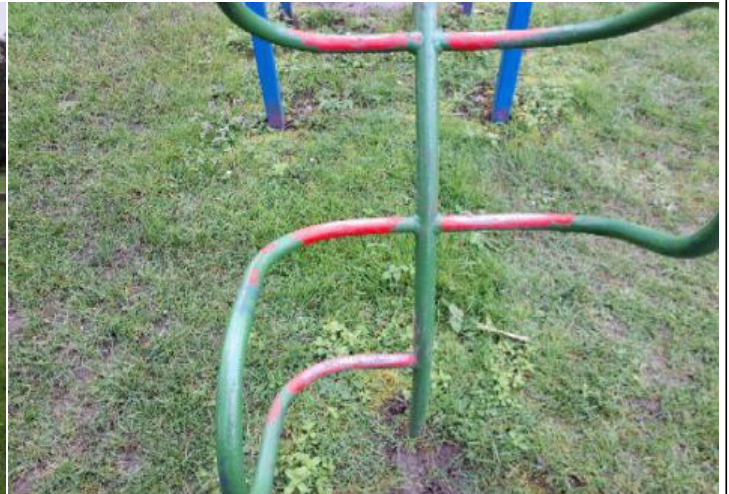
**Item:** Activity Equipment - Multi Play (Junior)  
**Manufacturer:** Wicksteed Playgrounds

**Finding:** The paintwork on this item has been damaged or worn exposing the metal underneath which is rusting / corroding

**Action:** Treat affected areas and repaint

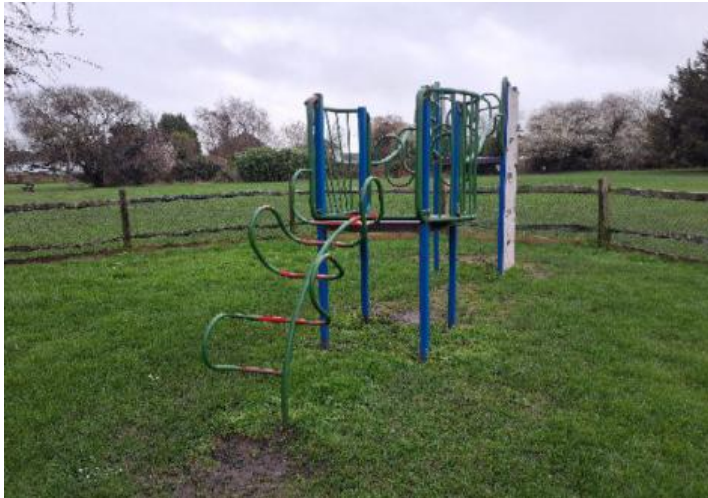
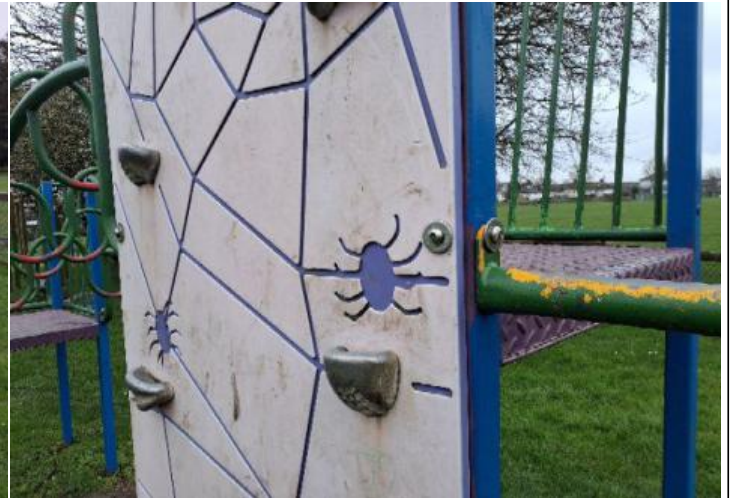
**Item:** Activity Equipment - Multi Play (Junior)  
**Manufacturer:** Wicksteed Playgrounds

**Finding:** A number of fixing(s) have worked loose

**Action:** Secure all loose fixings

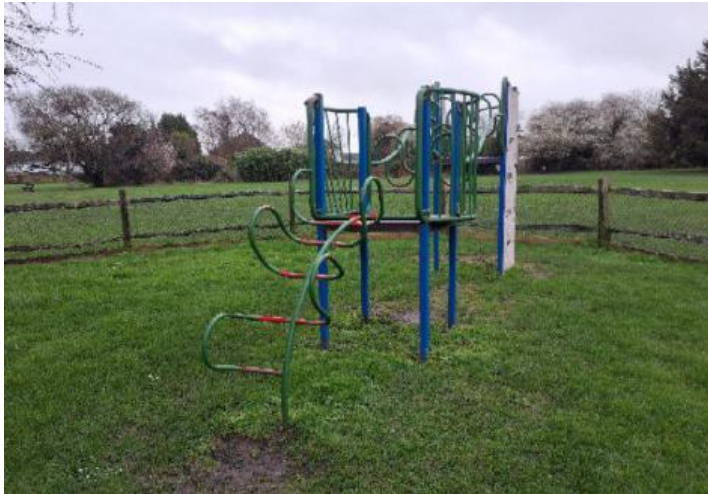
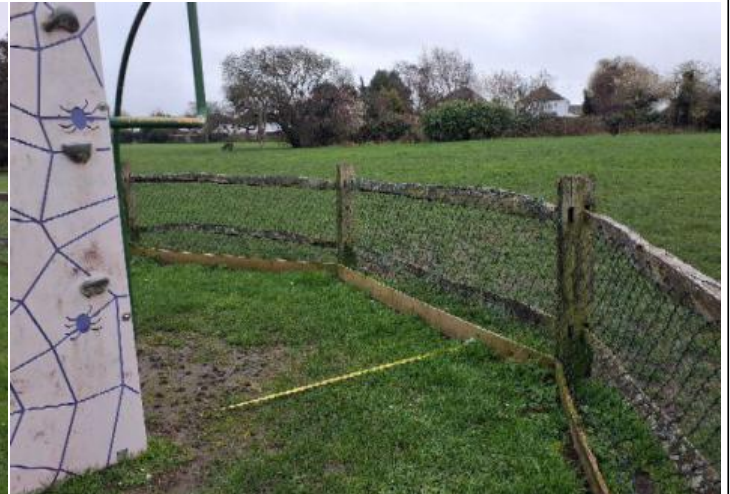
**Item:** Activity Equipment - Multi Play (Junior)  
**Manufacturer:** Wicksteed Playgrounds

**Finding:** The fence forms a hard object within the falling space of the equipment and there is also insufficient surfacing provided in contravention of BS EN 1176 Part 1

**Action:** Monitor - No action given the risk assessment

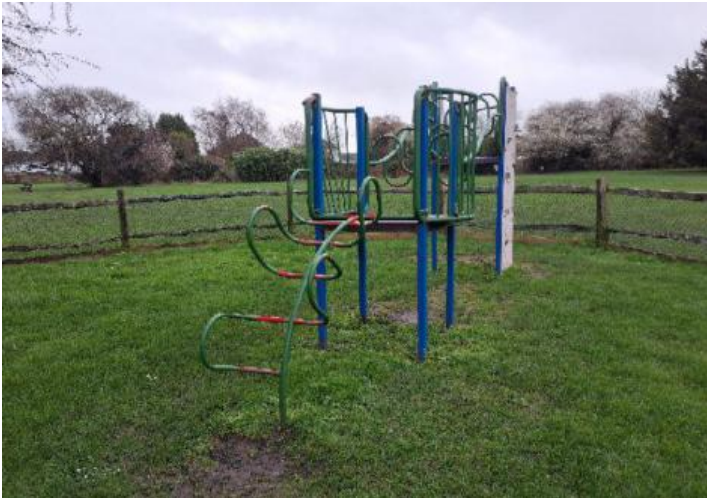
**Item:** Activity Equipment - Multi Play (Junior)  
**Manufacturer:** Wicksteed Playgrounds

**Finding:** The item has been damaged

**Action:** Monitor for any further deterioration and replace as required

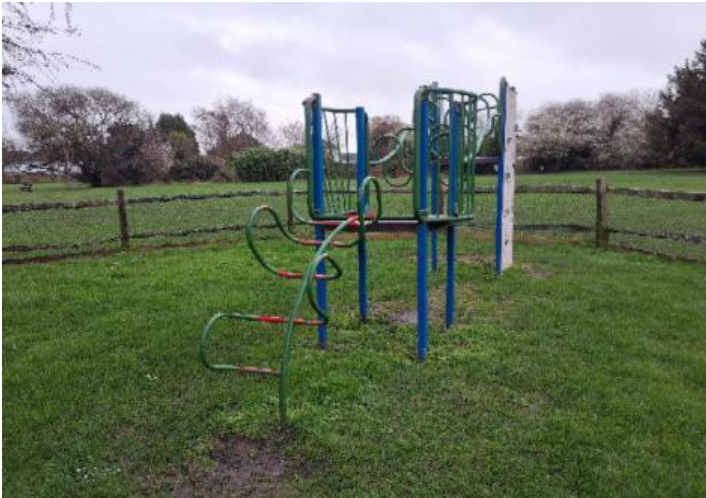
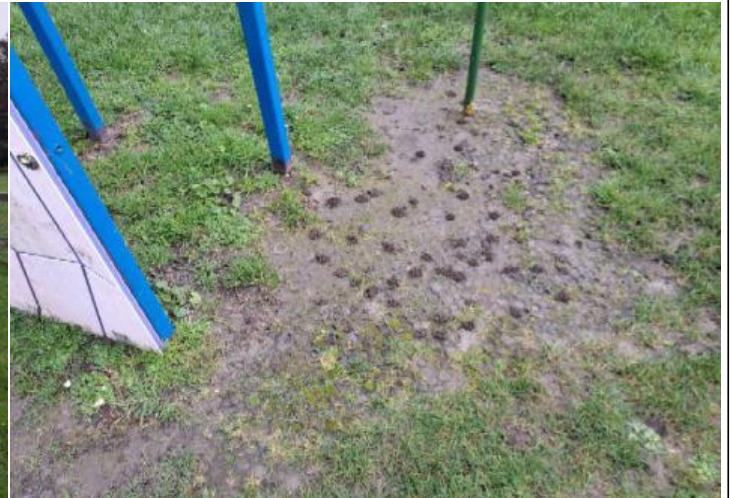
**Item:** Activity Equipment - Multi Play (Junior)  
**Manufacturer:** Wicksteed Playgrounds

**Finding:** Hard fixing pins have been installed in the grass mat tiles within the impact area of the equipment. Grass mat pins should only be installed at the perimeter of the tiles, and outside of any equipment impact areas. NOTE - where grass mat wear pads have been provided and the impact area includes surrounding surfaces, the grass mats should be tucked into the turf, and not pinned

**Action:** Remove pins from impact areas

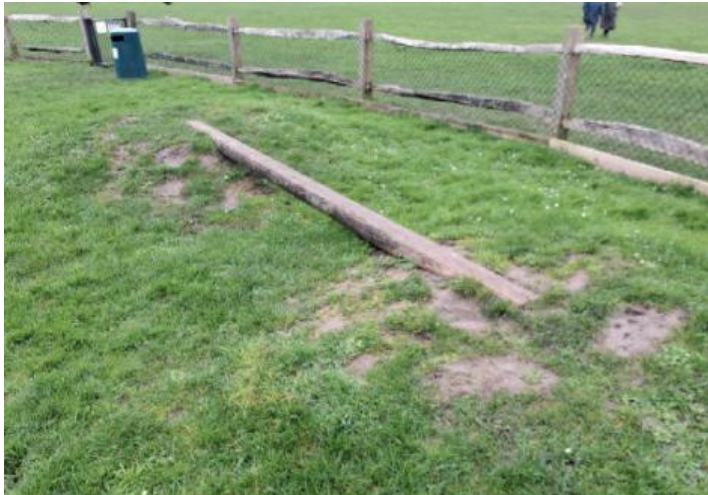
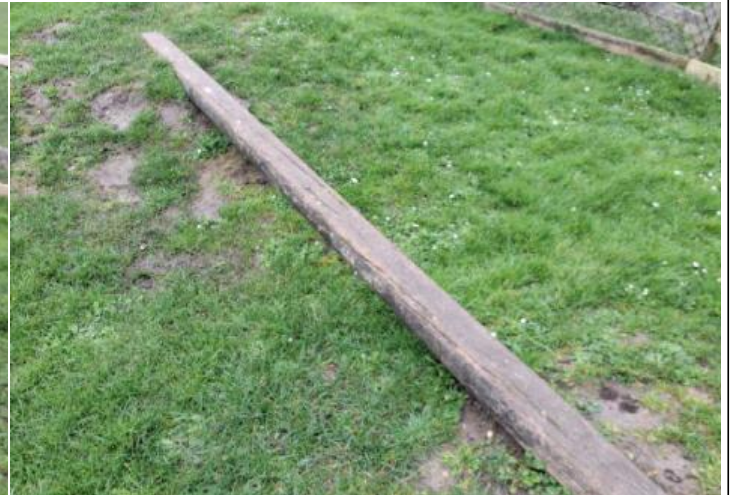
**Item:** Activity Equipment - Balance Beam  
**Manufacturer:** Not Identified

**Finding:** There is some evidence of rot in the timber

**Action:** Monitor for any further deterioration and replace as required

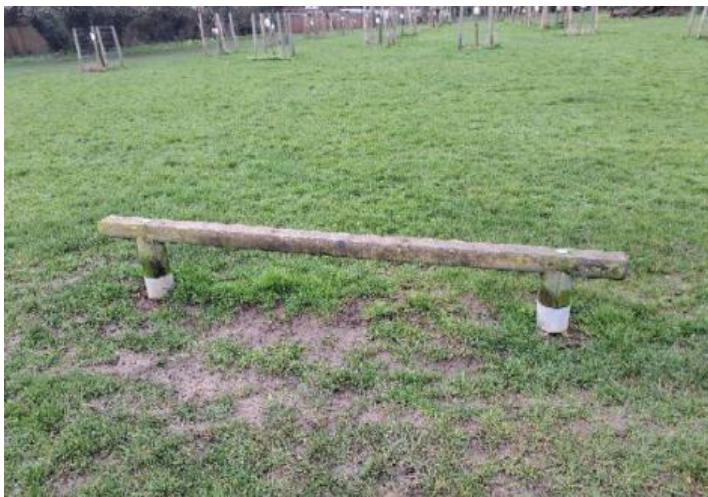
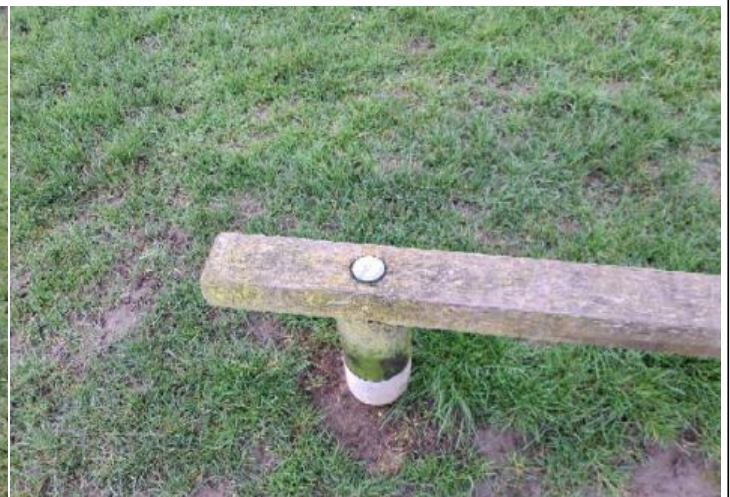
**Item:** Activity Equipment - Balance Beam  
**Manufacturer:** Wicksteed Playgrounds

**Finding:** There is algae or moss on the surface of the equipment

**Action:** Clean and treat appropriately

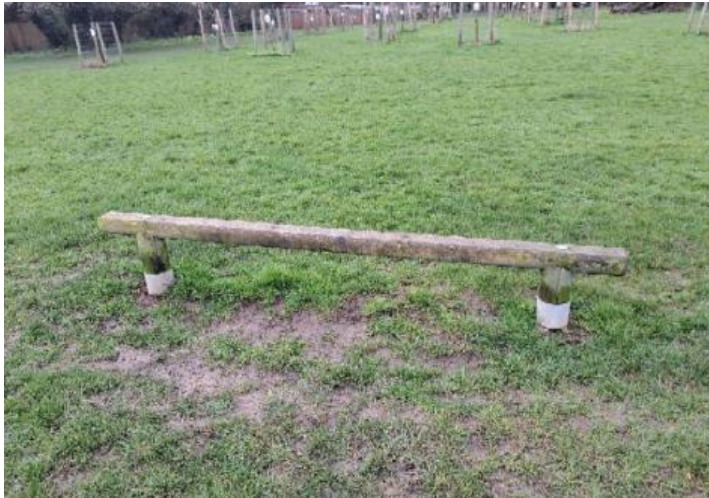
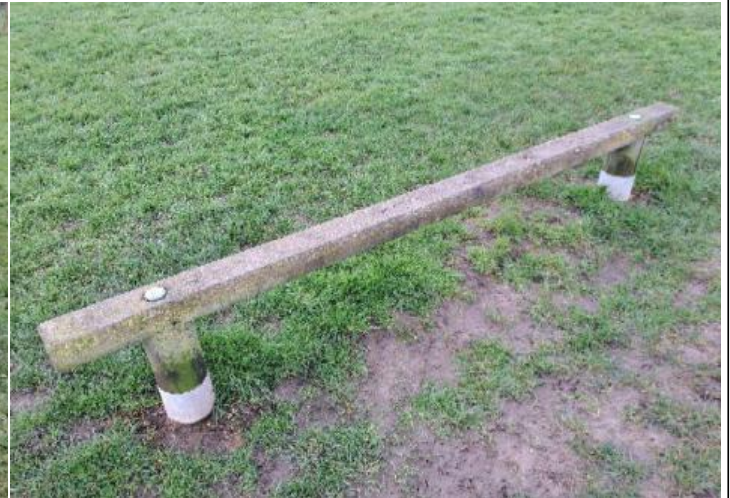
**Item:** Activity Equipment - Balance Beam  
**Manufacturer:** Wicksteed Playgrounds

**Finding:** There is some evidence of rot in the timber

**Action:** Monitor for any further deterioration and replace as required

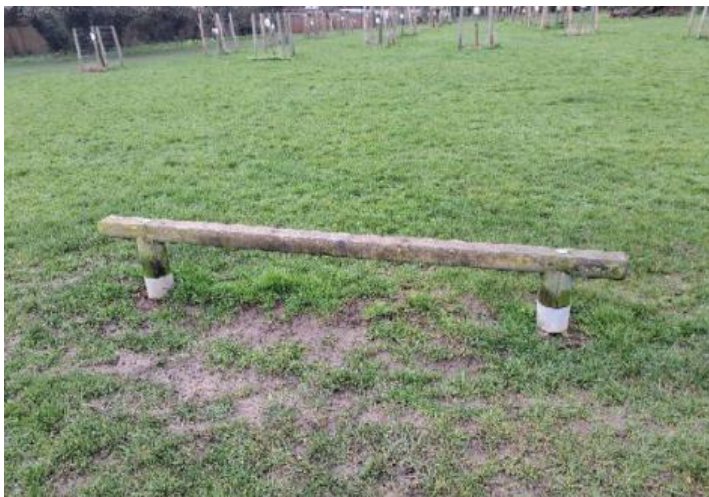
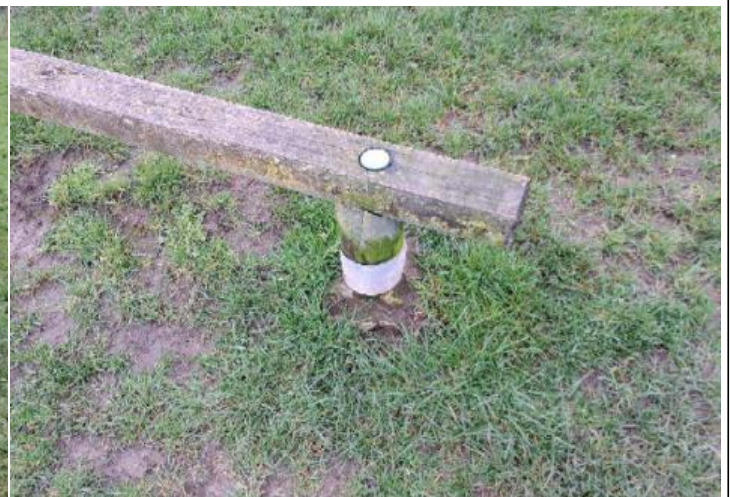
**Item:** Activity Equipment - Balance Beam  
**Manufacturer:** Wicksteed Playgrounds

**Finding:** There are post protectors around the timber posts that are preventing the inspector from thoroughly testing for signs of decay and we are unable to verify the condition of the posts in these locations. NOTE - timber rot / decay is possible even with the post protectors in place

**Action:** Refer to manufacturer inspection / maintenance recommendations

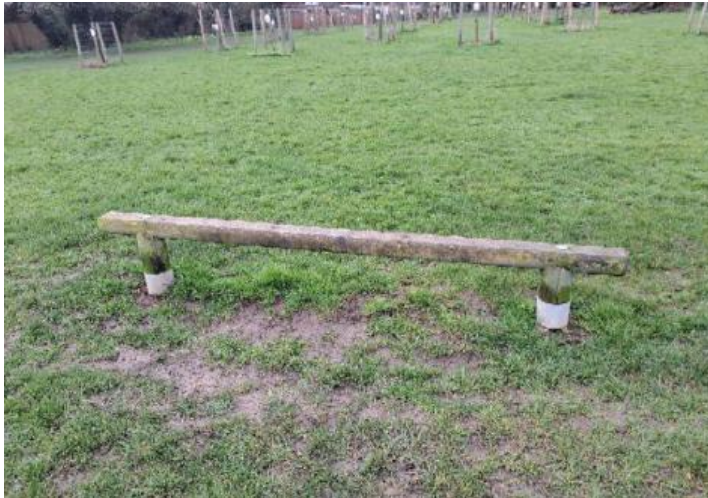
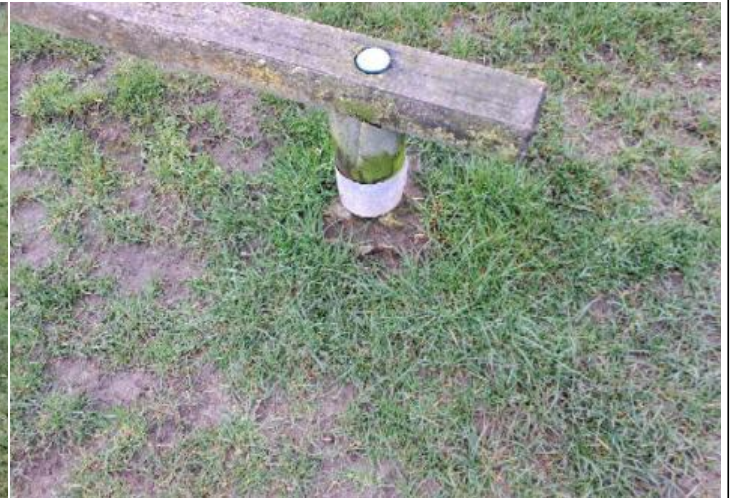
**Item:** Activity Equipment - Balance Beam  
**Manufacturer:** Wicksteed Playgrounds

**Finding:** The surface has eroded and the foundations are exposed

**Action:** Reinstate surrounding surfaces to cover the foundations

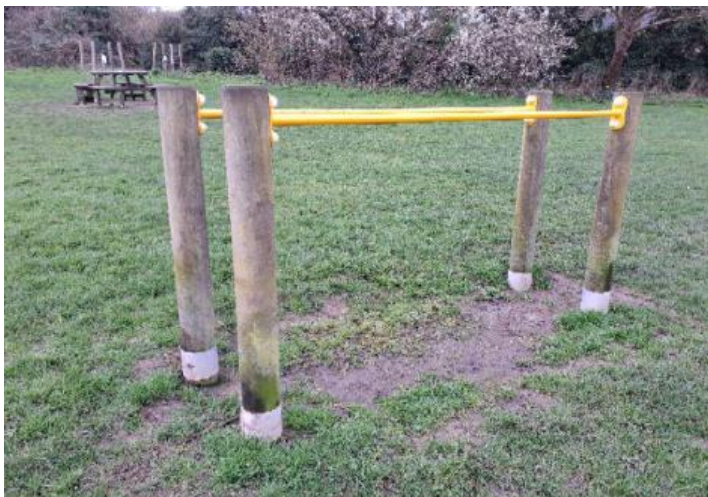
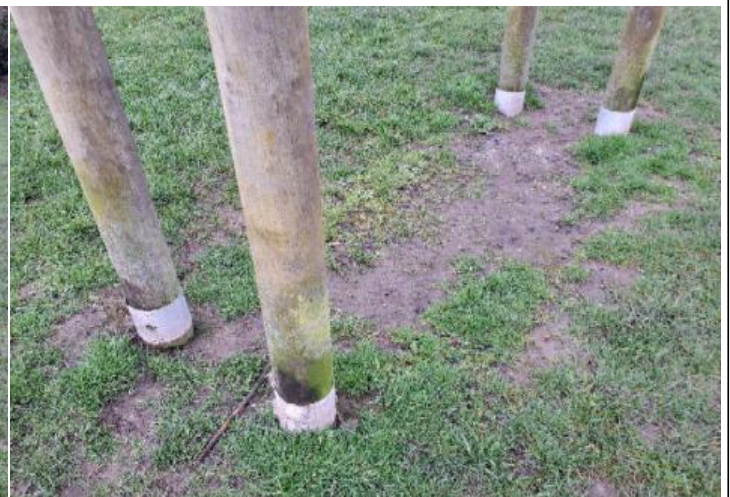
**Item:** Activity Equipment - Parallel Bars  
**Manufacturer:** Fawns Recreational Services Ltd

**Finding:** There are post protectors around the timber posts that are preventing the inspector from thoroughly testing for signs of decay and we are unable to verify the condition of the posts in these locations. NOTE - timber rot / decay is possible even with the post protectors in place

**Action:** Refer to manufacturer inspection / maintenance recommendations

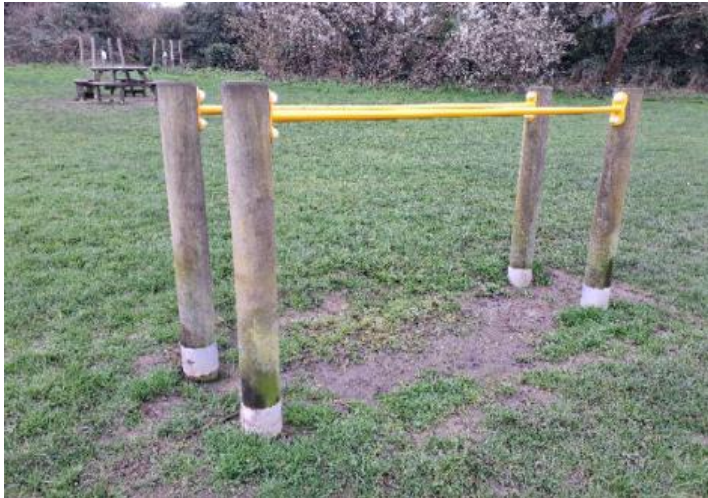
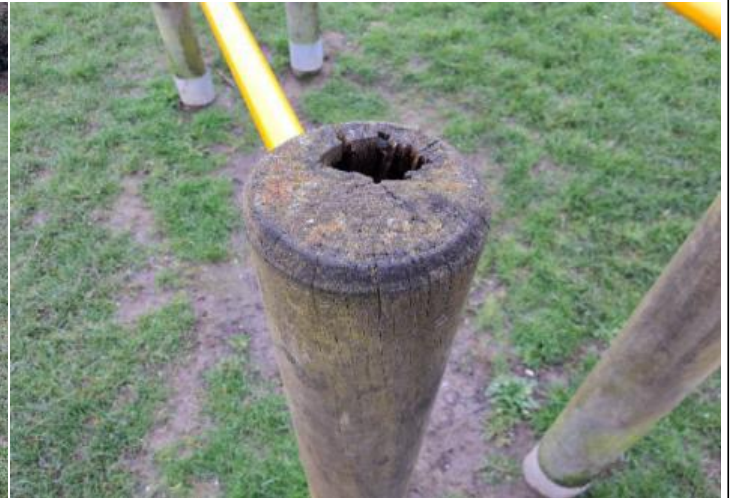
**Item:** Activity Equipment - Parallel Bars  
**Manufacturer:** Fawns Recreational Services Ltd

**Finding:** There are areas or parts of the timber on the structure that have rotted

**Action:** Replace all affected timbers

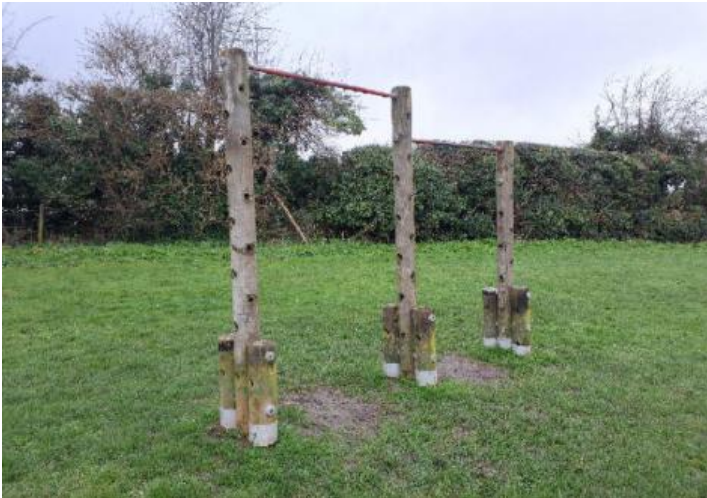
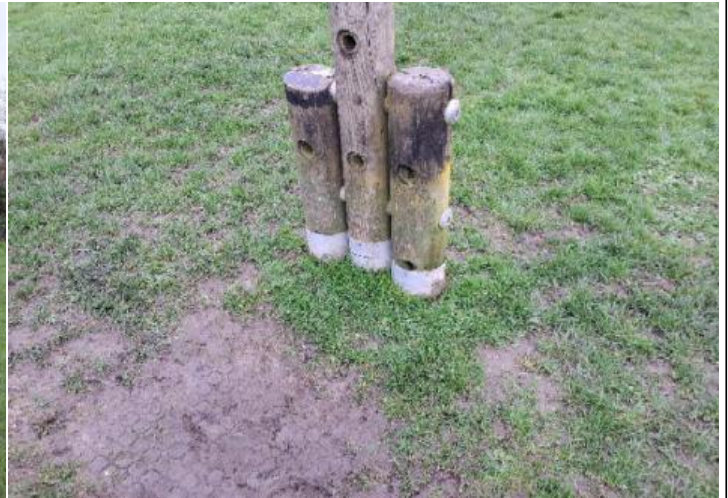
**Item:** Activity Equipment - Somersault Bars  
**Manufacturer:** Wicksteed Playgrounds

**Finding:** There are post protectors around the timber posts that are preventing the inspector from thoroughly testing for signs of decay and we are unable to verify the condition of the posts in these locations. NOTE - timber rot / decay is possible even with the post protectors in place

**Action:** Refer to manufacturer inspection / maintenance recommendations
