## COMMUNITY COMMITTEE MEETING HELD ON TUESDAY 3<sup>rd</sup> MARCH 2026 AT 7.30 PM AT THE STEYPING CENTRE

# DRAFT MINUTES

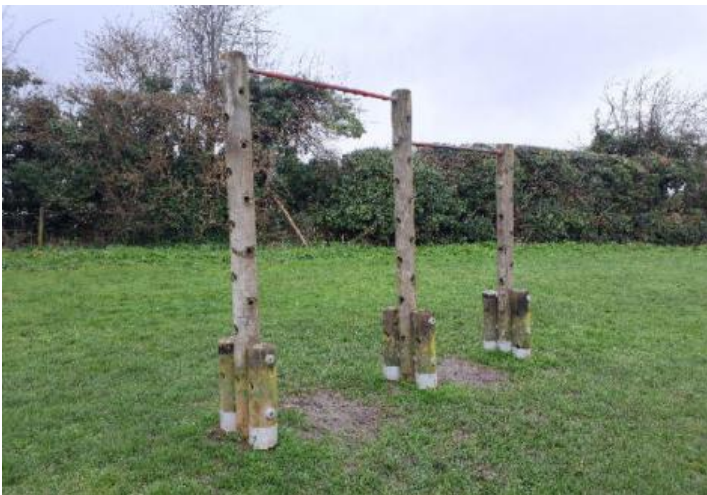
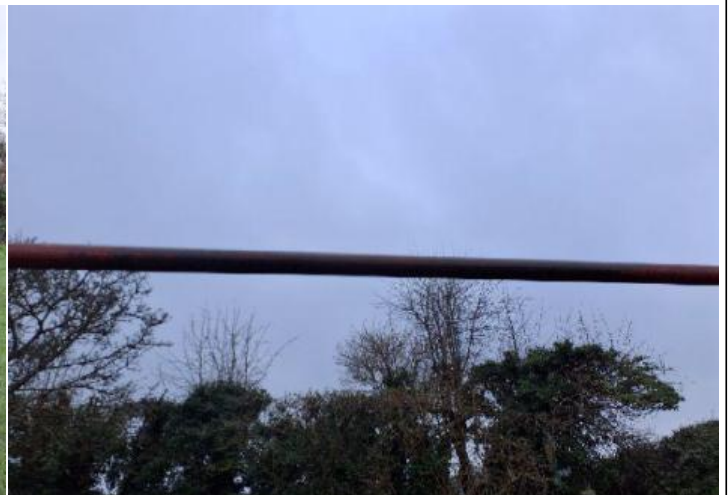
**Item:** Activity Equipment - Somersault Bars  
**Manufacturer:** Wicksteed Playgrounds

**Finding:** The paintwork on this item has been damaged or worn exposing the metal underneath which is rusting / corroding

**Action:** Treat affected areas and repaint

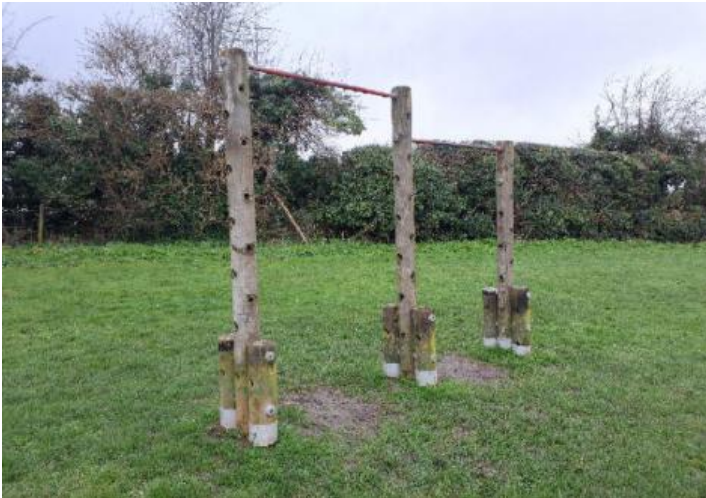
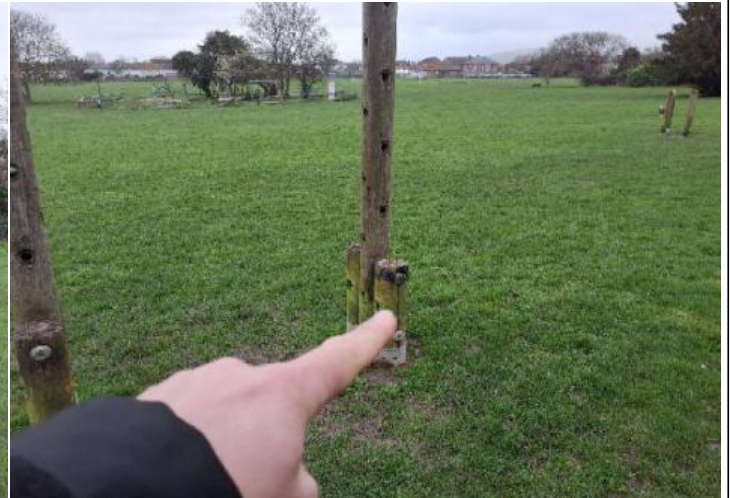
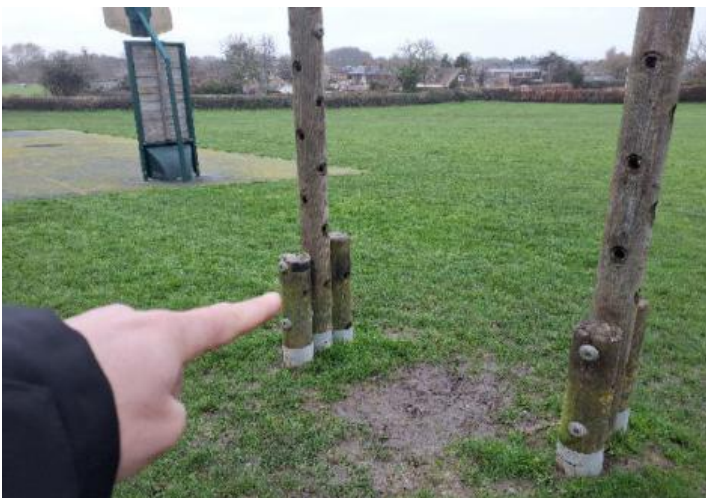
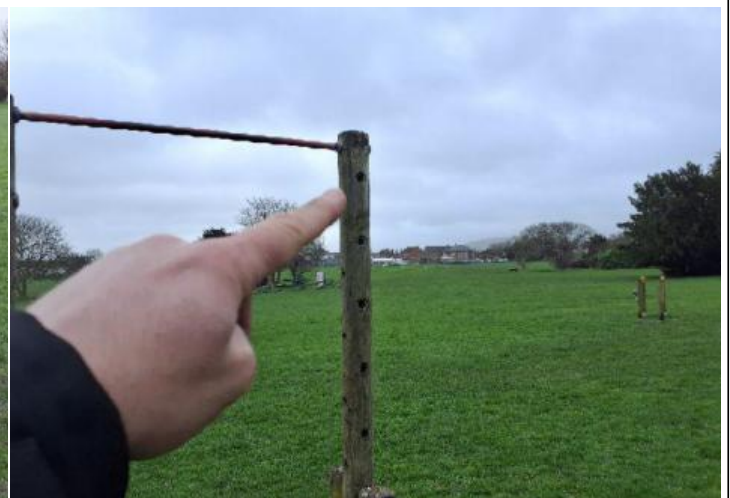
**Item:** Activity Equipment - Somersault Bars  
**Manufacturer:** Wicksteed Playgrounds

**Finding:** There are areas or parts of the timber on the structure that have rotted and the remaining timber is showing signs of rot

**Action:** Replace all rotted timbers

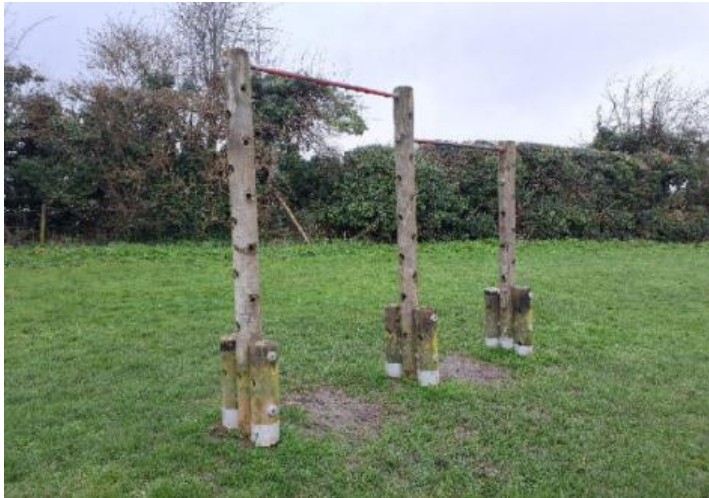
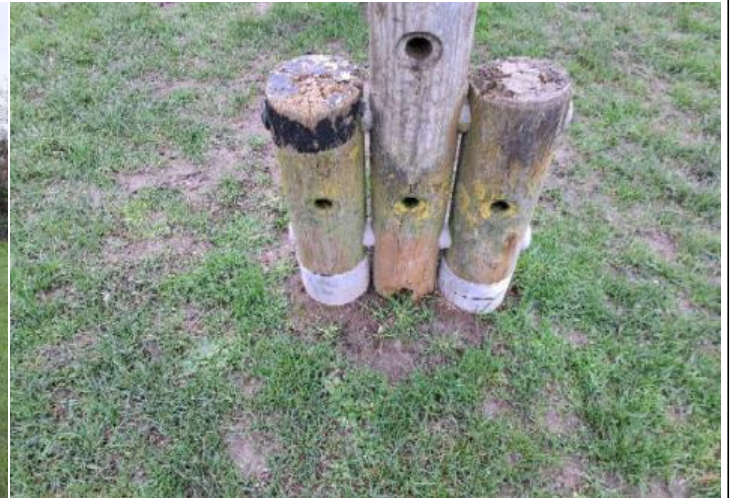
**Item:** Activity Equipment - Somersault Bars  
**Manufacturer:** Wicksteed Playgrounds

**Finding:** There is some strimmer / machinery damage apparent on the posts, this can penetrate the preservative applied to the timber and accelerate the rotting process

**Action:** Monitor for any deterioration (rot) and replace as required

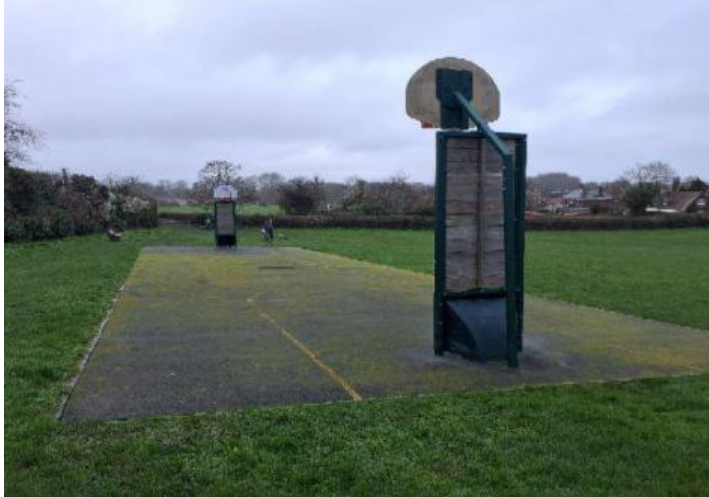
**Item:** Multi Use Games Area - Multi Use Games Area (MUGA)  
**Manufacturer:** Agorespace

**Finding:** A clearly visible facility sign should be provided in a prominent position with the wording as detailed BS EN 15312- the equipment is not intended for children less than 3 years old- the warning - Do not climb on the framework or nets- the warning - Do not hang on the ring (if provided)- the warning - Do not wear rings or other jewellery- name and telephone number of the administrator- number to call in case of accident

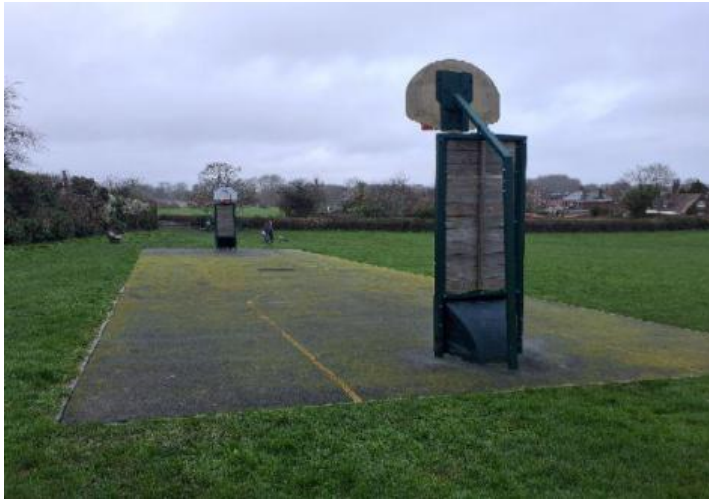
**Item:** Multi Use Games Area - Multi Use Games Area (MUGA)  
**Manufacturer:** Agorespace

**Finding:** The item is loose in its foundations

**Action:** Reinstall item to secure

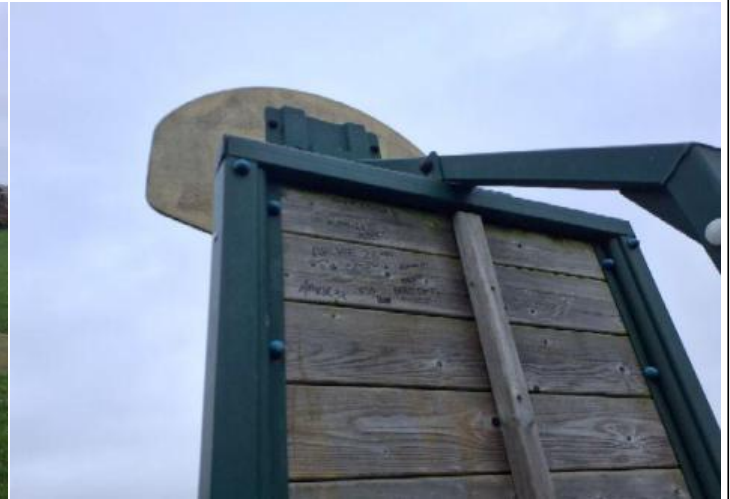
**Item:** Multi Use Games Area - Multi Use Games Area (MUGA)  
**Manufacturer:** Agorespace  
**Risk Level:** N - Risk Assessment not Undertaken  
**Surface:** Wet Pour

**Finding:** There is some graffiti present

**Action:** Remove the graffiti

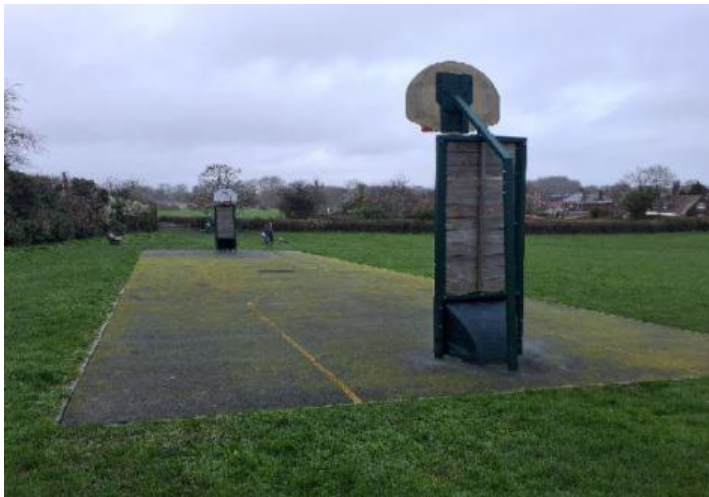
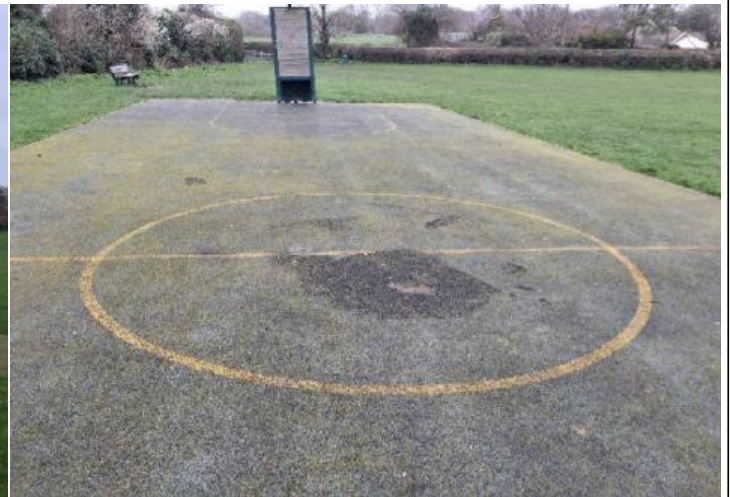
**Item:** Multi Use Games Area - Multi Use Games Area (MUGA)  
**Manufacturer:** Agorespace  
**Risk Level:** L - Low Risk  
**Surface:** Wet Pour

**Finding:** There is some evidence of fire damage to the surfacing

**Action:** Repair all damaged areas

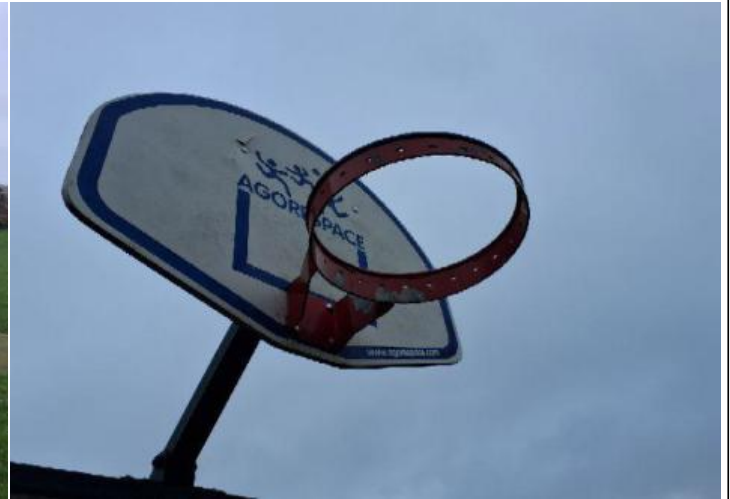
**Item:** Multi Use Games Area - Multi Use Games Area (MUGA)  
**Manufacturer:** Agorespace  
**Risk Level:** L - Low Risk  
**Surface:** Wet Pour

**Finding:** The paint is flaking off the metalwork

**Action:** Rub down and re-paint

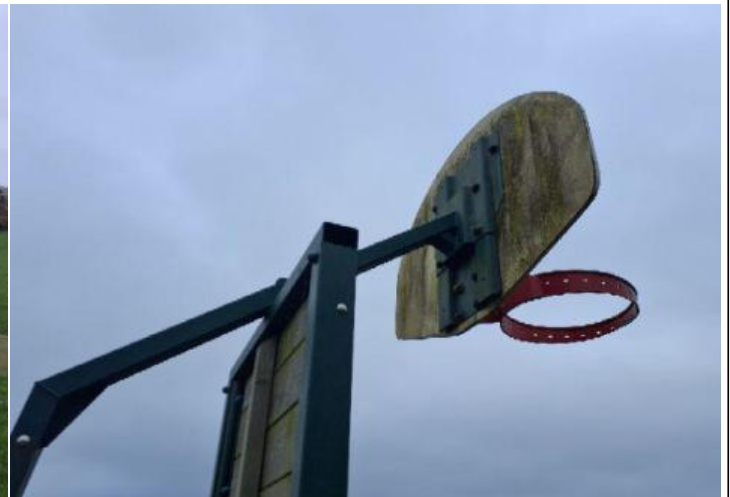
**Item:** Multi Use Games Area - Multi Use Games Area (MUGA)  
**Manufacturer:** Agorespace  
**Risk Level:** L - Low Risk  
**Surface:** Wet Pour

**Finding:** There is / are post or end caps missing / damaged on the item

**Action:** Replace missing / damaged post or end caps

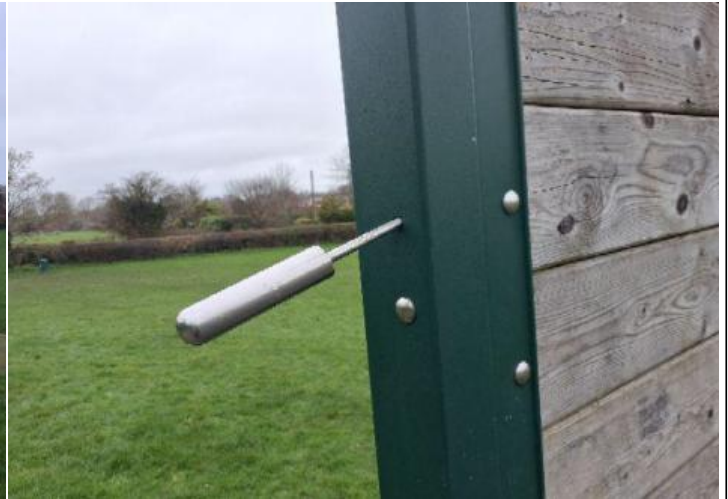
**Item:** Multi Use Games Area - Multi Use Games Area (MUGA)  
**Manufacturer:** Agorespace

**Finding:** There is/are finger entrapments in the frame due to missing inserts and the item fails to meet the requirements of BS EN 15312 Clause 4.4.2.2 Entrapment of fingers  
**Action:** Replace all missing inserts

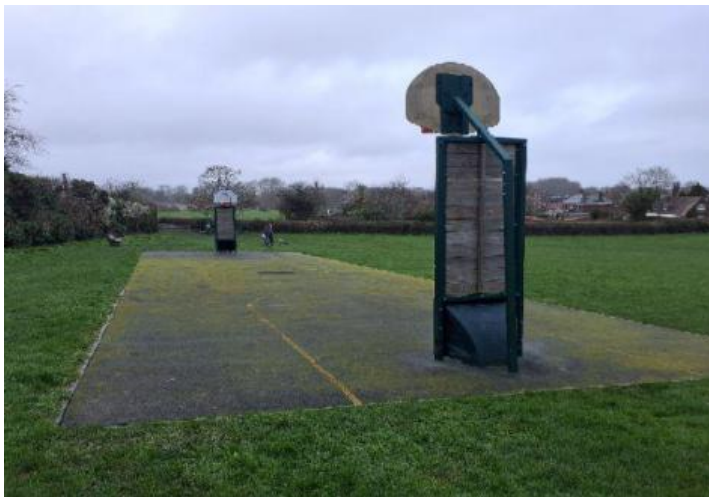
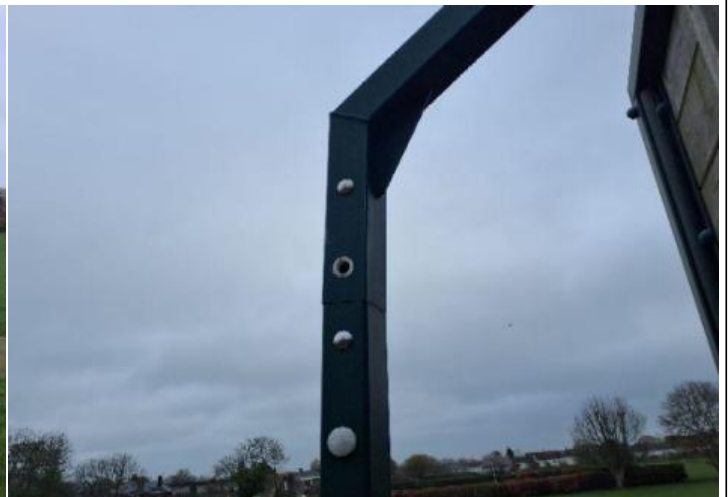
**Item:** Multi Use Games Area - Multi Use Games Area (MUGA)  
**Manufacturer:** Agorespace

**Finding:** There is or are fixings missing on the item  
**Action:** Replace all missing fixings
