**Rublees Allotment: Further Investigation of Existing Water Supply Constraints**

## **Rublees Site Visits (19th & 21st June 2020)**

## Rublees Allotments: Preliminary Investigation of Existing Water Supply Issues

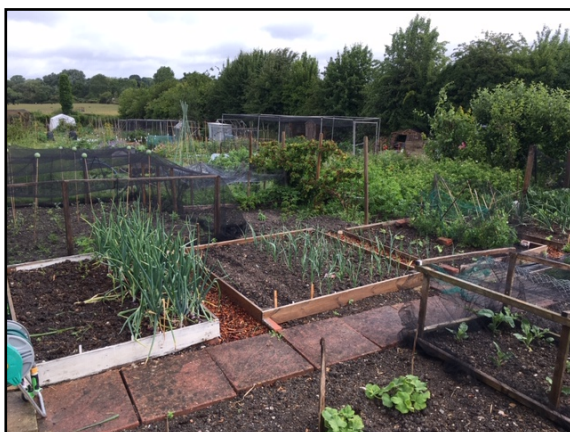
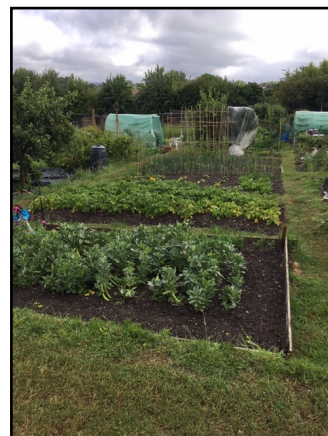
(a) - The Rublees allotment is currently in a first class condition and that is a credit to all allotment holders and the Allotment Association management. On request the SPC have supplied a number of skips to transport cleared debris away from the site and that has assisted in the achievement of the current tidy state of affairs. The latest report states that only two vacant plots remain available on the Rublees whilst no vacant plots remain available at Canada Gardens. The allotments are therefore providing a much appreciated and well used facility for the residents of Steyning.

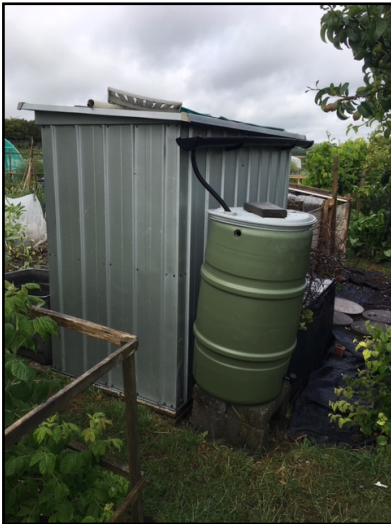
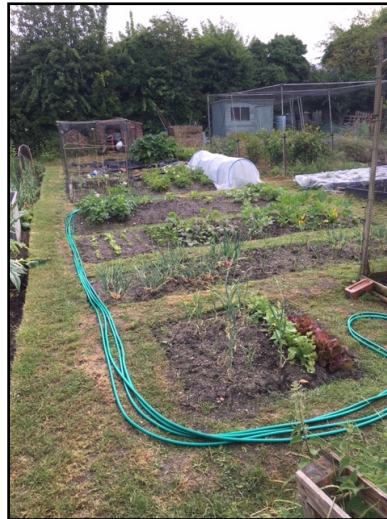
(c) Increasing the level of rainwater harvesting is unlikely to be viable on the Rublees because the existing and future roof collection areas are limited in extent. Rainwater harvesting on long commercial size polytunnels can be economic but such structures would not fit well into the SDNP environment. Where it is currently used water harvesting can be beneficial.

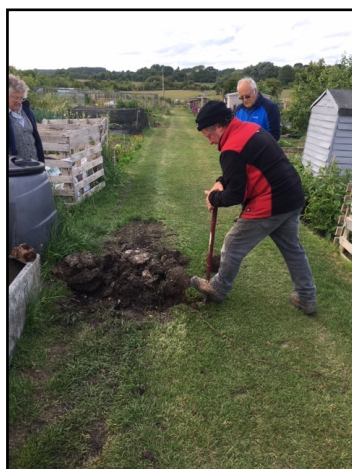
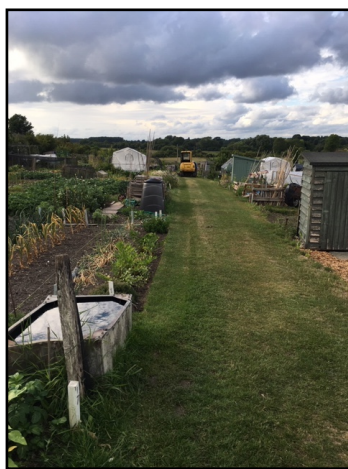
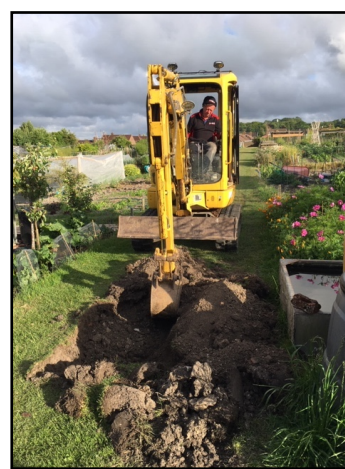
Initially the digging was undertaken by hand but it was found that the soil was very compacted and the depth of the mainline pipe was deeper than first thought. The excavator was used to carefully remove the soil layers one by one without damaging the water pipe. During excavation the source of the apparent water leak was actually discovered to be a small hole in the tank adjacent to the standpipe rather than from the buried water pipe.

The 'T' junction was finally revealed and it could be seen that 25 mm pipe was used throughout the mainline down to the bottom end of the allotment. The pipe had been professionally installed about 20 years ago to a good depth by excavator to avoid frost damage and the pipe itself appeared to be in very good condition. If it were to be decided to install additional capacity in the future then the existing pipe would have to be left in place and a new pipe would be run parallel on the other side of the main grass path.

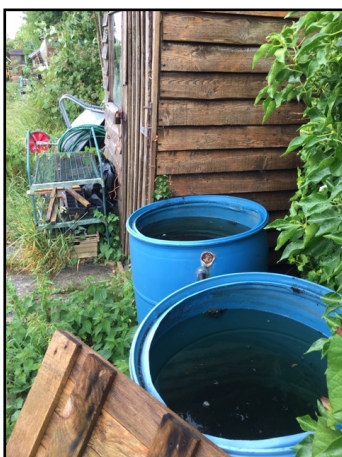
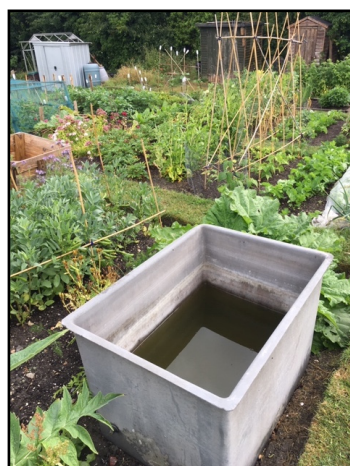
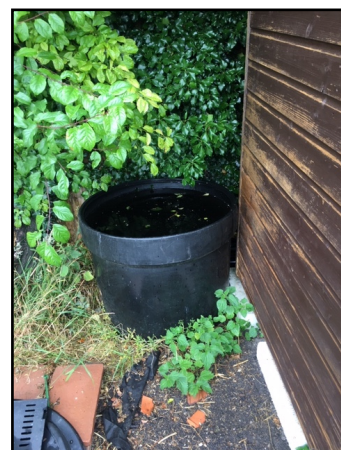
A visit to the allotment on Sunday, 21st June 2020, confirmed that a number of allotment holders have their own water tanks on their plots.
