## Annual Inspection

Steyping Parish Council

Memorial Playing Field Play Area

Charlton Street, Steyping, Sussex, BN44 3LE

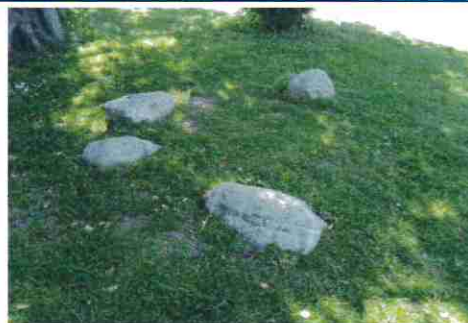
This item is satisfactory - no work required -

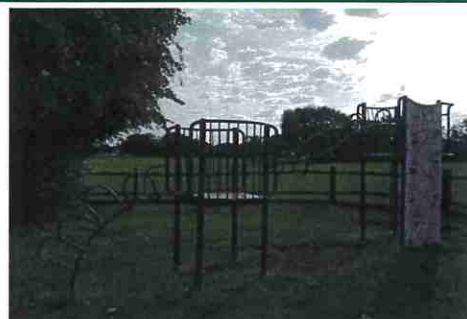
Top right climbing wall fixing has worked loose - Secure all loose fixings replace rubber washers

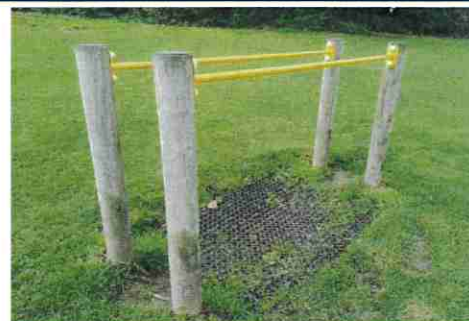
This item is satisfactory - no work required -

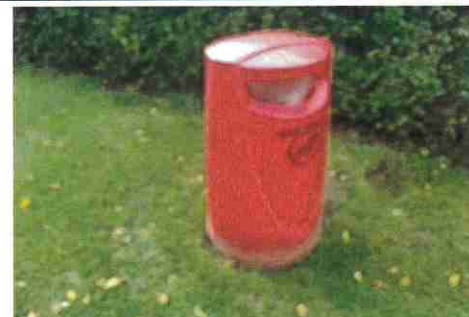
This item is satisfactory - no work required -

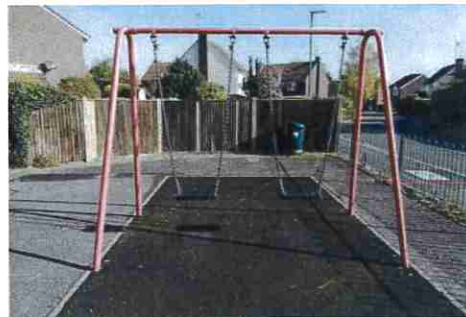
This item is satisfactory - no work required -

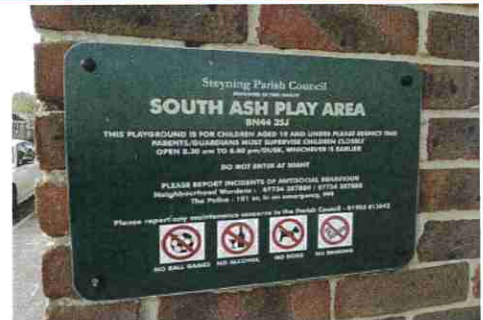
This item is satisfactory - no work required -

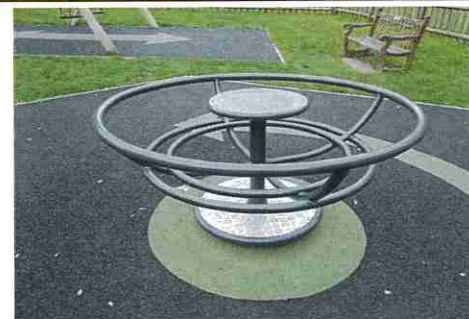
There are significant gaps (over 30mm) between the surface and the edging or between the joints in the surface; these are large enough for a small foot to enter - Repair surfacing edge 27m black

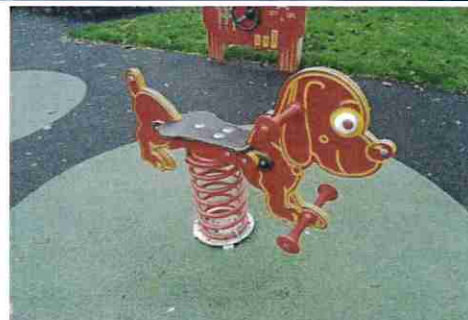
This item is satisfactory - no work required -

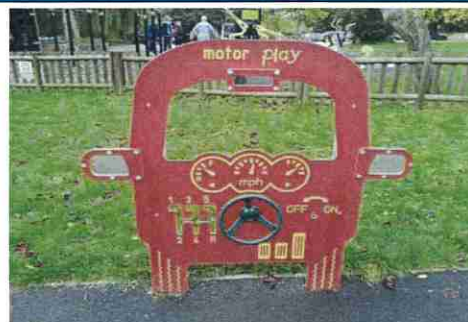
This item is satisfactory - no work required -

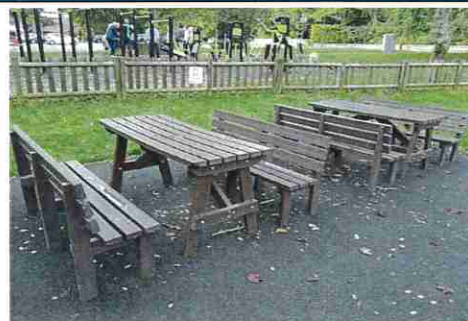
There is some evidence of fire damage to the item - Monitor for any further deterioration and repair as required

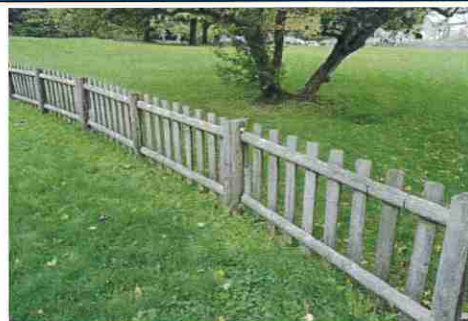
This item is satisfactory - no work required -

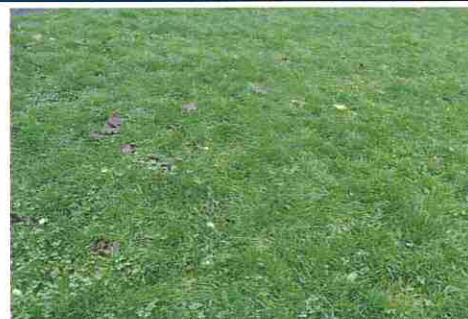
Ground eroded - Reinstate surface

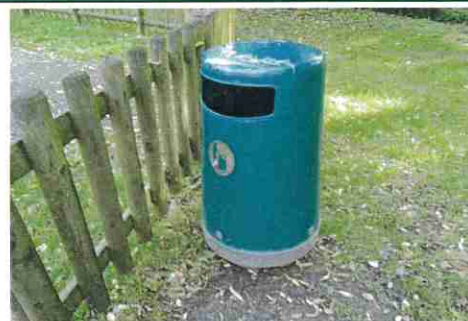
The bin is not securely fixed to the surface and there is some possibility of the item tipping or rolling over - Secure the bin to the ground

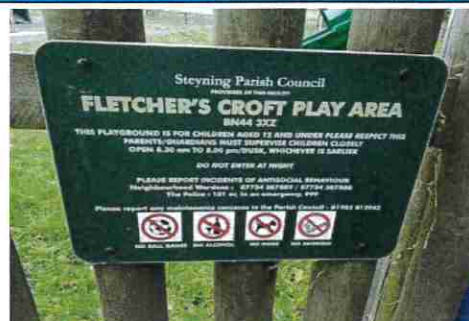
This item is satisfactory - no work required -

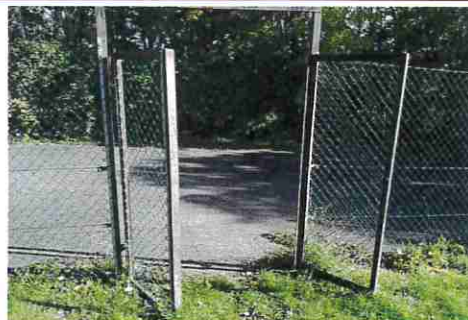
The gate is snagging on the surrounding surface - Carry out remedial works to ensure the gate closes correctly

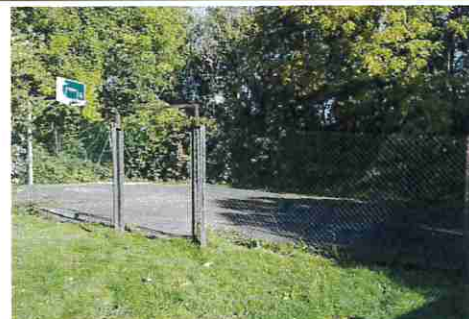
It is recommended that signage, with information including the site address, contact information for maintenance issues and emergency contact details are provided for the facility - Provide in accordance with the recommendations

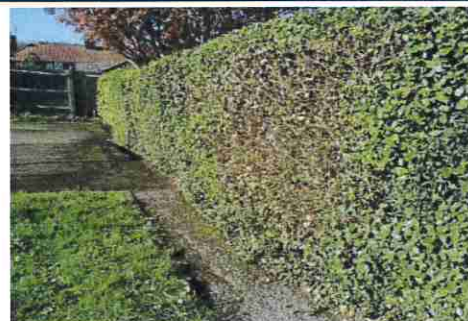
Item: Hedge  
Manufacturer: Unknown  
Surface Type: Soil  
Item Quantity: 1  
Equipment Compliance: N/A  
Surface Area Compliance: N/A

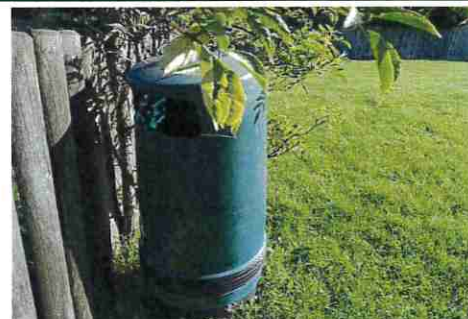
Item: Litter Bin  
Manufacturer: Unknown  
Surface Type: Grass  
Item Quantity: 1  
Equipment Compliance: N/A  
Surface Area Compliance: N/A

There is some damage to the lid on the item - Monitor for any further deterioration and repair as required

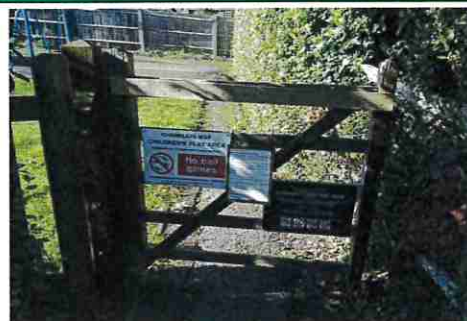
**Item:** Gate - Pedestrian  
**Manufacturer:** Unknown  
**Surface Type:** Tarmac  
**Item Quantity:** 1  
**Equipment Compliance:** N/A  
**Surface Area Compliance:** N/A

There are openings that are less than 12mm that could trap or crush fingers - Where possible a 12mm gap should be maintained on both sides or between the gate leafs

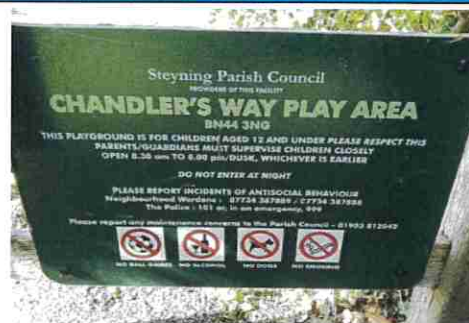
Item: Playground Sign  
Manufacturer: Unknown  
Surface Type: N/A  
Item Quantity: 1  
Equipment Compliance: N/A  
Surface Area Compliance: N/A

This item is satisfactory - no work required -

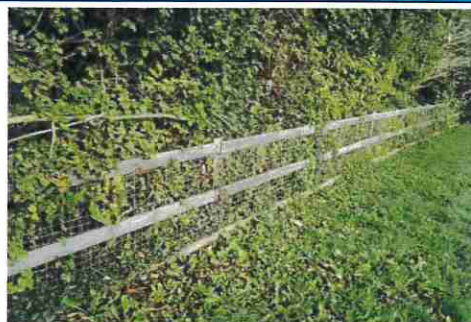
Item: Fence - Timber & Mesh Infill  
Manufacturer: Unknown  
Surface Type: Grass  
Item Quantity: 1  
Equipment Compliance: N/A  
Surface Area Compliance: N/A

This item is satisfactory - no work required -

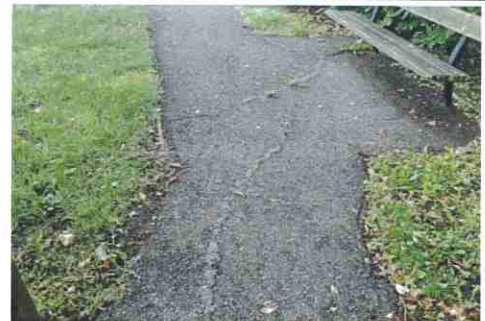
**Item:** Tarmac  
**Manufacturer:** Unknown  
**Surface Type:** Tarmac  
**Item Quantity:** 1  
**Equipment Compliance:** N/A  
**Surface Area Compliance:** N/A

This item is satisfactory - no work required -

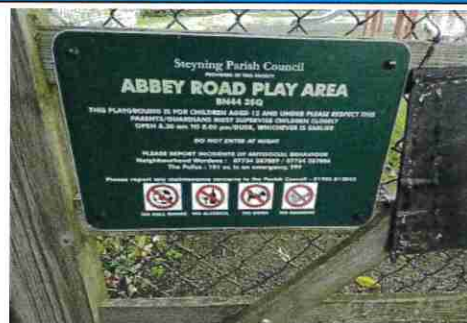
Item: Playground Sign  
Manufacturer: Unknown  
Surface Type: N/A  
Item Quantity: 1  
Equipment Compliance: N/A  
Surface Area Compliance: N/A

This item is satisfactory - no work required -
